Clean Water Act Section 404: Site Visit/Case Development

| Site Name | Chelkas Chassidim Cemetery | Start Date | October 5, 2021 |

Map with GPS Points and Photolog

CWA 404 Inspection
Chelkas Chassidim Cemetery
Brick Church Road
New Hempstead, Rockland County, NY

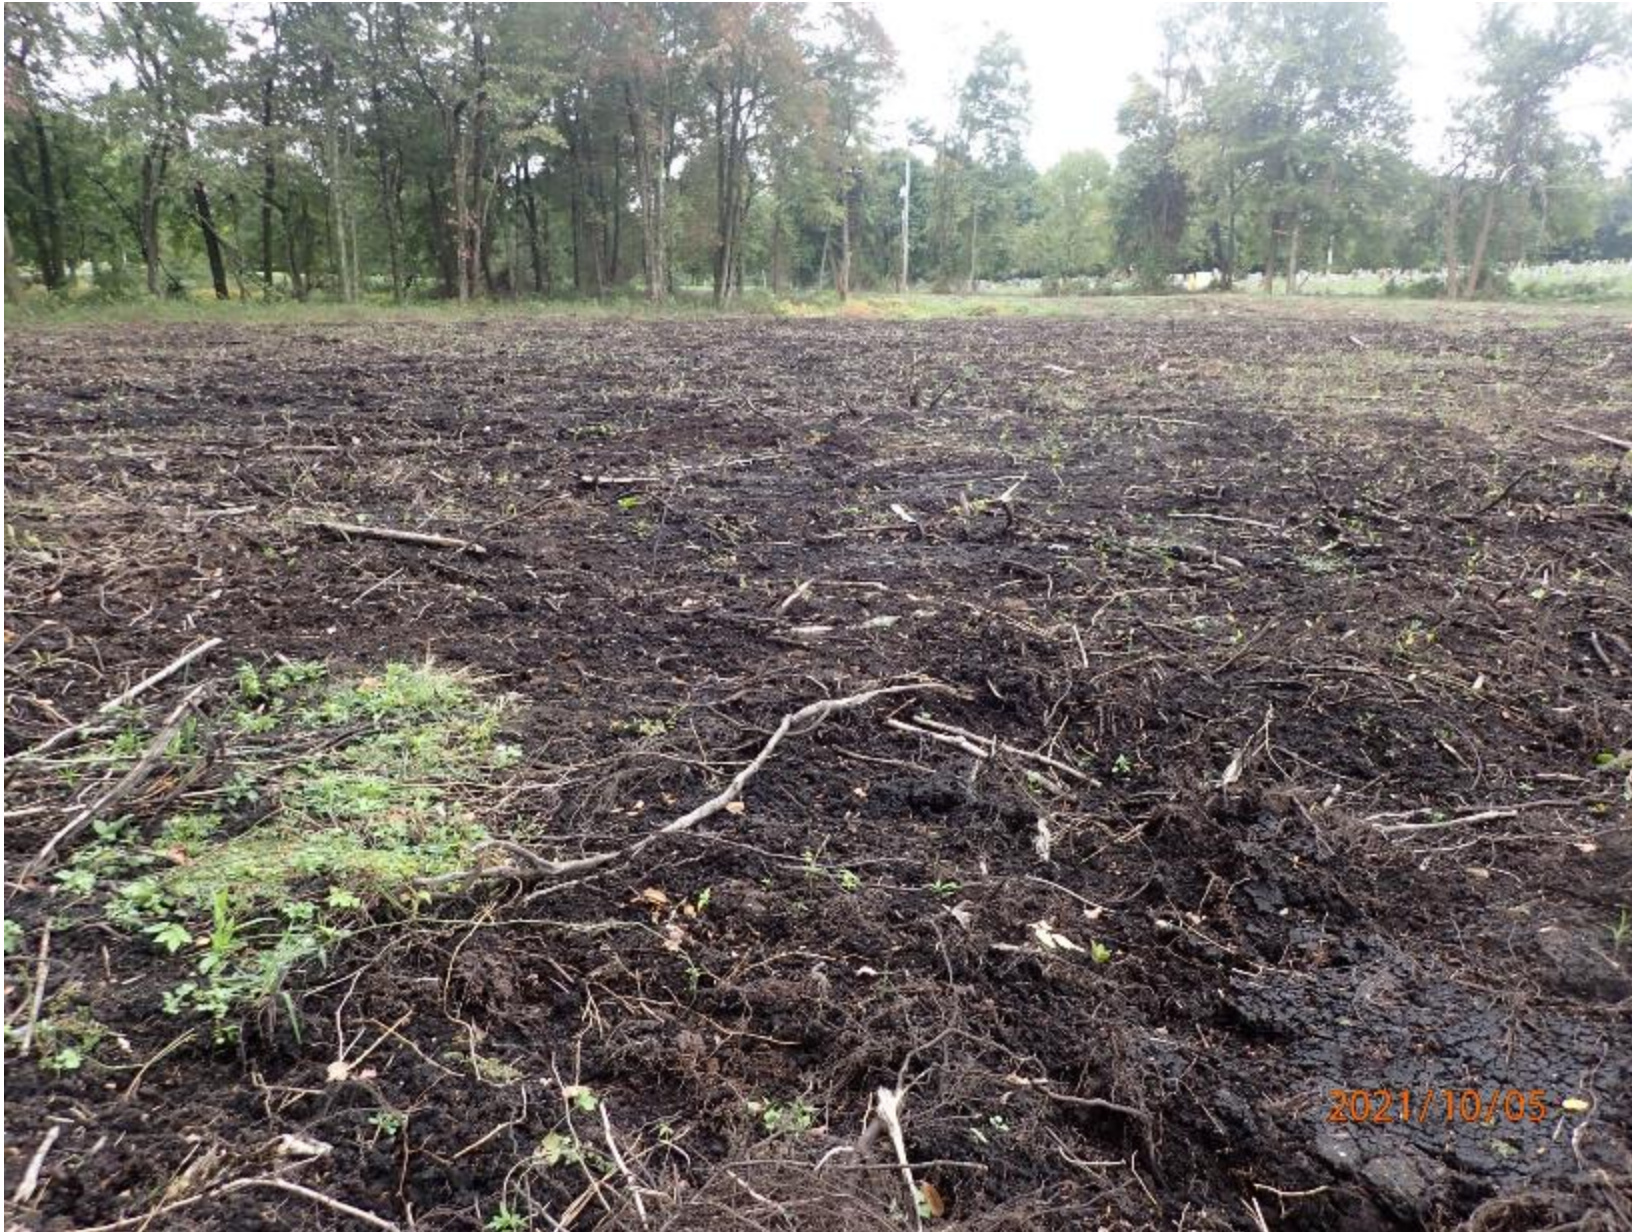
Date: 10/05/2021
Time: 3:13 PM
Photographer: SSA
Photo ID: 13 – PA0050156

Photo taken of disturbance from
NW Limit of Disturbance; photo
facing southeast

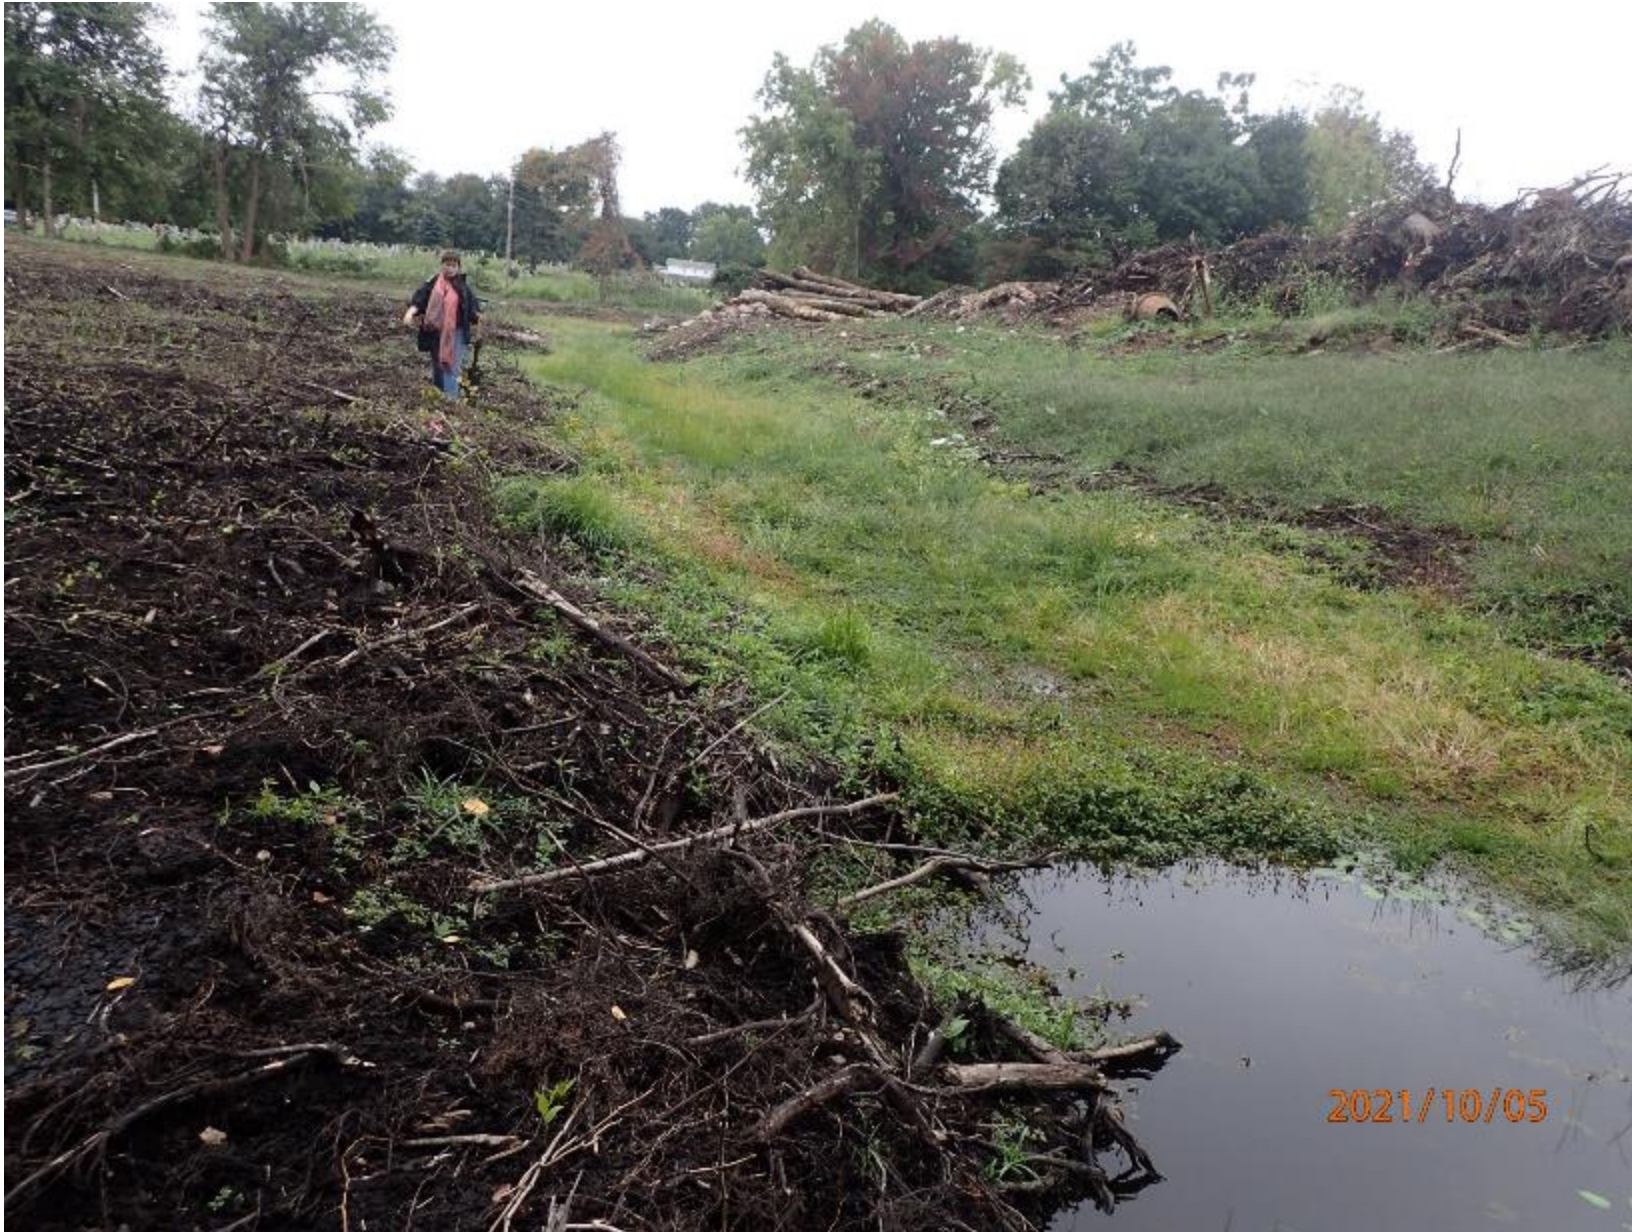
Date: 10/05/2021
Time: 3:13 PM
Photographer: SSA
Photo ID: 14 – PA0050157

Photo of potential wetland and
ditch/stream facing Brick
Church Road

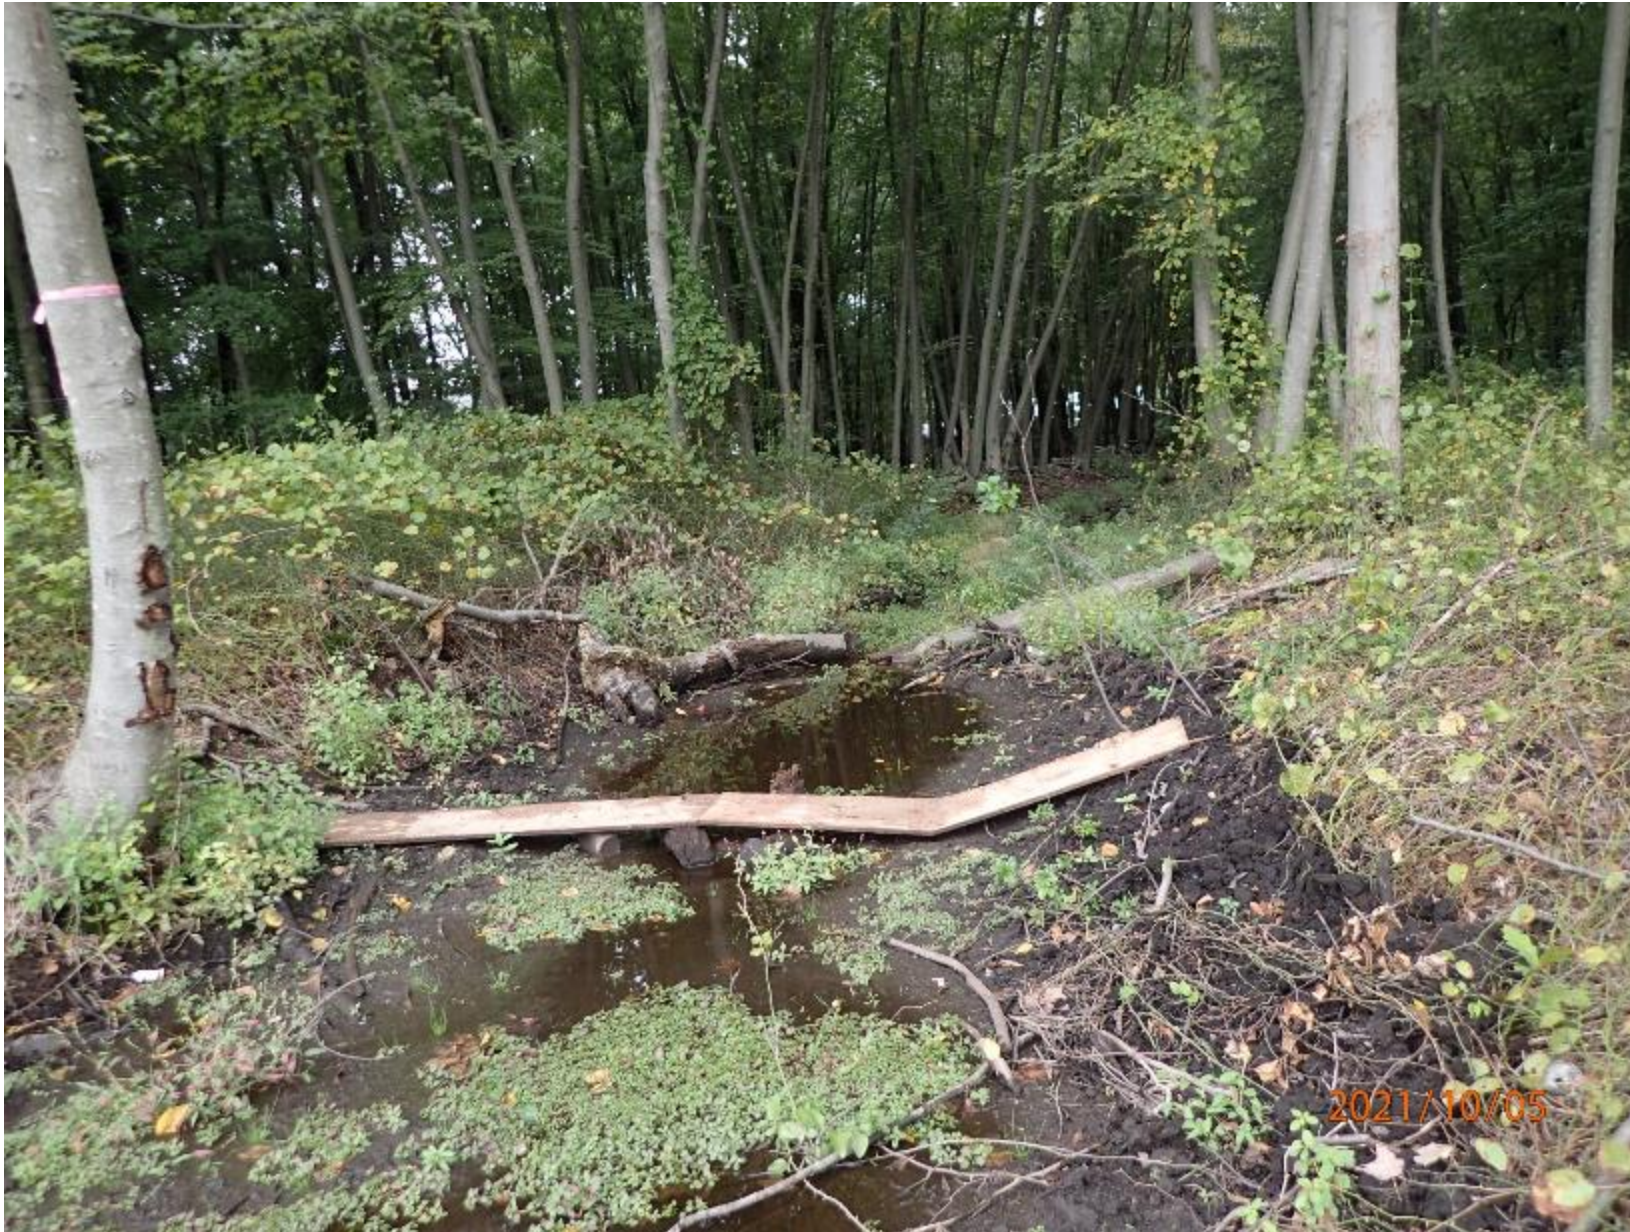
Date: 10/05/2021
Time: 3:15 PM
Photographer: SSA
Photo ID: 15 – PA0050158

Photo of potential wetland and ditch/stream facing treeline/neighbor property to north

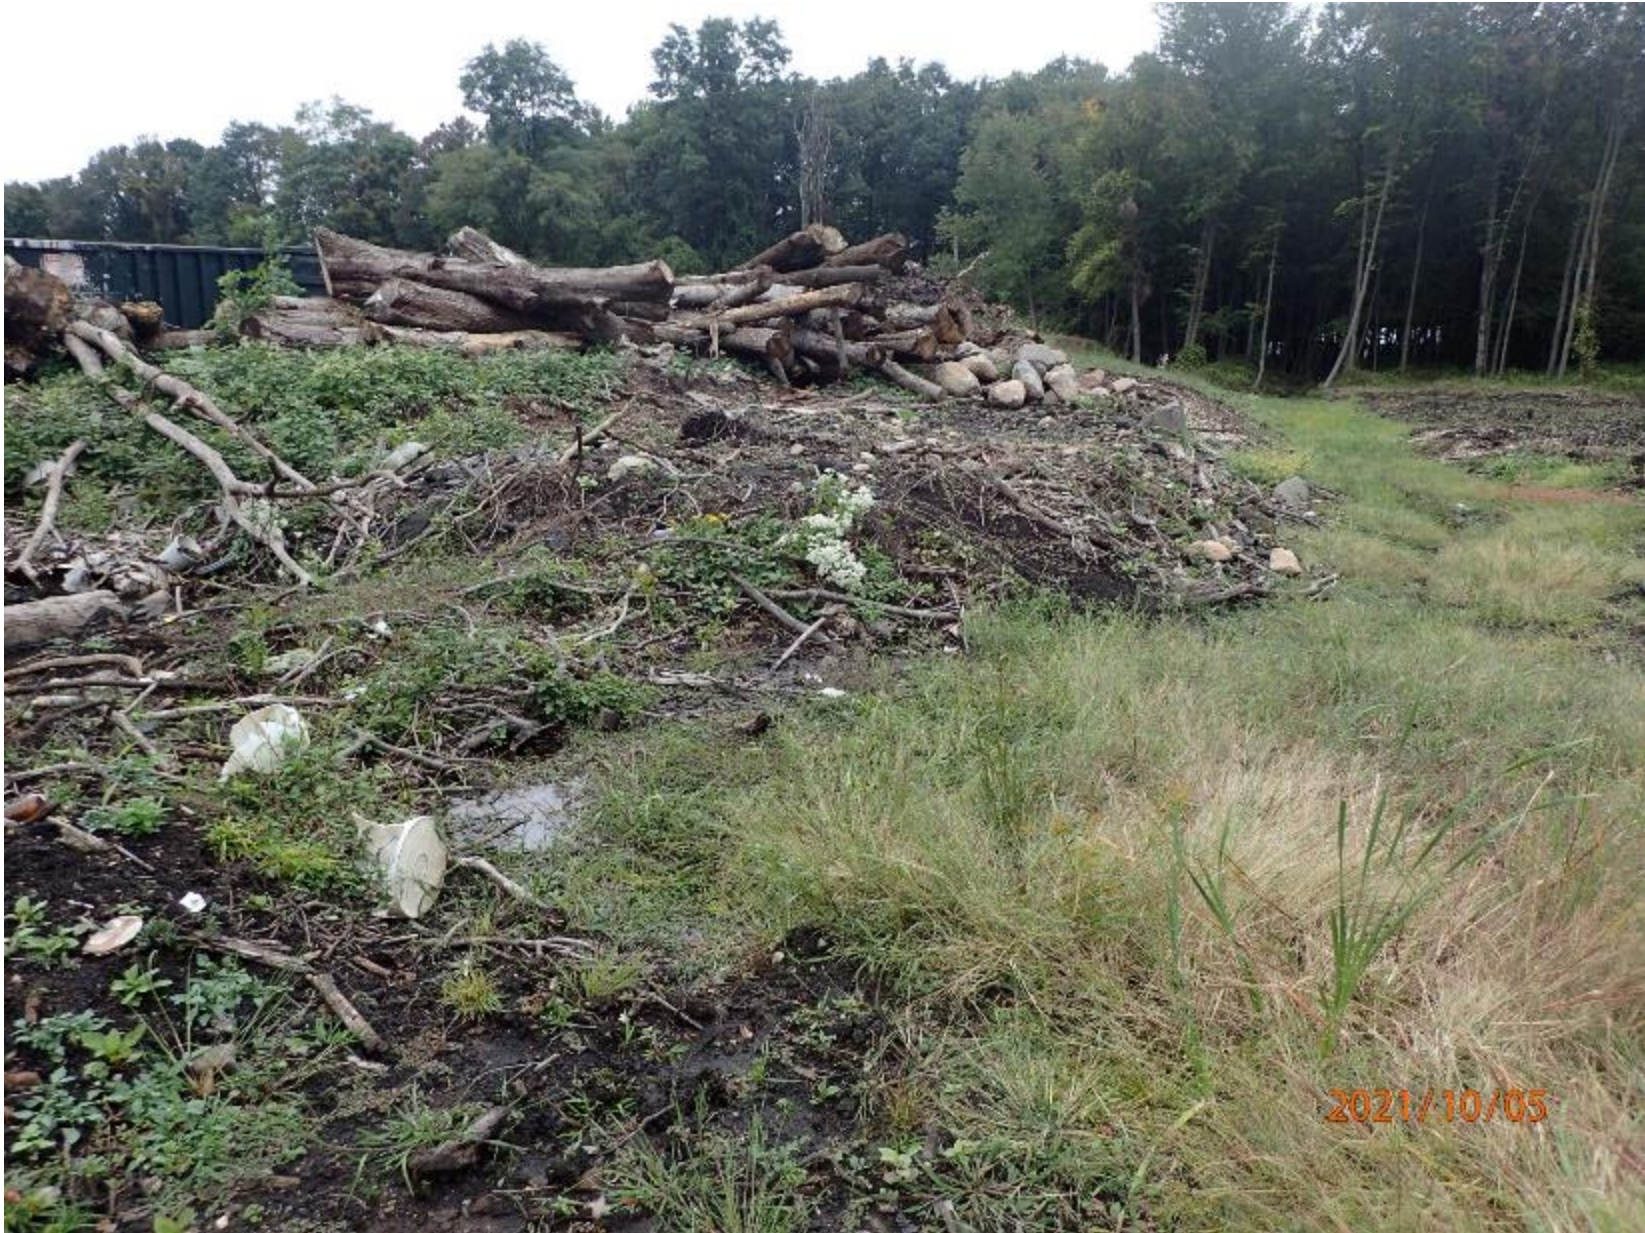
Date: 10/05/2021
Time: 3:22 PM
Photographer: SSA
Photo ID: 16 – PA0050159

Description:
Debris/earthen fill material
deposited by a previous owner
located on west side of
ditch/stream

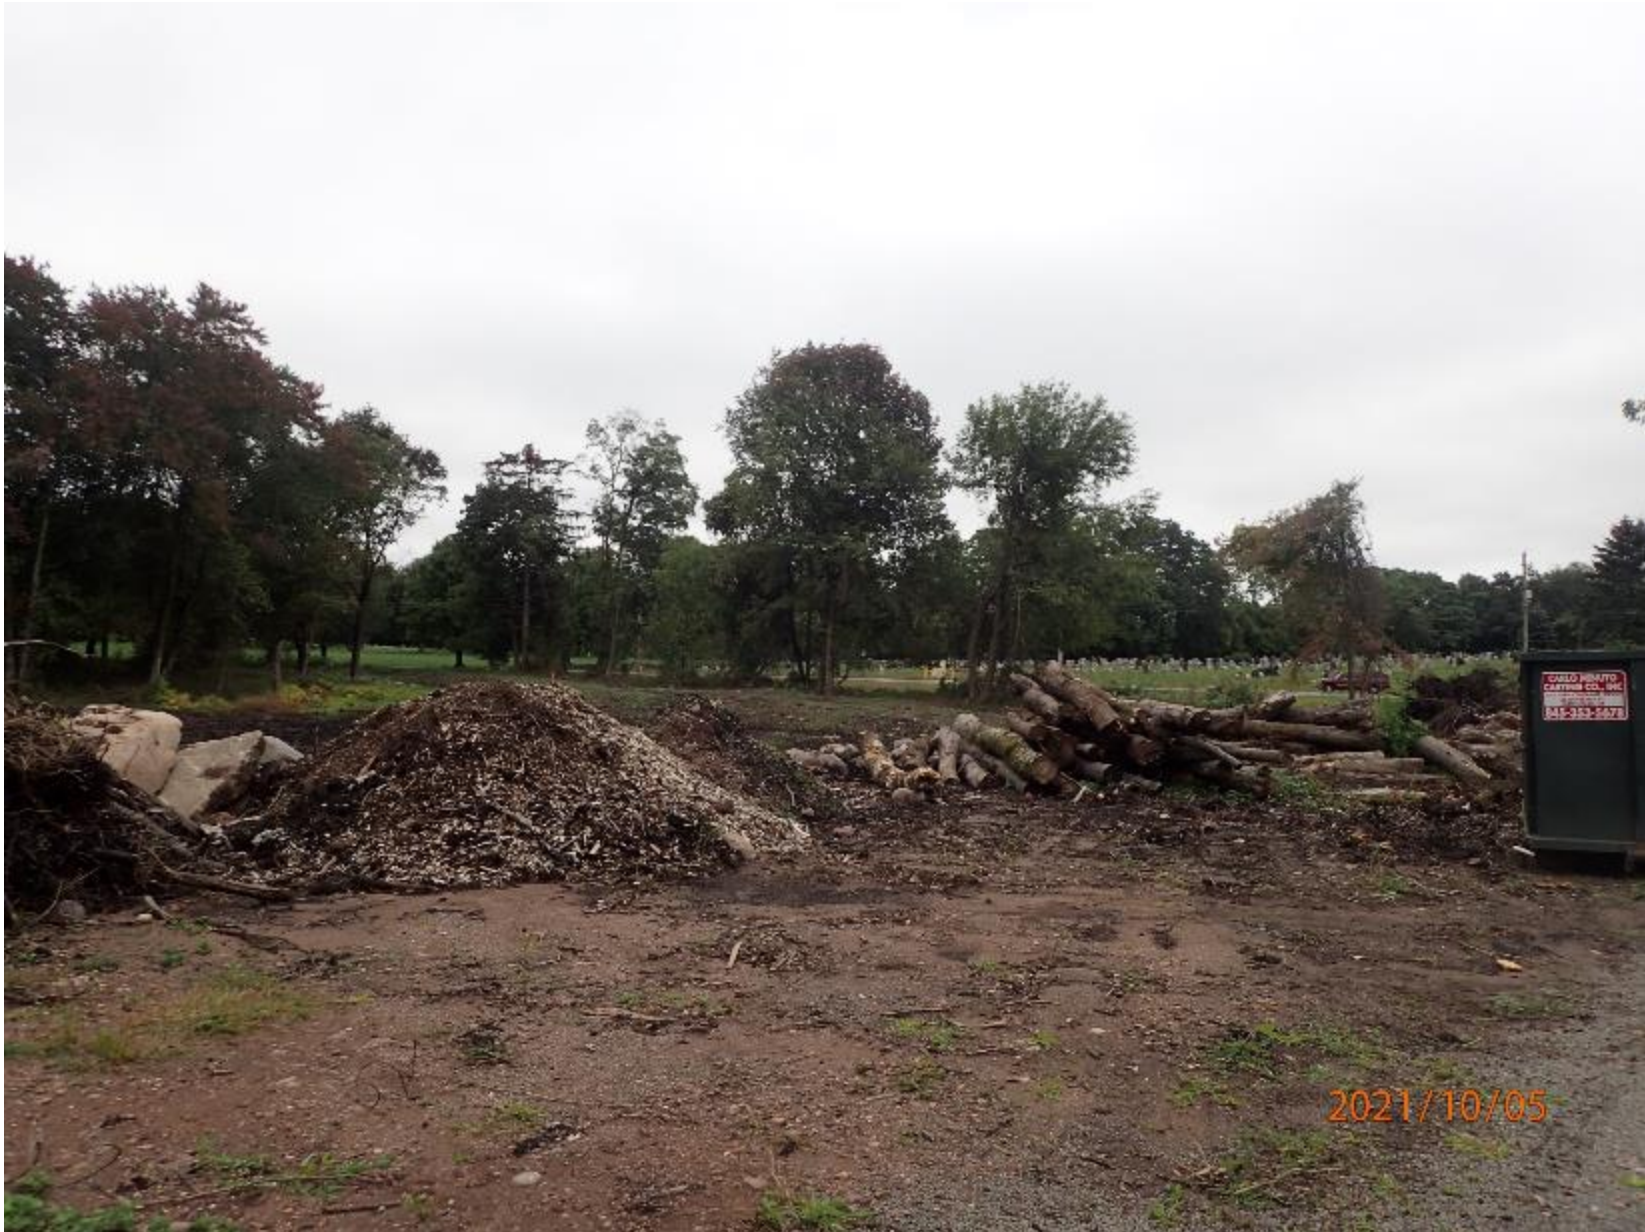
Date: 10/05/2021
Time: 3:35 PM
Photographer: SSA
Photo ID: 17 – PA0050160

Description:
Photo of trunks of trees removed from disturbed area.
Photo taken from the private unpaved road that run downs the middle of the parcel.
