**Region 6 - Enforcement & Compliance Assurance Division**  
**INSPECTION REPORT**

| Inspection Date(s): | 07/16/2024 | |
| Company Name: | <b>LBOC, LLC</b> | |
| Facility Name: | <b>Baker Sand Unit Tank Battery</b> | |

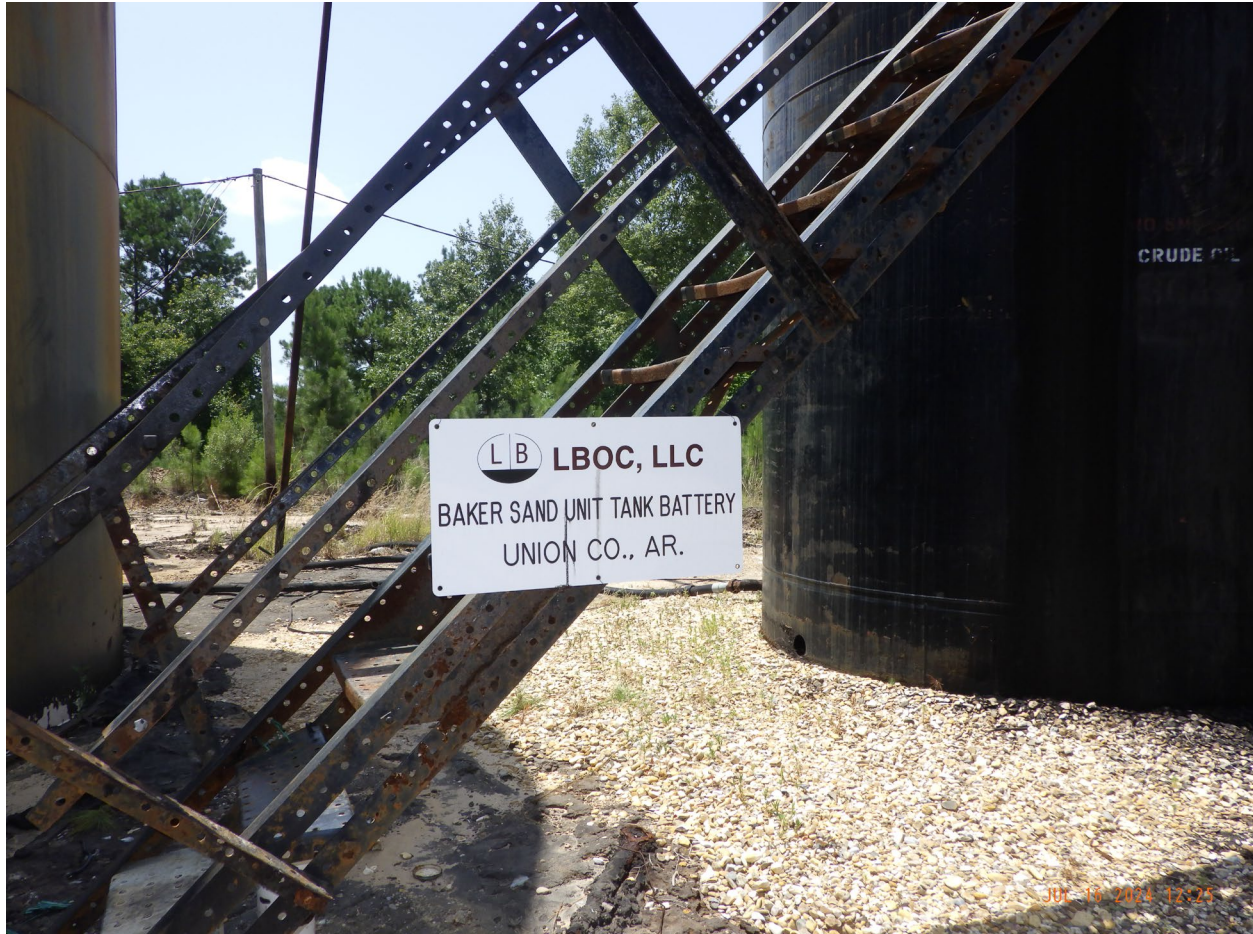
Photo No. 1

I observed the LBOC, LLC / Baker Sand Unit Tank Battery, signage, and storage tanks; see Appendix 1 (Photographs Log), Photo No. 1. For additional GPS location and photo metadata, see Appendix 1.

**Description:** Looking SSW, signage located at the facility.

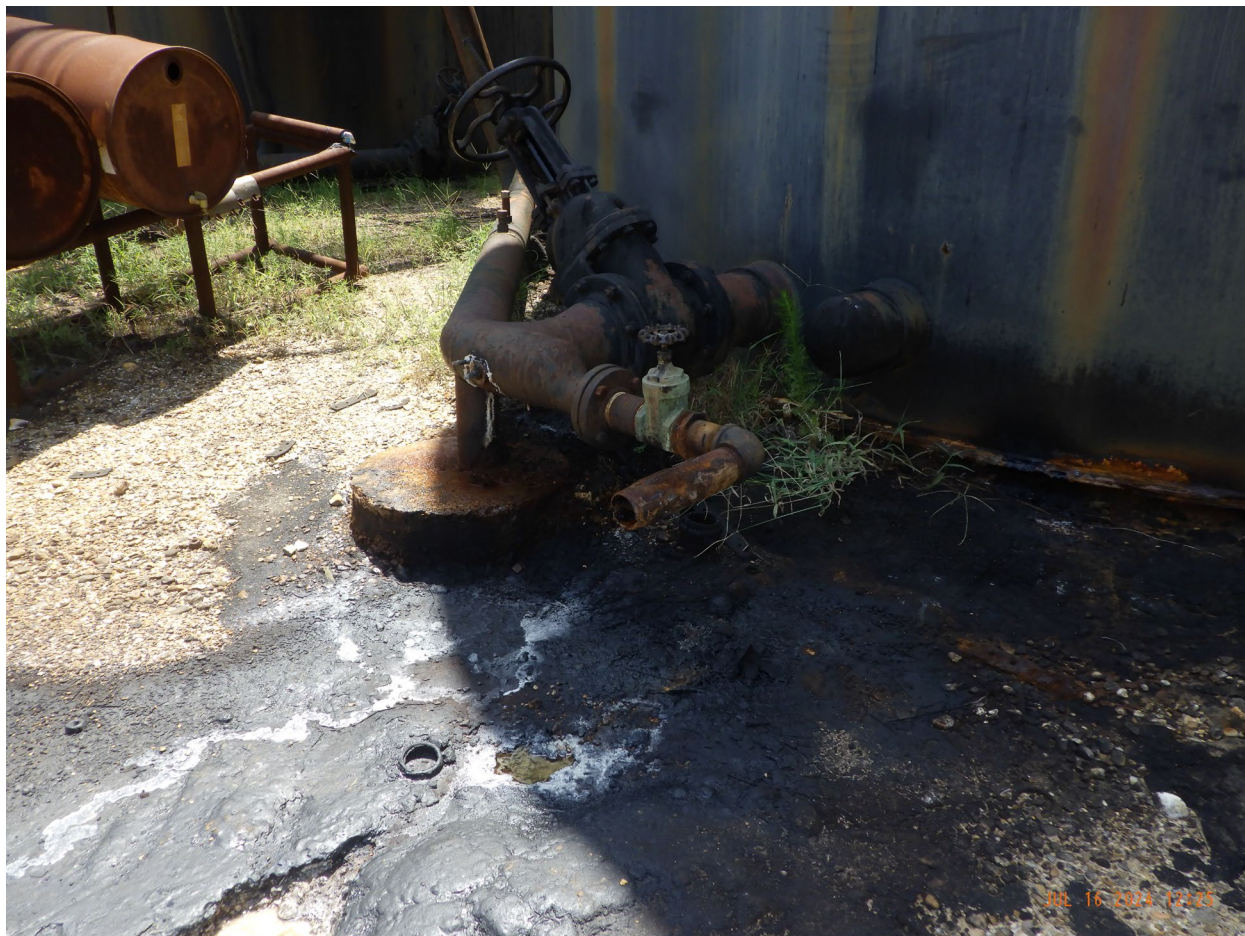
I observed an active leak of saltwater from a fitting in a pipe from a storage tank inside secondary containment with salt crystals noted on the ground, see Photo No. 2 and No. 3.

**Description:** Looking SSE, an active leak of saltwater from a fitting in a pipe at one storage tank inside secondary containment. Salt crystals were noted on the ground from a saltwater discharge.

Inspector will conduct follow-up phone calls with the company representative(s) over the coming weeks and months to ensure areas of concern are properly addressed. Similar areas of concern were noted in the 12/13/2023 inspection conducted by Inspector Chelsey Sherwood.

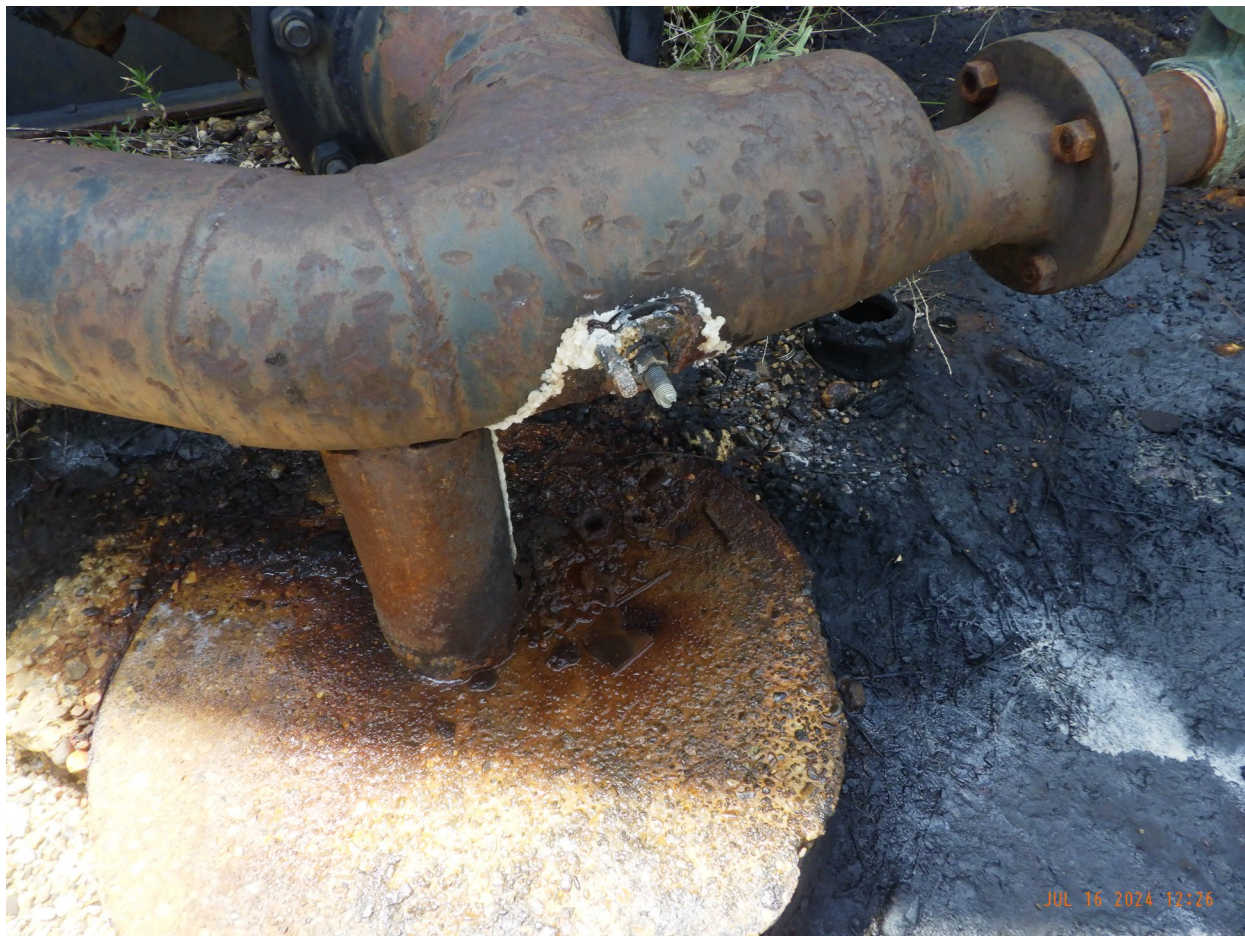
Photo No. 3

**Description:** Looking SSW, a closeup of the active leak from a fitting in a pipe in Photo No. 2.

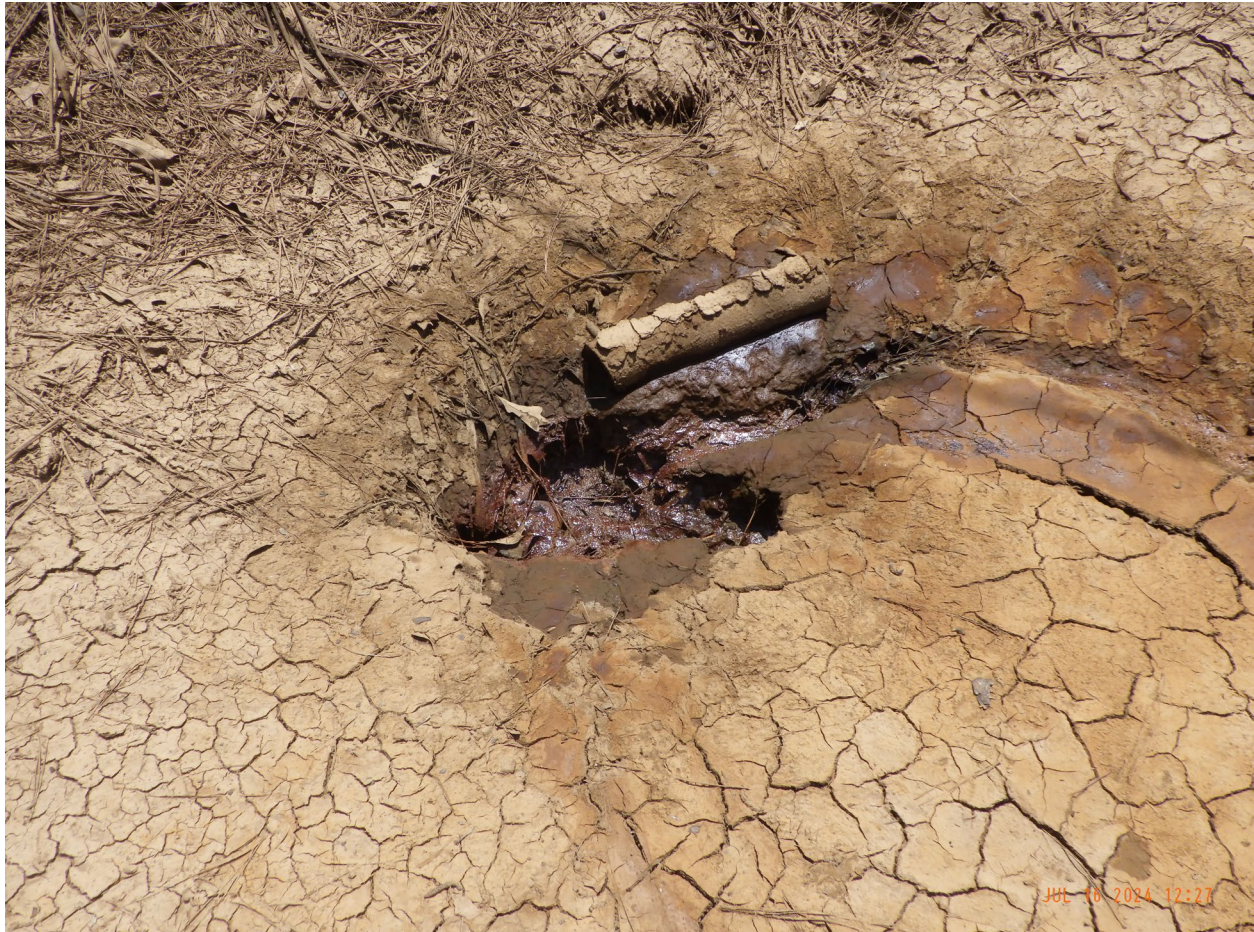
I observed the drainpipe for secondary containment (interior view) with saltwater sheen and staining, see Photo No. 4 and No. 5.

**Description:** Looking ESE, drainpipe for secondary containment (interior view) with saltwater sheen and staining from previous saltwater releases inside secondary containment.

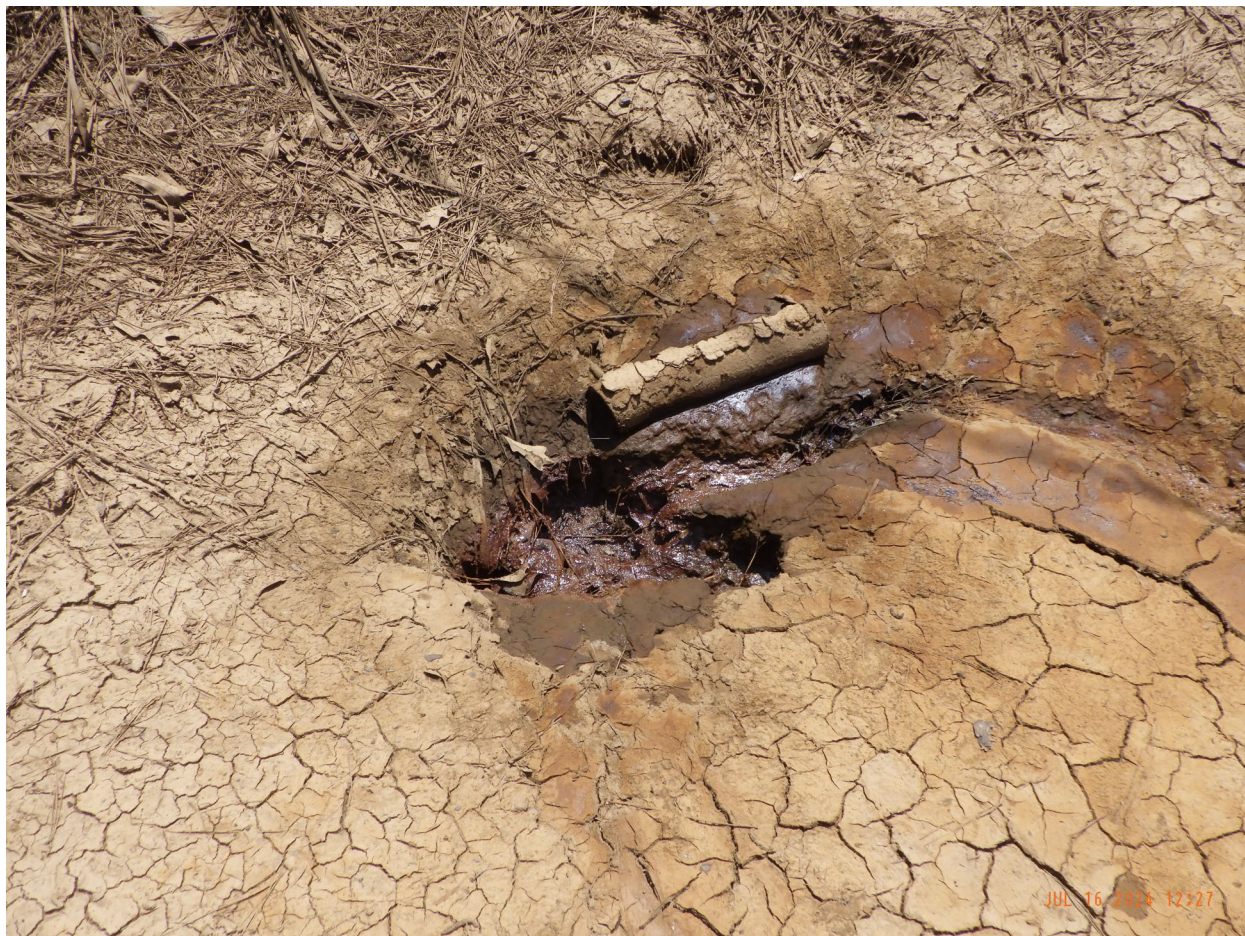
Photo No. 5

**Description:** Looking SE, a closeup of the drainpipe from Photo No. 4.

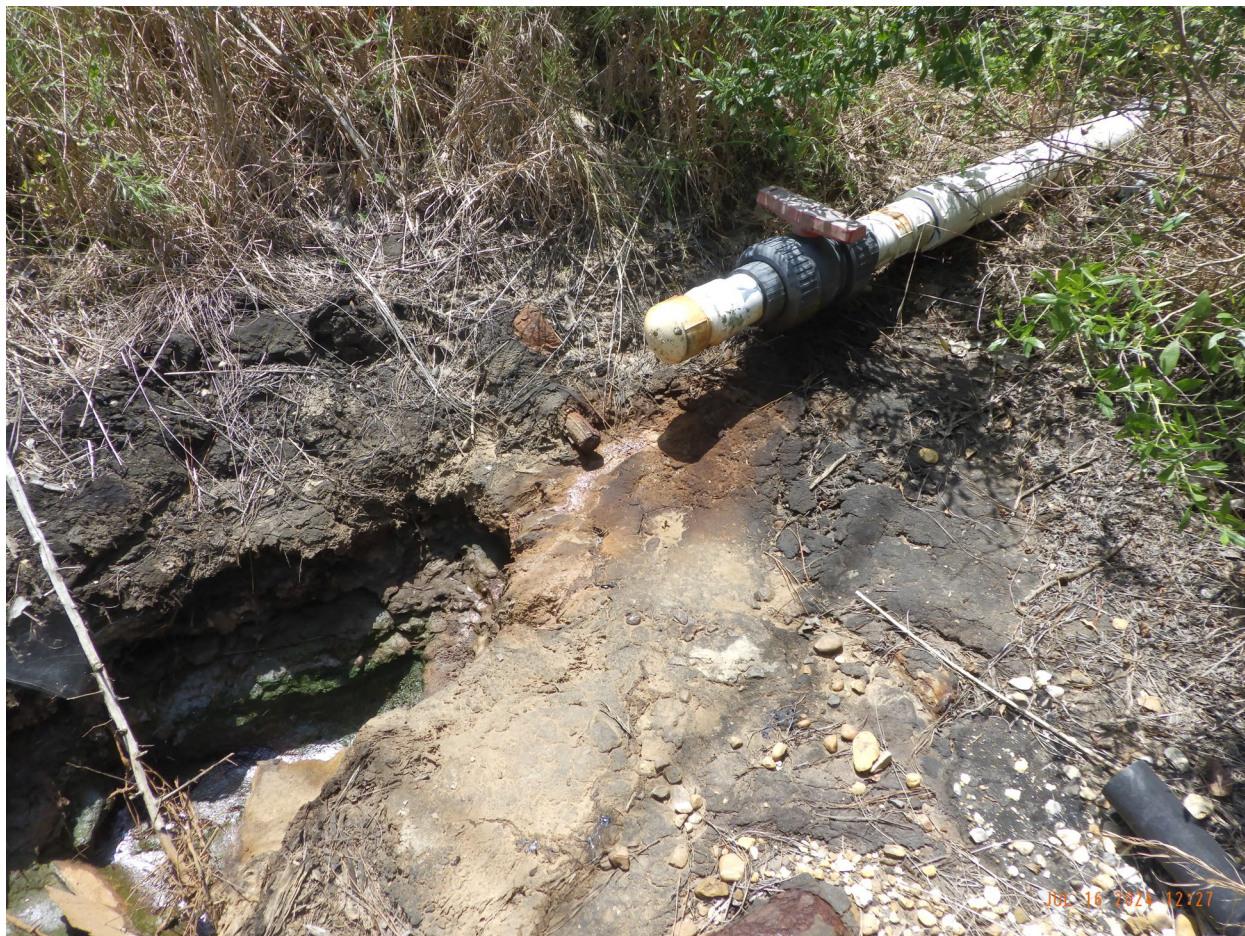
Photo No. 6

I observed the drainpipe for secondary containment (exterior view) with saltwater staining and salt crystals from previous discharge(s) of stormwater commingled with saltwater, see Photo No. 6.

**Description:** Looking S, the drainpipe for the secondary containment (exterior view) with saltwater staining and salt crystals from previous discharges of stormwater commingled with saltwater.

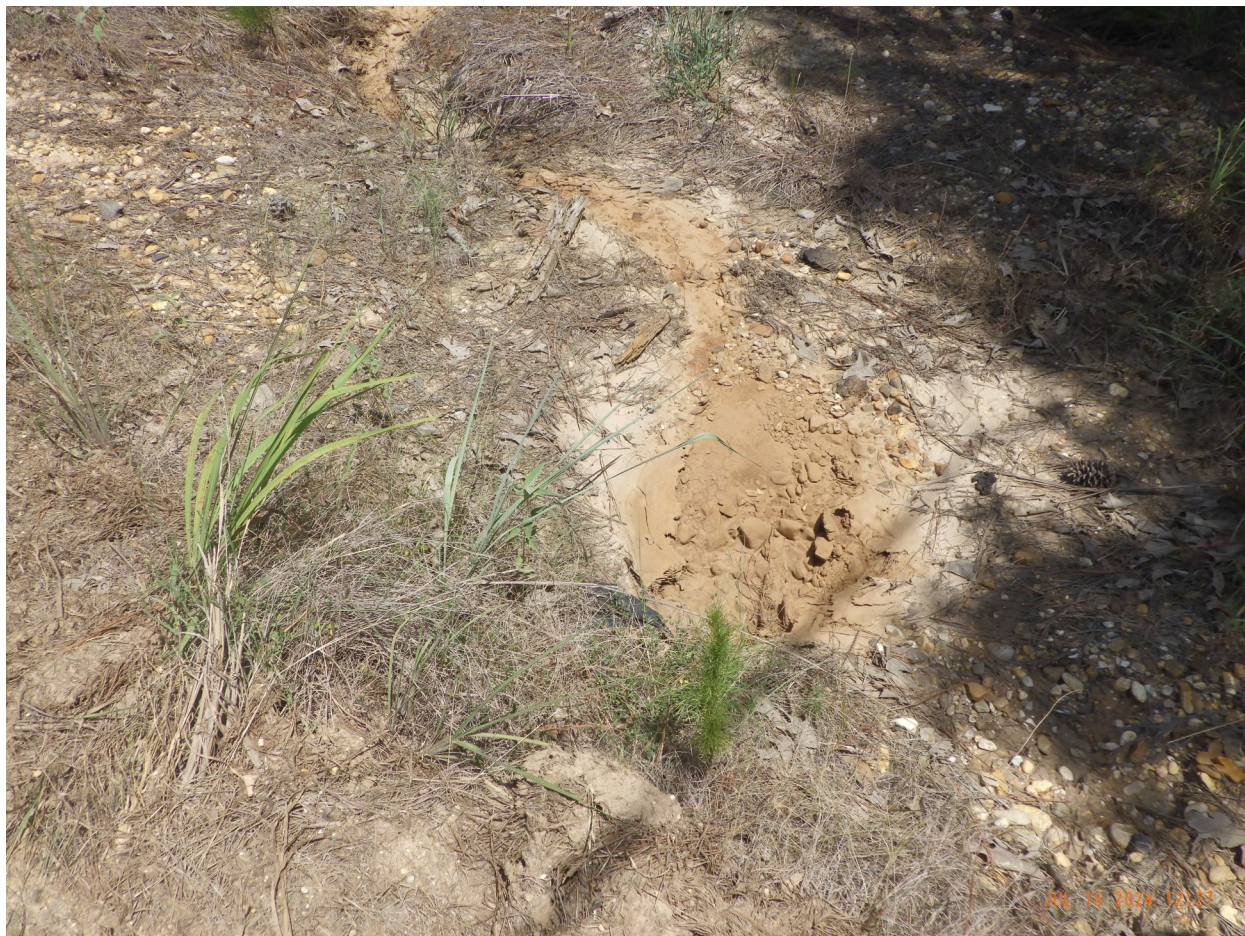
Photo No. 7

I observed the drainage flowpath for the drainpipe for secondary containment, which leads to the Ouachita River; see Photo No. 7.

**Description:** Looking NNW, drainage path for the drainpipe for secondary containment, which leads to the Ouachita River.
