**UNITED STATES ENVIRONMENTAL PROTECTION AGENCY**

Re: EPA RCRA Case Development Inspection – March 28-29, 2019; EPA ID# OKD042146324  
– January Environmental Services – Oklahoma City, Oklahoma

**INSPECTION REPORT**

**Case Development Inspection (CDI)**

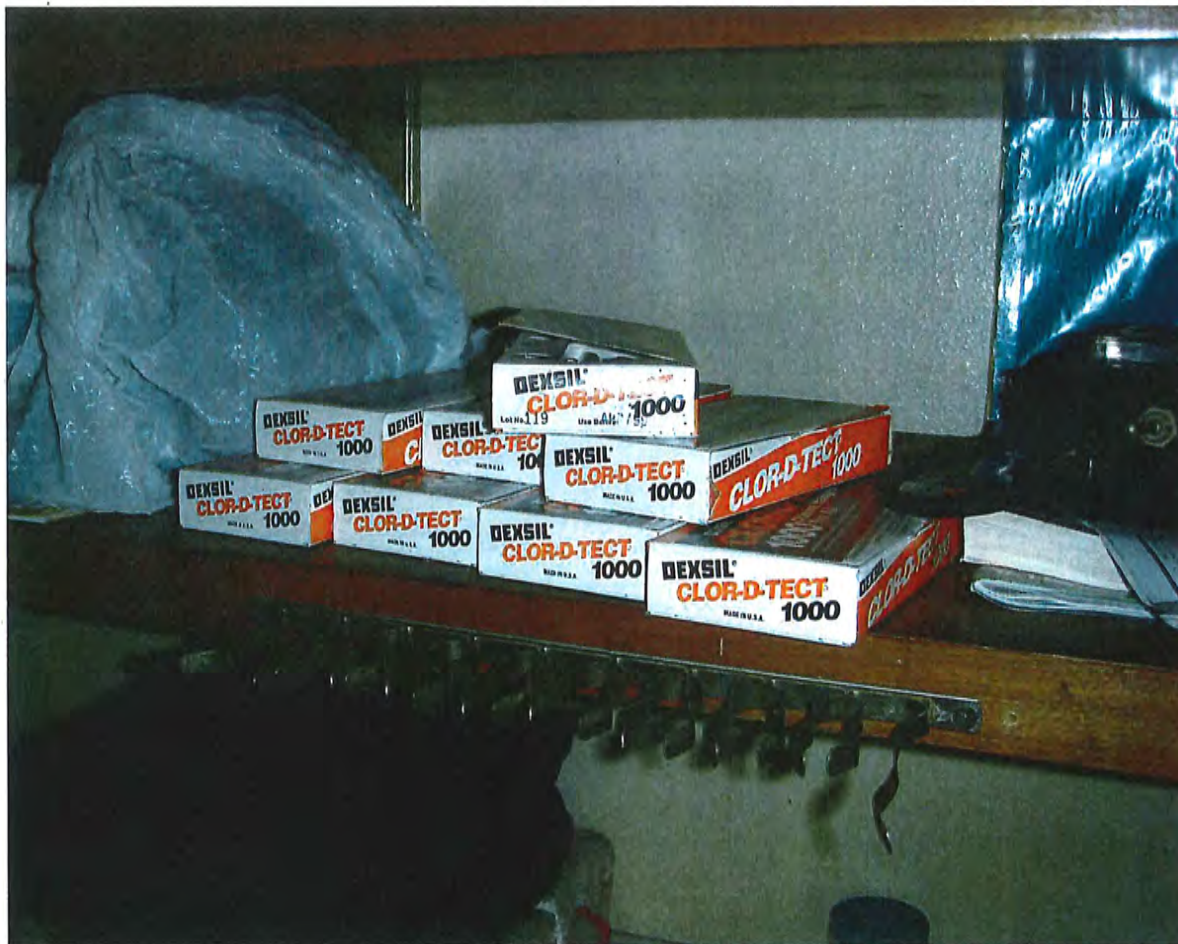
Photo No. 1

| Description: | CLOR-D-TECT kits with expiration date of April '99 | | | | | |

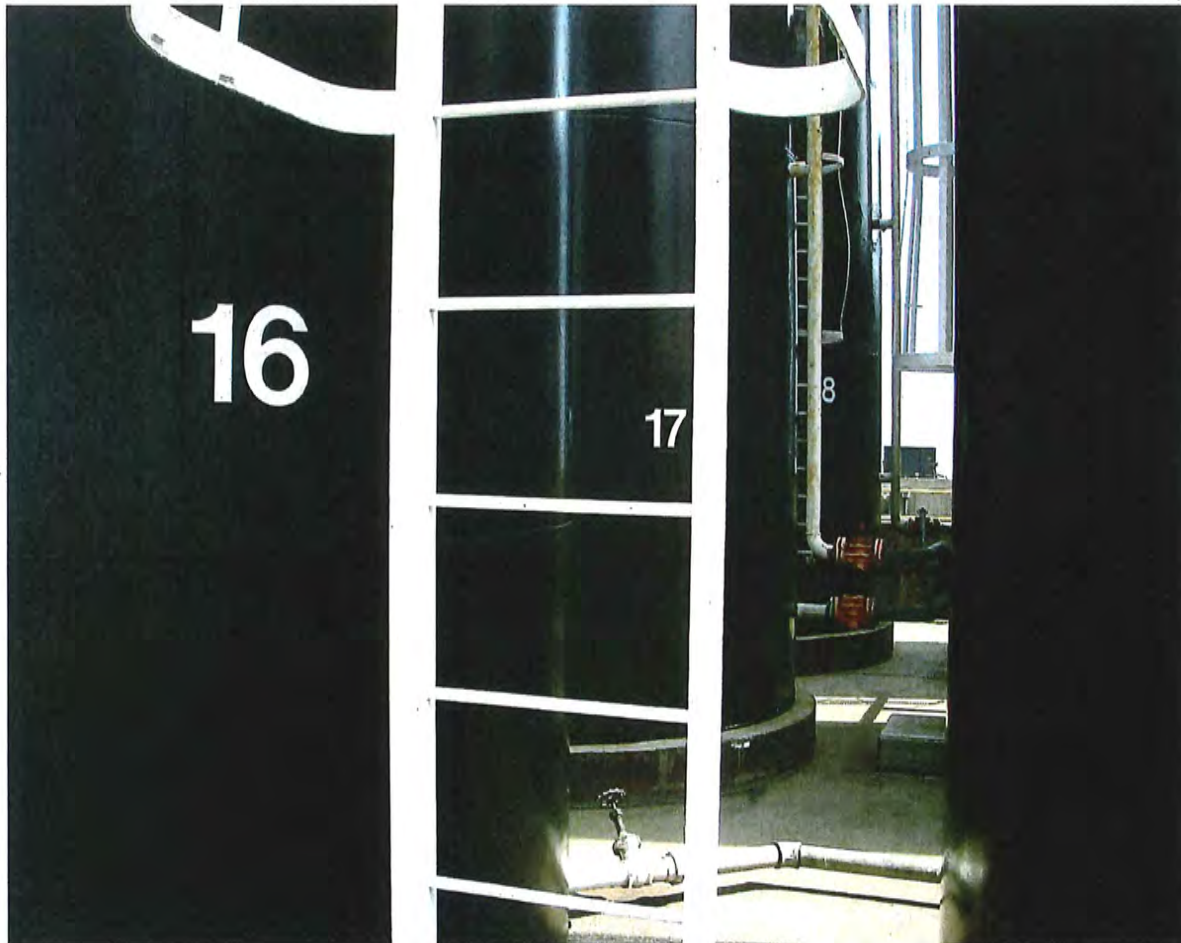
Photo No. 3

| Description: | Used oil tanks 16, 17, and 18 showing no used oil labels | | | | | |

The EPA team observed tank 22 (cooker) relocated since the 2017 inspection and a new process was being installed. Mr. January Jr. said they were installing a flash tower and new heater. We asked for information on the process. The EPA team observed oil storage tanks 2, 16, 17 and 18 not labeled with the words "used oil" (Appendix 1, Photos 3 & 4).

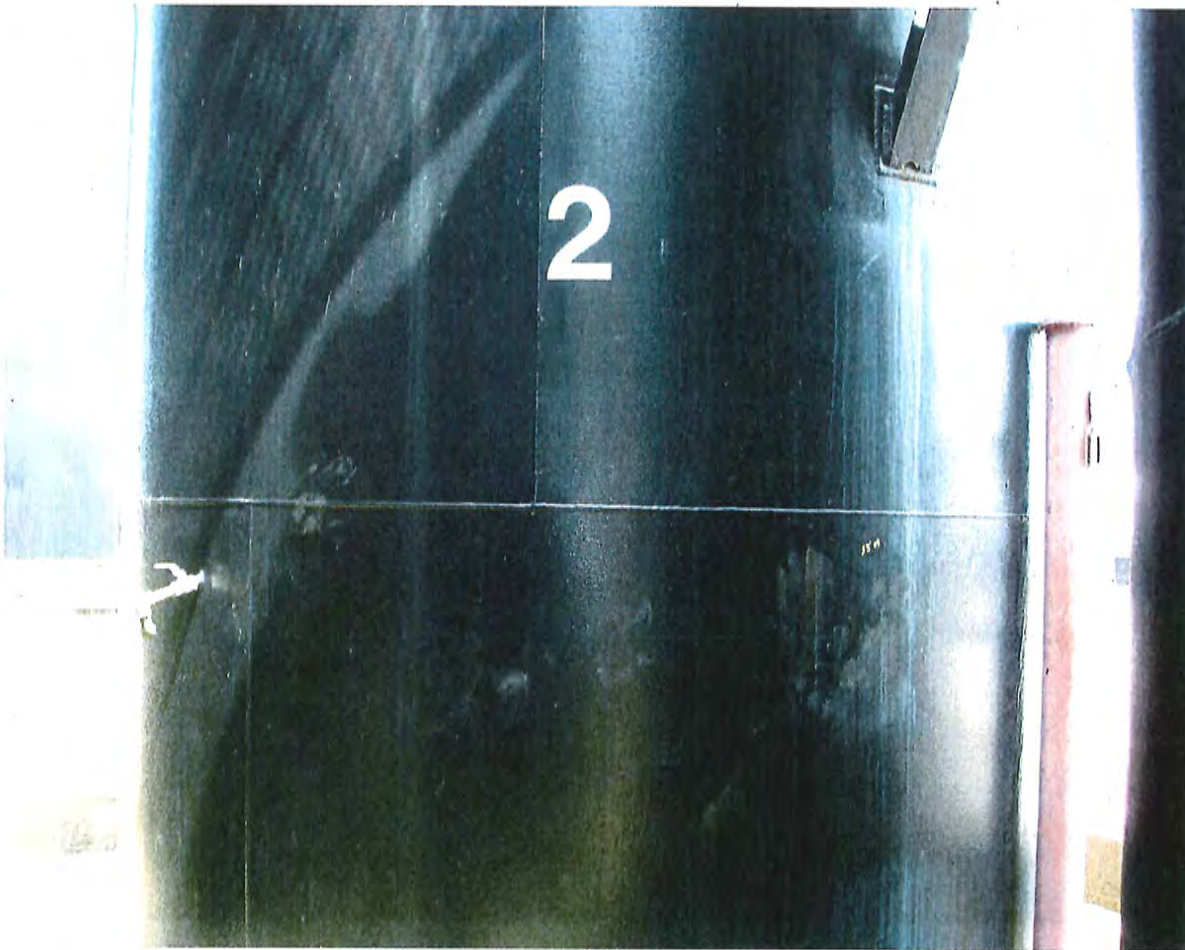
Photo No. 4

| Description: | Tank number 2 showing no used oil label | | | | |

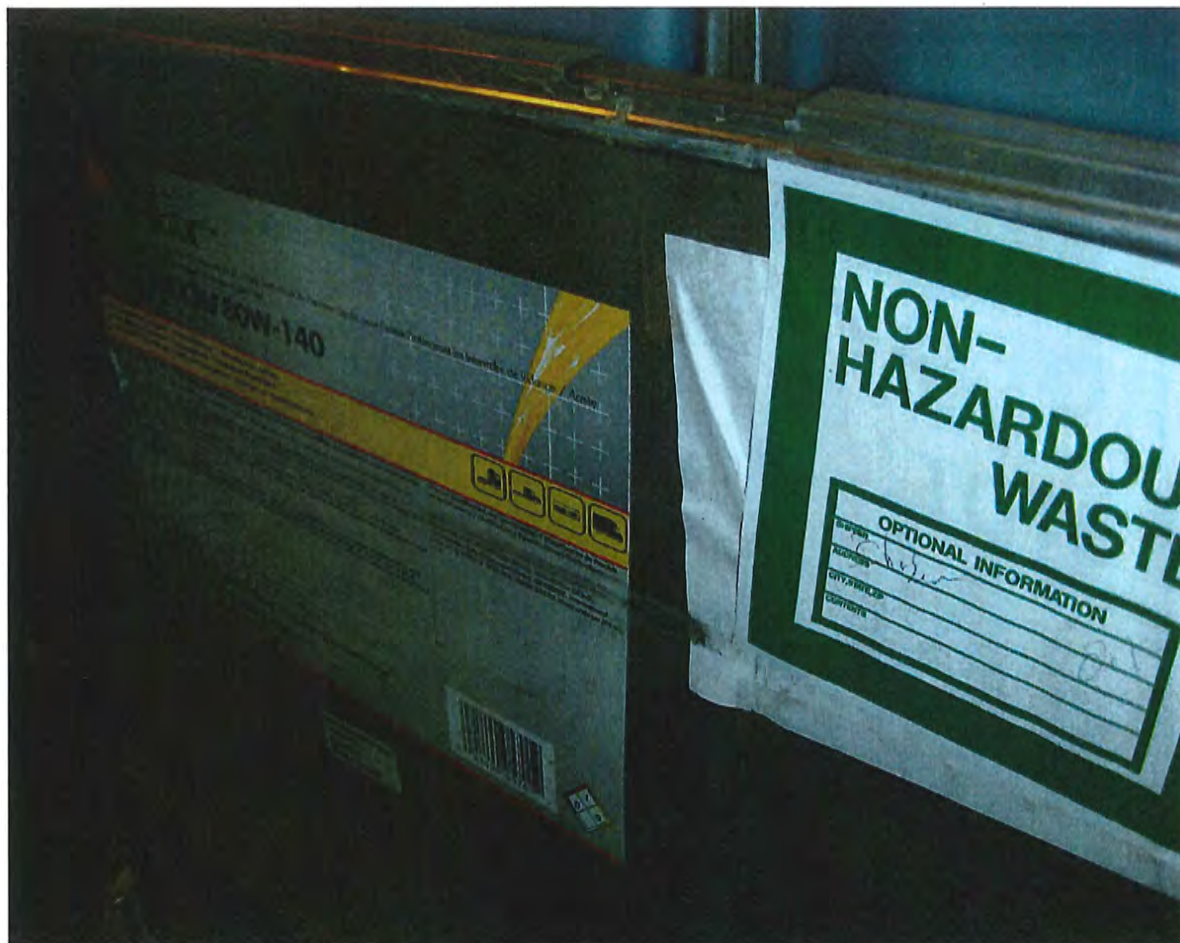
Photo No. 5

| Description: | Tote in warehouse labeled used oil | | | | | |

- Four (4) totes from Schlumberger: one full and a second half full of used oil (Appendix 1, Photo 5);
- Pump used by JES (Appendix 1, Photo 7);
- Empty used oil filter dumpsters;
- Open drum with no label containing used oil (Appendix 1, Photo 6);
- Two (2) empty drums with Subaru labeling;
- One tote with fracking gel. The oil would be pumped off and the remainder sent to landfill;
- Nine (9) drums containing spent carbon from RedCliff Midstream. Waste destined for the landfill, and
- One tote containing "Dmulz" (a product used in the used oil processing).

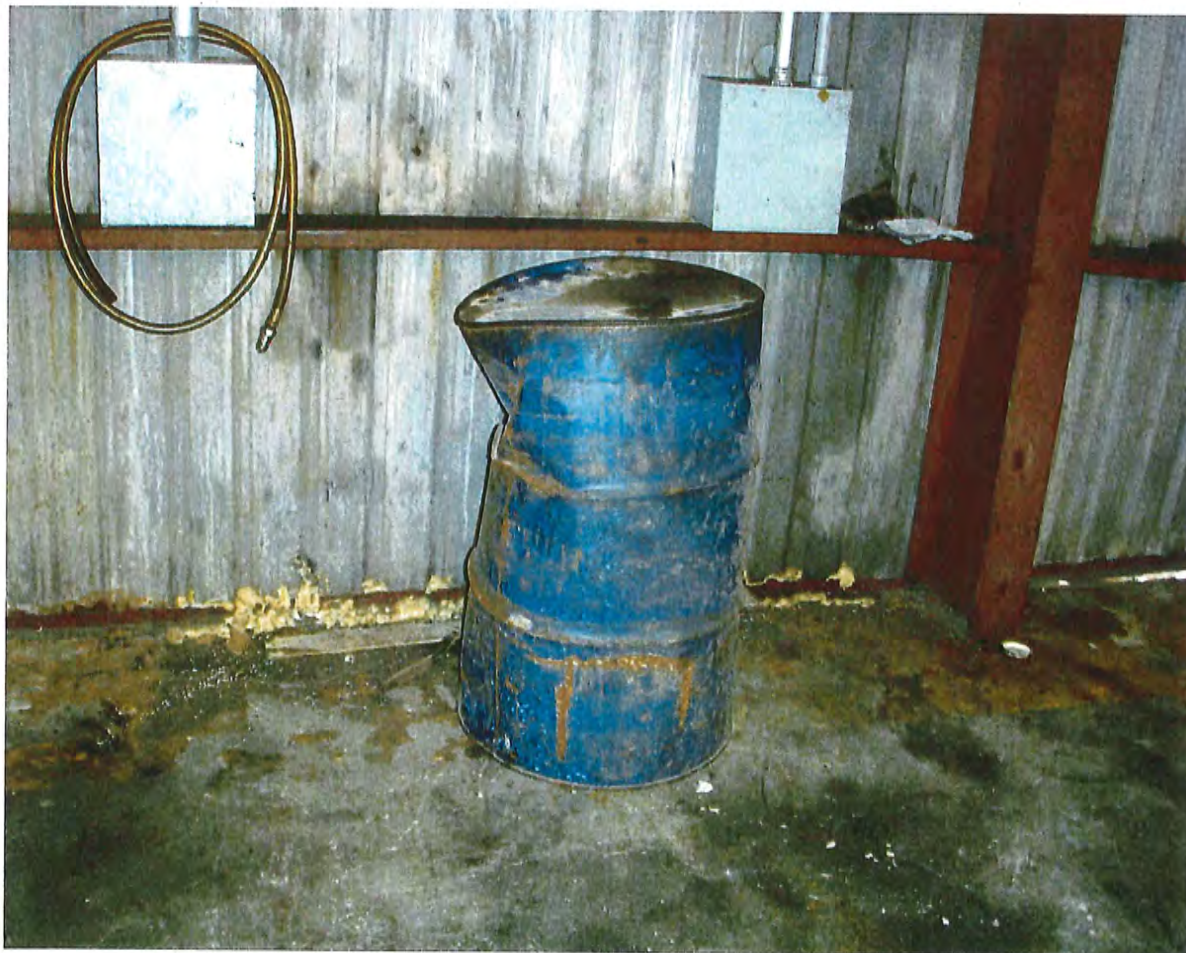
Photo No. 6

| Description: | Unlabeled drum in warehouse, Cris January Jr. said it was used oil. | | | | |

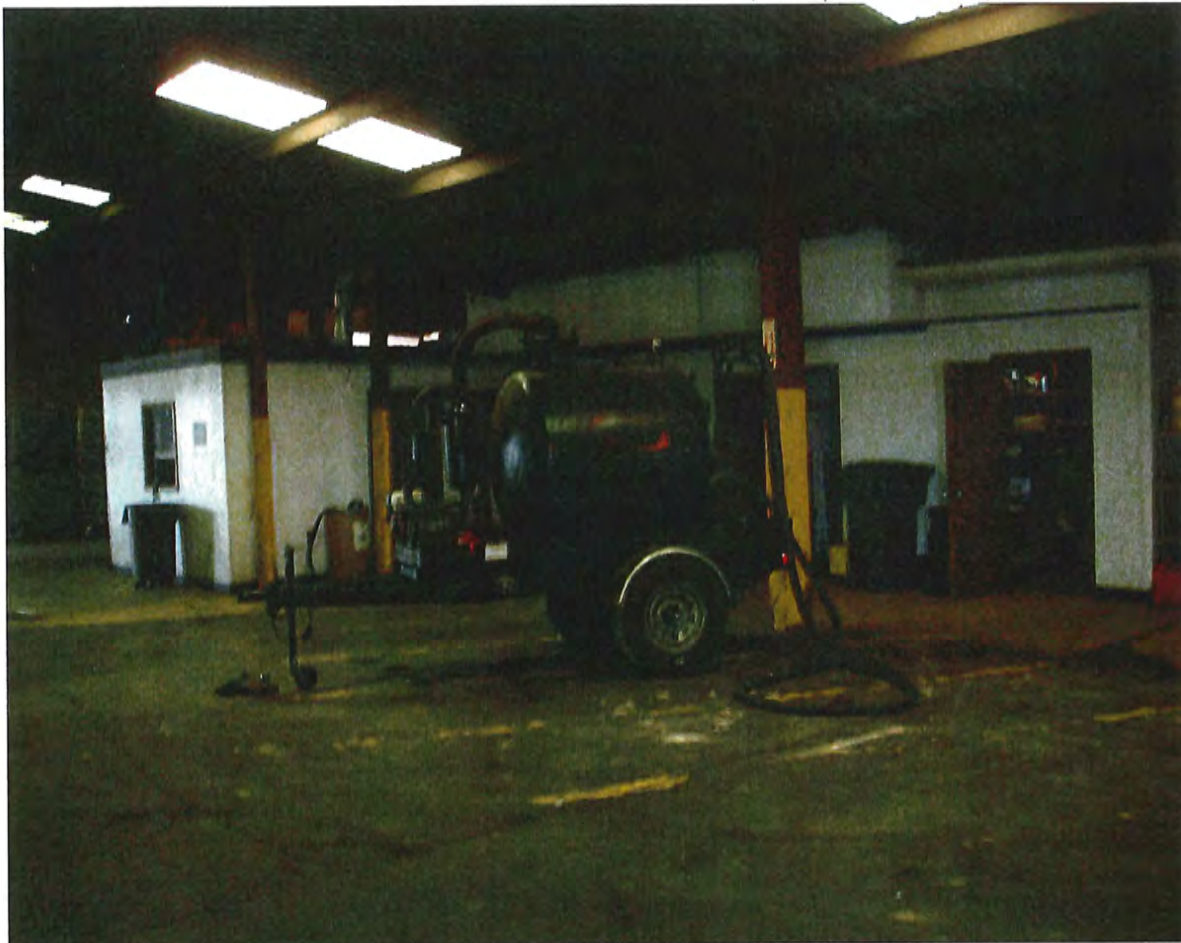
Photo No. 7

| Description: | Pump in warehouse | | | | | |

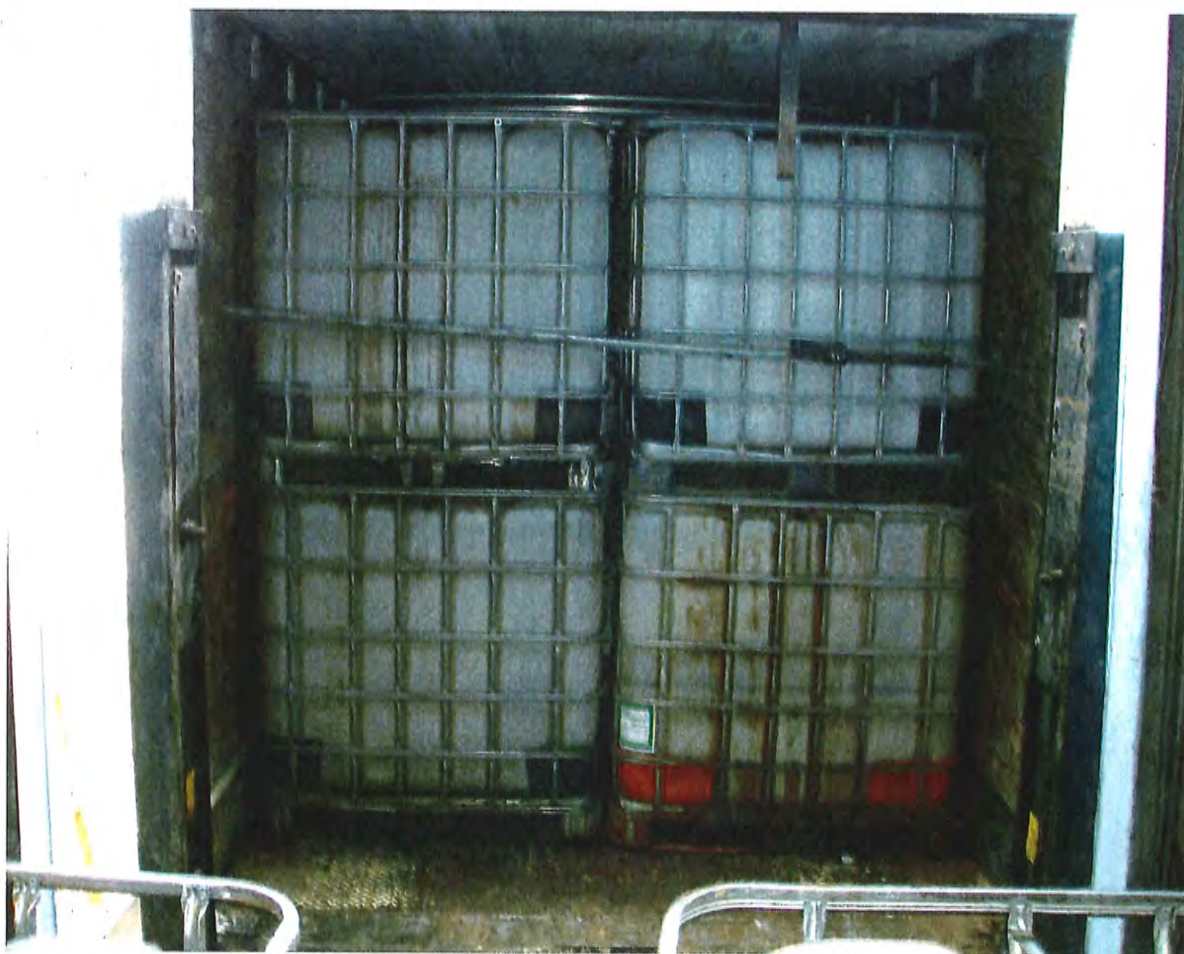
Photo No. 8

| Description: | Inside of truck trailer at loading dock. Cris January Jr. said the totes are headed to a landfill. | | | | |

At the loading dock a truck box trailer was observed to contain totes and plastic buckets (Appendix 1, Photo 8). Mr. January Jr. said the totes and buckets were going to be hauled to a landfill. The recycling company JES used, is no longer accepting plastic. Recycler's name is Hite Plastics Inc.

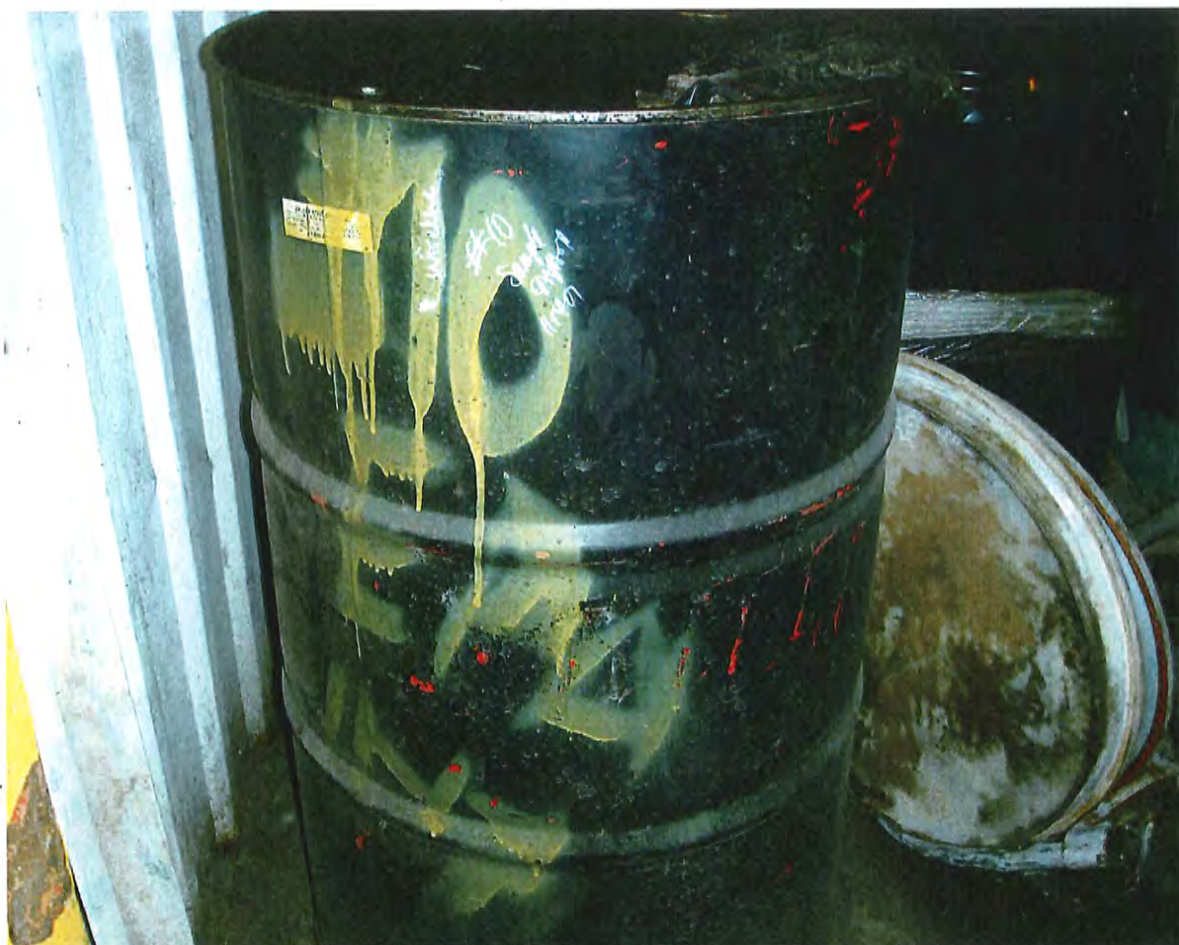
Photo No. 9

- One drum marked #10 EPA in yellow paint (Appendix 1, Photo 9)
- Two drums in front wrapped – water/used oil from roll-off # 25036
- Two drums in back – grease/water from roll-off # 25276D
- Two drums – grease/water from roll-off # C2576D
- One drum with no label.

- Use of "sniffer" to determine halogen content of used oil (Appendix 1, Photos 29 through 33).
- Used oil filters observed in roll-off containers not crushed or punctured Appendix 1, Photos 19, 20, 23 & 24).
- No aisle space around totes and used oil filter bins (Appendix 1, Photo 17 & 26.
- Tanks 2, 16, 17 and 18 not labeled with the words "used oil" (Appendix 1, Photos 3 & 4)
- Storage of drum containing waste MEK since 11/2019 (Appendix 1, Photo 9 & 10).
- No labeling on MEK waste drum (Appendix 1, Photo 9 & 10).

| Description: | Drum in warehouse with EPA marking from previous inspection sampled by EPA in 2017 | | | | | |

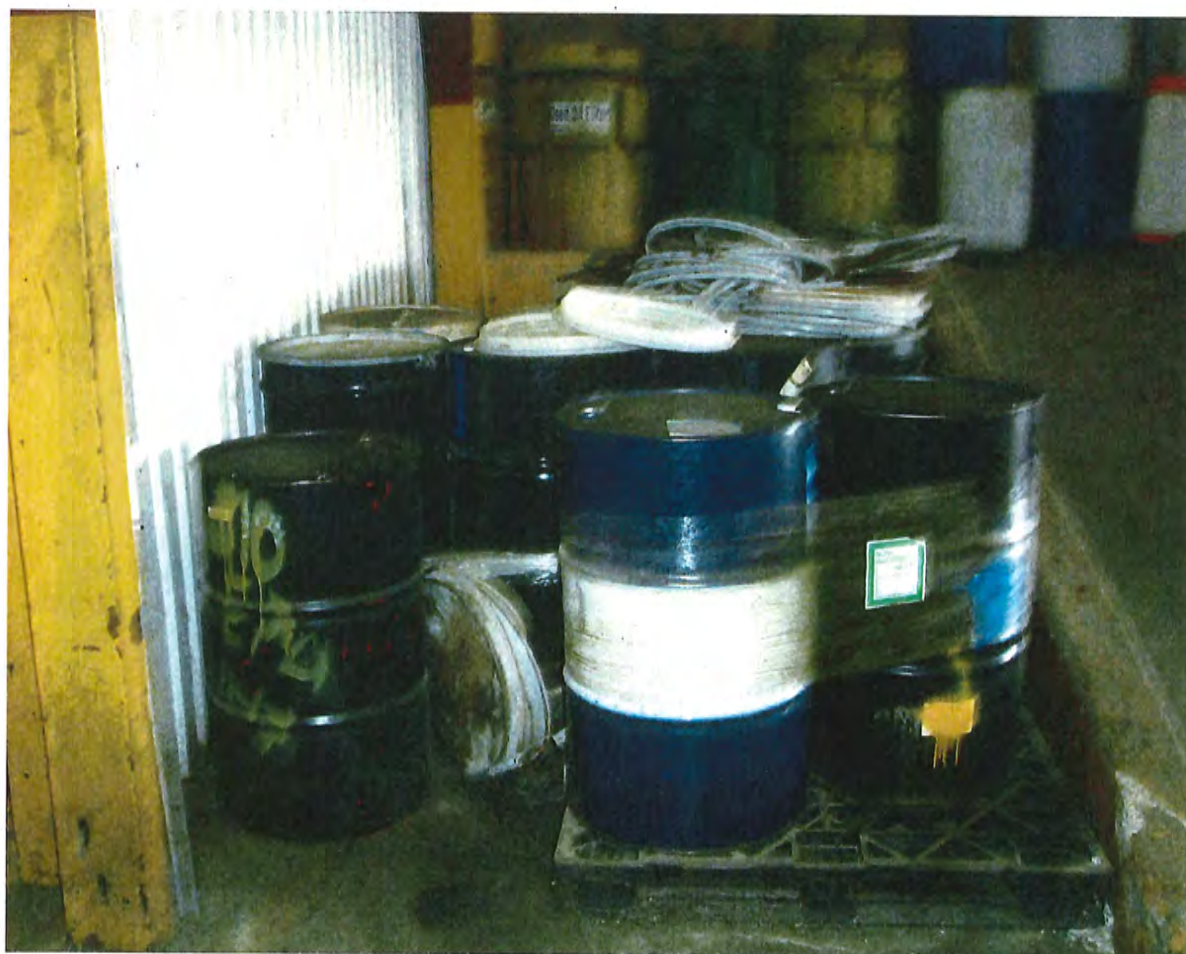
| Description: | Overview of drums in the warehouse. Cris January Jr. said they were quarantined from the previous EPA inspection in 2017. | | | | |

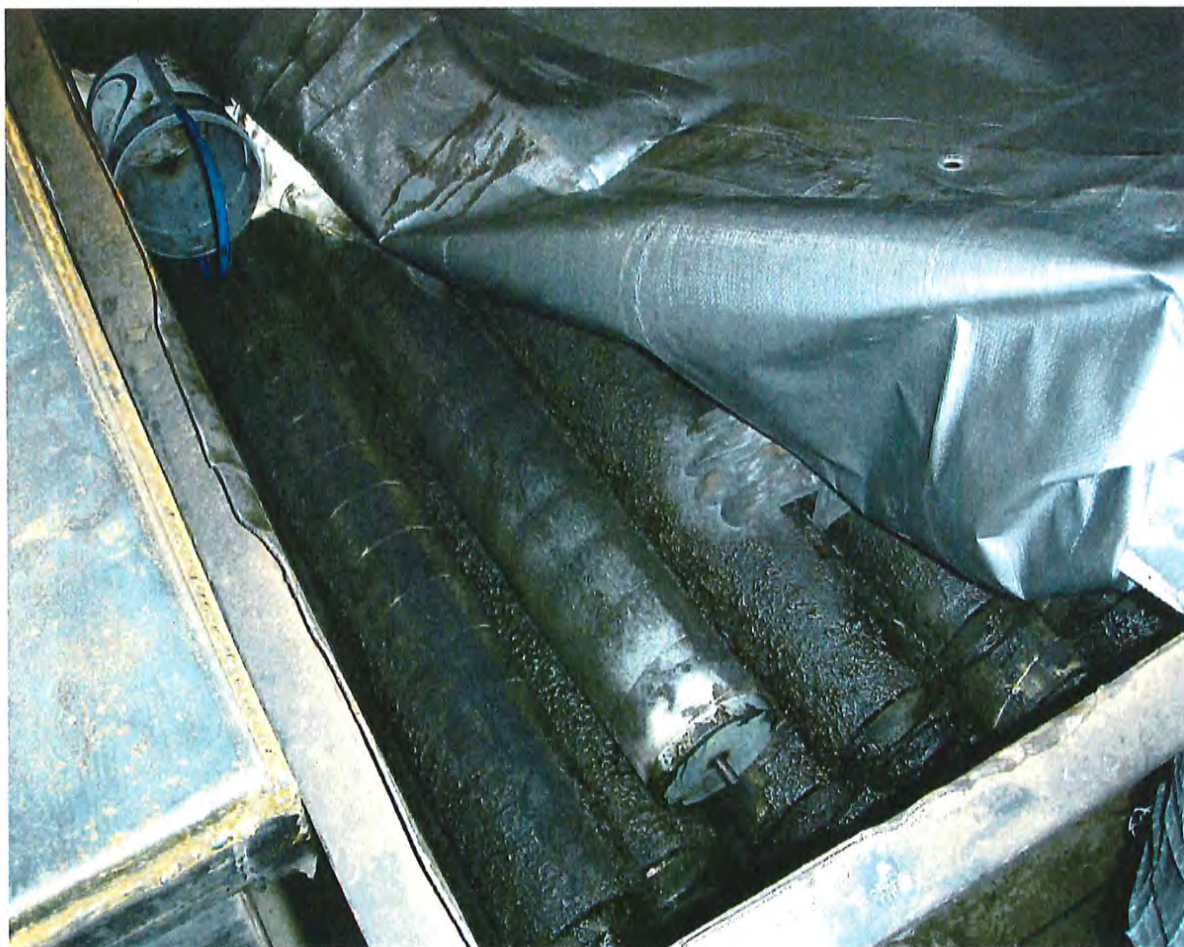
The back part of the warehouse contained many 7-yard bins stacked for future use or repair, a product storage area and other 7-yard bins with compressor filters draining off the fluids (Appendix 1, Photos 11 & 12). A small metal container was observed holding a heating unit to contain leaking fuel. However, the container was leaking fuel to the concrete floor (Appendix 1, Photo 14).

| Description: | Large metal container (7 yards) with compressor filters. PID reading of 1.8 ppm | | | | |

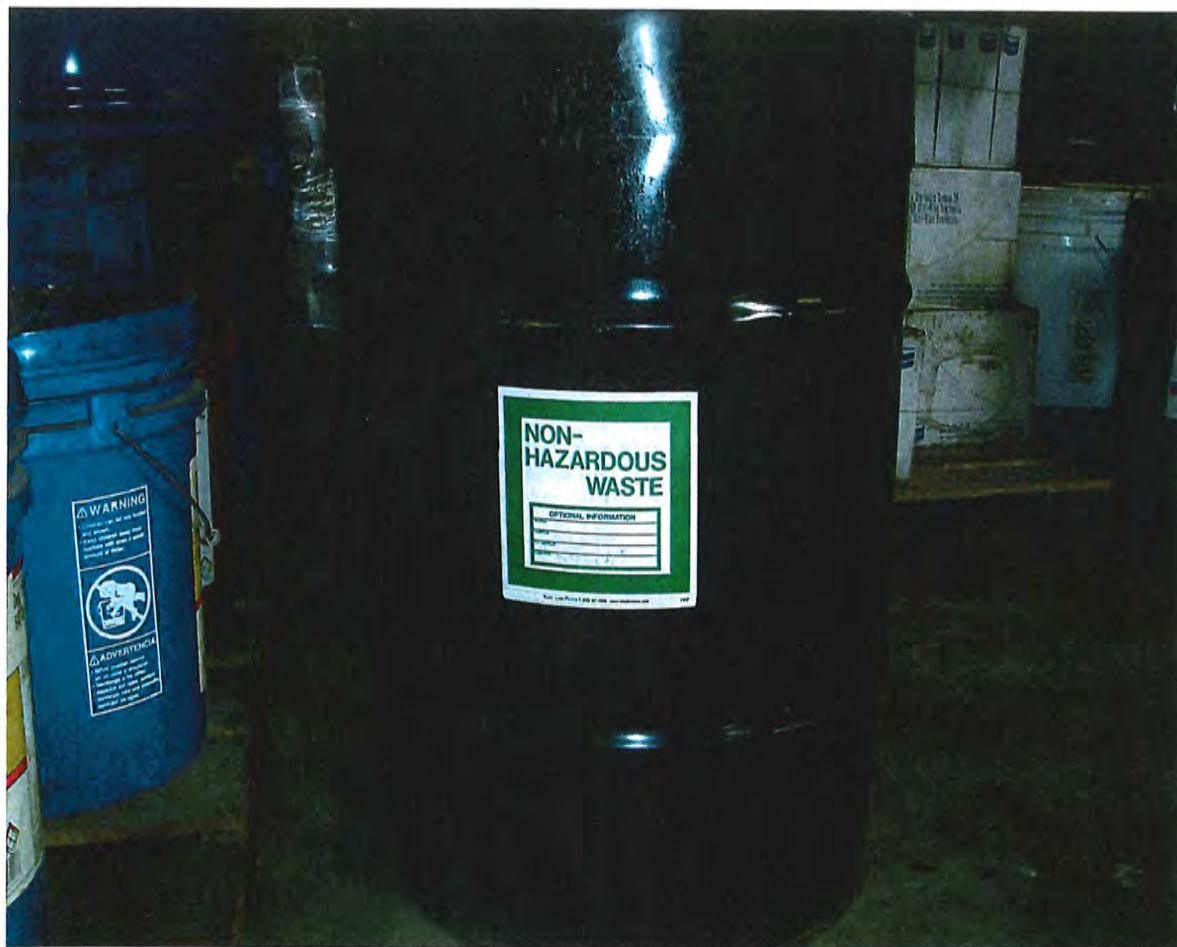
- One drum with a non-hazardous waste label, labeled as “solvent” (Appendix 1, Photo 13 & 28).

| Description: | Drum in warehouse labeled Non-hazardous waste solvent | | | | | |

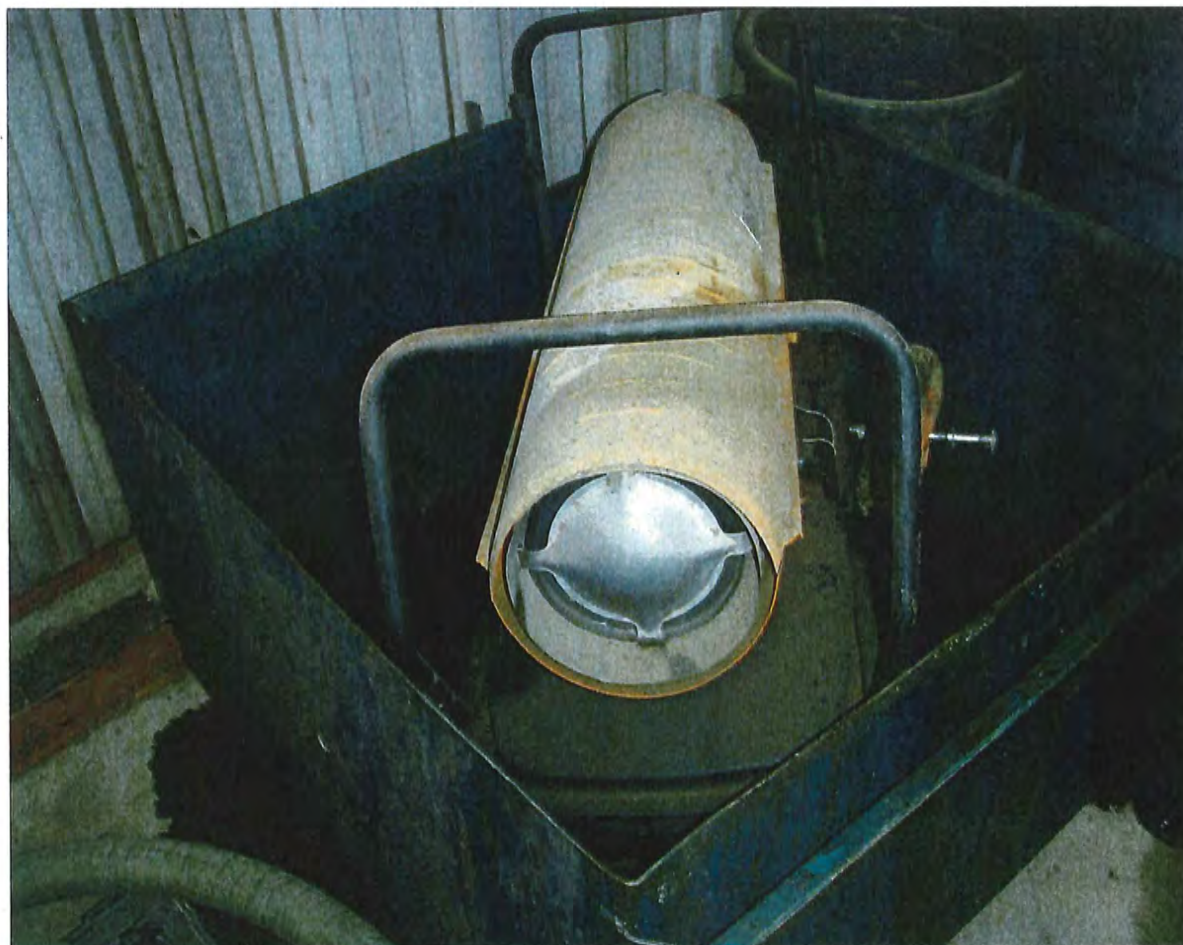
| Description: | Metal container with a heater and fuel. The container was leaking. | | | | | |

| Regulation | Concerns in 2017 | Concerns March 28-29, 2019 |
|---|---|---|
| <b>279.54(b) Condition of units. (containers/tanks) in good conditions and not leaking (no visible leaks).</b> | <i>Dumpster in warehouse was leaking.</i> | Leaking bin observed in warehouse containing a heater unit. |

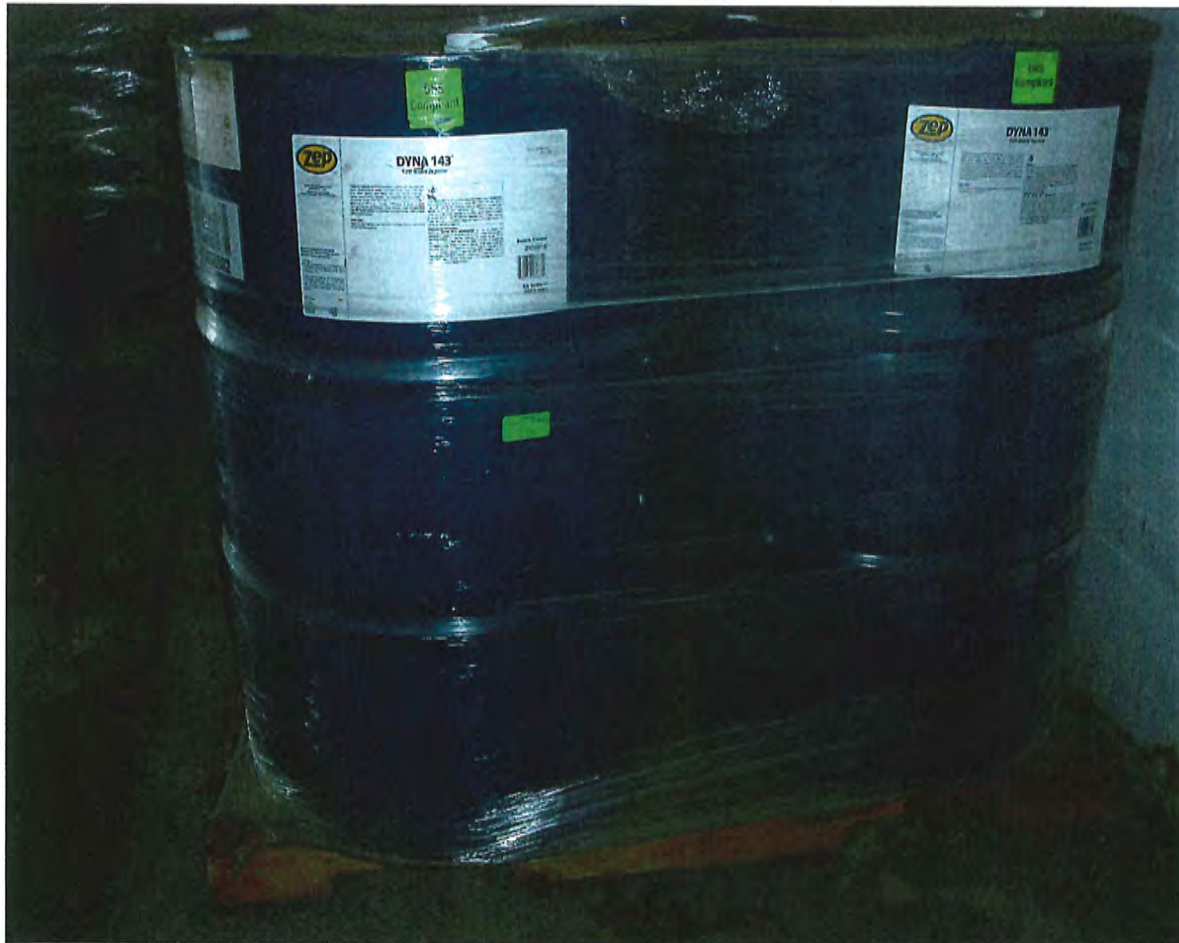
The EPA team observed five (5) drums on wood pallets labeled triethanolamine 99% (Appendix 1, Photo 16). Mr. January Jr. did not know if the drums contained product or waste. We asked him to provide information related to these drums. Also observed were four (4) Zep DYNA 143 drums in shrink wrapped. Mr. January Jr. indicated it was product they were looking to sell (Appendix 1, Photo 15).

| Description: | Drums of product in ER Building. Cris January Jr. said they are trying to find a buyer. | | | | | |

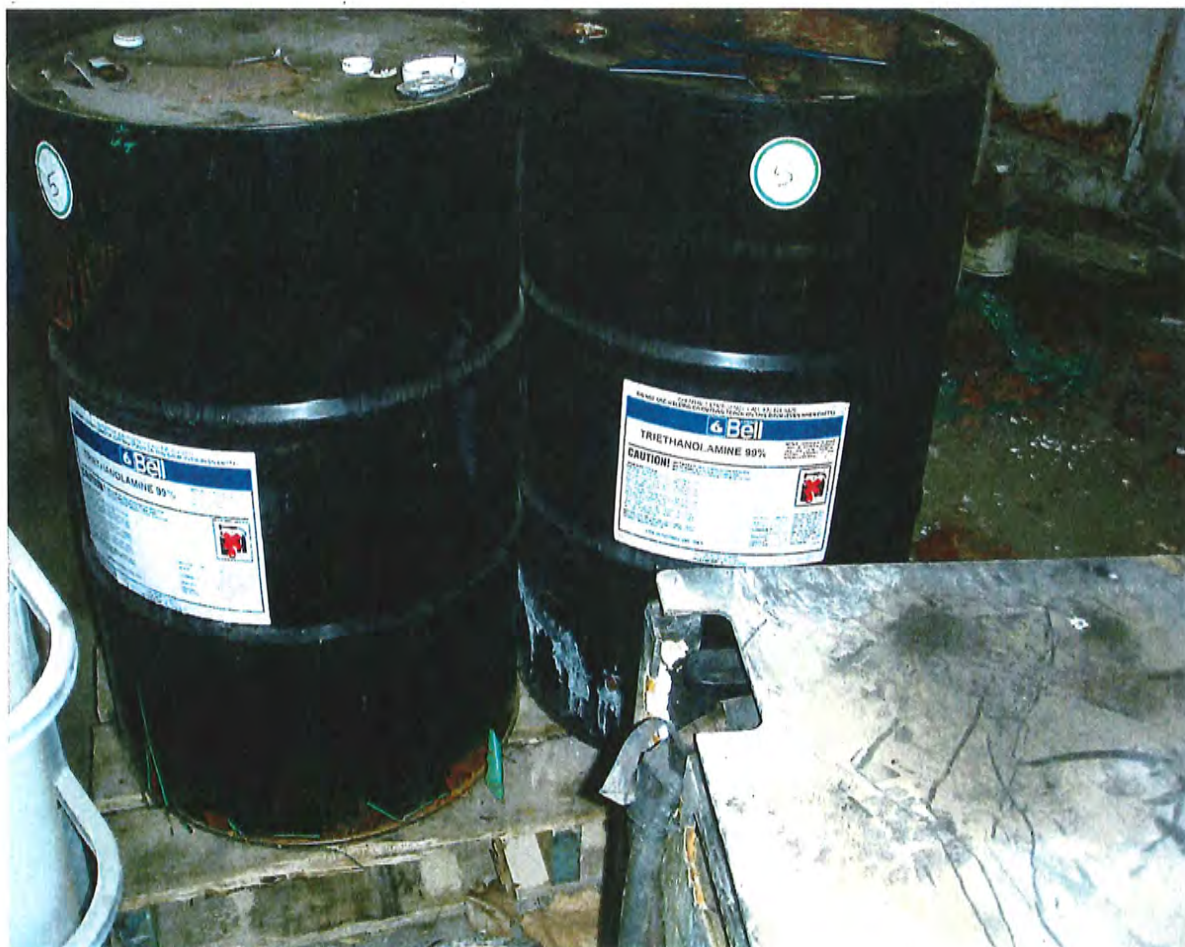
| Description: | Drums in ER Building. Cris January did not know what they were used for at the time. | | | | | |

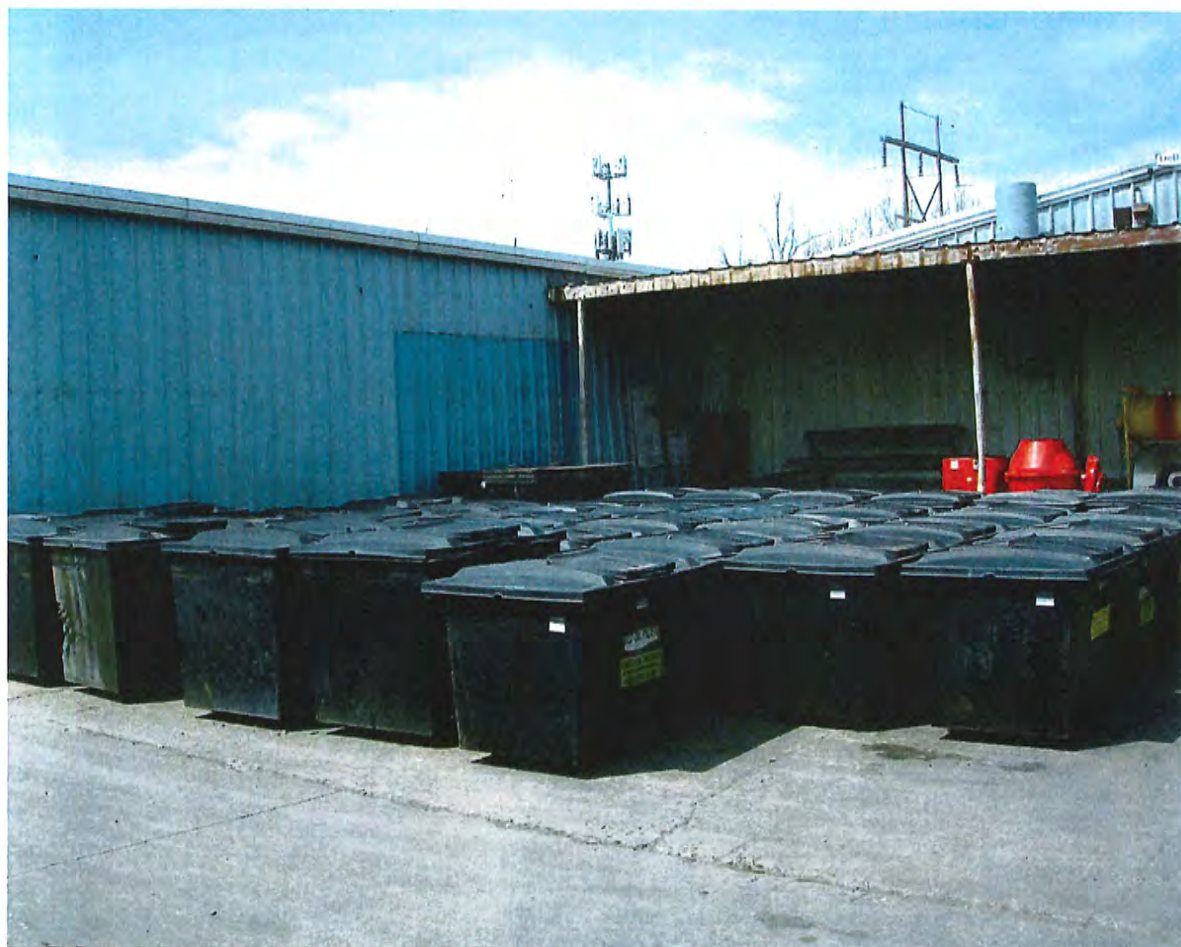
We observed approximately 38 used oil filter containers (bins) behind the main warehouse. Mr. January Jr. said these were 4-yard bins (Appendix 1, Photo 17). Mr. January Jr. said the contents of these containers would eventually be emptied into the roll-off containers. He did not know how long the containers would sit before being put into the roll-offs.

Bins were staged in rows without aisle space. The EPA team was unable to gain access to all the bins except for the ones on the perimeter (Appendix 1, Photo 17). EPA observed the contents of several bins containing debris of various types, and used fuel and oil filters (Appendix 1, Photos 18, 24 & 25). A 7-yard bin, located against the warehouse wall, was full of soil. Mr. January Jr. was asked for waste profiles for all the bins and shipping papers.

| Description: | Overview of used oil filter containers (bins) | | | | | |

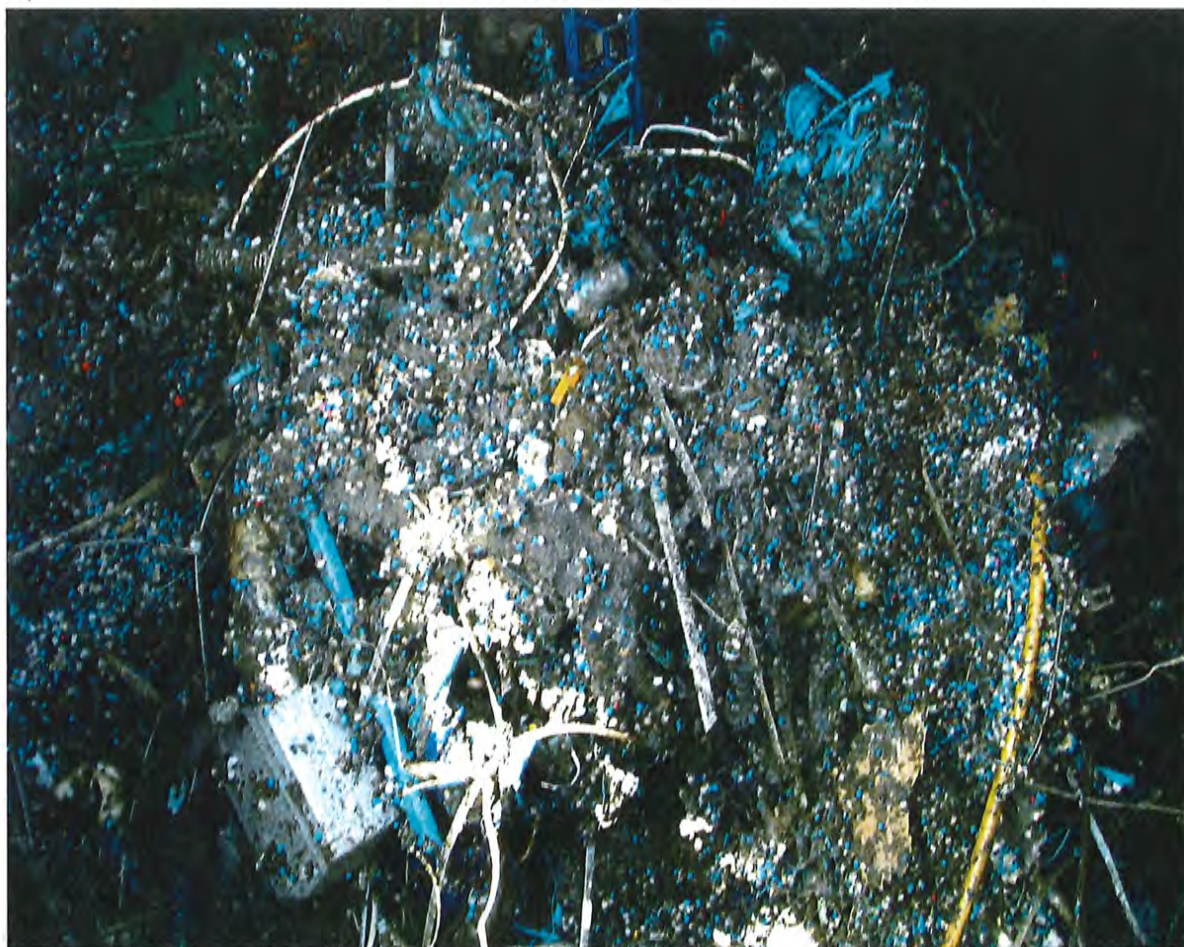
| Description: | Contents of one of the used oil filter containers | | | | | |

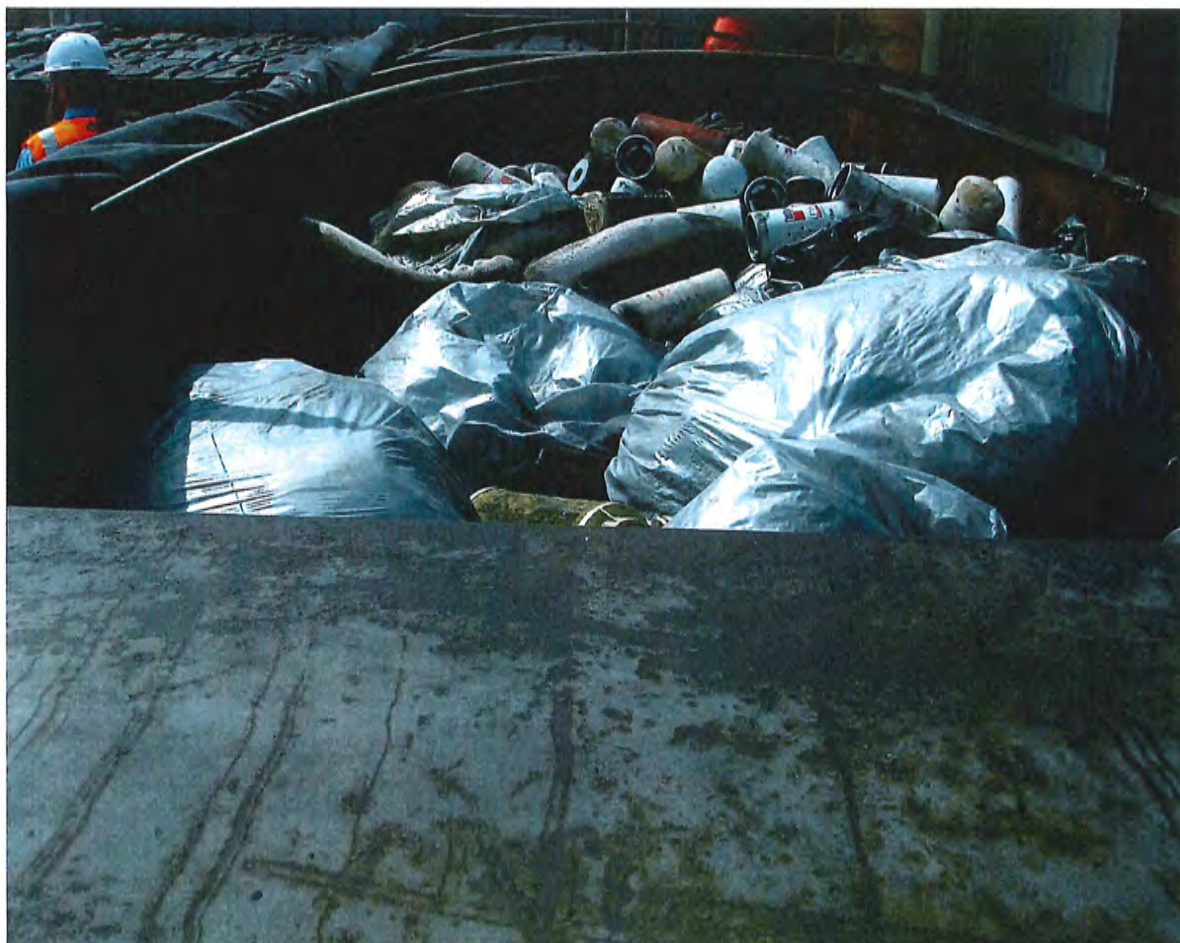
- #R25007: used oil, fuel and other filters, garbage bags, debris. (Appendix 1, Photos 19 & 20).
- #R25038: empty
- #DE-SW-439 or DE-NW-243: grease with rain water. Mr. January Jr. said drums put into the roll-off are taken to the landfill.
- #R25036: frac sand.
- #R25022 – used/spent carbon. Mr. January Jr. identifies the generator as RedCliff Midstream and contents destined for landfill.

| Description: | Roll off box R25007 with used filters and other wastes. PID reading 15 ppm. | | | | | |

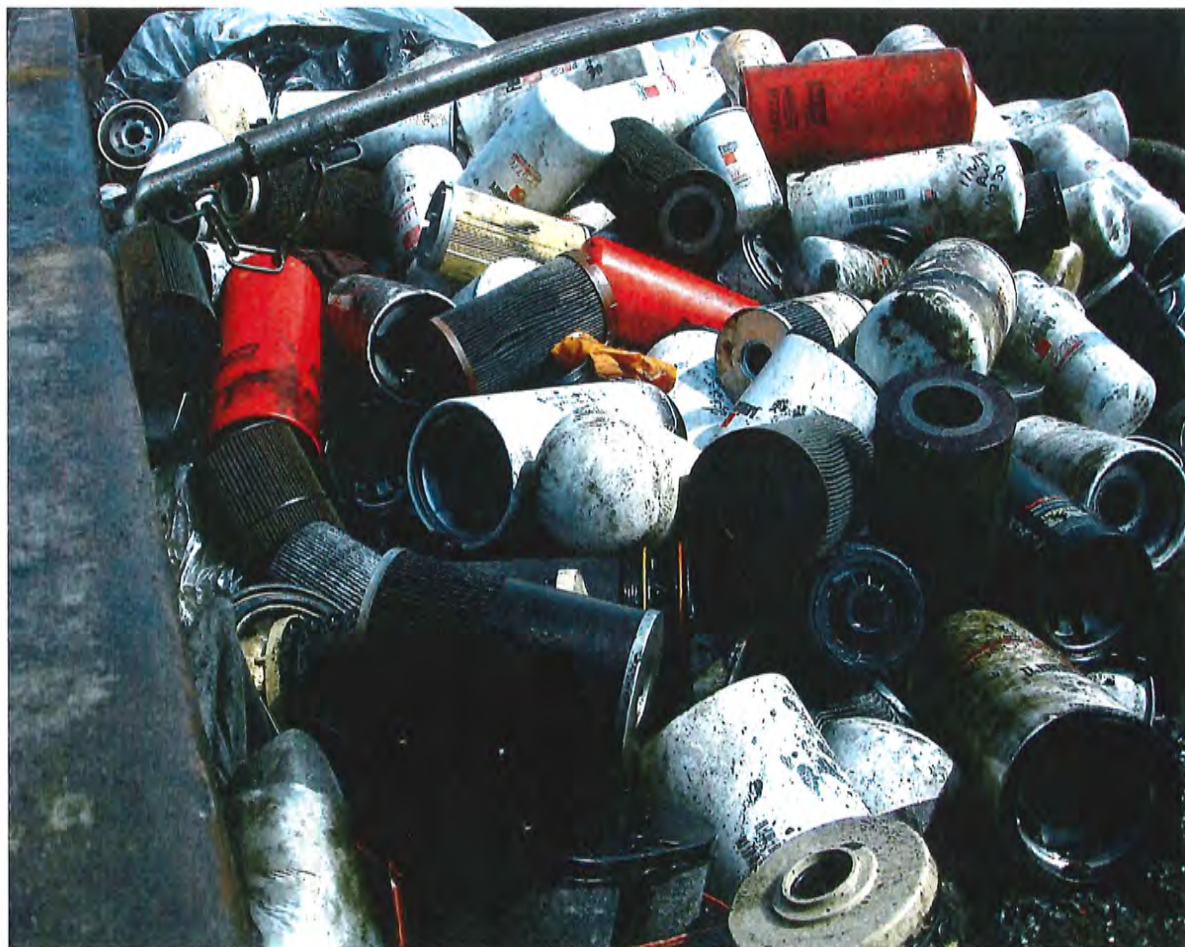
| Description: | Close-up inside roll off box R25007 | | | | | |

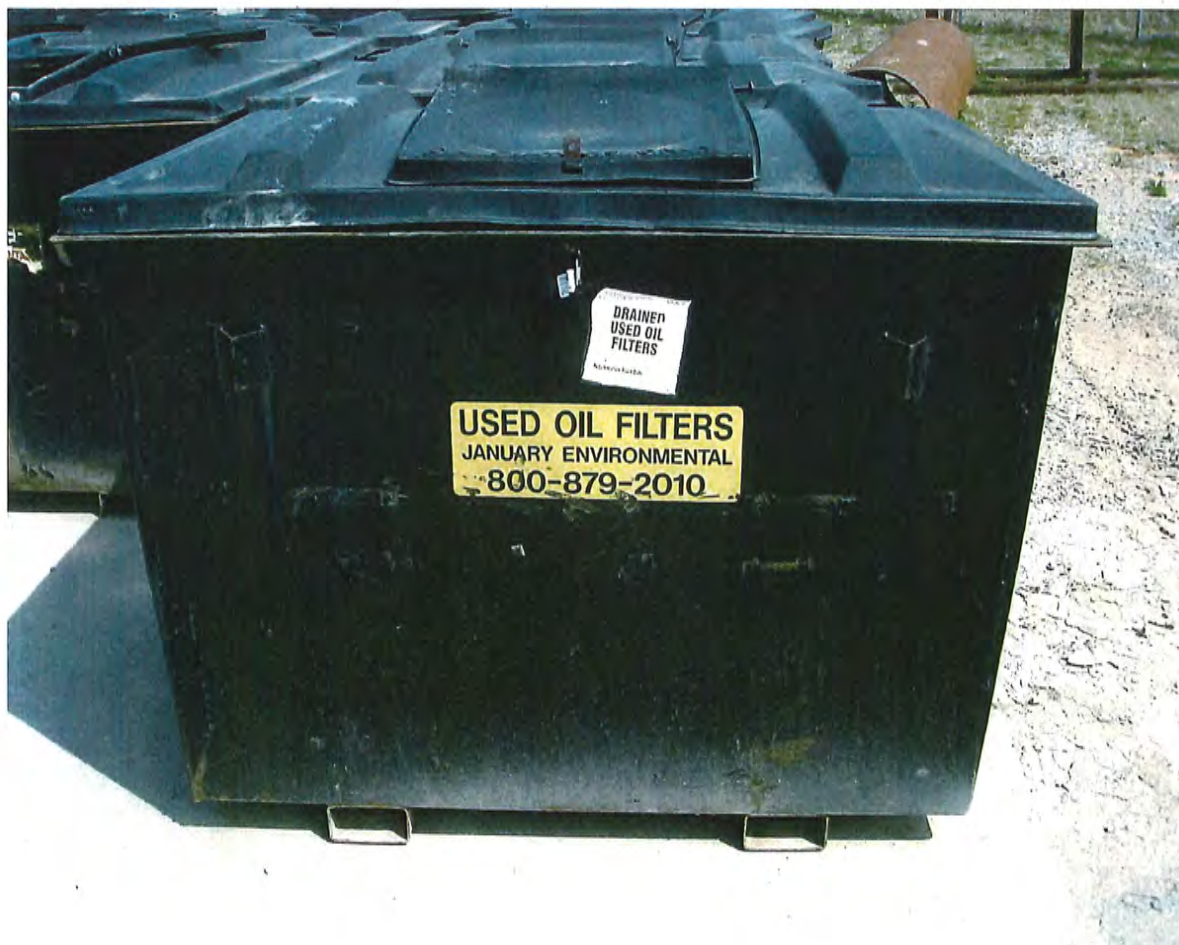
Used oil filter bins were also located along the side and behind the ER/Maintenance Building (Appendix 1, Photos 21 & 26). These bins were delivered to the facility during the inspection and unloaded in this location (Appendix 1, Photo 23). Bins contained spill pads, frac sand, various filter types, tyvek, gloves, and soil (Appendix 1, Photo 22). The EPA team detected an odor when the lid of the bin containing soil was lifted. Some bins were located directly along the edge of the concrete pad adjacent to the ground with no berm or edging.

| Description: | Used oil filter container behind ER/Maintenance Building. No curbing on concrete pad. | | | | | |
