**UNITED STATES ENVIRONMENTAL PROTECTION AGENCY**

Re: EPA RCRA Case Development Inspection – March 28-29, 2019; EPA ID# OKD042146324  
– January Environmental Services – Oklahoma City, Oklahoma

**INSPECTION REPORT**

**Case Development Inspection (CDI)**

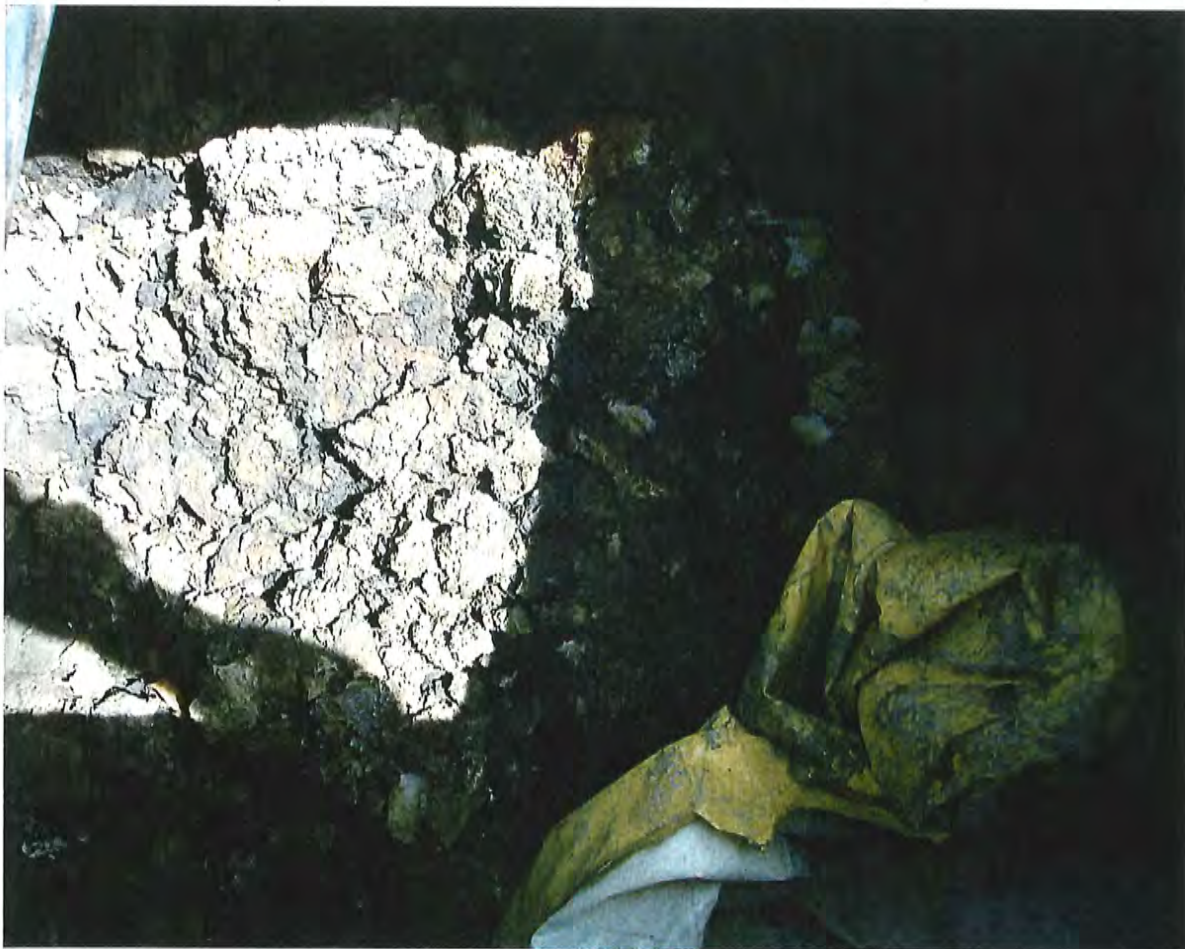
| Description: | Contents of used oil filter container in picture 21 | | | | | |

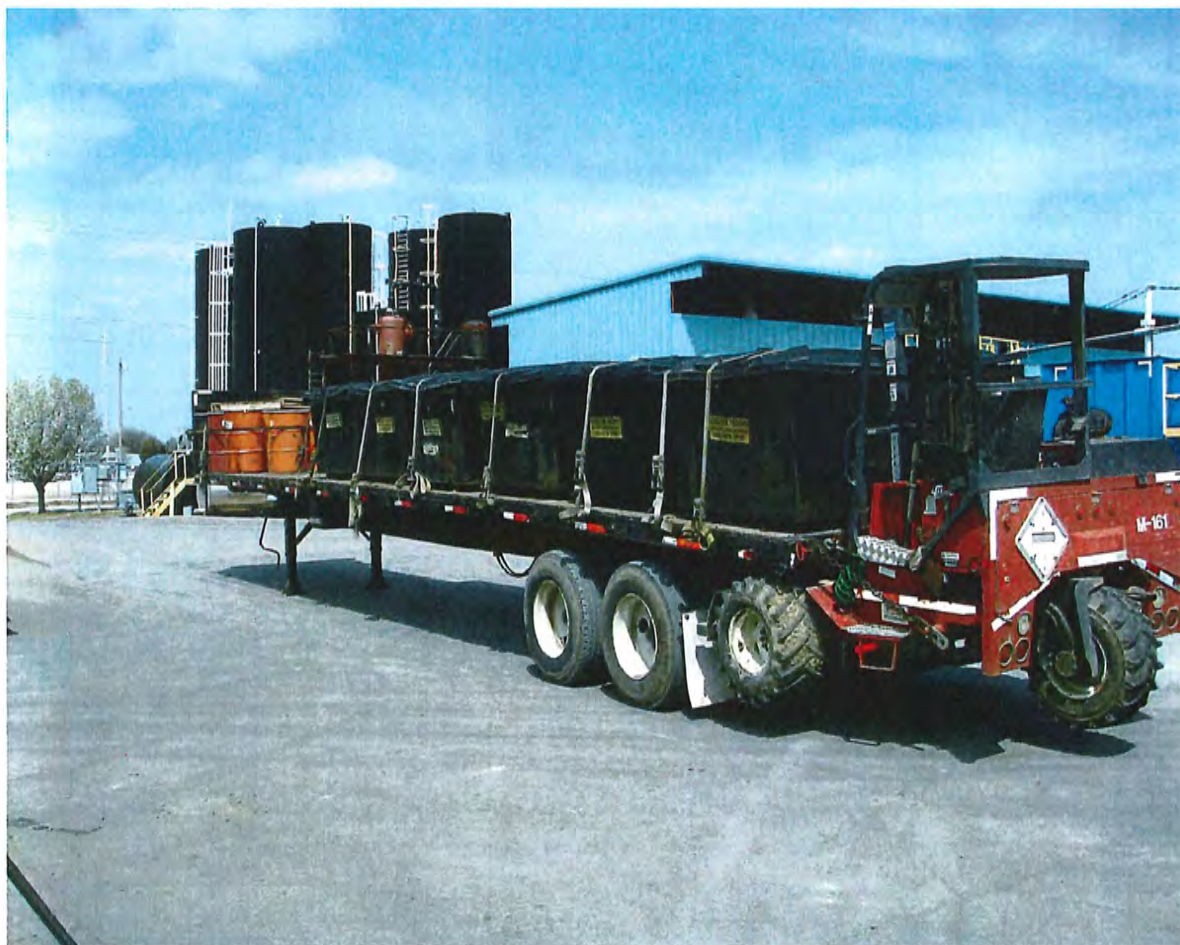
During the walkthrough on 3/28/2019, a collection run returned a load to JES. The load contained used oil filter bins and several drums. On 3/29/2019, the load had been offloaded from the trailer. The customer was identified by Mr. January Jr. as KLX Energy and La Salle Co.

| Description: | Trailer onsite that was ready to offload | | | | | |

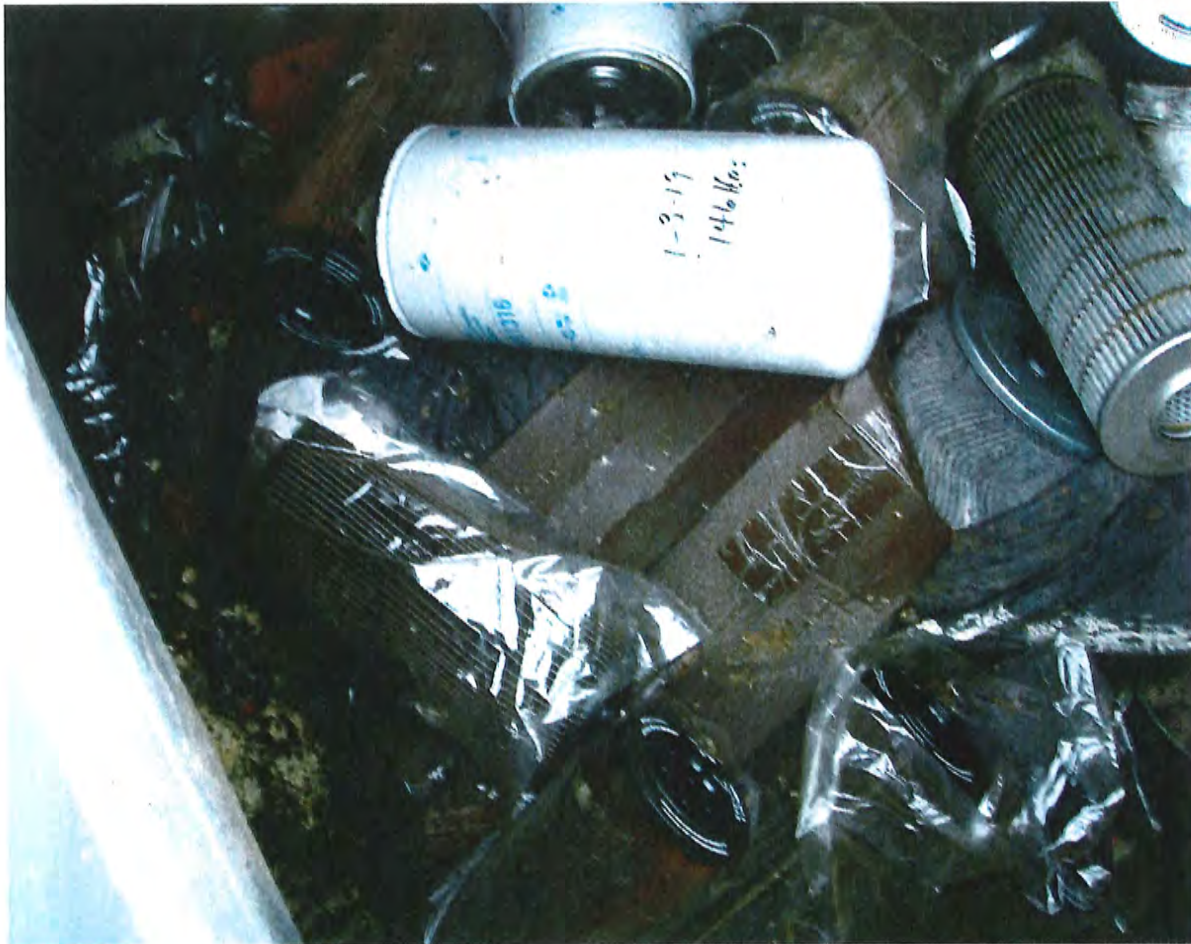
- Use of "sniffer" to determine halogen content of used oil (Appendix 1, Photos 29 through 33).
- Used oil filters observed in roll-off containers not crushed or punctured Appendix 1, Photos 19, 20, 23 & 24).
- No aisle space around totes and used oil filter bins (Appendix 1, Photo 17 & 26.
- Tanks 2, 16, 17 and 18 not labeled with the words "used oil" (Appendix 1, Photos 3 & 4)
- Storage of drum containing waste MEK since 11/2019 (Appendix 1, Photo 9 & 10).
- No labeling on MEK waste drum (Appendix 1, Photo 9 & 10).

| Description: | Contents of used oil filter bin showing a mix of fuel and oil filters and other wastes | | | | | |

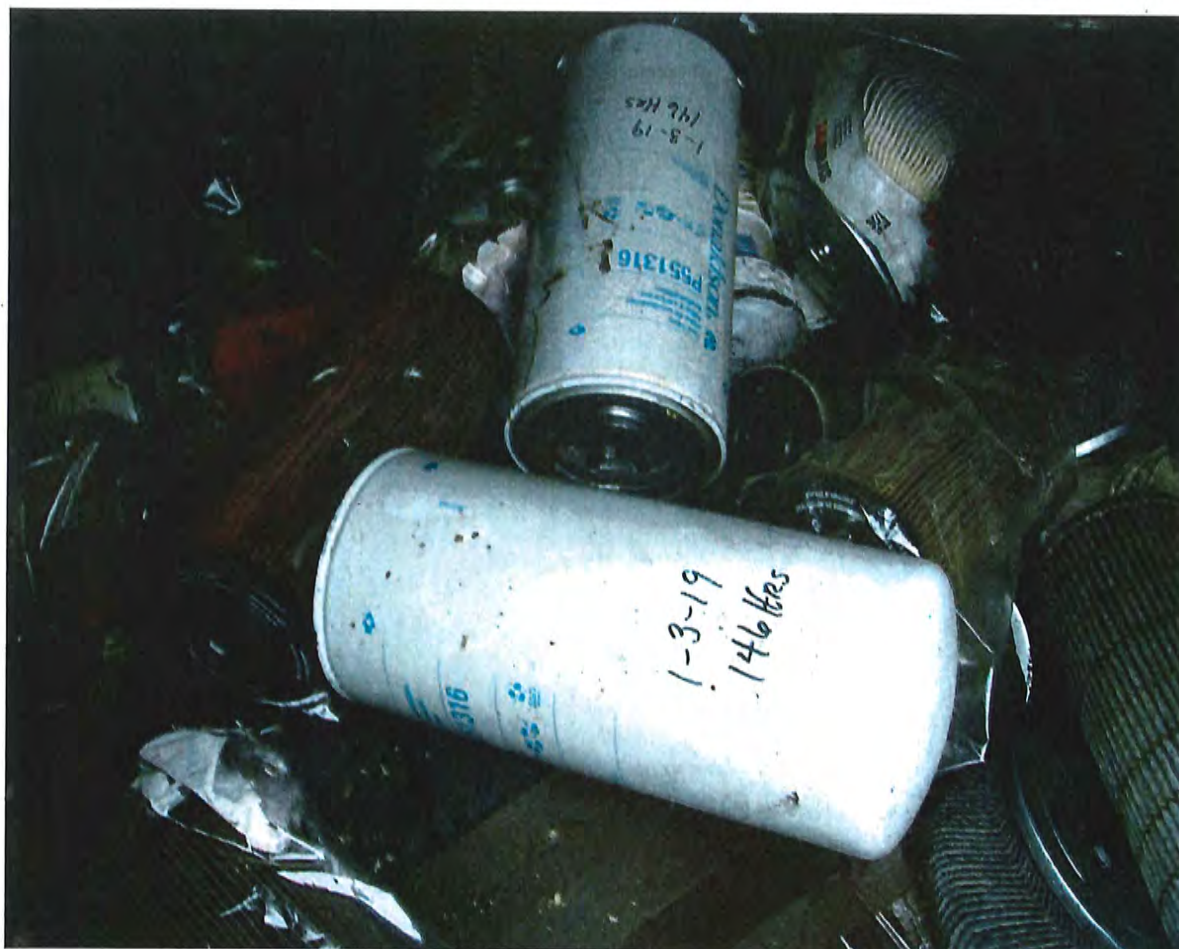
| Description: | Contents of used oil filter bin showing a mix of fuel and oil filters and other wastes | | | | | |

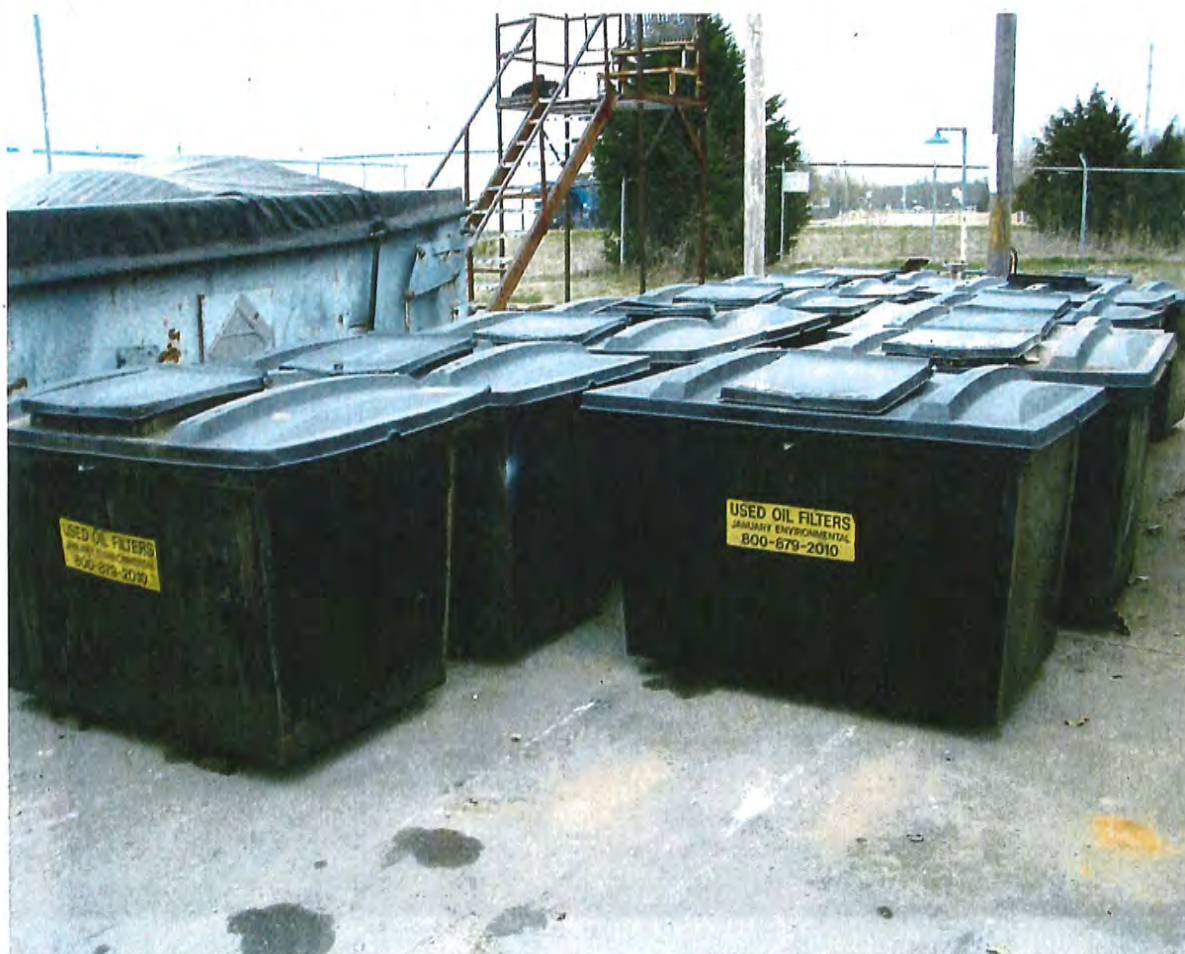
Used oil filter bins were also located along the side and behind the ER/Maintenance Building (Appendix 1, Photos 21 & 26). These bins were delivered to the facility during the inspection and unloaded in this location (Appendix 1, Photo 23). Bins contained spill pads, frac sand, various filter types, tyvek, gloves, and soil (Appendix 1, Photo 22). The EPA team detected an odor when the lid of the bin containing soil was lifted. Some bins were located directly along the edge of the concrete pad adjacent to the ground with no berm or edging.

| Description: | Used oil filter bins unloaded from the trailer in picture 23. Located on the east side of the ER/Maintenance Building. | | | | | |

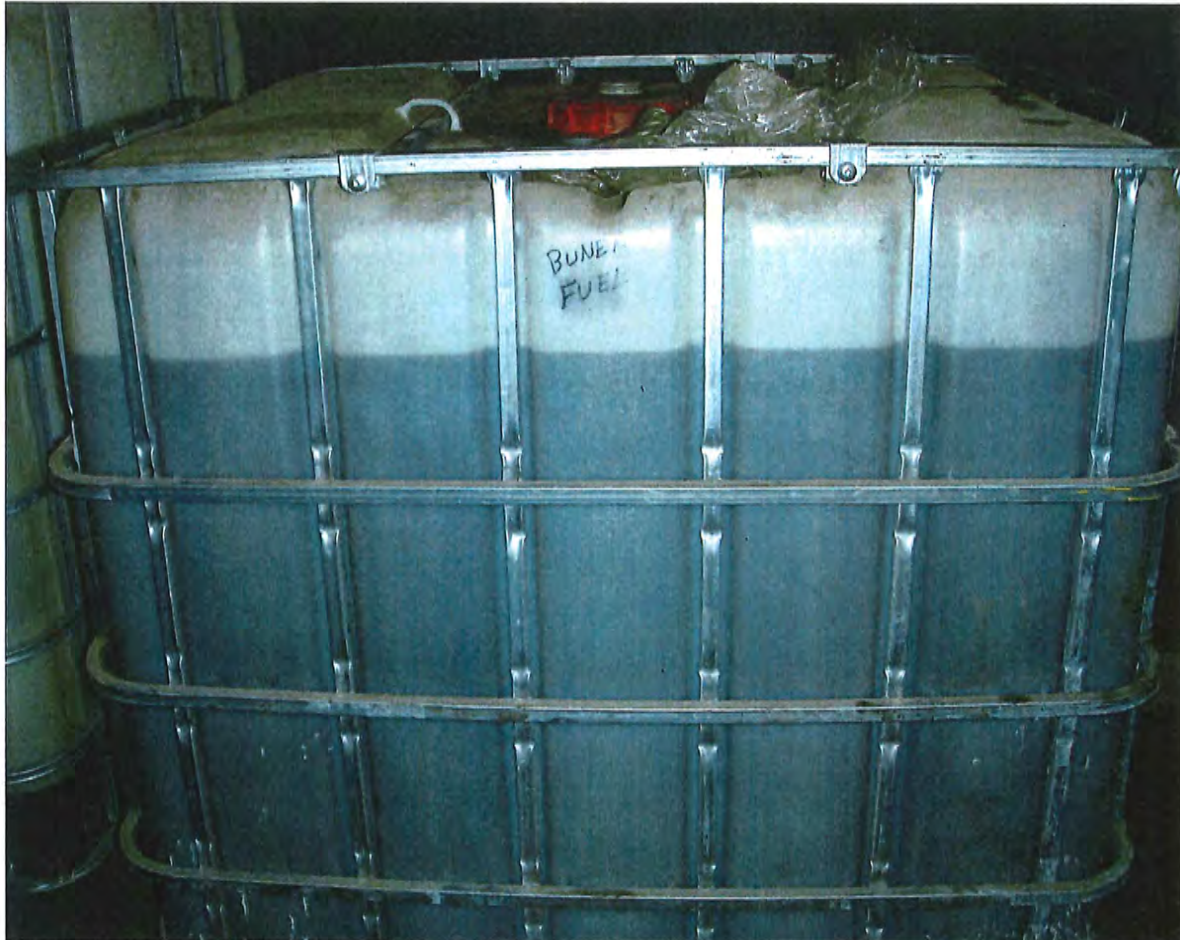
| Description: | Tote that was labeled new solvent, now labeled as Burner Fuel | | | | | |

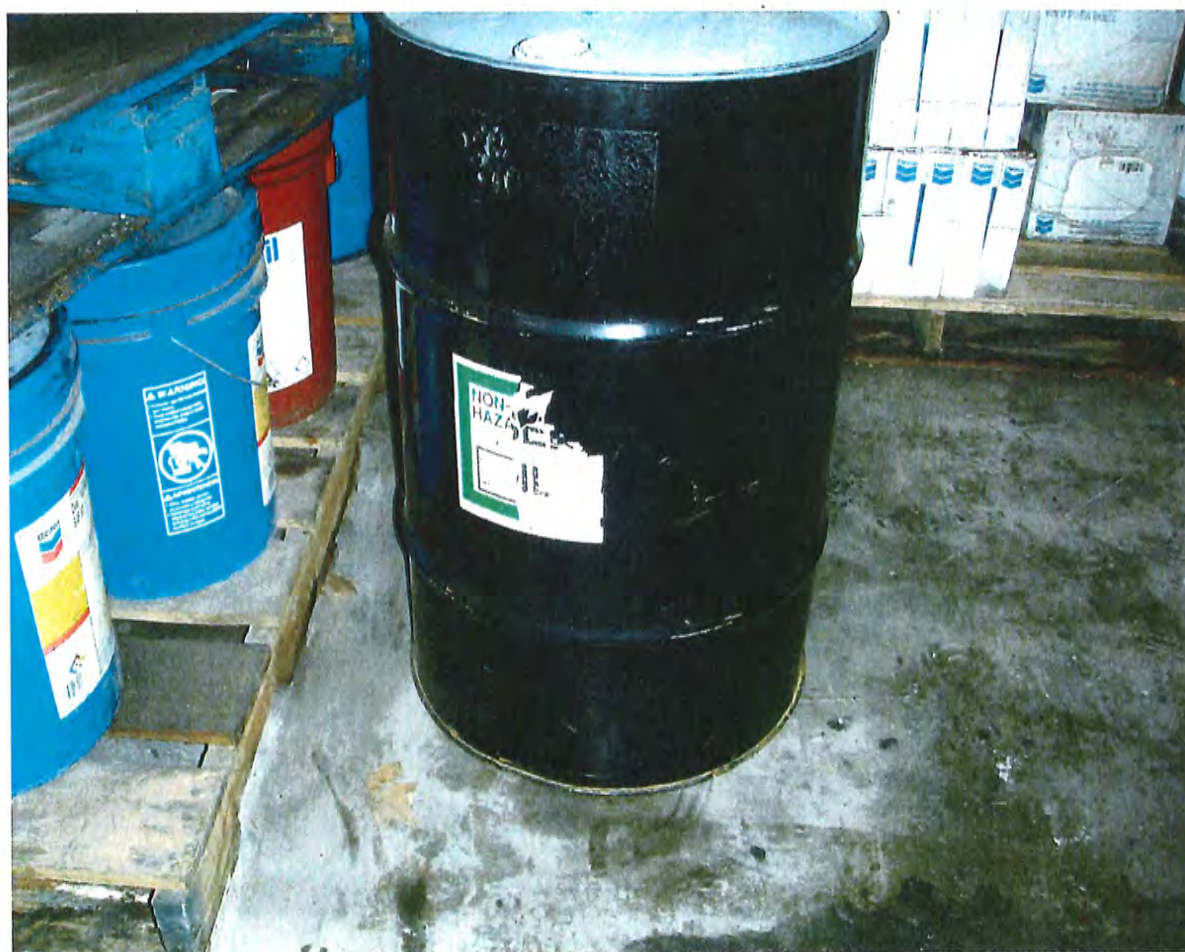
- One drum with a non-hazardous waste label, labeled as “solvent” (Appendix 1, Photo 13 & 28).

| Description: | Drum also in photo 13 with non-hazardous waste label removed. Cris January Jr. says it is leftover virgin solvent that used to be in the tote in photo 27. | | | | | |

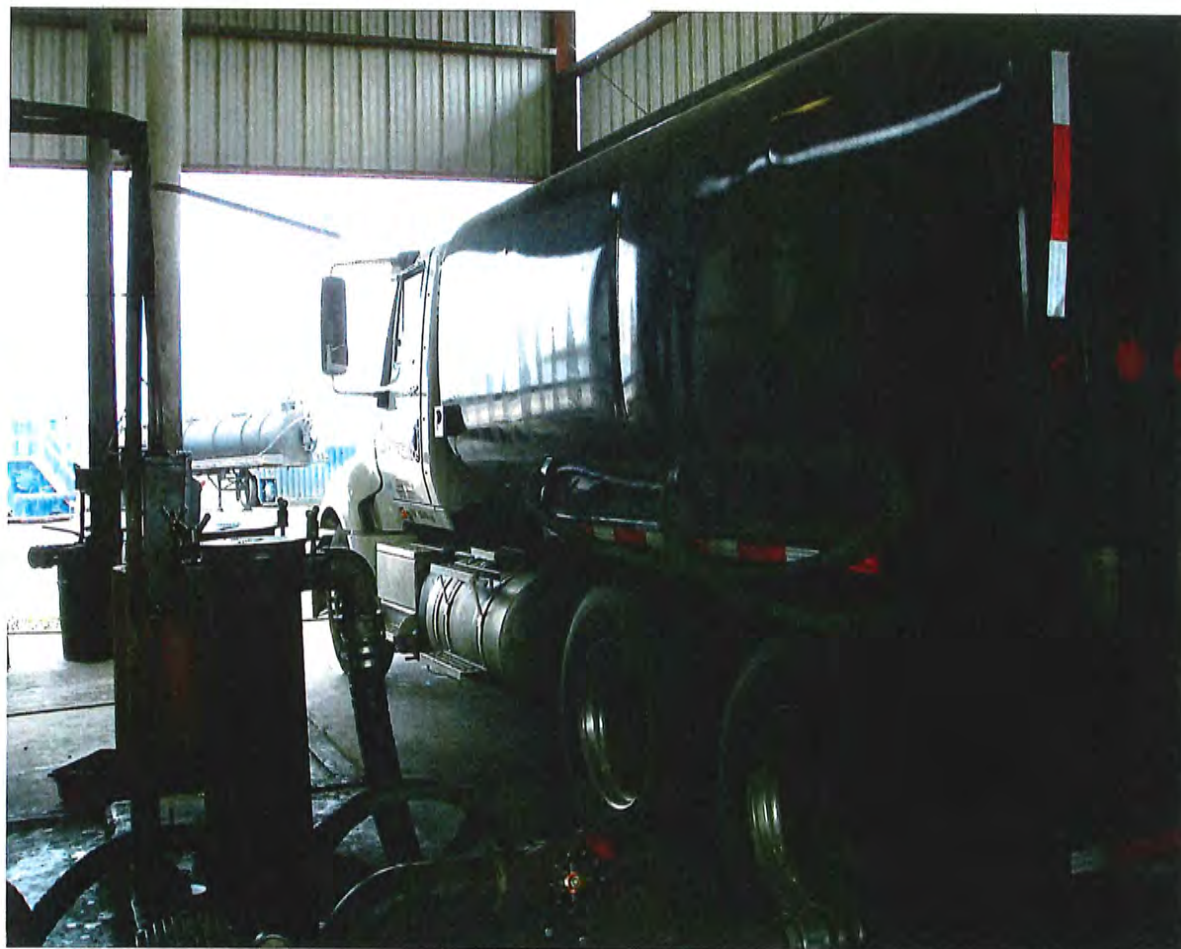
On 3/29/2019, the EPA team observed the offloading of a JES vacuum truck that had completed morning customer pickups. Mr. January Jr. explained that the employee would test the used oil using a sniffer. The employee (Daniel) conducted the testing at the top of the truck at the opening of each compartment of the tanker (Appendix 1, Photos 29 through 34). Mr. January Jr. said employees use the sniffer at the customer site and before unloading. A sample of used oil was collected and tested for specific gravity and water content.

| Description: | JES vacuum truck getting ready to unload | | | | | |

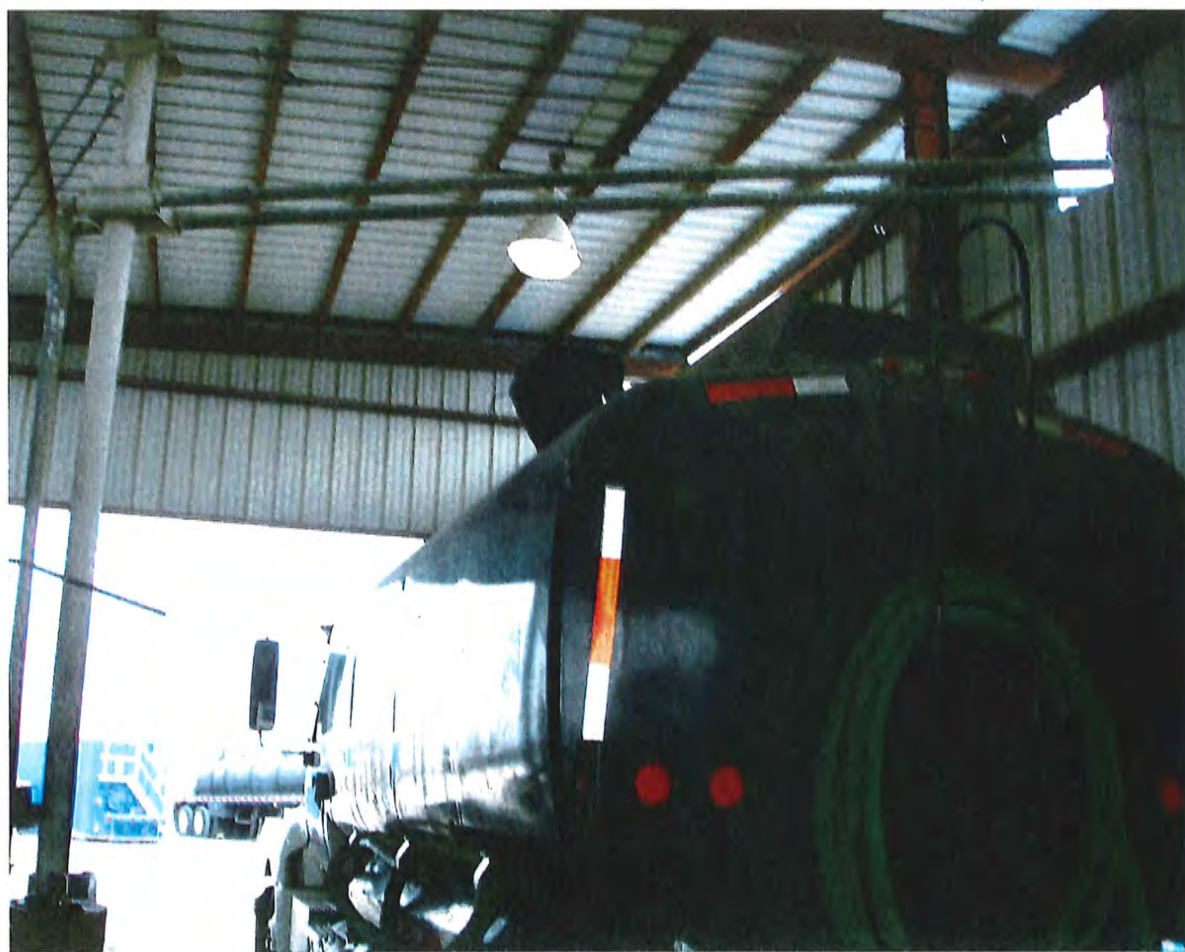
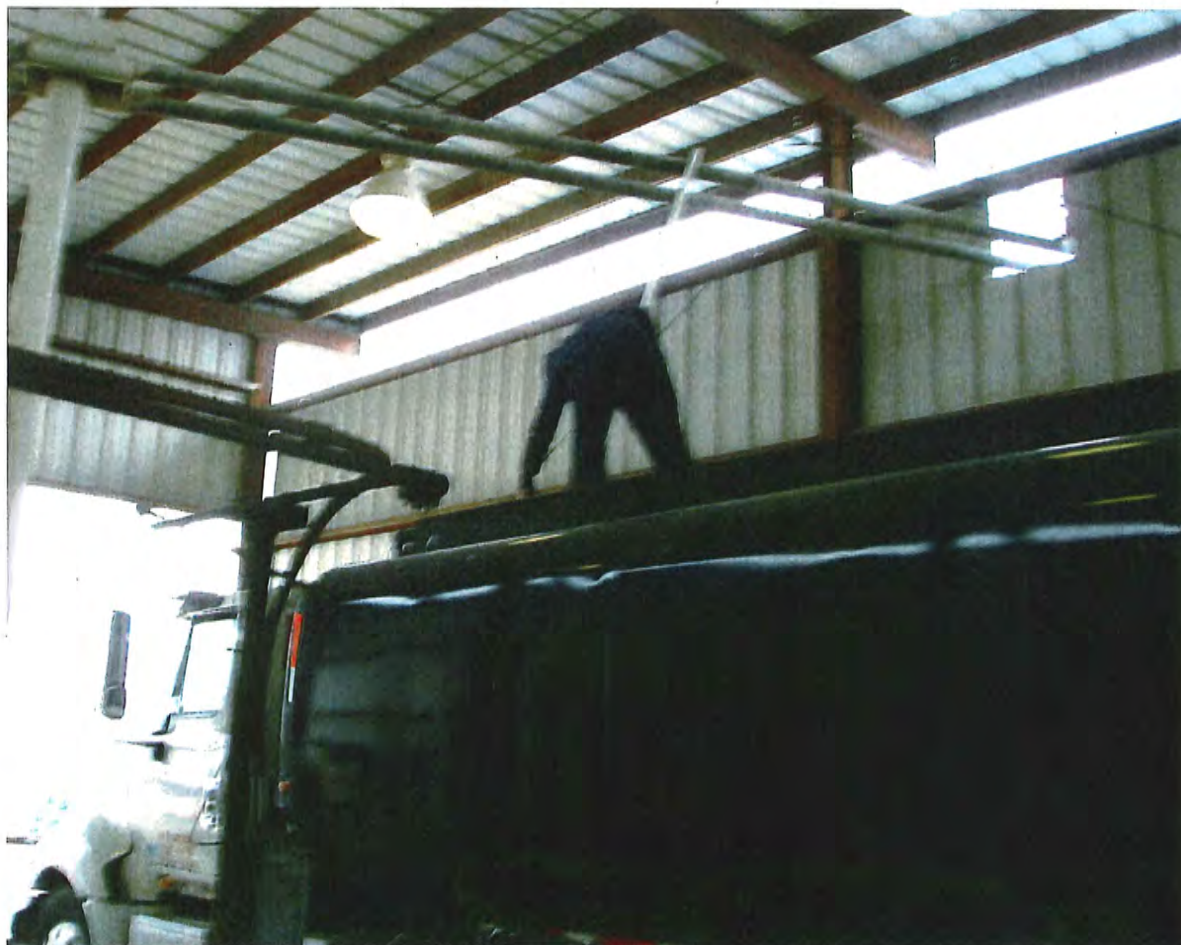
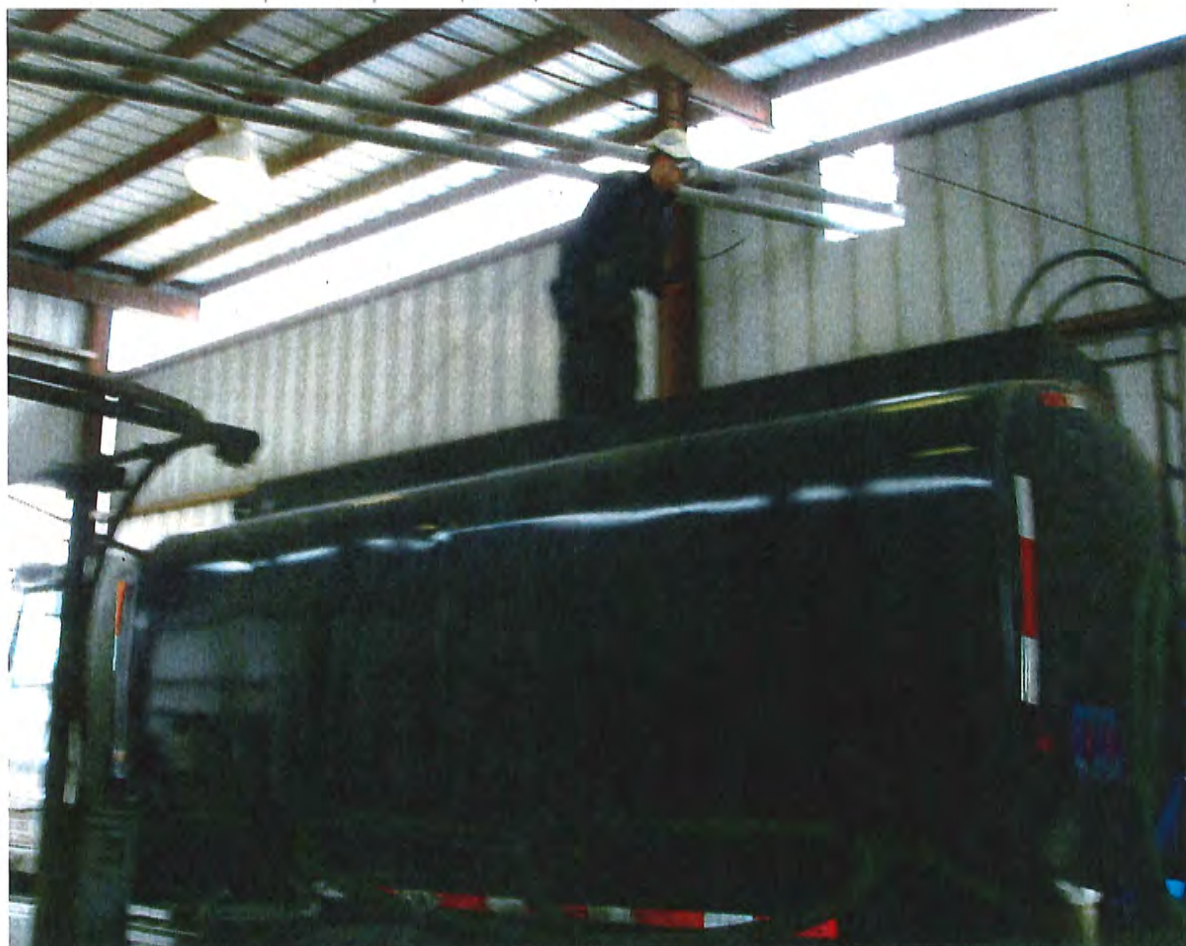
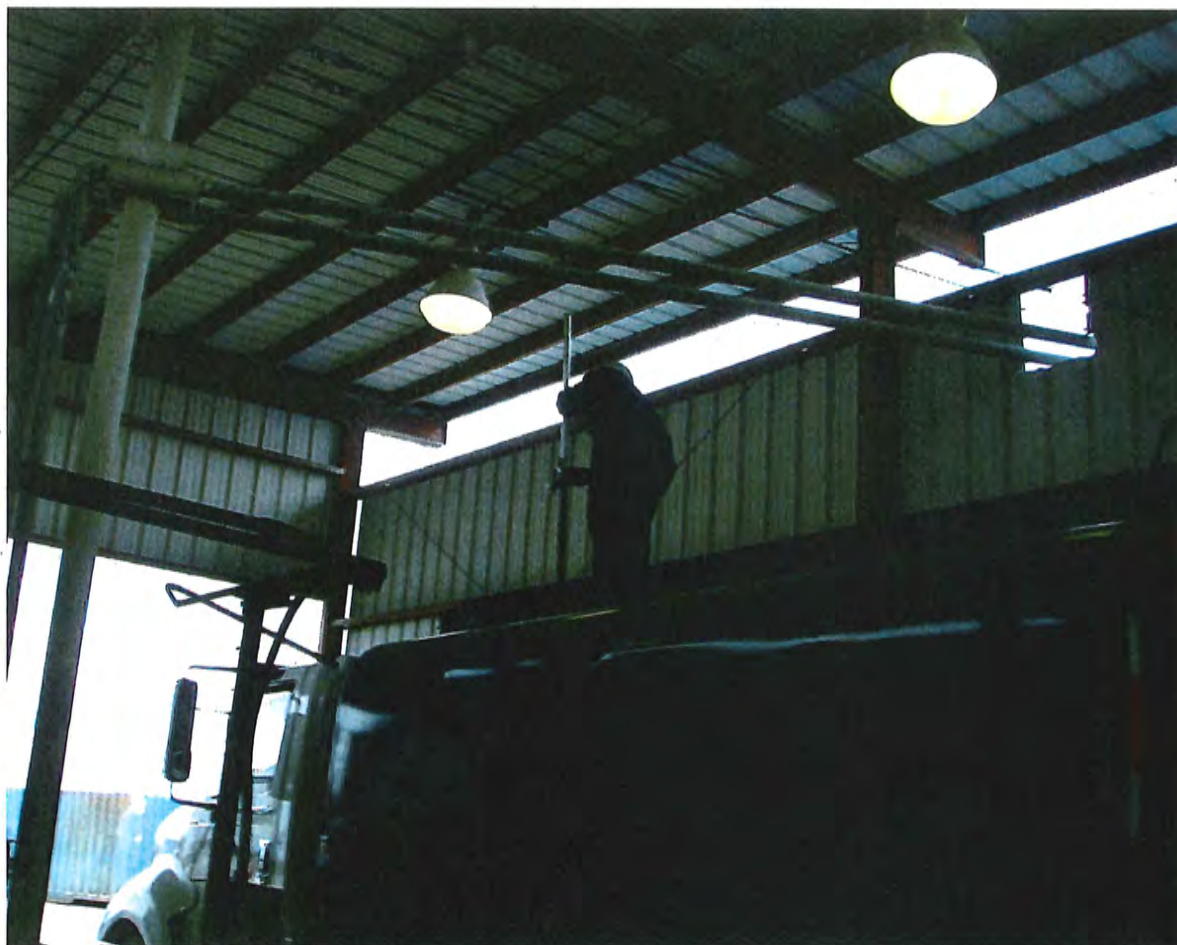
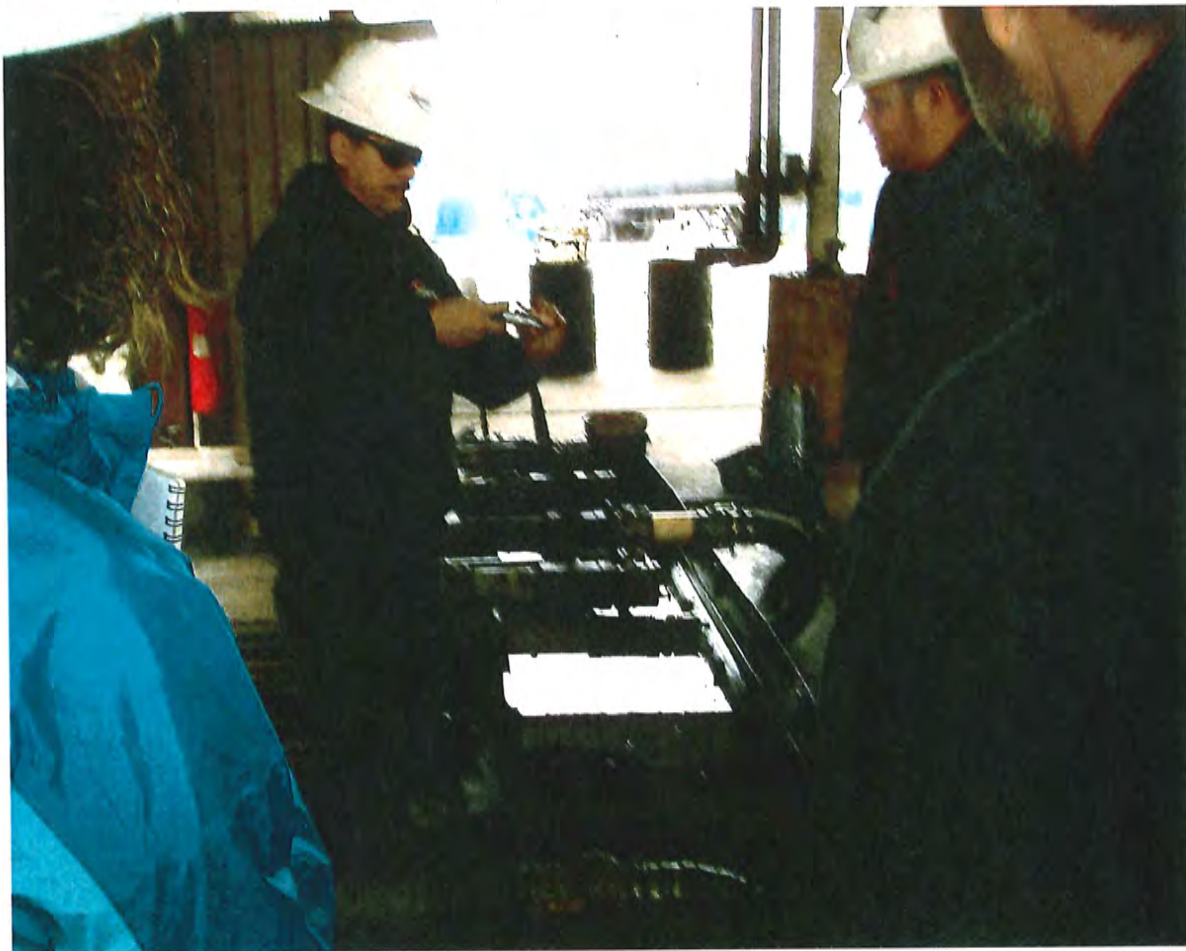
| Description: | JES employee opening hatches on top of truck | | | | | |

| Description: | JES employee taking a reading with a "sniffer" | | | | | |

| Description: | JES employee holding the sniffer after taking a reading | | | | | |

| Description: | JES employee pulling a sample of the truck's contents | | | | | |

| Description: | JES employee taking a gravity measurement | | | | | |

| Regulation | Concerns in 2017 | Concerns March 28-29, 2019 |
|---|---|---|
| <b>279.53 - processor must determine total halogen content of used oil managed at facility is below 1,000 ppm</b> | <i>Using unapproved method "sniffer". JES indicated use of Clor-D-tect but no records and contradicting statements of use.</i> | EPA inspectors observed JES employees use a "sniffer" during the unloading of used oil collected that morning from customers. Clor-D-tects were not used. |
