**Region 6 Enforcement and Compliance Assurance Division  
INSPECTION REPORT**

| Inspection Date(s): | 04/16/2019 | | |
| Company Name: | <b>City of Lewisville</b> | | |
| Facility Name: | <b>Department of Public Services - Water Production</b> | | |

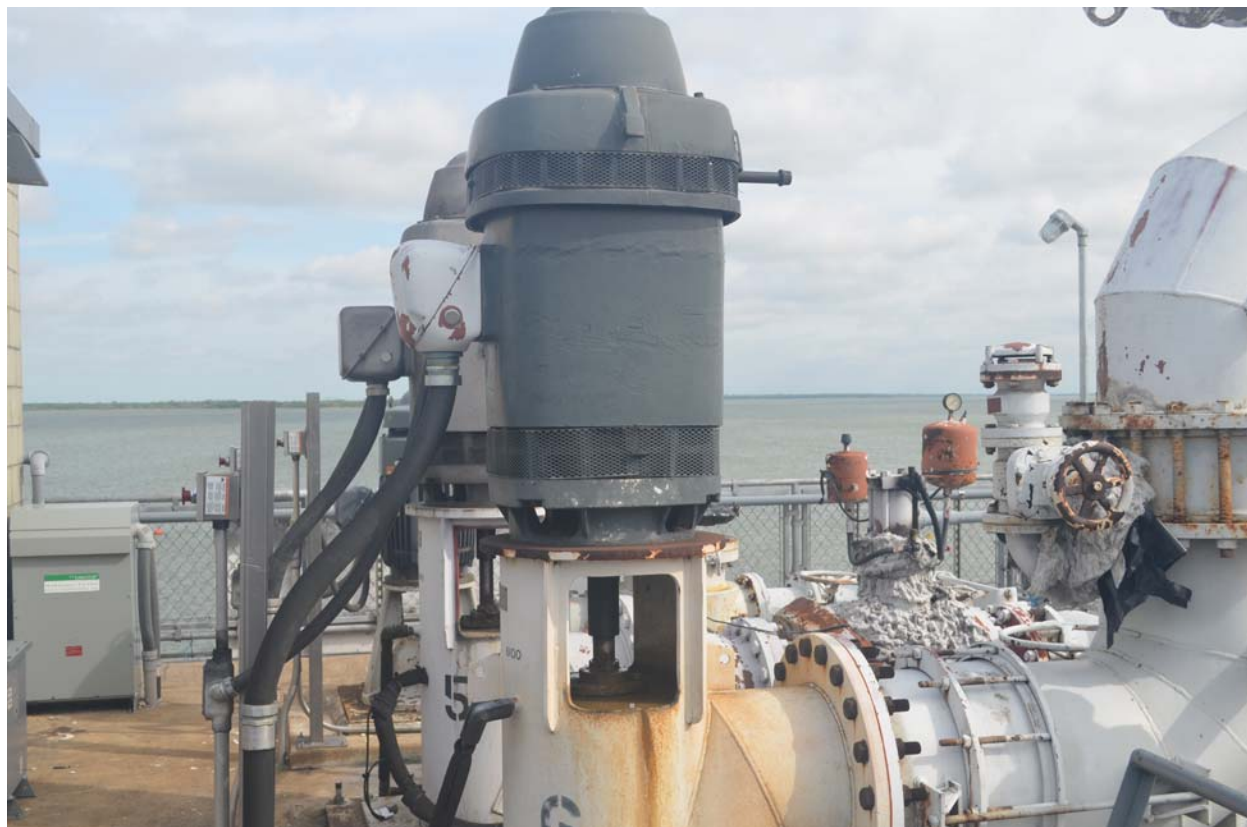
Photo No. 1

Description: Lewisville Water Intake Station pumps

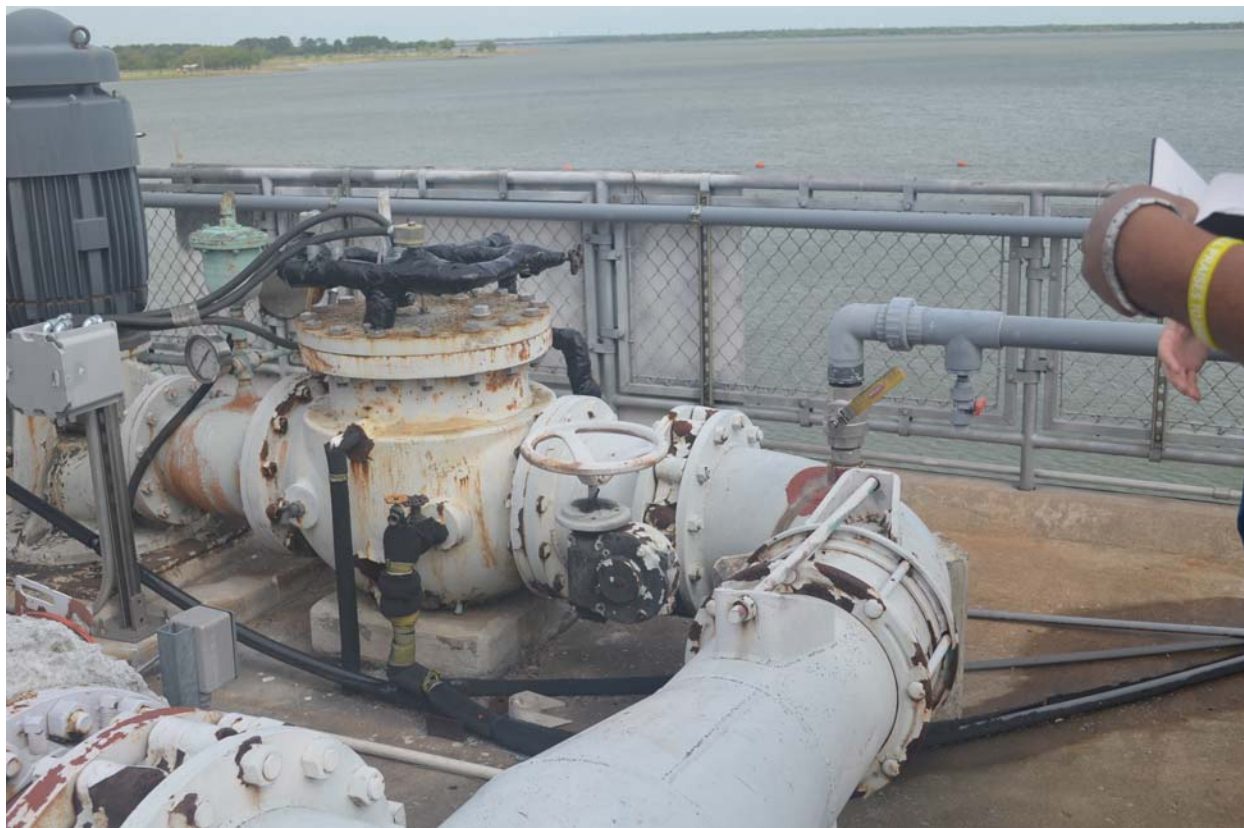
Photo No. 2

Photo File Name: H:\6PD\6MM-XP\Enforcement\ENFORCEMENT SENSITIVE\FY2017\2017-084  
Lewisville, TX Copper Ion Generator\Lewisville Water Plant Pictures 4-16-19\DSC\_0076.JPG  
Date of Photo: April 16, 2019  
Time of Photo: 10:15 AM  
Photographer: Chuck Ruple  
Description: Lewisville Water Intake Station Colloidal copper solution injection point #1

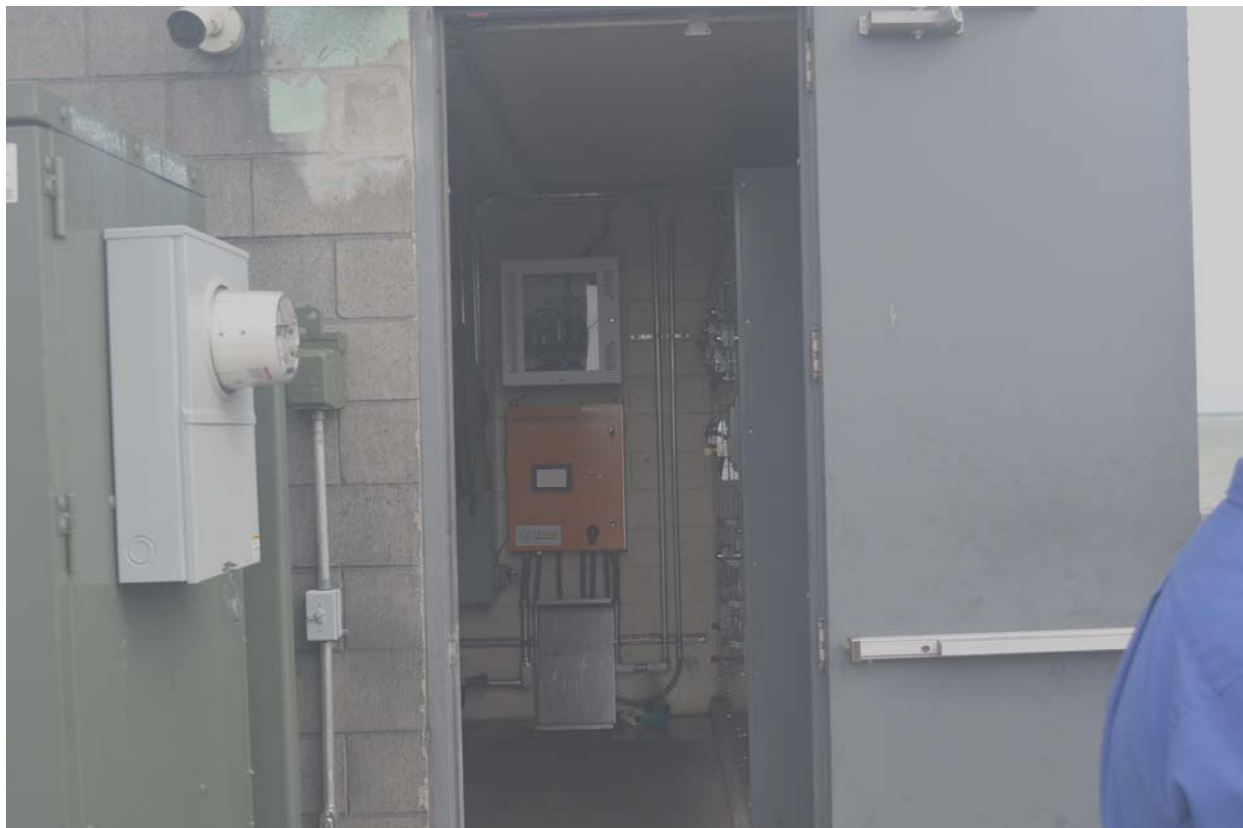
Photo No. 3

Photo File Name: H:\6PD\6MM-XP\Enforcement\ENFORCEMENT SENSITIVE\FY2017\2017-084  
Lewisville, TX Copper Ion Generator\Lewisville Water Plant Pictures 4-16-19\DSC\_0078.JPG  
Date of Photo: April 16, 2019  
Time of Photo: 10:16 AM  
Photographer: Chuck Ruple  
Description: ONG Fortress MC control panel located at the Lewisville Water Intake Station

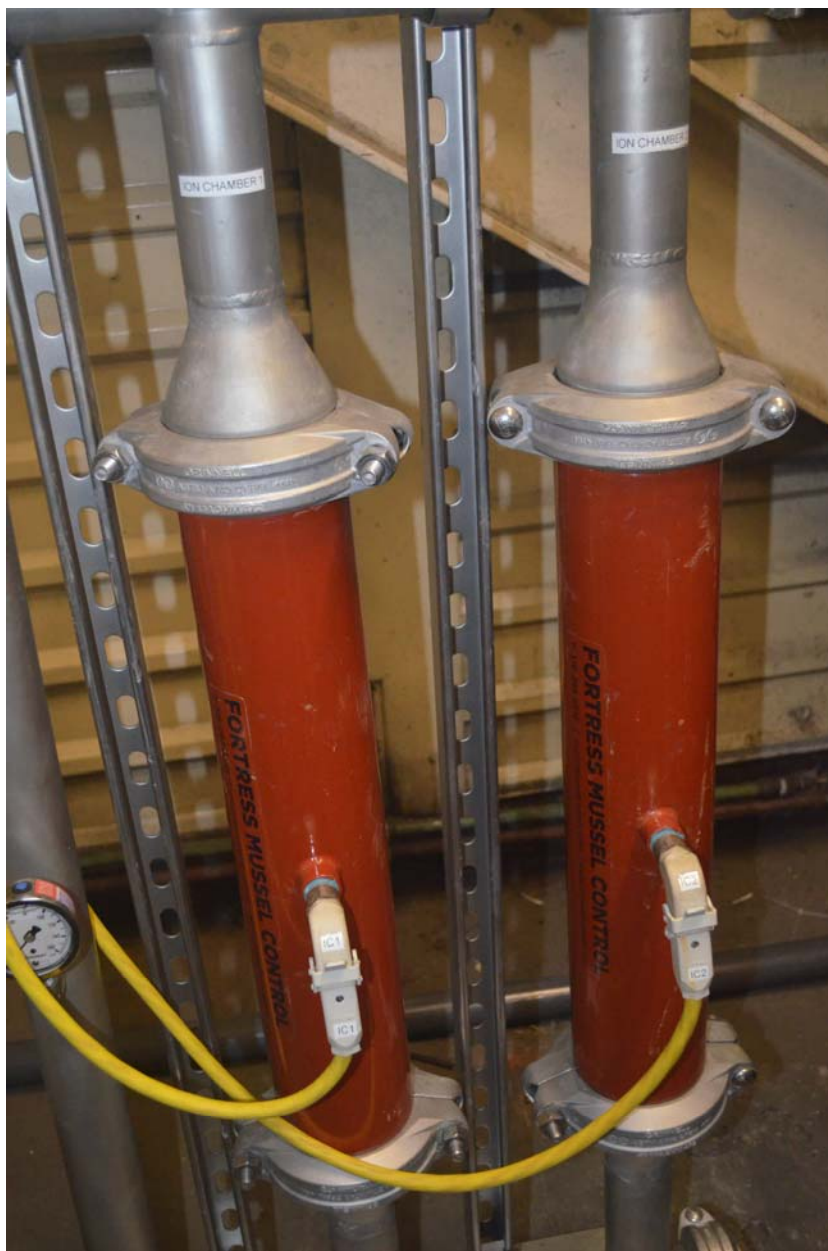
Photo No. 4

Description: Copper Ionization Chamber housed in the Lewisville/Trinity Shared Water Intake Station

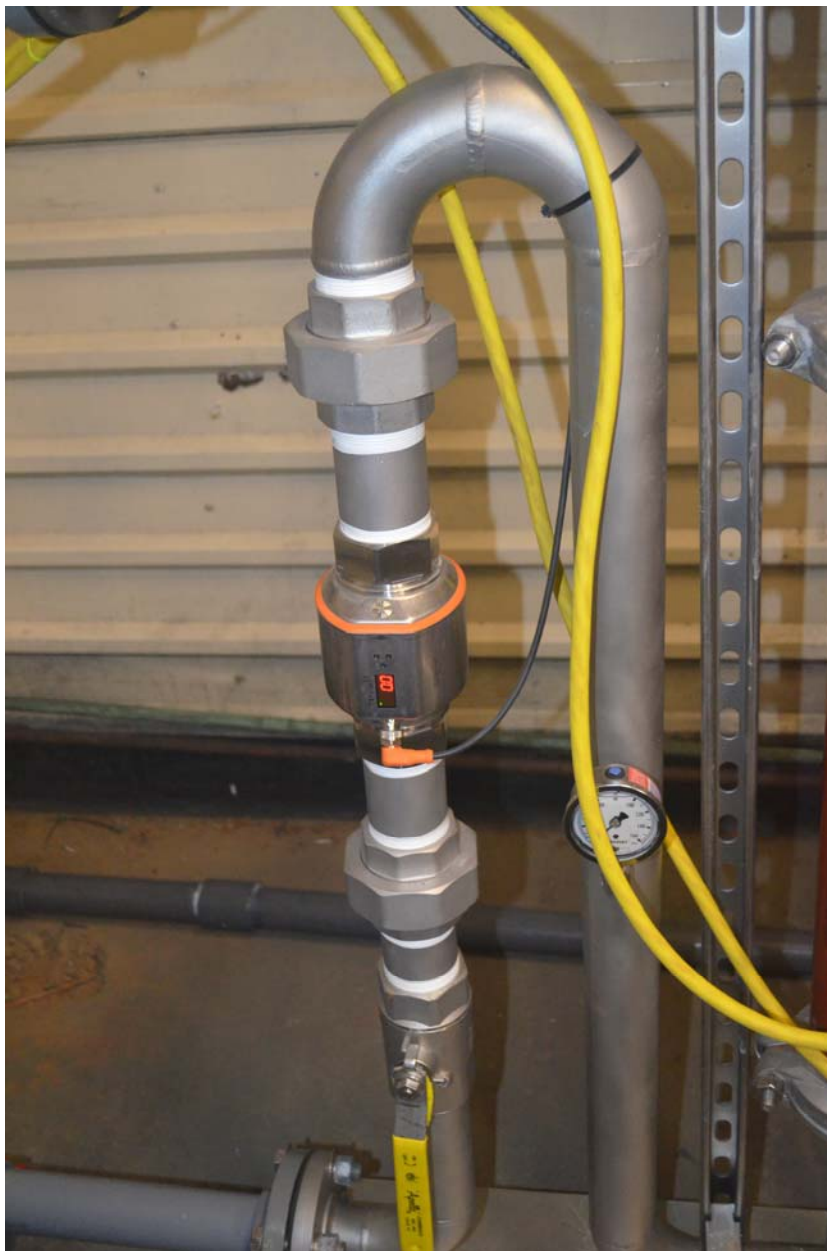
Photo No. 5

Photo File Name: H:\6PD\6MM-XP\Enforcement\ENFORCEMENT SENSITIVE\FY2017\2017-084  
Lewisville, TX Copper Ion Generator\Lewisville Water Plant Pictures 4-16-19\DSC\_0085.JPG  
Date of Photo: April 16, 2019  
Time of Photo: 10:30 AM  
Photographer: Chuck Ruple  
Description: Copper-ion generator flow meter in the Lewisville/Trinity Shared Water Intake Station

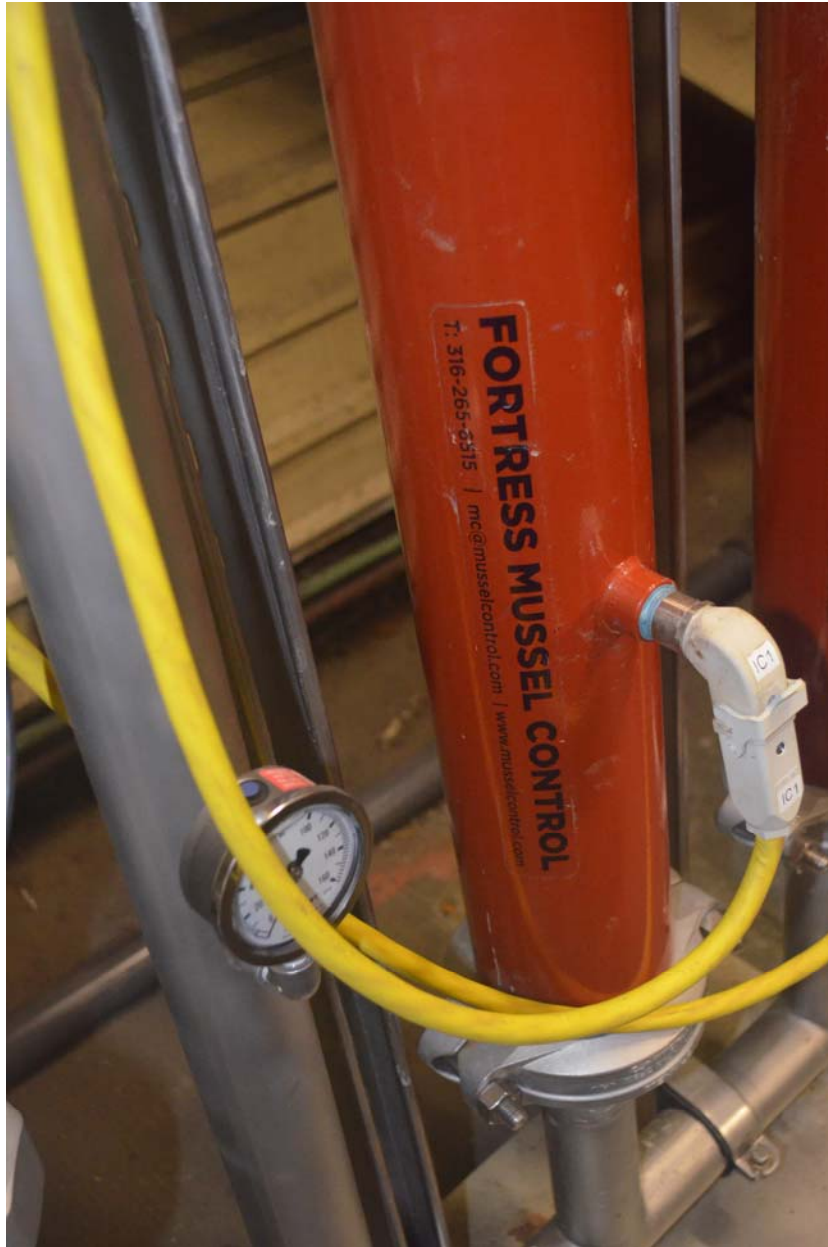
Photo No. 6

I observed the installation of two Fortress MC system copper-ion generators for the control of zebra mussels at the Lewisville water production facility. However, only one of the generators was active at the time of the inspection. Neither of the Fortress MC systems had pesticide registration under the regulations of FIFRA. Both generators are potentially in violation of FIFRA because at the time of the inspection they were unregistered pesticides. Inspector Ruple and I made the facility aware of the status of the generators and presented the facility with a copy of the Federal Register Notice [EPA- HQ--OPP- 2007--0949; FRL-8149-4]: Pesticide Registration; Clarification for Ion-Generating Equipment. The inspection was concluded at approximately 11:30 AM and I exited the facility.

Description: Copper Ionization Chamber Label view in the Lewisville/Trinity Shared Water Intake Station
