| <b>Inspector</b> | Matthew Allen | <b>MIT Date</b> | 08/19/2024 | <b>Time</b> | 14:00 |
| <b>Operator Info</b> | GKM Oil & Gas, Inc.<br>P.O. Box 3897<br>Afton, OK 74331<br>Phone: 918-633-8807 | <b>Inventory ID</b> | OS1306000 | | |
| | | <b>Lease Name</b> | Keystone | | |
| <b>Type of MIT</b> | Ada Pressure Test | <b>Test Reason</b> | Routine | | |

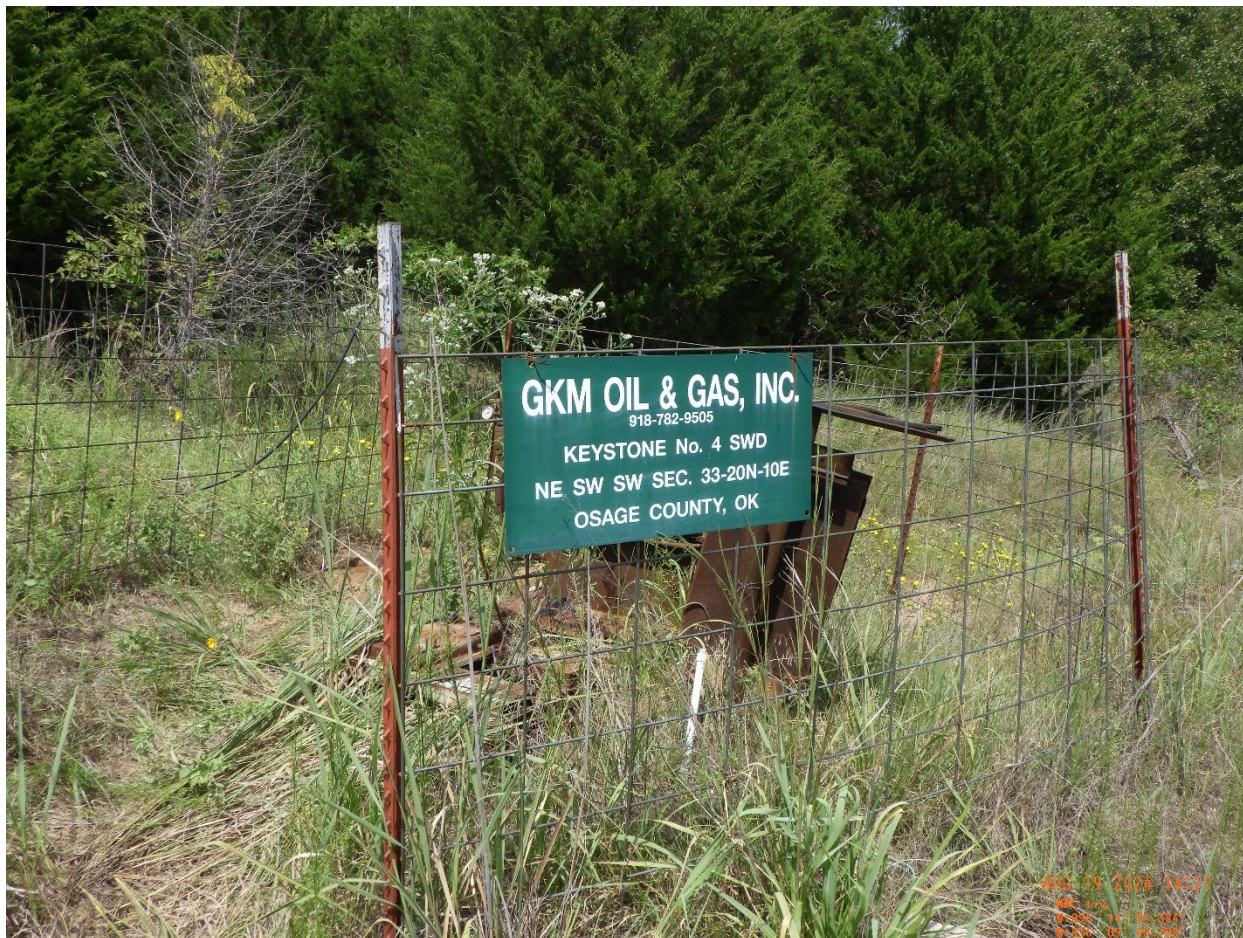
Photo No. 1

**Description:** This was the well sign for OS1306000 and a general overview of the well location.

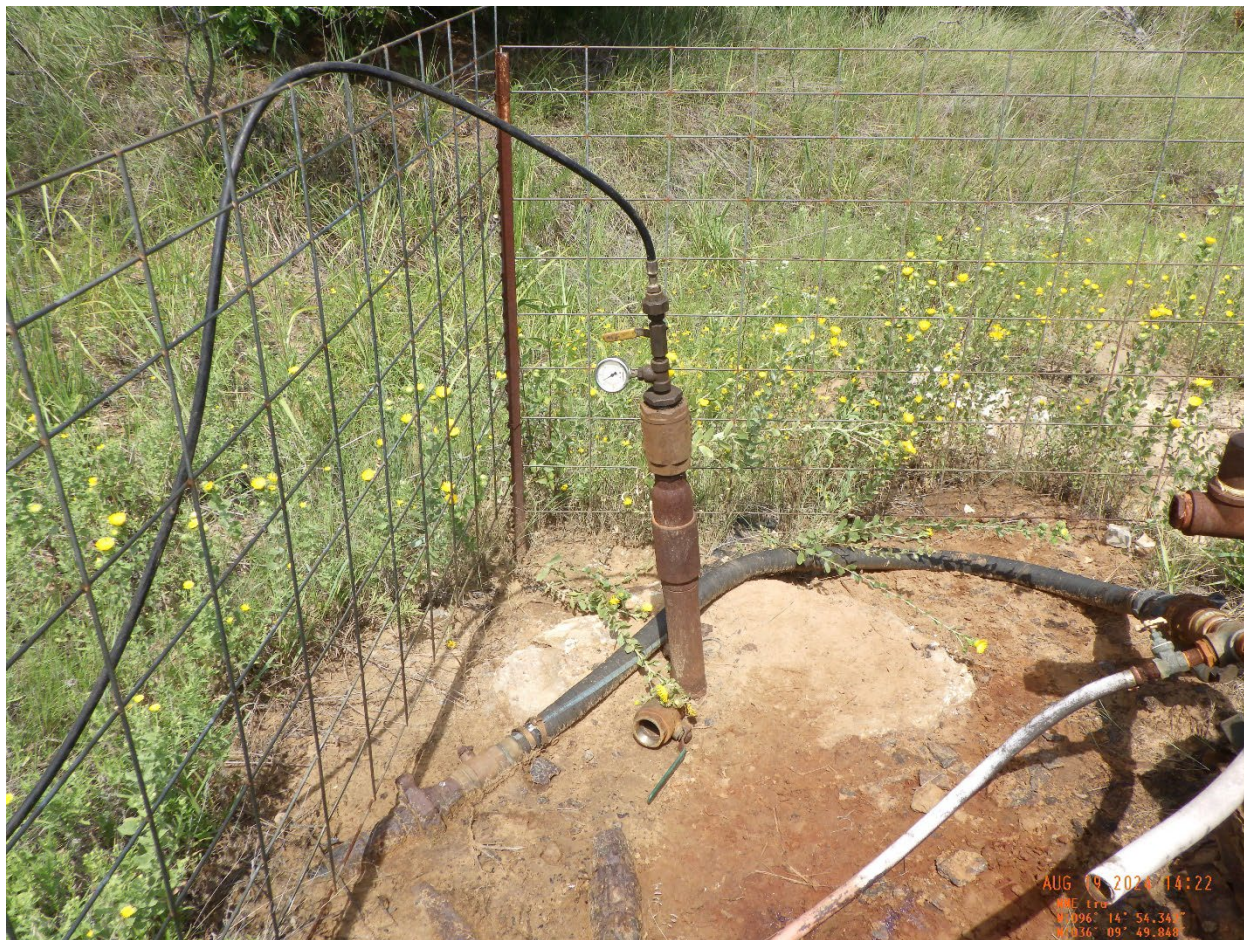
Photo No. 2

| <b>Inspection Comments</b> | Well OS1306000 reached the required test pressure of 263psig but was unable to maintain pressure within the required 10% loss/gain for the required 30 minutes. | | | | |

**Description:** This was well OS1306000 with the nitrogen pressure hose and pressure gauge connected during the pressure test.
