### INSPECTION REPORT

| Regulatory Program(s) | NPDES - Oil and Gas, Produced/Brine Water | | |
| Company Name: | Samson Lone Star, LLC | | |
| Facility Name: | Ruth Central Tank Battery (RRC Comingle No. 5446) | | |

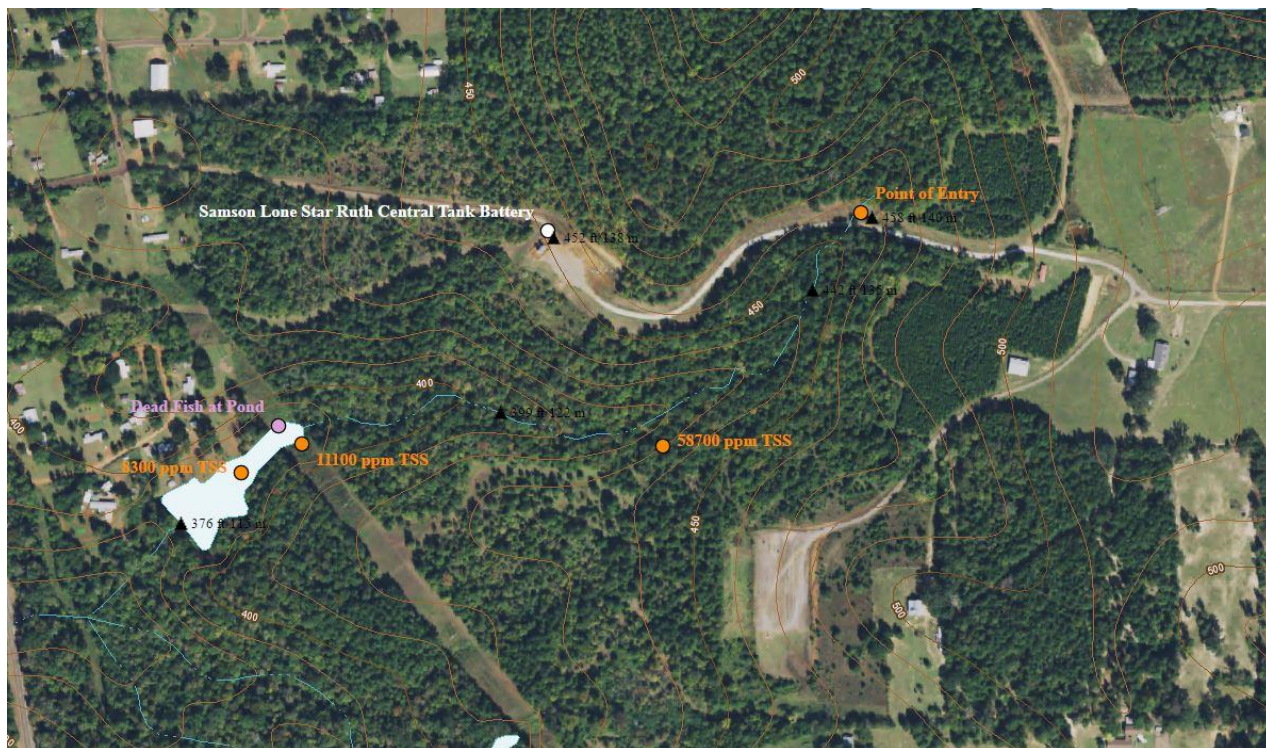
Photo No. 1

Description: This image shows a USGS Topo-Imagery map. The white dot on the map represents the location of the facility. The orange dots on the map represent the Point of Entry and the Total Soluble Salts (TSS) readings along the tributary of Bayou Loco. The light purple dot on the map represents the location where we observed dead fish at the ponded area along the tributary of Bayou Loco.

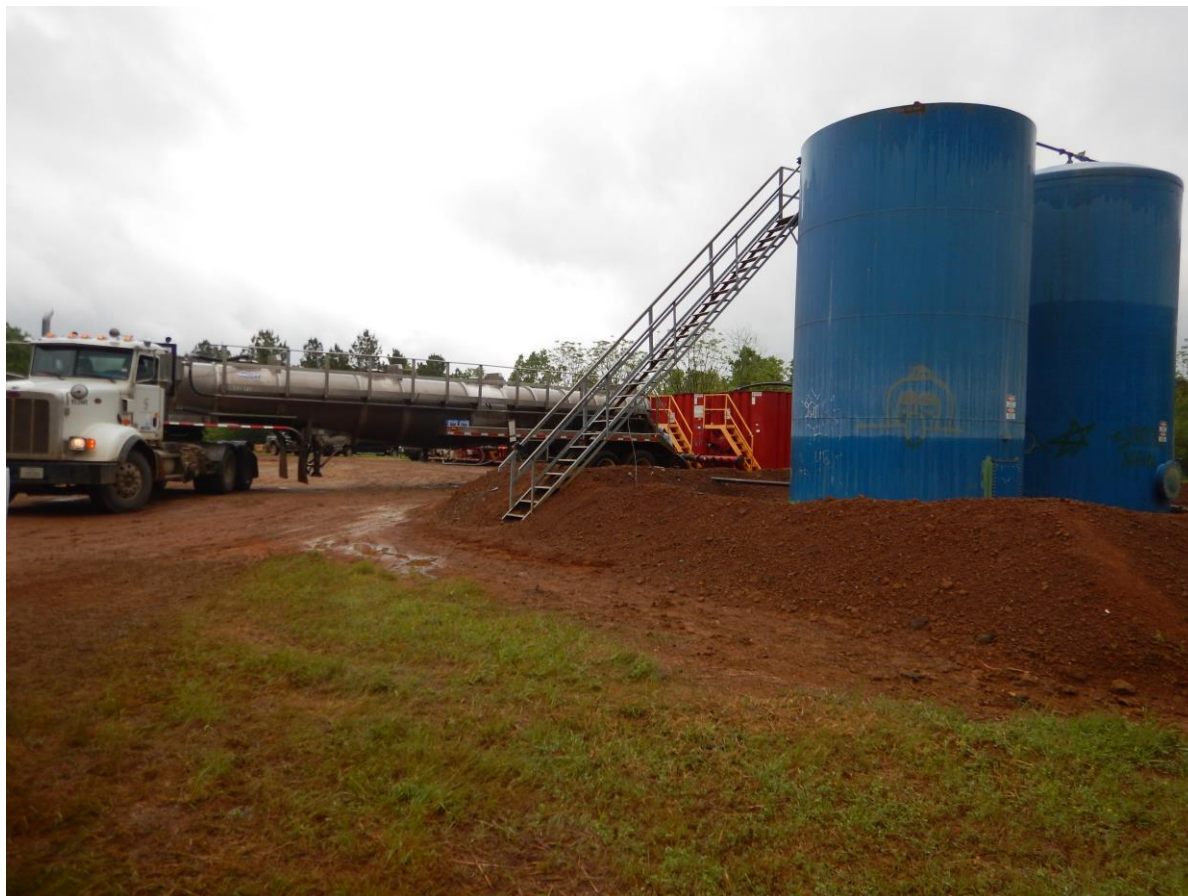
Photo No. 3

The facility is known as the Samson Lone Star, LLC – Ruth Central Tank Battery and is located in Nacogdoches, Nacogdoches County, Texas. The facility consists of two storage tanks that were approximately 600 barrels each. See Photo Nos. 1 – 2 in Appendix 1. The facility is located at latitude 31.678383 N and longitude -94.737317 W.

Description: This image shows an overview of the Ruth Central Tank Battery, which has two produced water tanks that are approximately 600 barrels each.

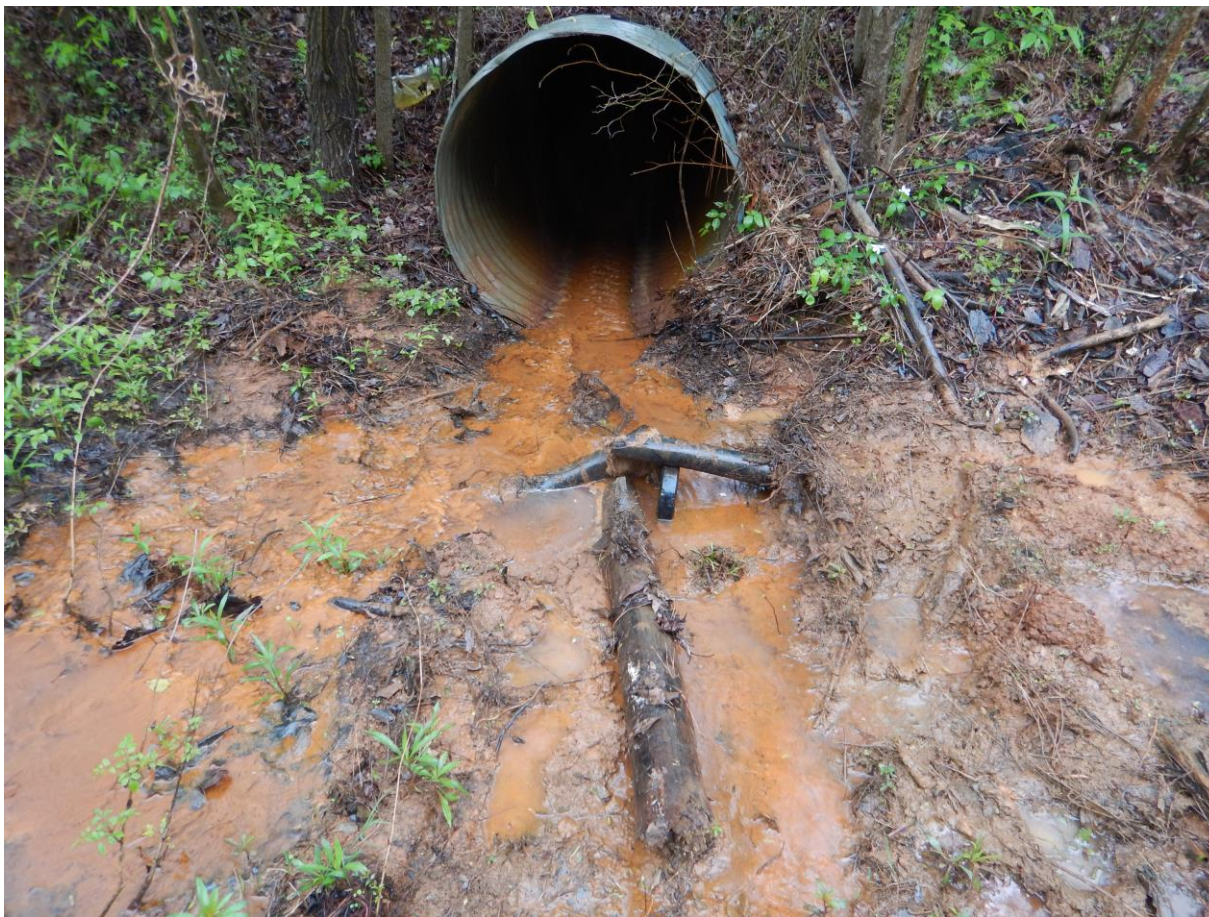
Photo No. 4

reported a brine/produced water spill into the tributary of Bayou Loco on March 24, 2016 to the National Response Center at approximately 05:30 PM. According to the report and the on-site representative, the source of the brine discharge was a detached four-inch pressurized poly-line that transports produced water from the Ruth Central Tank Battery to a nearby disposal well. At approximately 01:30 PM the pipeline discharge was shut-in, or stopped, by the response actions of the company on March 24, 2016. At the time of the inspection, Mr. Turner and Mr. Foxworth stated that the estimated break in the disposal line occurred approximately March 6, 2016, and approximately 2,100 barrels of produced wastewater was released into the tributary of Bayou Loco. The pressurized force of the transfer line was approximately 50 to 60 pounds per square inch (psi). The line was rated for approximately 2,000 psi, according to the on-site production manager, Mr. Foxworth. Mr. Turner informed us that the Texas Railroad Commission (RRC) did an on-site assessment on March 26, 2016. We also noted that according to the Production Manager, Mr. Foxworth, the produced waste water tanks pulls water into the disposal transfer line from the bottom of the tank battery, so as not to have oil in the wastewater disposal lines and the operations do not pull the produced wastewater tanks fluid levels all the way to the bottom to also prevent oil from being put into the disposal lines from the produced wastewater tanks.

**The produced wastewater transfer line which was the point of discharge (POD) and Point of Entry (POE) was** located at latitude 31.678535 N and longitude -94.734162 W. The transfer line was busted and leaked into the tributary of Bayou Loco for approximately 3 weeks. See Photo No. 1 in Appendix 1. The transfer line had a pressurized force of approximately 50 to 60 pounds per square inch (psi). It transported produced wastewater from the Ruth Central Tank Battery to a nearby disposal well. At the POE, which is also the POD, into the tributary of Bayou Loco a Total Soluble Salts (TSS) reading of 1,900 parts-per-million (ppm) was taken. The tributary was approximately 5 to 10 feet wide and 6-inches to 10-inches deep at the POE. See Photo Nos. 4-5 in Appendix 1.

Description: This image shows the point of discharge and the point of entry into the tributary of Bayou Loco. We observed that a produced water transfer pipe broke and leaked produced wastewater into the tributary of Bayou Loco.

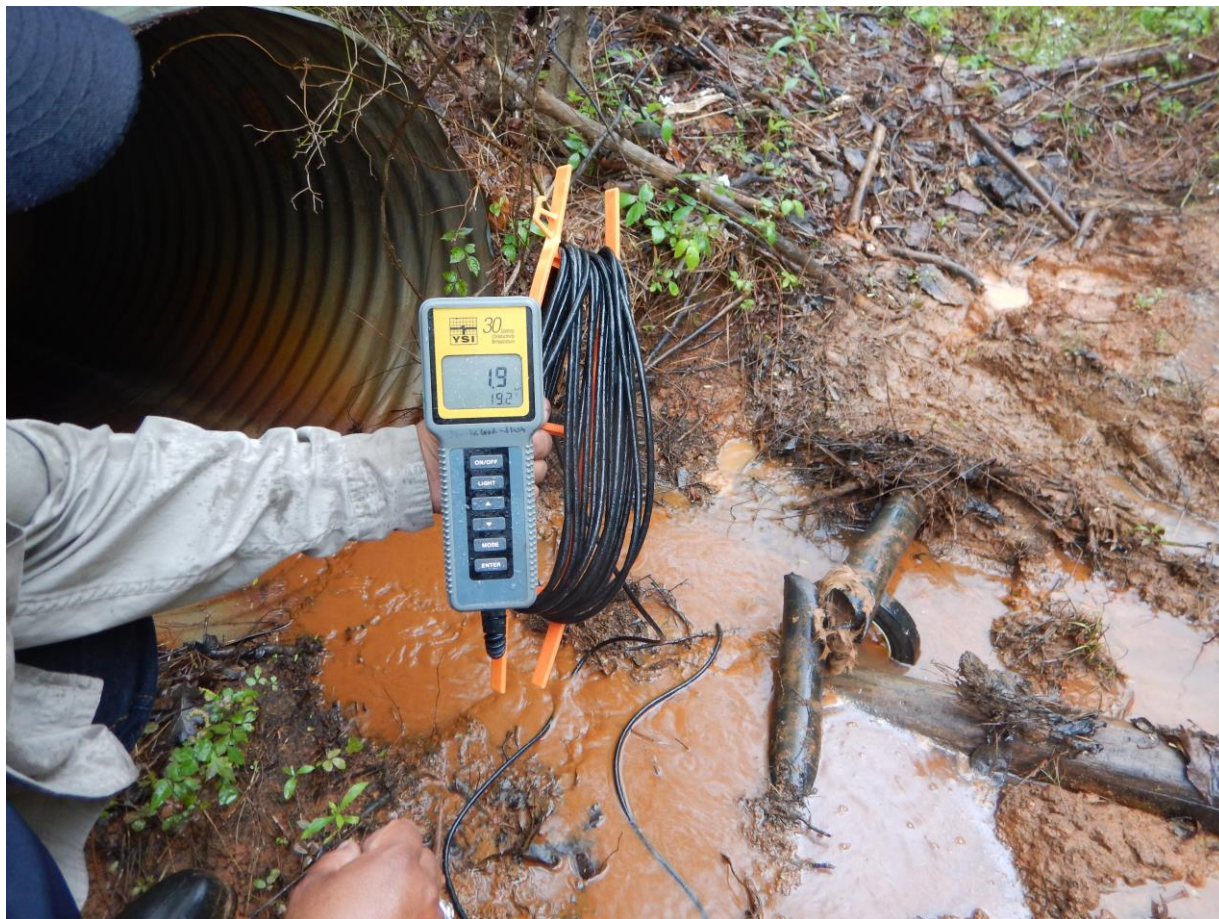
Photo No. 5

Description: This image shows the point of discharge and the point of entry into the tributary of Bayou Loco. We observed that a produced water transfer pipe broke and leaked produced wastewater into the tributary of Bayou Loco. A Total Soluble Salts (TSS) reading of 1,900 parts-per-million (ppm) was taken as the point of discharge and point of entry into tributary of Bayou Loco.

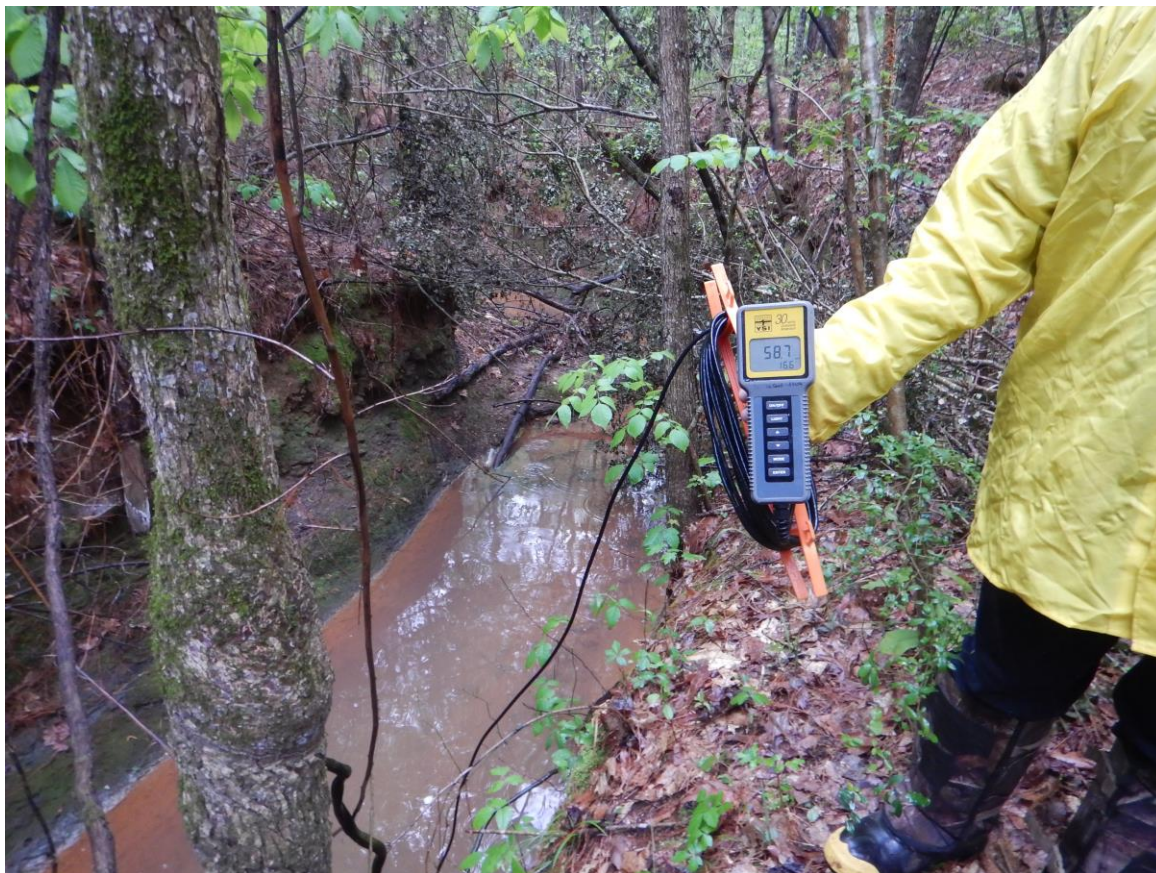
Photo No. 6

| <i>Latitude</i> | <i>Longitude</i> | <i>TSS Reading</i> | <i>Distance from POE</i> | <i>Photo No. in Appendix 1</i> |
|---|---|---|---|---|
| 31.676539 N | -94.736160 W | 58,700 ppm | Approx. 915 feet | 6 |

Description: This image shows a measurement of Total Soluble Salts (TSS) reading of 58,700 parts-per-million (ppm) downstream from the Point of Entry (POE) approximately 915 feet.

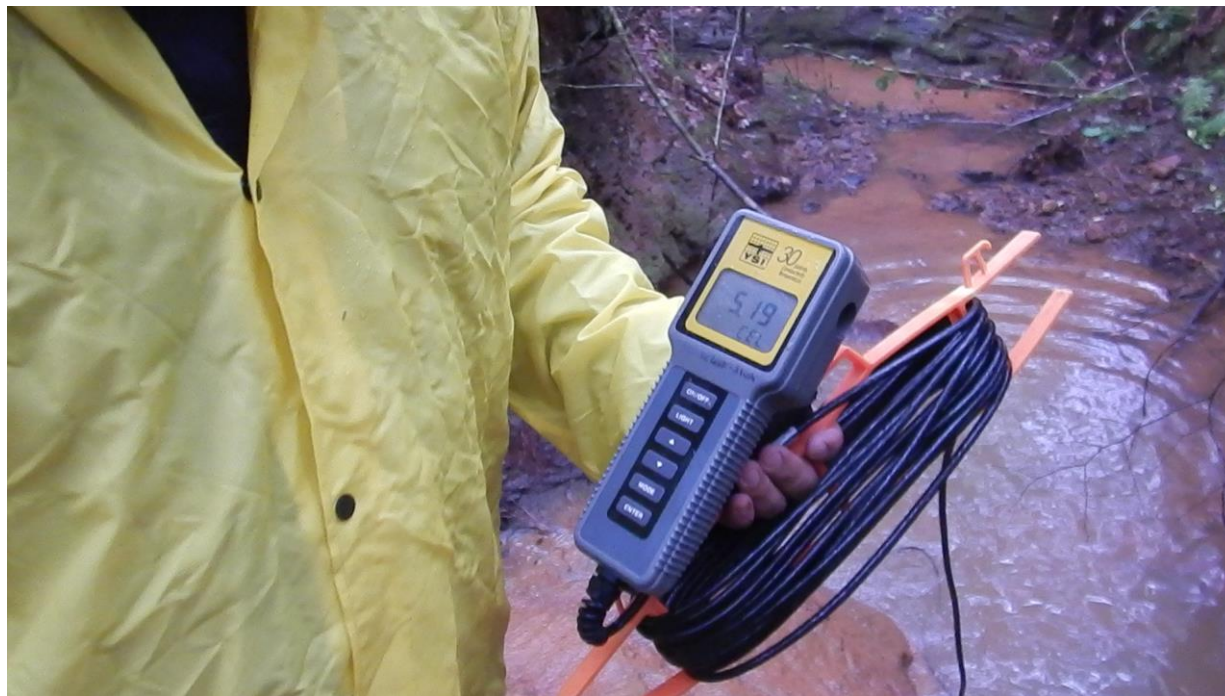
Photo No. 7

| <i>Latitude</i> | <i>Longitude</i> | <i>TSS Reading</i> | <i>Distance from POE</i> | <i>Photo No. in Appendix 1</i> |
|---|---|---|---|---|
| 31.677216 N | -94.735172 W | 51,900 ppm | Approx. 630 feet | 7 |

Description: This image shows a TSS reading of 51,900 ppm downstream from the POE approximately 630 feet.

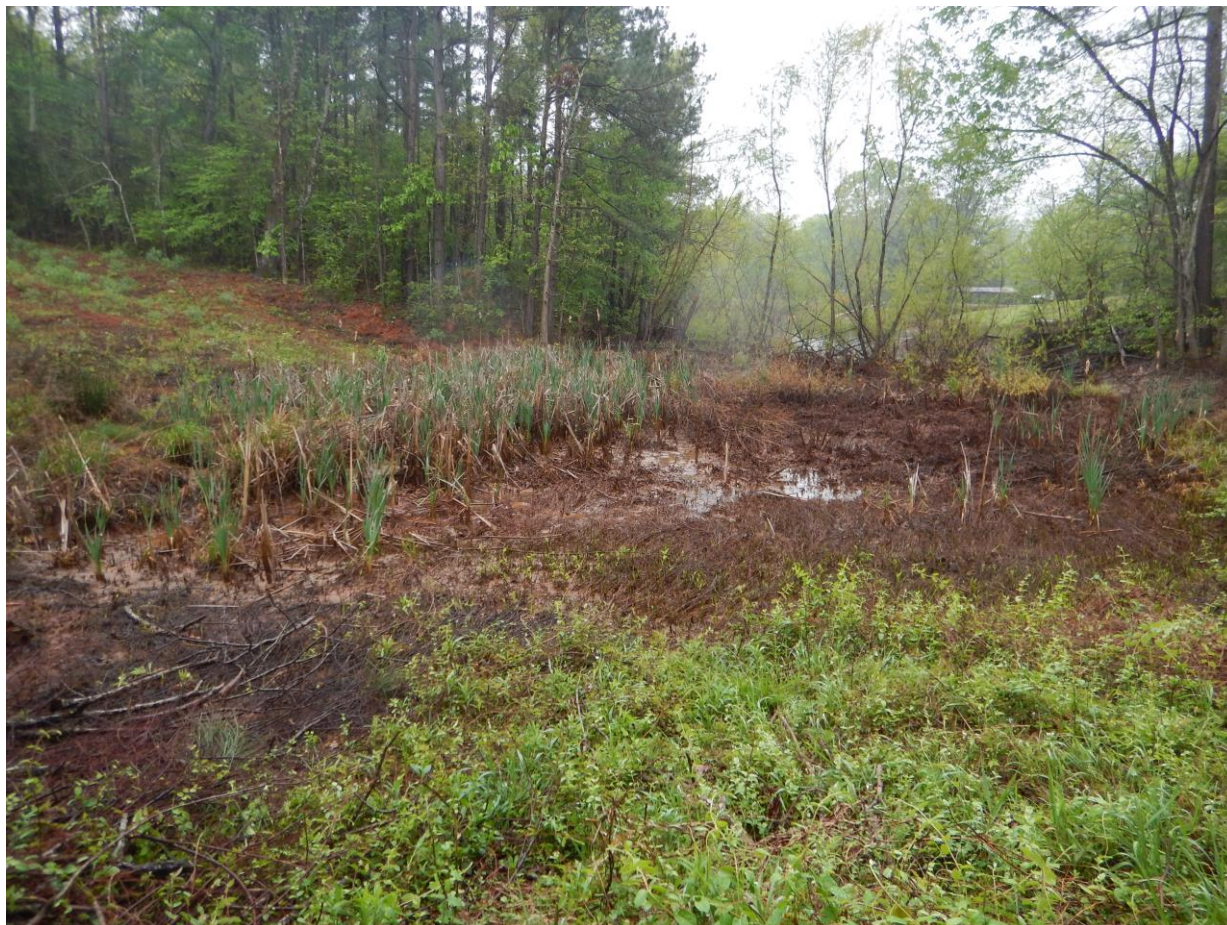
Photo No. 8

While gathering TSS readings, we also observed impacted vegetation and aquatic wildlife at the time of the inspection downstream from the POE. We saw that along the tributary of Bayou Loco, near the ponded area, approximately 2,640 feet downstream from the POE, that the north side of the ponded area was negatively impacted from the spill and remediation operations. See Photo Nos. 8 and 13 in Appendix 1. According to Mr. Turner, the facility removed approximately 735 dead fish from the pond prior to the inspection. We counted several dead fish at the time of the inspection. See Photo Nos. 10 – 11 in Appendix 1. We observed the facility pumping from the ponded area, which was approximately 1.25 acres in size and 13 feet deep, produced wastewater. The pond was being pumped out at a rate of over 7 barrels per minute at the time of the inspection. The pumping operation is shown in Photo No. 14 in Appendix 1. The wastewater was being removed and hauled for disposal into a commercial disposal well, according to Mr. Turner.

Description: This image shows a downstream view of a large ponded area approximately 0.5 mile from the POE. We observed impacted riparian vegetation and dead fish upstream of the ponded area along the tributary of Bayou Loco.

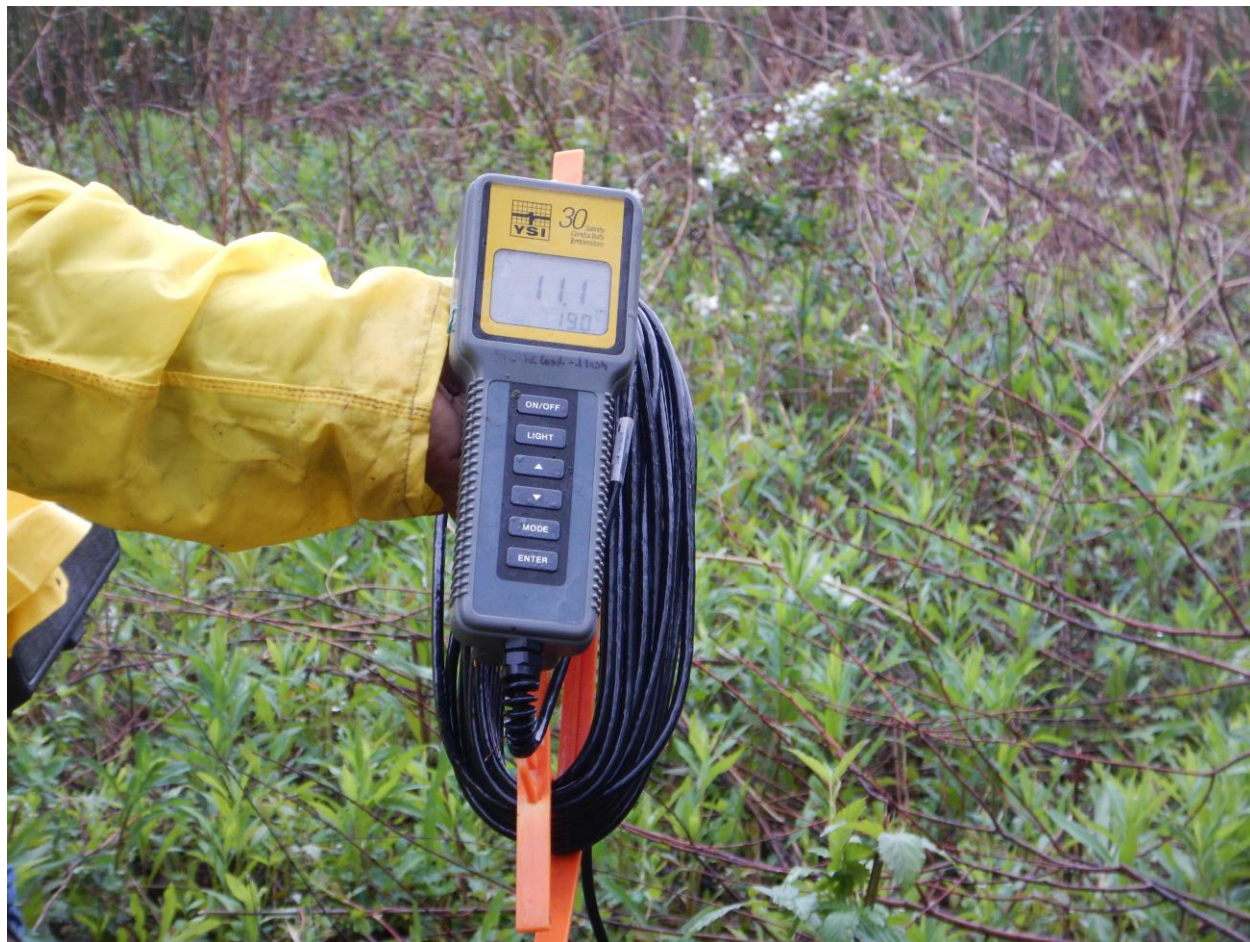
Photo No. 9

| <i>Latitude</i> | <i>Longitude</i> | <i>TSS Reading</i> | <i>Distance from POE</i> | <i>Photo No. in Appendix 1</i> |
|---|---|---|---|---|
| 31.676553 N | -94.739798 W | 11,100 ppm | Approx. 2,640 feet | 9 |

Description: This image shows a TSS reading of 11,100 ppm at the headwaters of the ponded area along the tributary of Bayou Loco, shown in Photo No. 8. The TSS reading was taken approximately 0.5 miles downstream from the POE.

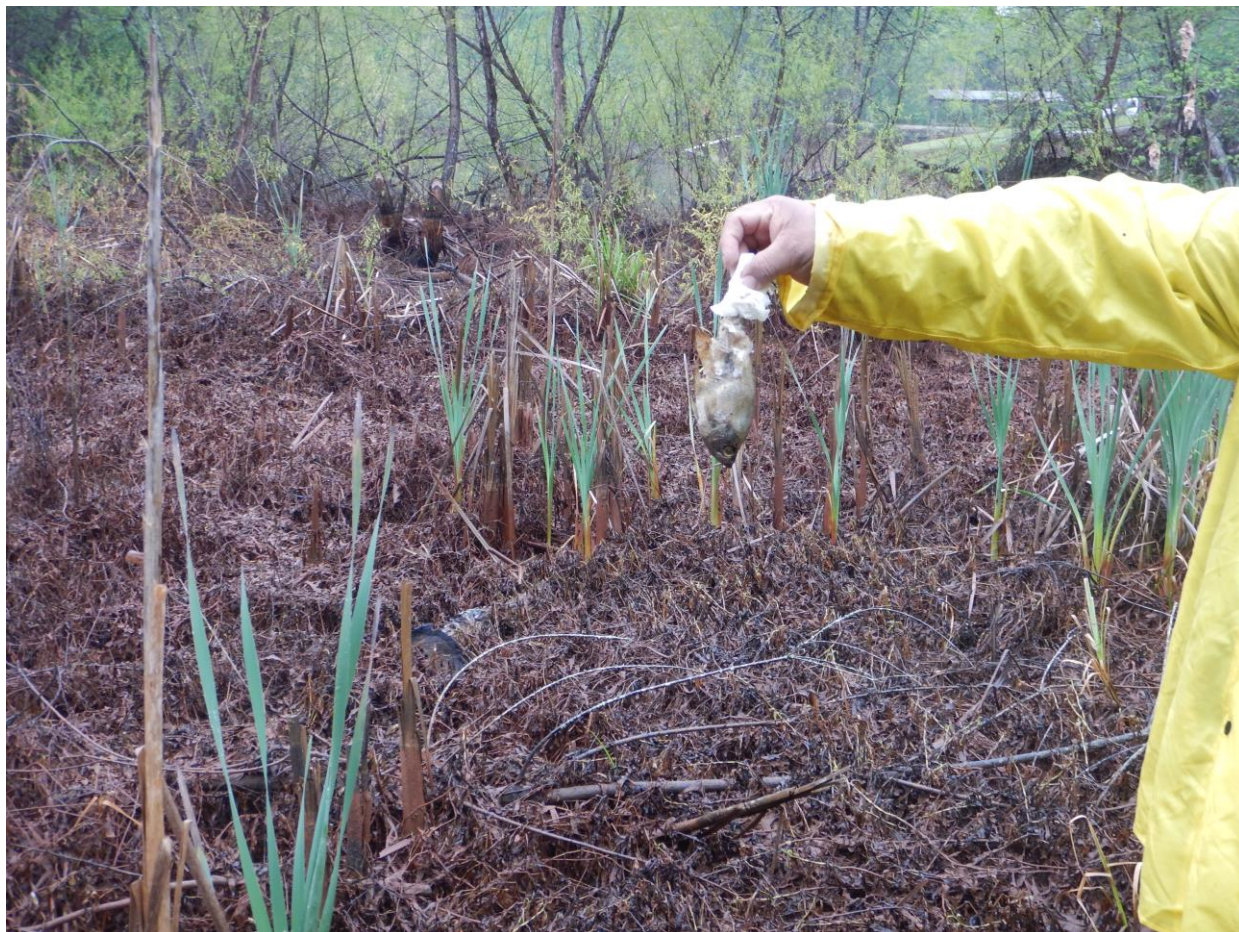
Photo No. 10

Description: This image shows a dead fish found at the headwaters of the ponded area along the tributary of Bayou Loco. We observed several dead fish at the headwaters of the ponded area in the impacted riparian vegetation, approximately 0.5 miles downstream from the POE. We observed the company pumping out the wastewater at the southwestern corner of the ponded area along the tributary of Bayou Loco and hauling the wastewater off for disposal.

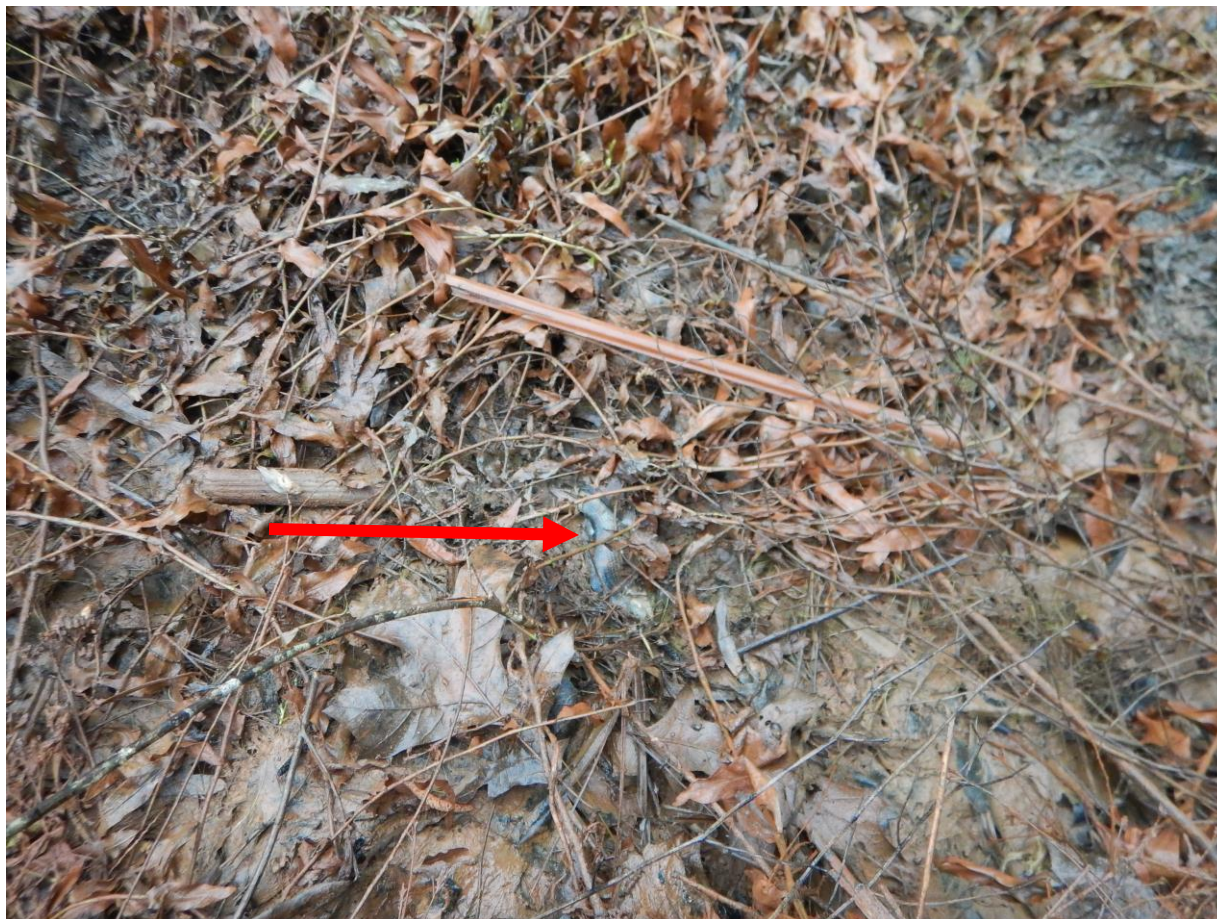
Photo No. 11

Description: This image shows another dead fish found at the headwaters of the ponded area along the tributary of Bayou Loco, as identified by the red arrow in the above image. We observed several dead fish at the headwaters of the ponded area in the impacted riparian vegetation, approximately 0.5 miles downstream from the POE.

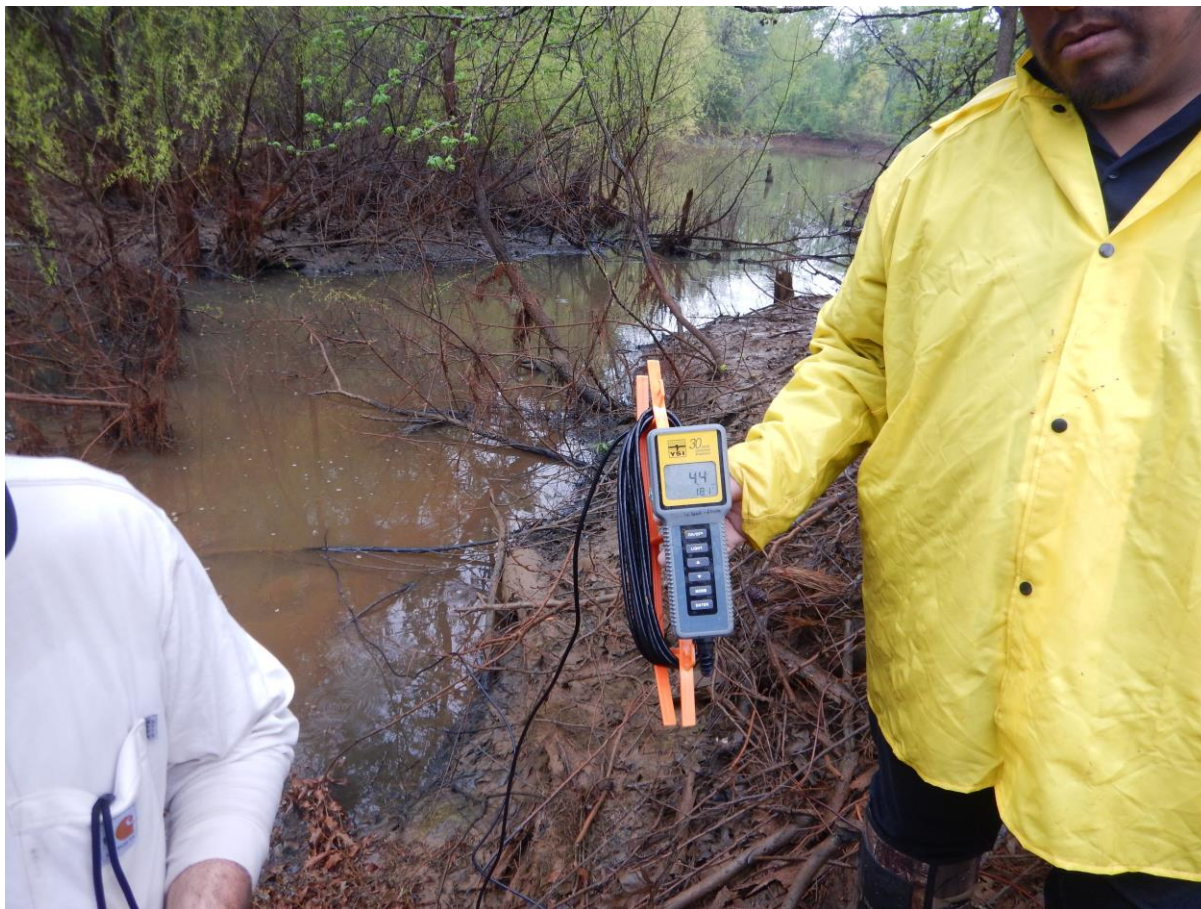
Photo No. 12

| <i>Latitude</i> | <i>Longitude</i> | <i>TSS Reading</i> | <i>Distance from POE</i> | <i>Photo No. in Appendix 1</i> |
|---|---|---|---|---|
| 31.676710 N | -94.740039 W | 4,400 ppm | Approx. 2,690 feet | 12 |

This image shows a TSS reading of 4,400 ppm taken at the same location as the Photo No. 11, where we observed several dead fish. This TSS reading was taken approximately 0.5 miles downstream of the POE and approximately 50 feet downstream from Photo No. 9, where a TSS reading of 11,100 ppm was measured.

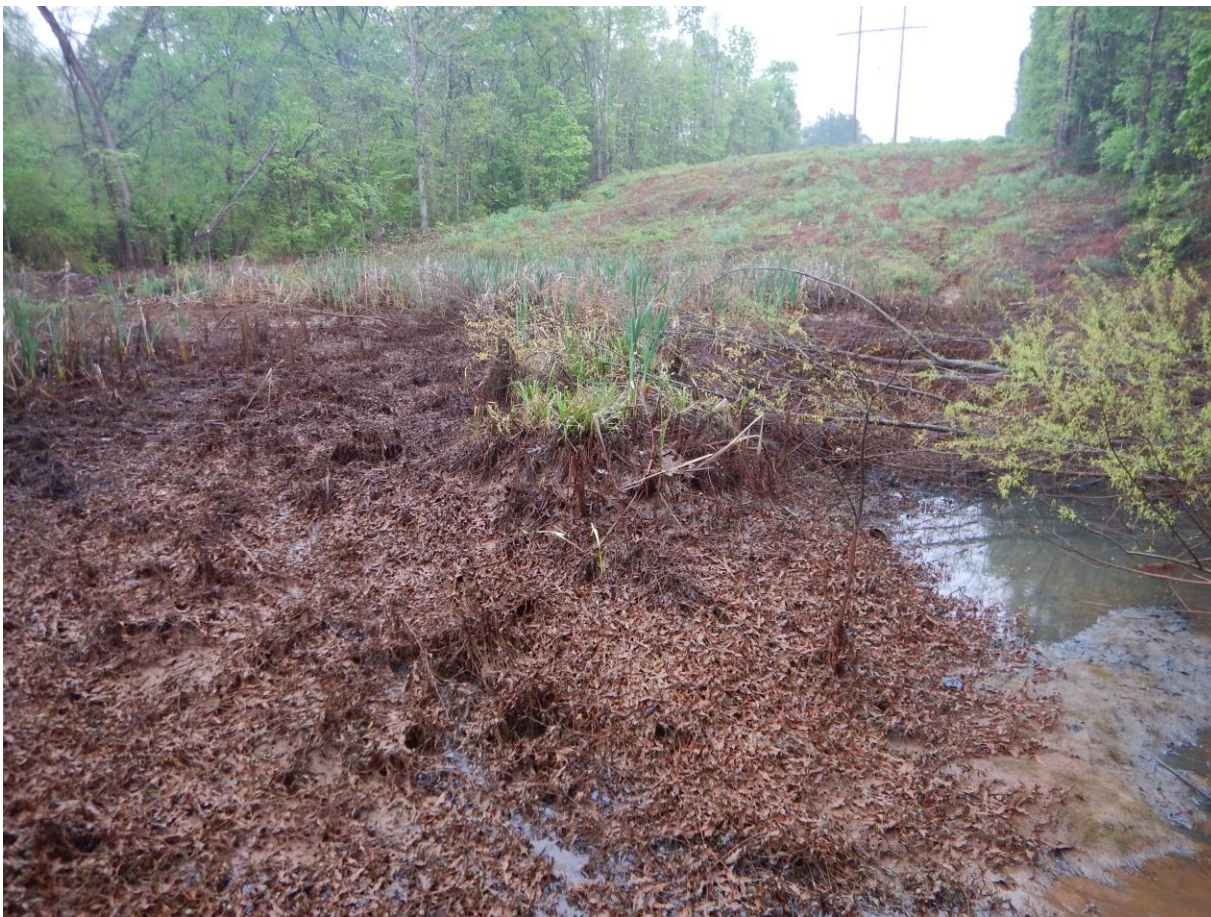
Photo No. 13

Description: This image shows an upstream view of the tributary of Bayou Loco as the ponded area approximately 0.5 miles downstream from the POE, as seen in Photos No. 8 – 12. We observed dead and negatively impacted riparian vegetation along the tributary and headwaters of the ponded area. We also observed dead fish. At the time of the inspection, the company was pumping out produced wastewater from the tributary of the Bayou Loco to prevent further impacts downstream from the ponded area downstream.

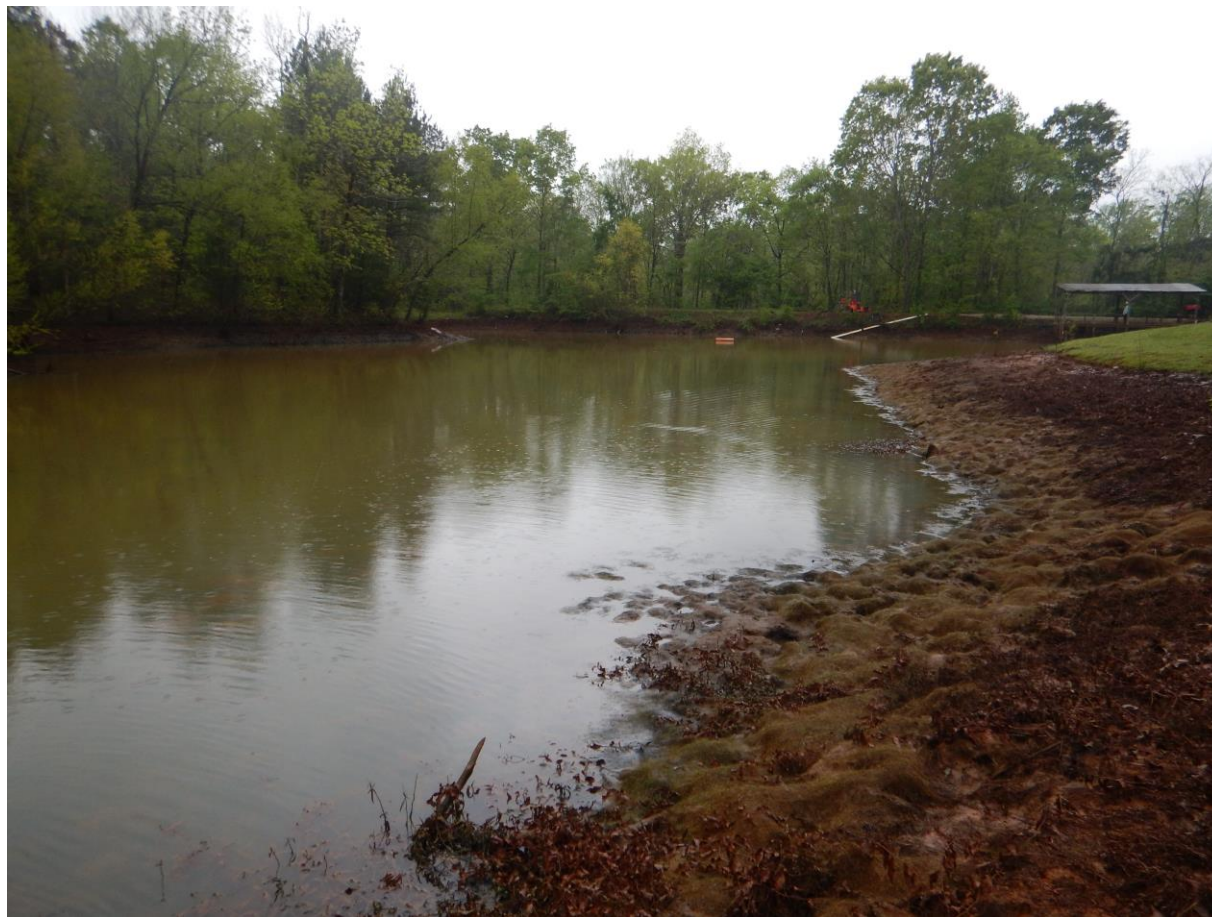
Photo No. 14

Description: This image shows a downstream view of the ponded area along the tributary of Bayou Loco, approximately 0.5 miles downstream. The western end, or downstream end of the pond was the location where the company was pumping wastewater from the pond to the tank battery location and then to haul off for disposal. We observed the pump in operation and the receding banks of the ponded area during the inspection.

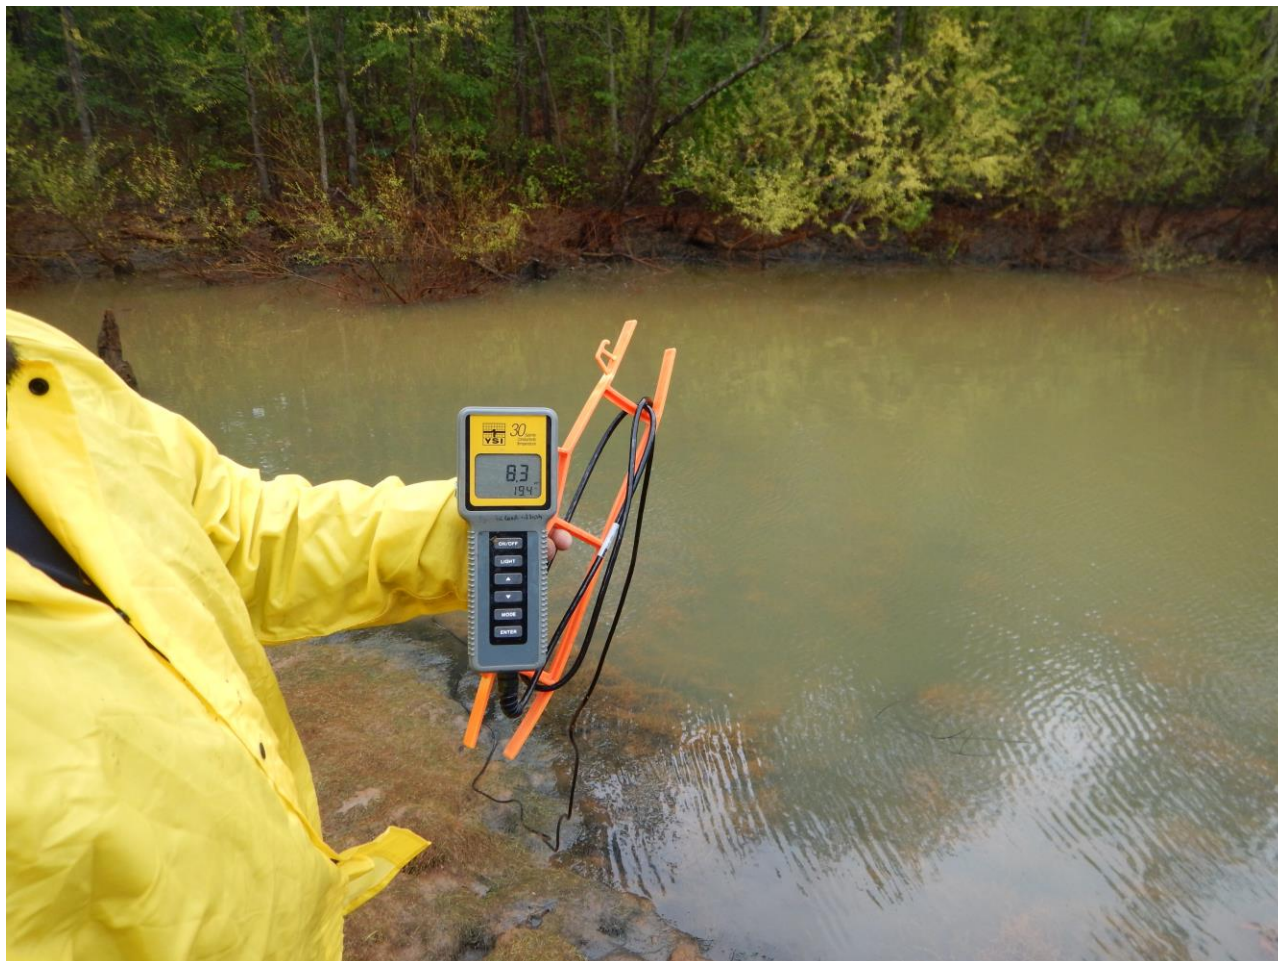
Photo No. 15

| <i>Latitude</i> | <i>Longitude</i> | <i>TSS Reading</i> | <i>Distance from POE</i> | <i>Photo No. in Appendix 1</i> |
|---|---|---|---|---|
| 31.676311 N | -94.740413 W | 8,300 ppm | Approx. 3,000 feet | 15 |

Description: This image shows a TSS reading of 8,300 ppm approximately 0.5 miles downstream from the POE. The TSS reading was taken from the same position along the ponded area of the tributary of Bayou Loco as Photo No. 14 was taken.

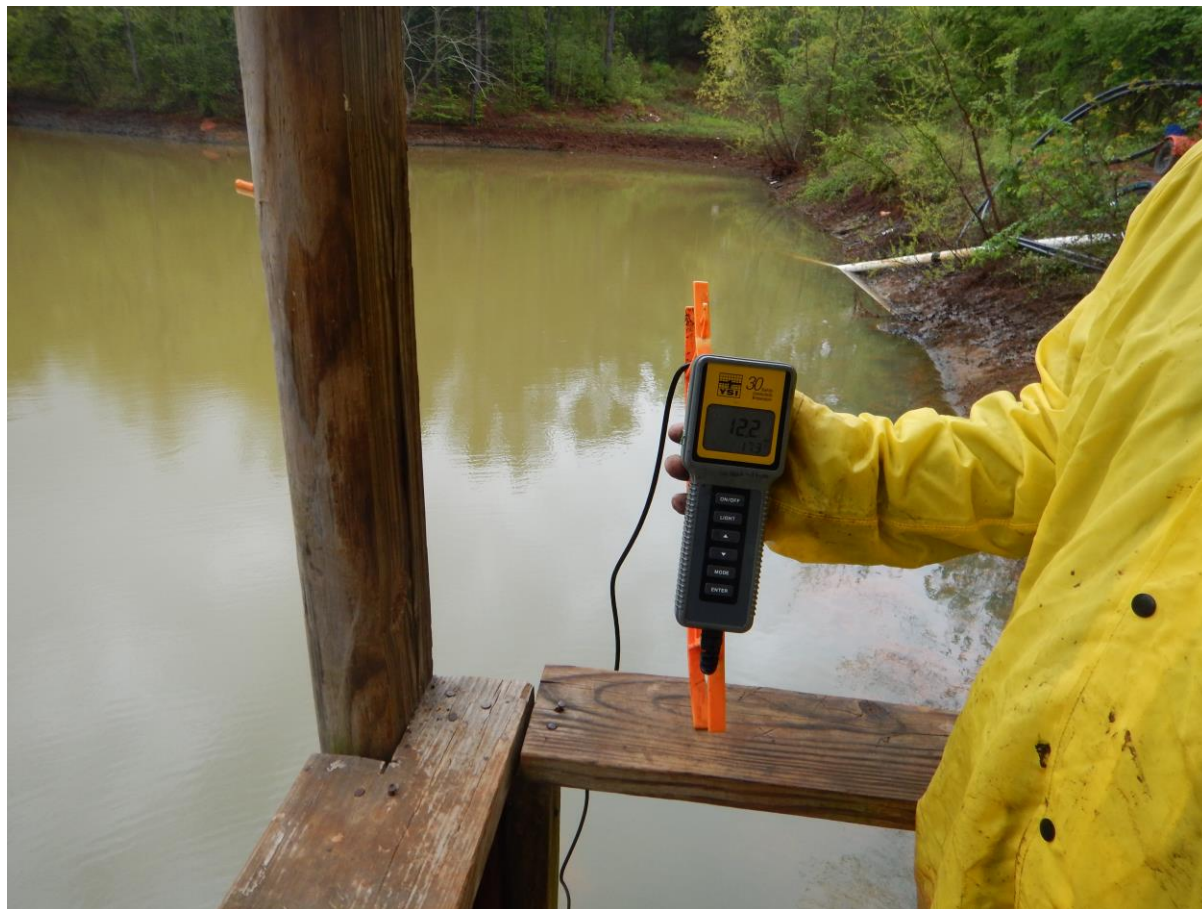
Photo No. 16

| <i>Latitude</i> | <i>Longitude</i> | <i>TSS Reading</i> | <i>Distance from POE</i> | <i>Photo No. in Appendix 1</i> |
|---|---|---|---|---|
| 31.676067 N | -94.740989 W | 12,200 ppm | Approx. 3,050 feet | 16 |

Description: This image shows a TSS reading of 12,200 ppm approximately 0.5 miles downstream from the POE. The TSS reading was taken from the southwestern most point, near the pumping from the ponded area of Bayou Loco operations. We identified this measurement point as one of the deepest points of the ponded area.

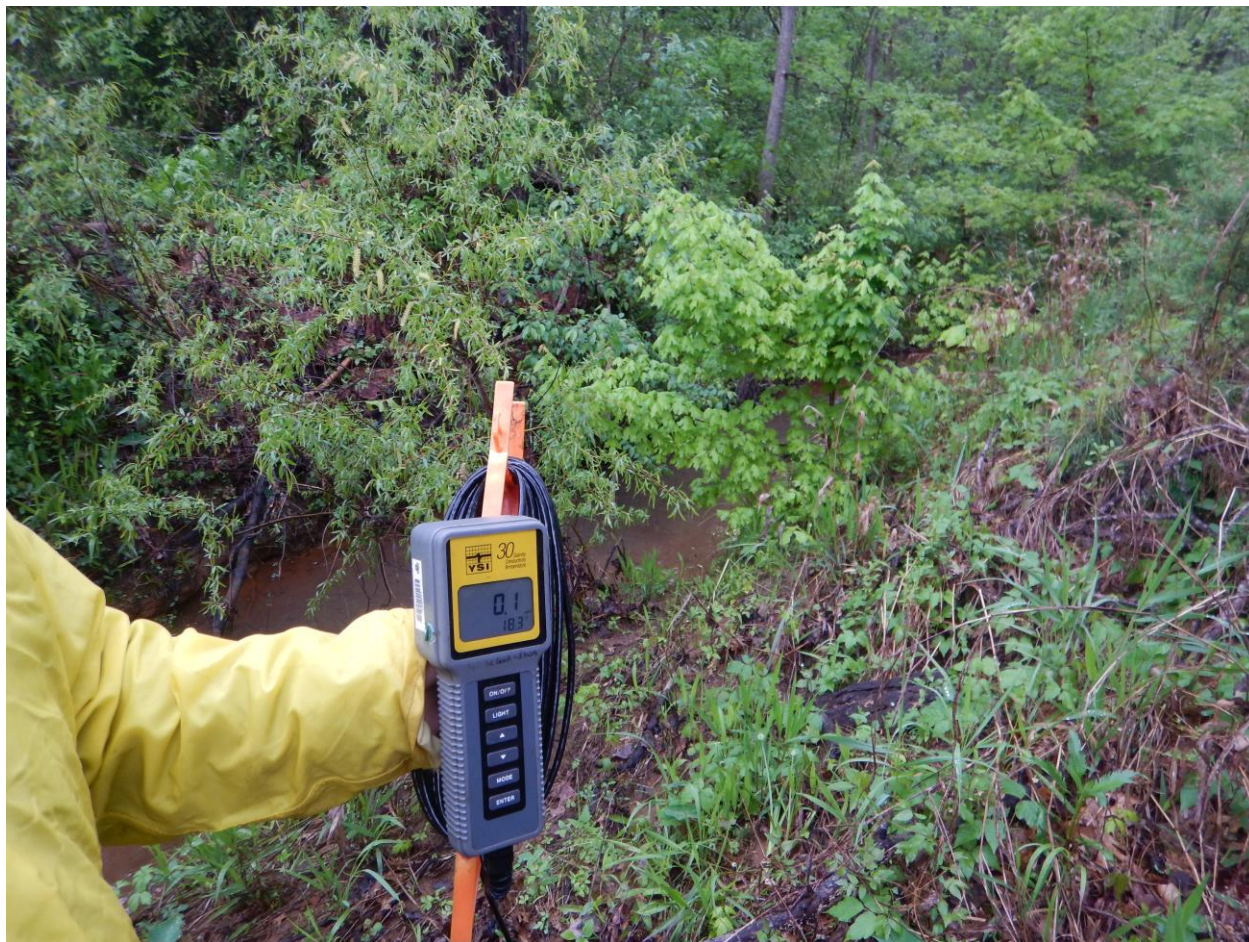
Photo No. 17

| <i>Latitude</i> | <i>Longitude</i> | <i>TSS Reading</i> | <i>Distance from POE</i> | <i>Photo No. in Appendix 1</i> |
|---|---|---|---|---|
| 31.675121 N | -94.742572 W | 100 ppm | Approx. 3,325 feet | 17 |

Description: This image shows a TSS reading of 100 ppm approximately 0.63 miles downstream from the POE. The TSS reading was taken downstream from the ponded area along the tributary of Bayou Loco.

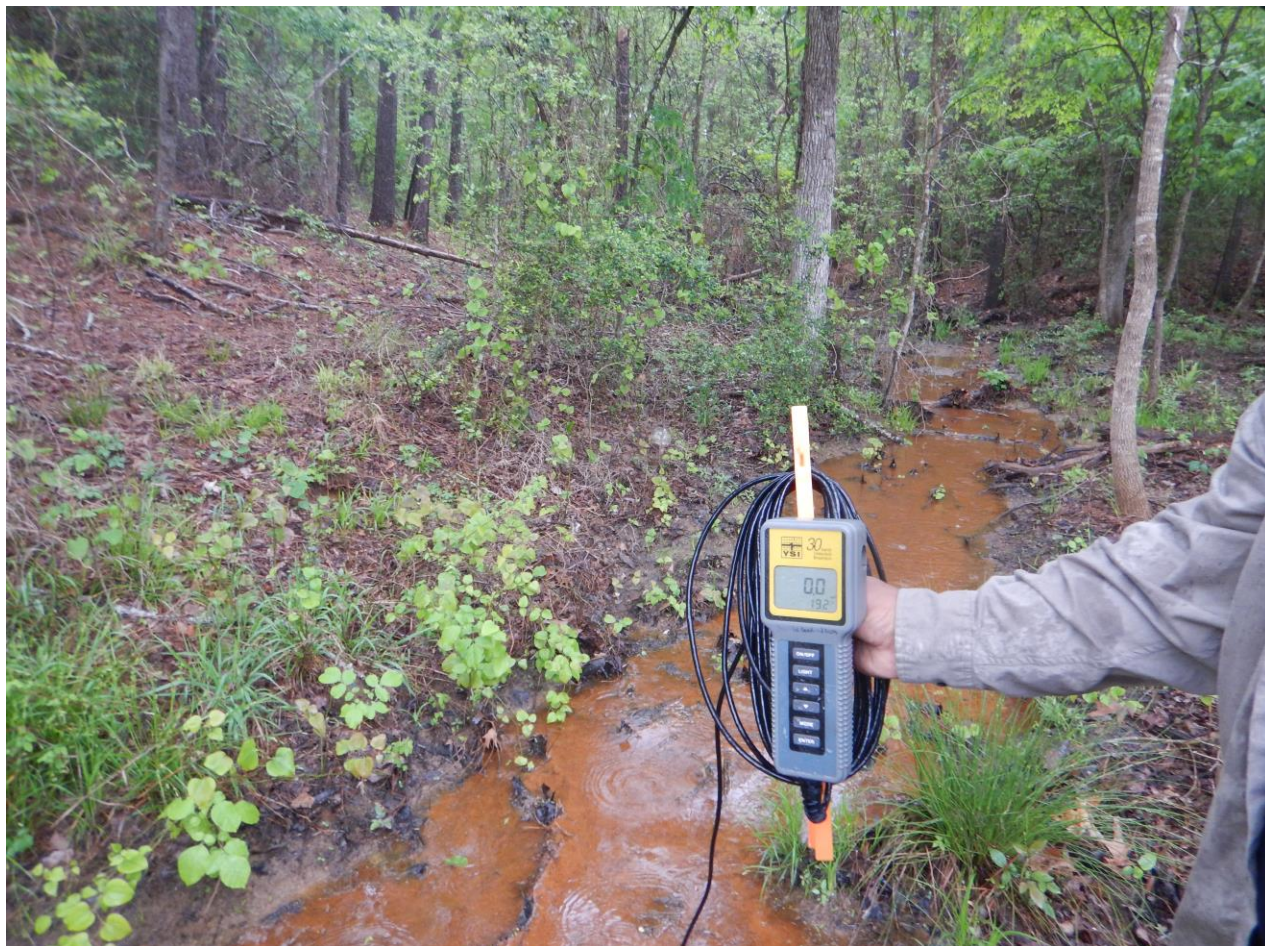
We measured the TSS to determine water quality data, such as water quality in the area, approximately 50 feet upstream of the POE to the tributary of Bayou Loco. We measured TSS of less than 100 ppm at Latitude 31.67869 N and Longitude -94.73409 W. See Photo No. 18 in Appendix 1.

Description: This image shows a TSS reading of less than 100 ppm approximately 50 feet upstream from the POE along the tributary of Bayou Loco, which is the background measurement.
