INSPECTION REPORT

| Regulatory Program | Resource Conservation and Recovery Act (RCRA) | | |
| Type of Inspection | Compliance Evaluation Inspection (CEI) | | |
| Facility or Site Name | ConocoPhillips Alaska Inc - Kuparuk Oil Field | | |

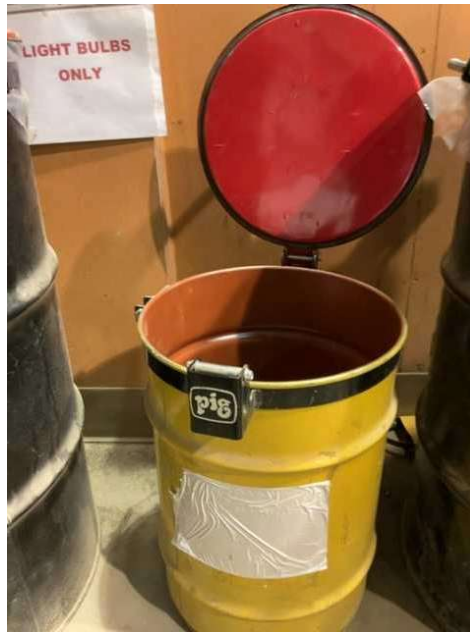
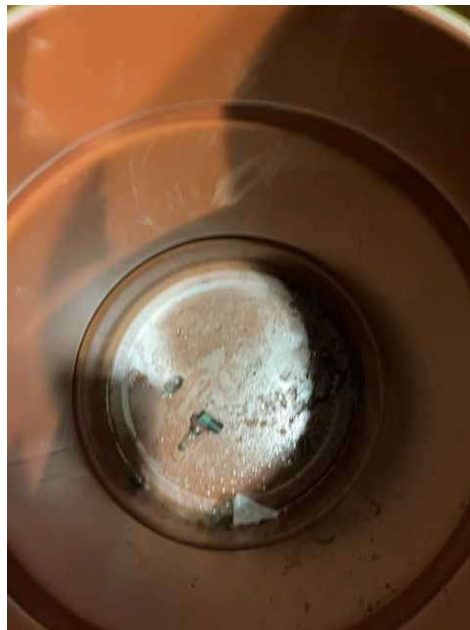
| Little Red SAA UW Lamps Container | | | IMG-20240626115020502063286.jpg |

| Container of waste lamps- no AOC. | | | |

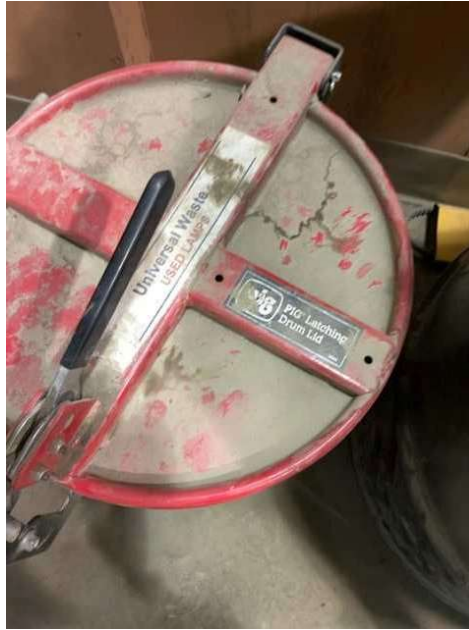
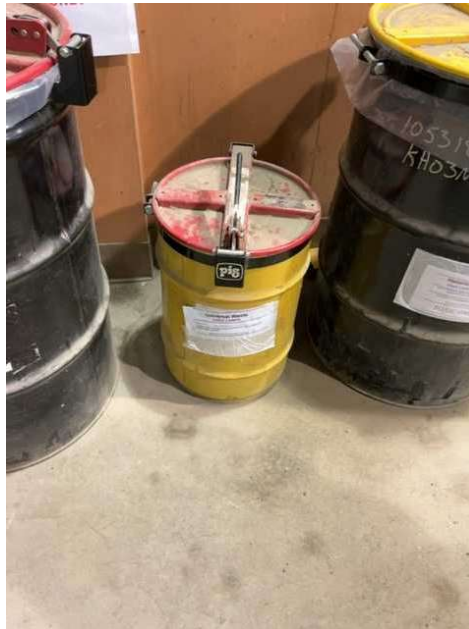
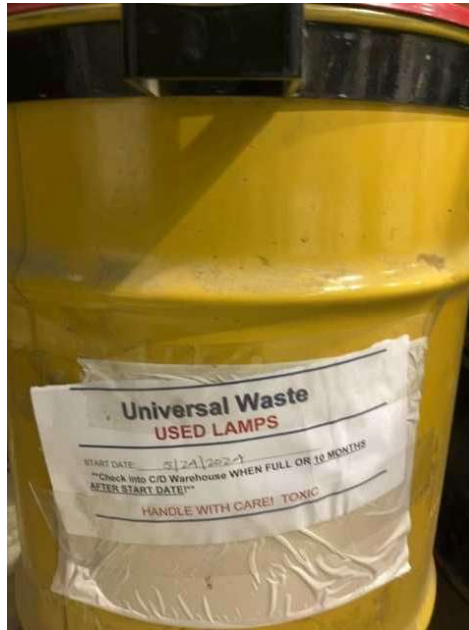
| Little Red SAA UW Lamps Container | | | IMG-20240626115122512272188.jpg |

At the time of the inspection, we observed a container of waste lamps that was properly labeled with the words "used lamps" but did not have an accumulation start date. While labeling containers with an accumulation start date is an internal protocol, Ms. Mahan was able to determine an accumulation start date based on the waste log associated with the container in the SAA. This date was within a year and Ms. Mahan labeled the container with the date "5/24/24".

| Container of waste lamps with "UW Used Lamps" label- no AOC. | | | |

| Container of waste lamps with date added- no AOC. | | | |

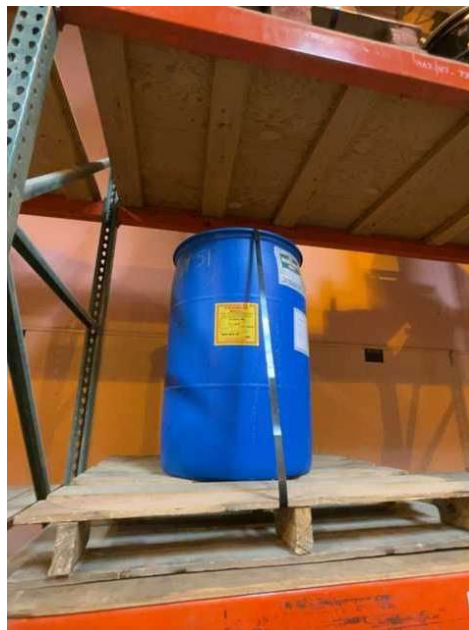
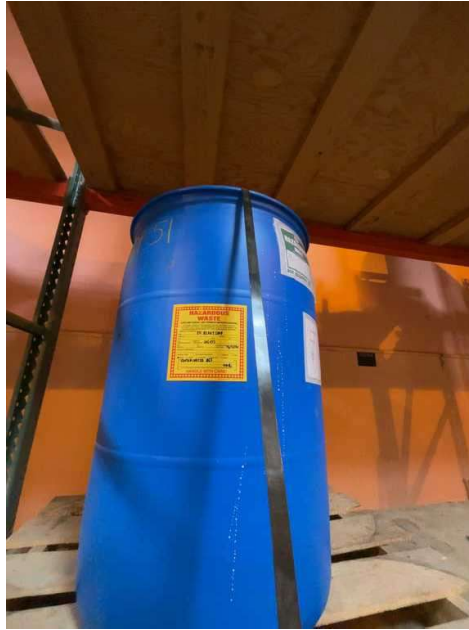
| 55-Gallon Poly Container in CAA Pending Analysis | | | IMG-2024062613061361372998.jpg |

At the time of the inspection, we observed one 55- gallon poly drum pending analysis. This drum was labeled both with a "hazardous waste" label and a "non-hazardous waste" label. It was not marked with a hazard indicator. Ms. Mahan stated that she would have CAA personnel add a hazard indicator.

| One 55- gallon poly drum labeled as "hazardous waste" pending analysis, not marked with a hazard indicator. | <b>Regulation:</b> | <b>Sections:</b> |

| One 55-gallon poly pending analysis and marked "hazardous waste", not marked with a hazard indicator. | | | |

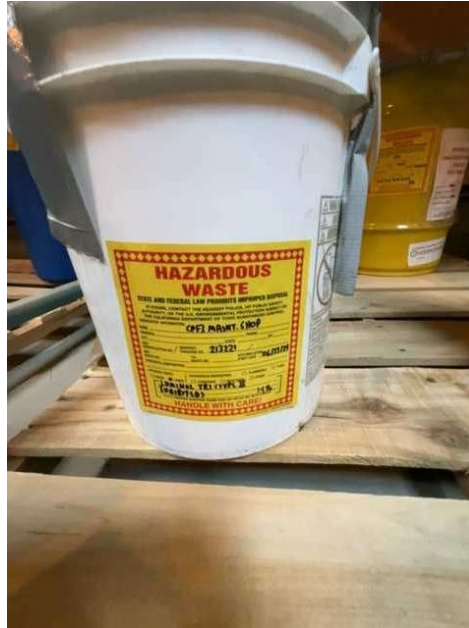
| 5-Gallon Bucket in CAA without a Hazard Indicator | | | IMG-2024062613082082077307.jpg |

At the time of the inspection, we observed one 5-gal white bucket labeled "hazardous waste". It was not marked with a hazard indicator. Ms. Mahan labeled this container with a hazard indicator during the inspection.

| One 5-gallon white bucket labeled "hazardous waste", not marked with a hazard indicator. | <b>Regulation:</b> | <b>Sections:</b> |

| One 5-gallon white bucket labeled "hazardous waste", not marked with a hazard indicator. | | | |

| One 5-gallon white bucket labeled "hazardous waste" and marked with a hazard indicator. | | | |

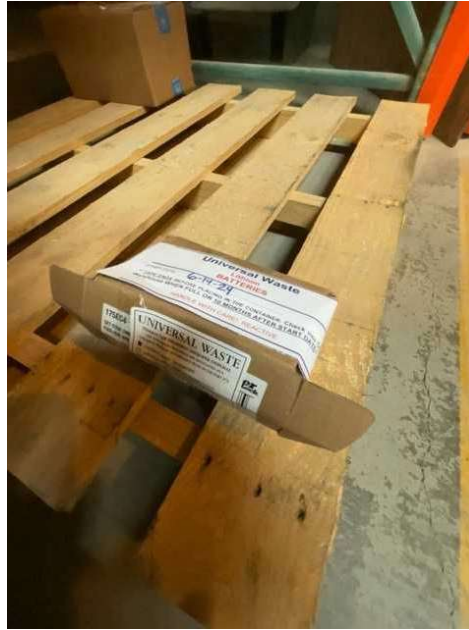
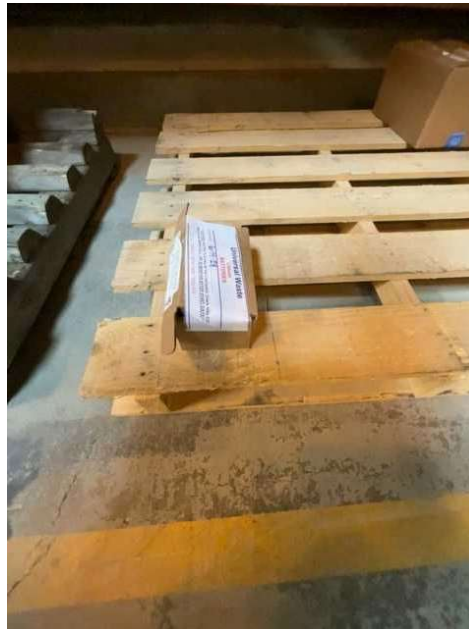
| Box of Lithium Batteries in CAA not Closed | | | IMG-2024062613160916978155.jpg |

At the time of the inspection, we observed a small box of universal waste lithium batteries that was not closed properly because it contained too many batteries. Ms. Mahan stated that she would repackage this container.

| One small box of UW lithium batteries that is not closed. | | | |

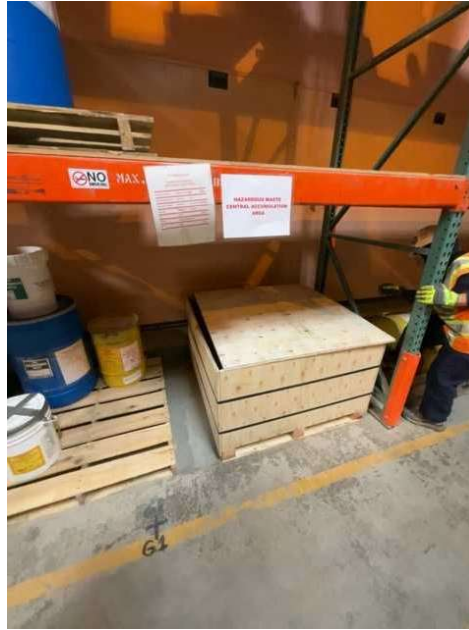
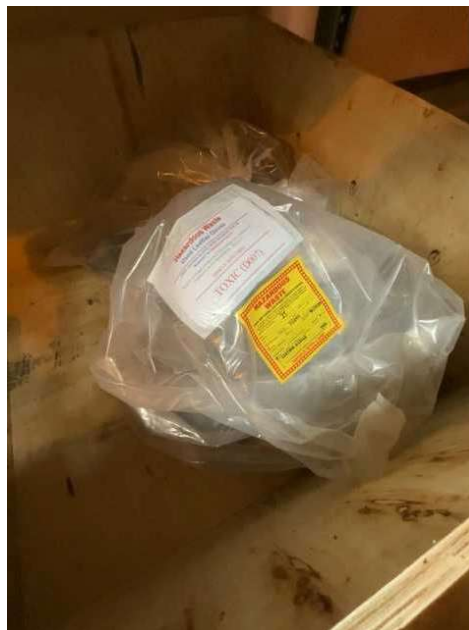
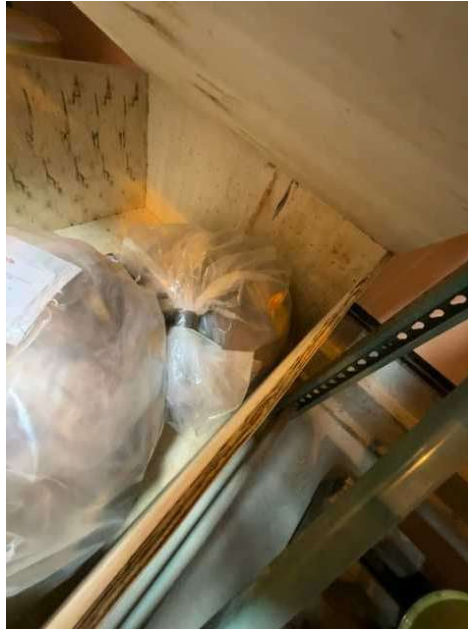
| Crate of Waste Leather Gloves in CAA not Labeled Hazardous Waste or Marked with a Hazard Indicator | | | IMG-20240626132021202176882.jpg |

At the time of the inspection, we observed a large crate of waste leather gloves not labeled "hazardous waste", nor marked with a hazard indicator. However, two bags inside the box were labeled appropriately. Ms. Mahan stated that she would have CAA personnel label the crate with the words "hazardous waste" and with a hazard indicator.

| One large crate of waste leather gloves, not labeled hazardous waste nor marked with a hazard indicator. | <b>Regulation:</b> | <b>Sections:</b> |

| One large crate of waste leather gloves that is not labeled "hazardous waste" and is not marked with a hazard indicator. | | | |

| Two bags of waste leather gloves inside of an unlabeled crate. Bags are labeled as "hazardous waste" and with hazard indicators. | | | |

In an email received from Ms. Mahan after the inspection, photos were provided addressing areas of concern identified during the inspection. This included: labeling the crate of hazardous waste gloves with a hazardous waste label and a hazard indicator, repackaging the box of lithium batteries to ensure the container was closed, and labeling the appropriate containers as "non-hazardous" after receiving confirmation from analyses. In relation to these drums, she stated that the contents were found to be blast media, glycol A, and glycol B.

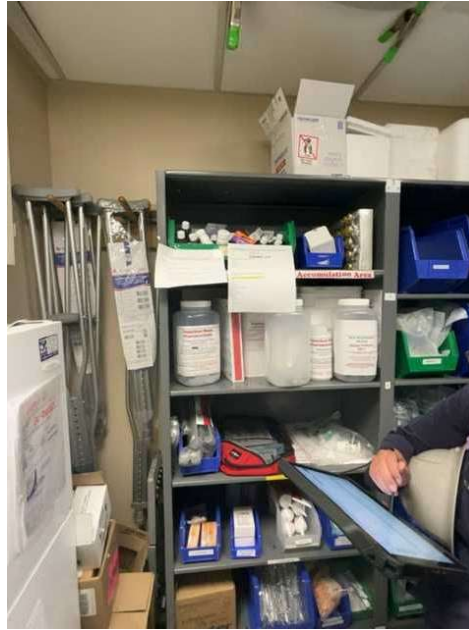
| Hazardous Waste Pharmaceuticals in Medical Clinic SAA | | | IMG-20240627081713171381632.jpg |

This SAA is where hazardous waste pharmaceuticals are handled. Clinic personnel stated that hazardous waste pharmaceuticals generated in the clinic are managed as hazardous waste. Non-hazardous waste pharmaceuticals that are expired are donated to a clinic in Anchorage to be re-used. This clinic does utilize a reverse distributor for any potentially creditable pharmaceuticals.

| Medical Clinic SAA overview. | | | |

| Hazardous waste pharmaceuticals container. | | | |

| Non-hazardous waste pharmaceuticals to be sent to Anchorage for re-use. | | | |

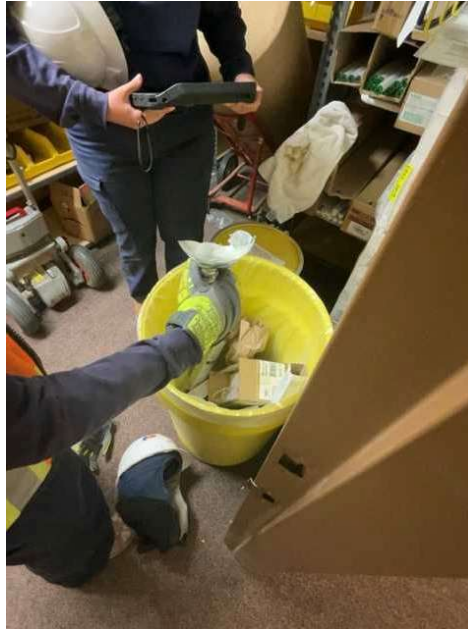
| Broken Lamp in Trash in KCC Rec Room SAA | | | IMG-2024062708470547583203.jpg |

At the time of the inspection, we observed a broken bulb in a trash can. Ms. Mahan was unsure if this bulb was hazardous or non-hazardous. She removed the bulb from the trash can and placed it into the appropriate universal waste container. She stated that she would determine the kind of bulb it was to determine if hazardous or non-hazardous.

| One broken bulb observed in a trash can. | <b>Regulation:</b> | <b>Sections:</b> |

| One broken lamp found in a trash can. | | | |

In an email received from Ms. Mahan after the inspection, she stated that the bulb was a non-hazardous Sylvania brand 250-watt incandescent heat lamp. She provided a photo of this label and the Safety Data Sheet, as well as a photo of the stamp inside the bulb itself.

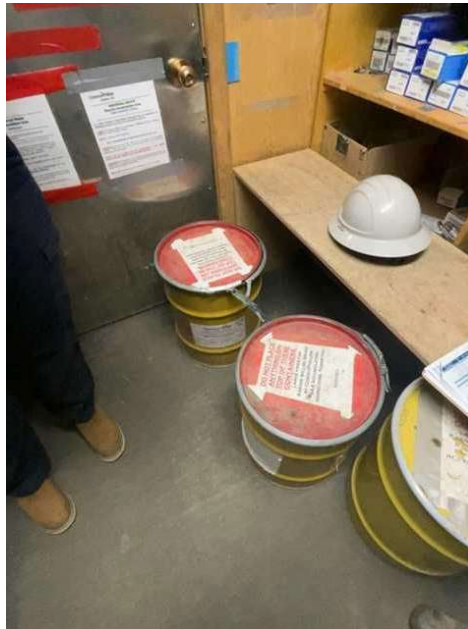
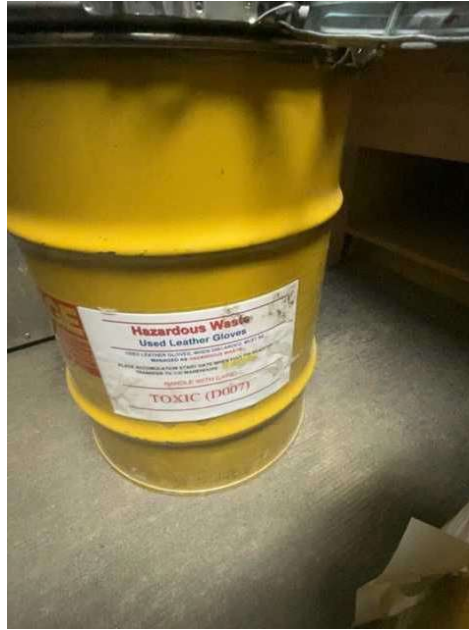
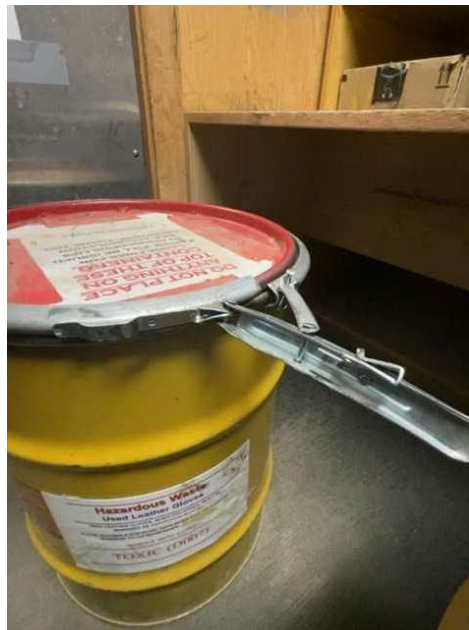
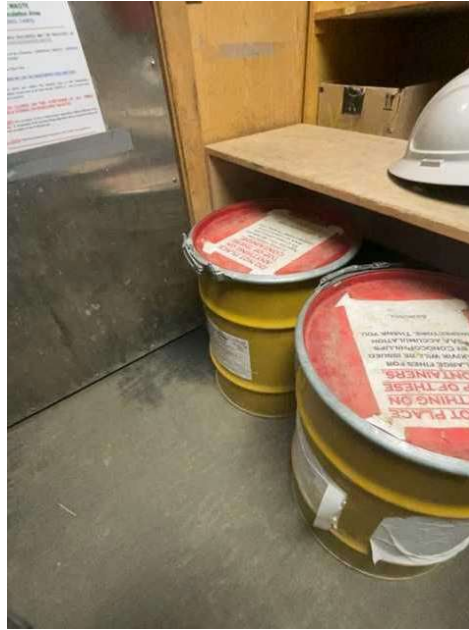
| Waste Leather Glove Container not Closed in KOC Corrosion SAA | | | IMG-20240627091145114580099.jpg |

At the time of the inspection, we observed a container of waste leather gloves that was not closed. This container was labeled appropriately with the words "hazardous waste" and a hazard indicator. Ms. Mahan closed this container during the inspection.

| One container of waste leather gloves that is not closed. | | | |

| One container of waste leather gloves that is closed during the inspection. | | | |

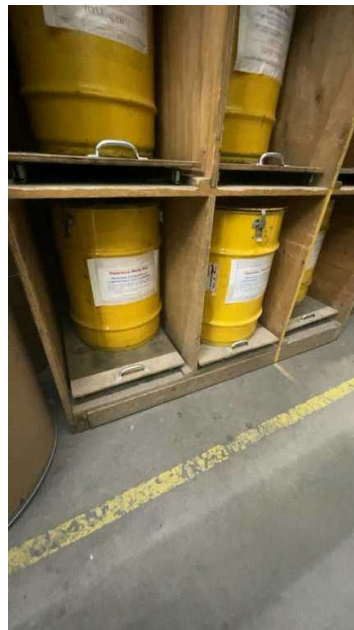
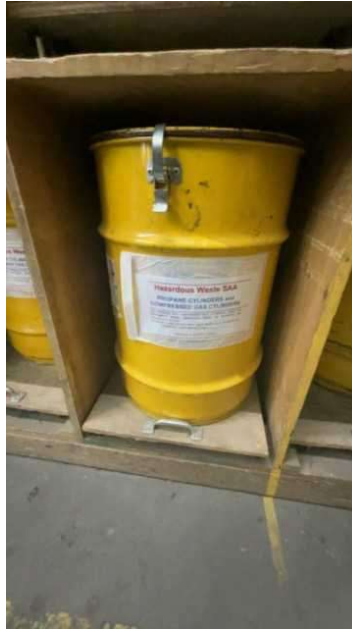
| Two Containers of Compressed Gas Cylinders without Hazard Indicators in CPF-1 Central Shop SAA | | | IMG-202406270926032631177197.jpg |

At the time of the inspection, we observed two containers of compressed gas cylinders that were labeled with the words "hazardous waste" but were not marked with a hazard indicator. Ms. Mahan asked shop personnel to label these containers with the correct hazard indicator.

| Two containers of waste compressed gas cylinders, not marked with hazard indicators. | <b>Regulation:</b> | <b>Sections:</b> |

| Two containers of waste compressed gas cylinders without hazard indicators. | | | |

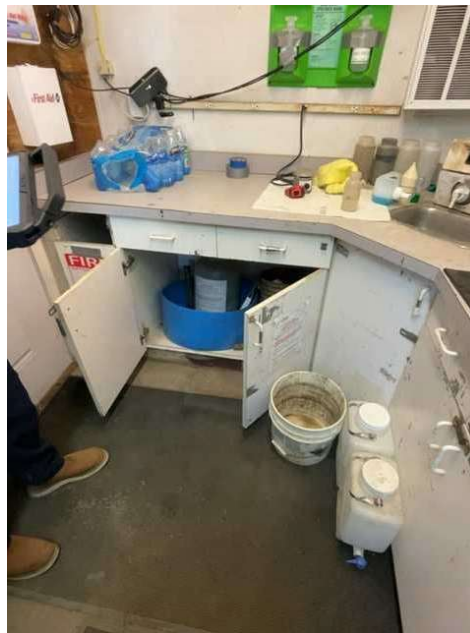
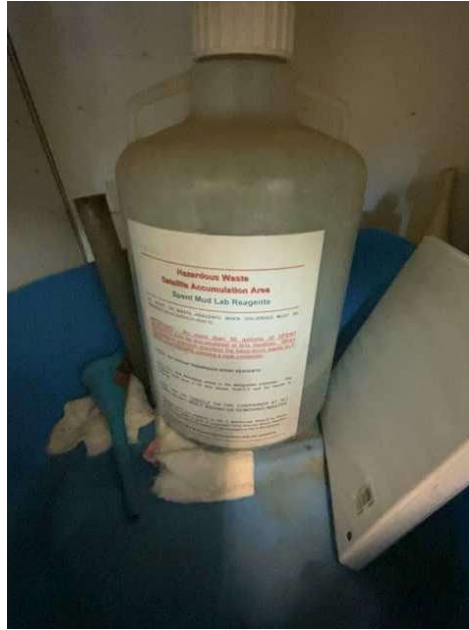
| Container of Spent Mud Lab Reagents in Nabors 7ES SAA without a Hazard Indicator | | | IMG-20240627101651165176996.jpg |

| <p>At the time of the inspection, we observed a container of spent mud lab reagents that was labeled with the words "hazardous waste" but was not labeled with a hazard indicator. Ms. Mahan labeled this with the hazard indicator "toxic" and stated that she would ensure that there were no other appropriate indicators that need to be added.</p> <p>In an email received from Ms. Mahan after the inspection, photos were provided demonstrating that the container of spent mud lab reagents had been labeled with the hazard indicators "toxic" and "ignitable".</p> | |

| One container of spent mud lab reagents, not marked with a hazard indicator. | <b>Regulation:</b> | <b>Sections:</b> |

| SAA container of spent mud lab reagents that is not marked with a hazard indicator. | | | |

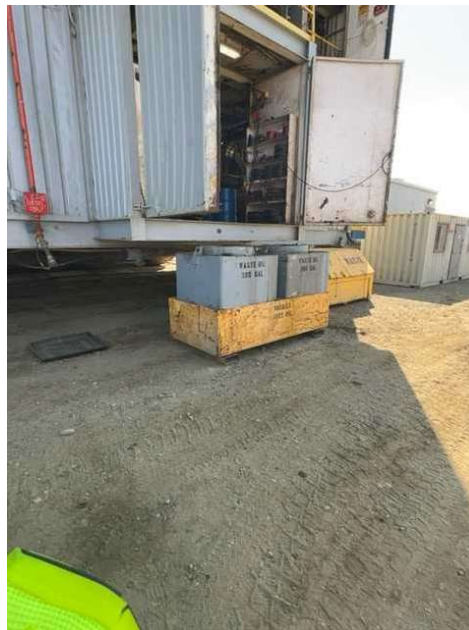
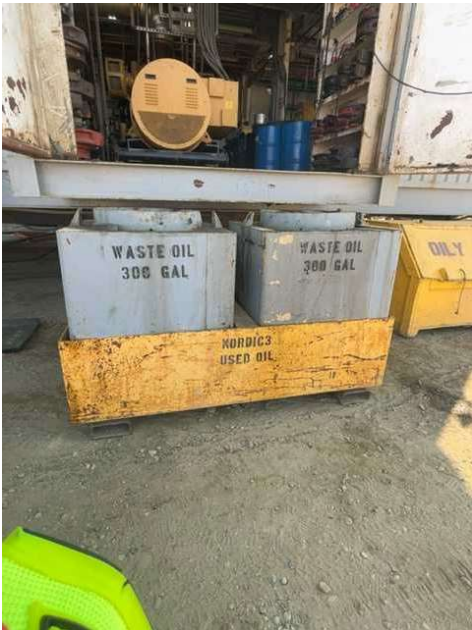
| Two Containers of Used Oil at Nordic 3 Rig Labeled as "Waste Oil" | | | IMG-20240627121654165499271.jpg |

| <p>At the time of the inspection, we observed two 300-gallon tanks of used oil outside of the rig labeled "waste oil". The containment device holding these two tanks was labeled "used oil". Ms. Mahan stated that these tanks would be re-labeled with the words "used oil".</p> <p>At the time of the inspection, we observed a container of waste lamps in the SAA in the rig that did not have an accumulation start date. While labeling containers with an accumulation start date is an internal protocol, Ms. Mahan was able to determine a start date based on the waste log associated with the container in the SAA. This date was within a year and Ms. Mahan labeled the container with the date "5/16/24".</p> | | | |
