**Region 6 - Enforcement & Compliance Assurance Division**  
**INSPECTION REPORT**

| Inspection Date(s): | 06/13/2023 | |
| Company Name: | Bar H Livestock Marketing, LLC | |
| Facility Name: | Elk City Livestock Auction (35.381028, -99.398969) | |

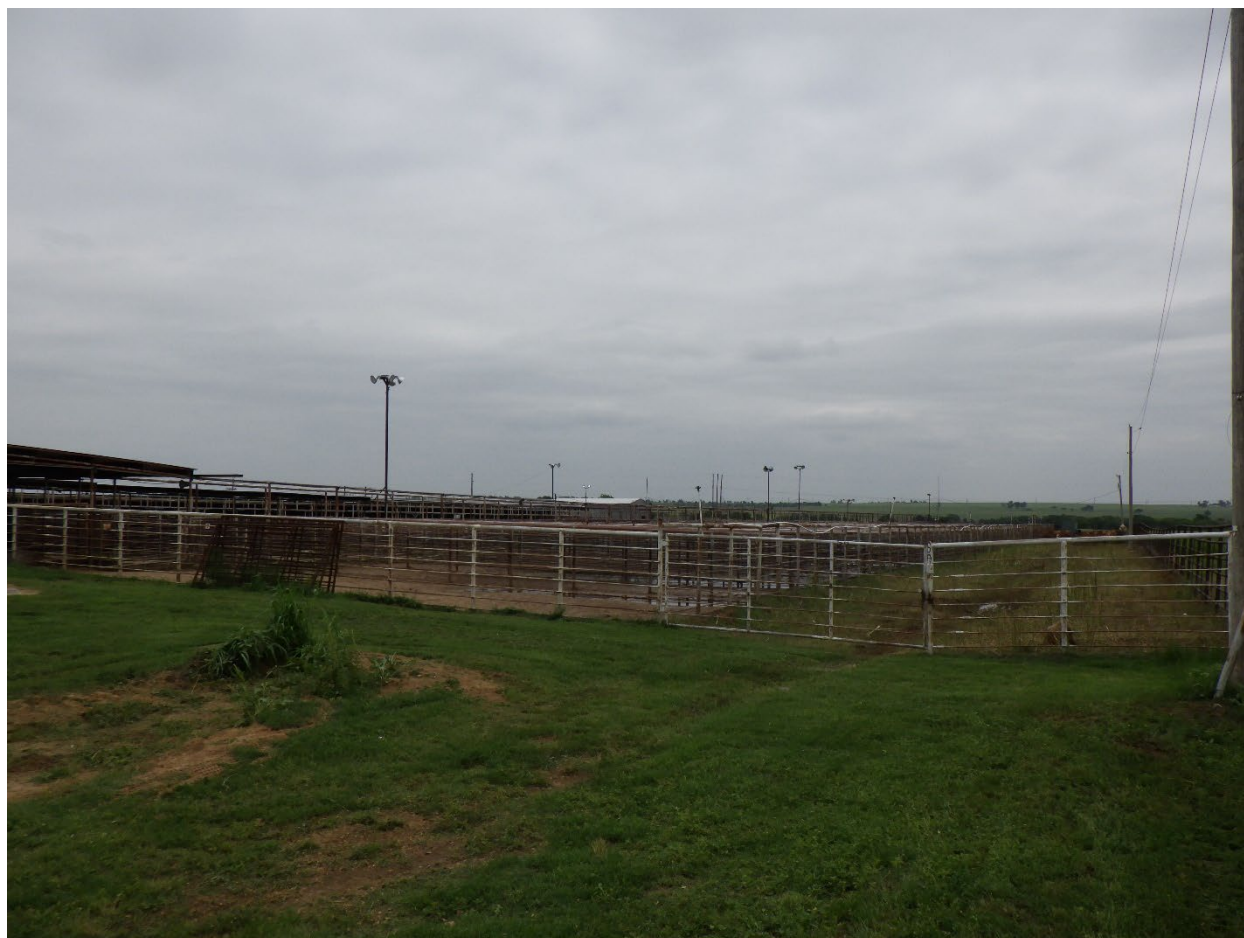
*Photo No. 1*

Description: View to the east. South edge of the facility. Notice topography creating a flowpath for drainage and berm on the south end.

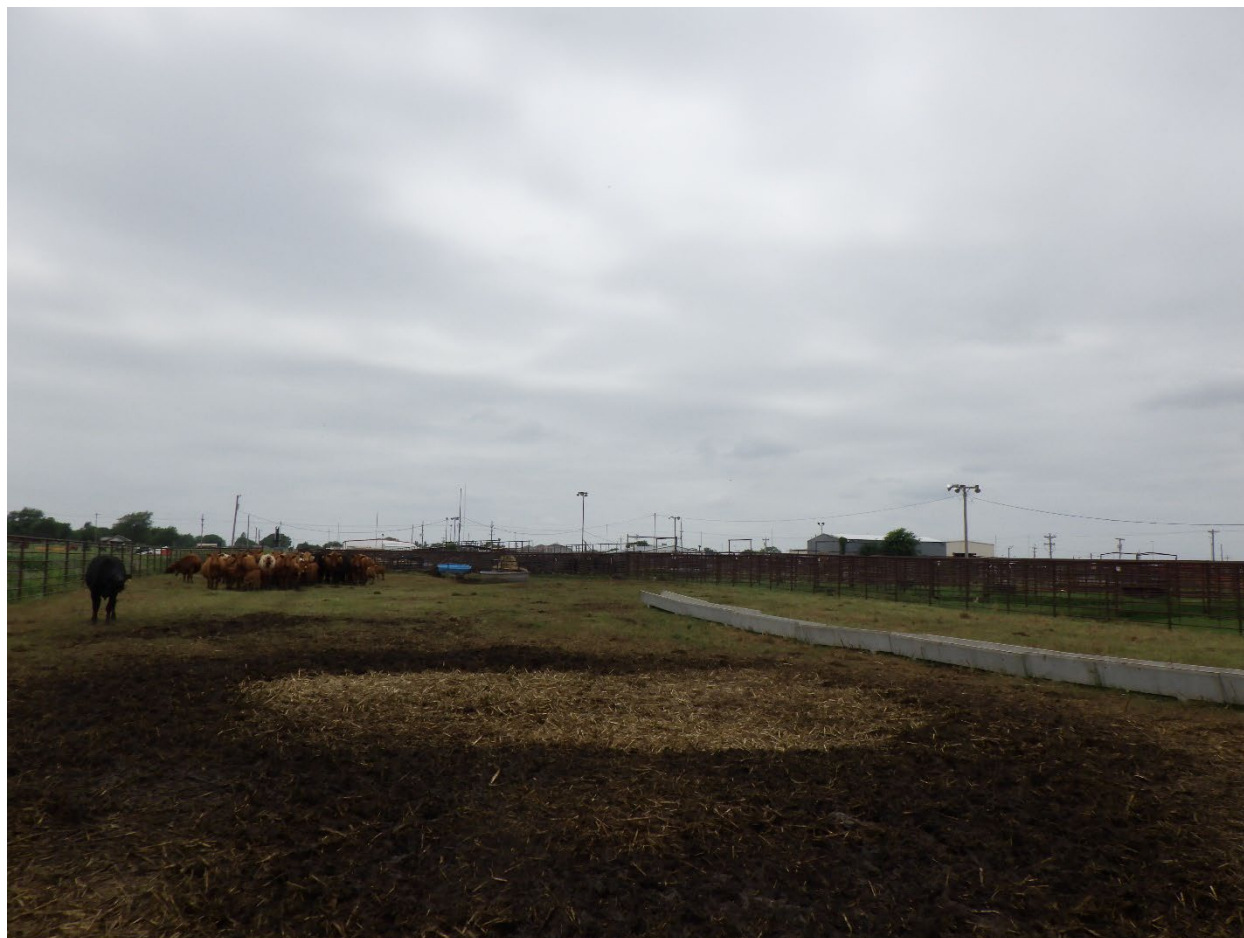
*Photo No. 2*

Description: View to the west-northwest. Taken from the eastern edge of the facility to show grade of pens towards the photographer.

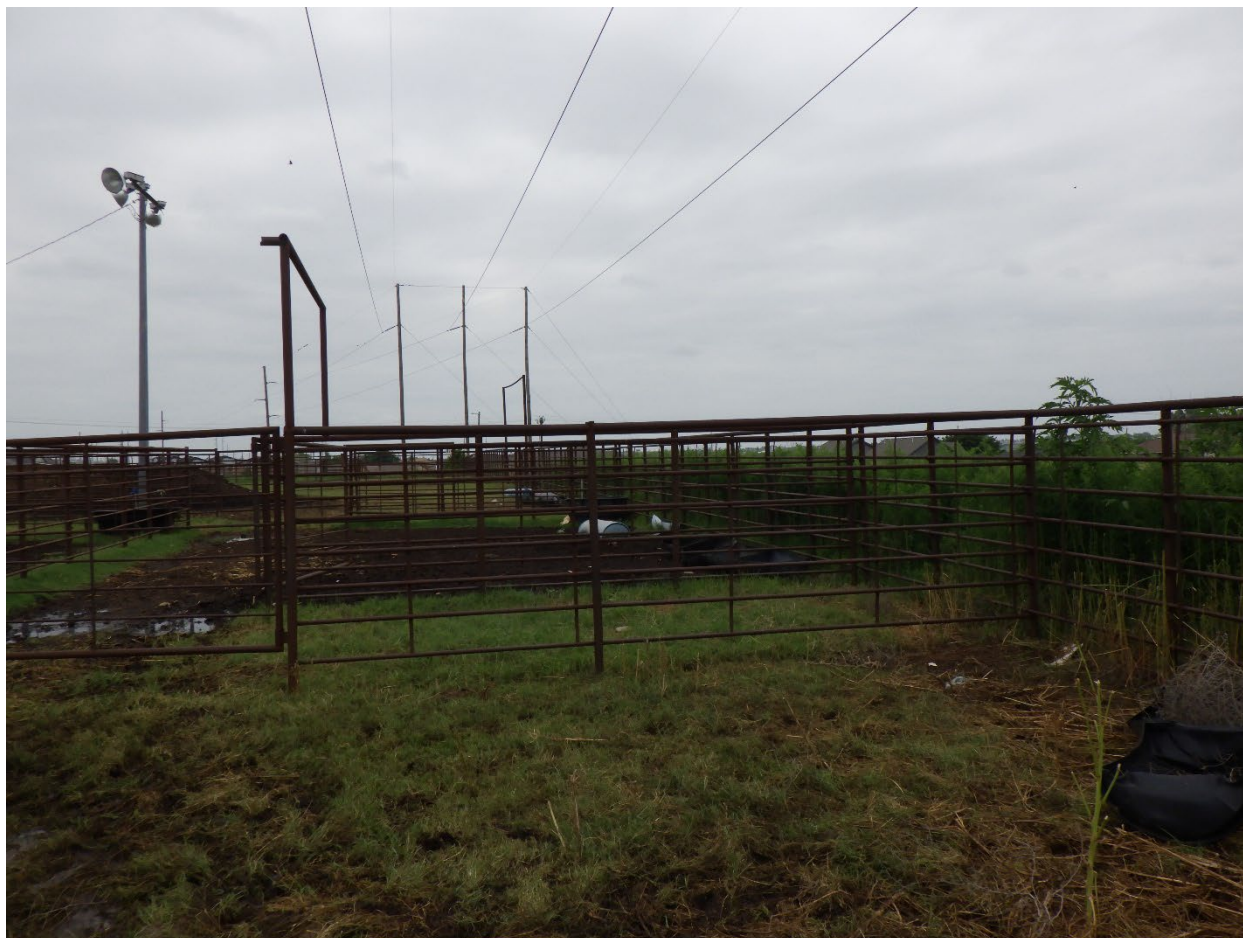
*Photo No. 3*

Description: View to the north. East edge of facility. Notice berm outside of the pens to contain runoff and runoff.

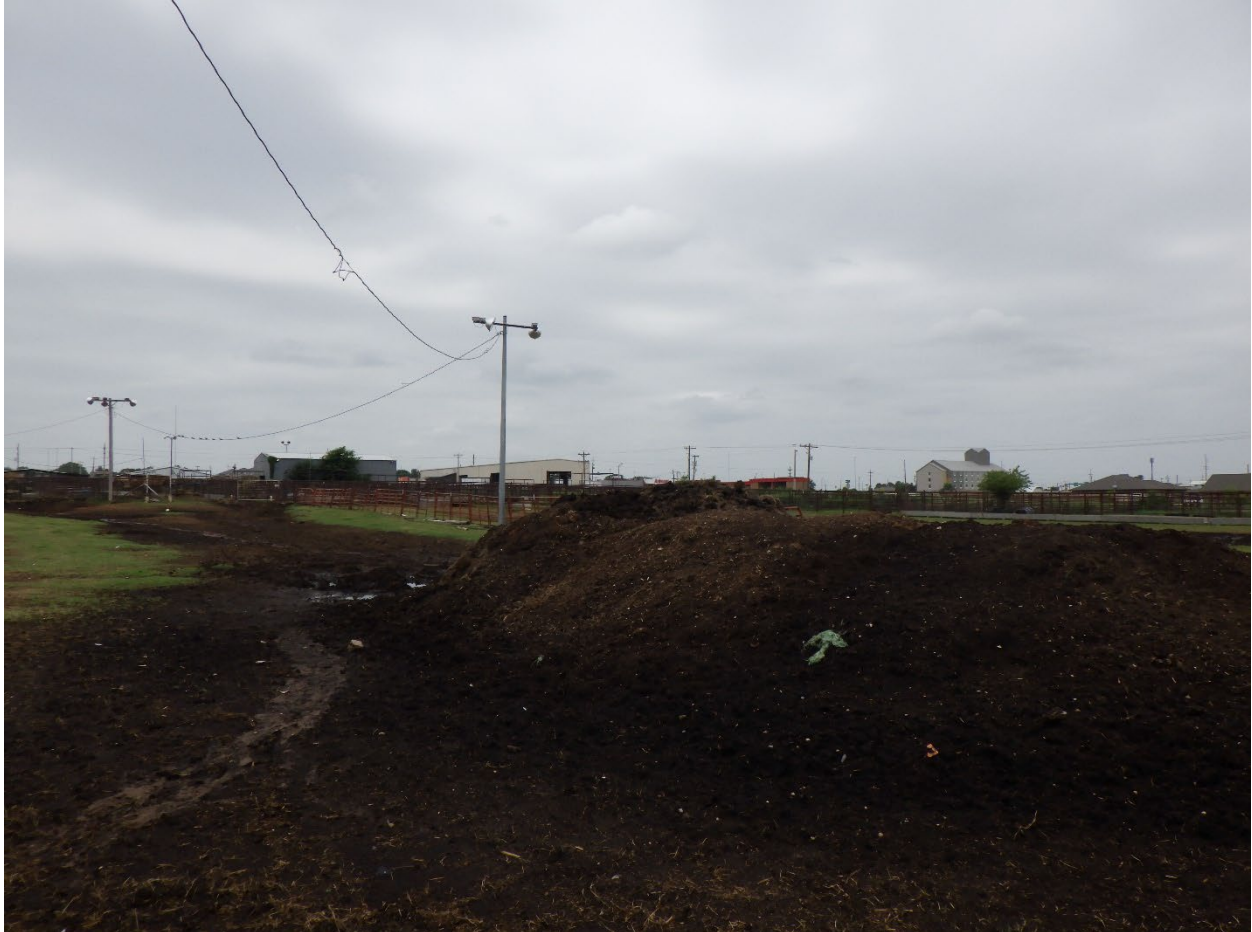
*Photo No. 4*

Description: View to the west-northwest. Photo of manure pile in the drainage of the grated manhole.

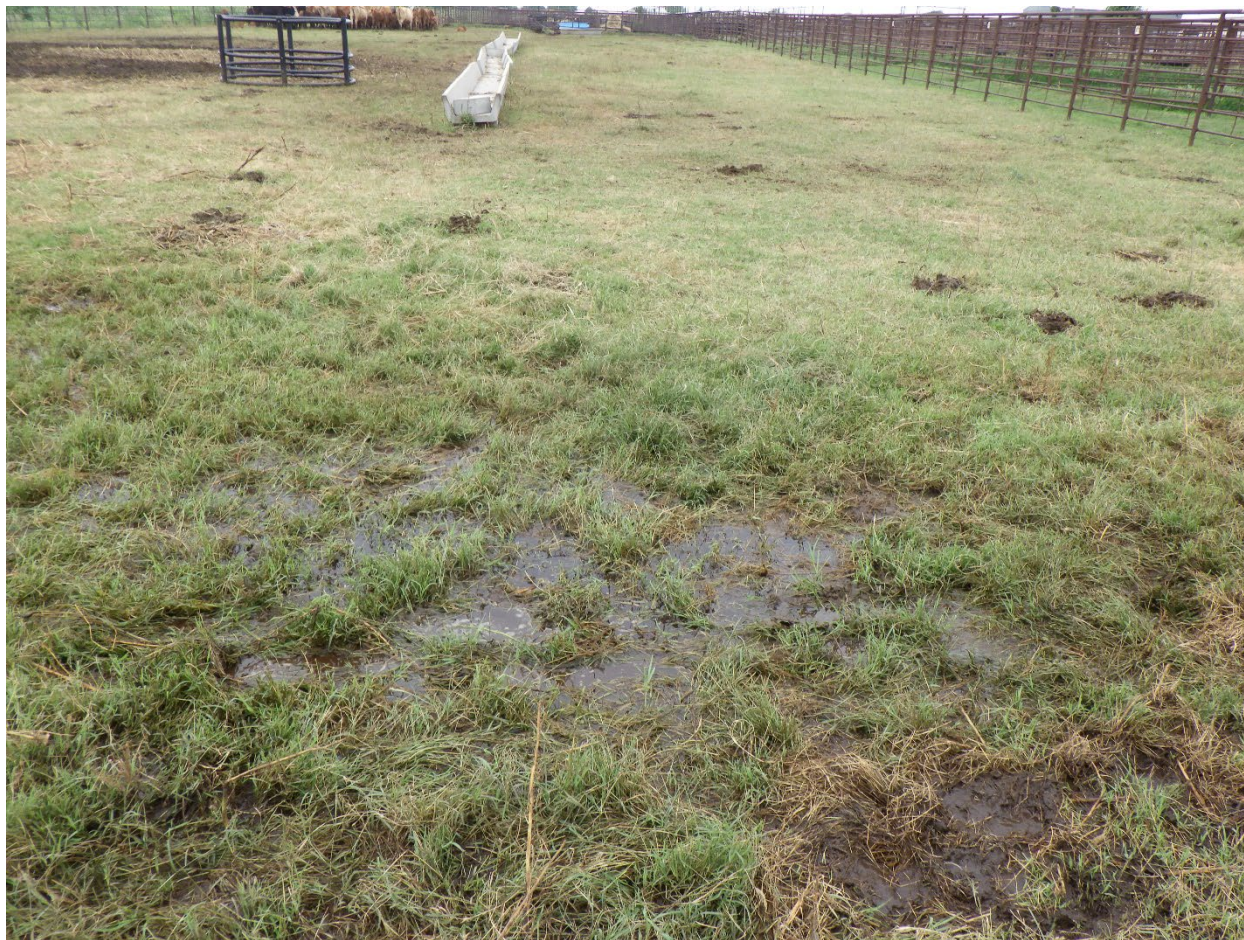
*Photo No. 5*

Description: View to the west. Photo of the manhole where water is pumped to the city.

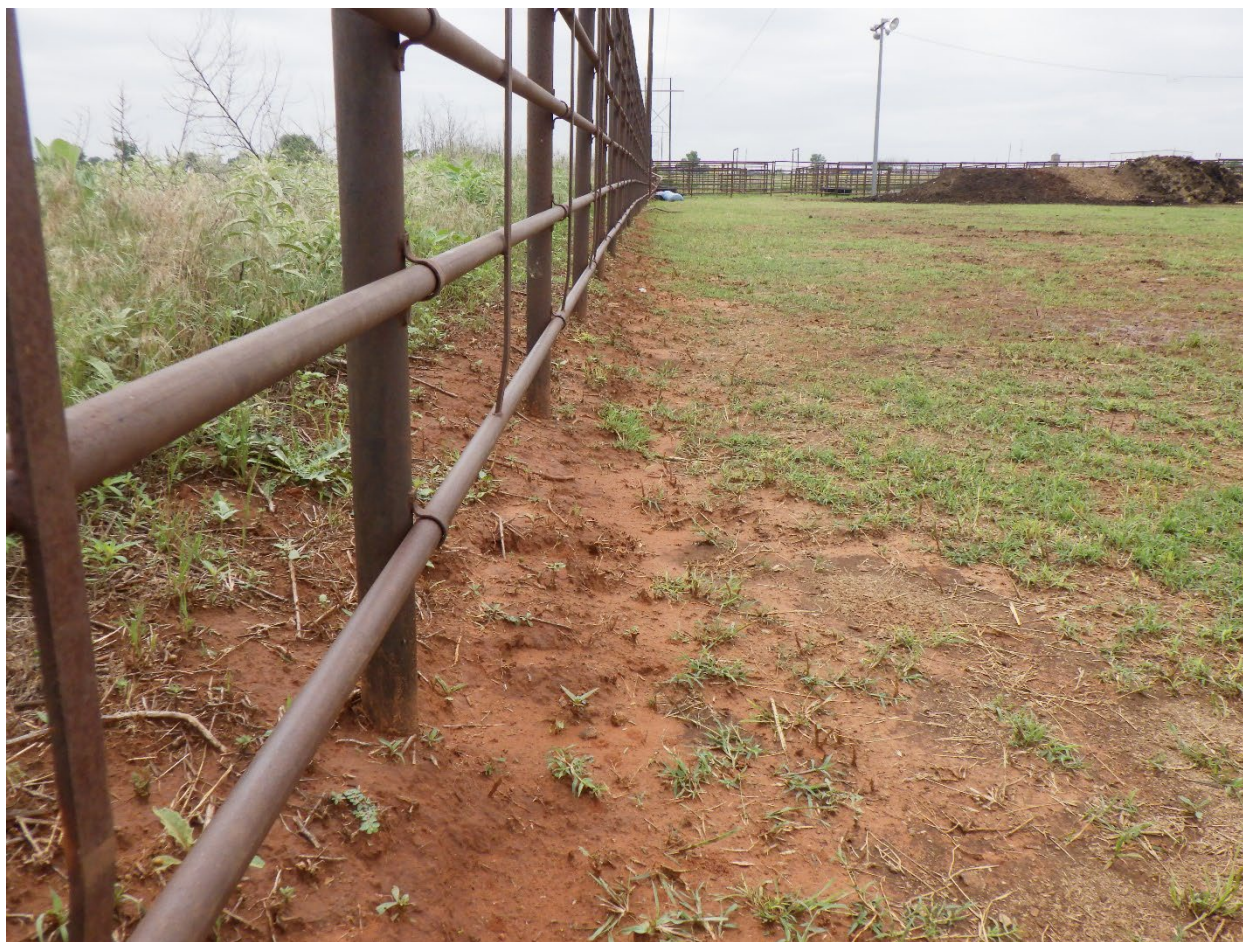
*Photo No. 6*

Description: View to the south. Photo of the berm on the east edge of the facility to control runoff and runon.

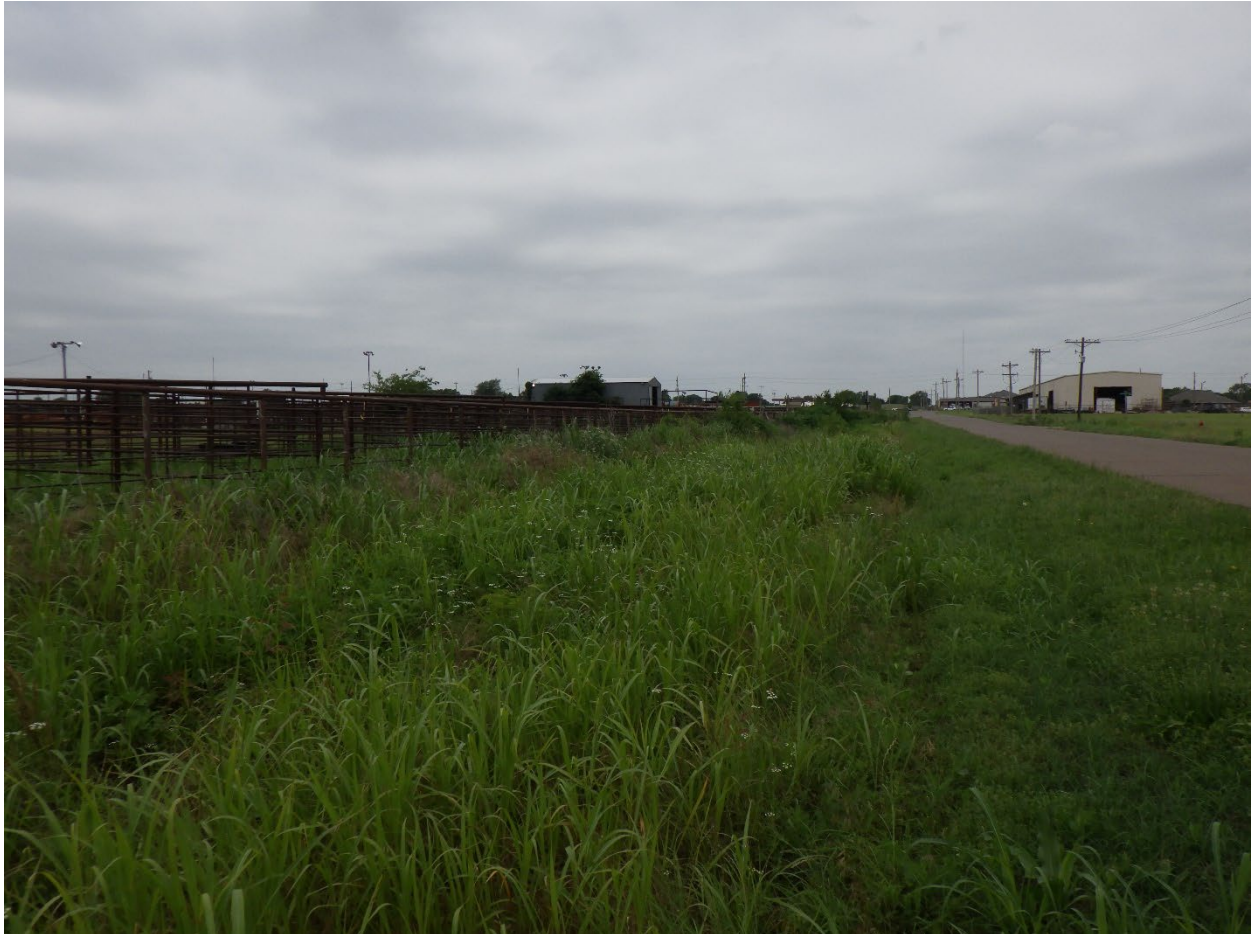
*Photo No. 7*

Description: View to the west. North edge of the facility along Cattleman Road with drainage flow toward the photographer.

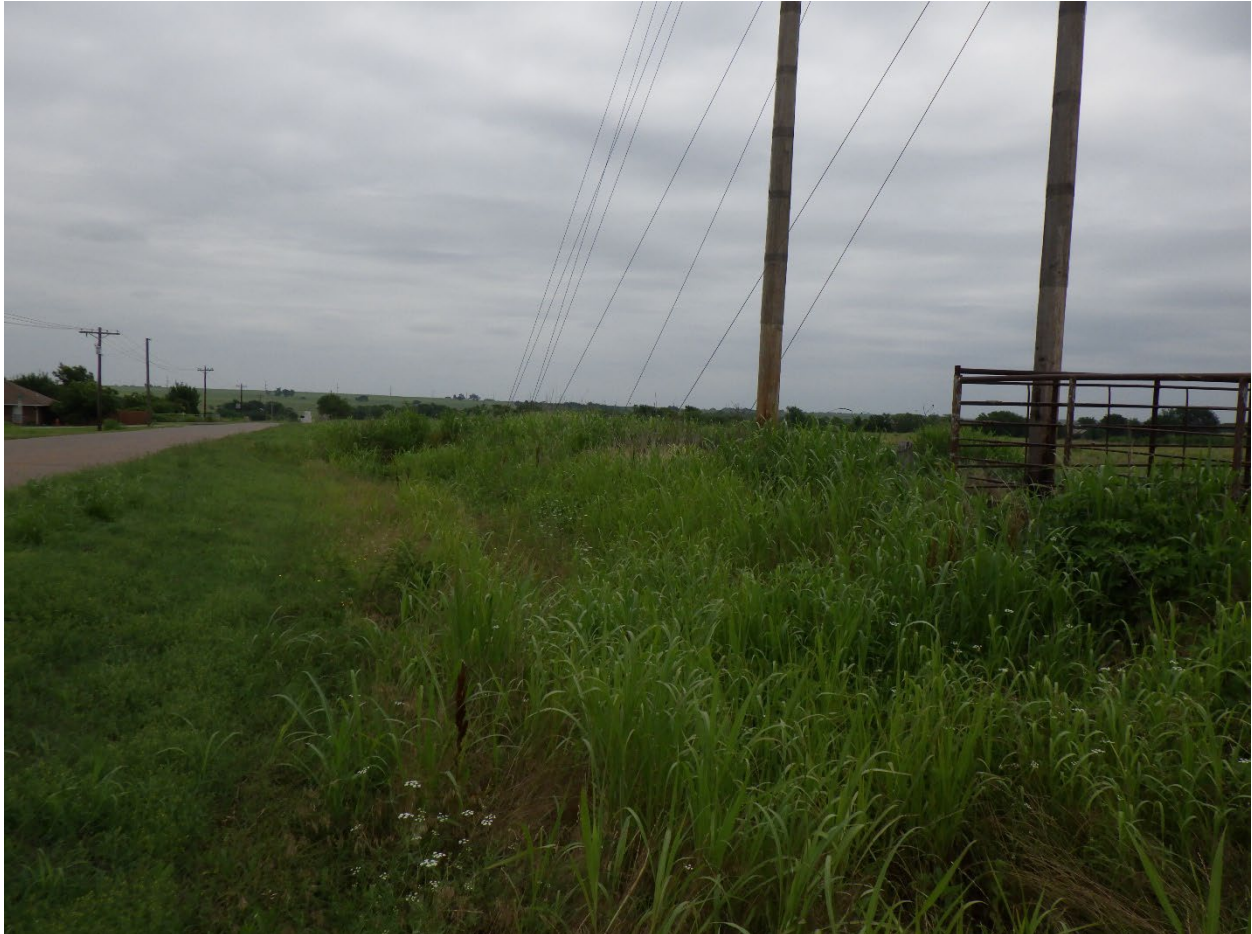
*Photo No. 8*

Description: View to the east. North edge of the facility with drainage flowing to the east toward Elk Creek.

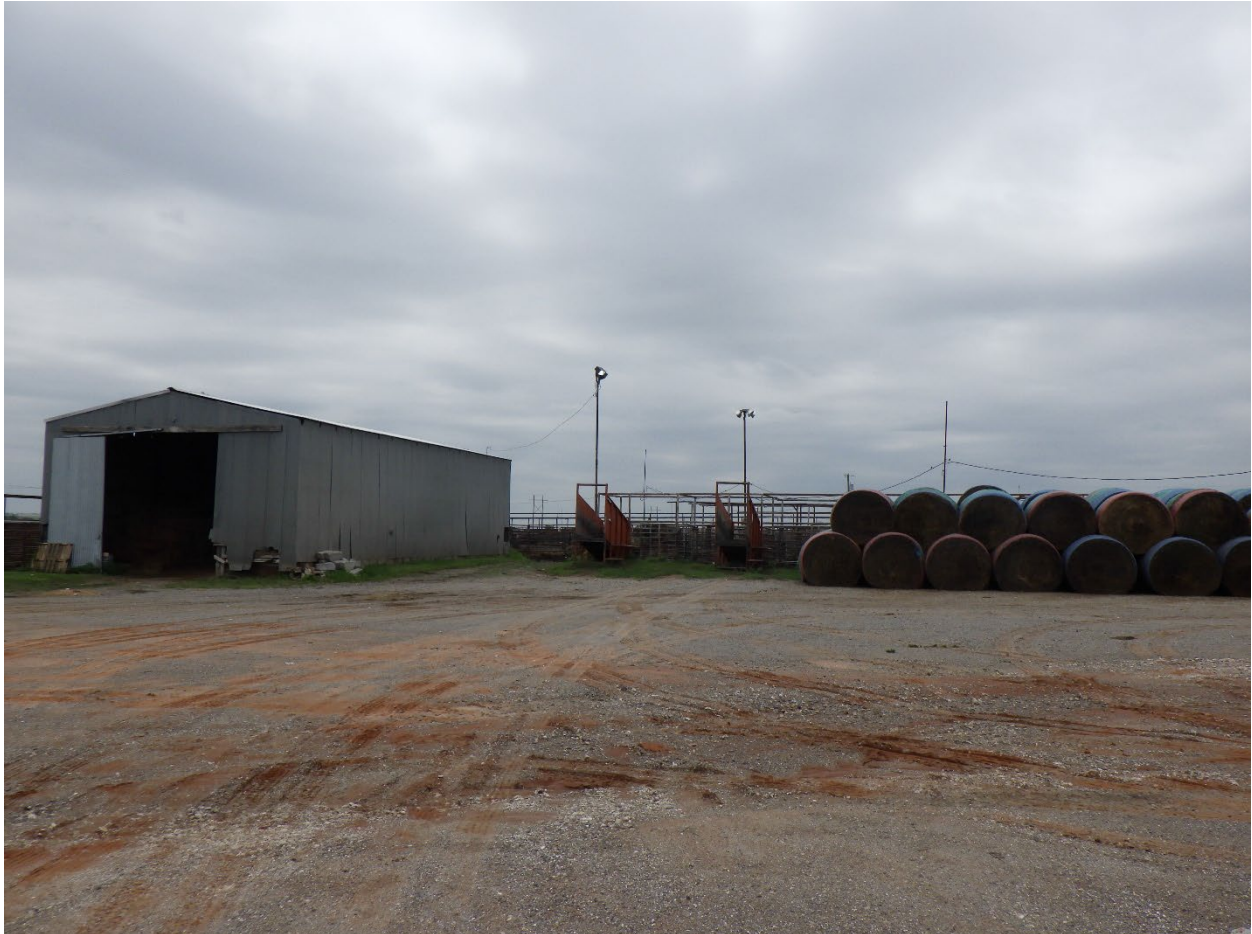
*Photo No. 9*

Description: View to the southeast. Commodity and hay storage.

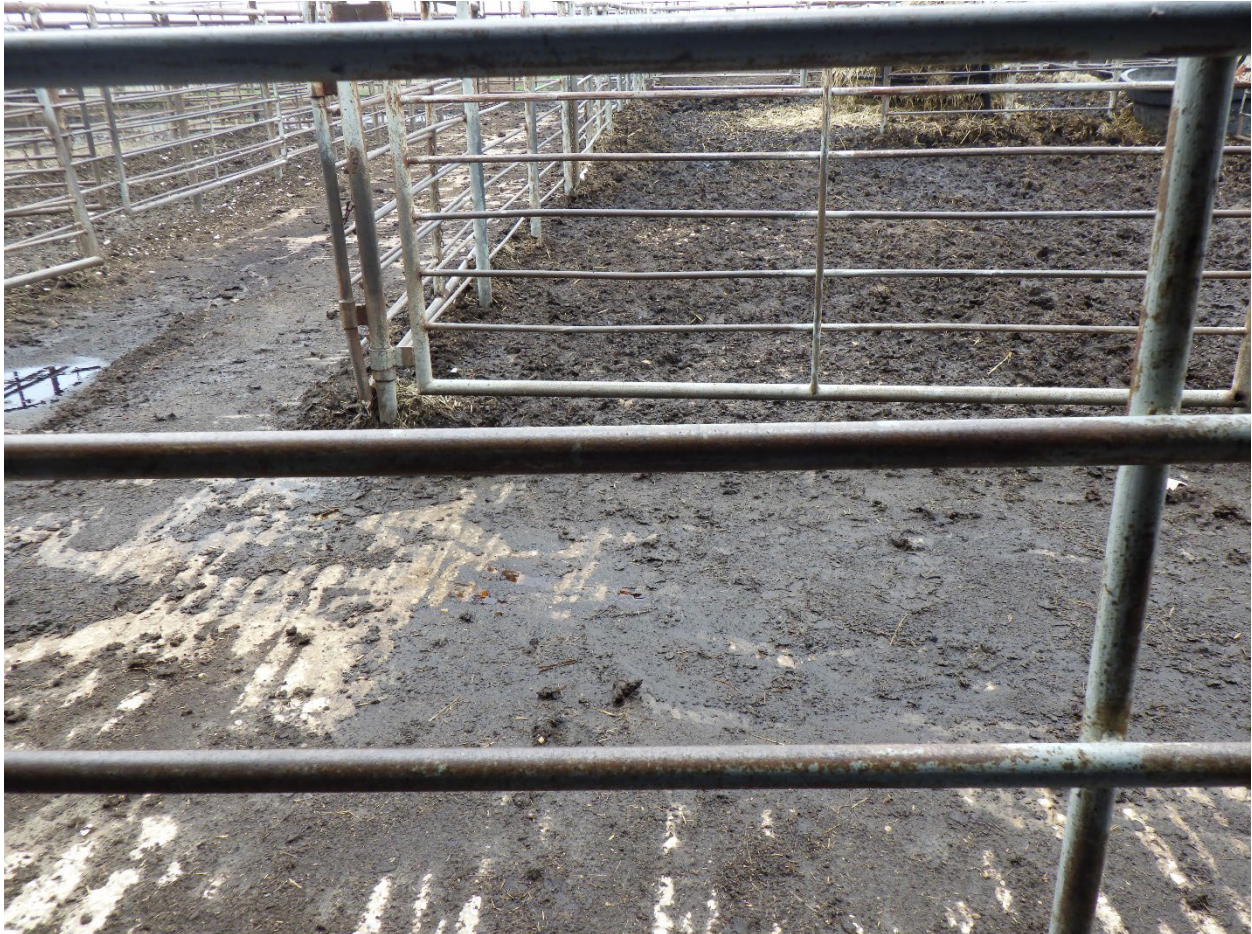
*Photo No. 10*

Description: View to the south. Cement alley in pens that directs runoff to the grated manhole.

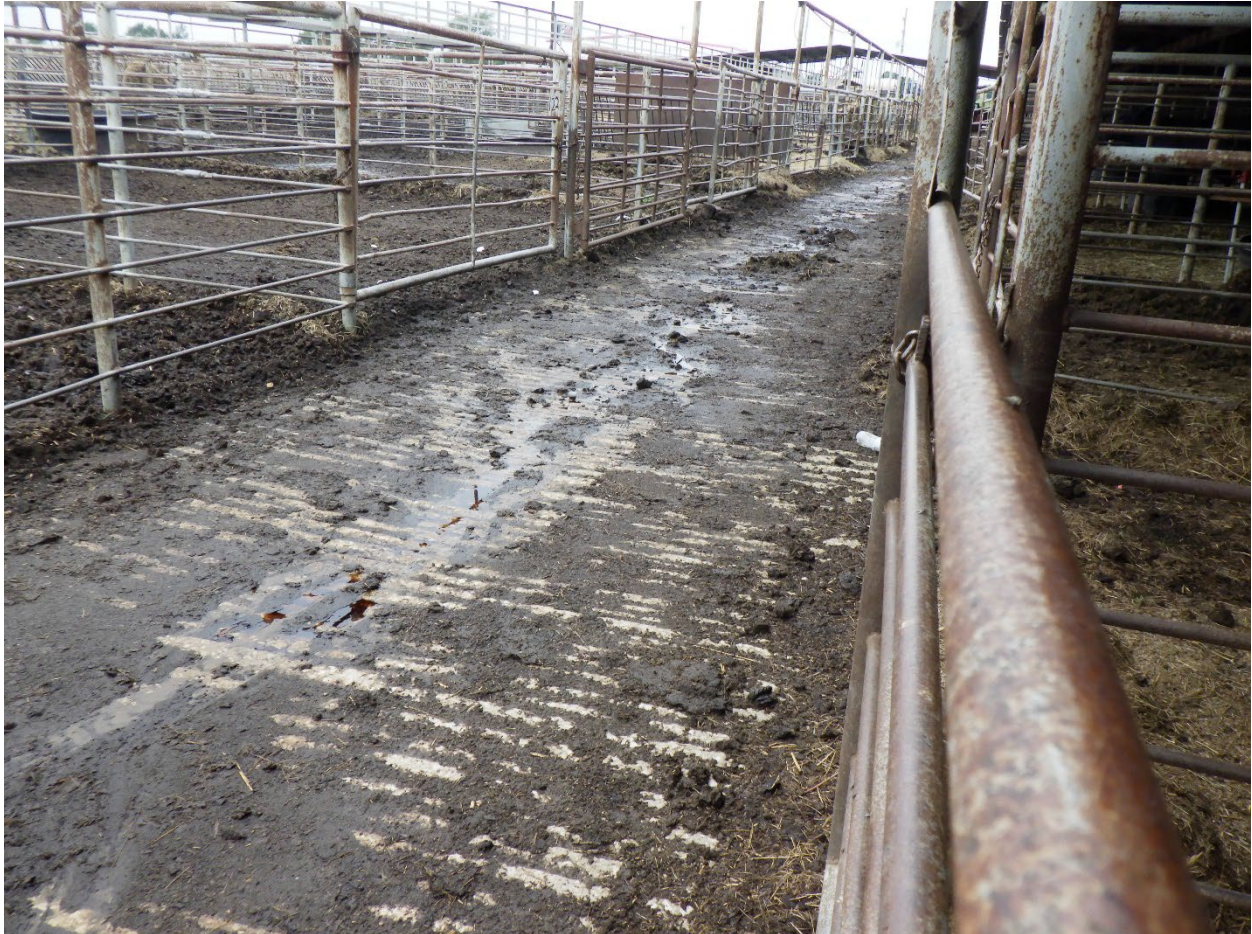
*Photo No. 11*

Description: View to the west. Cement alley that directs runoff to the grated manhole.

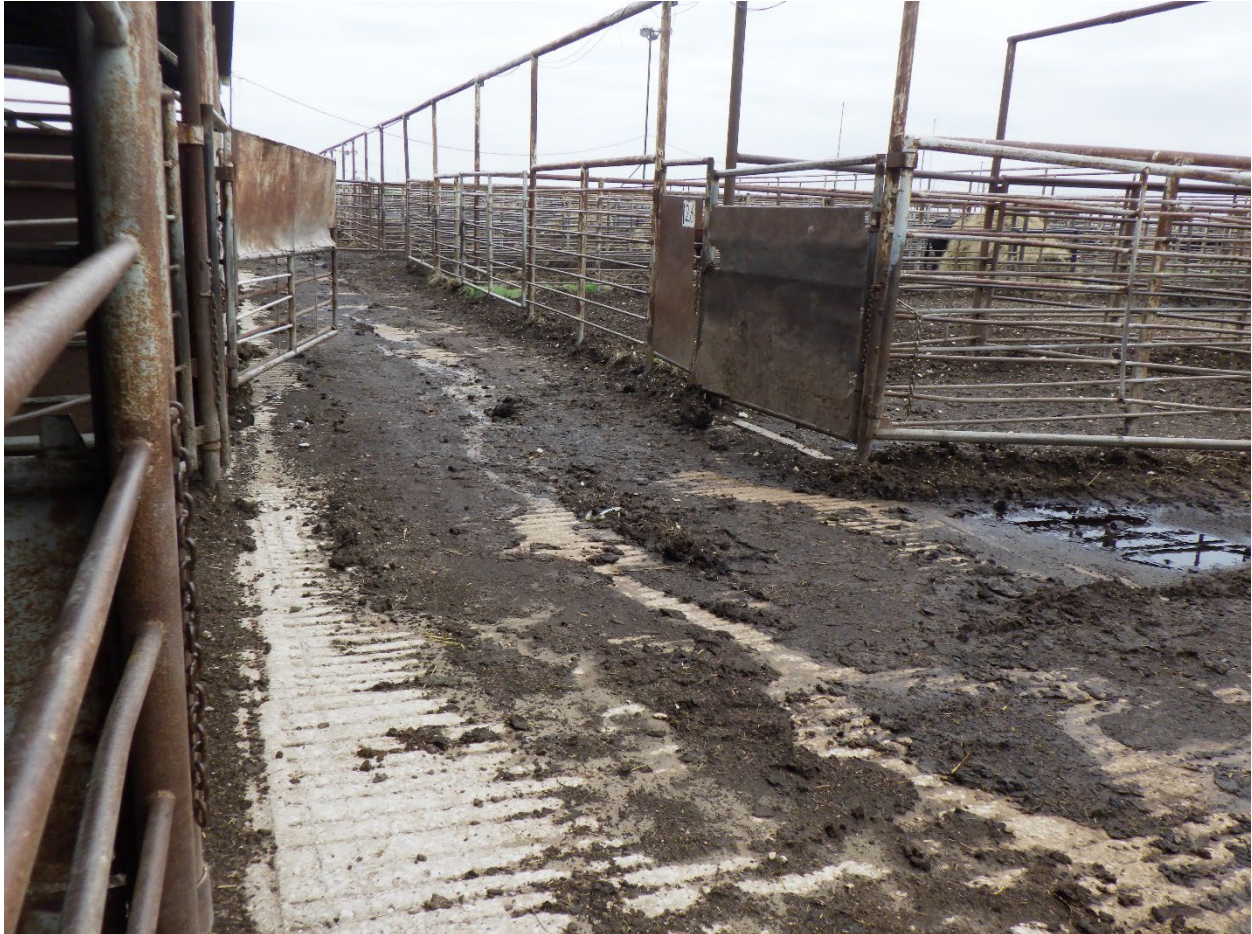
*Photo No. 12*

*Description: View to the east. Cement alley that directs runoff to the grated manhole.*
