## Region 6 - Enforcement & Compliance Assurance Division

### INSPECTION REPORT

| Company Name: | <b>WELLCO Energy</b> | |
| Facility Name: | <b>Anderson/Cottonmouth Lease</b> | |

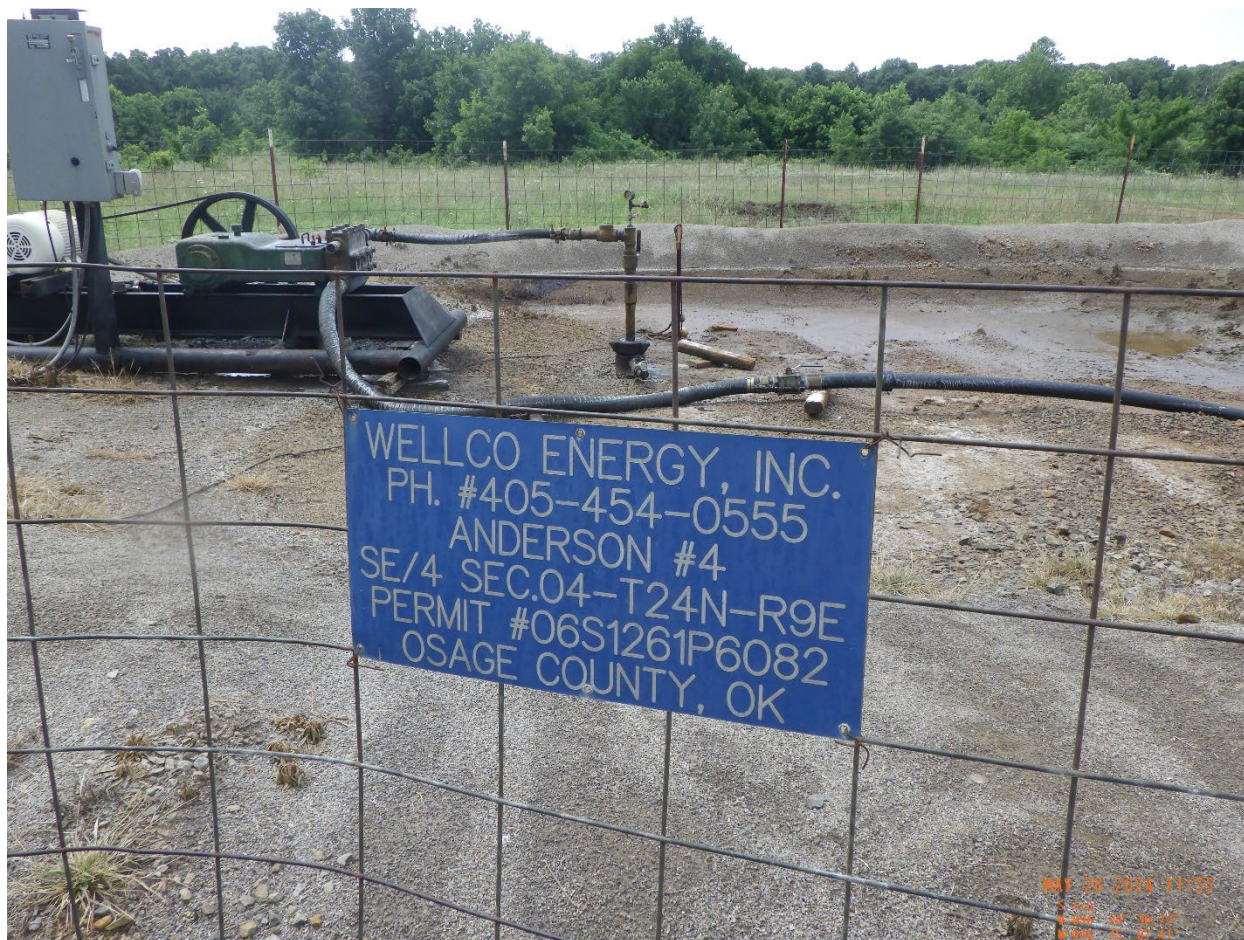
Photo No. 1

I observed the Anderson #4 well and the facility signage. The Anderson #4 was the release point of the spill. The ¼-inch gauge blew off the well, causing saltwater to spill onto the land surface, filing and overtopping the containment berm. See Photos No. 1 and 2 of Appendix 1 (photo log). For additional GPS location information and photo metadata, see the attached photo log.

**Description:** This was the Anderson-Cottonmouth well #4, which was the release point of the spill. The ¼-inch gauge blew off the well, allowing saltwater to fill the berm area, overtopping the berm, and migrating SE to an unnamed tributary (UT) of Birch Creek.

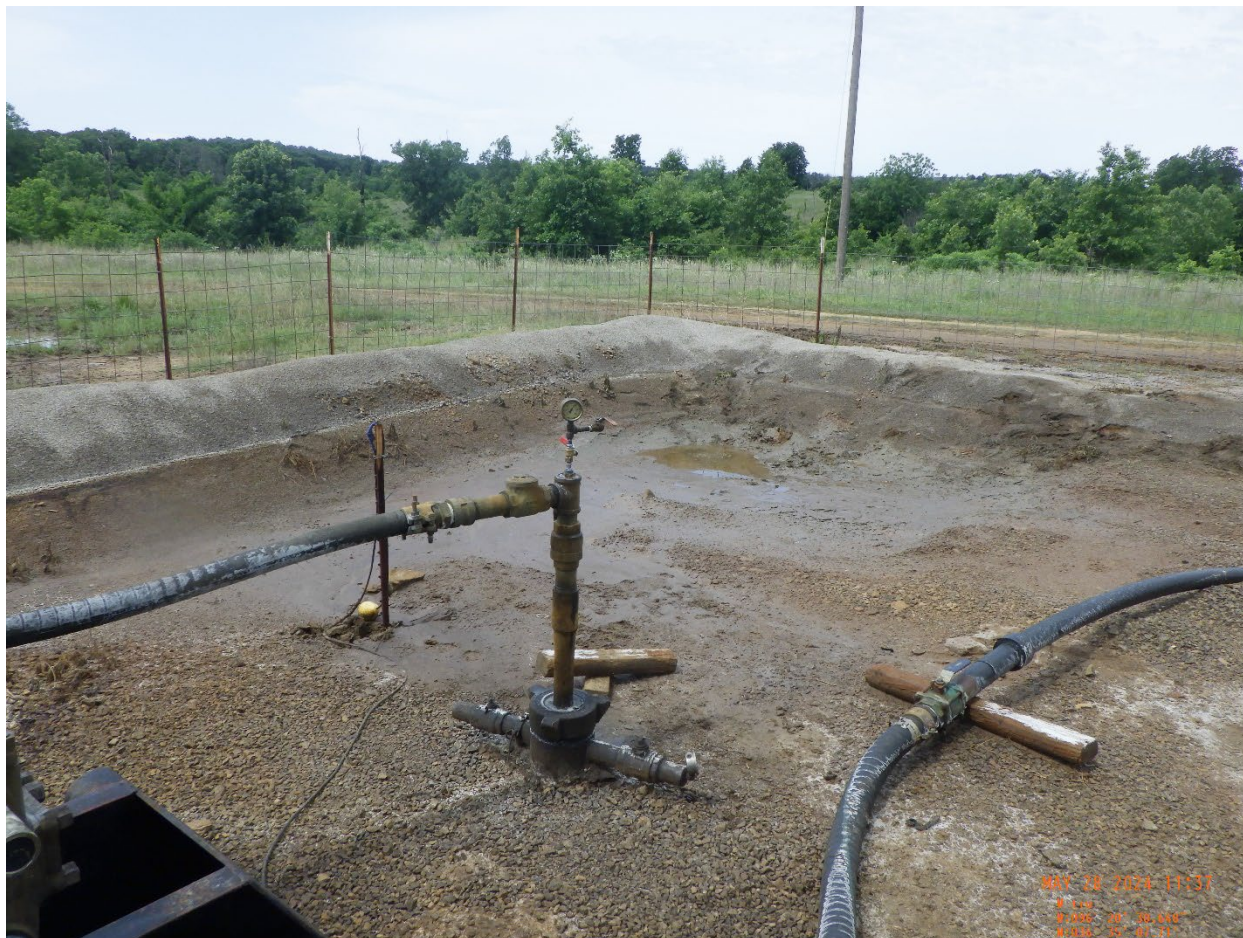
Photo No. 2

**Description:** This was Well #4 and the berm area.

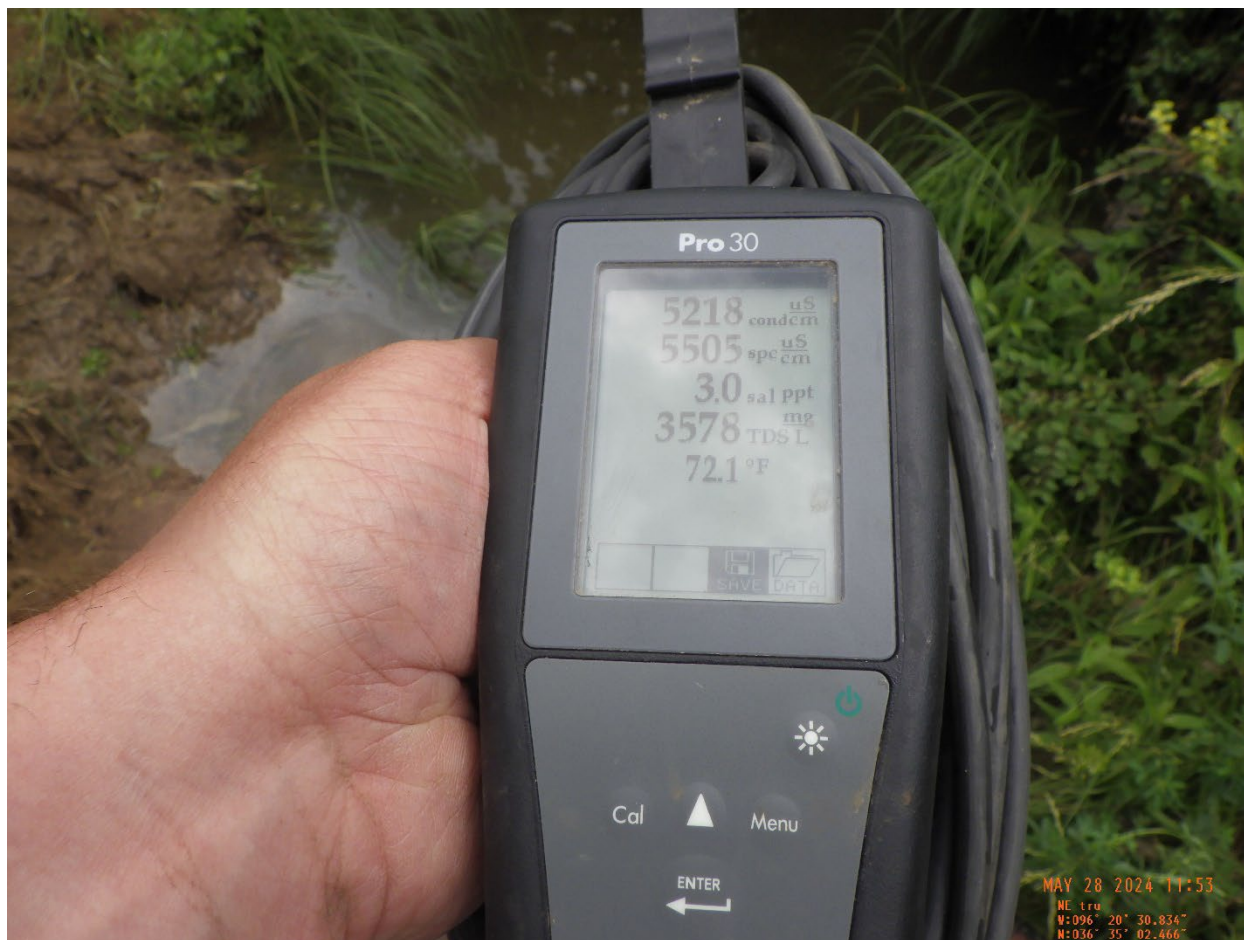
Photo No. 3

I observed the point of entry (POE) and a temporary containment dam, which had been placed by the operator to prevent downstream migration of spill impacts. The spill only impacted one (1) pool of water in the unnamed tributary (UT) of Birch Creek. At this same location, I observed an elevated TDS field reading of 3,578 mg/L. At the time of the inspection, the operator was pumping the impacted water from the tributary with a gasoline water pump as well as a vacuum truck. See Photos No. 3 and 4.

**Description:** This was an elevated TDS field reading of 3,578 mg/L observed at the point of entry (POE) and the temporary containment dam.

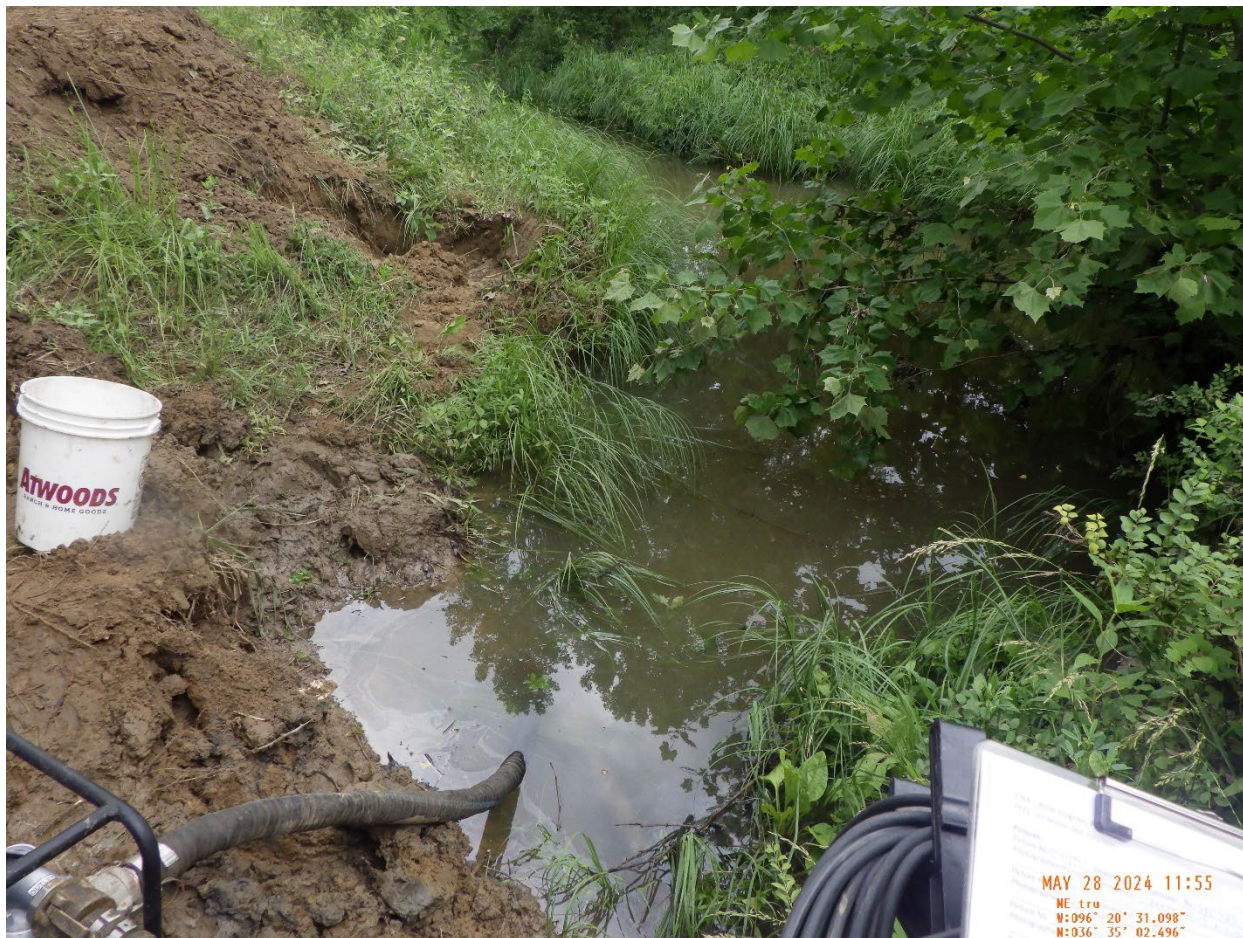
Photo No. 4

**Description:** This was the temporary containment dam and the trash pump used to remove water from the impacted pool of the UT of Birch Creek.

Inspector will conduct a follow-up inspection to ensure impacted waters were removed from the impacted tributary.

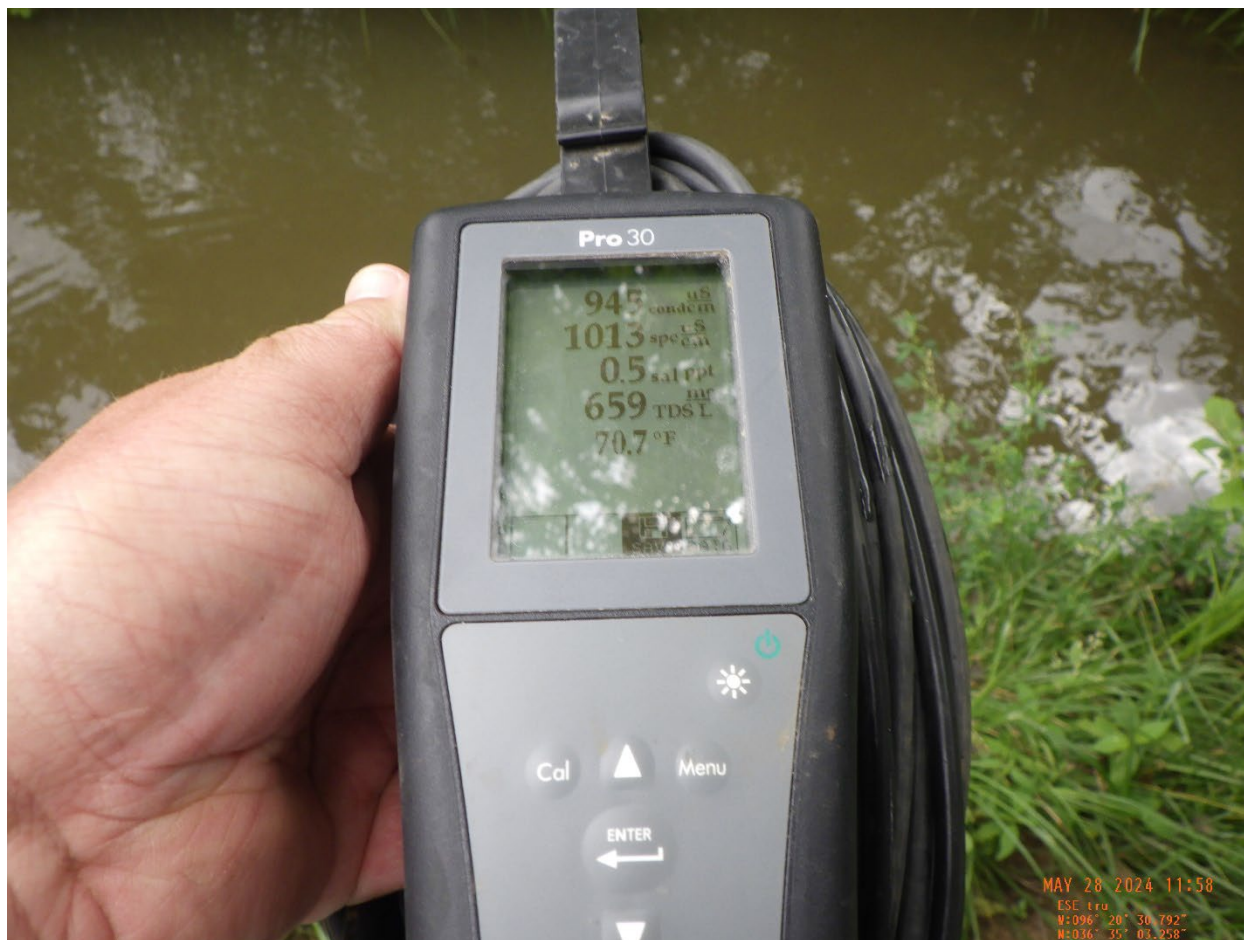
Photo No. 5

I observed a background TDS field reading of 659 mg/L taken upstream from the POE. This observation should be used when determining background TDS levels for the area.

**Description:** A background TDS field reading of 659 mg/L was taken upstream from the POE into the UT of Birch Creek.
