## RCRA Compliance Evaluation Inspection Report

Pall Aeropower Corporation  
10540 Ridge Rd  
New Port Richey, Florida 34654-5129  
EPA ID: FLD046855086

March 31, 2022, 9:30 a.m.

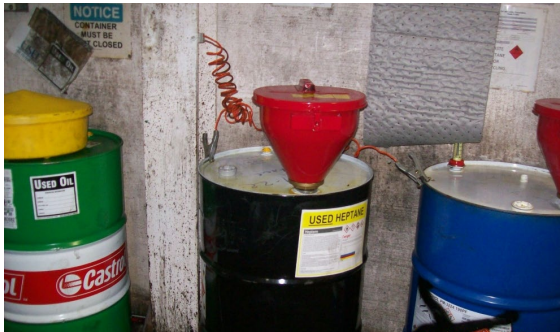
- One closed 55-gallon container of spent isopropyl alcohol for recycling (while a "flammable" label was present, the container was not marked "Hazardous Waste" nor contained a "Toxic" hazard of the content label);
- One closed 55-gallon container of "Used Heptane" for recycling (while a "flammable" label was present, the container was not marked "Hazardous Waste" nor contained a "Toxic" hazard of the content label) (Photograph #1);
- Three closed 55-gallon containers marked "Used Oil" (Photograph #1); and
- One closed 55-gallon container of non-hazardous oily debris/absorbents.

Photograph #1 – Used heptane container without “Hazardous Waste” and hazard indication label.

**Pursuant to Fla. Admin. Code Ann. r. 62-730.160(1) [40 C.F.R. § 262.15(a)(5)(ii)], which is a condition of the SAA Permit Exemption, a generator must mark or label its containers with the following: (ii) an indication of the hazards of the contents (examples include, but are not limited to, the applicable hazardous waste characteristic(s) (i.e., ignitable, corrosive, reactive, toxic); hazard communication consistent with the Department of Transportation requirements at 49 C.F.R. part 172 subpart E (labeling) or subpart F (placarding); a hazard statement or pictogram consistent with the Occupational Safety and Health Administration Hazard Communication Standard at 29 C.F.R. 1910.1200; or a chemical hazard label consistent with the National Fire Protection Association code 704).**

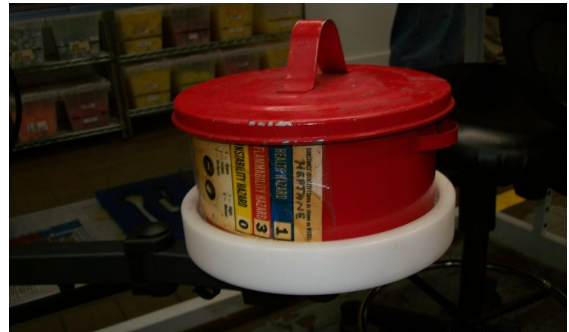
- One heptane parts washer;
- Three closed half-gallon containers of used heptane; and
- One closed half-gallon container of spent isopropyl alcohol (Photograph #2). All four half-gallon containers were not marked with the words “Hazardous Waste” and had no indication of the hazards of the contents. Both “Flammable” and “Toxic” labels should be affixed to the containers.

Photograph #2 – Half-gallon container of IPA without labels.

**Pursuant to Fla. Admin. Code Ann. r. 62-730.160(1) [40 C.F.R. § 262.15(a)(5)(i-ii)], which is a condition of the SAA Permit Exemption, a generator must mark or label its containers with the following: (i) the words “Hazardous Waste,” (ii) an indication of the hazards of the contents (examples include, but are not limited to, the applicable hazardous waste characteristic(s) (i.e., ignitable, corrosive, reactive, toxic); hazard communication consistent with the Department of Transportation requirements at 49 C.F.R. part 172 subpart E (labeling) or subpart F (placarding); a hazard statement or pictogram consistent with the Occupational Safety and Health Administration Hazard Communication Standard at 29 C.F.R. 1910.1200; or a chemical hazard label consistent with the National Fire Protection Association code 704).**

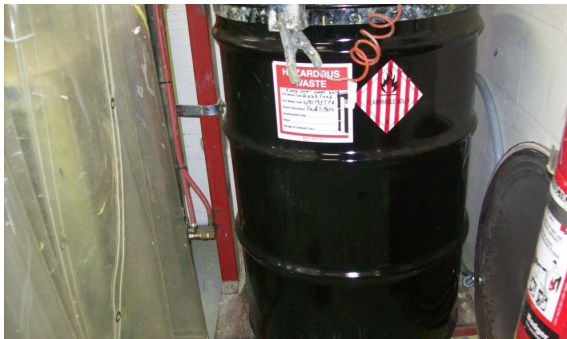
- One closed 55-gallon container of paint booth filters marked with the words “Hazardous Waste” and a “Flammable” label (a “Toxic” hazard of the content label was not present). The container is equipped with a hydraulic press to flatten filters to accommodate additional filters in the container (Photograph #3). The inspectors indicated the 55-gallon container should be managed as a less than 90-day storage container. An indication of the hazards of the contents and an accumulation start date must be affixed on the container. In addition, weekly inspection must be completed and documented of the container. The facility’s contingency plan (CP) also be updated to reflect the less than 90-day storage container;

Photograph #3 – 55-gallon container of paint filter without an accumulation date.

**Pursuant to Fla. Admin. Code Ann. r. 62-730.160(1) [40 C.F.R. § 262.17(a)(5)(i)(B-C)], which is a condition of the LQG Permit Exemption, Pall must mark or label container of paint booth filters with the following: (B) an indication of the hazards of the contents (examples include, but are not limited to, the applicable hazardous waste characteristic(s) (i.e. toxic); hazard communication consistent with the Department of Transportation requirements at 49 C.F.R. part 172 subpart E (labeling) or subpart F (placarding); a hazard statement or pictogram consistent with the Occupational Safety and Health**

**Administration Hazard Communication Standard at 29 C.F.R. 1910.1200; or a chemical hazard label consistent with the National Fire Protection Association code 704); and (C) the date upon which each period of accumulation begins clearly visible for inspection on each container.**

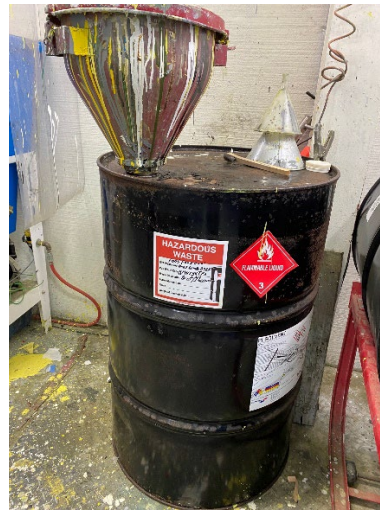
- One closed 55-gallon container of spent paint thinner waste marked “Hazardous Waste” and “Flammable.” The container was not marked with a “Toxic” hazard of the content label (Photograph #4);

Photograph #4 - 55-gallon container of paint thinner without indication of hazards.

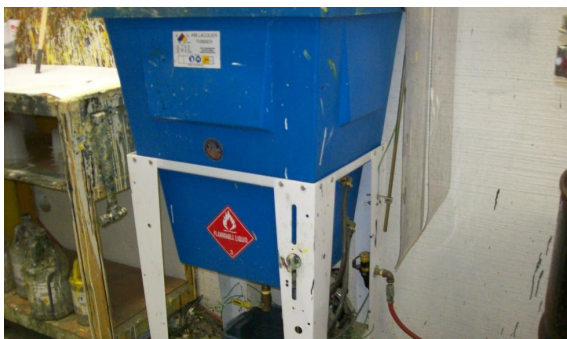
- One closed container 55-gallon container of paint gun cleaning waste (Photograph #5). The container was not marked “Hazardous Waste” and had no indication of the hazards of the contents (“Flammable” and “Toxic”).

Photograph #5: Paint gun cleaner container without “Hazardous Waste” and indication of hazards “Toxic” label.

**Pursuant to Fla. Admin. Code Ann. r. 62-730.160(1) [40 C.F.R. § 262.15(a)(5)(i-ii)], which is a condition of the SAA Permit Exemption, Pall must mark or label the 55-gallon container of paint gun cleaning waste with the following: (i) the words “Hazardous Waste,” (ii) an indication of the hazards of the contents (examples include, but are not limited to, the applicable hazardous waste characteristic(s) (i.e., ignitable, corrosive, reactive, toxic); hazard communication consistent with the Department of Transportation requirements at 49 C.F.R. part 172 subpart E (labeling) or subpart F (placarding); a hazard statement or pictogram consistent with the Occupational Safety and Health Administration Hazard Communication Standard at 29 C.F.R. 1910.1200; or a chemical hazard label consistent with the National Fire Protection Association code 704).**

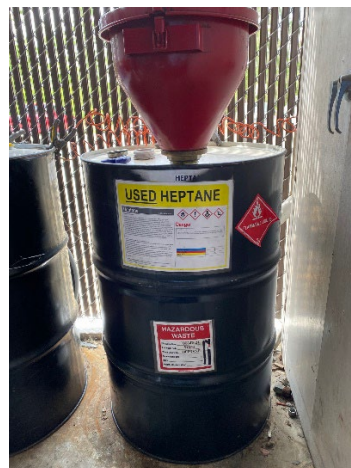
- One closed 55-gallon container of used heptane marked “Hazardous Waste” and “Flammable.” The container was not marked with an indication of the hazards of the contents “Toxic” (Photograph #6);
- One closed 55-gallon container of used aviation fuel marked “Hazardous Waste” and “Flammable.” The container was not marked with an indication of the hazards of the contents “Toxic” (Photograph #7); and
- One 55-gallon container of non-hazardous spent absorbent pig mats.

Photograph #6: 55-gallon container of used heptane without an indication of hazards “Toxic” label.

**Pursuant to Fla. Admin. Code Ann. r. 62-730.160(1) [40 C.F.R. § 262.15(a)(5)(i-ii)], which is a condition of the SAA Permit Exemption, Pall must mark or label the 55-gallon container of paint gun cleaning waste with the following: (i) the words “Hazardous Waste,” (ii) an indication of the hazards of the contents (examples include, but are not limited to, the applicable hazardous waste characteristic(s) (i.e., ignitable, corrosive, reactive, toxic); hazard communication consistent with the Department of Transportation requirements at 49 C.F.R. part 172 subpart E (labeling) or subpart F (placarding); a hazard statement or pictogram consistent with the Occupational Safety and Health Administration Hazard Communication Standard at 29 C.F.R. 1910.1200; or a chemical hazard label consistent with the National Fire Protection Association code 704).**

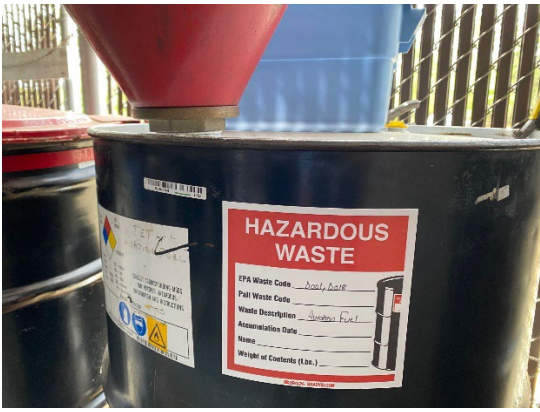
Photograph #7 – 55-gallon container of aviation fuel without hazards contents label.

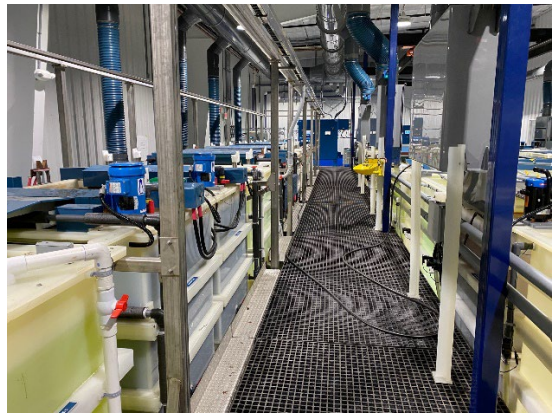
The new plating building has been constructed and will replace the current plating room in near future. The new room comes equipped with three plating lines (Photograph #8). No wastes were observed in the new plating building during the inspection.

Photograph #8 – New Plating Building.

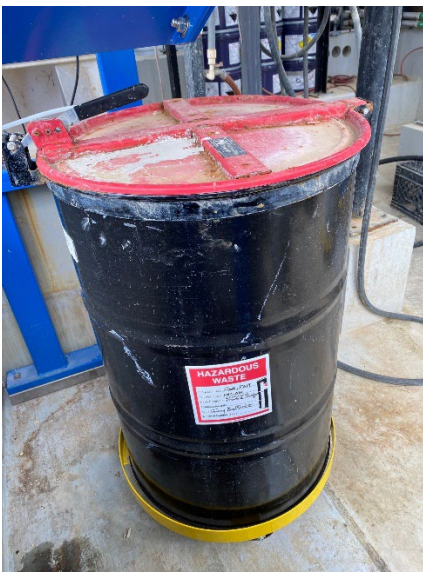
The inspectors observed a closed 55-gallon of filter press solids marked "Hazardous Waste" (Photograph #9). The container had no indication of the hazards of the contents.

Photograph #9 – 55-gallon container of filter press sludge with no indication of hazards of the contents.

**Pursuant to Fla. Admin. Code Ann. r. 62-730.160(1) [40 C.F.R. § 262.15(a)(5)(ii)], which is a condition of the SAA Permit Exemption, Pall must mark or label the 55-gallon container of paint gun cleaning waste with the following: (ii) an indication of the hazards of the contents (examples include, but are not limited to, the applicable hazardous waste characteristic(s) (i.e., ignitable, corrosive, reactive, toxic); hazard communication consistent with the Department of Transportation requirements at 49 C.F.R. part 172 subpart E (labeling) or subpart F (placarding); a hazard statement or pictogram consistent with the Occupational Safety and Health Administration Hazard Communication Standard at 29 C.F.R. 1910.1200; or a chemical hazard label consistent with the National Fire Protection Association code 704).**

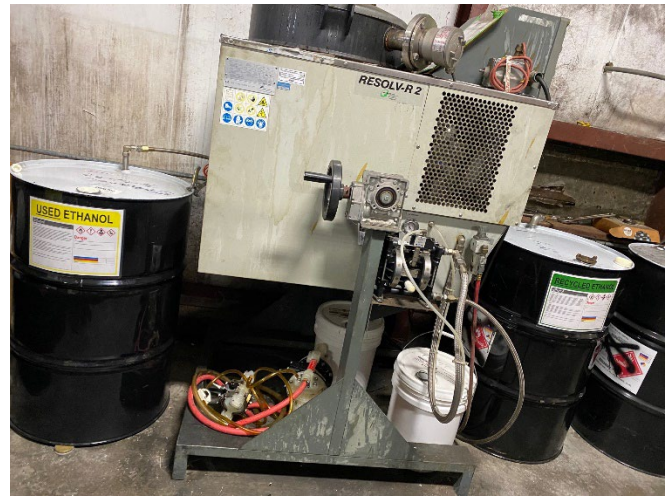
A less than 90-day hazardous waste storage area and two solvent recyclers (Resolv-r 2 and Siva S-10 solvent recovery system) to distill spent alcohol and heptane are located in the Chemical Building (Photographs #10-11). The following waste containers were observed in the Chemical Building:

Photograph #10 – Resolv-r 2 solvent recovery system.

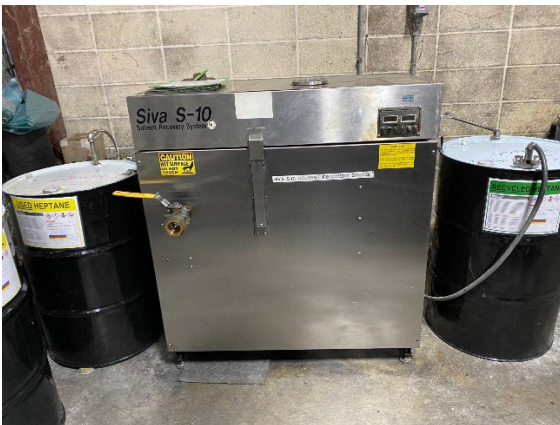
Photograph #11 – Siva S-10 solvent recovery system.

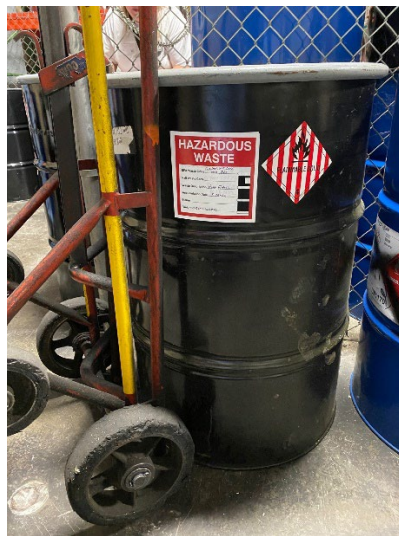
- One closed 500-gallon poly "Used Oil" tank;
- Two closed 55-gallon containers of waste paint filter marked "Hazardous Waste," with an indication of the hazards of the contents, and dated March 28, 2022 (Photograph #12) and March 11, 2022;

Photograph #12 – 55-gallon container of paint filter dated 3/28/22 in the Chemical Building.

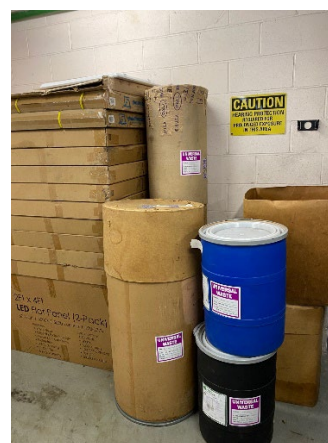
The Compressor Room stores Pall's universal wastes (Photograph #14). The facility is currently in the process of switching to LED lighting. The containers in this area included:

- One 8-foot long tube spent lamps box and one 4-foot long tube spent lamps box;
- Two square boxes for compact spent lamps; and
- Two 30-gallon containers marked "Universal Waste Batteries".

All universal wastes containers were closed and had accumulation start dates of December 6, 2021. The four lamp boxes were marked "Universal Waste Lamps."

Photograph #14 – Universal wastes containers in the Compressor Room.
