# NPDES Compliance Inspection Report

## Granite Creek Quarry

Lease Area 2, 3, & 7

**Inspection Date: 6/3/2024**

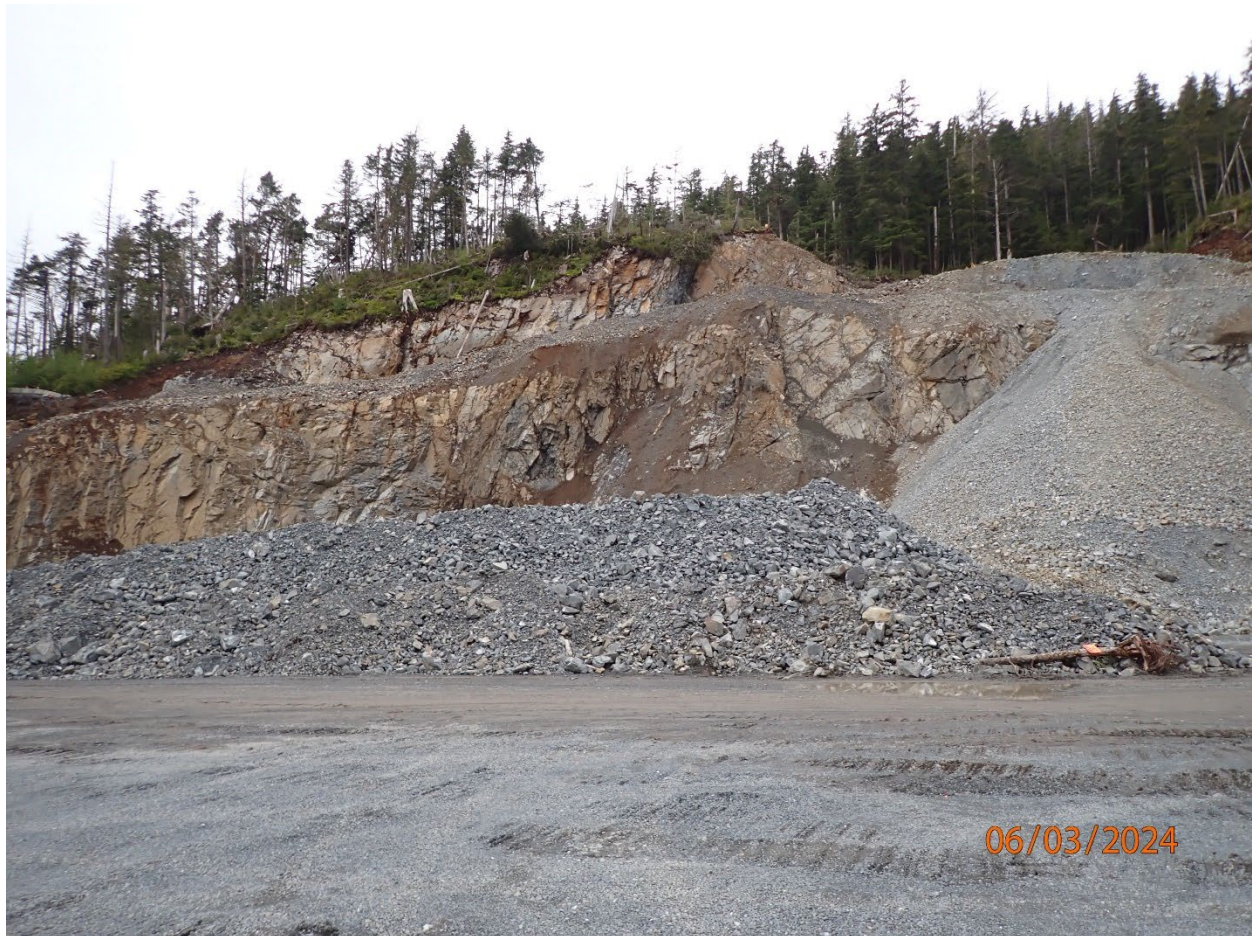
Granite Creek Quarry has two main operations occurring at the facility. On Lease Areas 2 & 3, the facility drills (**Photo 1**), blasts, and extracts aggregate. The facility plans on moving/extracting approximately 75,000 cubic yards of material in the next 2 – 3 years of time. Drilling and blasting activities are conducted by third parties and by Colaska employees. The facility also utilizes a cone crusher to process materials on site. Surplus aggregate is stockpiled on site and hauled off & used as necessary.

*Photo 1 - Drilling and blasting area*

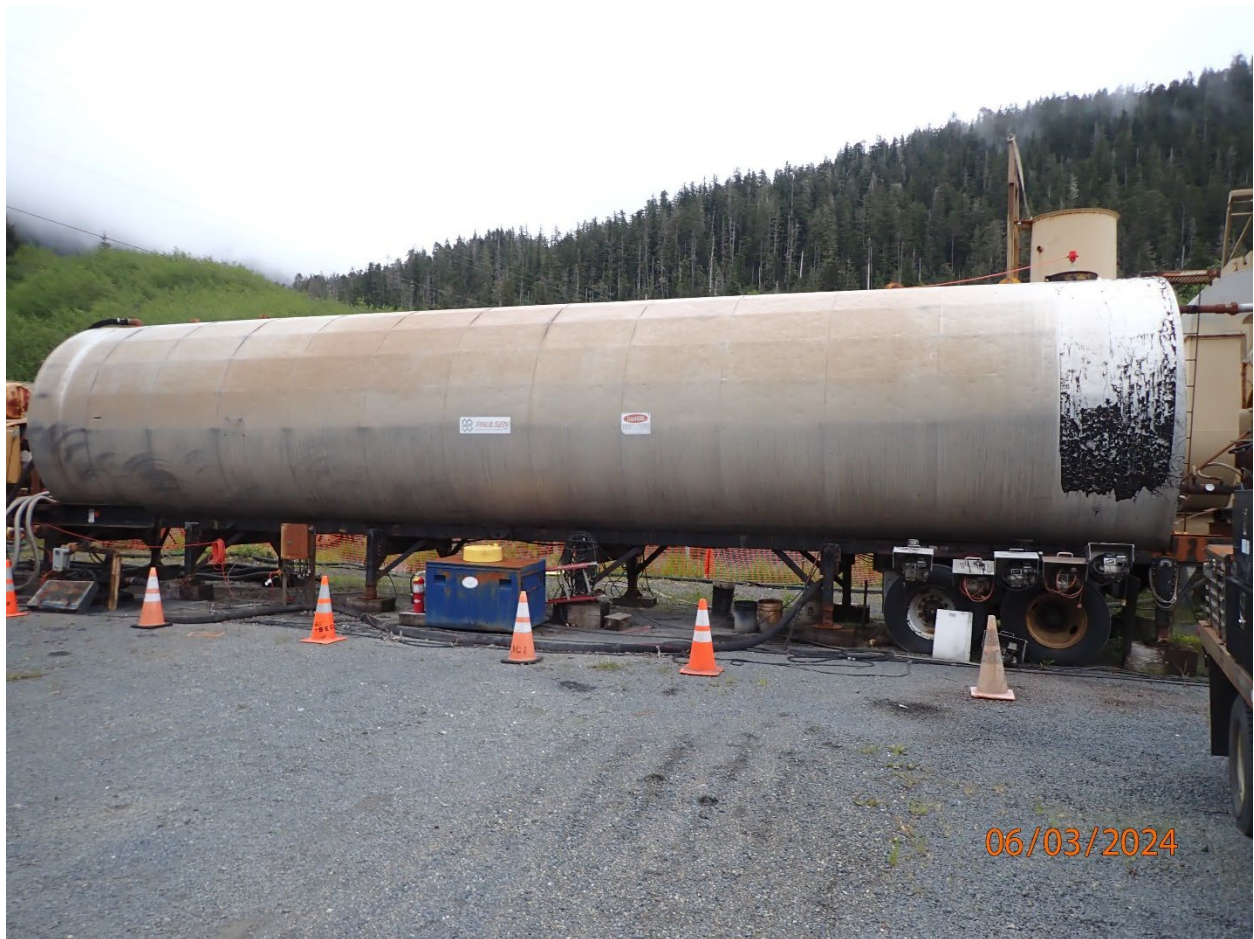
The facility also includes an asphalt hot mix plant on site at Lease Area 7. The plant includes a mixer, a batch hopper to load trucks, mobile asphalt tanks (**Photo 2**), a control house, a quality control lab, and stockpiles of aggregate for the production of asphalt. At the time of my inspection, the asphalt plant was in a maintenance only status and was not in operation.

Photo 2 - Mobile asphalt tank

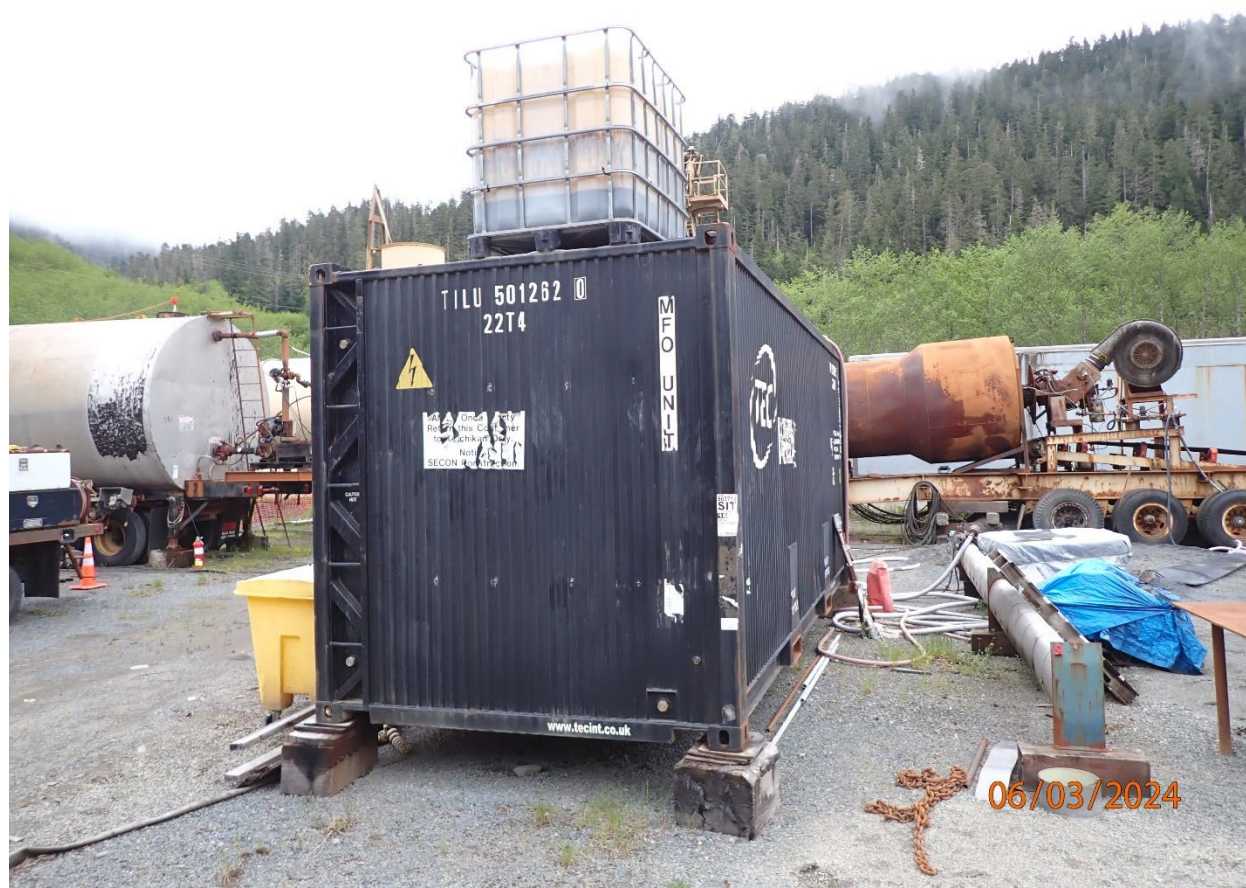
The large majority of the site grounds are composed of aggregate and crushed aggregate. No permanent fuel storage will be constructed on site and mobile equipment is removed during the off season. The facility does store asphalt oil in double-walled tanks and also stores modified fuel (burner oil) (**Photo 3**) in a tank when the asphalt plant is in operation.

Photo 3 - MFO Unit with burner oil

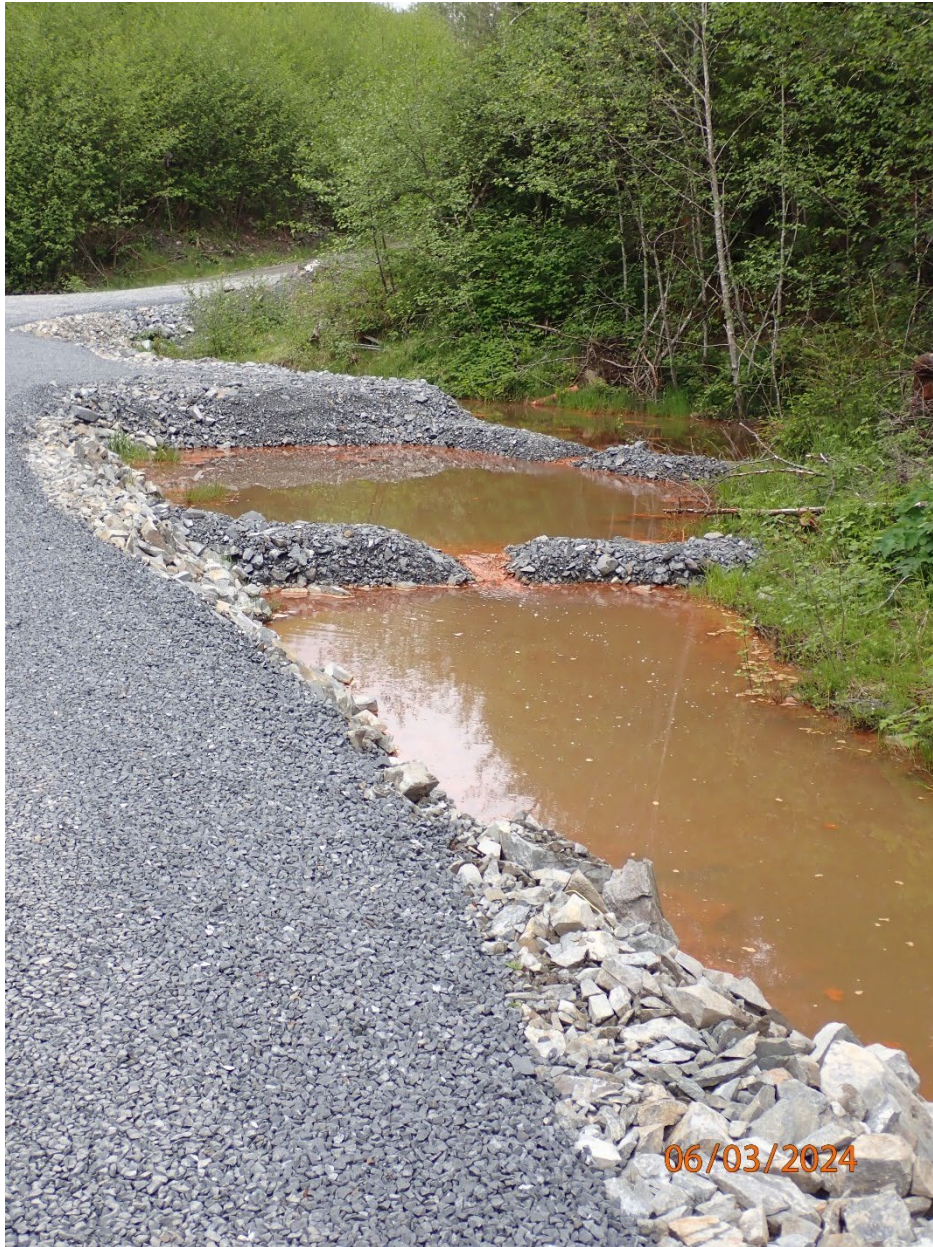
For stormwater, the facility utilizes a series of check dams (**Photos 4 & 5**) and settling ponds (**Photo 6**) before outfalls (**Photos 7 & 8**) to reduce flow velocity and to settle out suspended solids. The naturally occurring gravel and vegetation on the facility grounds slows the flow of stormwater and allows it to infiltrate the ground. Gravel berms are also used to direct and slow flow. BMPs appeared to be well maintained and effective during the time of my inspection.

Photo 4 - Check dams

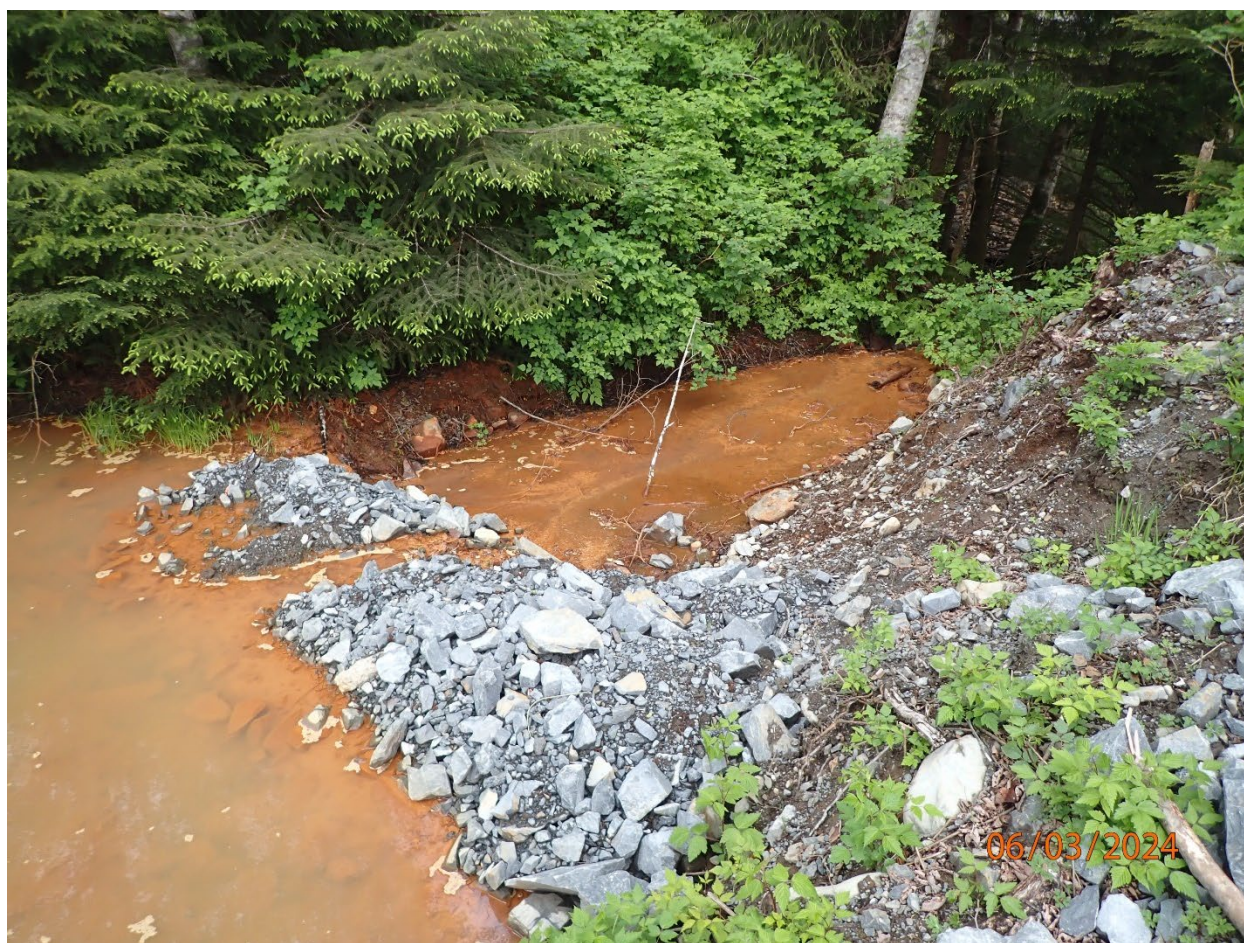
*Photo 5 - Check dam*

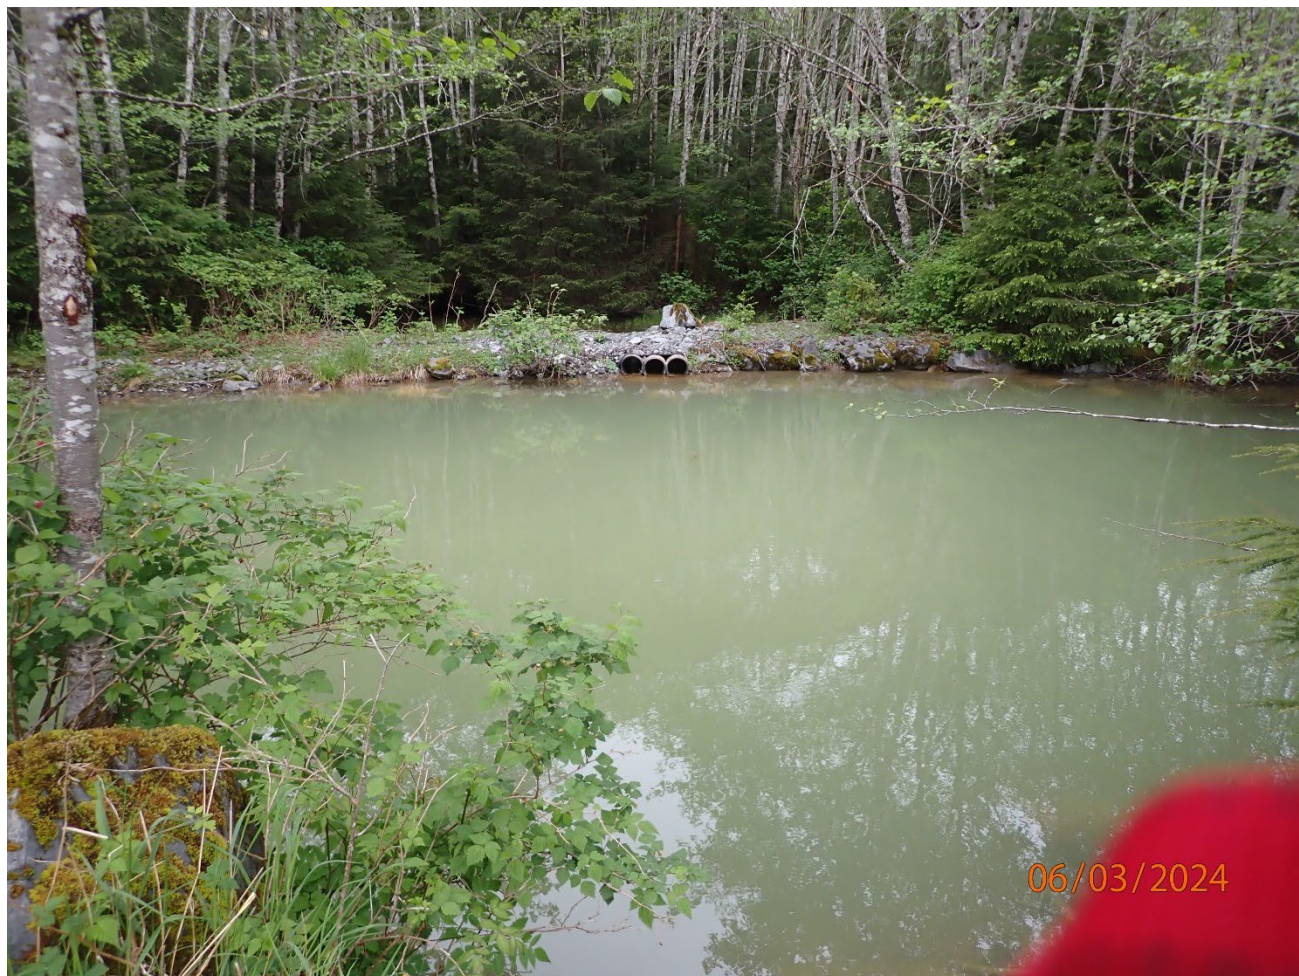
*Photo 6 - settling pond*

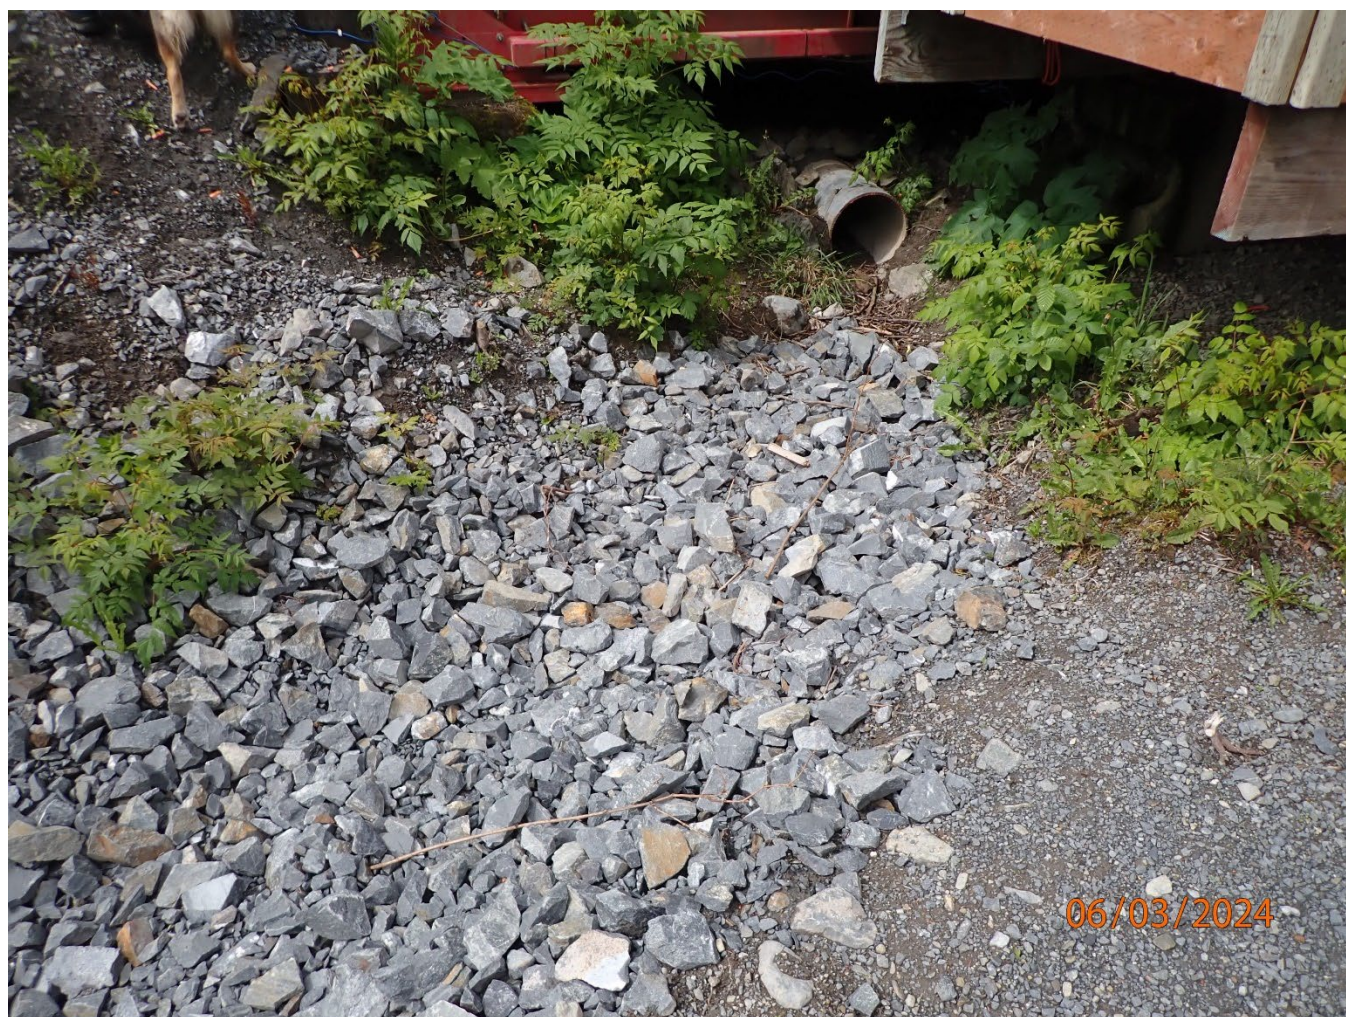
Photo 7 - Outfall 003

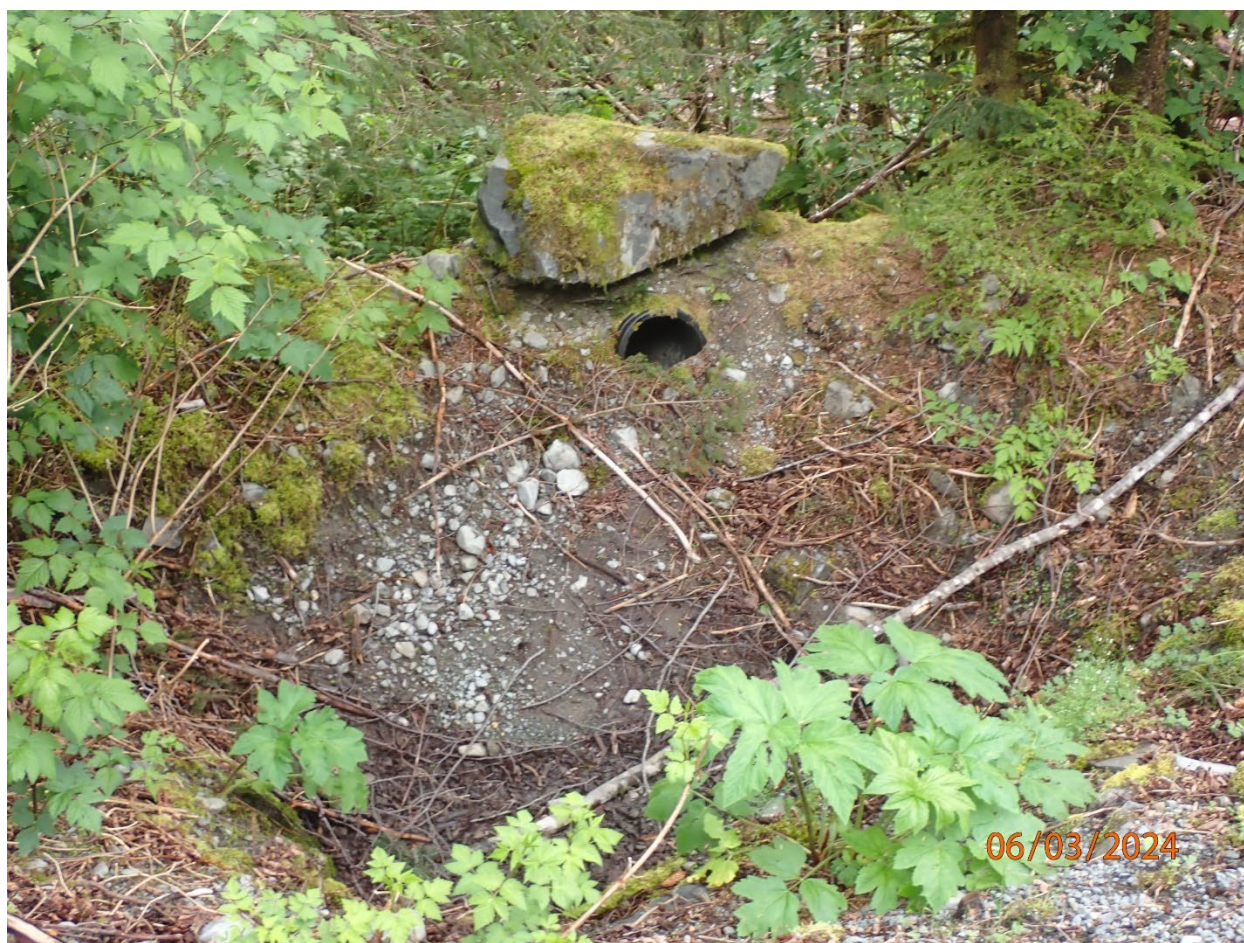
*Photo 8 - Outfall 002*
