U.S. Environmental Protection Agency Region 5

Purpose: Industrial User Pretreatment Compliance Inspection

Facility: Green Plains Mount Vernon LLC
8999 W Franklin Road
Mount Vernon, IN 47620

Inspection Date: February 23-24, 2021

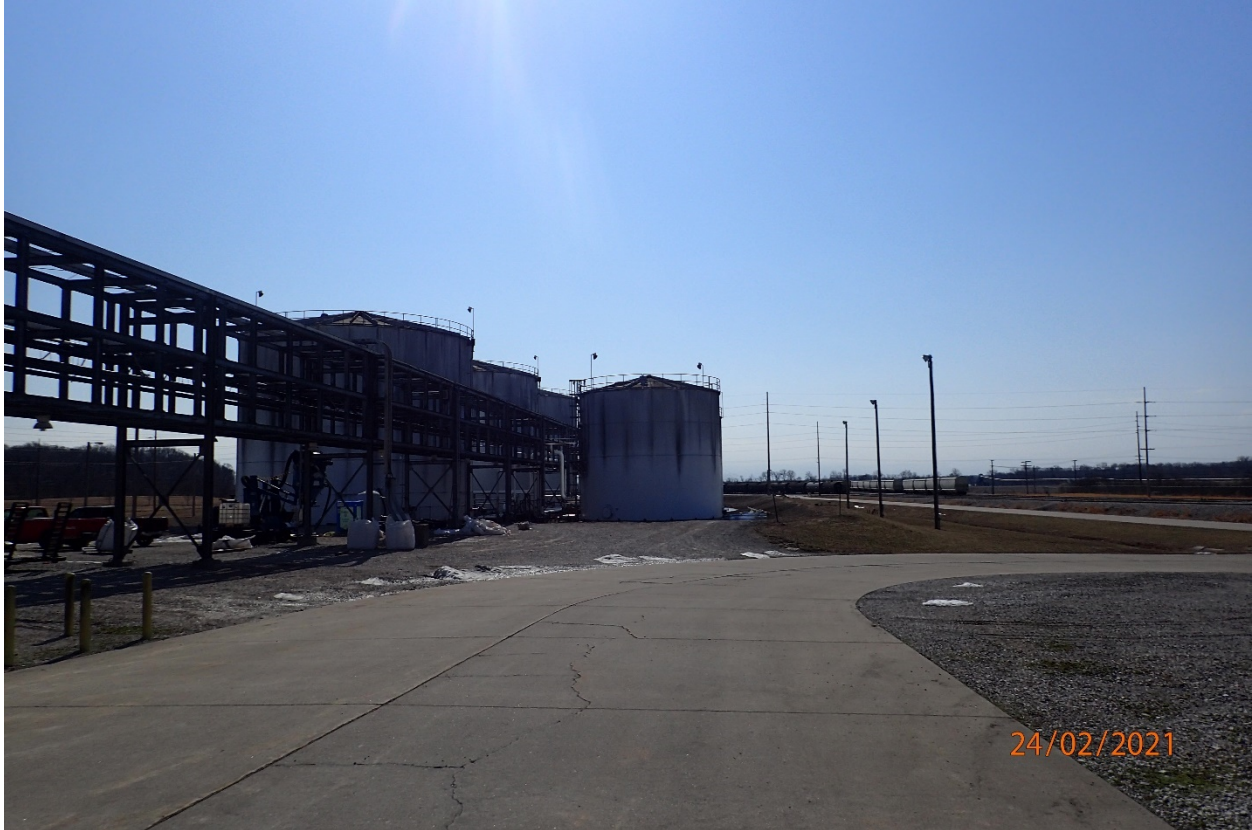
Photo Number: P2240009

Description: Ethanol Storage, Denaturing Tank, and Shifter Tank

Mr. Labhart escorted us to Ethanol Storage, Denaturing Tank, and Shifter Tank area located south of the truck loading area on the southwest side of the facility (photo 9). These 7 tanks are housed in a large rectangular diked area to contain any spill. I asked Mr. Labhart if the facility has had any such product spillage in this diked area since its 2016 acquisition and he confirmed that the facility has not had any spill in the diked area. While at this location, we inspected the Ethanol and Corn Oil Truck Loading Area (photo 10). Mr. Labhart stated that the spill during loading of the ethanol or corn oil would flow to the drain at the Truck Loading Area (photo 12) and flow through underground piping to the Spill Containment Area (photo 11).

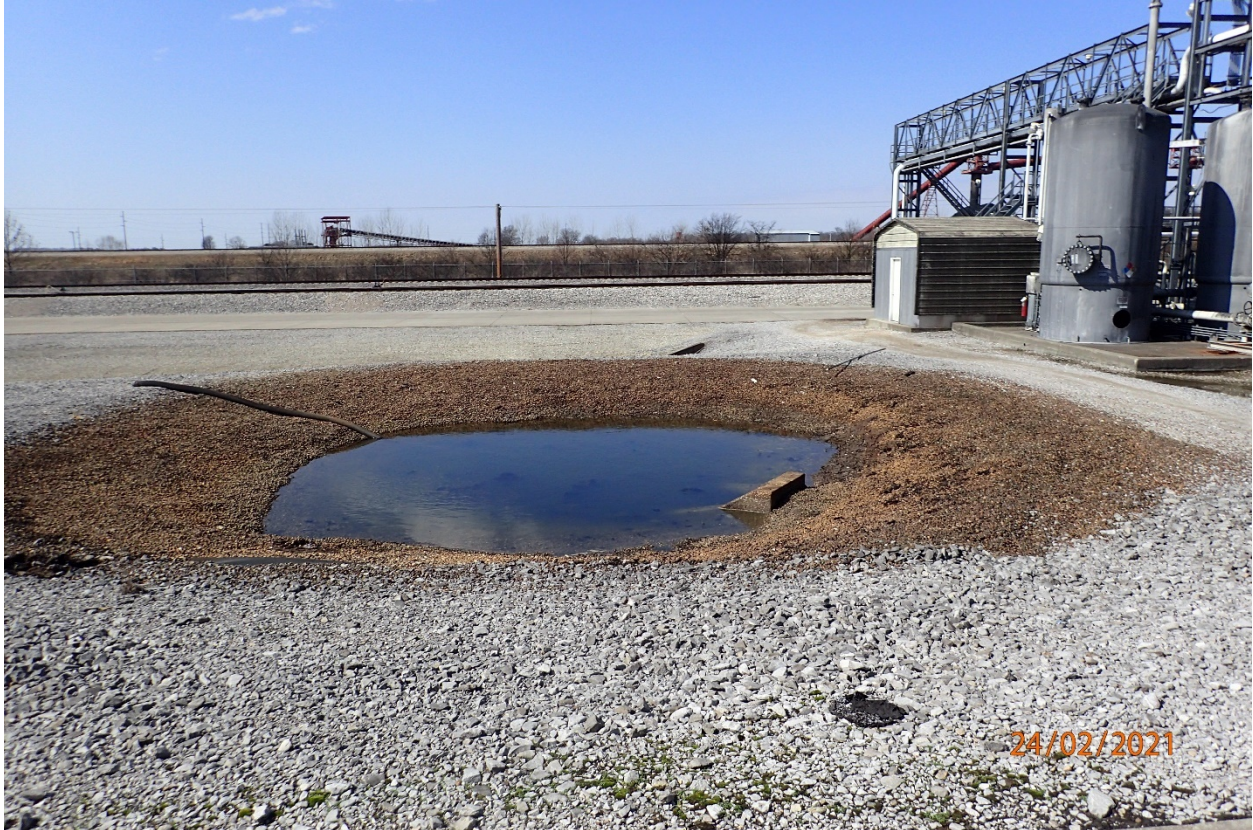
Photo Number: P2240011

Description: Spill Containment for the Truck Loading Area for the Corn Oil and Ethanol

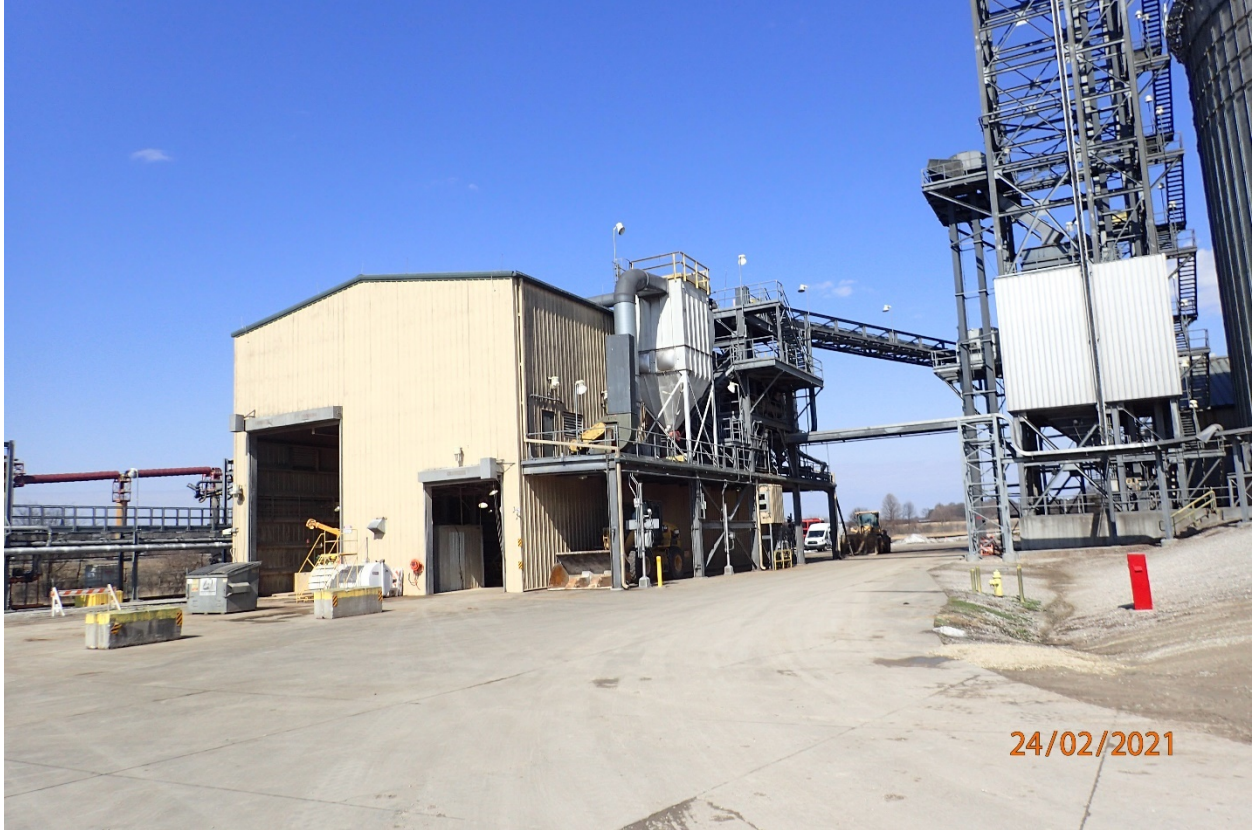
Photo Number: P2240013

Description: Grain Receiving Area

We then proceeded to the first step of grain receiving area (photo 13), where grains are received via rail cars (photo 14). We noticed Corn oil storage near the rail lines without secondary containment (photo 17).

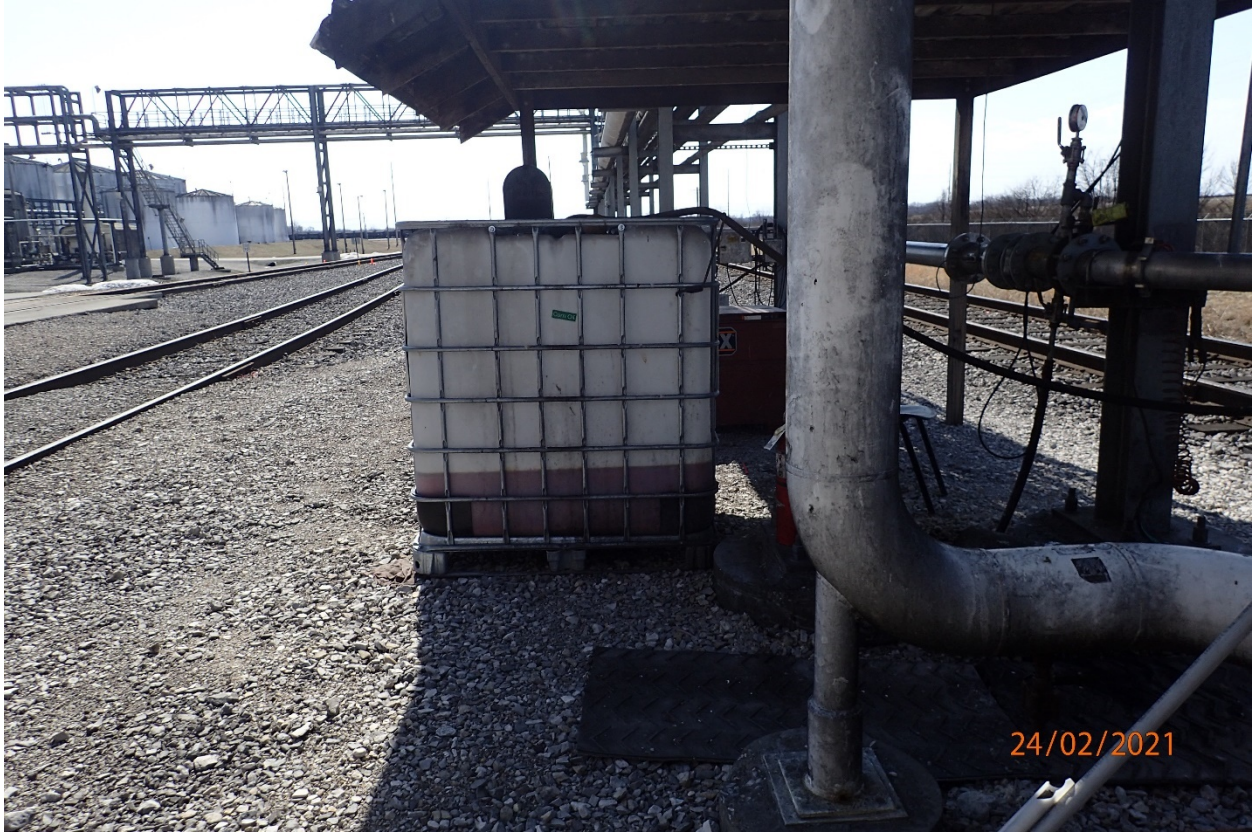
Photo Number: P2240017

Description: Corn oil storage near the rail lines without secondary containment

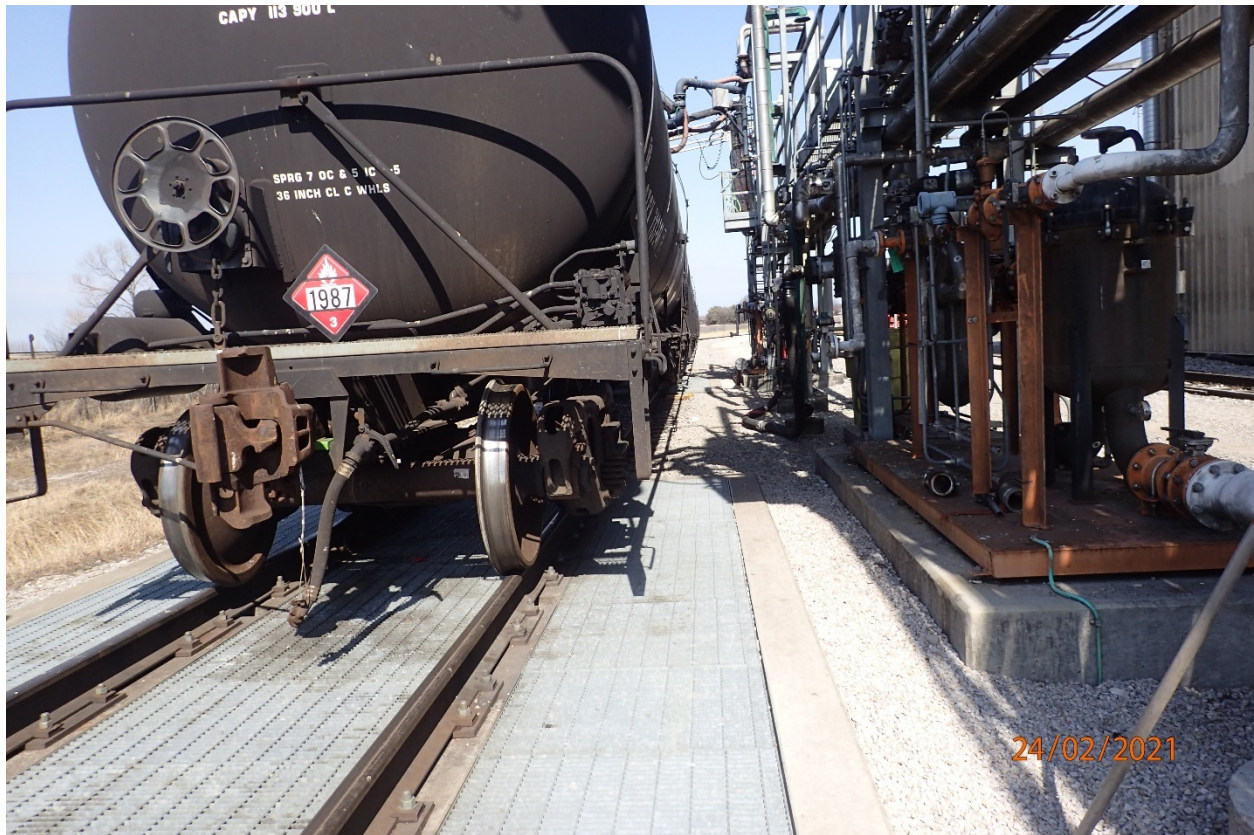
Photo Number: P2240018

Ethanol is filled in the rail cars from the top. Mr. Labhart stated that they have not had ethanol spill at the rail lines and there have only been rare occurrences of corn oil spills, which are first captured in the catch basin on the rail lines (photo 19). The facility has a dedicated containment area (located between the rail track and fence) to capture any corn oil and ethanol spills (photo 20), which would pump off any spill collected from the containment area for off-site disposal.

Description: Ethanol is filled in the rail cars from the top

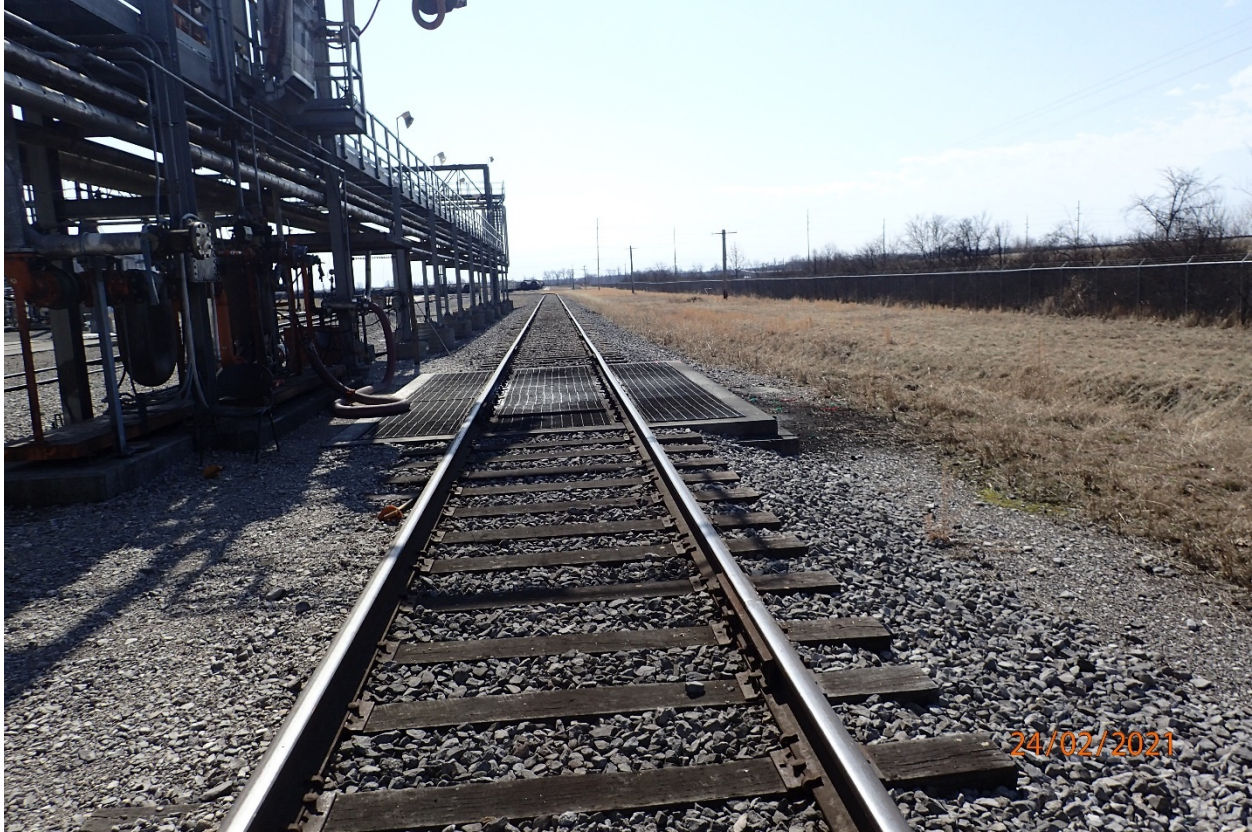
Photo Number: P2240019

Description: The catch basin on the rail lines to capture any corn oil spillage

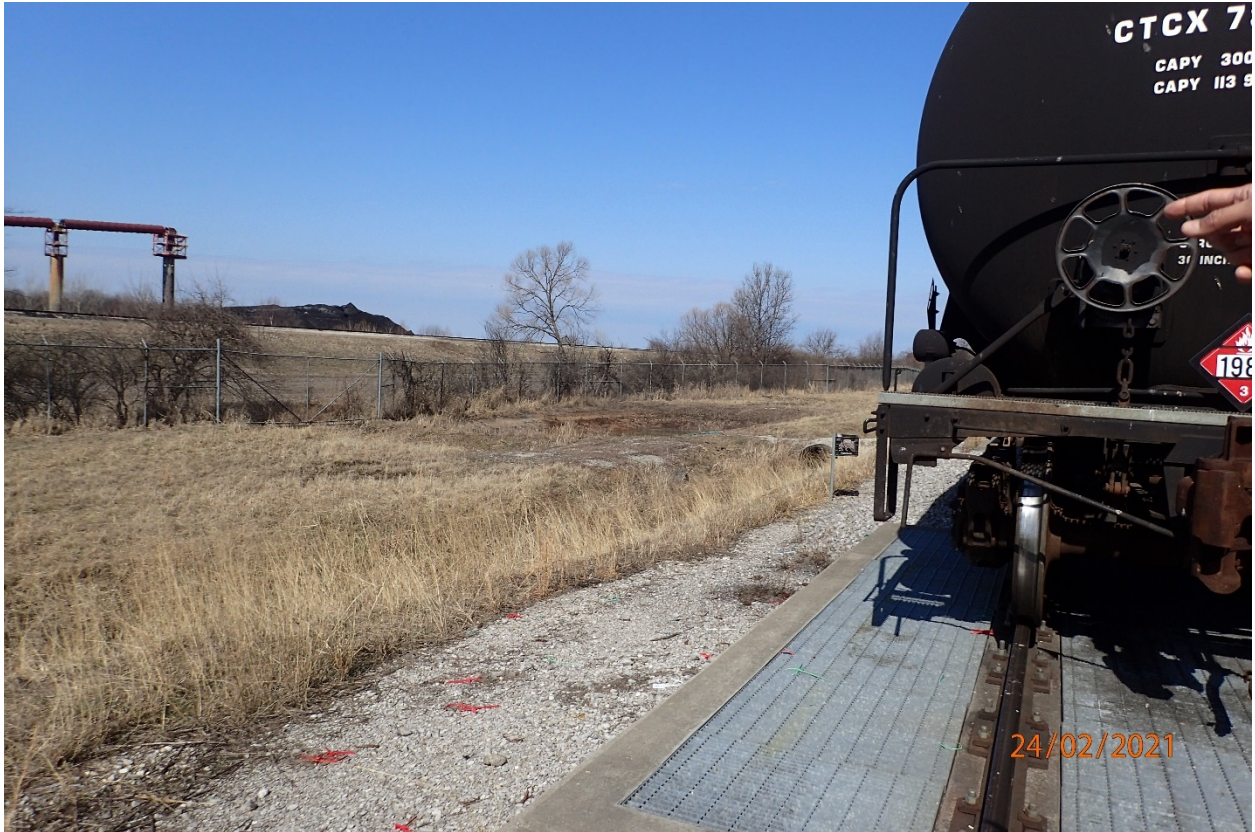
Photo Number: P2240020

Description: Containment area between the rail track and fence - for corn oil and/or ethanol spill

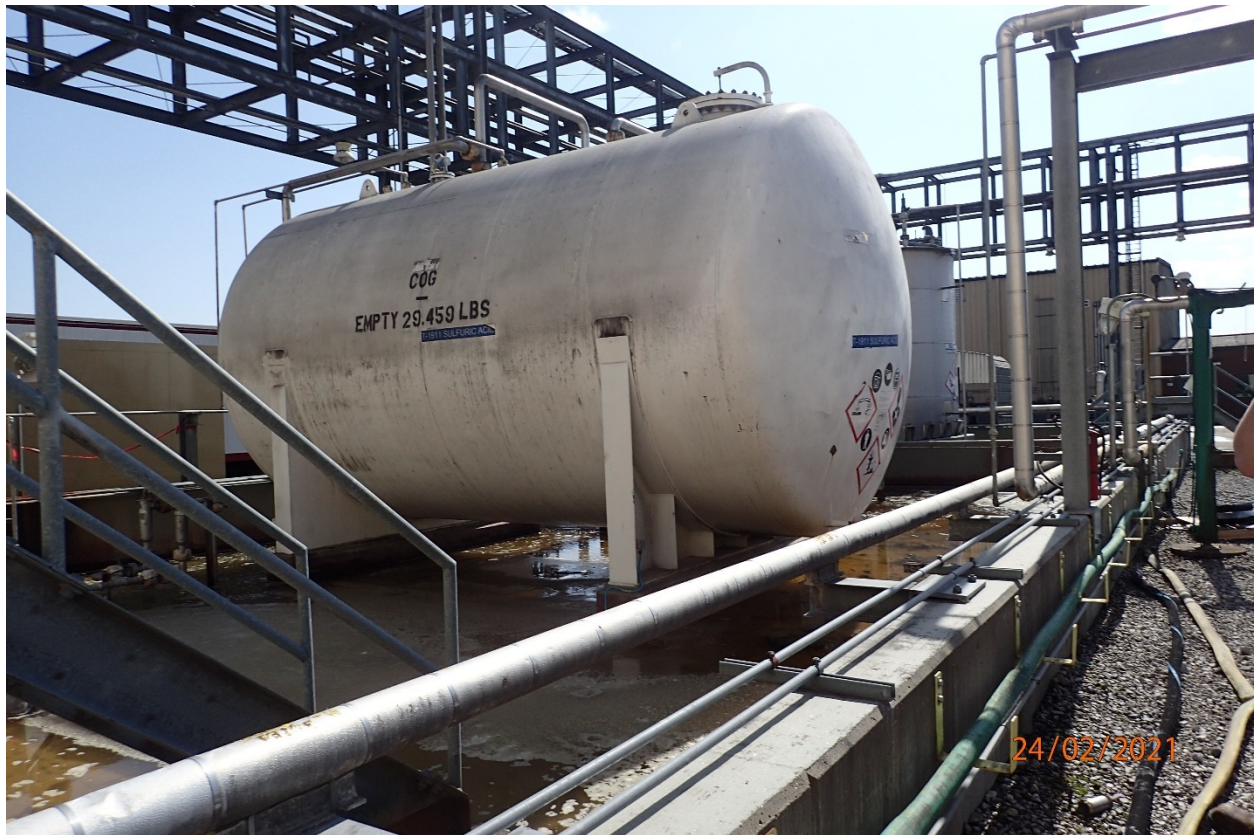
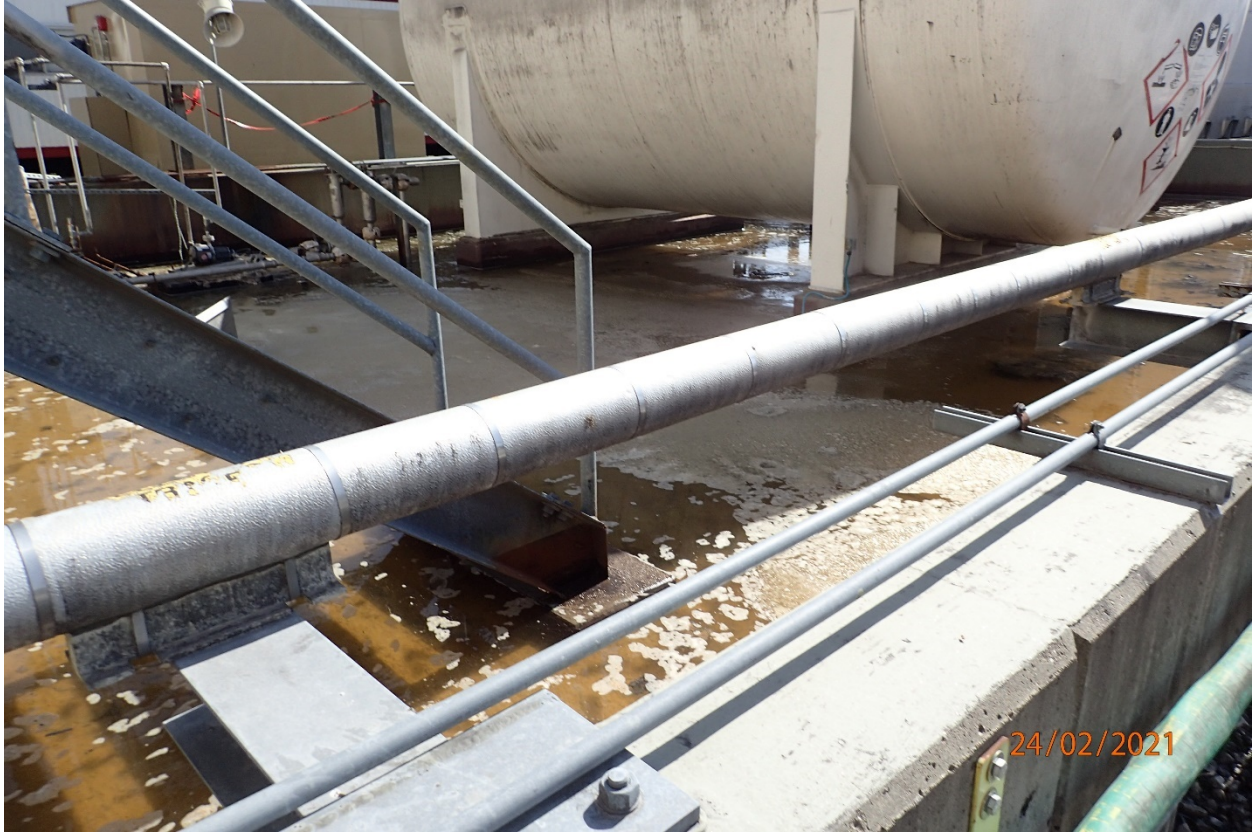
Photo Number: P2240021

Description: Above Ground Chemical Storage Area with concrete secondary containment

The inspection continued towards the east of the facility. We passed through two large corn storage bins and the flour mill area (photo 14). We then proceeded to inspect the above ground chemical Storage area (center of the facility – south of the cook building). It houses Phosphoric Acid, Sulfuric Acid, and Anhydrous Ammonia (photos 21 & 22) stored within concrete containment. Since these tanks are stored outside, they are exposed to stormwater. Mr. Labhart stated that the visible contaminated stormwater is rainwater and dust and is free from chemicals. He stated that it is disposed of in accordance with the facility's Spill Prevention, Control, and Countermeasure (SPCC) plan and all chemical deliveries occur via hose connections between the transfer location and the tank under the supervision of an employee. The chemical delivery area is paved and sloped. In the event of a spill, it would be noticed immediately, mitigated, and disposed of in accordance with the SPCC plan. The concrete catch basin was epoxy coated to contain potential hose drips/leaks during chemical transfer.

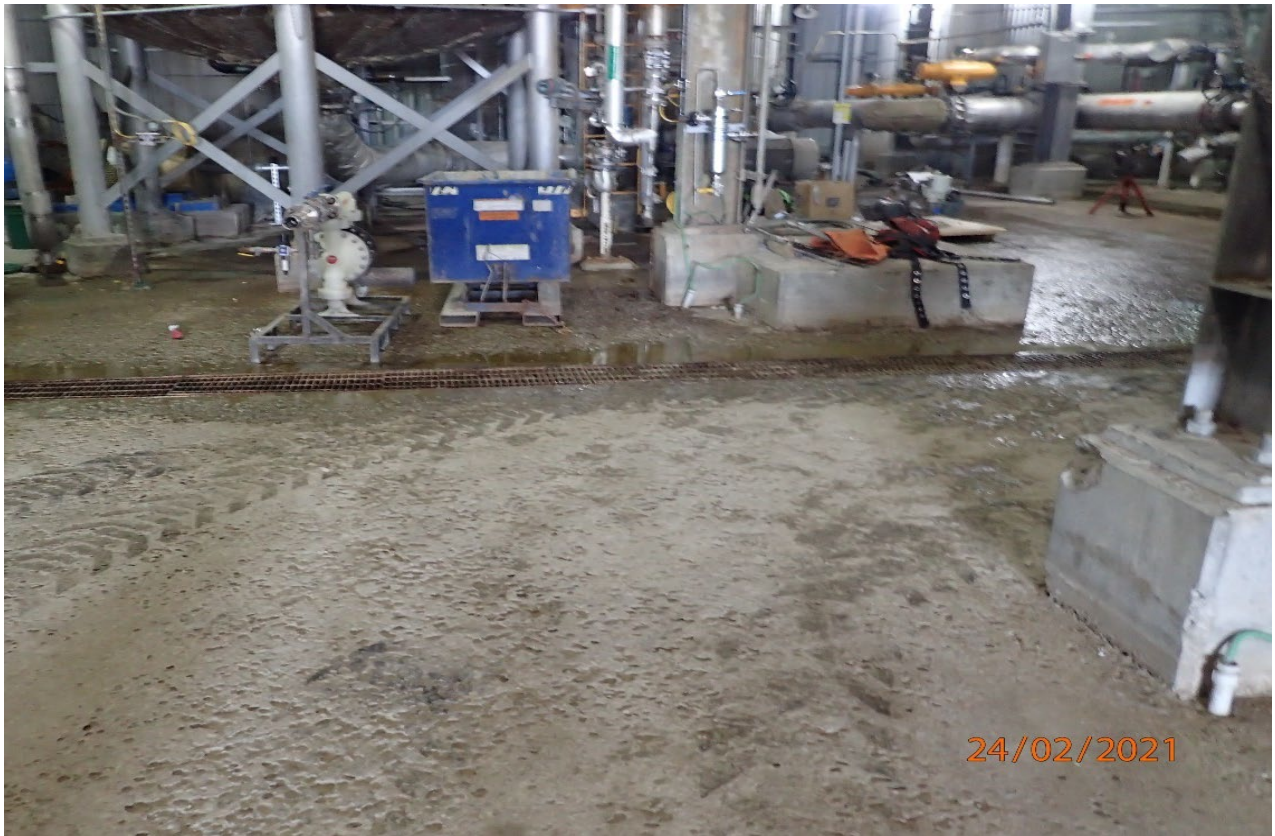
Photo Number: P2240024

Drains within the cook building (photo 24) collect water from the floor washing to an underground holding tank, which would pump the water (photo 25) to the digester tank T-7002. Antibiotics used for fermentation are stored in the Cook Building (photo 26).

Description: Drains within the Cook Building

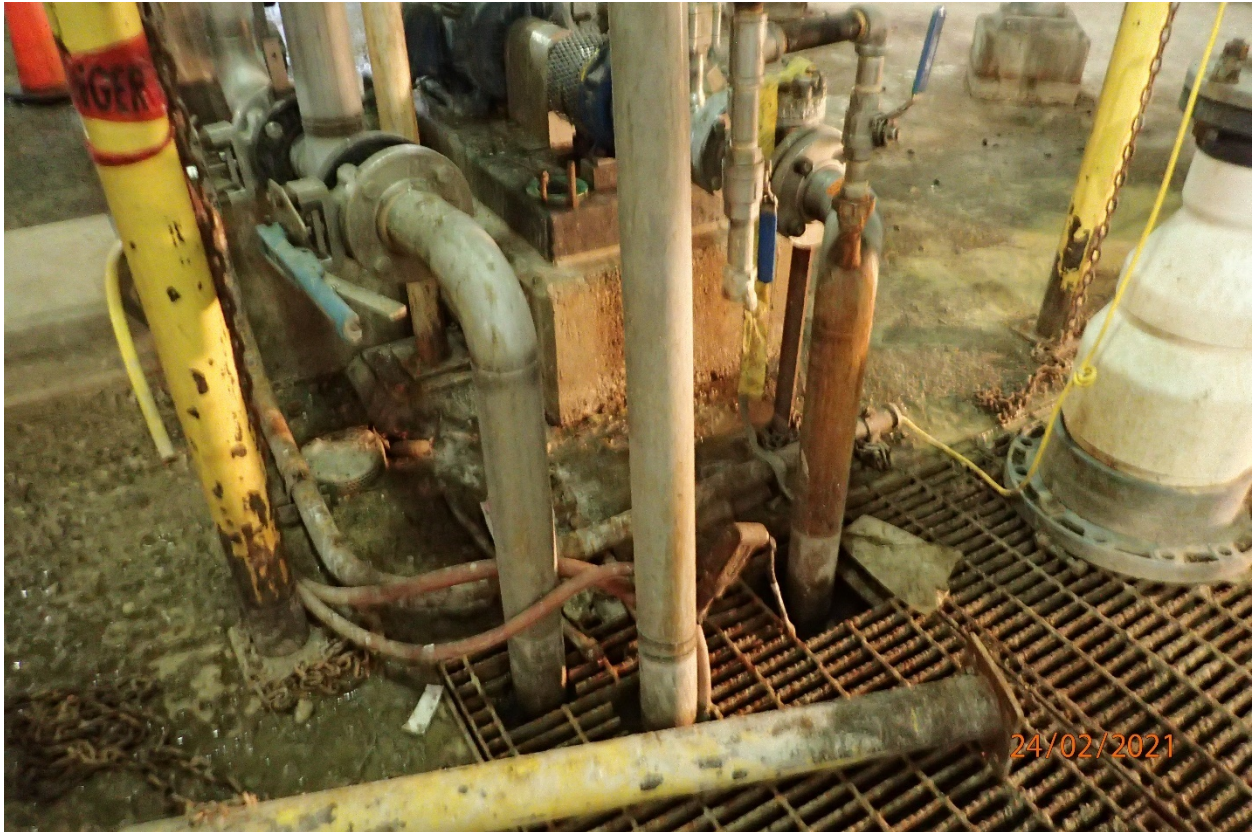
Photo Number: P2240025

Description: Pump area within the Cook Building for the wastewater collected in the drains within the Cook Building

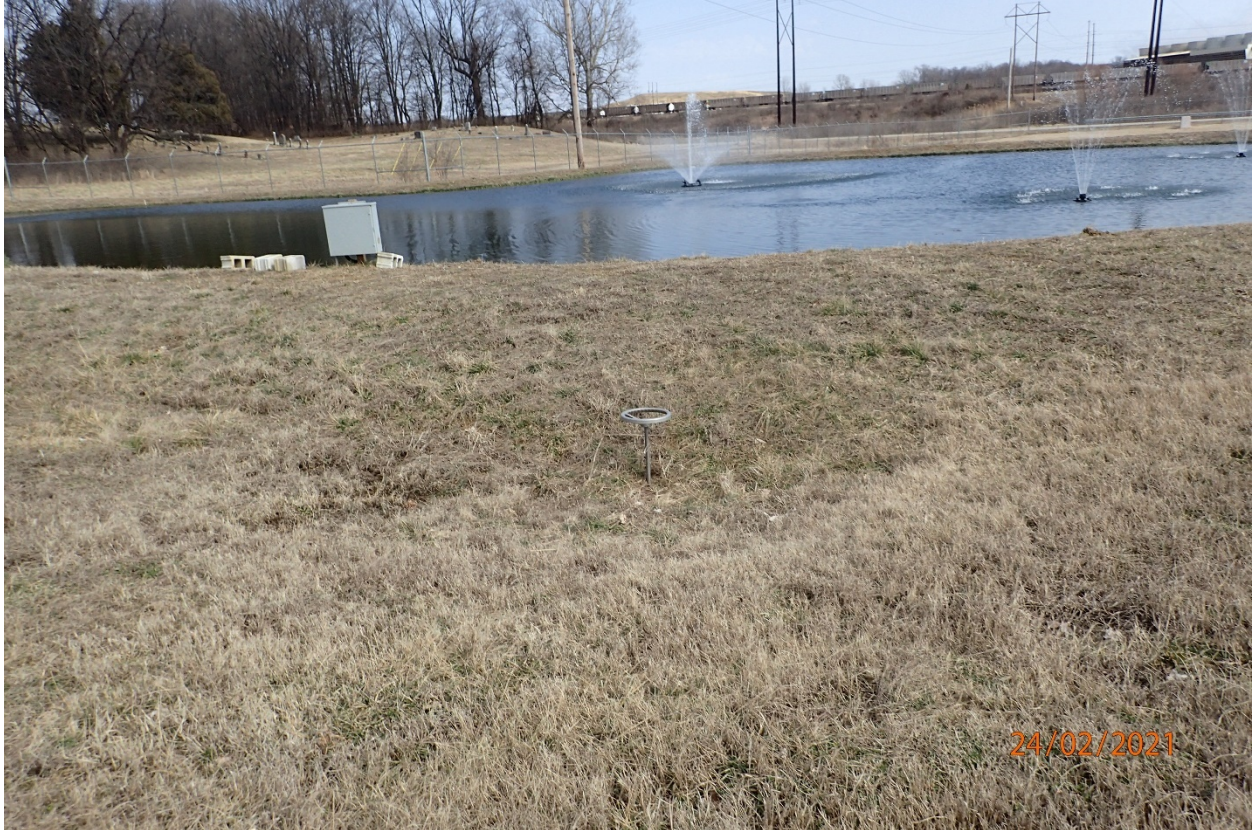
Photo Number: P2240029

Stormwater from the eastern portion of the industrial section is diverted above ground via drainage conveyances to a retention basin (underground) southeast of the six large fermentation tanks (photo 32), to allow infiltration and settling of solids prior to discharging from stormwater Outfall 001S. A normally closed gate valve (photo 29) mitigates the probability of unintentional

Description: Stormwater Outfall 001S Gate Valve

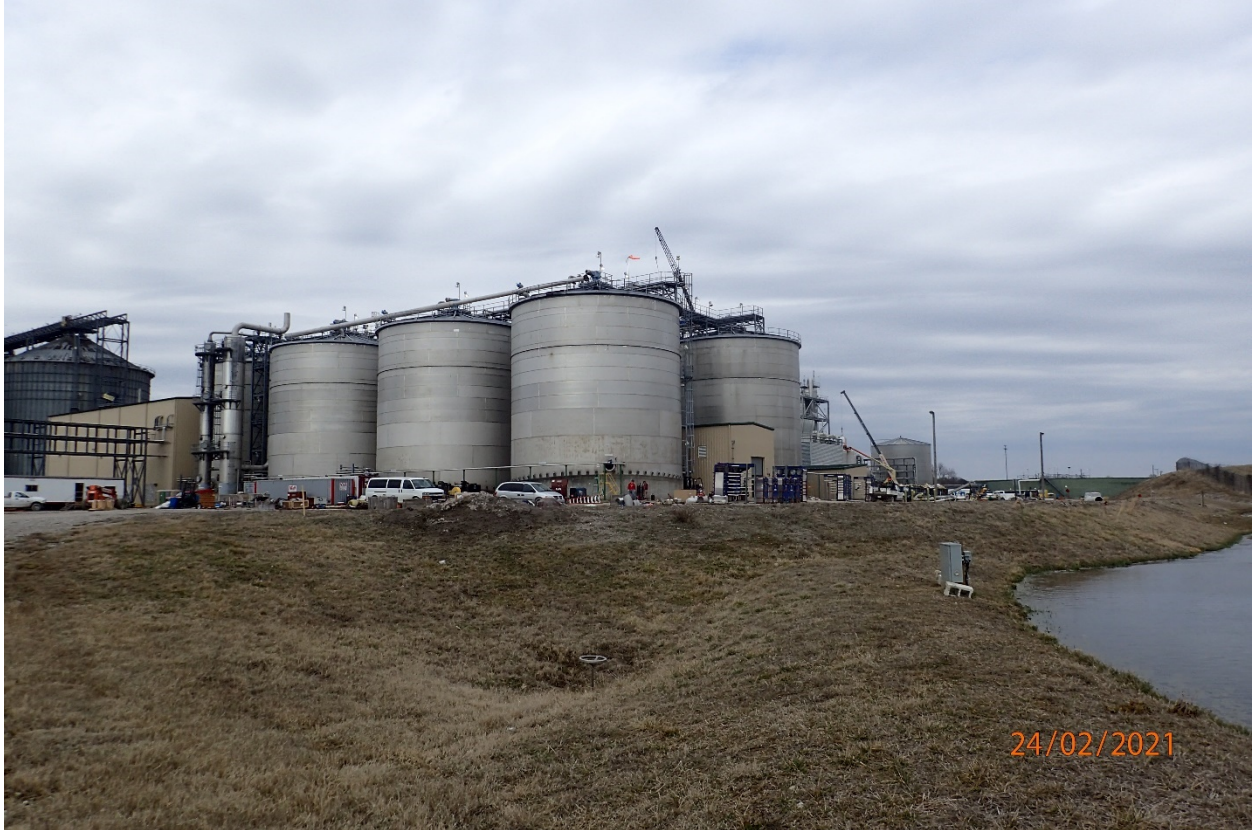
Photo Number: P2240033

We walked past the six large (1 million-gallon each) Fermentation Tanks (photo 32). Prior to 2021, these tanks were operated as continuous fermentation. Mr. Labhart stated that these tanks will operate as batch fermentation tanks after March 2021. They will remain at their existing locations. Each tank is currently being upgraded and retrofitted to the batch operation.

Description: 1 million-gallon Fermentation Tanks (six)

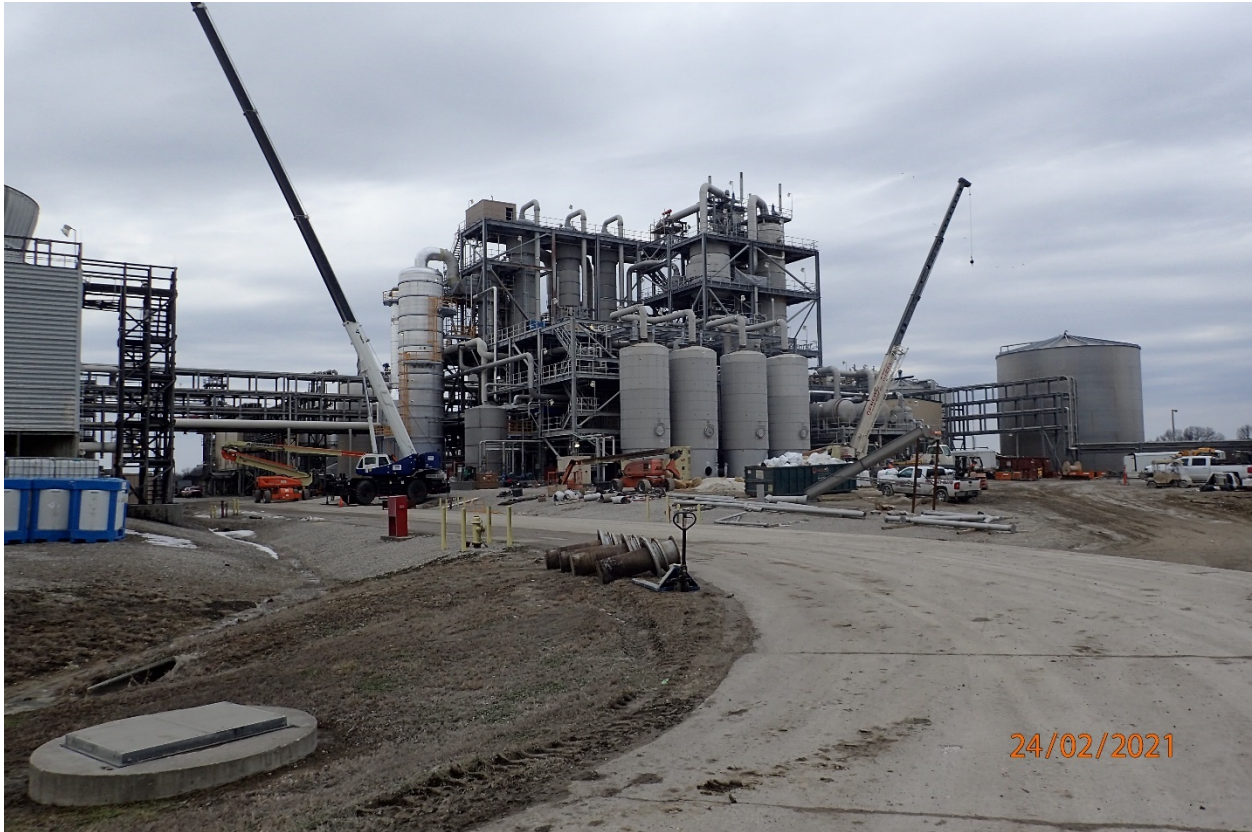
Photo Number: P2240034

Description: Distillation Area, Beer Well, Evaporation tanks, and the eductor tank

Mr. Labhart escorted us to the Distillation Area, Beer Well, Evaporation Tanks, Eductor Tank area (photo 34) and cooling towers (3 chillers – photo 36). On our way to these process areas, we noticed an oil sheen in the stormwater culvert located east of the cooling tower. I asked Mr. Rezac for the potential source of the oil and he stated that the source could have been from the parked maintenance vehicles near the culvert. Mr. Rezac mentioned that the oil sheen couldn't have resulted from the non-contact sump pump malfunctioning (as they have in the past), since the plant was not in the operation at that time.

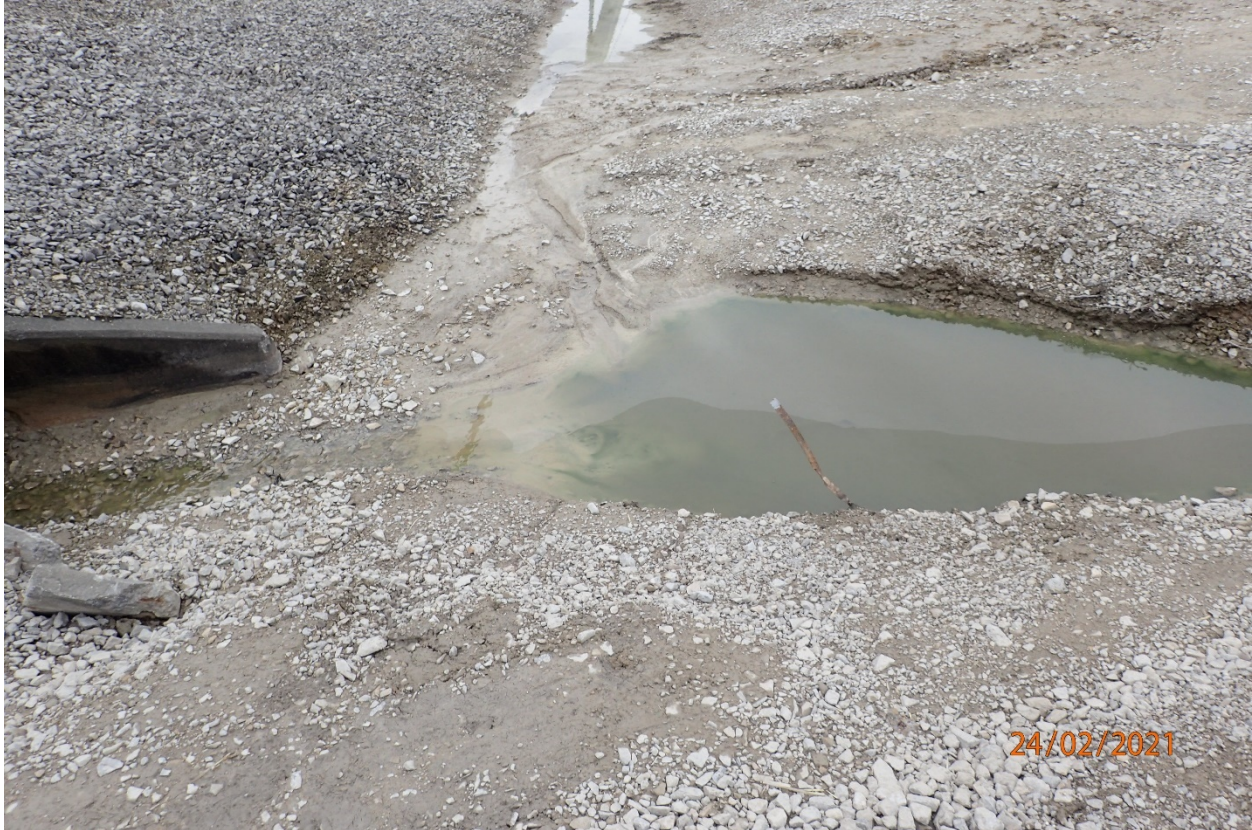
Photo Number: P2240035

During the closing conference, we had not discussed the concern related to the oil sheen observed in the stormwater culvert located east of the cooling tower. Mr. Rezac stated that the

source could have been from the parked maintenance vehicles near the culvert and that he would look into preventing similar occurrences in the future.

Description: Stormwater culvert – noticeable oil sheen

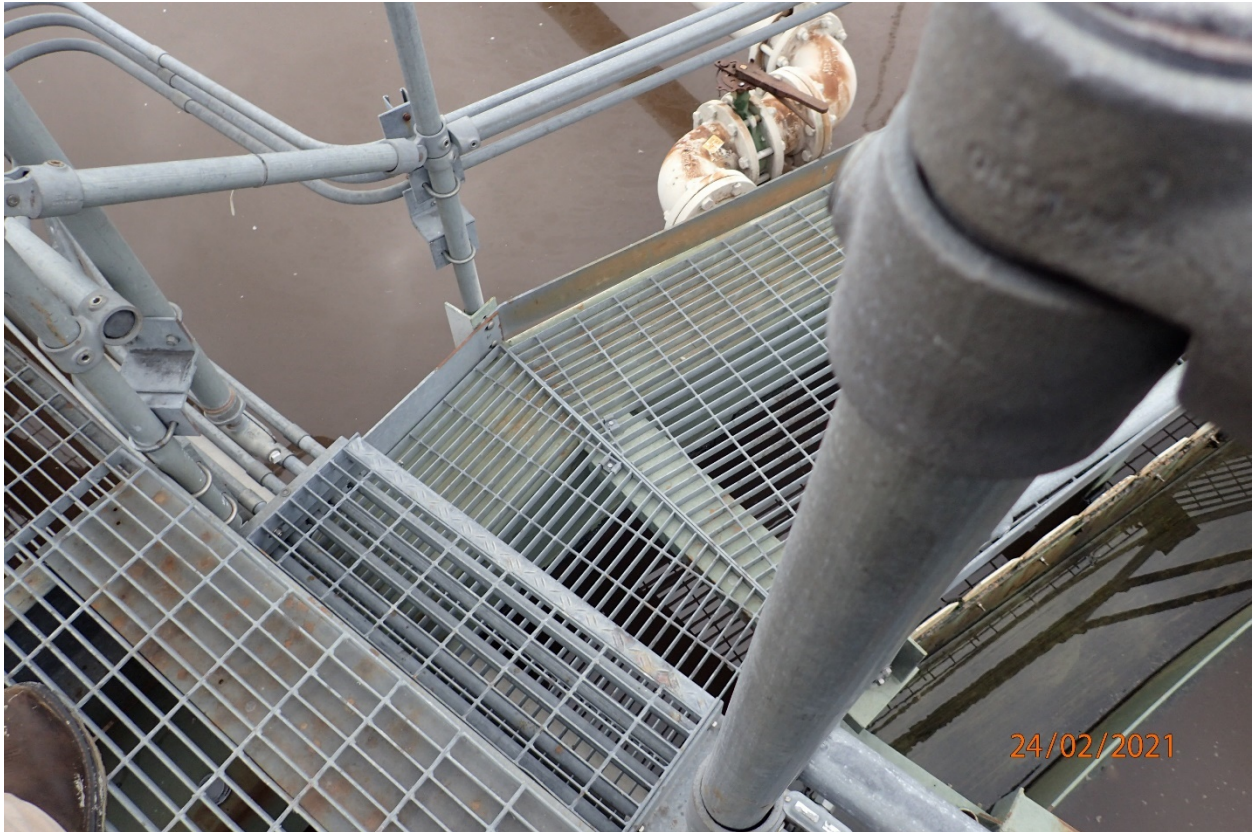
Photo Number: P2240037

The inspection continued towards the wastewater treatment system (aerobic digester) located on the northeast side of the facility (photos 37 thru' 41). Mr. Labhart stated that the discharge from Outfall 001 consists of filter backwash and filter-press wastewater, RO reject water (photo 53), softener regenerant, boiler blowdown, non-contact cooling water, and condensate from heat exchangers, as well as storm water. The outfall has an average discharge of approximately 0.95 million gallon per day (MGD) into the unnamed ditch to the Ohio River.

Description: On top of the Digester, which was turned off at the time of the inspection

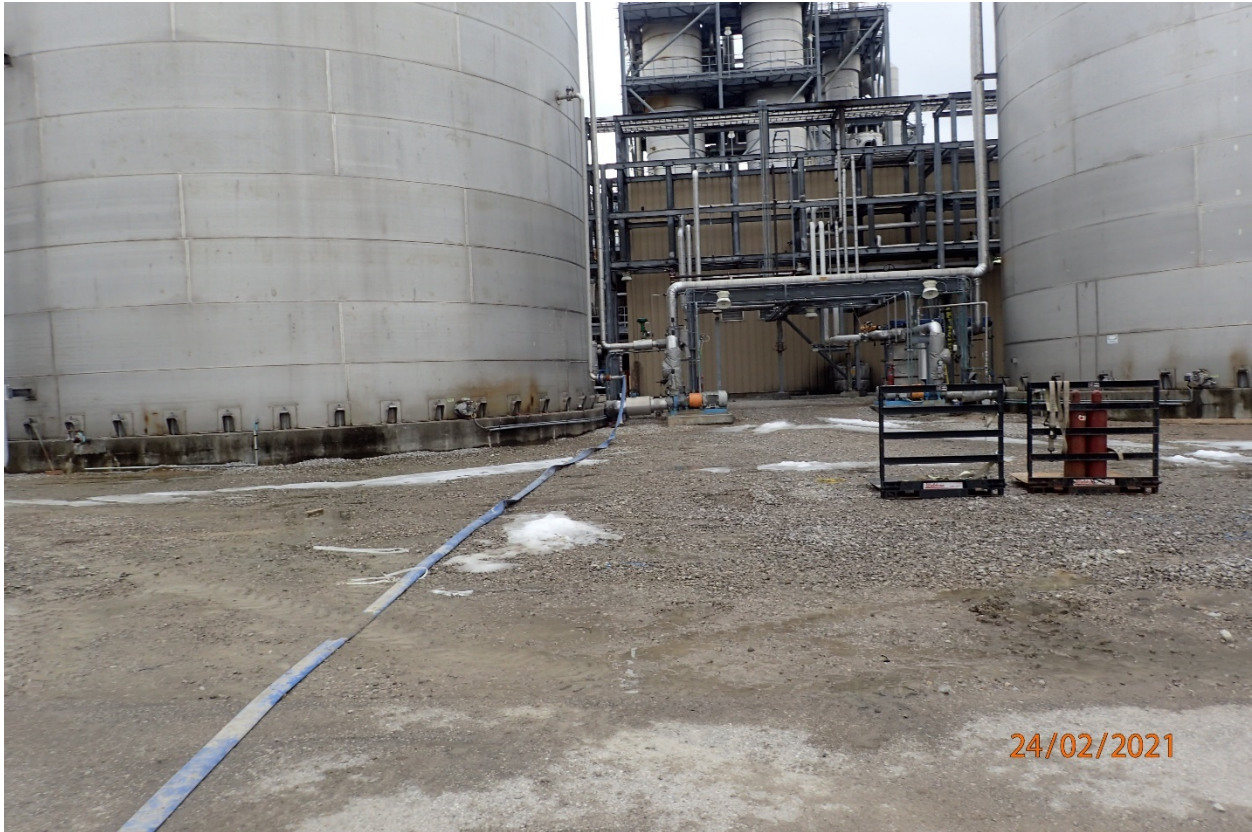
Photo Number: P2240043

Description: Equalization Tank 7001 and treated wastewater holding tank 7002

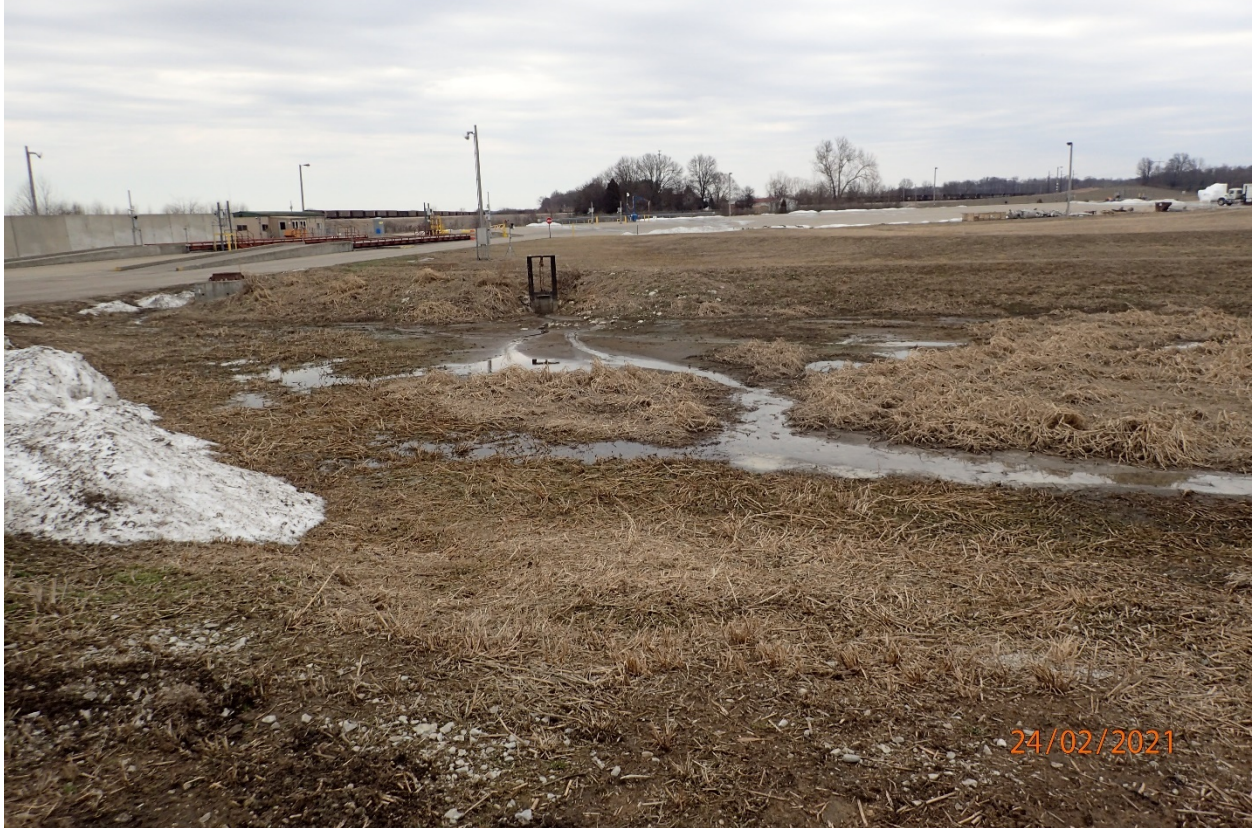
Photo Number: P2240044

The inspection continued to the northwest side of the facility where we inspected outfall, discharge, and sampling locations for Outfall 002 and Outfall 002S (photos 44, 48, 49). Before we ended the facility walk-through, we inspected the Wet Distillers Grains storage area (photo 45) and the newly installed evaporator and beer well (photo 51). Finally, we entered the energy center building to inspect the flow meter that measures the flow from RO reject water, softener regenerant, boiler blowdown, non-contact cooling water and condensate from heat exchangers

Description: Sluice Gate at Stormwater Outfall 002S

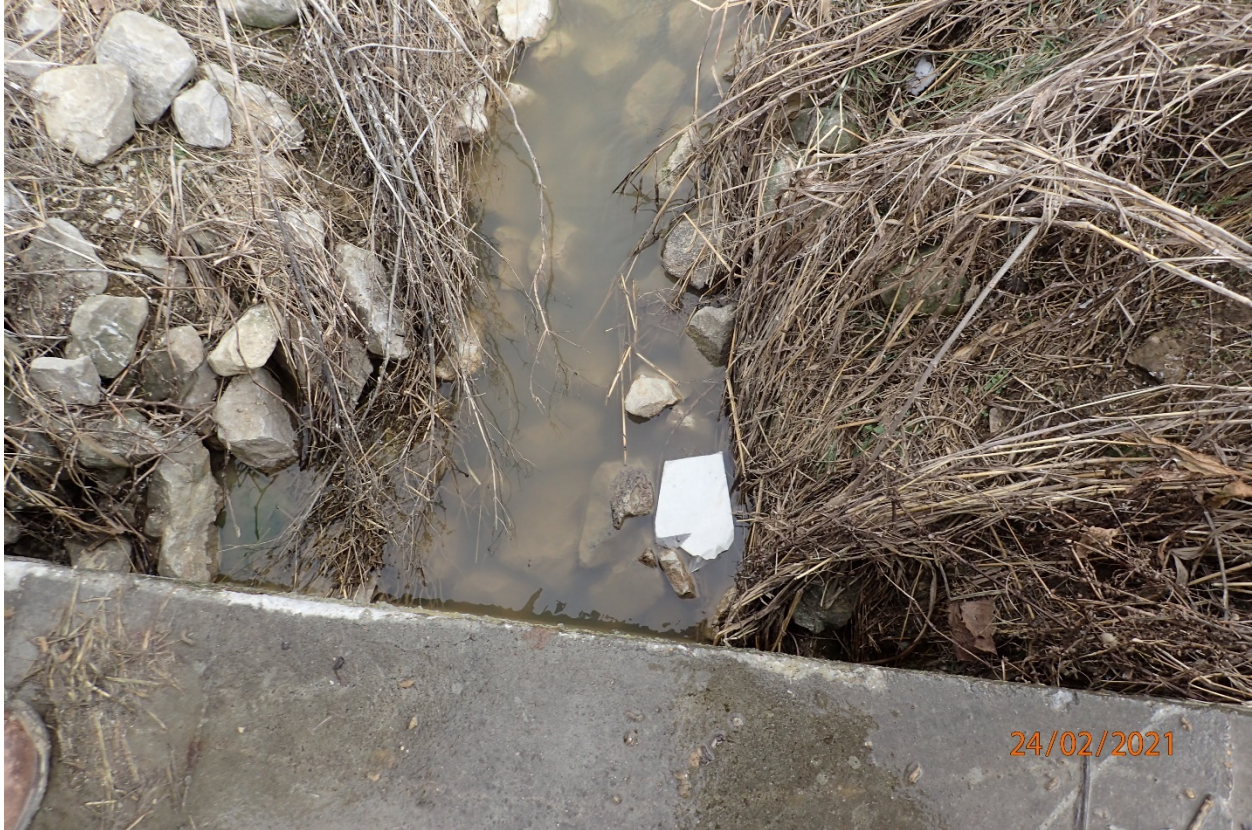
Photo Number: P2240048

Description: Sample Collection for Outfall 002S

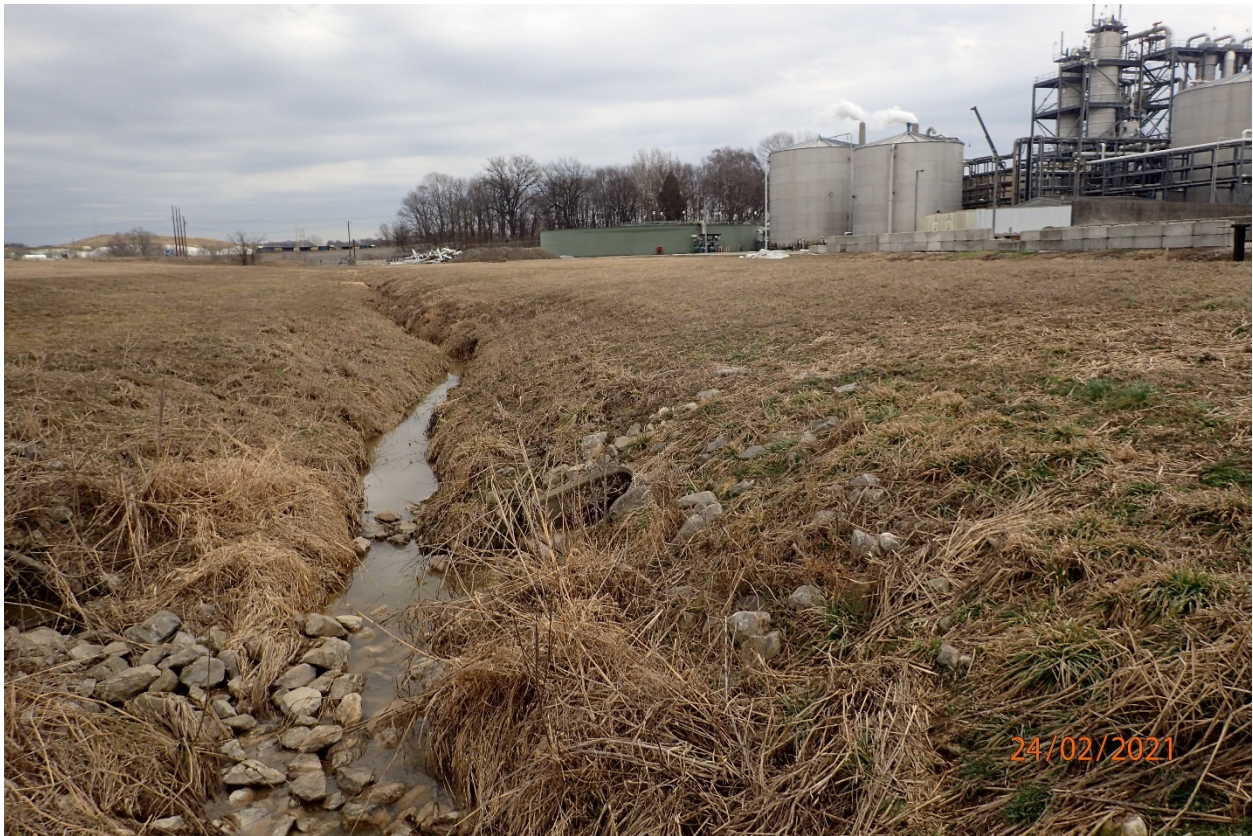
Photo Number: P2240049

Description: Outfall discharge location for outfall 002S
