U.S. Environmental Protection Agency Region 5

Purpose: Industrial User Pretreatment Compliance Inspection

Facility: Green Plains Mount Vernon LLC
8999 W Franklin Road
Mount Vernon, IN 47620

Inspection Date: February 23-24, 2021

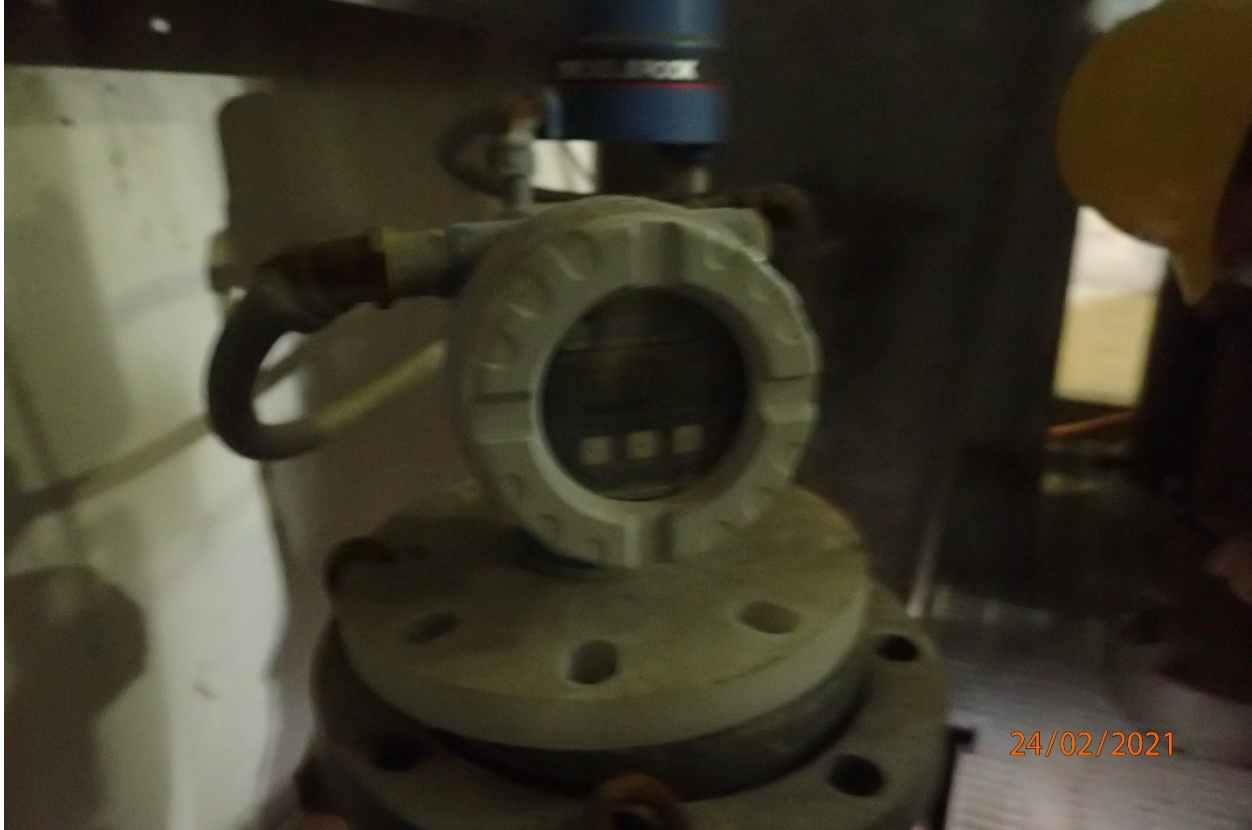
Photo Number: P2240054

Description: Level meter that is triggered when the water level reaches a certain height in the tank
