INSPECTION REPORT

| <b>Type of Inspection</b> | Focused Compliance Inspection (FCI) | | | |
| <b>Facility or Site Name</b> | Bollinger Fourchon, LLC | | | |
| <b>Type of Operation</b> | Ship Building and Repairing | | | |

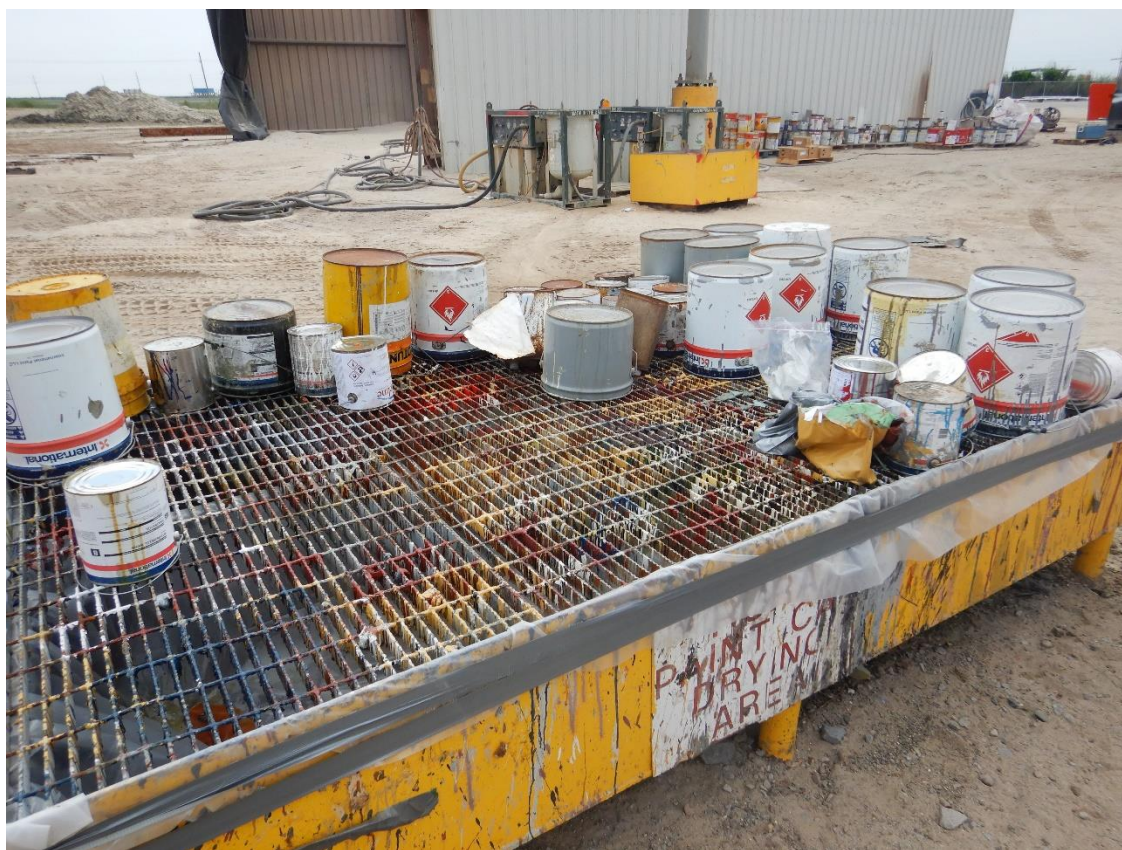
Photo No. 1

Description: View of the paint can drying area where RCRA-empty paint cans are overturned and residuals allowed to dry before paint can disposal.

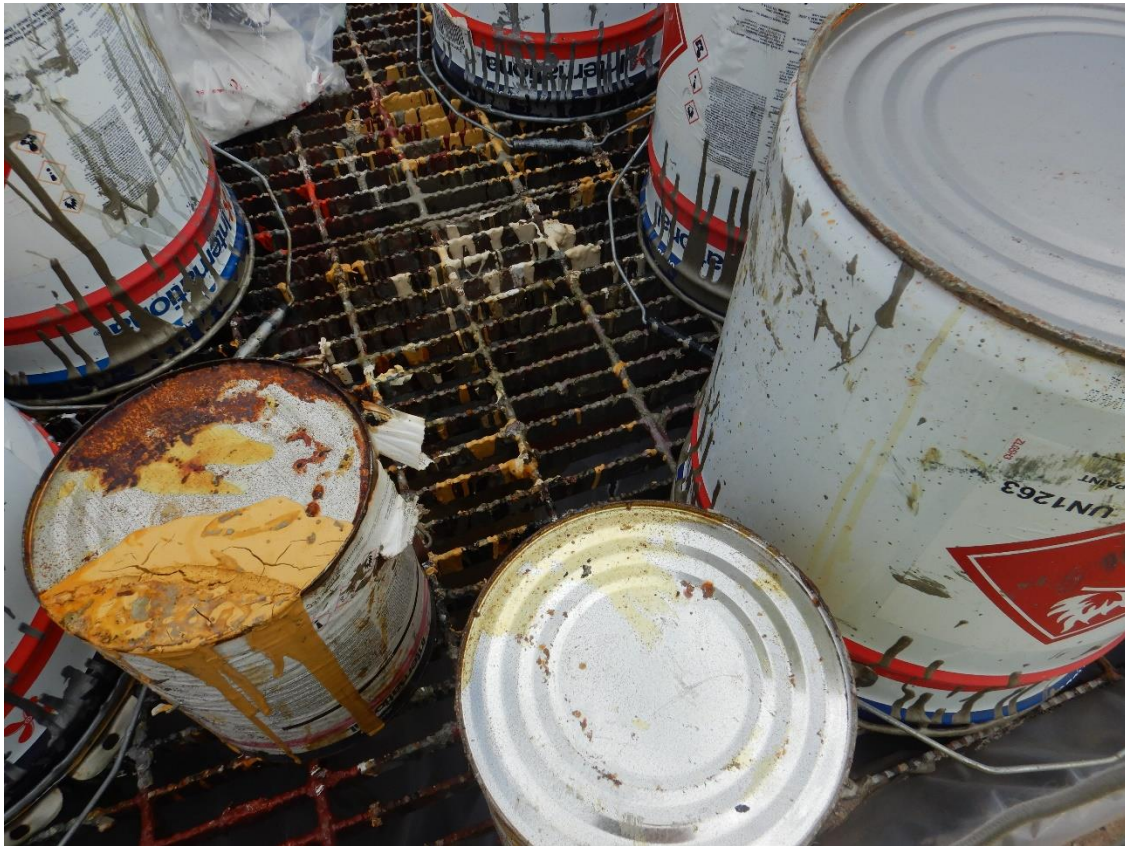
Photo No. 2

Description: View of the grating at the paint can drying area. Residuals on the grating were dry, and no liquid paint was accumulated in the plastic sheeting below the grating.

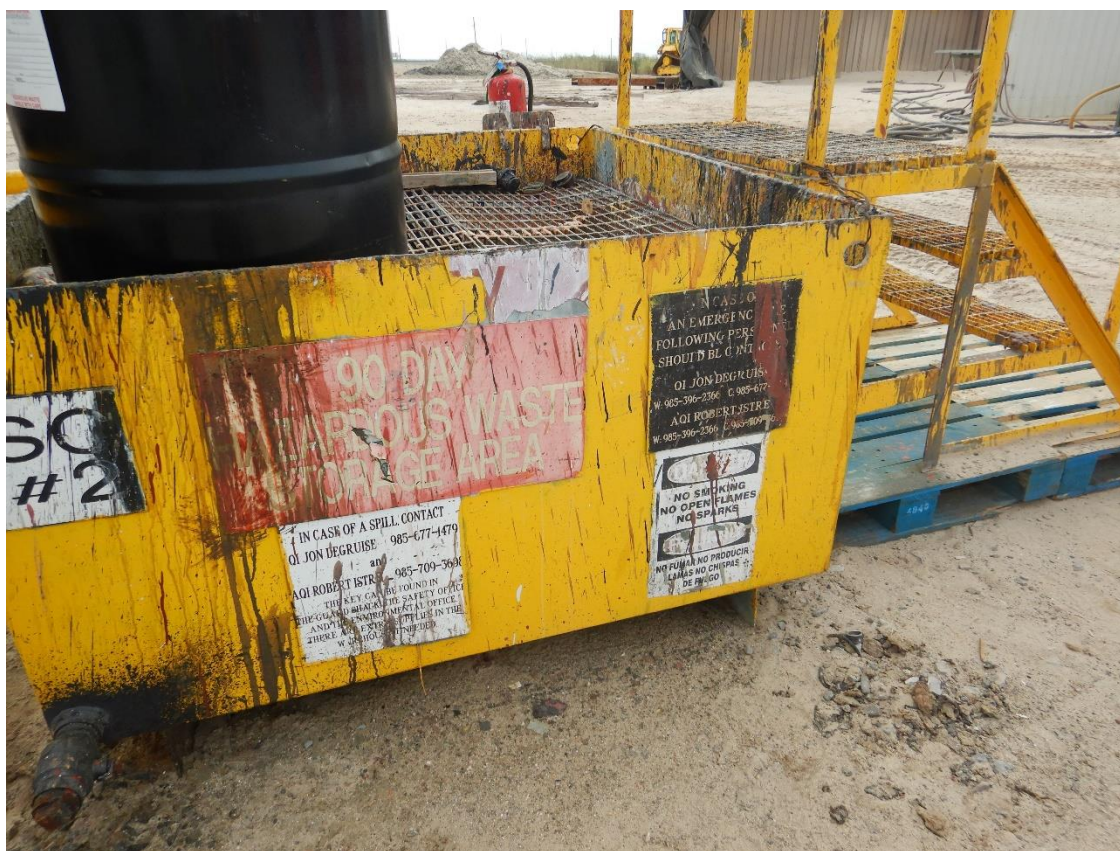
Photo No. 3

Description: View of the CAA labeling, including a "No Smoking" sign to the bottom right.

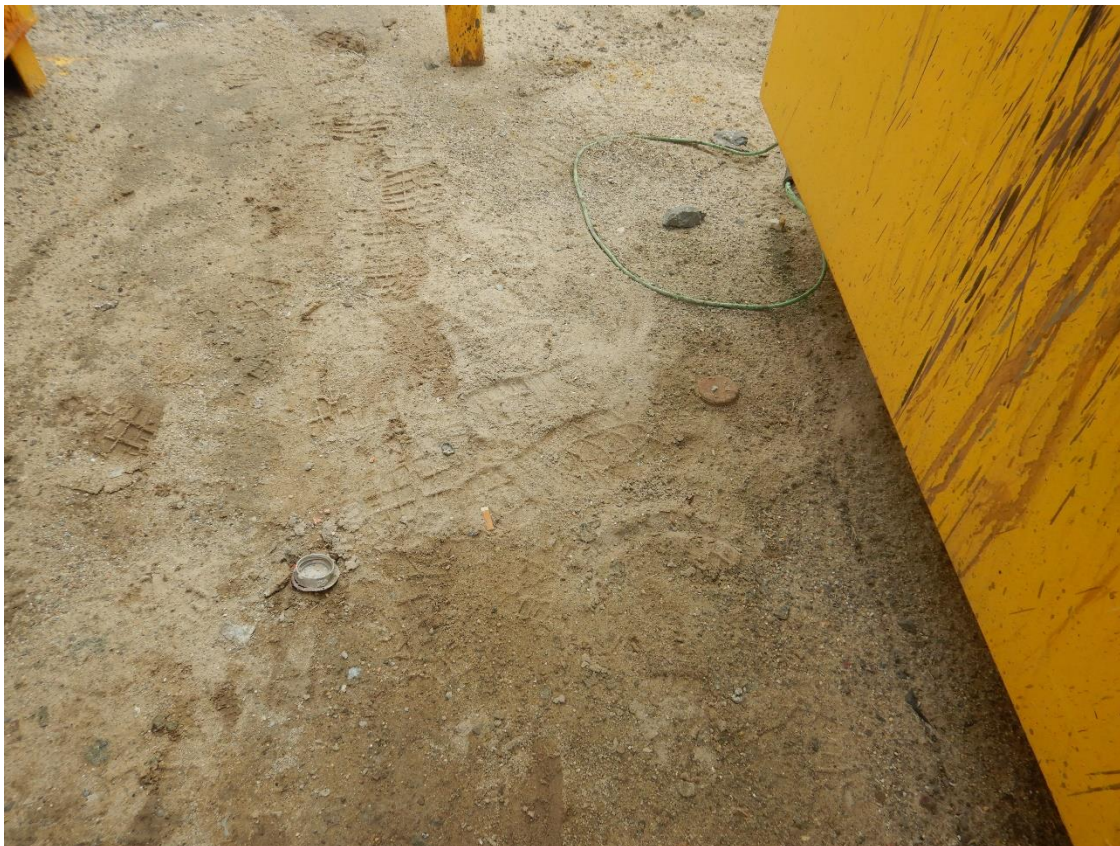
**Photo No. 4**

| Tenant: Bollinger Fourchon, LLC | | |
|---|---|---|
| <b>AOC #1</b> – Bollinger did not take precautions to protect and separate ignitable waste from smoking as a source of ignition. | <b>Citation:</b> 40 CFR 262.17(a)(1)(vi)(B) | Section: 2 |

Description: Cigarette butt observed on the ground immediately adjacent to the CAA on site, which held ignitable hazardous waste.

- Bollinger posted additional "No Smoking" signage at the CAA on site and conducted additional training for workers pertaining to hazardous waste storage requirements, including smoking restrictions (photo and training log in Appendix 2).

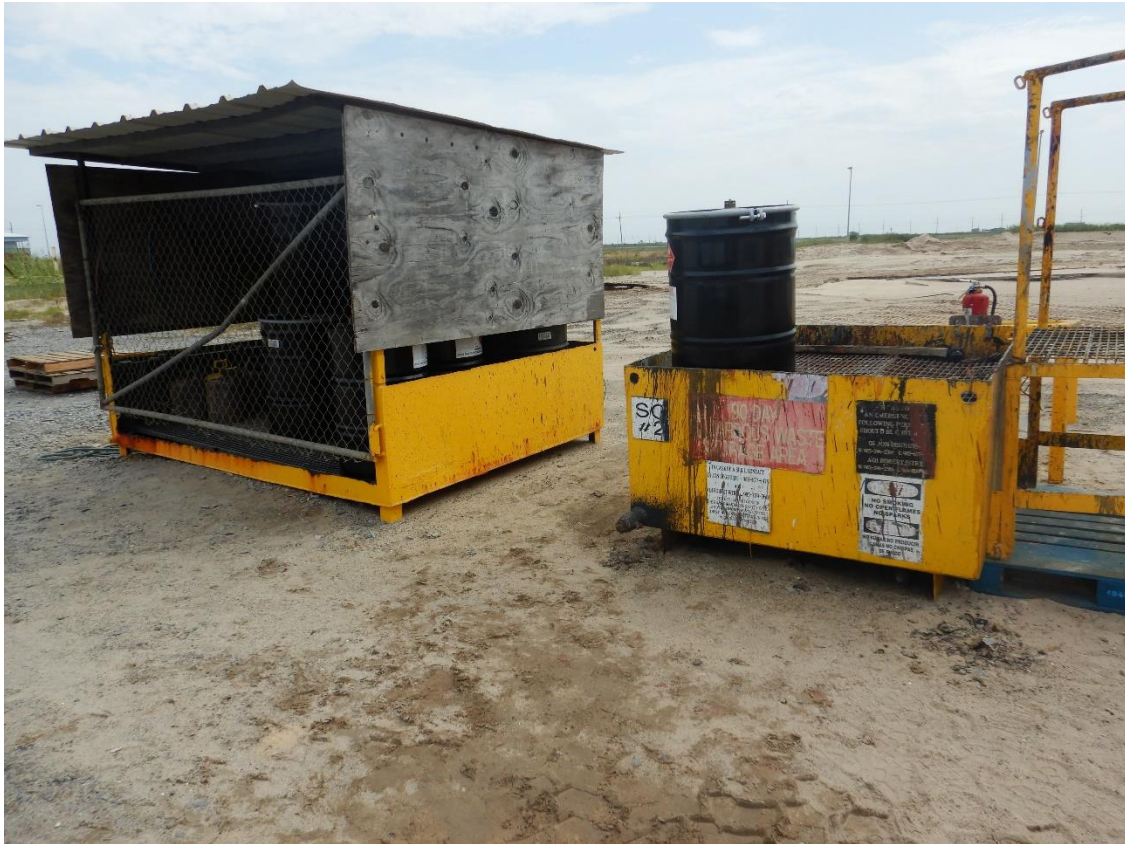
Photo No. 5

Description: View of the CAA on site to the right of the image. There was one 55-gallon drum of hazardous waste present in the CAA at the time of the inspection. The covered structure to the left of the image is for raw materials.

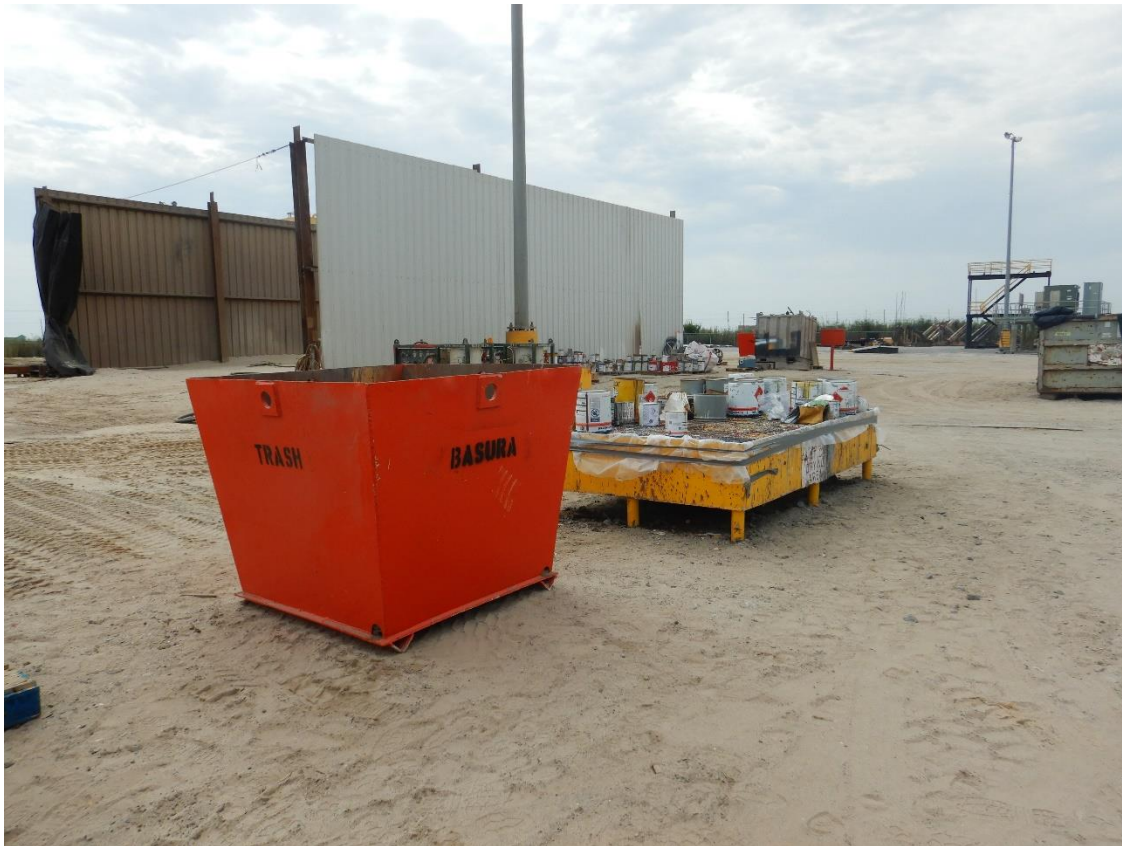
**Photo No. 6**

Description: View of the paint can drying area and nonhazardous waste disposal bin.
