**Region 6 Compliance Assurance and Enforcement Division  
INSPECTION REPORT**

| Inspection Date(s): | 02/12/2015 | | |
| Company Name: | <b>Lutex Oil, Ltd</b> | | |
| | Subject: | Inspection Report Clean Water Act (CWA) Brine Discharge | |

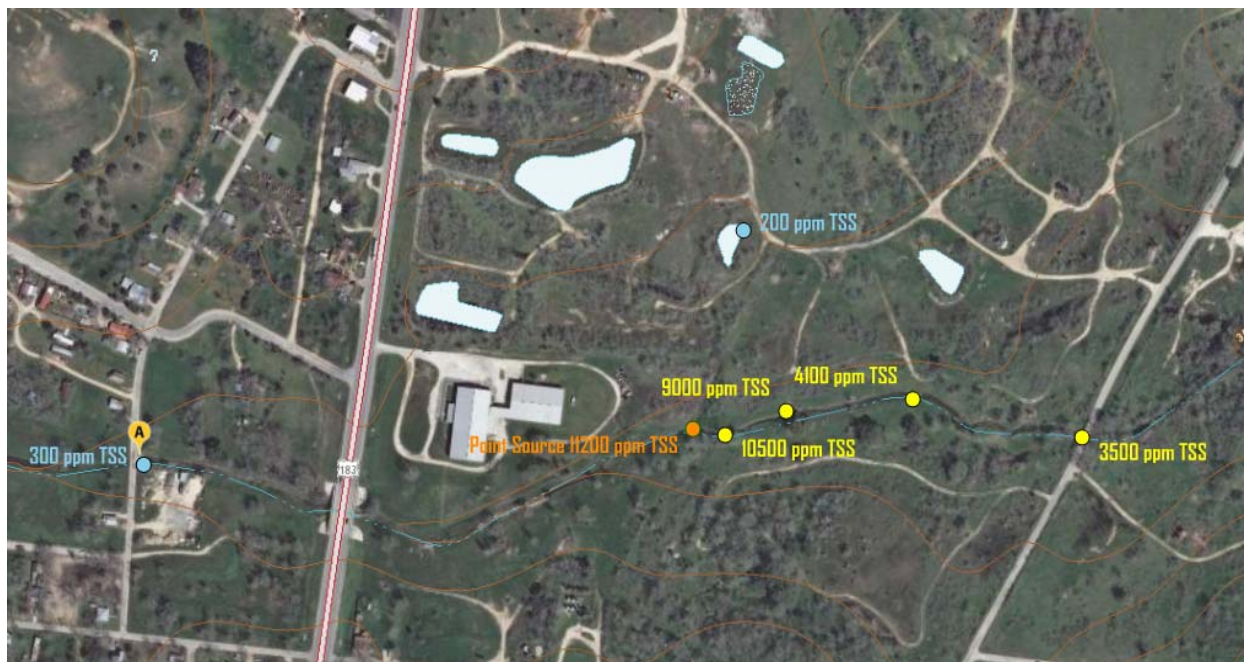
Photo No. 1

Description: Layout of Lutex Oil Ltd. Orange point indicates the highest salinity concentration of 11,200 parts-per-million (ppm) Total Soluble Salts (TSS) that was observed in Salt Creek. Blue points indicates back ground salinity for Salt Branch Creek in relation to the facility data (200 and 300 ppm TSS). Yellow indicates the TSS concentrations observed along Salt Branch Creek (between 3,500 to 10,500 ppm TSS).

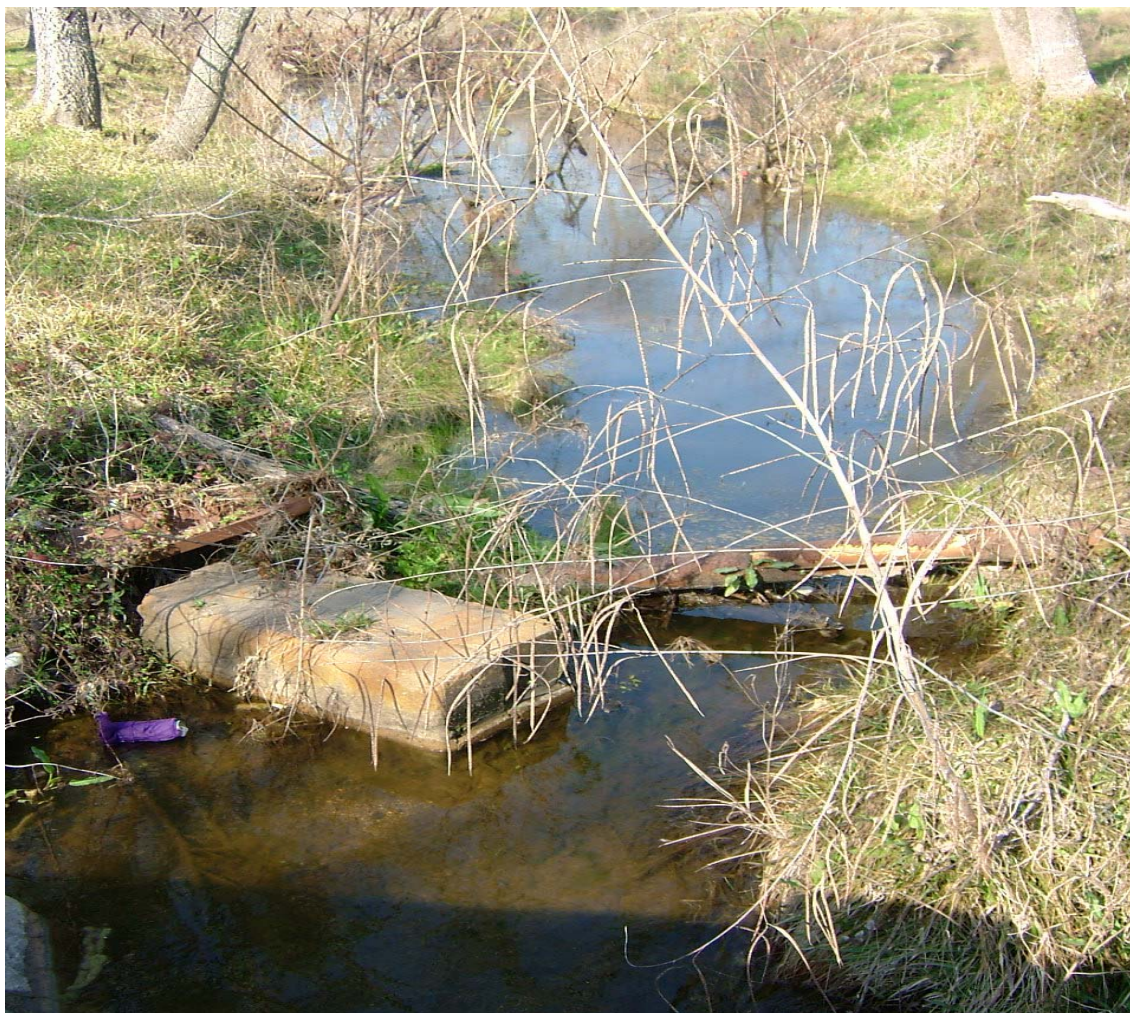
Photo No. 2

Description: We are standing on CR 128 and looking to the west at Salt Branch Creek. Overview of the Salt Branch Creek showing a rusted flow line in the creek. At this location we determined the Total Soluble Salt (TSS) of Salt Branch Creek to be 3,500 parts-per-million (ppm) TSS. I did not observe aquatic life and found dead vegetation.

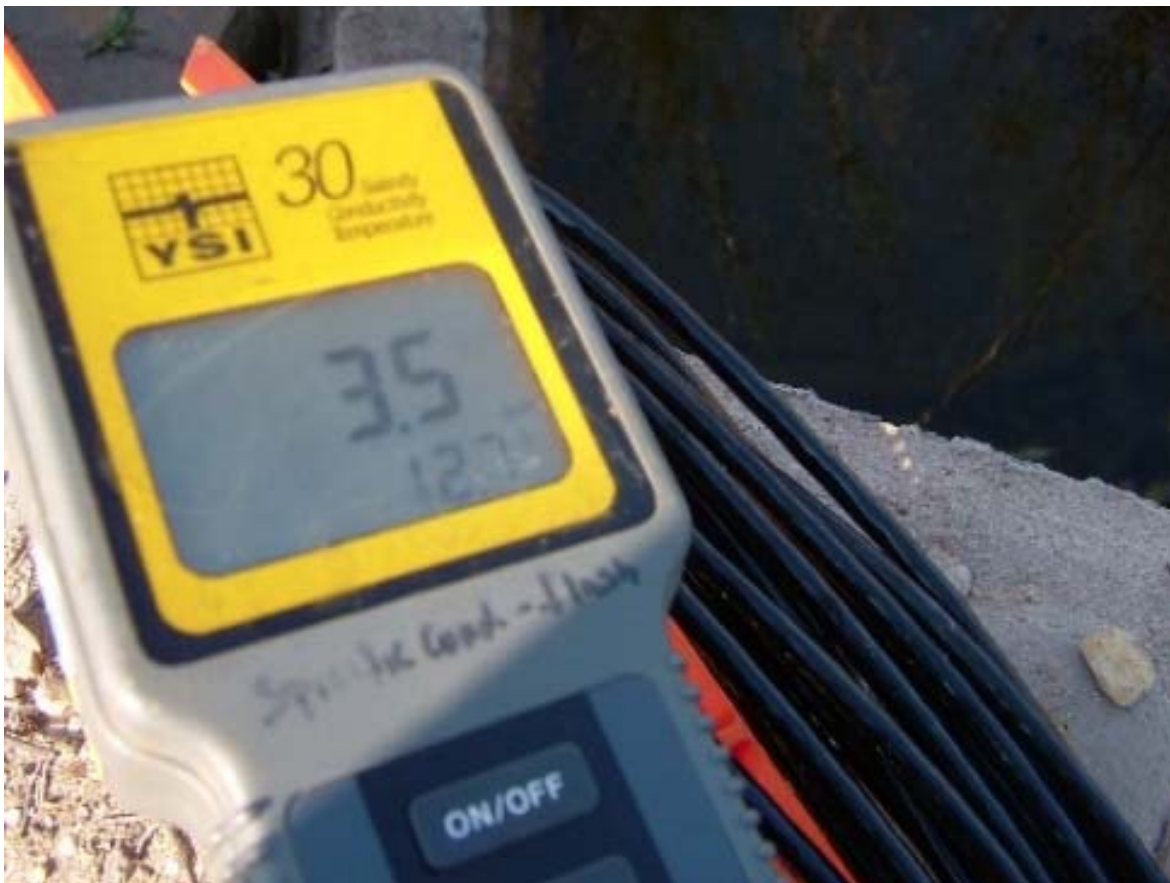
Photo No. 3

Description: We are standing on CR 128 and looking to the west at Salt Branch Creek. At this location we determined the Total Soluble Salt (TSS) of Salt Branch Creek to be 3,500 parts-per-million (ppm) TSS.

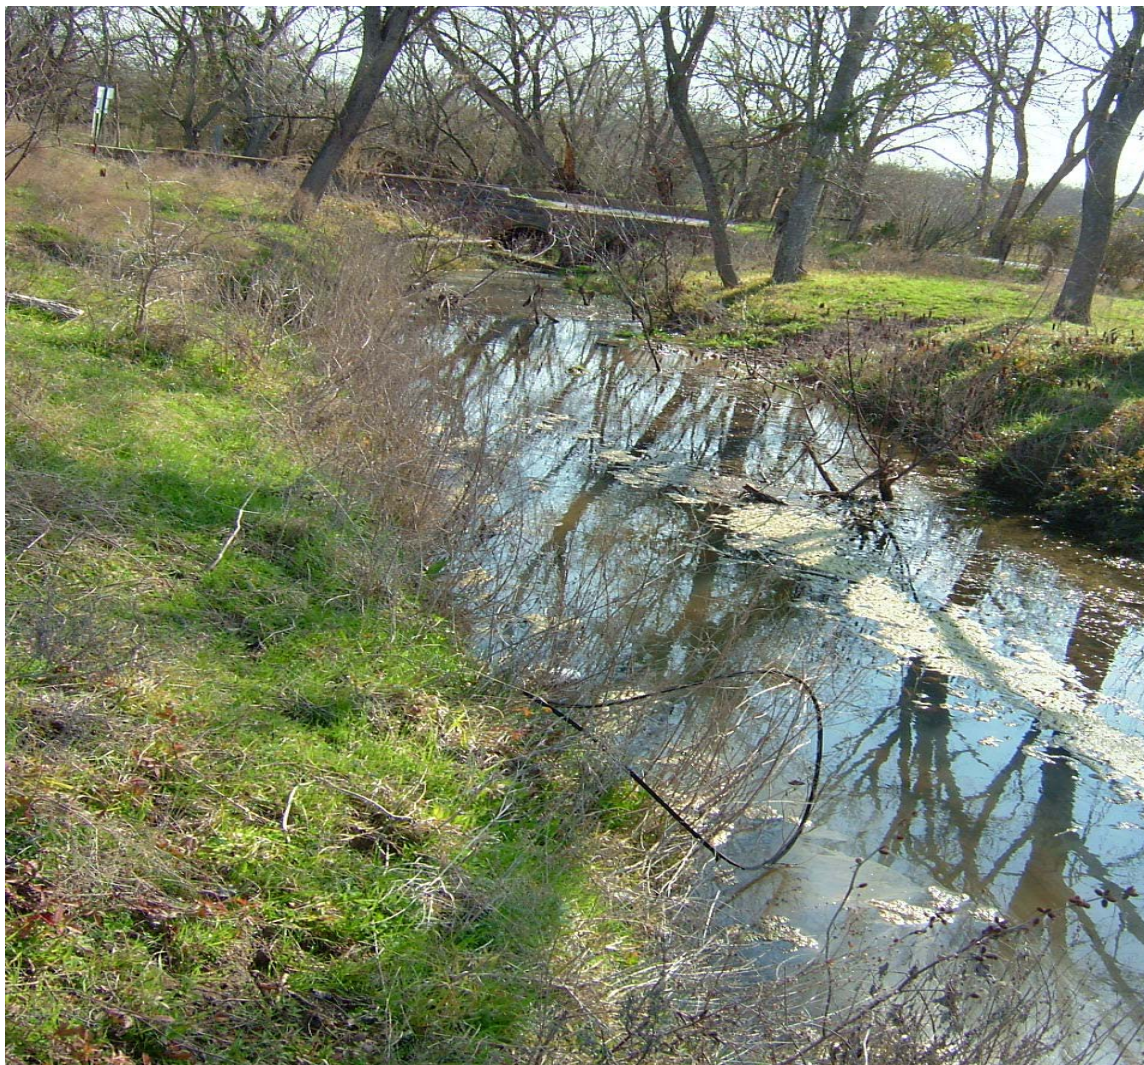
Photo No. 5

Description: North side of the creek. Looking east with CR 128. An overview of Salt Branch Creek showing dead vegetation and foam formations. The Total Soluble Salts (TSS) reading was 3,500 ppm. I did not observe aquatic life.

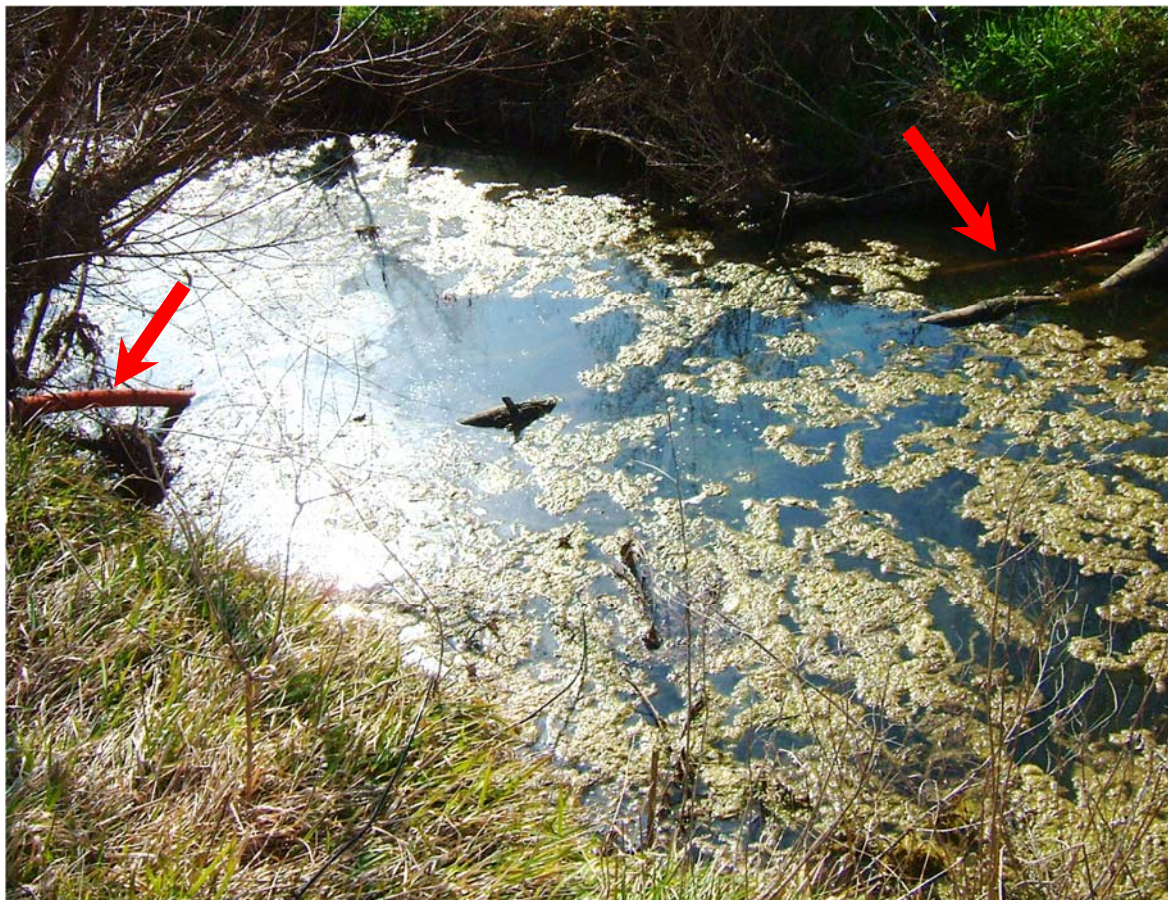
Photo No. 6

Description: Overview of Salt Branch Creek showing a polypipe line going into the creek and foam and algae formations. The Total Soluble Salt (TSS) reading was 4,100 ppm. I did not observe aquatic life.

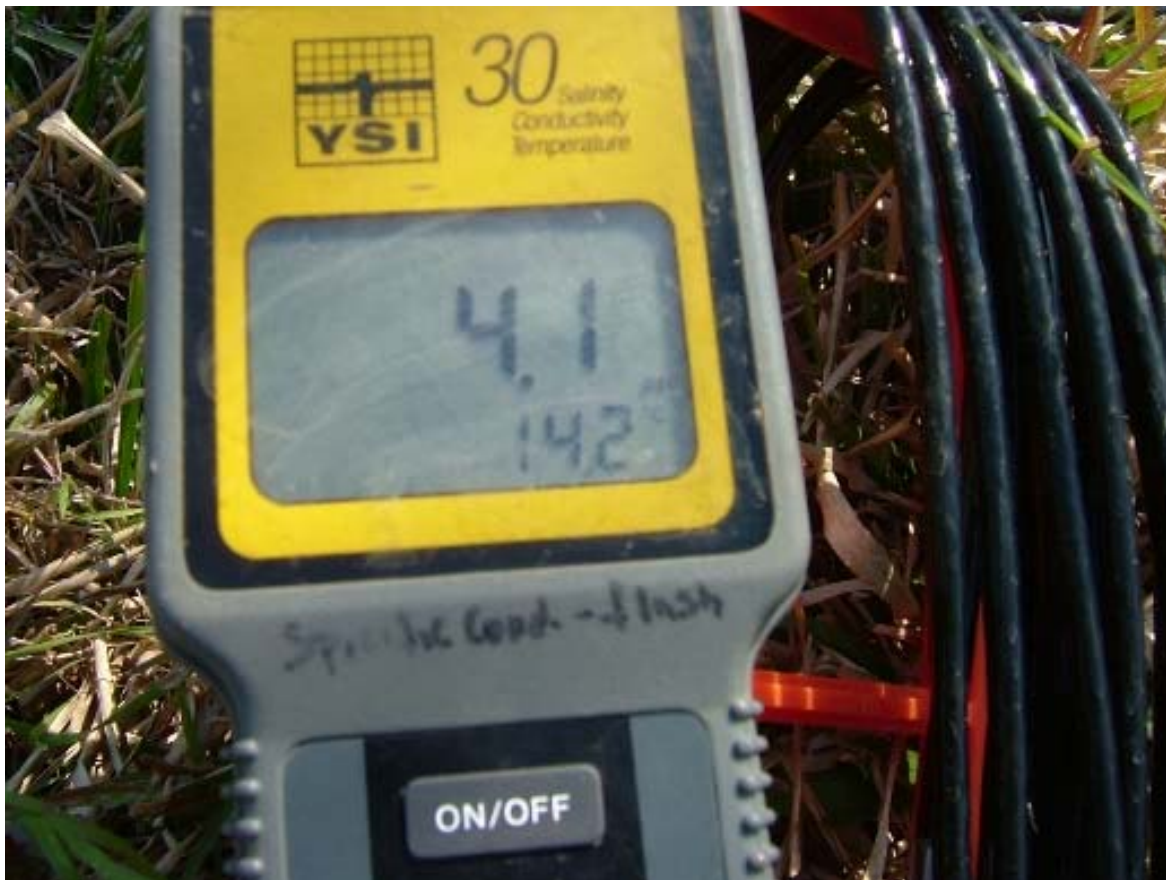
Photo No. 7

Description: The Total Dissolve Salt (TSS) reading was 4,100 ppm.

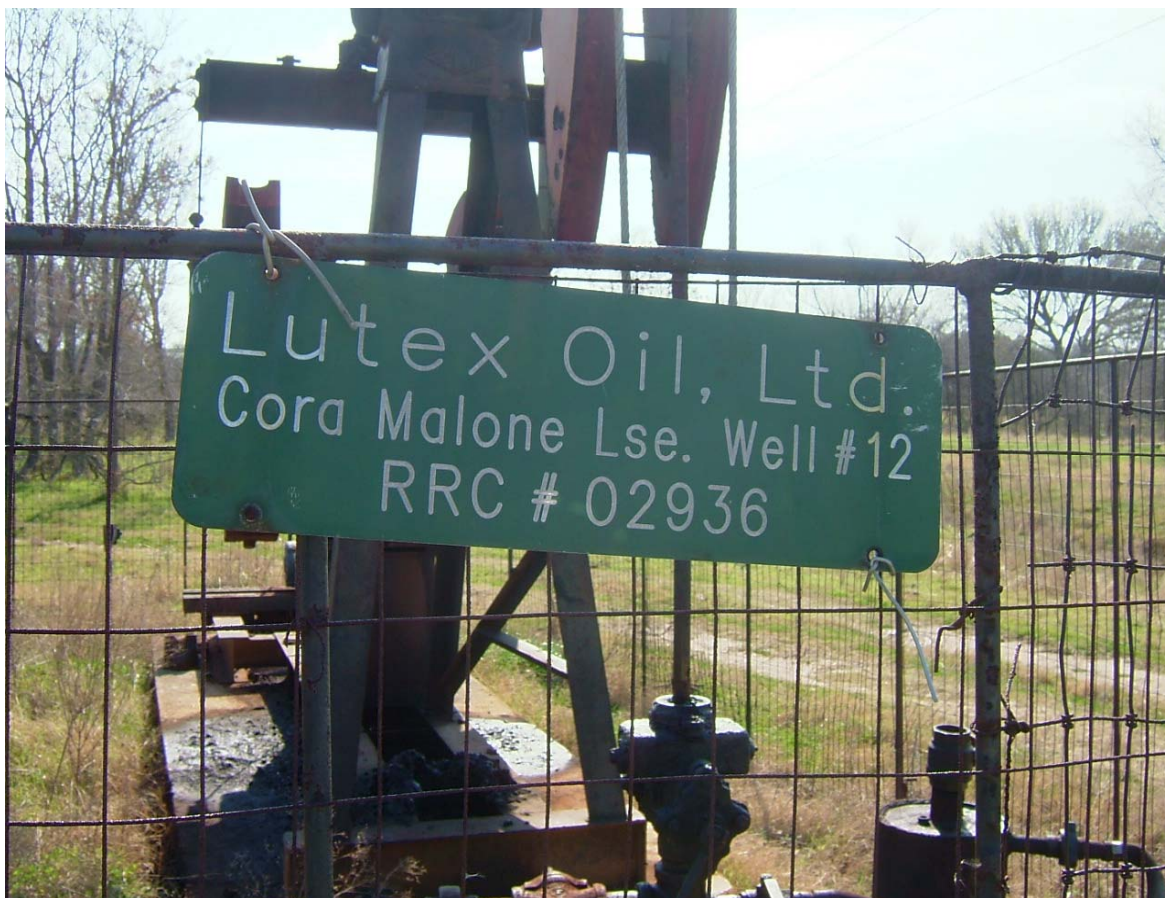
Photo No. 8

Description: Overview of the Lutex Oil Ltd. Cora Malone Lease, Well#12 RRC#02936. This well is approximately 70 feet north from Salt Branch Creek. It was operating at time of inspection.

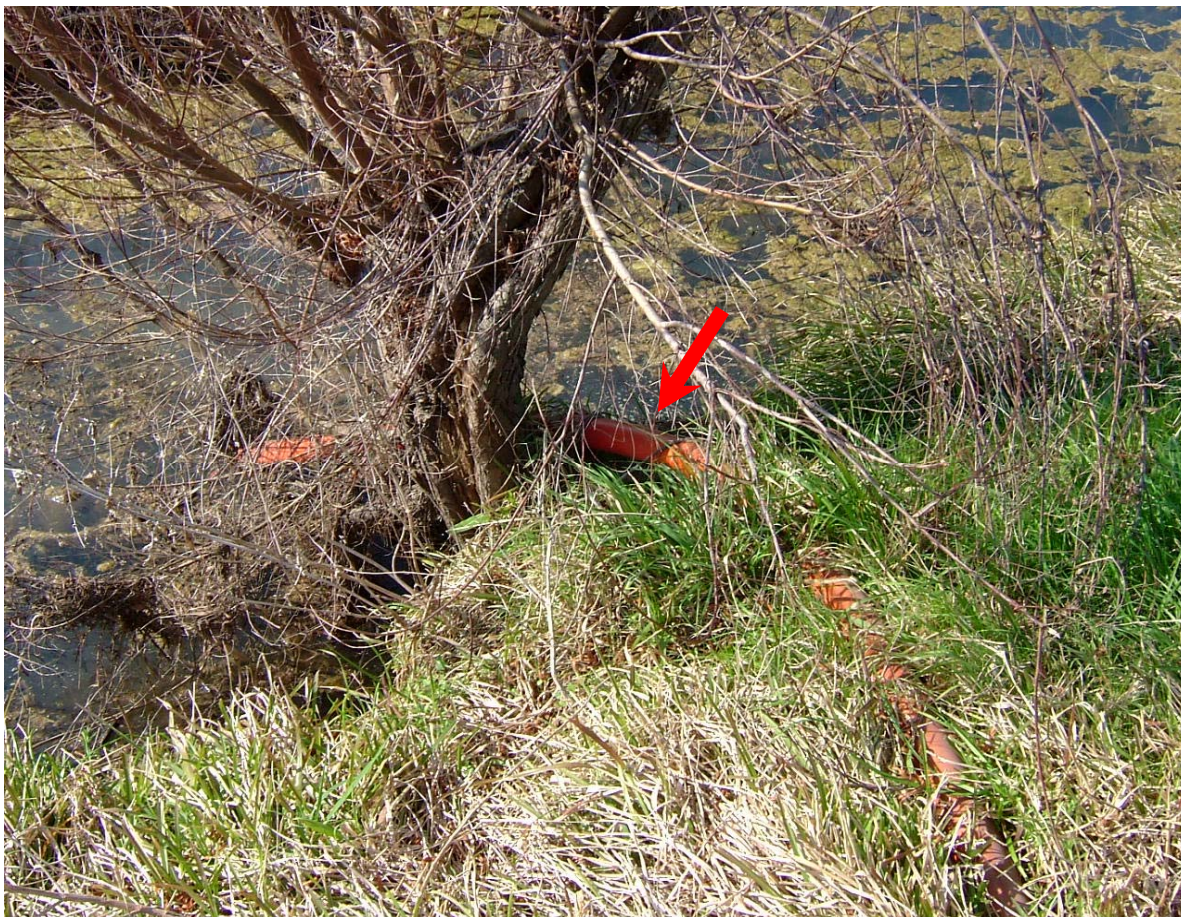
Photo No. 9

Description: Overview of Salt branch creek showing a polypipe going into the creek (see photo 6). It is located approximately 70 feet south from Cora Malone Lease, Well#12 RRC#02936.

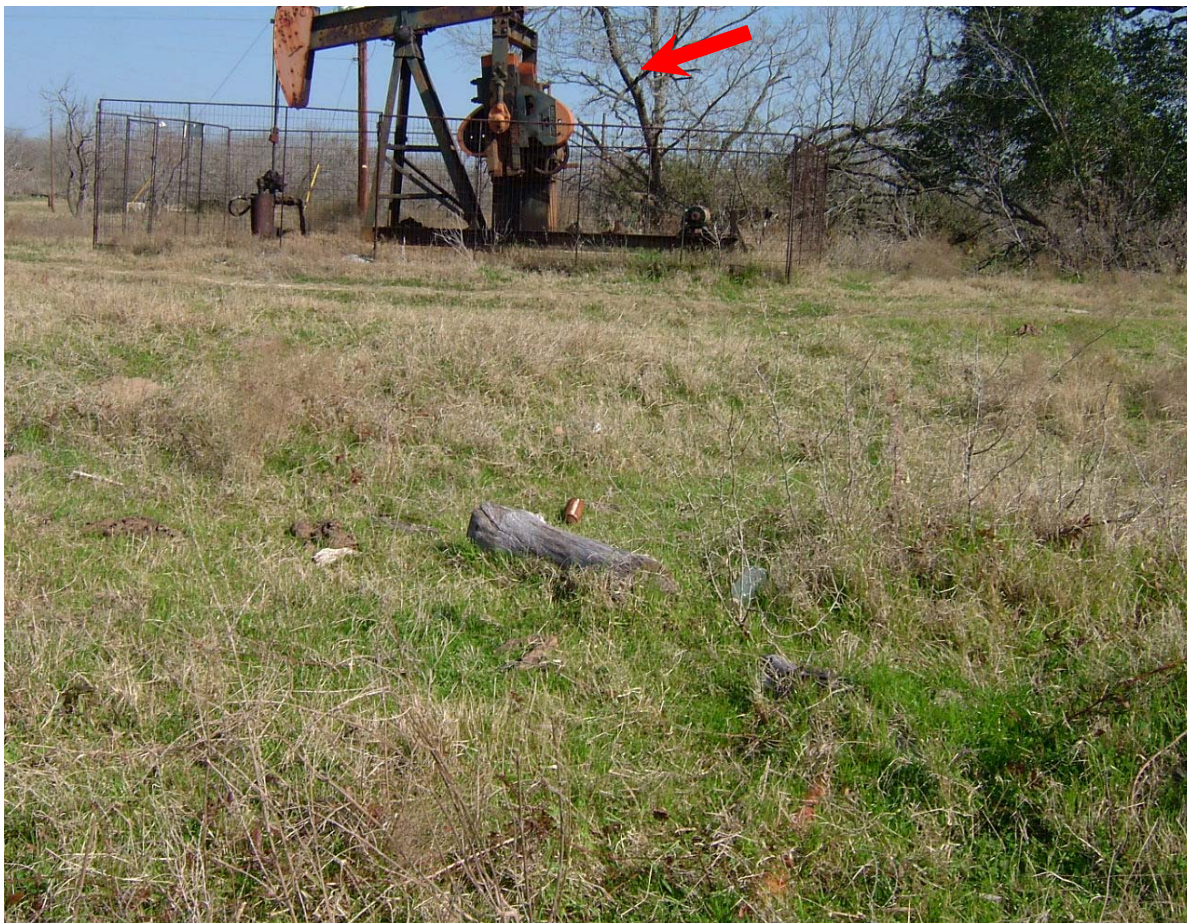
Photo No. 10

Description: Overview of the Lutex Oil Ltd. Cora Malone Lease, Well#3 RRC#02936. This well is approximately 120 feet north from Salt Branch Creek.

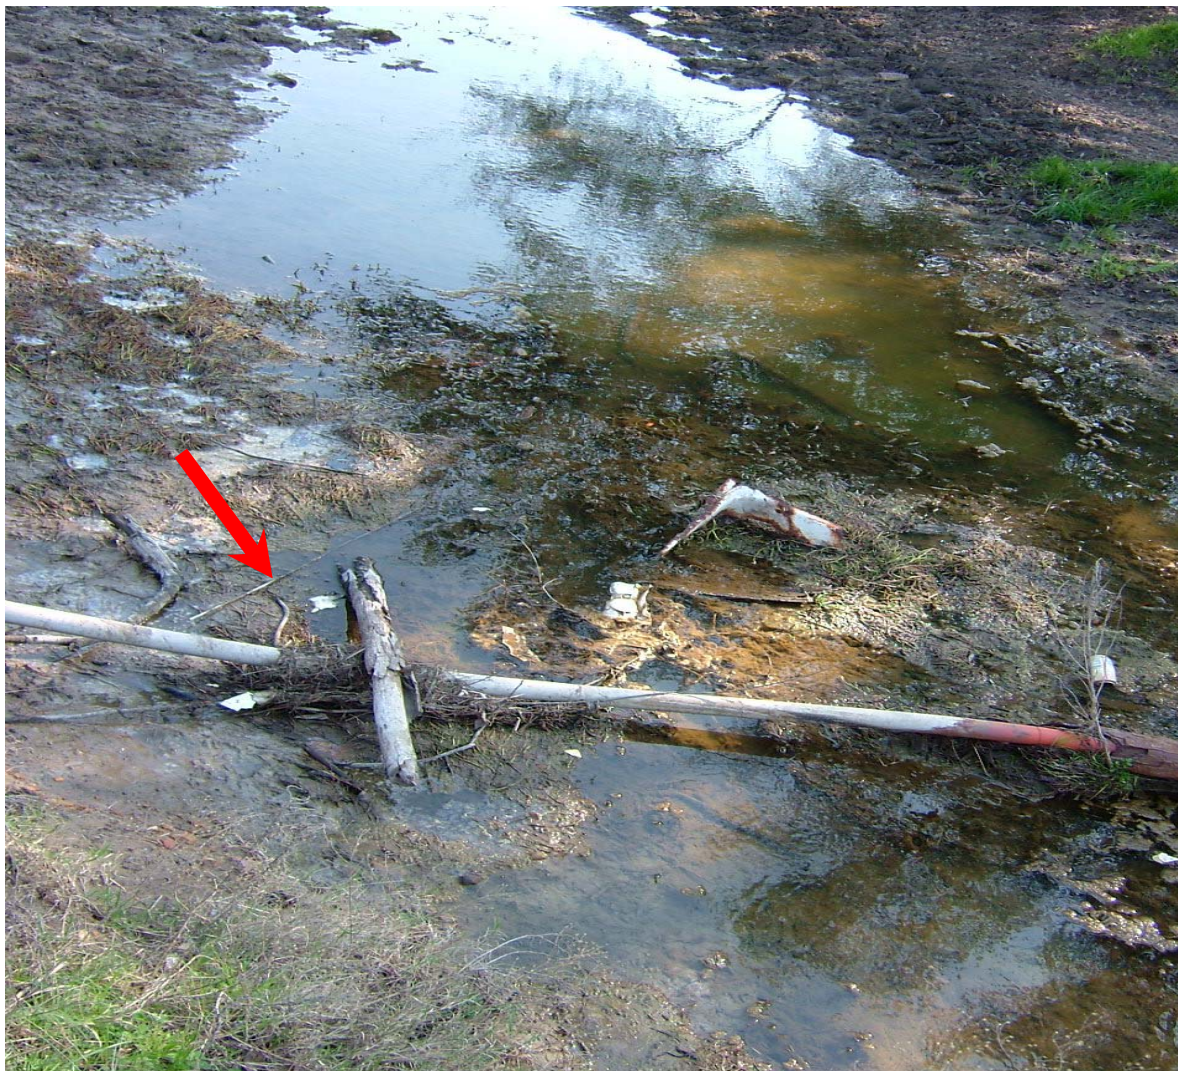
Photo No. 11

Description: Part 1, overview of a PVC pipe going into the Salt branch Creek. I measured the Total Soluble Salts (TSS) and obtained a measurement of 9,000 ppm TSS. This PVC Pipe is going into corroded pipe and is located approximately 114 feet south from the Lutex Oil Ltd. Cora Malone Lease, Well#3 RRC#02936.

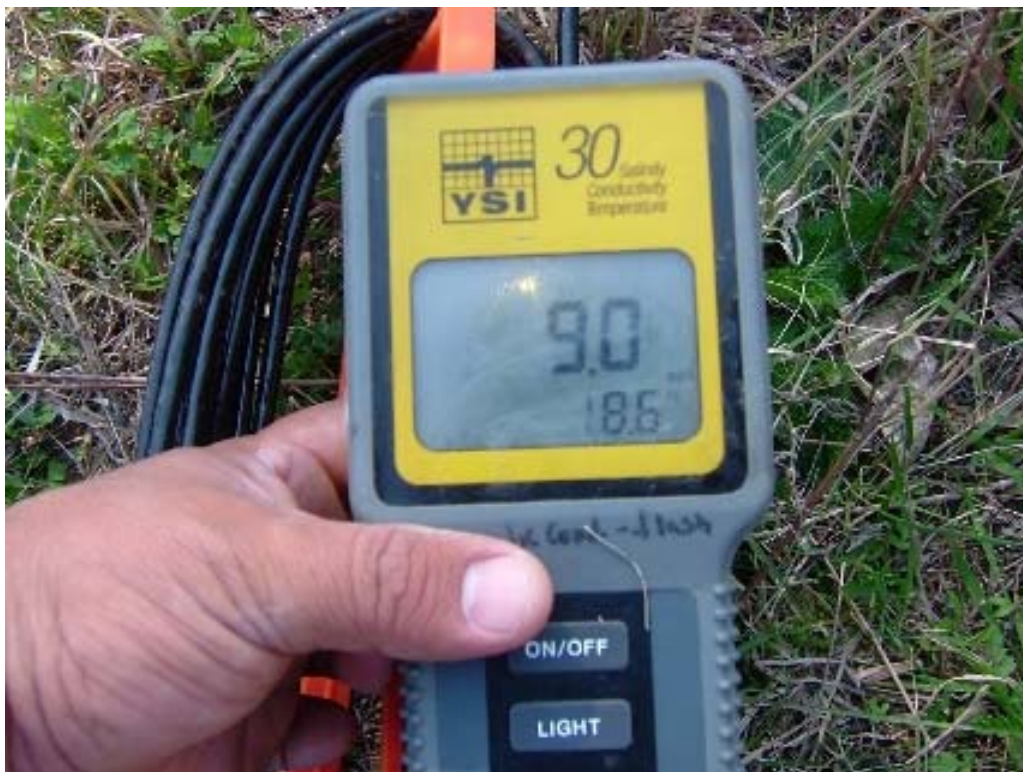
Photo No. 12

Description: Part 2, Total Soluble Salts (TSS) measurement was 9,000 ppm TSS.

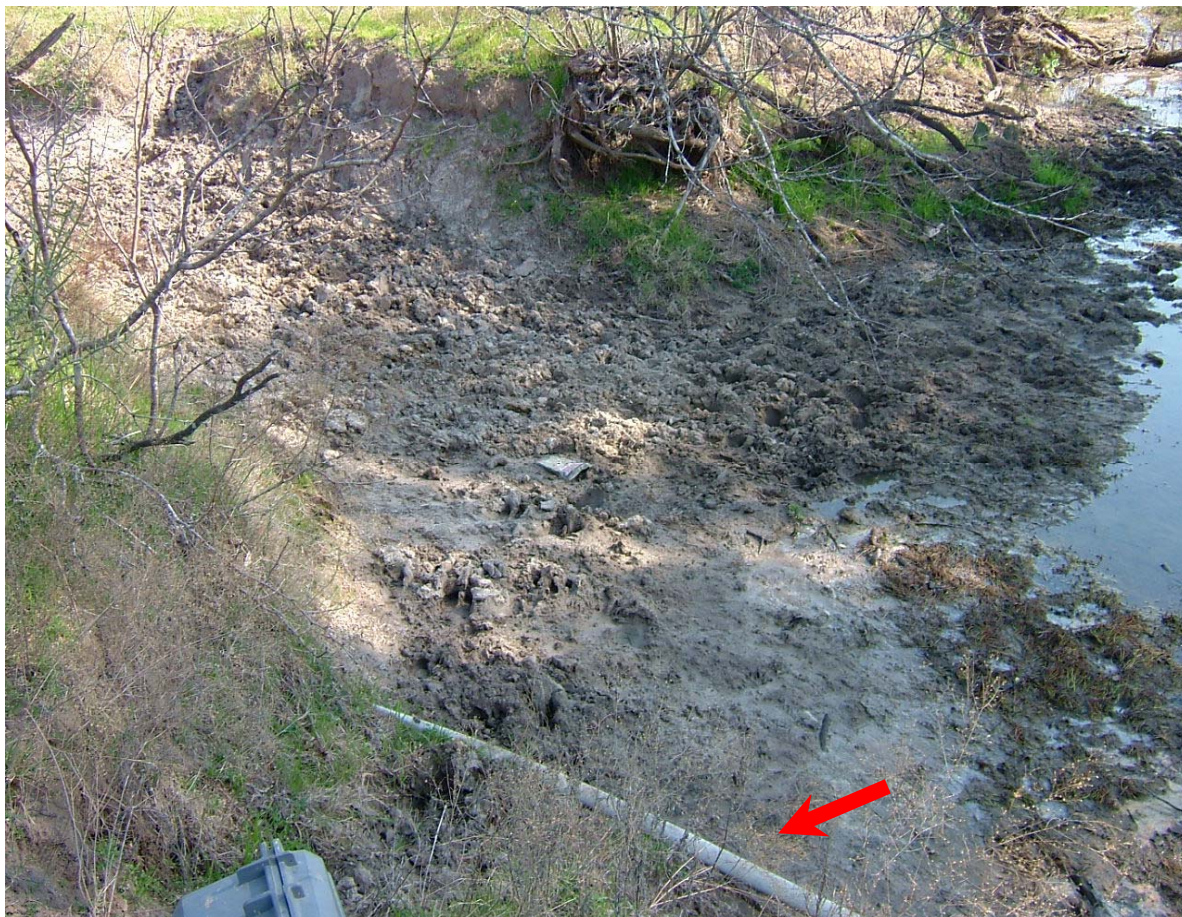
Photo No. 13

Description: Part 3, overview of a PVC pipe going into the Salt branch Creek (see photo 11). I measured the Total Soluble Salts (TSS) and obtained a reading of 9,000 ppm TSS. This PVC Pipe is located approximately 114 feet south from the Lutex Oil Ltd. Cora Malone Lease, Well#3 RRC#02936.

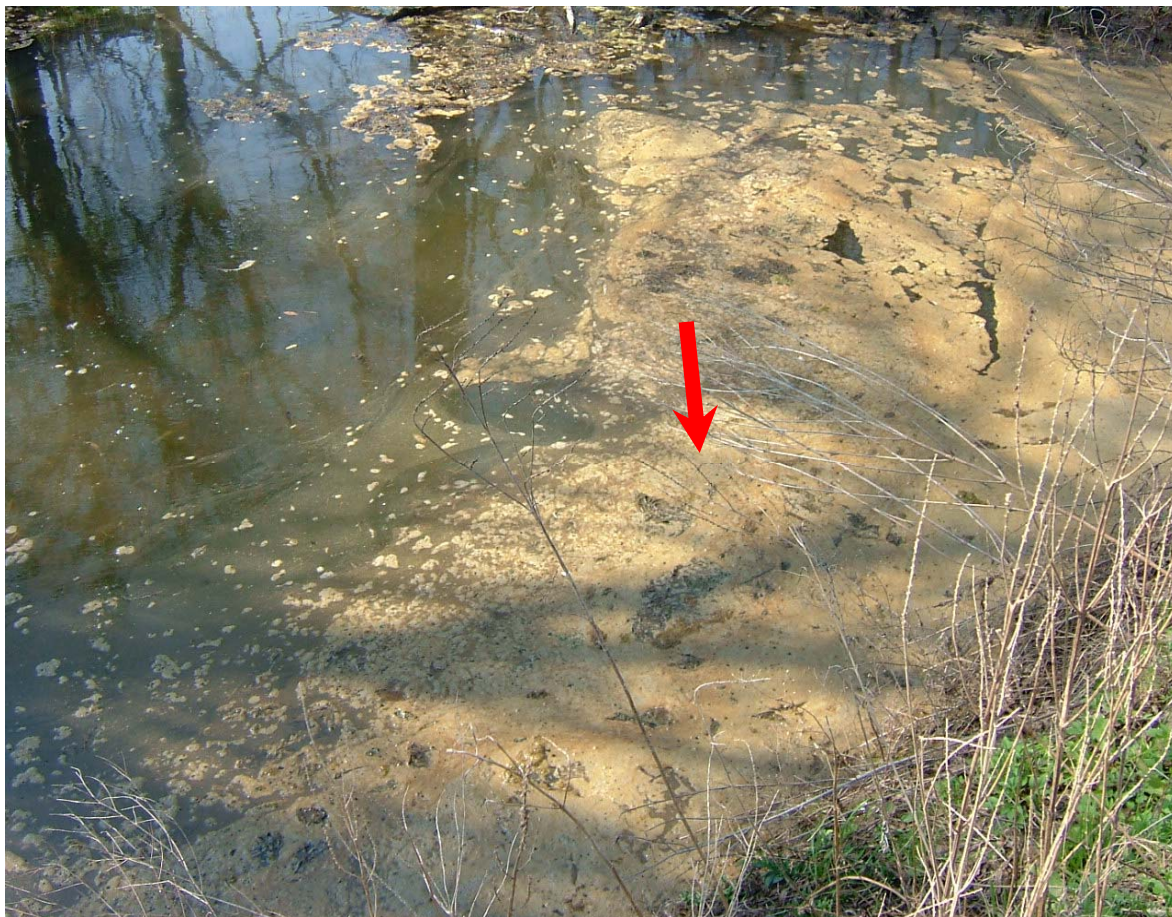
Photo No. 14

Description: North side of banck looking south. Overview of foam formations and oil residues floating on Salt Branch Creek. I measured the Total Soluble Salts and obtained a reading of 10,500 ppm TSS. This point is approximately 150 feet south of the Lutex Oil Ltd. Cora Malone Lease, Well#3 RRC#02936.

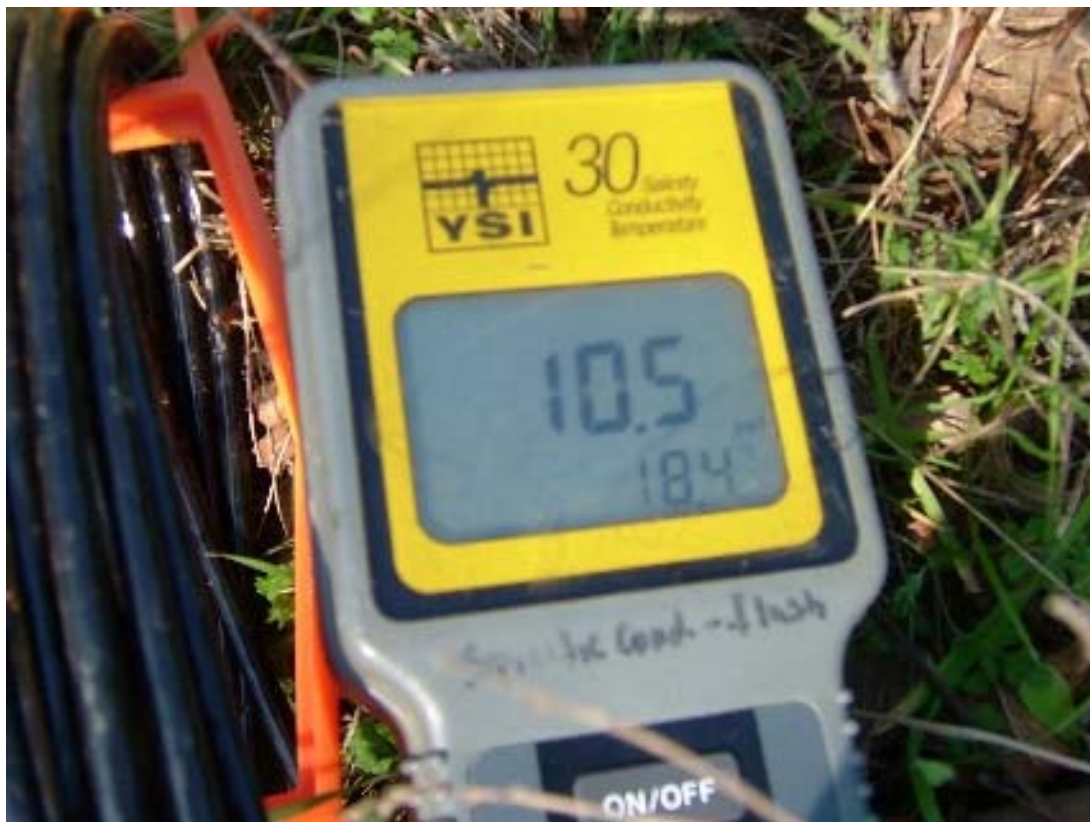
Photo No. 15

Description: Total Soluble Salts obtained a reading of 10,500 ppm TSS. This point is approximately 150 feet south of the Lutex Oil Ltd. Cora Malone Lease, Well#3 RRC#02936

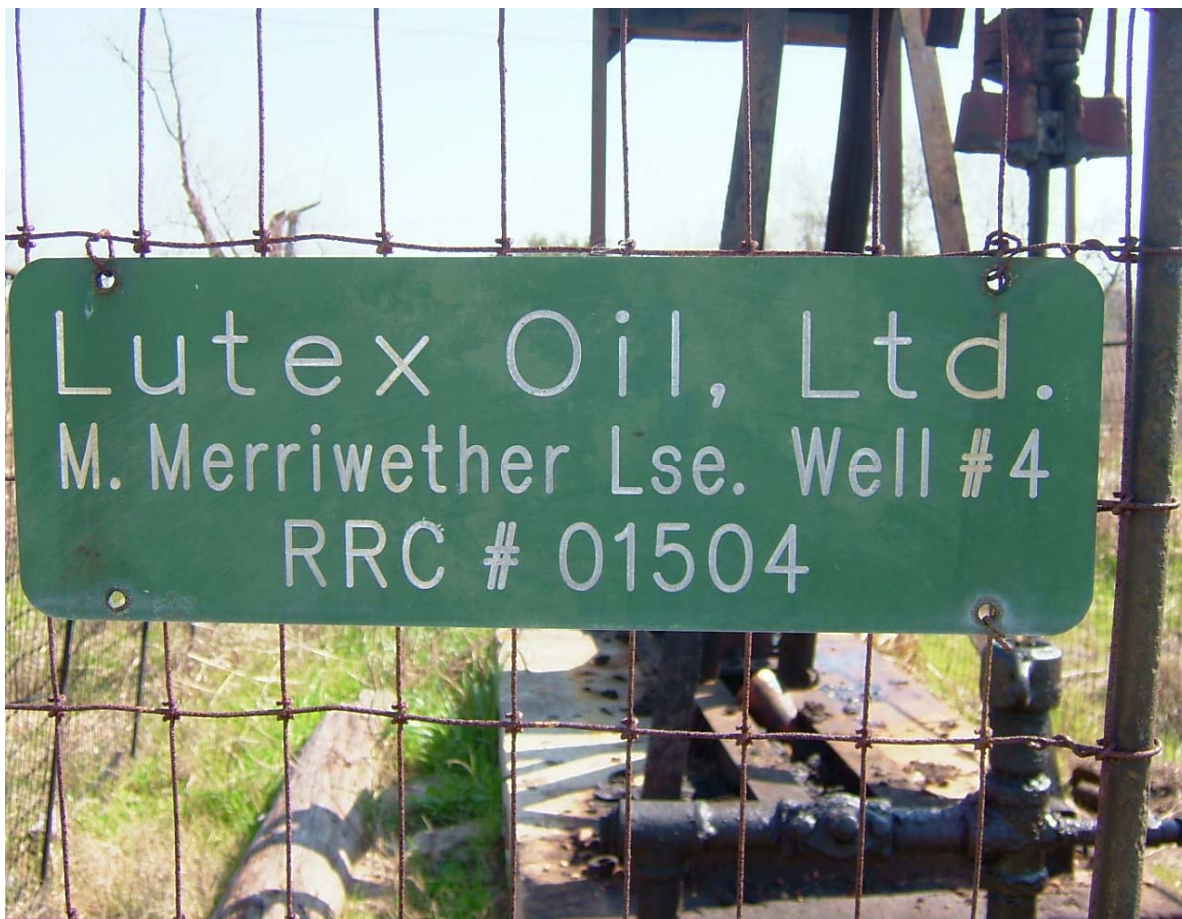
Photo No. 16

Description: Overview of the Lutex Oil Ltd. M. Merriwether Lease, Well#4 RRC#01504. This well is approximately 108 feet North from Salt Branch Creek.

When we arrived at this facility on February 12, 2015, I noticed that some battery tanks were surrounded with vegetation and the containing walls around the tanks were small and improperly constructed. We drove around the facility area and observed flow paths of fluids, flow lines on the ground, PVC and polypipe lines going into the pond and creek (photos 2, 6, 9, 11, 13, 17). We found that the Salt Branch creek flows through the facility (Photo 1 and 2). At Latitude: 29.687265N and Longitude: -97.639825W, we observed a rusted flow line going into Salt Branch Creek (photo 2). We measured the Total Dissolve Salt (TSS) and obtained a reading of 3,500 ppm TSS (photo 2). We did not observed aquatic life, and found dead vegetation and foam formations. Next to the road, there was an illegal dumping notice located 5 feet from Salt Branch Creek (photo 4 ). At Latitude: 29.687572N and Longitude: -97.641376W in Salt Branch Creek, we found a polypipe line going into the creek and observed foam formations floating on the water (photos 5 and 6). The Total Dissolve Salt (TSS) was 4,100 ppm. We did not observed aquatic life (photo 6). The polypipe is located approximately 70 feet from Cora Malone Lease, Well#12 RRC#02936 (photo 8). At Latitude: 29.687460N and Longitude:-97.642541W, we found a PVC pipe going into Salt Branch Creek (photos 11 and 13). We measured the Total Soluble Salts (TSS) and obtained a lecture of 9,000 ppm TSS (photo 12). This PVC Pipe is located approximately 114 feet south from the Lutex Oil Ltd. Cora Malone Lease, Well#3 RRC#02936 (photo 10). At Latitude: 29.687296N and Longitude: -97.643079W, we found foam formations and oil residues floating on Salt Branch Creek (photo 14). We measured the Total Soluble Salts and obtained a lecture of 10,500 ppm TSS (photo 15). This point is approximately 150 feet south of the Lutex Oil Ltd. Cora Malone Lease, Well#3 RRC#02936. At Latitude: 29.687336N and Longitude: -97.643366W, there was an indication of a pipeline placed in Salt Branch creek (photos 17 and 19). The pipe showed alternated holes that may allow discharge of produced water into the creek (photo 19). We measured the Total Soluble Salts and obtained a lecture of 11,200 ppm TSS (photo 18). This point is approximately 221 feet southeast of the Lutex Oil Ltd. M. Merriwether Lease, Well#4 RRC#01504 (photo

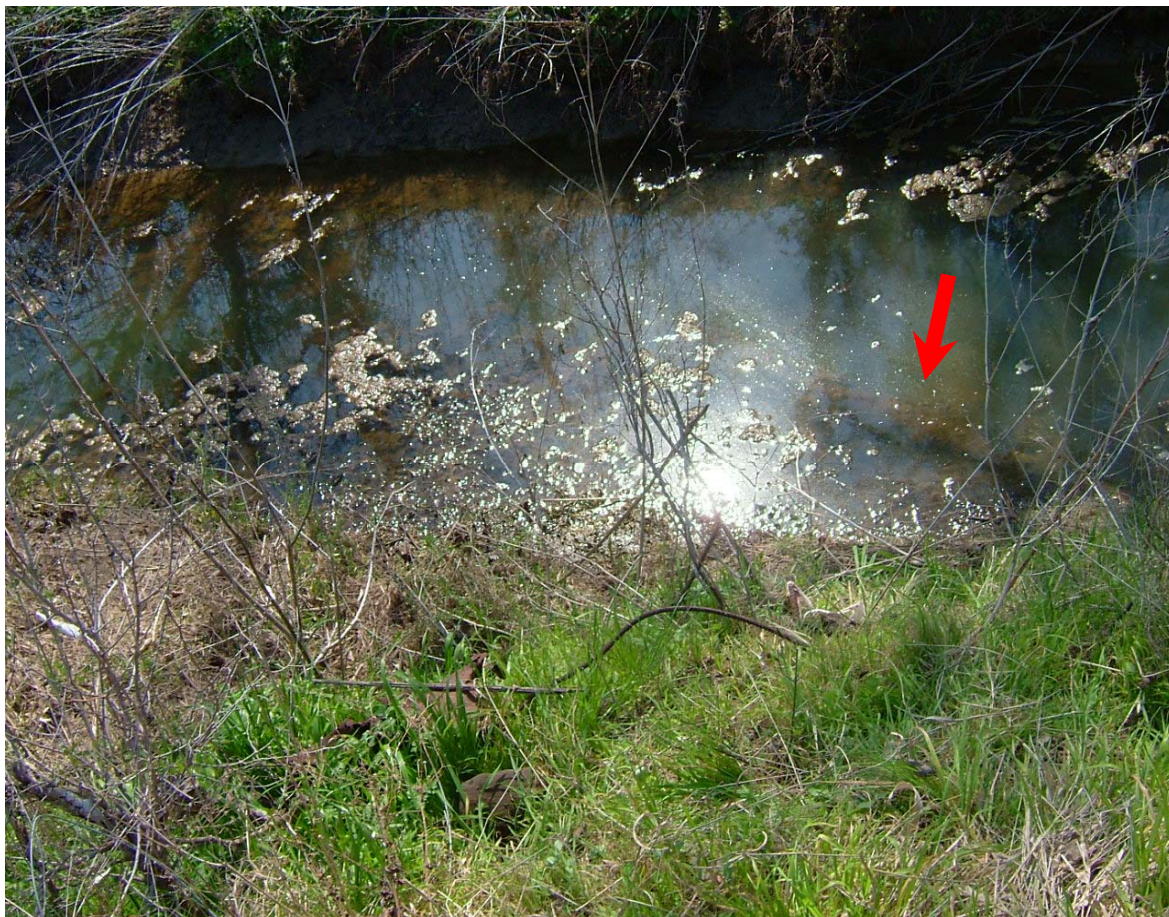
Photo No. 17

Description: I observed a perforated pipe line placed under water in Salt Branch creek. (See photo 19) Pipe showed alternated holes that may allow discharge of produced water into the creek. We were unable to determine what the pipe was connected to. We determined and measured the Total Soluble Salts of 11,200 ppm TSS at this location. This location is approximately 221 feet southeast of the Lutex Oil Ltd. M. Merriwether Lease, Well#4 RRC#01504. This location is also where we observed the highest TSS reading in Salt Branch Creek.

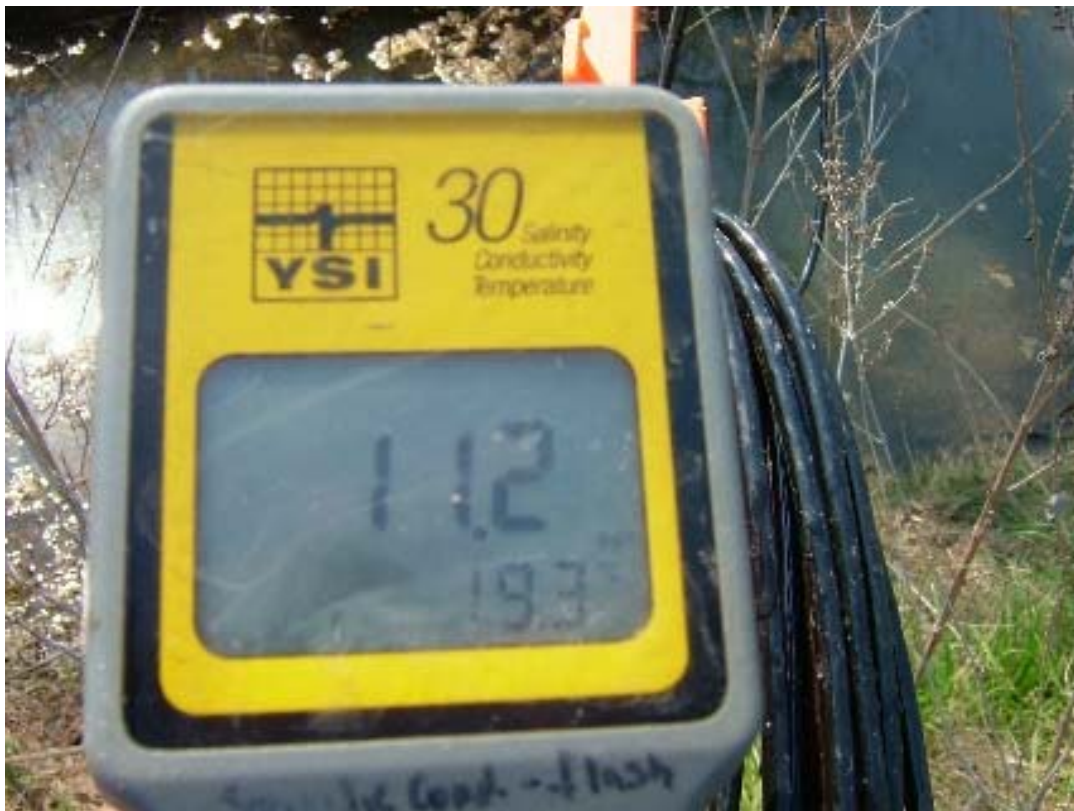
Photo No. 18

Description: Total Soluble Salts was 11,200 ppm TSS. This location is approximately 221 feet southeast of the Lutex Oil Ltd. M. Merriwether Lease, Well#4 RRC#01504. This location is also where we observed the highest TSS reading in Salt Branch Creek.

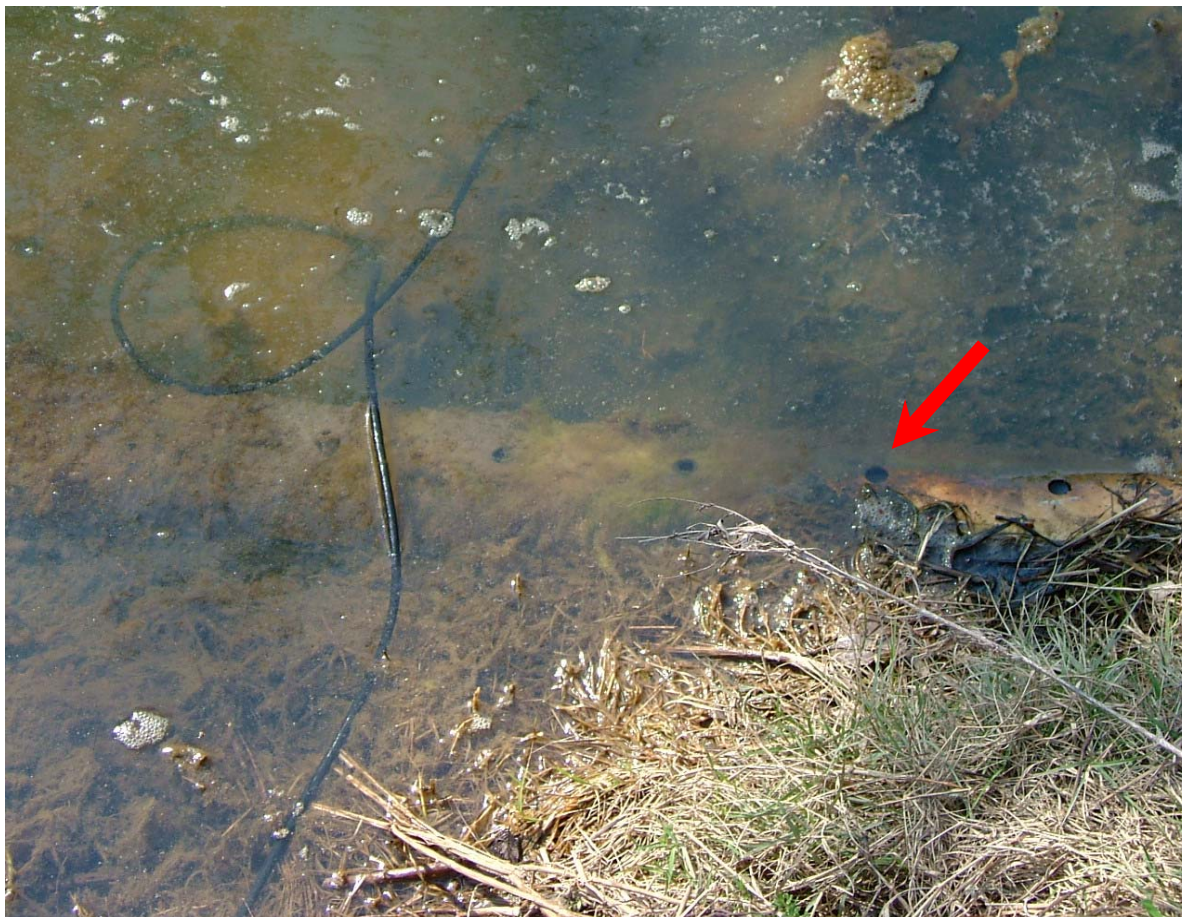
Photo No. 19

Description: Closeup of the perforated pipe from Photo 17. Most of the pipe was submerged under water.

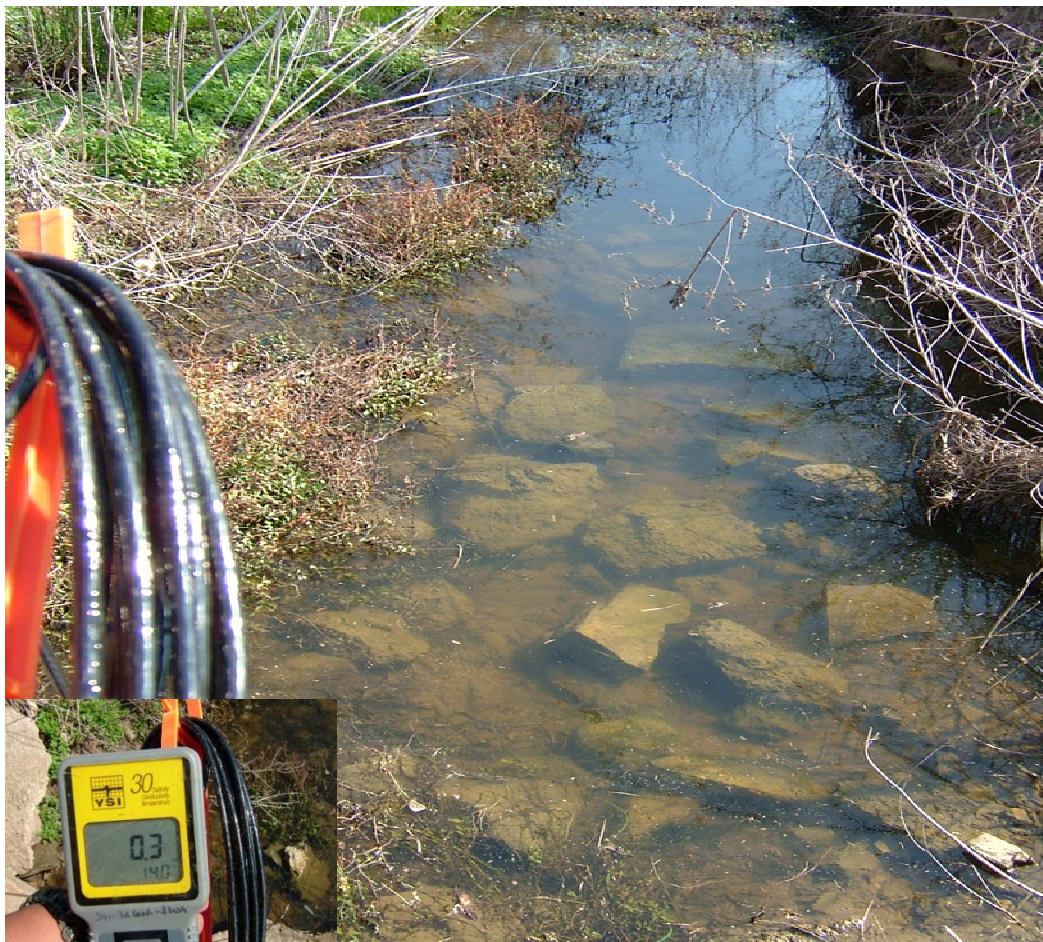
Photo No. 21

Description: This photo is of Salt Branch Creek approximately 1,645 feet (a third of a mile) upstream of where we observed the highest salinity concentration of 11,200 ppm TSS. At this location we determined the salinity (Total Soluble Salts) of Salt Branch to be 300 ppm TSS.

16). We collected background data. We went upstream 1,900 feet of Salt Branch Creek and measured Total Soluble Salts and obtained a lecture of 300 ppm TSS (photo 21). It was an indication of fresh water. We chose another point 547 feet north from salt branch creek and measured the Total Soluble Salts and obtained a lecture of 200 ppm TSS (photo 20).
