**Region 6 Compliance Assurance and Enforcement Division  
INSPECTION REPORT**

| Inspection Date(s): | 02/12/2015 | | |
| Company Name: | <b>Lutex Oil, Ltd</b> | | |
| | Subject: | Inspection Report Clean Water Act (CWA) Brine Discharge | |

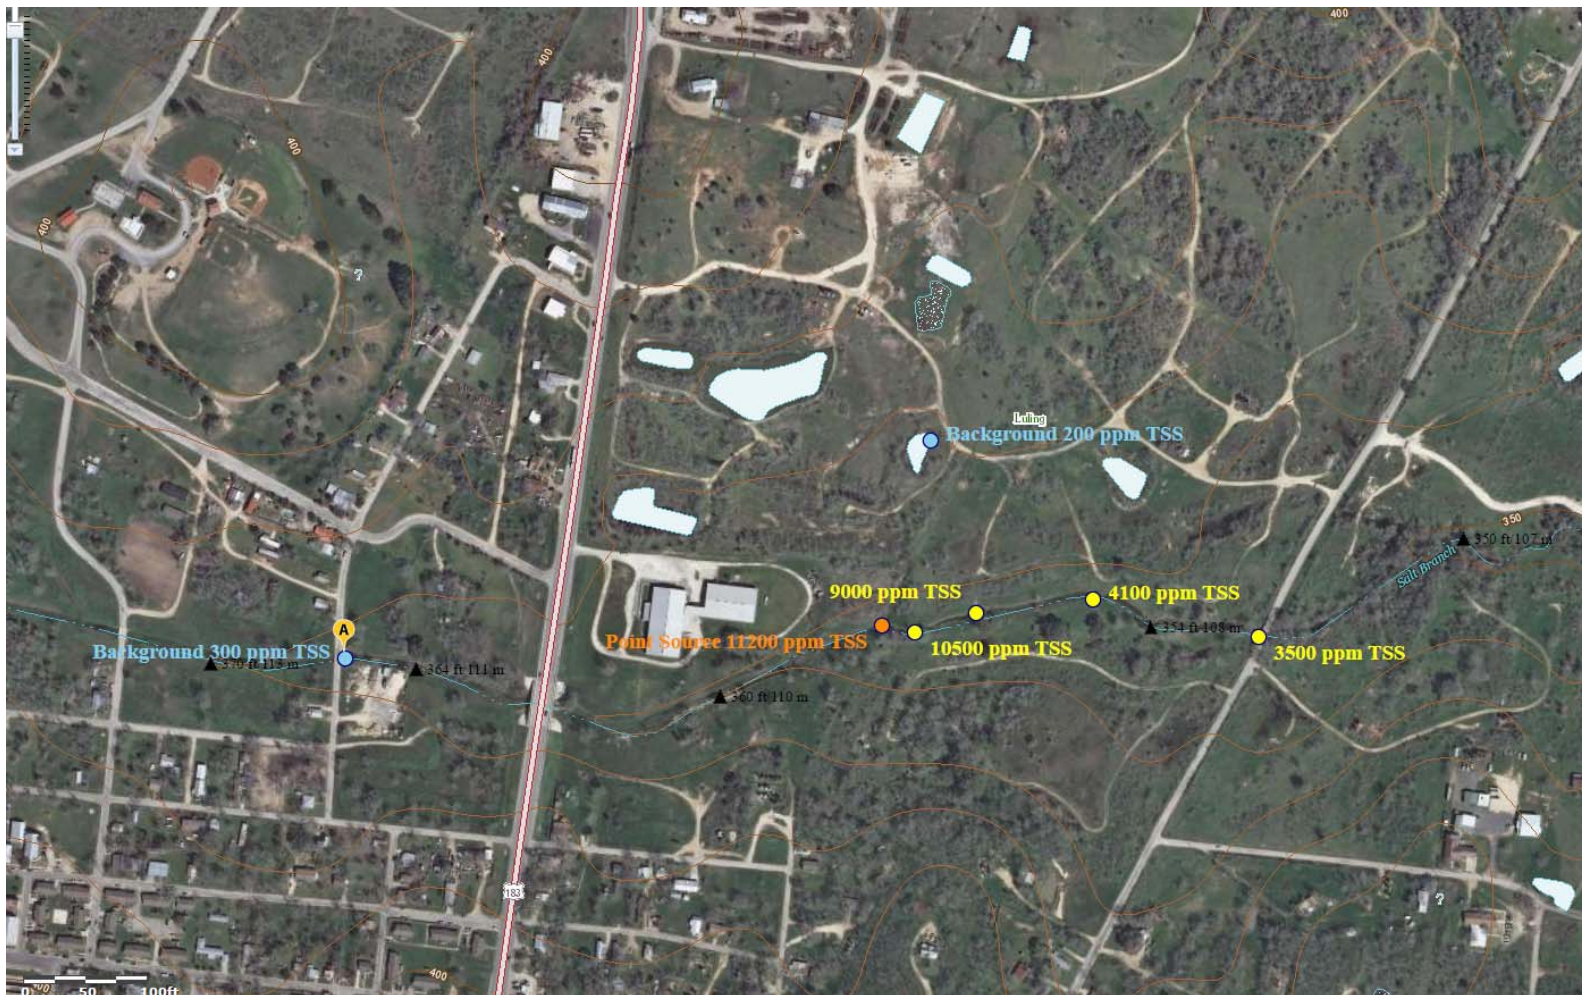
Photo No. 1

USGS Aerial map showing tributary of Salt branch. Blue line is an indication of relative permanence. Point Source elevation 358 ft. Elevation is between 350 and 370 ft. Background is between 200 and 300 ppm. Elevations demonstrated downstream flow of produced water (brine fluids) towards Salt Branch.
