### INSPECTION REPORT

| Company Name: | <b>U.S. Department of The Air Force</b> | |
| Facility Name: | <b>Joint Base San Antonio (JBSA) Fort Sam Houston</b> | |
| Identification/Permit Number(s): | TXR040409 and TXR05DB57 | |

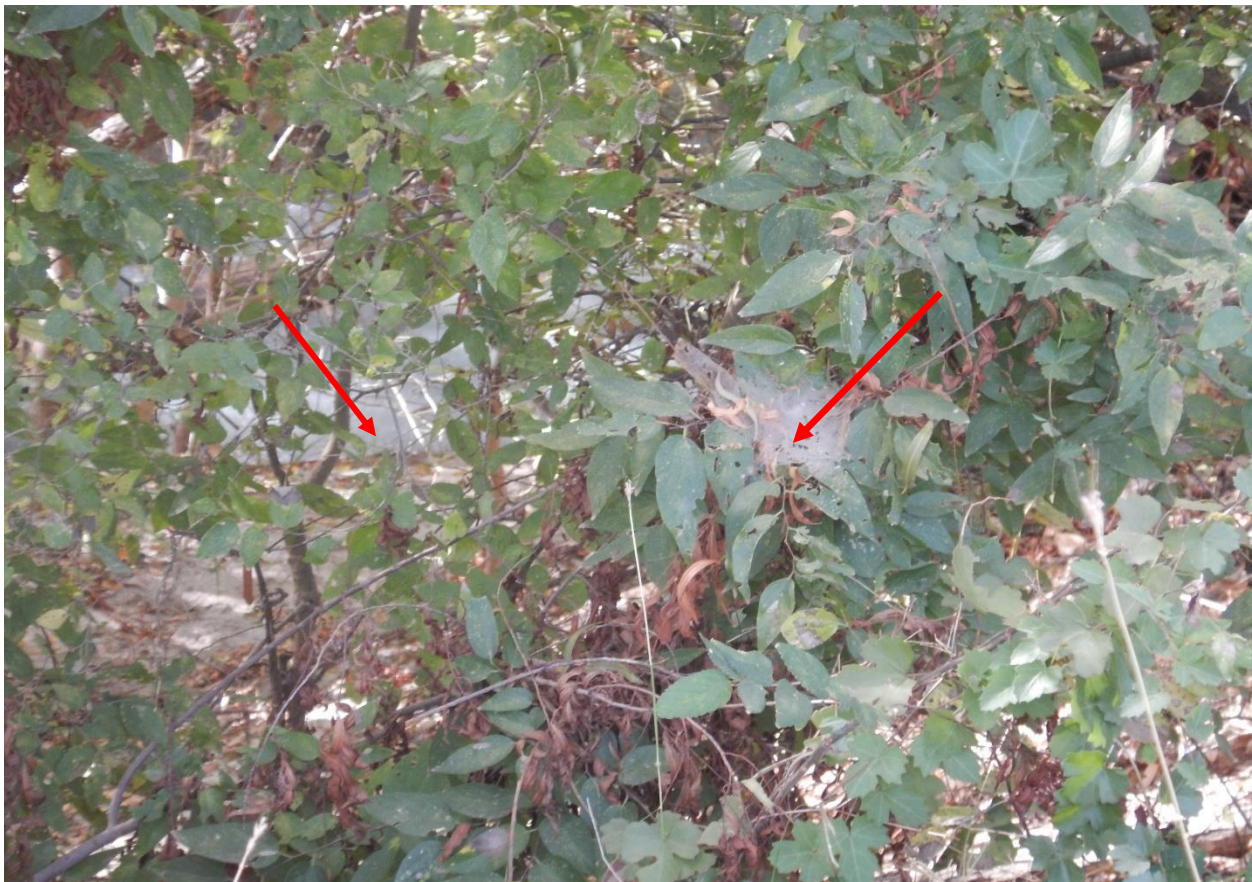
Photo No. 1

- i. During the on-site evaluation, the EPA Inspector identified a Sanitary Sewer Overflow (SSO) into the MS4 conveyance (see Appendix 1, Photograph # 1). Verbal requests from EPA on October 23<sup>rd</sup> and October 25<sup>th</sup>, and via email on October 30<sup>th</sup> and November 12<sup>th</sup> for additional details regarding the event (including a copy of the SSO notification(s) provided to the TCEQ, a copy of JBSA's incident investigation regarding this matter and any additional information associated with the incident) have gone unaddressed. As of the date of this inspection report, the request(s) remain outstanding.

Description: View, of MS4 conveyance located in wooded area with noted turbid (grayish) water from unknown sanitary sewer overflow (SSO). In addition, the area contained a pungent odor indicative of raw sewerage.

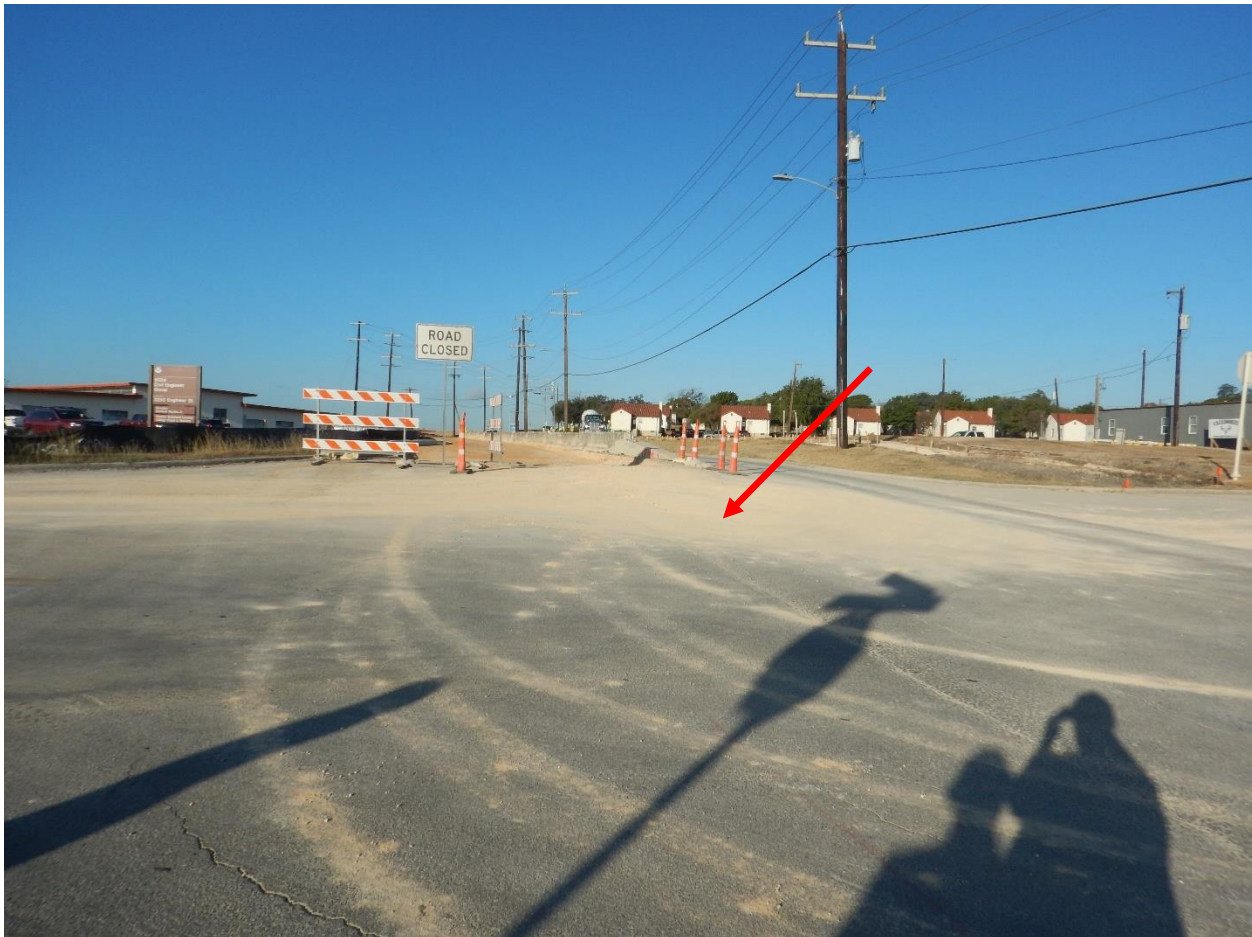
Photo No. 2

1. Application information such as NOIs, construction site notices, inspection records, *etc.*, as per Section 1.5.4 of the JBSA Environmental Specification document are not consistently provided to installation by contractors, prior to construction projects commencing;
2. A certified copy of the SWPPP is not being provided to members of the Installation Water Quality Program (environmental), as per the Section 1.6.f of the JBSA Environmental Specification document, prior to construction projects commencing; and
3. Contractors (specific projects) do not have BMPs in place and/or the measures in place are deficient (see Appendix 1, Photographs #2-7 for the Wilson Way Construction Project).

Description: View, of Wilson Way Construction Project area, with sediment carry over observed in the in the access street (red arrow).

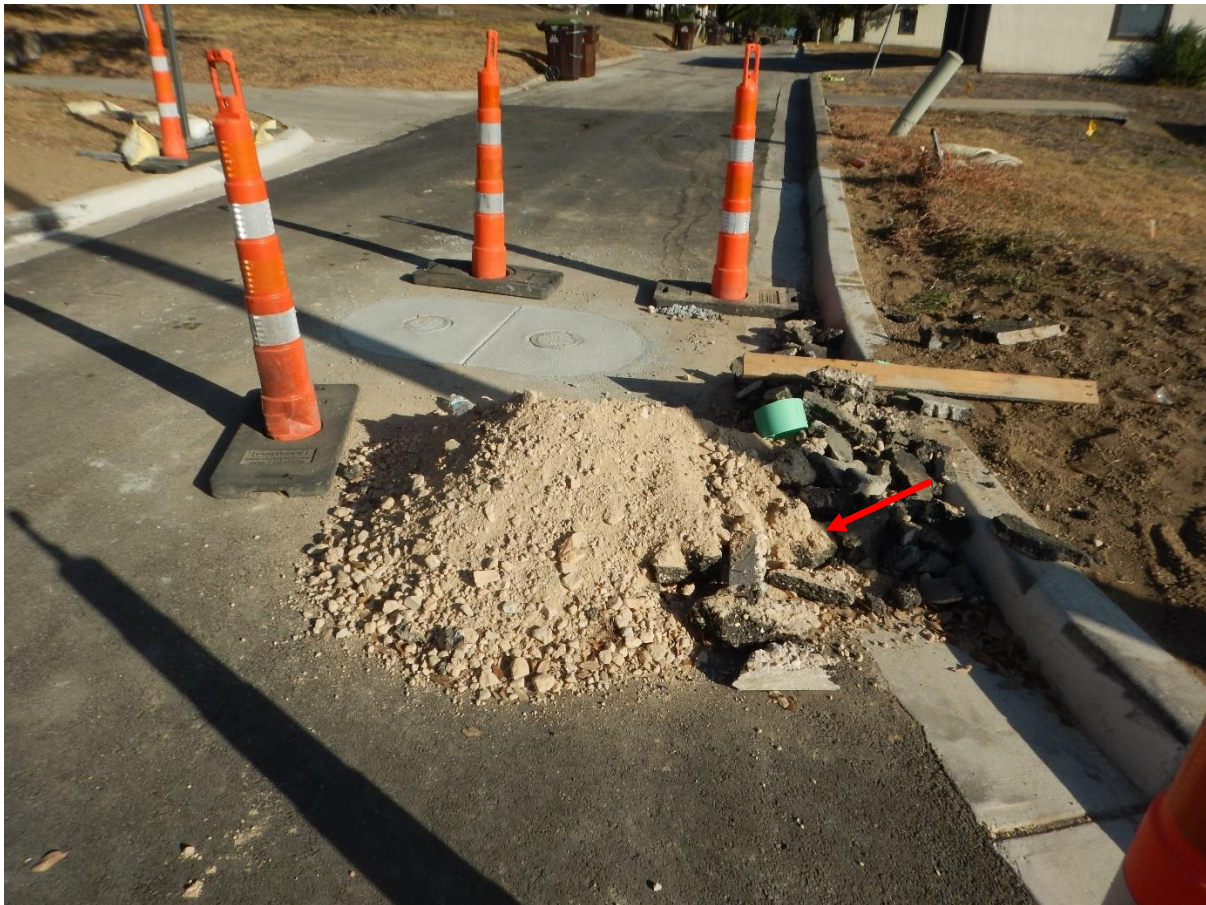
Photo No. 3

Description: View, of Wilson Way Construction Project area, with sediment carry over observed in the in the access street (red arrow) and poor housekeeping.

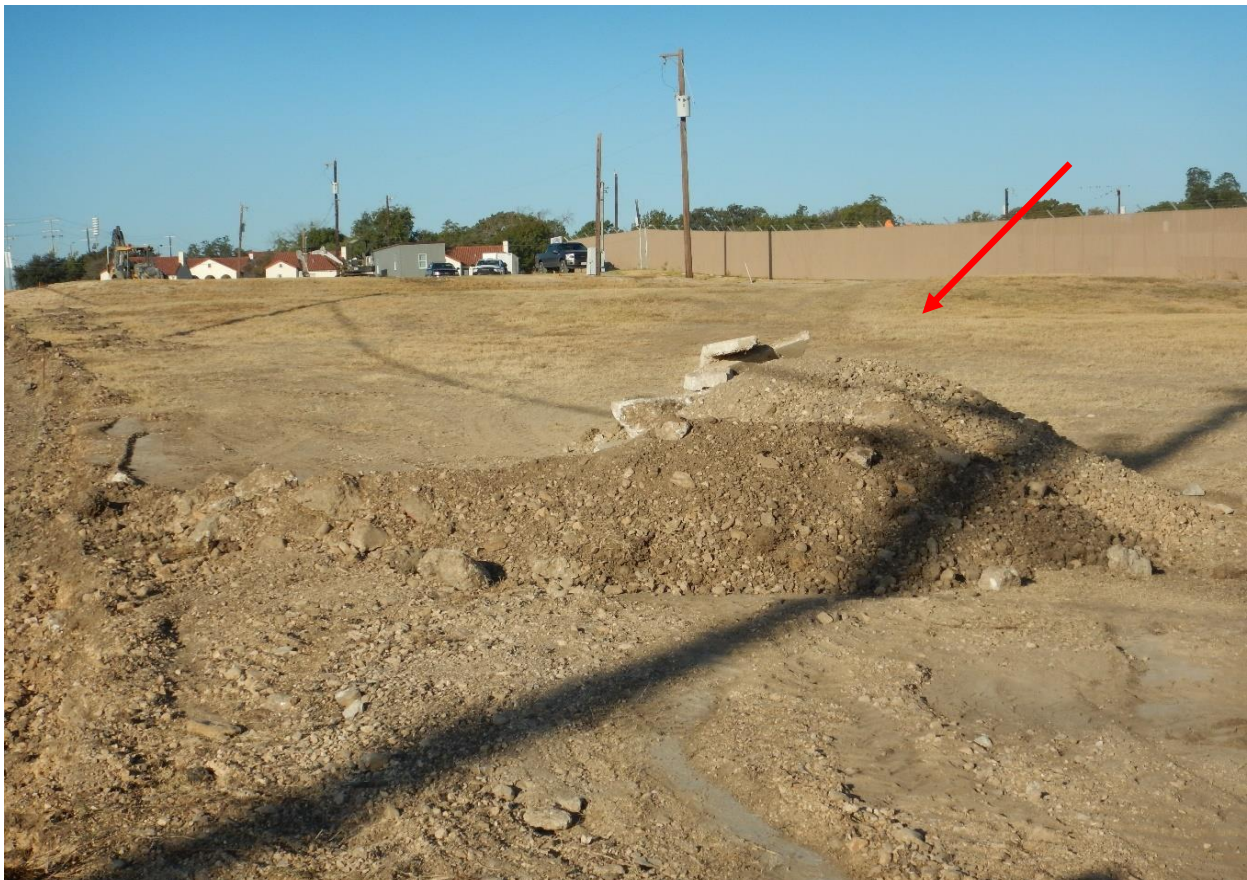
Photo No. 4

Description: View, of Wilson Way Construction Project area, with ineffective BMPs indicated by red arrow (i.e., no silt fencing around accumulated sediment and stored concrete/construction debris).

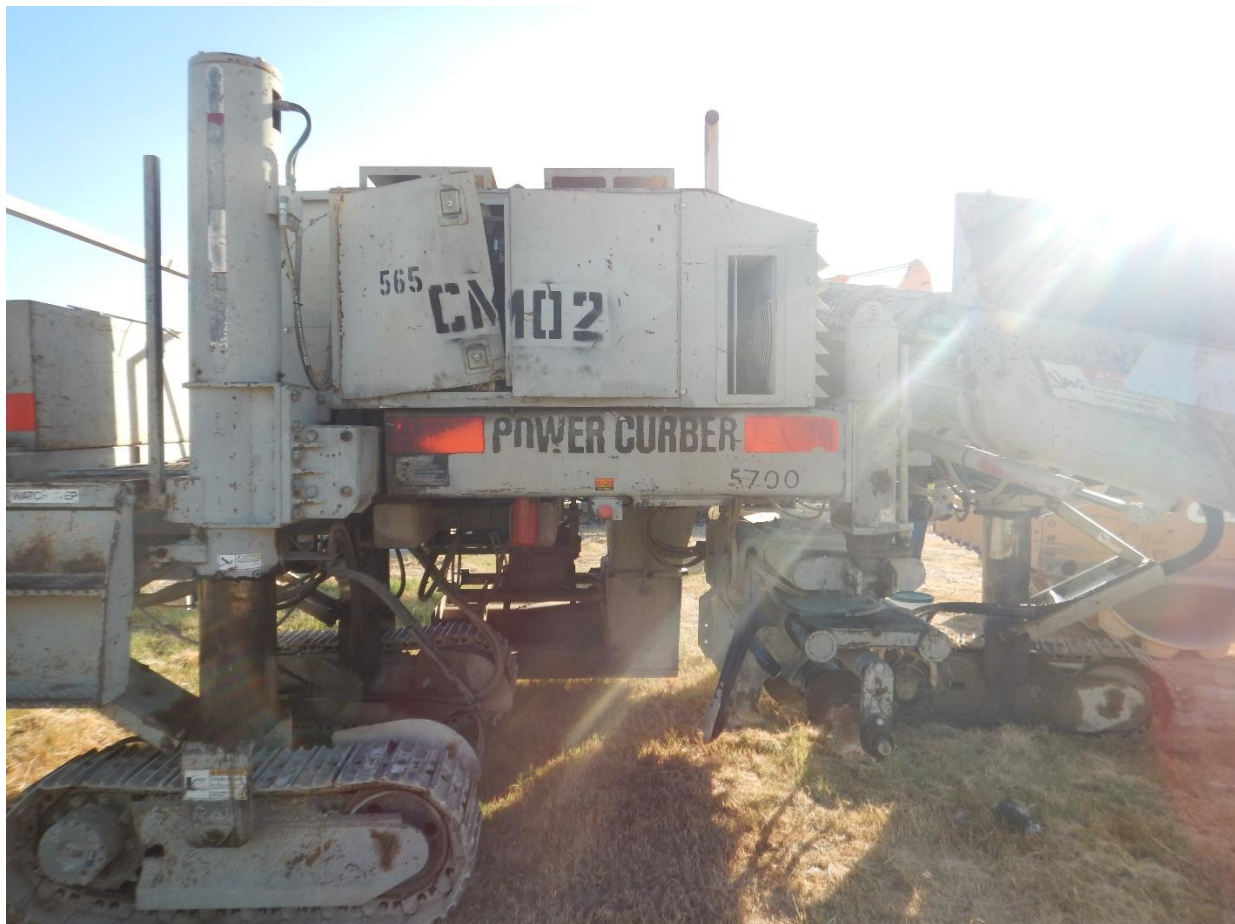
Photo No. 5

Description: View, of heavy equipment stored in laydown area associated with the Wilson Way Construction Project (closer view of leaking equipment noted in following photographs).

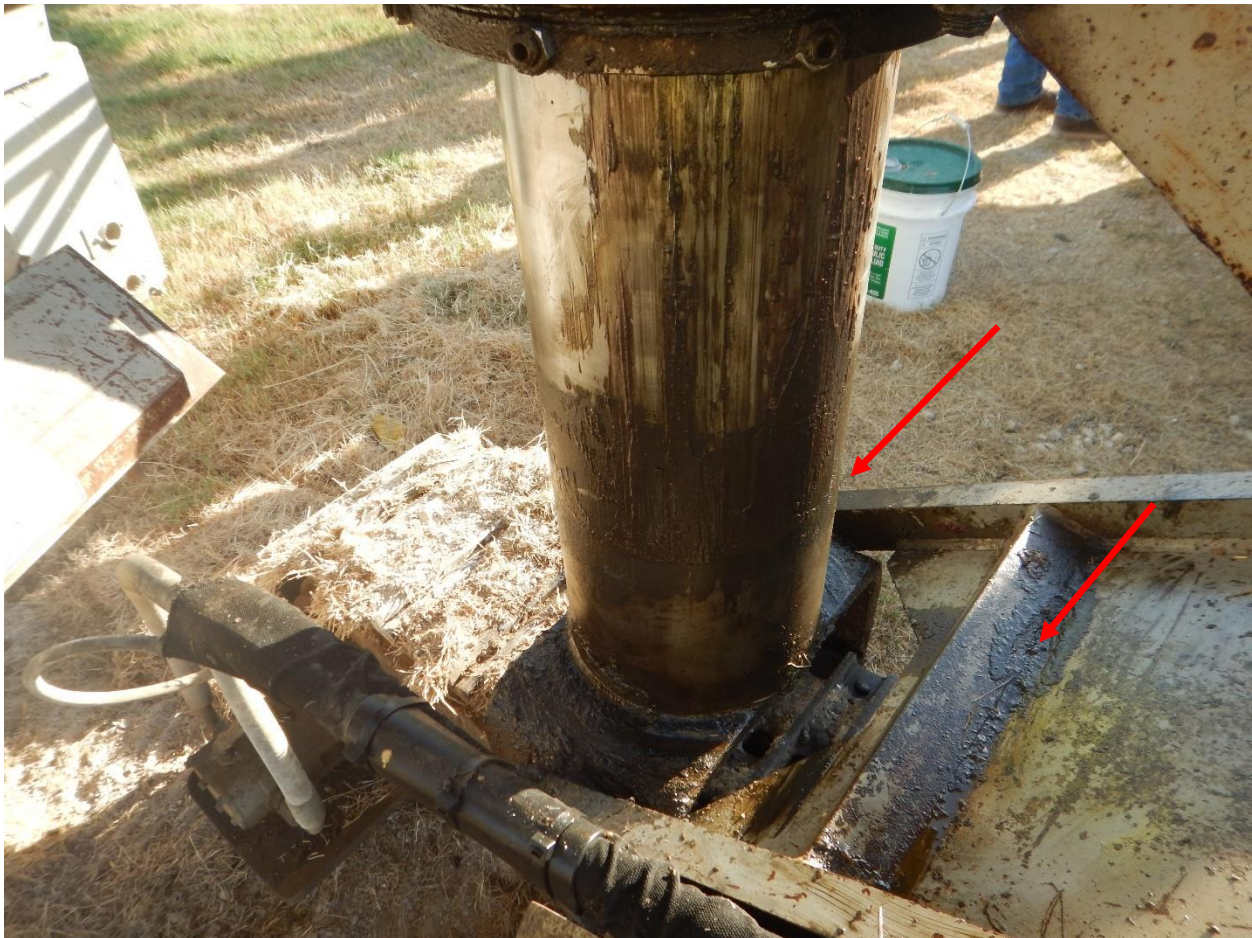
Photo No. 6

Description: Closer view, of heavy equipment stored in laydown area associated with the Wilson Way Construction Project, with leaking and/or oil-stained equipment.
