**Region 6 - Enforcement & Compliance Assurance Division**  
**INSPECTION REPORT**

| Company Name: | <b>Neilco (4063) 3G Energy</b> | |
| Facility Name: | <b>Frost F3 Tank Battery</b> | |

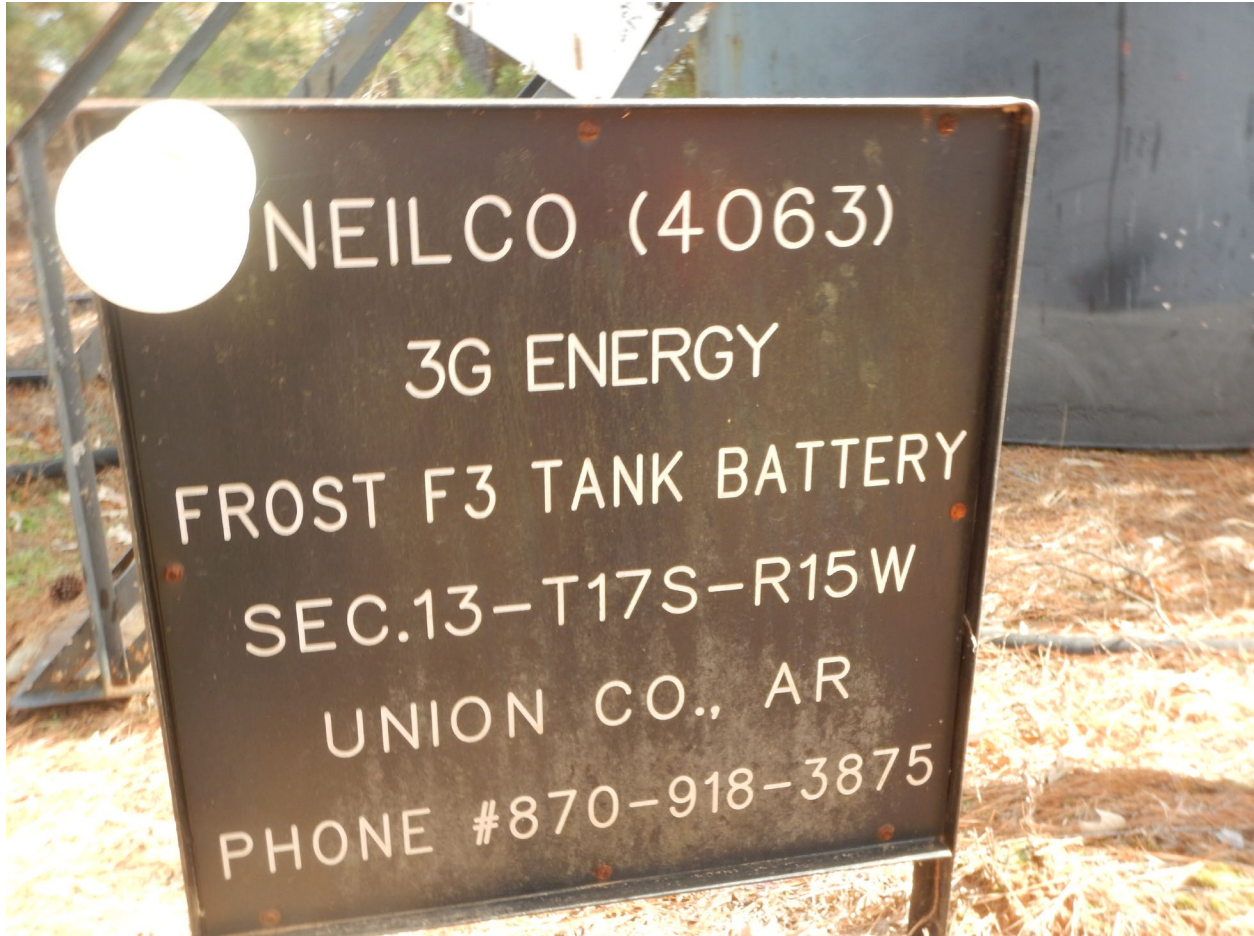
Photo No. 1

**Description:** This photo was taken looking E at the facility showing the facility sign.

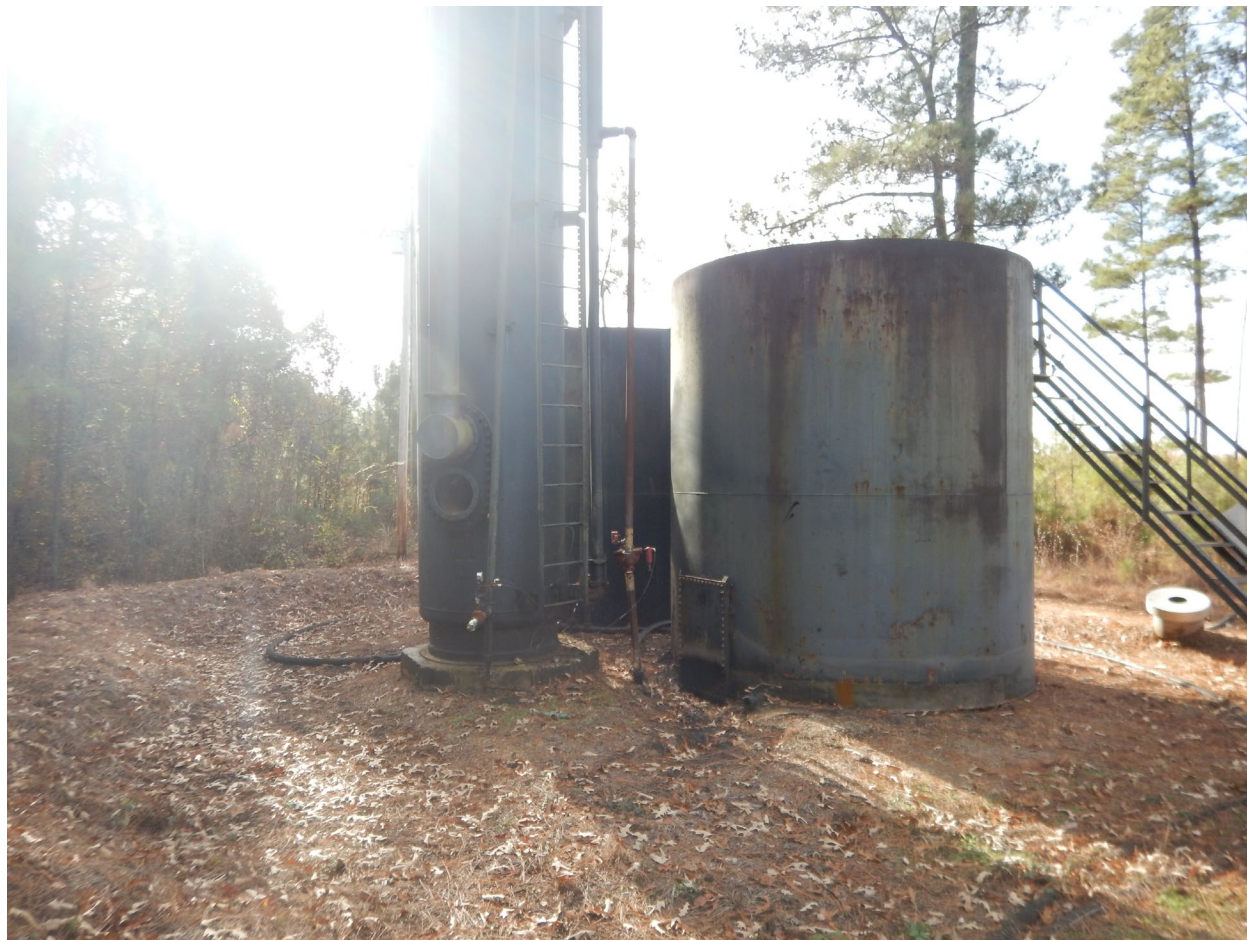
Photo No. 2

I observed no cap on the oil tank valve, see photo No. 2.

**Description:** This photo was taken looking W at the facility showing overall facility overview.

No closing conference was held due to no Neilco (4063) 3G Energy staff being present during the inspection. Areas of concern at the time of the inspection include: 1) secondary containment berm was low and should be built back up; 2) no cap on oil tank valve; and 3) active leaking from the heater treater.

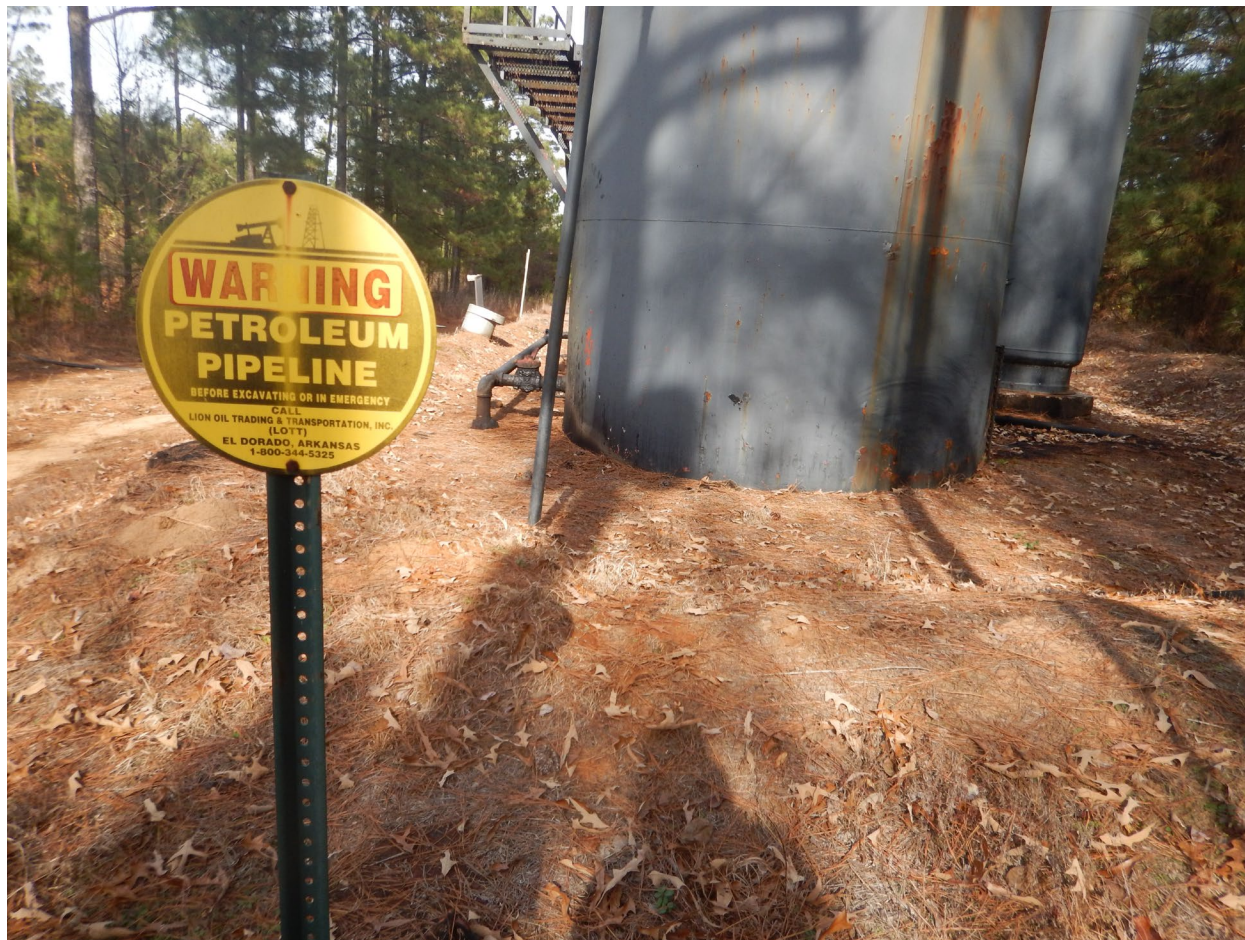
Photo No. 3

I observed a low spot in the secondary containment berm, see photo No. 3.

**Description:** This photo was taken looking N at the facility showing a low spot in the secondary containment berm.
