**Purpose:** NPDES SSO Inspection Trip Report

**Facility:** City of Cahokia Heights, Illinois

**Dates of Inspection:** July 25-26, 2022

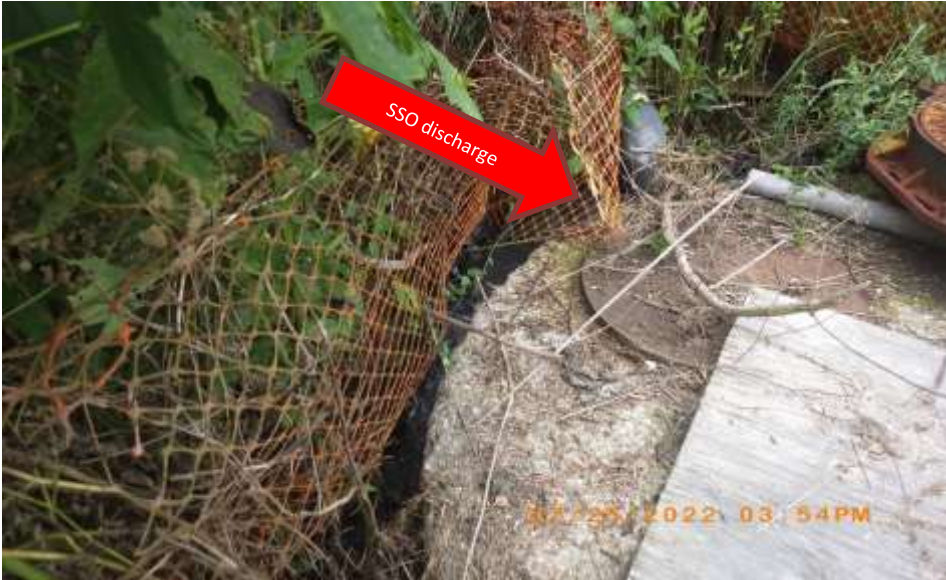
1: CCHM012

Description: The lift station was overflowing into the adjacent wetland when the pumps cycled on, approximately every 5 minutes. Red arrow denotes SSO discharge location.

<u>Location</u>	<u>Time</u>	<u>Observations</u>
Lauralee Drive, Lift Station 51, Cahokia Heights	3:54 P.M.	The lift station was overflowing into the adjacent wetland when the pumps cycled on, approximately every 5 minutes. (see Photo Log image CHHM0012). Video was also captured at this location. I informed the City sewer department of the situation.
Missouri Ave. Lift Station 57, Cahokia Heights.	4:15 P.M.	The water level in the lift station well was near the top. I did not observe a discharge. I informed the City sewer department of the situation.
Sewer cleanout location on North 82 <sup>nd</sup> Street, Cahokia Heights	4:25 P.M.	The sewer cleanout was not overflowing, and the ditch was dry.

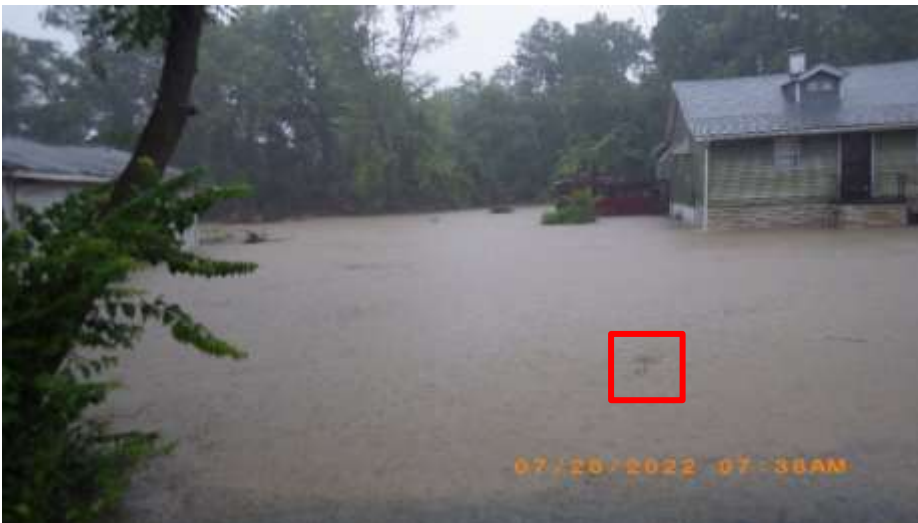
2: CHWW0027

Description: The cleanout (outlined in red) was overflowing. The ditch leading from the cleanout was inundated and yards in the area were flooded.

<u>Location</u>	<u>Time</u>	<u>Observations</u>
SSO from cleanout on North 82 <sup>nd</sup> Street, Cahokia Heights	7:38 A.M.	The cleanout was overflowing. The ditch leading from the cleanout was inundated and yards in the area were flooded. (see Photo Log image CHWW0027). Video was also captured at this location.
North 73rd Street, Cahokia Heights.	7:48 A.M.	The roadside ditches along the street were completely inundated with floodwater. Sanitary sewage was discharging from the manhole. (see Photo Log image CHWW0030). Video was also captured at this location.

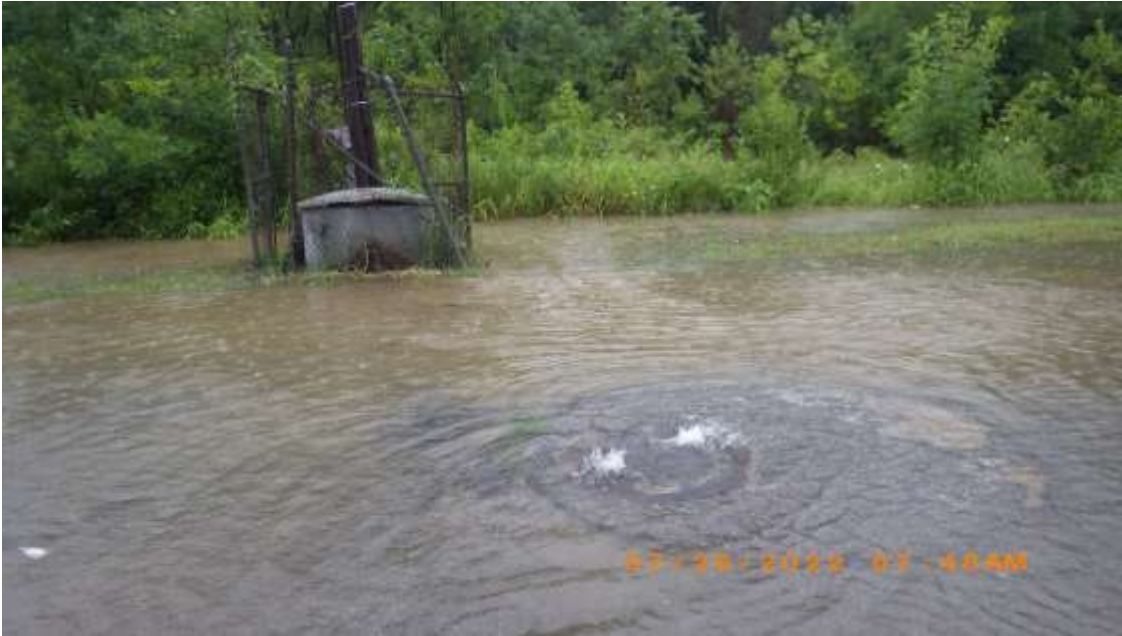
3: CHWW0030

Description: The roadside ditches along the street were inundated with floodwater, along with sanitary sewage discharging from the manhole.

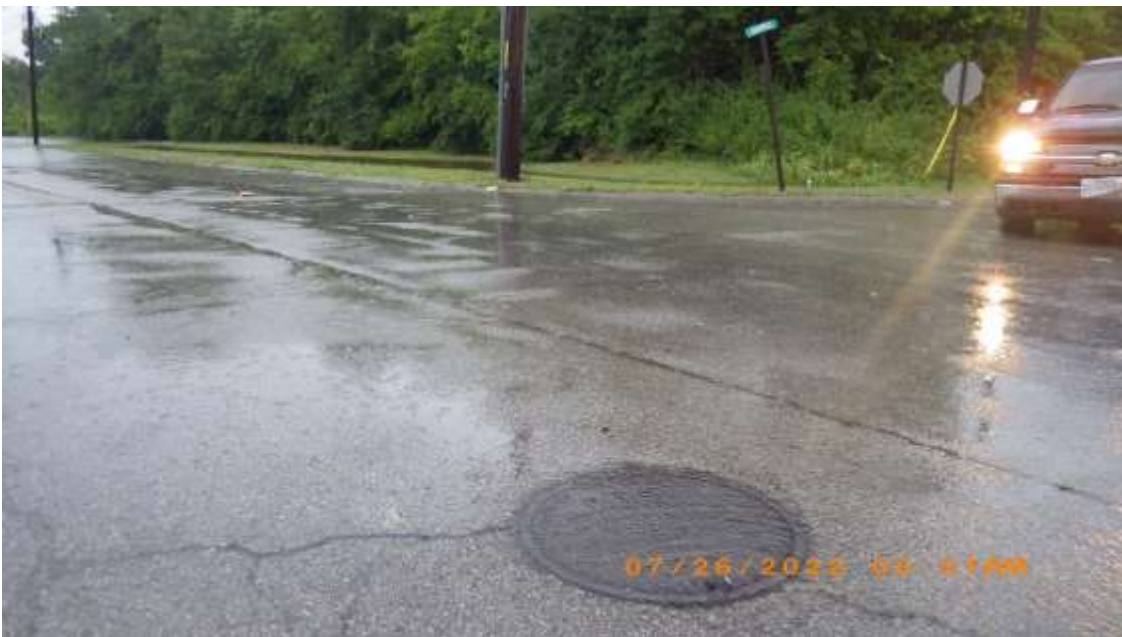
4: CHWW0034

Description: Sanitary sewage discharging from the manhole.

<u>Location</u>	<u>Time</u>	<u>Observations</u>
North 73rd Street and Dorris Street, Cahokia Heights.	8:01 A.M.	Sanitary sewage was discharging from the manhole. (see Photo Log images CHWW0034 and CHWW0037). Video was also captured at this location.
North 82nd Street & Belleview Avenue Lift Station, Cahokia Heights.	8:11 A.M.	Roadside ditches were inundated and a lift station structure on Belleview Avenue was partially submerged. (see Photo Log image CHWW0038). Video was also captured at this location.
North 61 <sup>st</sup> Street, Cahokia Heights.	8:26 A.M.	Street was flooded. (see Photo Log image CHWW0040).
Old Missouri Ave, Lady of Snows Lift Station, Cahokia Heights	8:51 A.M.	Lift station was submerged. (see Photo Log image CHWW0041). Also captured video of street runoff flowing into a sanitary sewer manhole.
Canal #1, North 80 <sup>th</sup> Street, Cahokia Heights	11:23 A.M.	Discharge to Canal #1. The stormwater discharges through a pair of culverts under N. 80th Street. The stormwater collects from roadside ditches throughout the area and includes discharge from a sanitary sewer overflow location on N. 82nd Street (see Photo Log image CHWW0047). Video was also captured at this location.

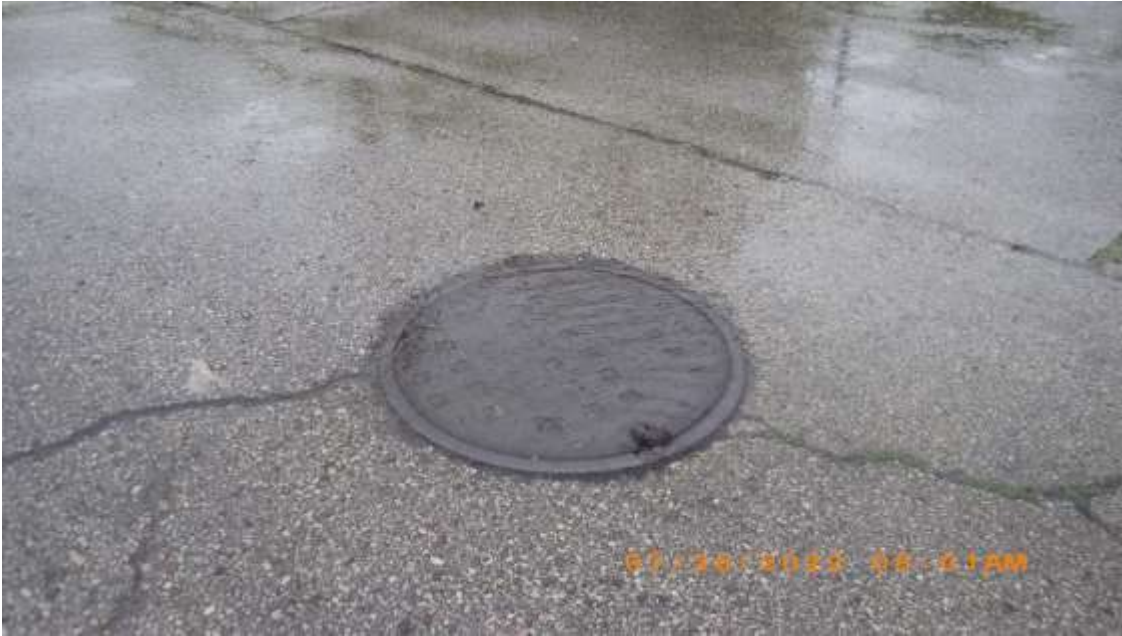
5: CHWW0037

Description: Sanitary sewage discharging from the manhole.

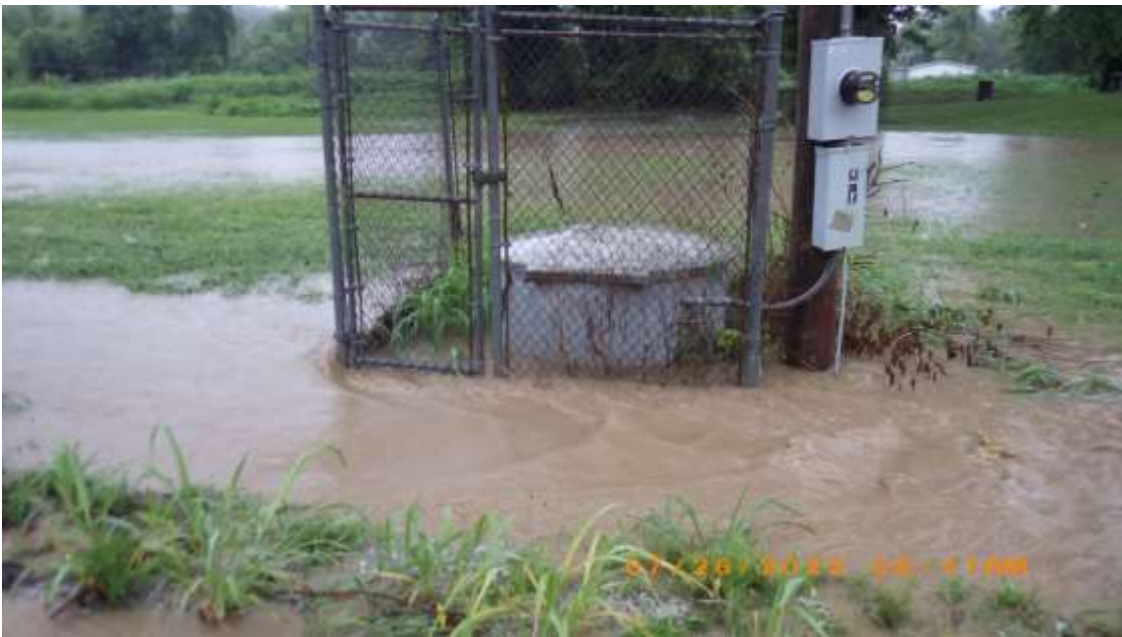
6: CHWW0038

Description: Inundated roadside ditches and a partially submerged lift station structure on Belleview Ave.

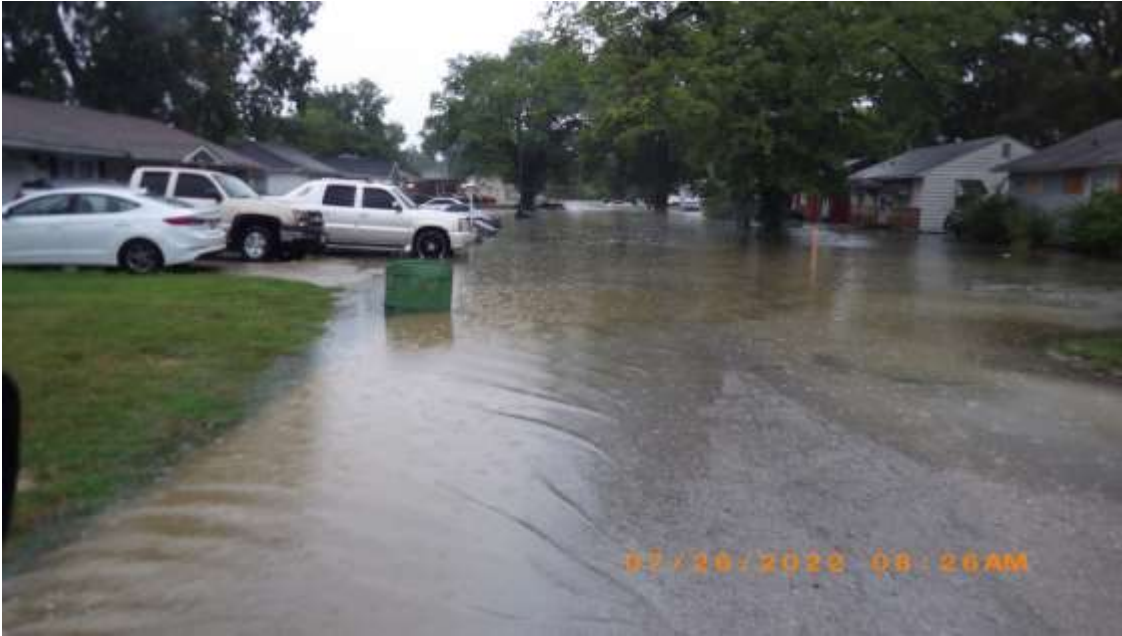
7: CHWW0040

Description: Steet flooding.

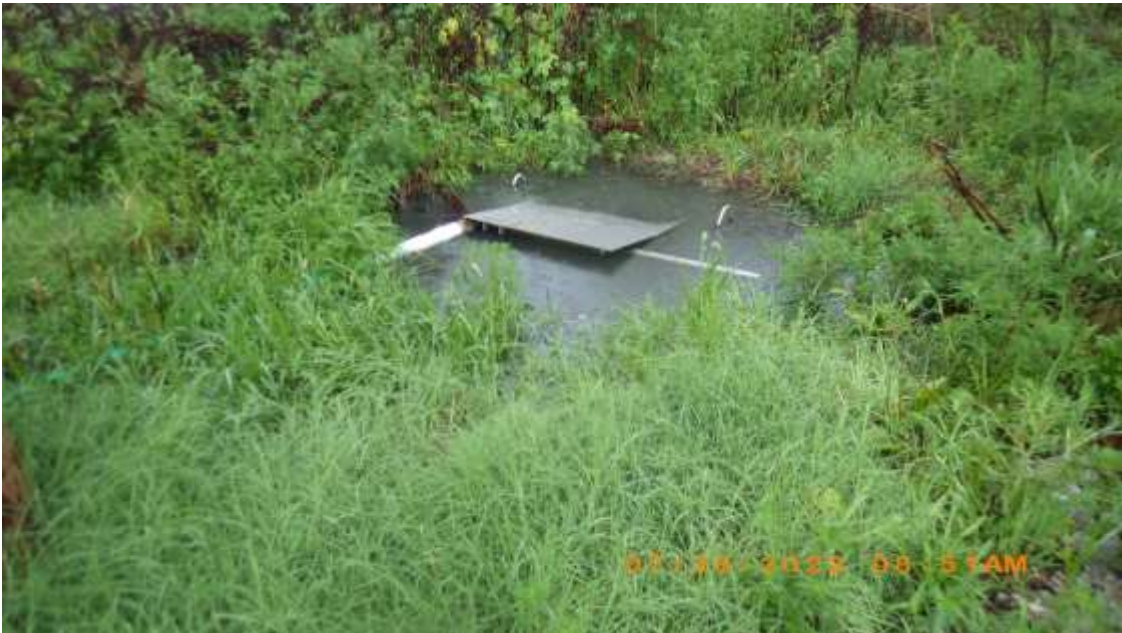
8: CHWW0041

Description: Lift station submerged.

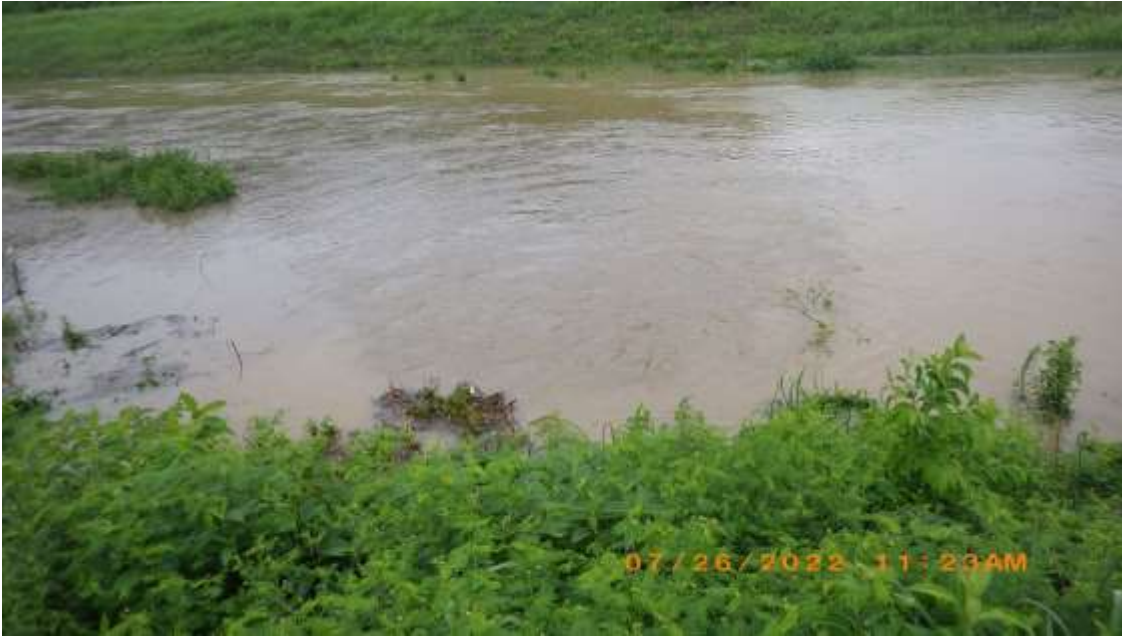
9: CHWW0047

Description: Discharge to Canal #1. The stormwater discharges through a pair of culverts under North 80<sup>th</sup> Street. The stormwater collects from roadside ditches throughout the area and includes discharge from a sanitary sewer overflow location on North 82<sup>nd</sup> Street.

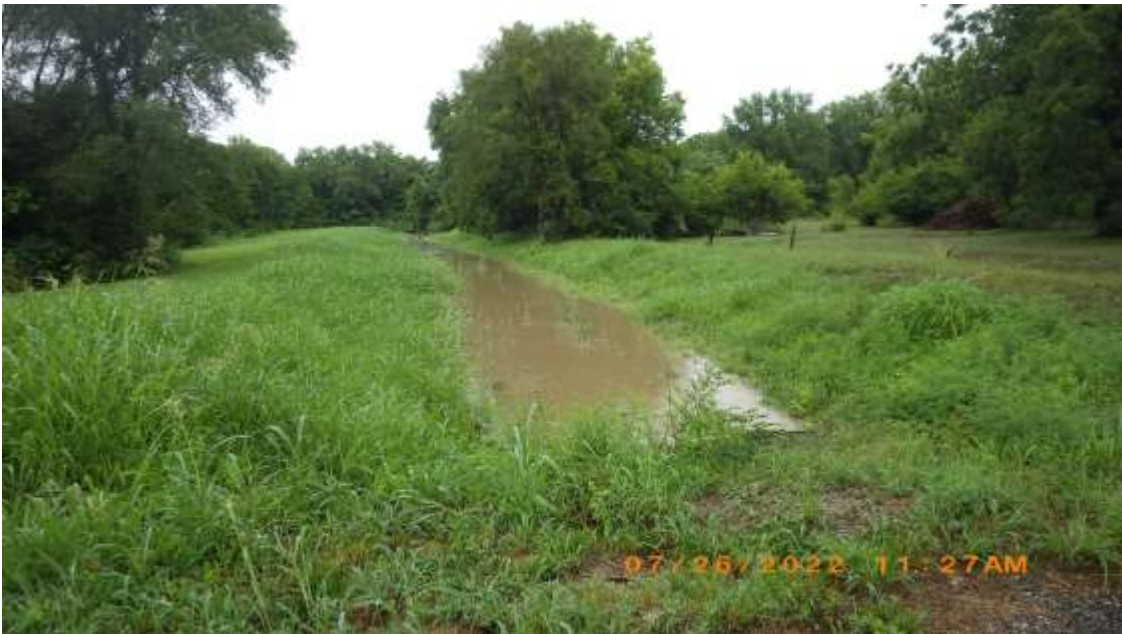
10: CHWW0049

Description: Water flowing in ditch towards Canal #1.

North 80 <sup>th</sup> Street near Belleview Avenue, Cahokia Heights	11:27 A.M.	Water was flowing in the ditch towards Canal #1. (see Photo Log image CHWW0049)
SSO from cleanout on North 82 <sup>nd</sup> Street, Cahokia Heights	11:33 A.M.	The cleanout was overflowing. The ditch leading from the cleanout was inundated and yards in the area were flooded. (see Photo Log image CHWW0053).
Lauralee Drive, Lift Station 51, Cahokia Heights	2:00 P.M.	City sewer crews were repairing the lift station when we arrived. The crew leader said a rag clogged the lift station pump, causing the dry-weather SSO on July 25, prior to the storm. I did not observe an SSO at this location on July 26.
SSO from cleanout on North 82 <sup>nd</sup> Street, Cahokia Heights	2:20 P.M.	The cleanout was overflowing. The ditch leading from the cleanout was full and flowing. Yard flooding had lessened since the 11:33 A.M. observation at this location. (see Photo Log image CHWW0055). Video was also captured at this location.

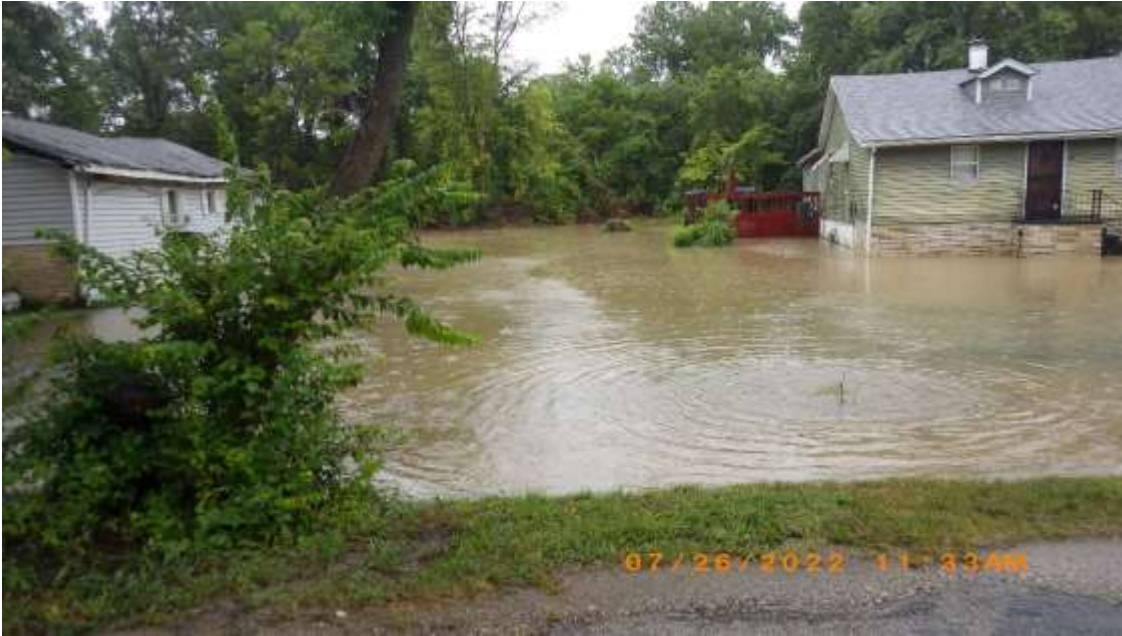
11: CHWW0053

Description: The cleanout was overflowing. The ditch leading from the cleanout was inundated and yards in the area were flooded.

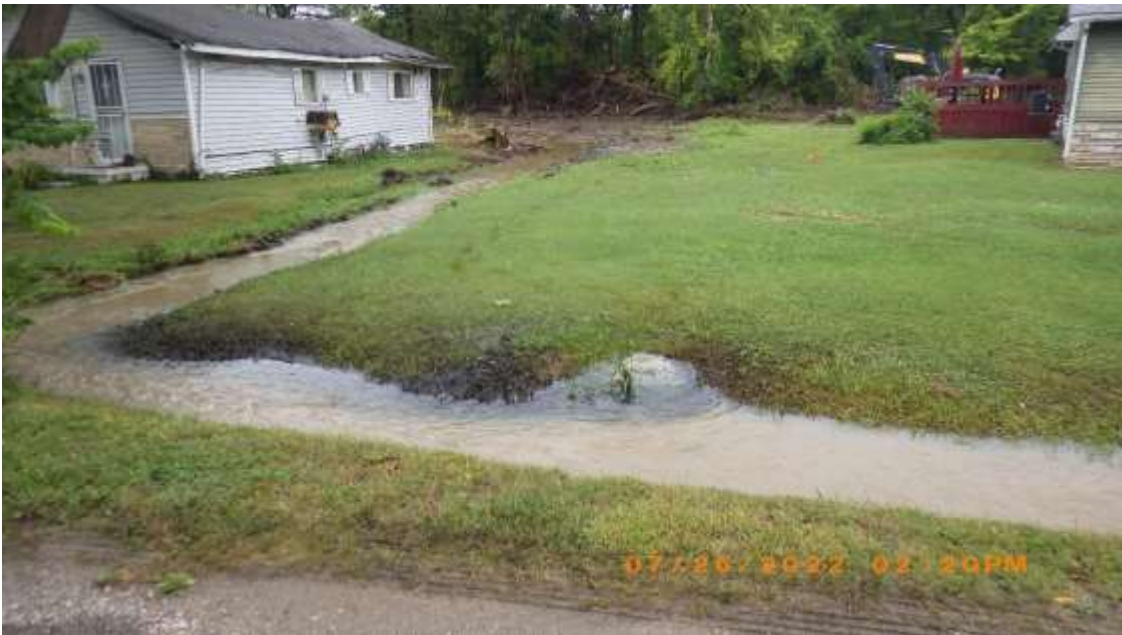
12: CHWW0055

Description: The cleanout was overflowing. The ditch leading from the cleanout was full and flowing. Yard flooding had subsided since the 11:33 A.M. observation at this location.
