## **RCRA Inspection Report**

Lighting Resources LLC  
1007 SW 16<sup>th</sup> Ln  
Ocala, FL 34471

EPA ID#: FLR000070565  
NAICS #: 562920 – Materials Recovery  
Facilities

August 8, 2023 10:22 a.m.

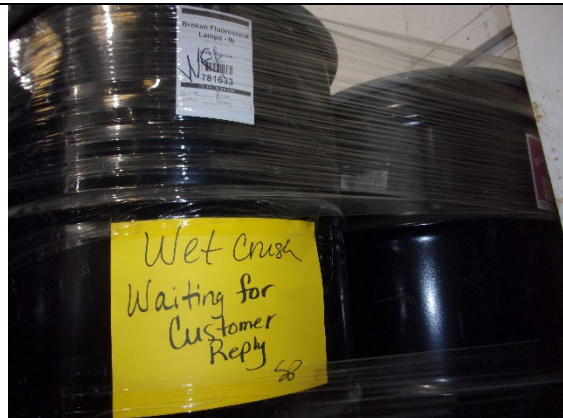
Nine (9) of the thirty-four (34) containers were rejected waste due to the contents being wet (Figure 3 and 4). Facility personnel stated it is being sent back to the respective customer client(s) for reevaluation before accepting the material again.

Figure 3: 11:25 AM Row 10  
Nine (9) of the thirty-four (34) containers in Row 10 were wet crush rejected waste.

Figure 4: 11:30 AM Row 10  
Nine (9) of the thirty-four (34) containers in Row 10 were wet crush rejected waste.

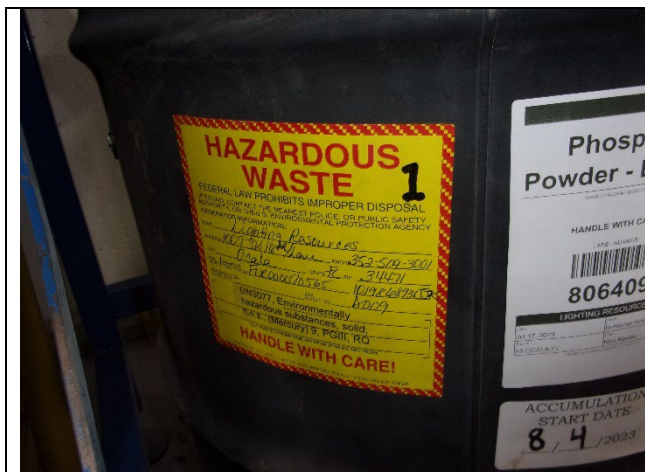
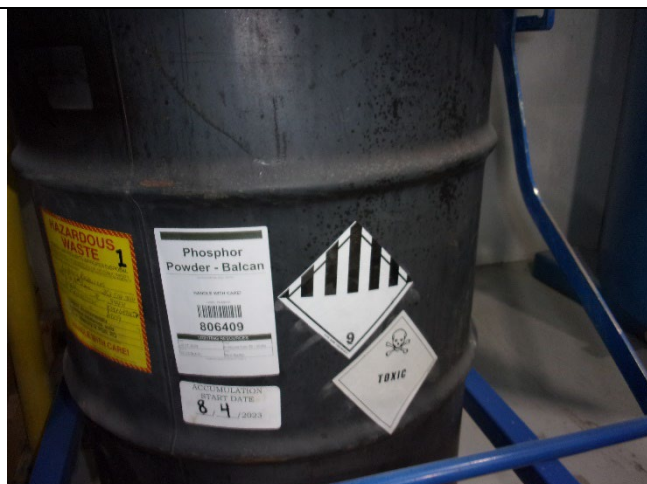
LR manages a SAA in the Balcan Room for managing hazardous waste phosphor powder that is generated by processed fluorescent lamps. The inspectors observed two (2) 55-gallon containers in this SAA. The containers were located under two (2) phosphor powder collection points for accumulating the phosphor powder, and they were equipped with a drum cover lid, which were closed. The first container was closed, dated, labeled D009 hazardous waste solid (mercury), and identified with an indication of the hazards of the contents (Figure 13 and 14). The second container observed was closed, dated, properly labeled, and identified with an indication of the hazards of the contents (Figure 15).

Figure 13: 12:47 PM Balcan Room  
One 55-gallon SAA container of phosphor powder observed.

Figure 14: 12:47 PM Balcan Room  
One 55-gallon SAA container of phosphor powder observed with hazardous waste label and indication of the hazards of the contents.

Figure 15: 12:51 PM Balcan Room  
One 55-gallon SAA container of phosphor powder observed.

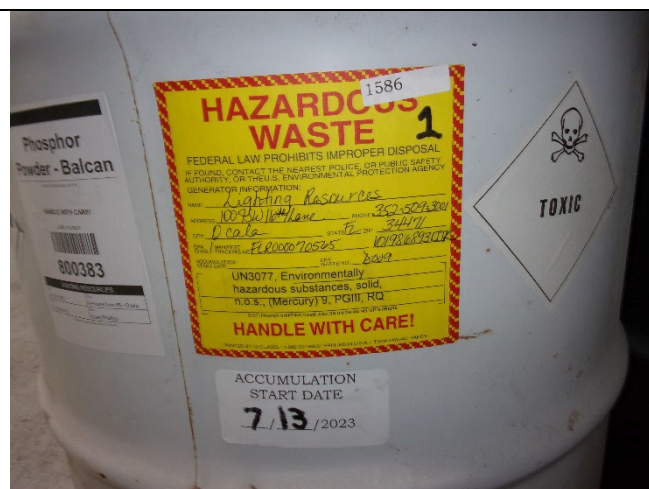
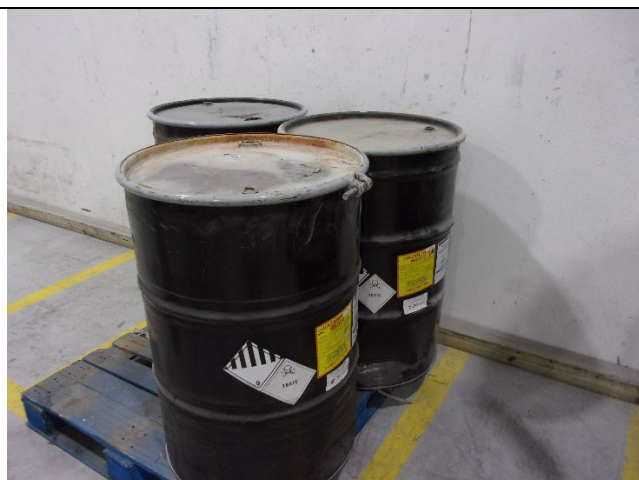
- Seven (7) 55-gallon drums of hazardous waste floor sweepings. The oldest accumulation start date was 4/5/2023;
- One 55-gallon drum of hazardous waste debris-A/C filters, spent PPE-gloves, masks, rags. The accumulation start date was 7/28/2023; and
- Eleven (11) 55-gallon drums of hazardous waste phosphor powder. The oldest accumulation start date was 7/13/2023 (Figures 16 through 19).

Figure 16: 12:57 PM Balcan Room CAA  
One of eleven (11) 55-gal containers of phosphor powder observed.

Figure 17: 12:57 PM Balcan Room CAA  
One of eleven (11) 55-gal containers of phosphor powder observed.

Figure 18: 12:58 PM Balcan Room CAA  
Two (2) of eleven (11) 55-gal containers of phosphor powder observed.

Figure 19: 12:58 PM Balcan Room CAA  
One of eleven (11) 55-gal containers of phosphor powder observed.

**Pursuant to Fla. Admin. Code Ann. r. 62-730.160(1) [40 C.F.R. § 262.17(b)], an LQG who accumulates hazardous waste for more than 90 days is an operator of a storage facility and is subject to the requirements of Fla. Admin. Code Ann. r. 62-730.180 [40 C.F.R. Parts 124, 264 through 268 and Part 270].**

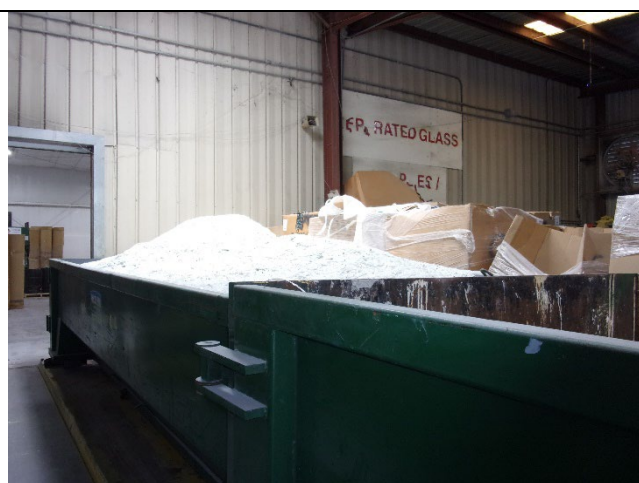
Inspectors observed glass cutlet accumulating in two (2) 20-yard roll-off containers; one was full and one was partially full (Figure 20). Sampling of glass cutlet to meet permit requirements is conducted in either the roll-off container or the tipper where the glass cutlet exits the Balcan in the Balcan Room. Inspectors asked facility personnel where exactly sampling takes place. On September 13, 2023, facility personnel stated in an email that sampling was taken at the end of two (2) process outlets from the Balcan Room.

Figure 20: 1:01 PM Warehouse C Area  
Two (2) 20-yard roll-off containers observed. One was full and one was partially full.
