**Region 6 - Enforcement & Compliance Assurance Division**  
**INSPECTION REPORT**

| Company Name: | LBOC, LLC | |
| Facility Name: | Staples-Olvey-Lion-SWD | |

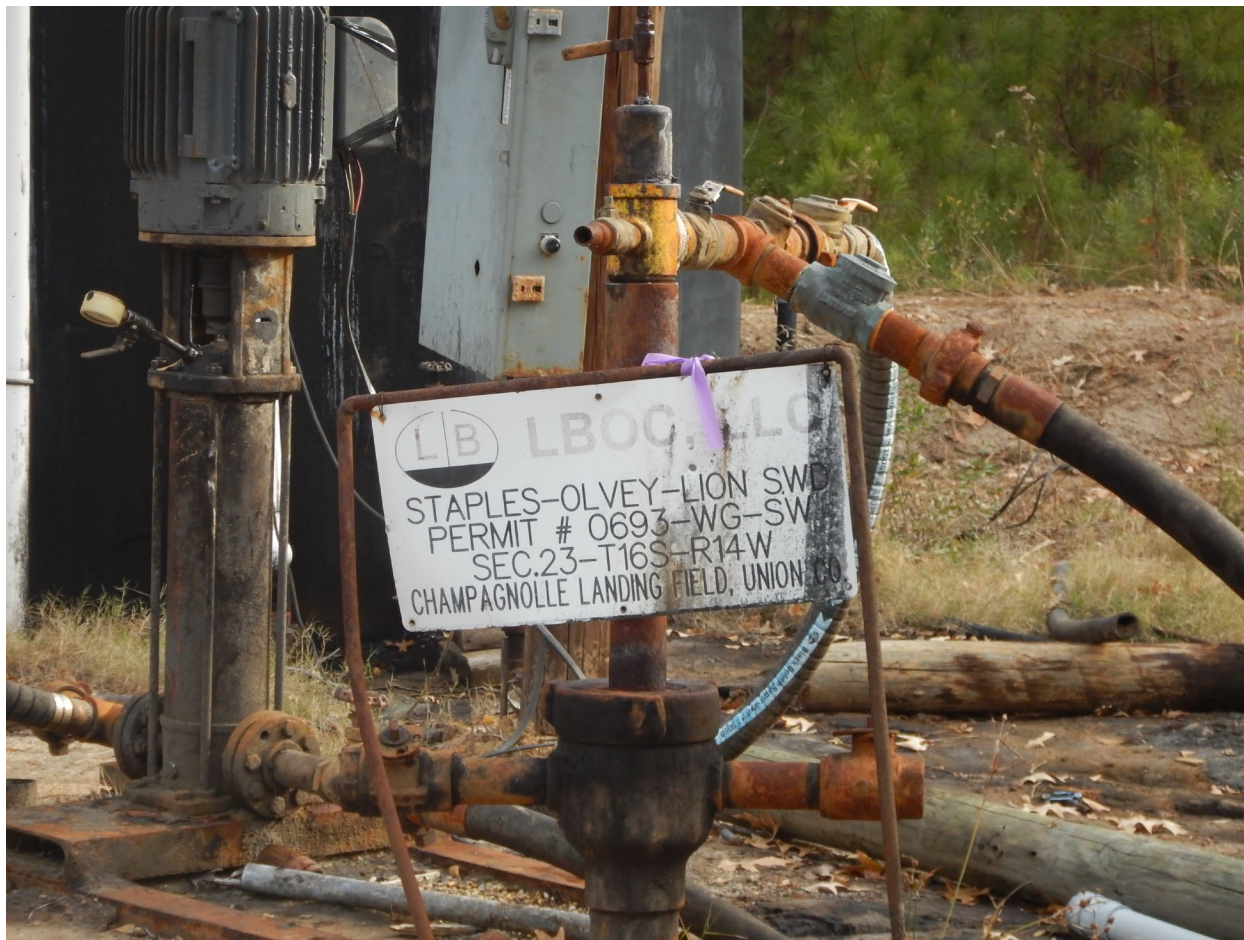
Photo No. 1

**Description:** This photo was taken looking N at the facility showing the facility sign.

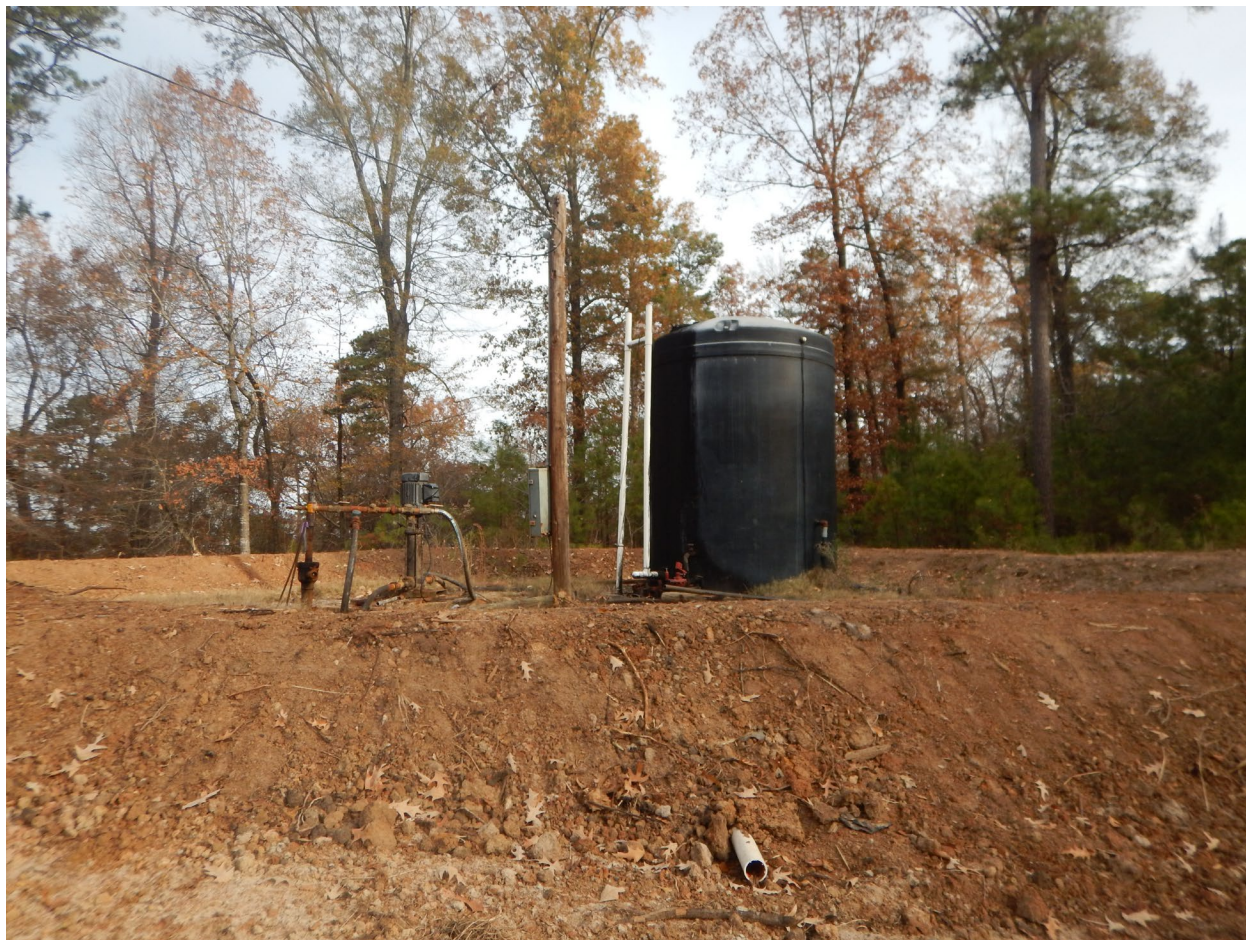
Photo No. 2

I observed no valve or cap on drainage pipe out of secondary containment, see photo No. 2.

**Description:** This photo was taken looking NW showing an overview of the facility. Note: no valve or cap on drainpipe out of secondary containment.

No closing conference was held due to no LBOC, LLC. staff being present during the inspection. Areas of concern at the time of the inspection include: 1) no valve or cap on drainage pipe out of secondary containment; 2) secondary containment had excessive debris that needs cleaned out; 3) soft, moist

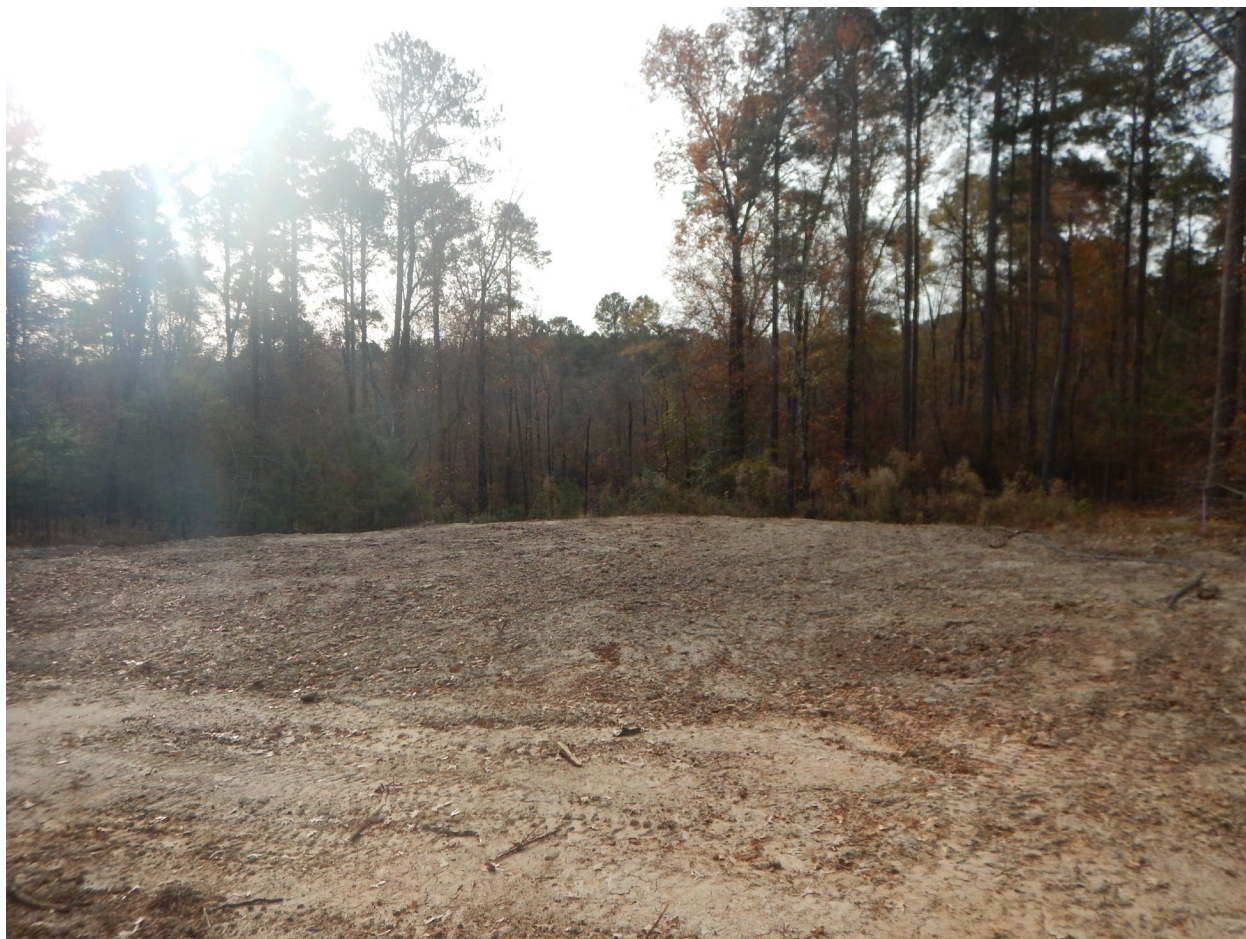
Photo No. 3

I observed soft, moist ground downhill from facility and brine crystallization on the surface, see photo No. 3.

**Description:** This photo was taken looking S down from the drainpipe from secondary containment.

**Note:** ground was soft and moist.

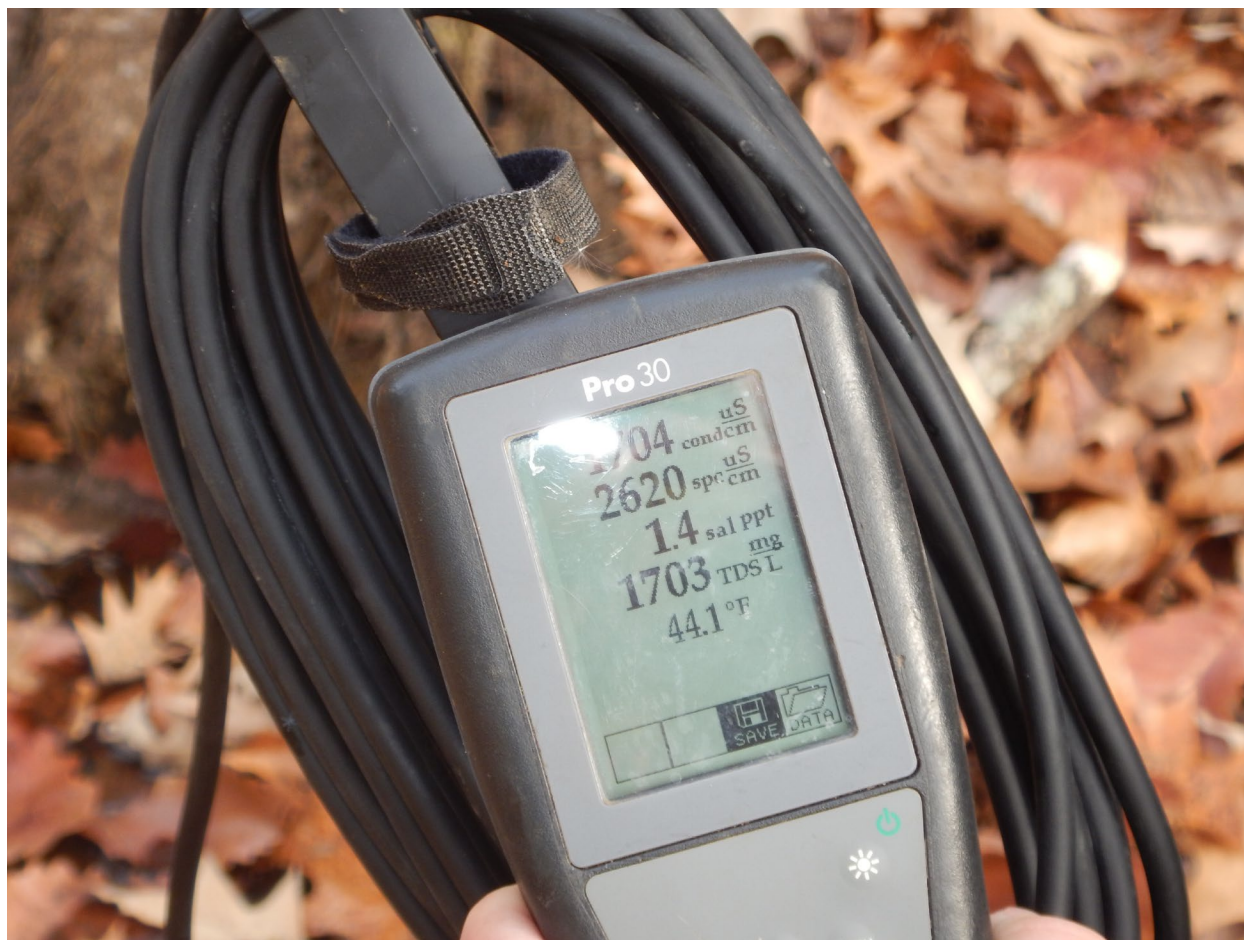
Photo No. 4

I observed a Total Dissolved Solids (TDS) reading of 1703 milligrams per liter (mg/L), approximately 445 feet downstream from facility, photo No. 4.

**Description:** This photo is showing YSI meter readings, with a Total Dissolved Solids (TDS) reading of 1703 milligrams per liter (mg/L), approximately 445 feet downstream from facility.

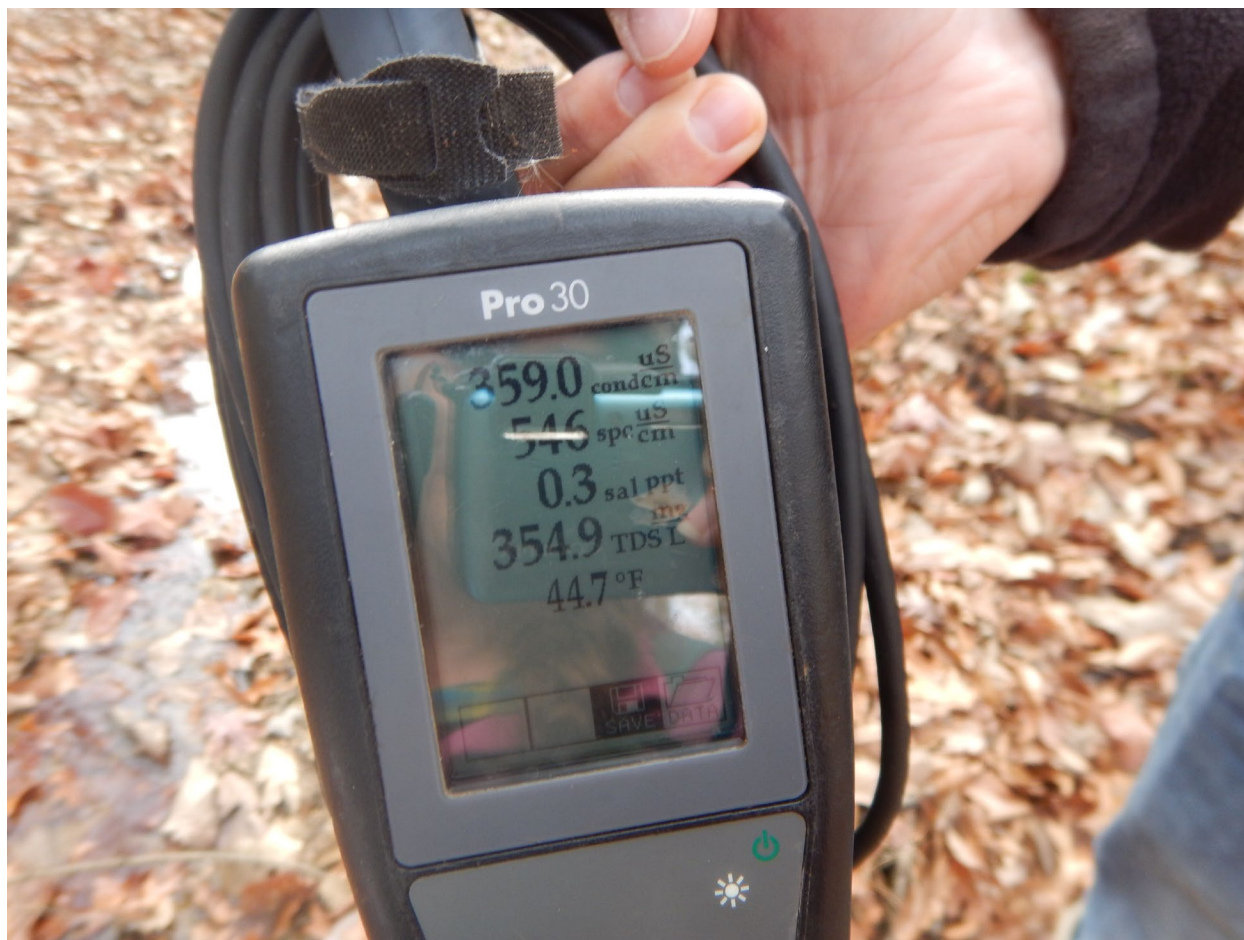
Photo No. 5

I observed a Total Dissolved Solids (TDS) reading of 354.9 milligrams per liter (mg/L), approximately 520 feet downstream from facility, photo No. 5.

**Description:** This photo is showing YSI meter readings, with a Total Dissolved Solids (TDS) reading of 354.9 milligrams per liter (mg/L), approximately 520 feet downstream from facility.

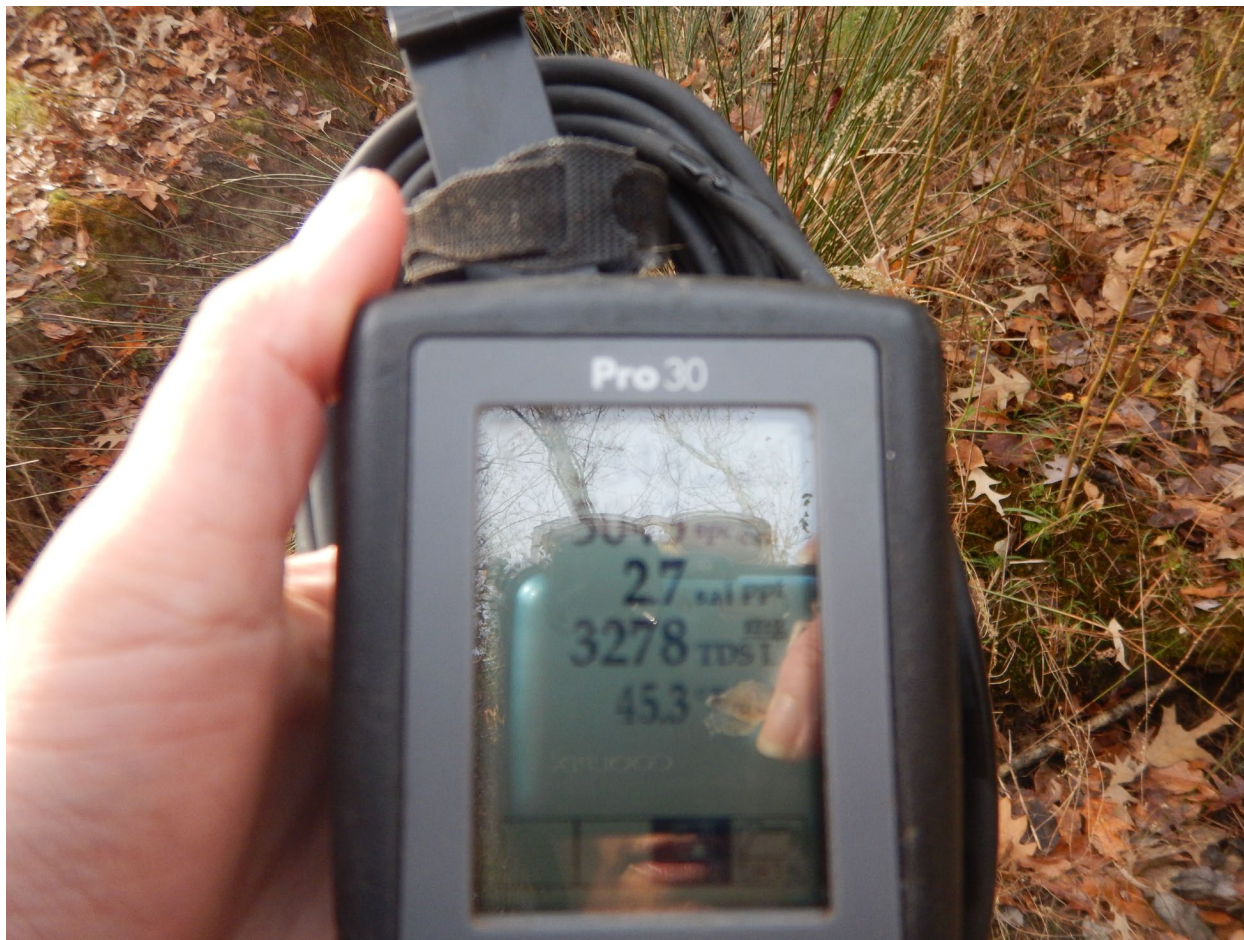
Photo No. 6

I observed a Total Dissolved Solids (TDS) reading of 3278 milligrams per liter (mg/L), approximately 395 feet downstream from facility, photo No. 6.

**Description:** This photo is showing YSI meter readings, with a Total Dissolved Solids (TDS) reading of 3278 milligrams per liter (mg/L), approximately 395 feet downstream from facility.

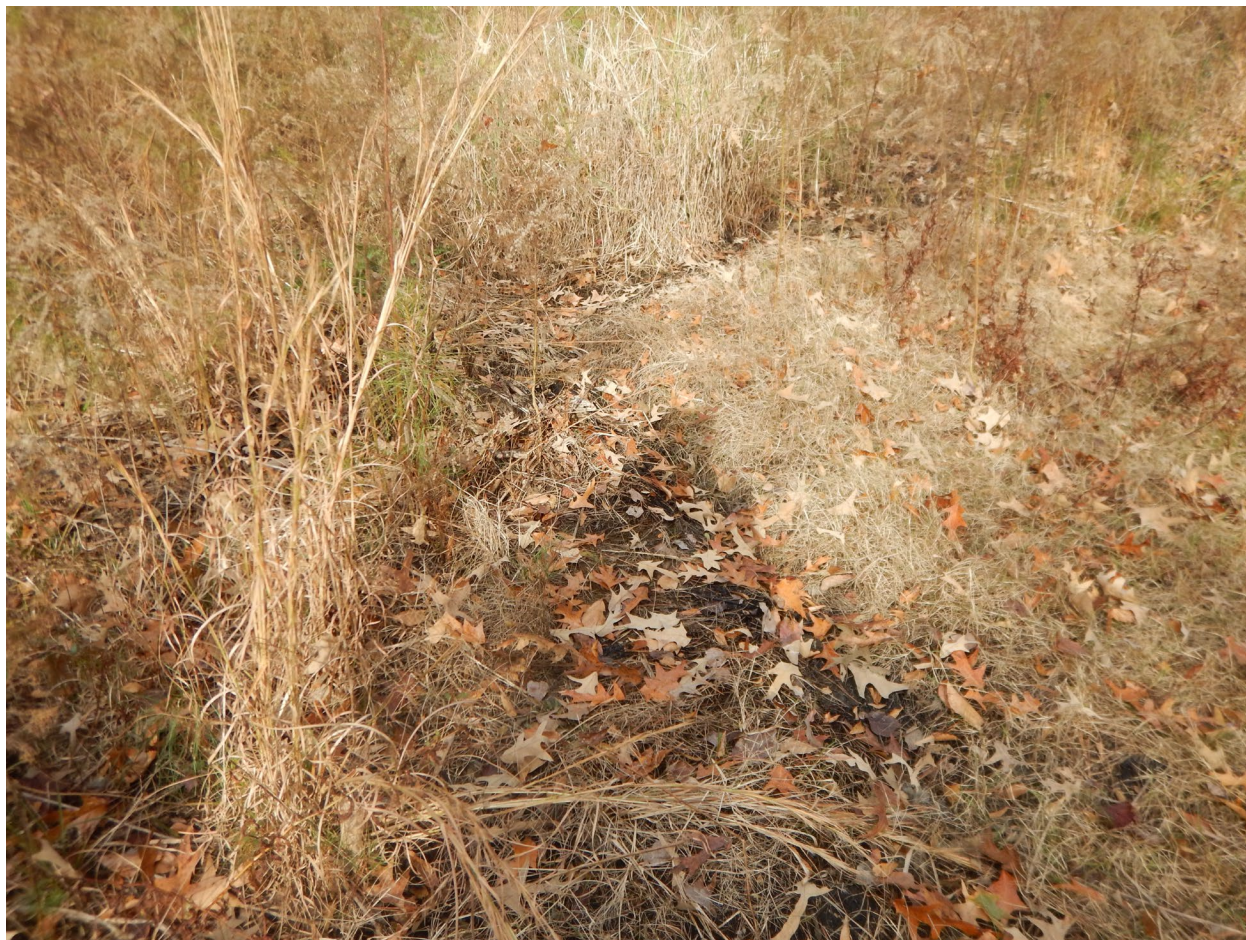
Photo No. 7

**Description:** This photo was taken looking SE showing the flow path.

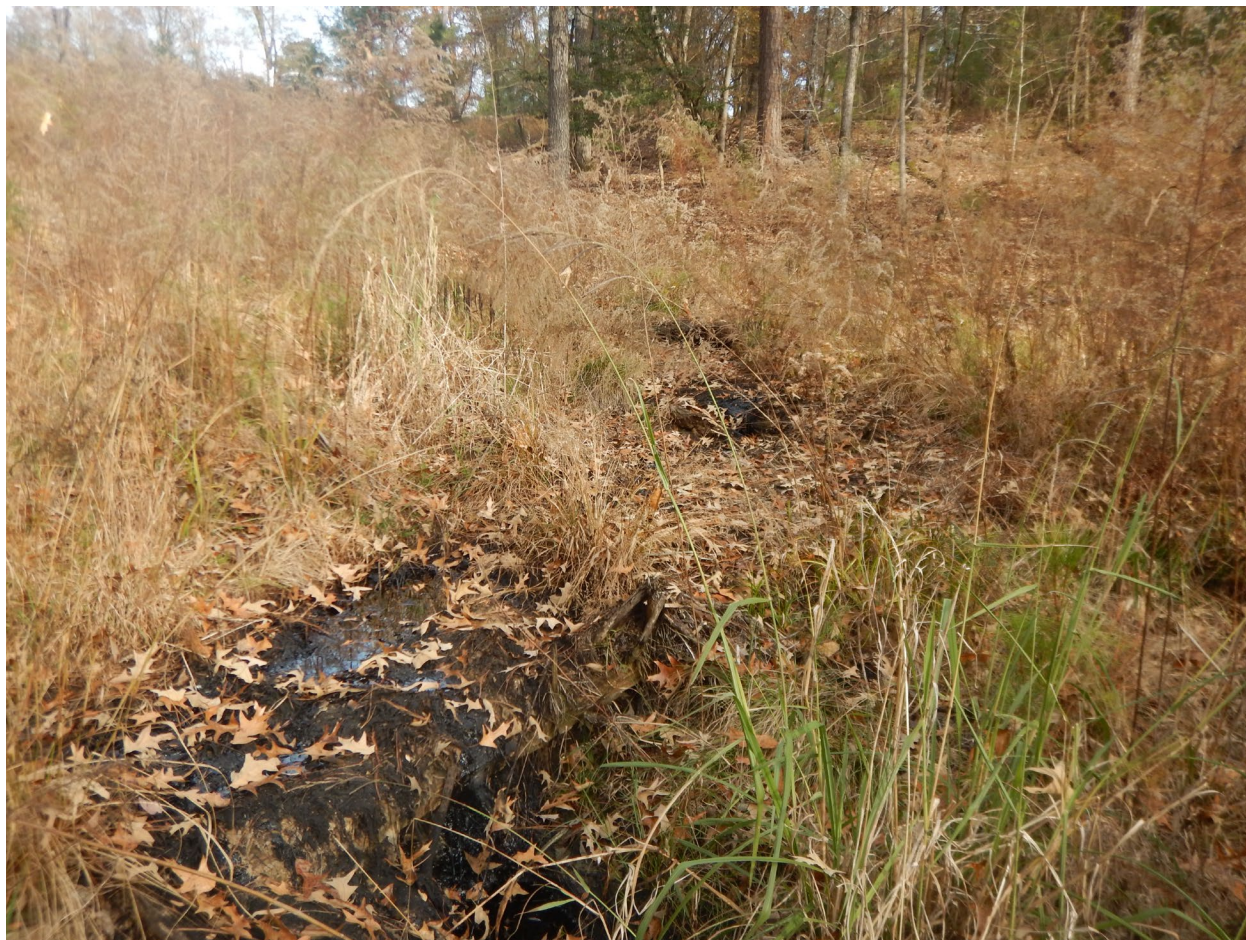
Photo No. 8

**Description:** This photo was taken looking N showing the flow path.

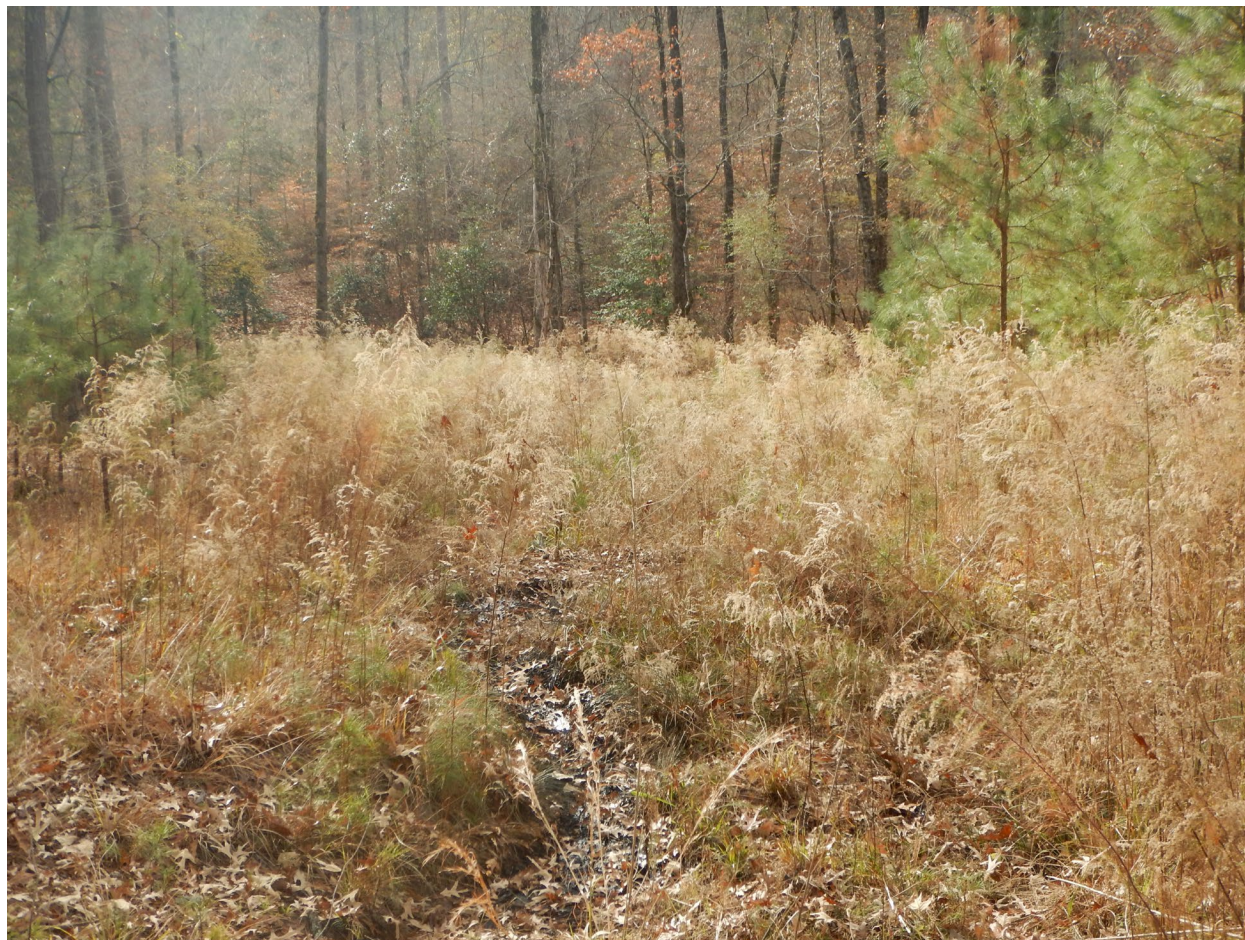
Photo No. 9

**Description:** This photo was taken looking S showing the flow path.
