INSPECTION REPORT

| Type of Inspection | Compliance Evaluation Inspection (CEI) | |
| Facility or Site Name | Environmental Safety & Health Consulting Service Inc. | |

**SECTION I – INTRODUCTION****Site Entry and Purpose of the Inspection**

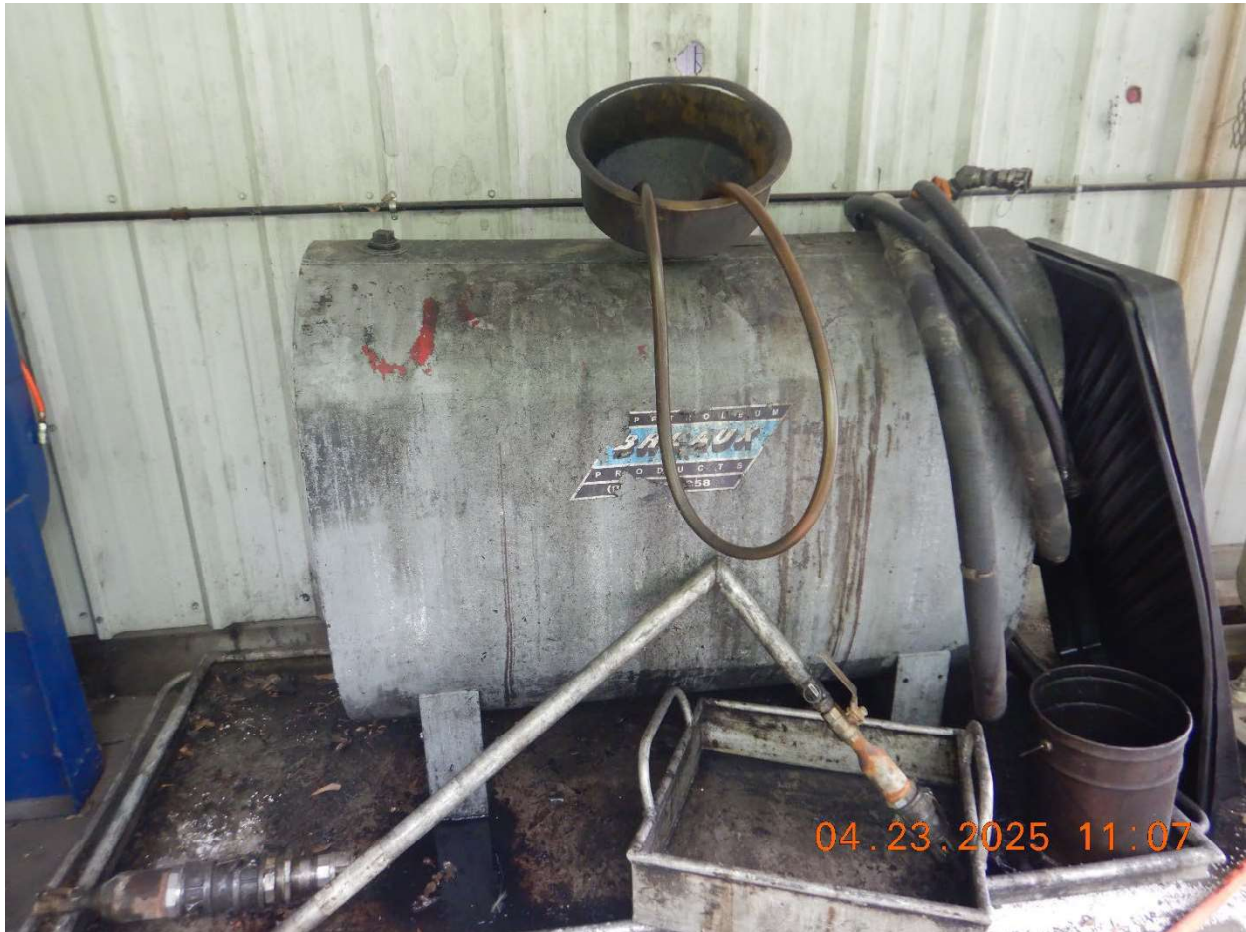
Photo No. 1

Description: View of a 150-gallon used oil storage tank in the used oil storage area that was not labeled "Used Oil."

| <b>Facility:</b> Environmental Safety & Health Consulting Service Inc. | | |
|---|---|---|
| <b>AOC #1</b> – ES&H did not clearly label containers used to store used oil with the words “Used Oil.” | <b>Citation:</b> 40 CFR 279.45(g)(1) | Section: 2.1 |

1. 4/25/25 ES&H email – Ms. Baskin provided the inspection team with photos of corrections made towards AOCs observed.

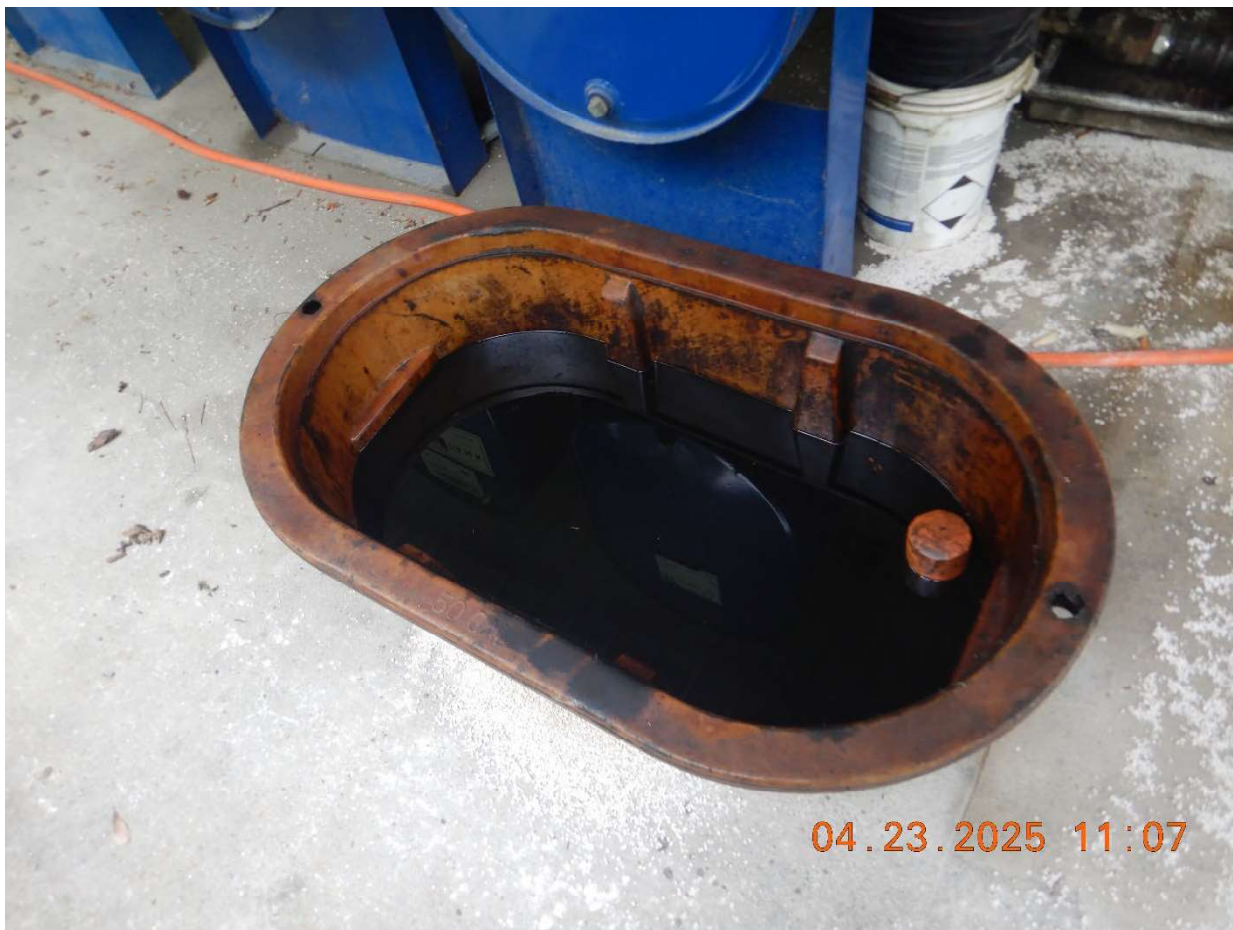
**Photo No. 2**

Description: View of a 40-gallon used oil drip bucket in the used oil storage area that was not labeled "Used Oil."

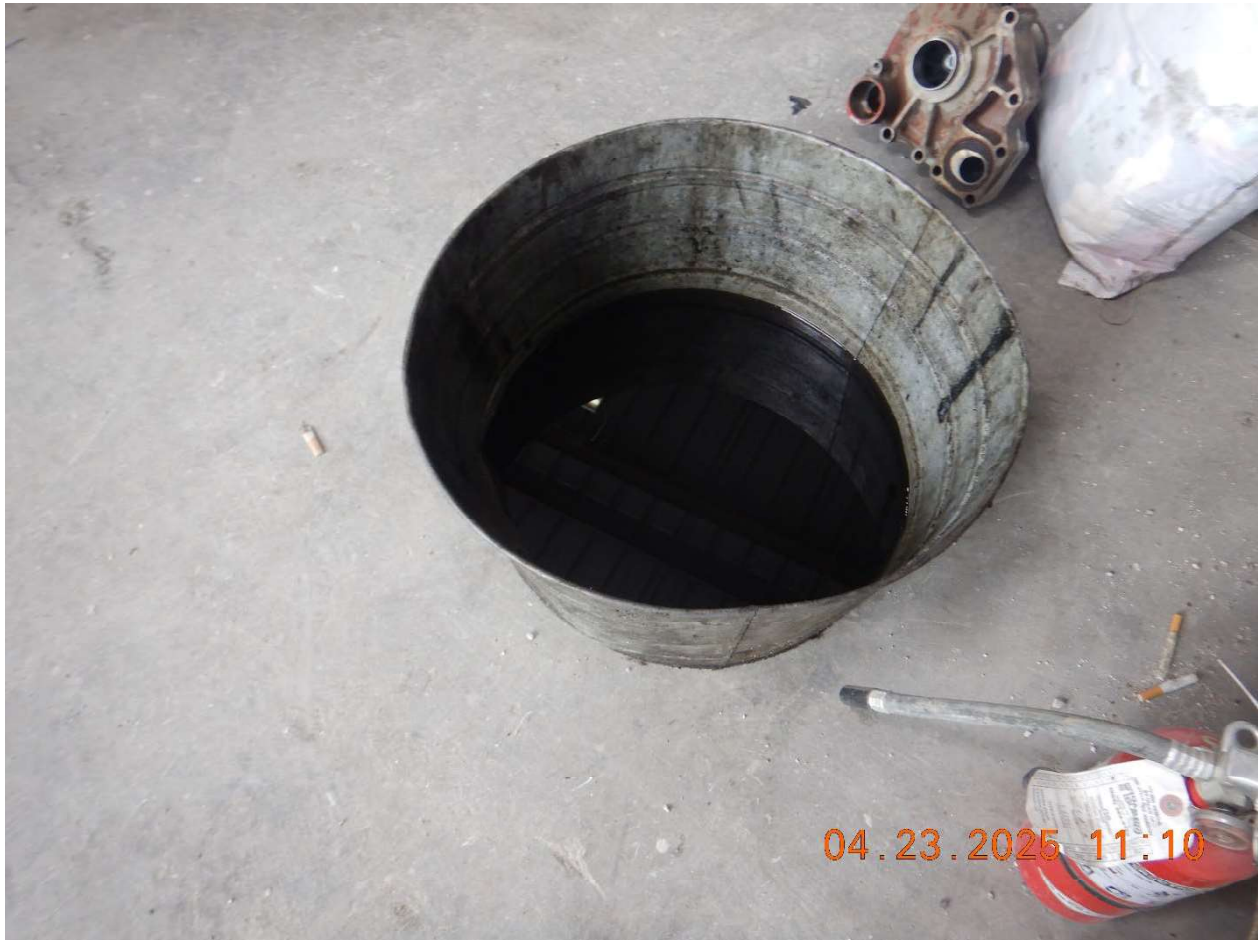
**Photo No. 3**

Description: View of a 10-gallon used oil drip bucket in the used oil storage area that was not labeled "Used Oil."

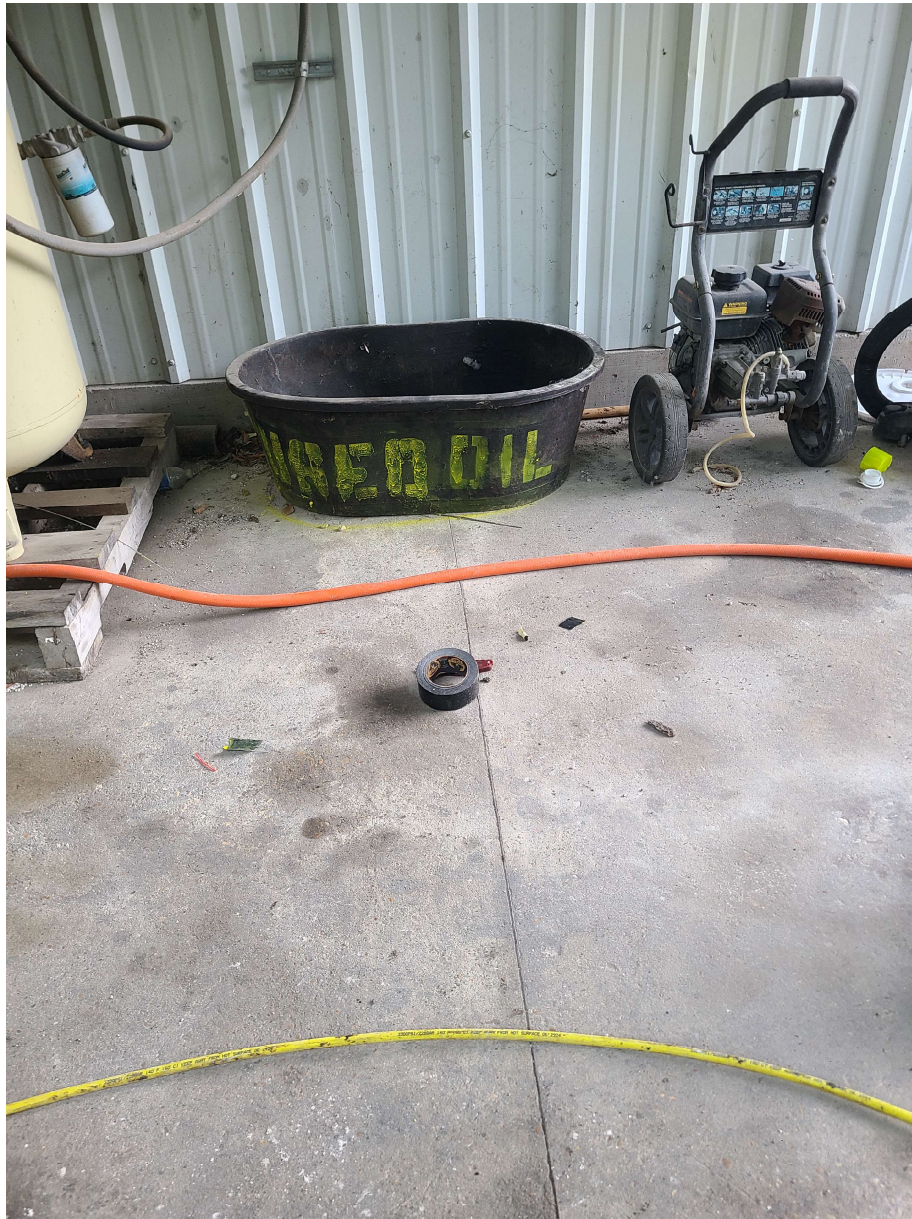
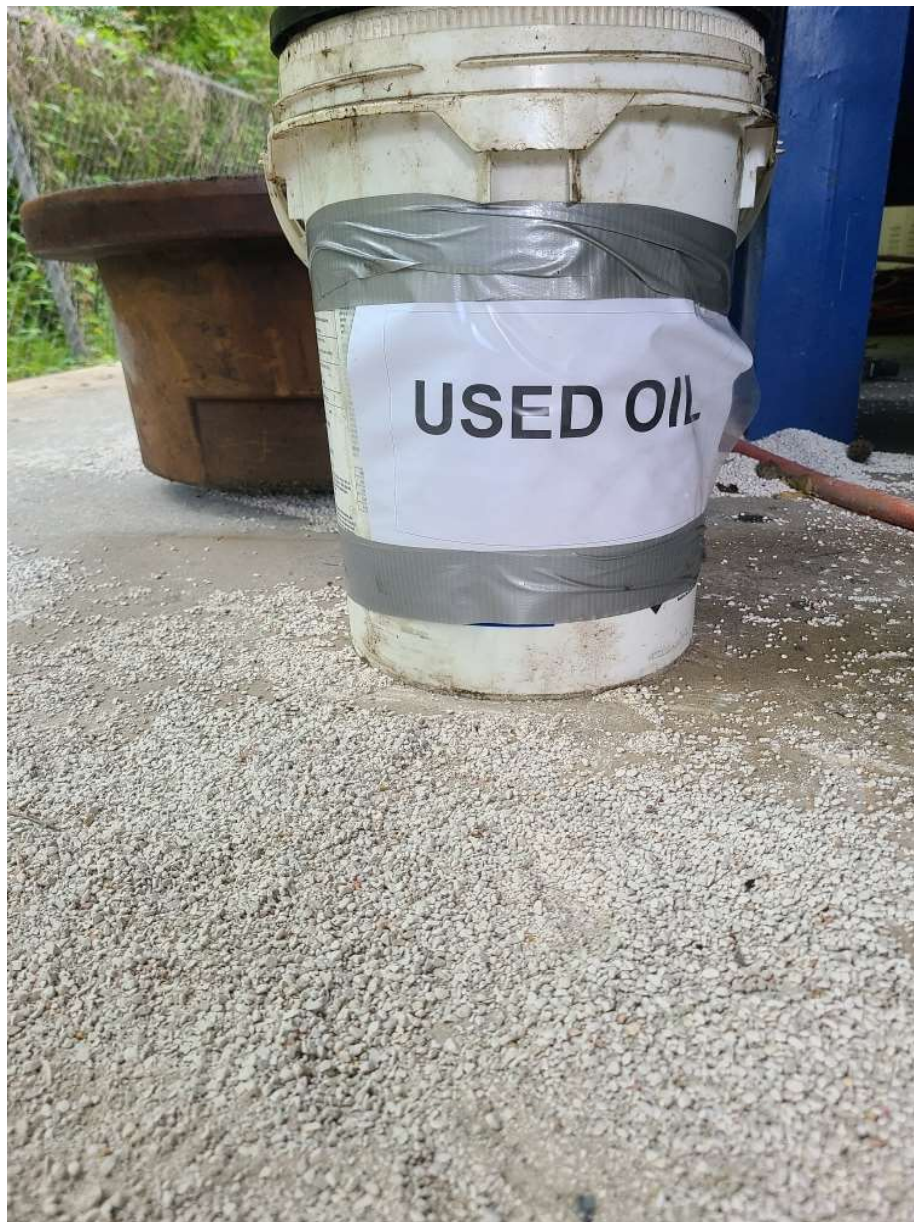
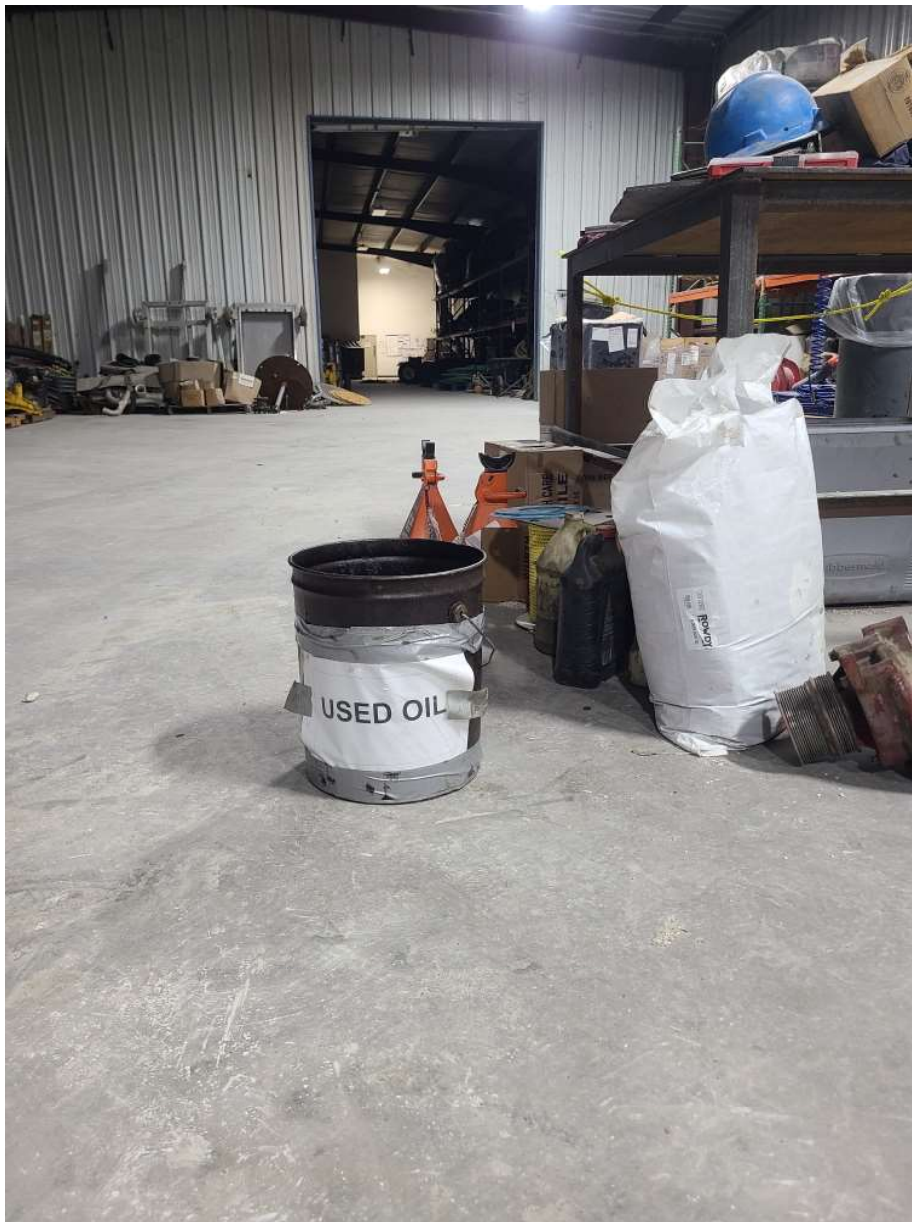
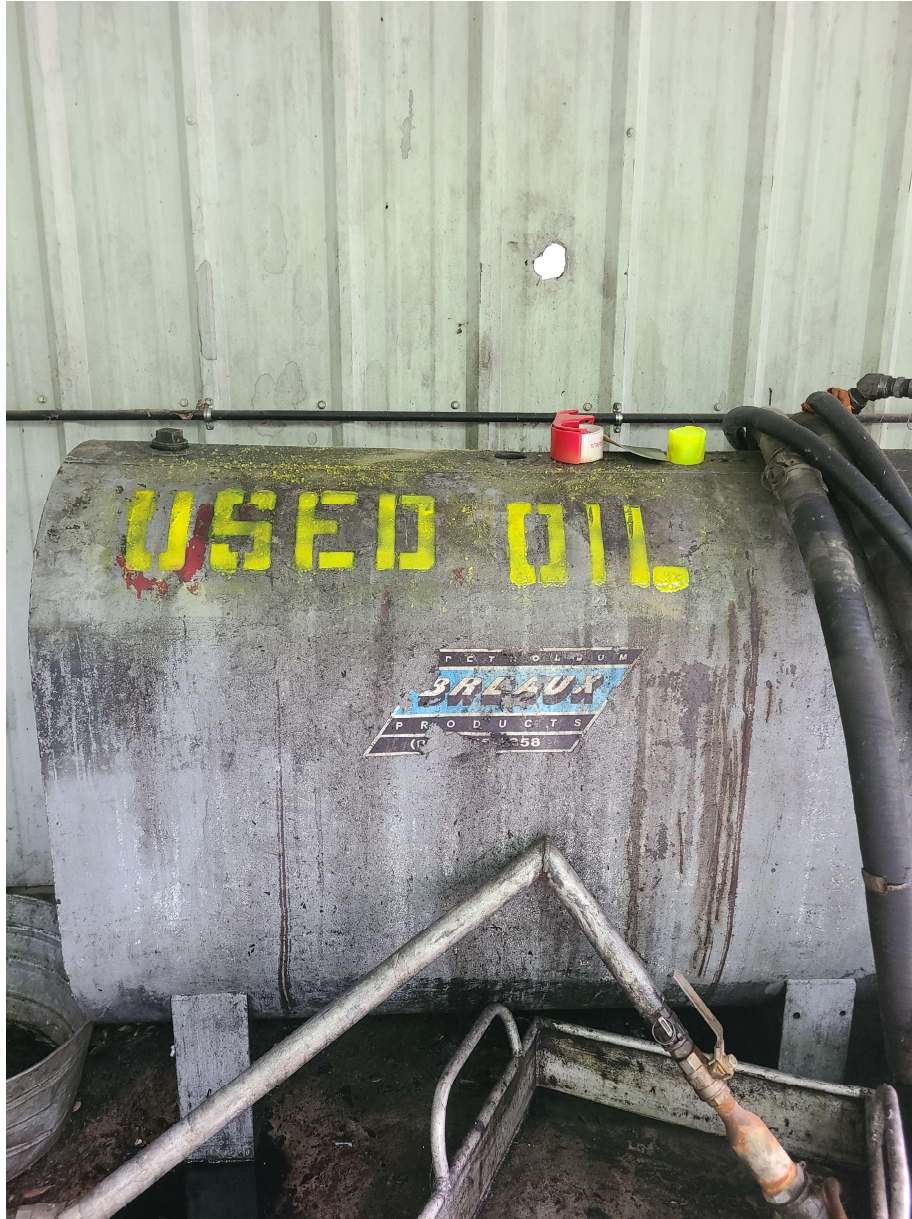
Used Oil Tank.jpg; Used Oil Bin (1).jpg; Used Oil Bucket (shop).jpeg; Used Oil Bucket (2).jpeg;

Attached are photos of the labeled containers. Let me know if you need any additional photos.  
Thanks.
