**Region 6 - Enforcement & Compliance Assurance Division**  
**INSPECTION REPORT**

| Company Name: | <b>Jerry Langley Oil Company, LLC</b> | |
| Facility Name: | <b>Flowline release from Tom #14 Tank Battery</b> | |

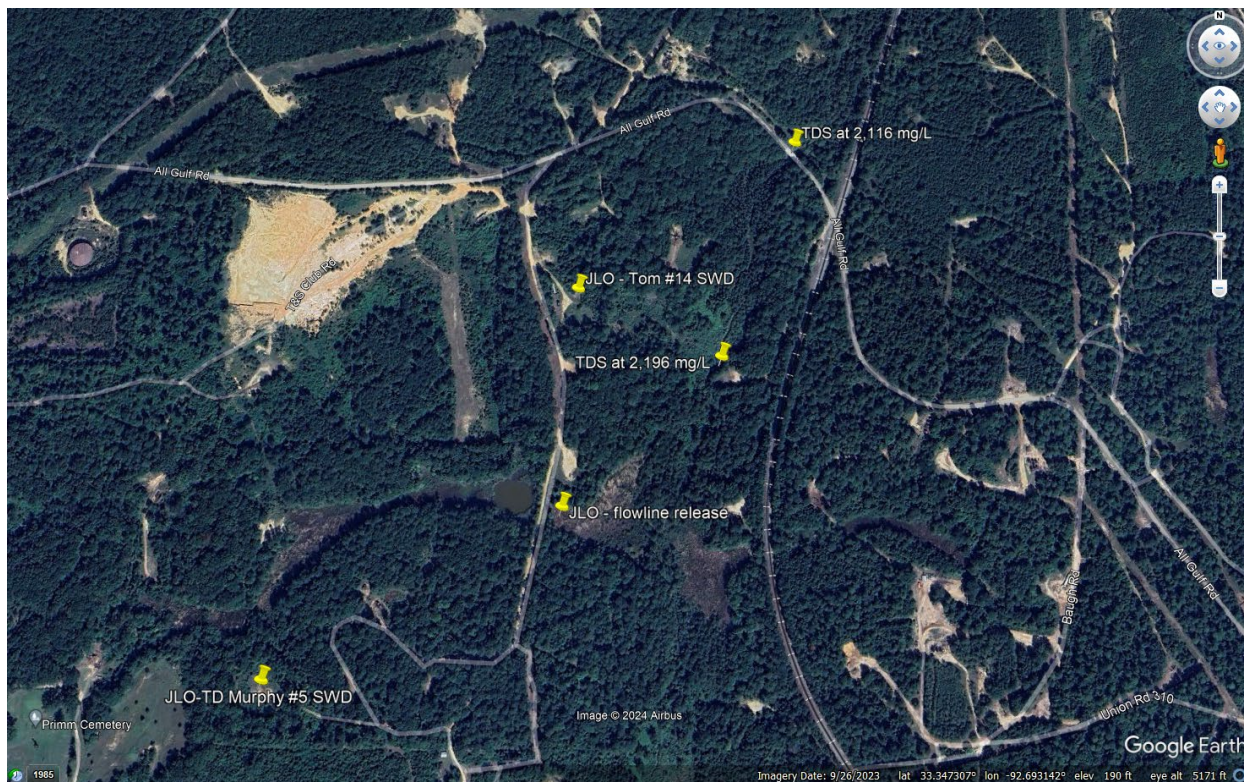
**Aerial Image 1.** Overview of the area of the release and the associated Jerry Langley Oil (JLO) SWD wells and downstream TDS readings for the unnamed tributary (UT) of Smackover Creek. Google Earth image date 09/26/2023.

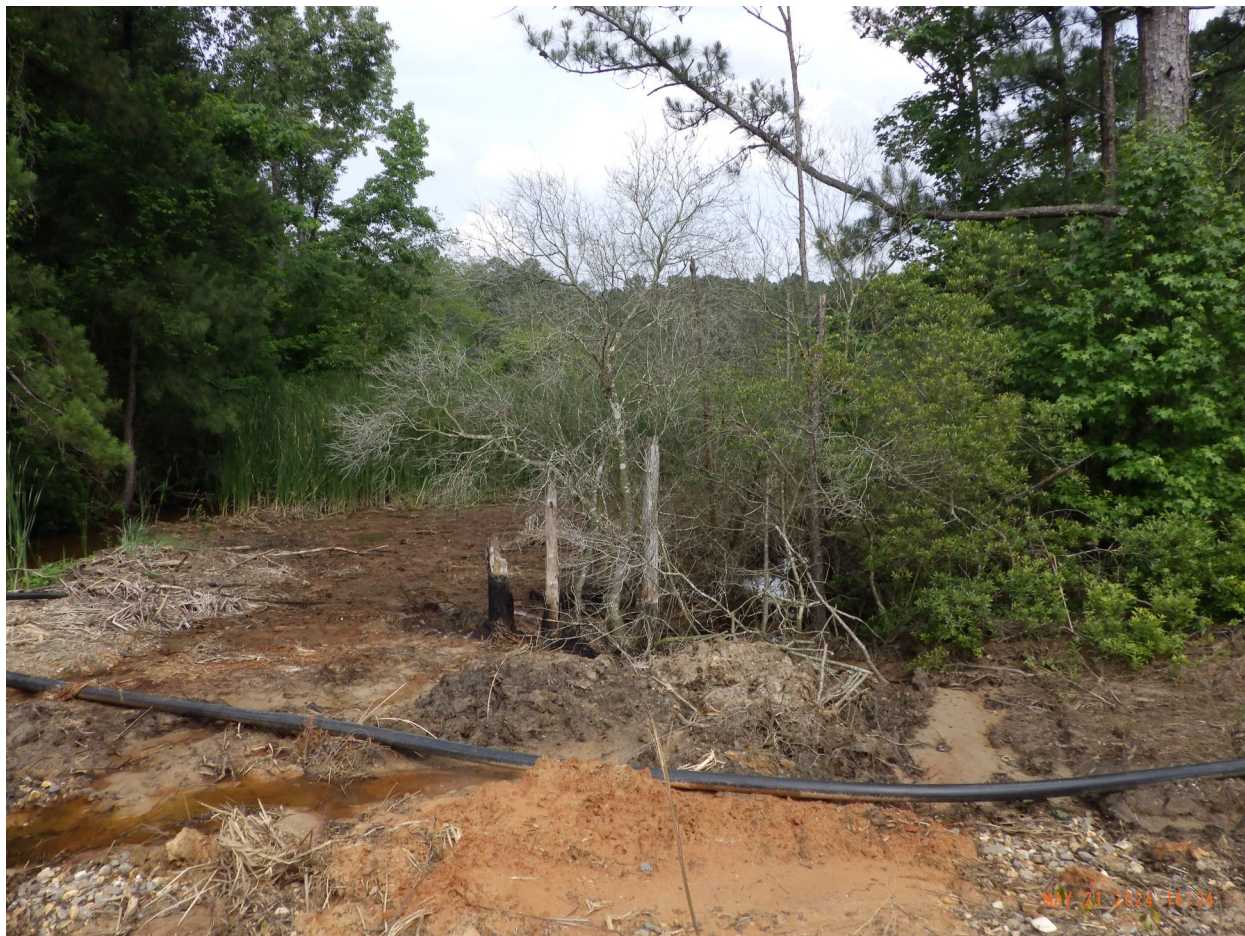
I observed repairs to the ruptured flowline and the impacted wetland, see Appendix 1 (Photograph Log), Photo No. 1 through No. 3. For additional GPS location and photo metadata, see Appendix 1.

- Residual crude oil and saltwater staining at the area of the ruptured flowline in the impacted wetland;
- Elevated TDS readings in the UT of Smackover Creek.

**Description:** Looking E-SE, this photo shows the wetland impacted by the Tom #14 Tank Battery flowline release noted in the 03/12/2024 inspection by Uma Lad. Jerry Langley Oil Co., LLC personnel had excavated and repaired the flowline.

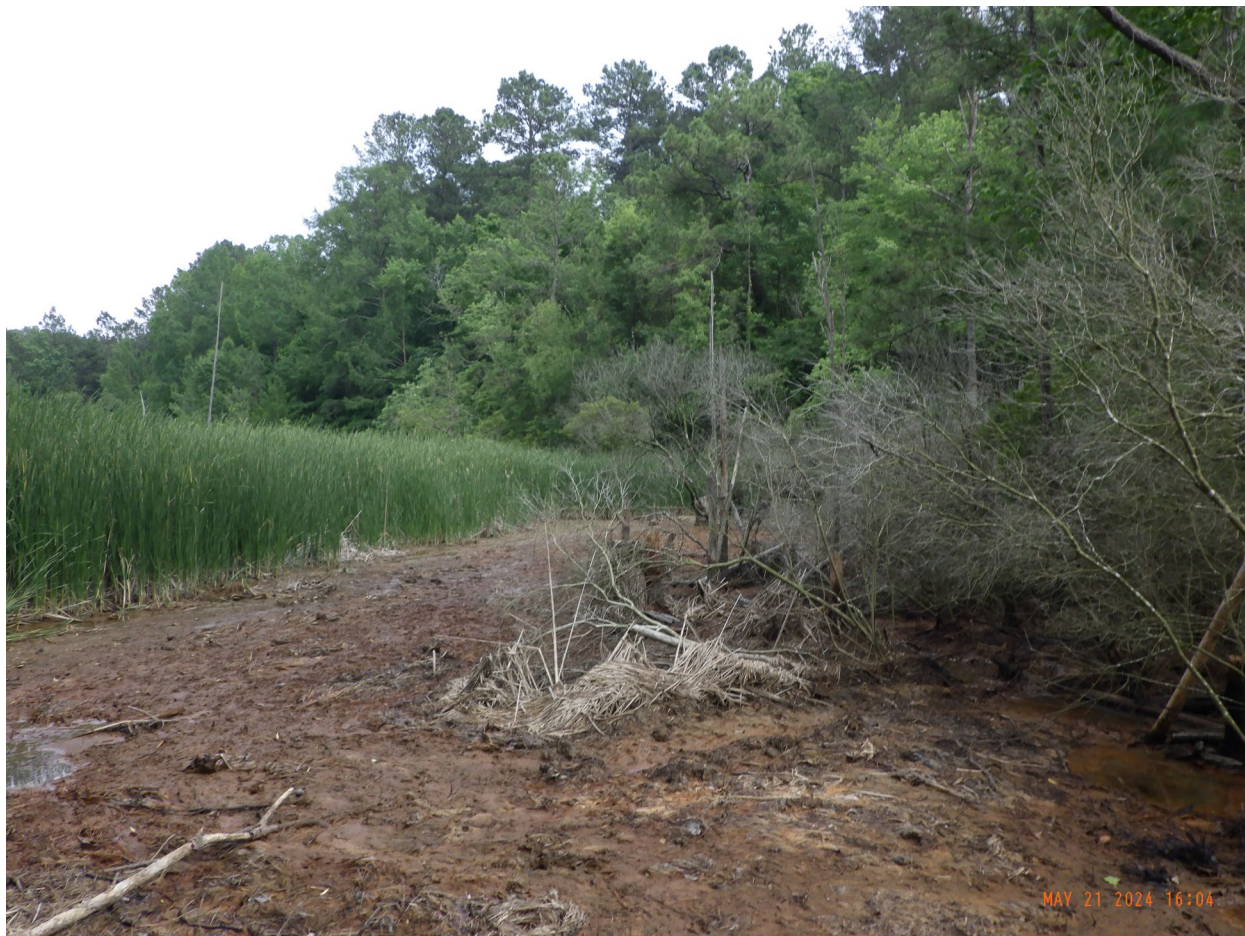
Photo No. 2

**Description:** Looking S-SE, this photo shows an additional view of the wetland impacted by the Tom #14 Tank Battery flowline release.

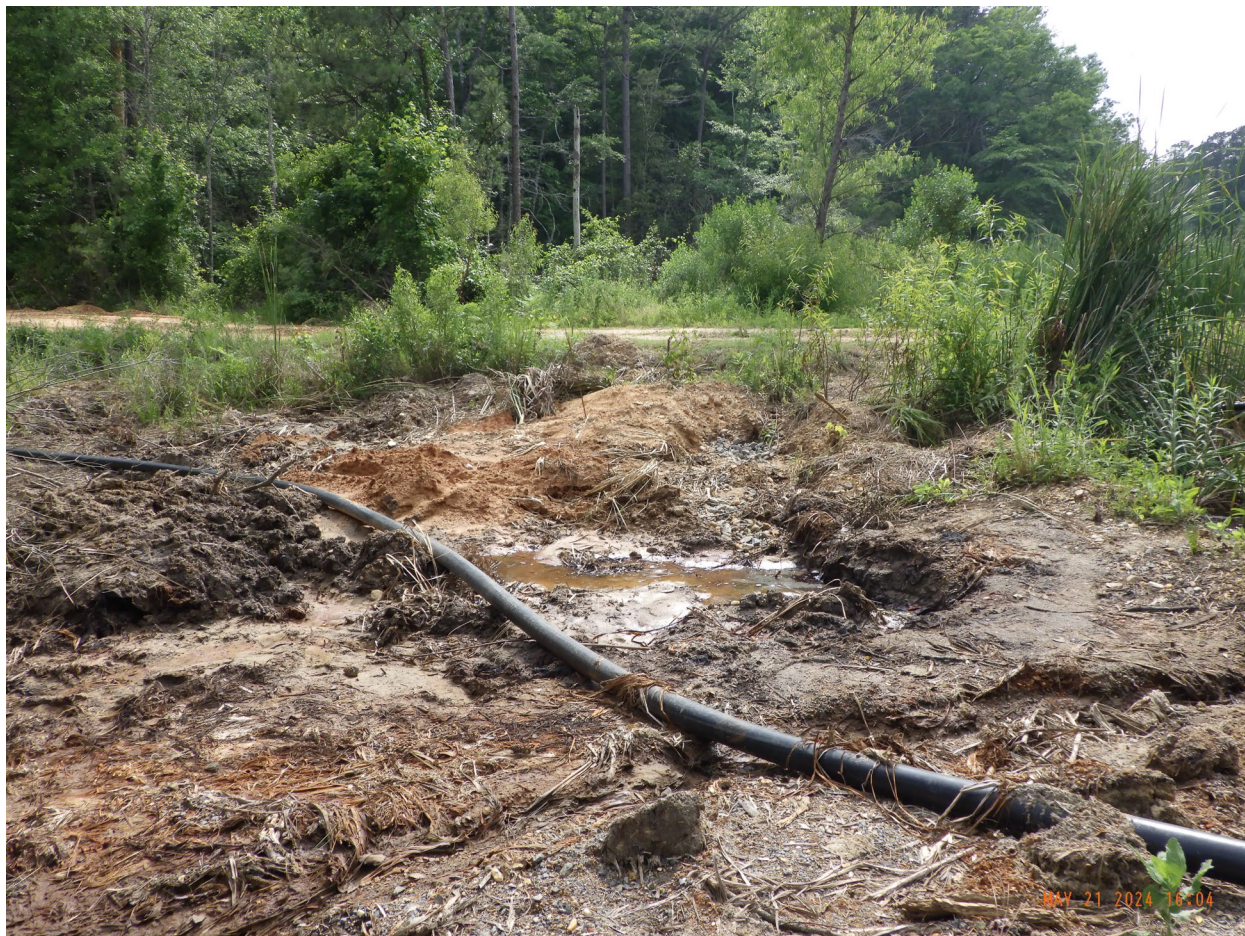
Photo No. 3

**Description:** Looking W-SW, this photo shows an additional view of the wetland impacted by the Tom #14 Tank Battery flowline release. Jerry Langley Oil Co., LLC personnel had excavated and repaired the flowline.

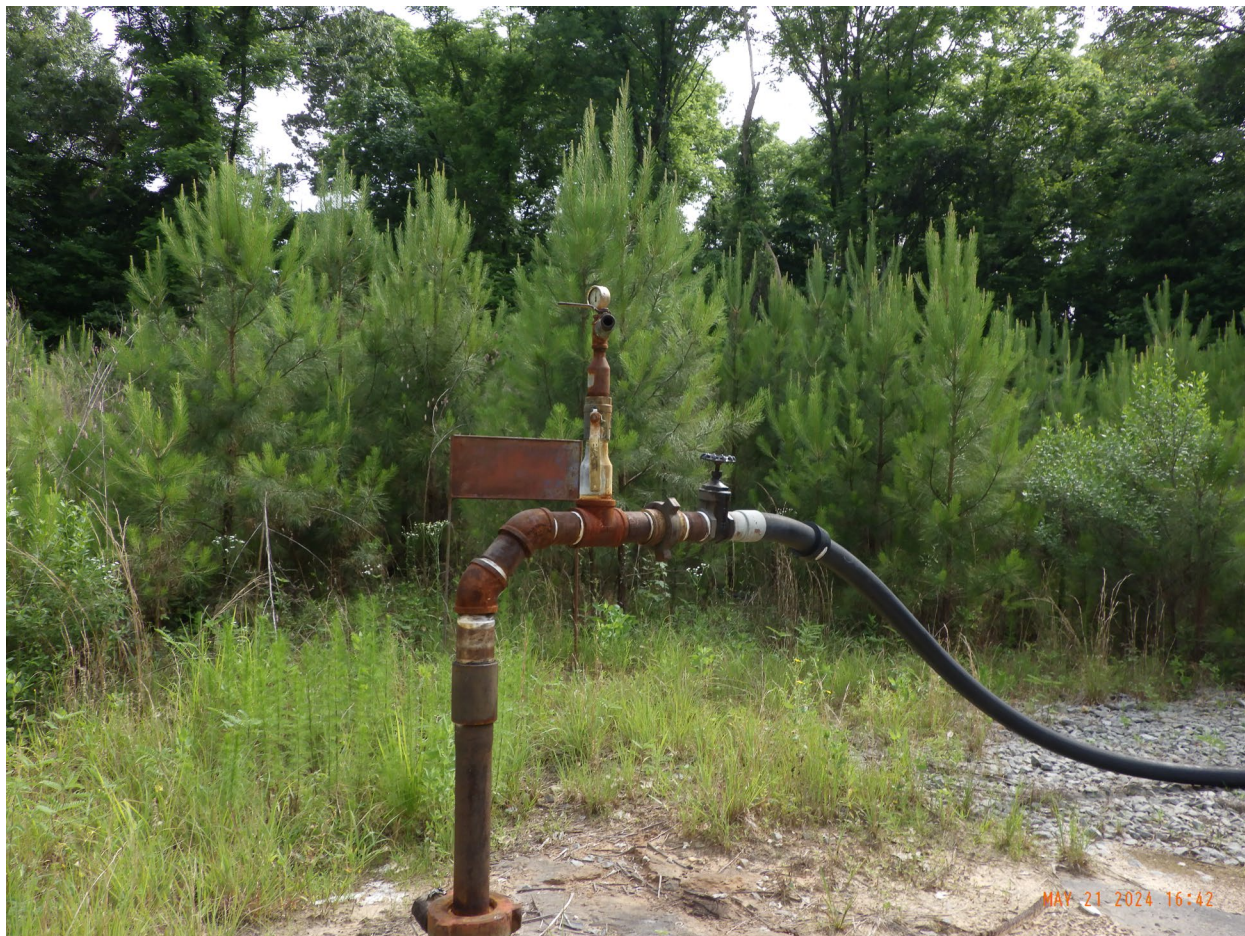
Photo No. 4

I observed the Jerry Langley Oil Co., LLC – TD Murphy #5 SWD injection well (no sign). The flowline was connected to this SWD well. See Photo No. 4.

**Description:** Looking SW, this photo shows the Jerry Langley Oil Co., LLC – TD Murphy #5 SWD well (with no sign). The ruptured flowline connects to this SWD well.

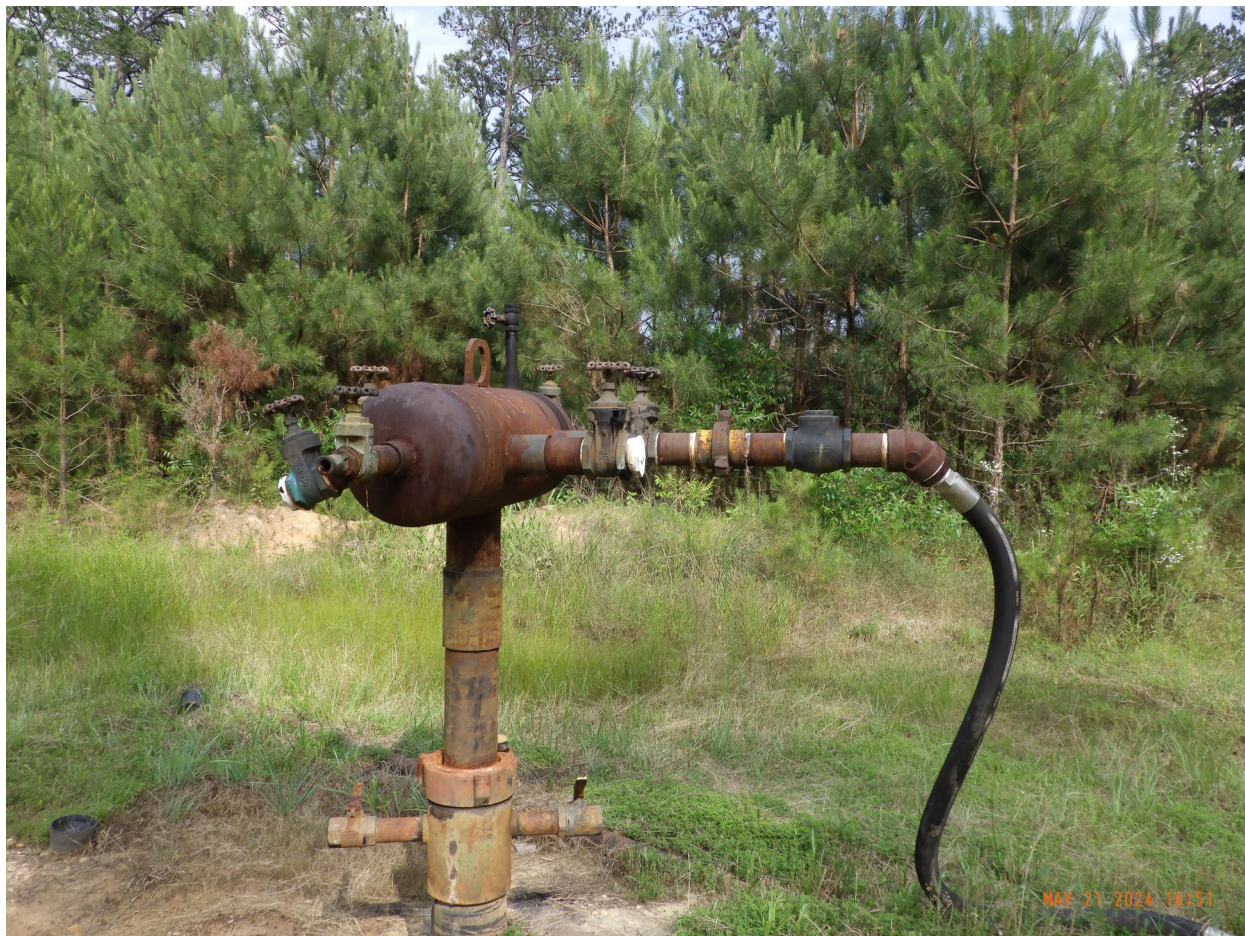
Photo No. 5

I observed the Jerry Langley Oil Co., LLC – Tom #14 SWD injection well and the Tom #14 Tank Battery. This SWD well receives most of the saltwater coming into the system. See Photo No. 5.

**Description:** Looking E-SE, this photo shows the Jerry Langley Oil Co., LLC – Tom #14 SWD well. This SWD well is located at the tank battery and receives most of the saltwater collected at the tank battery.

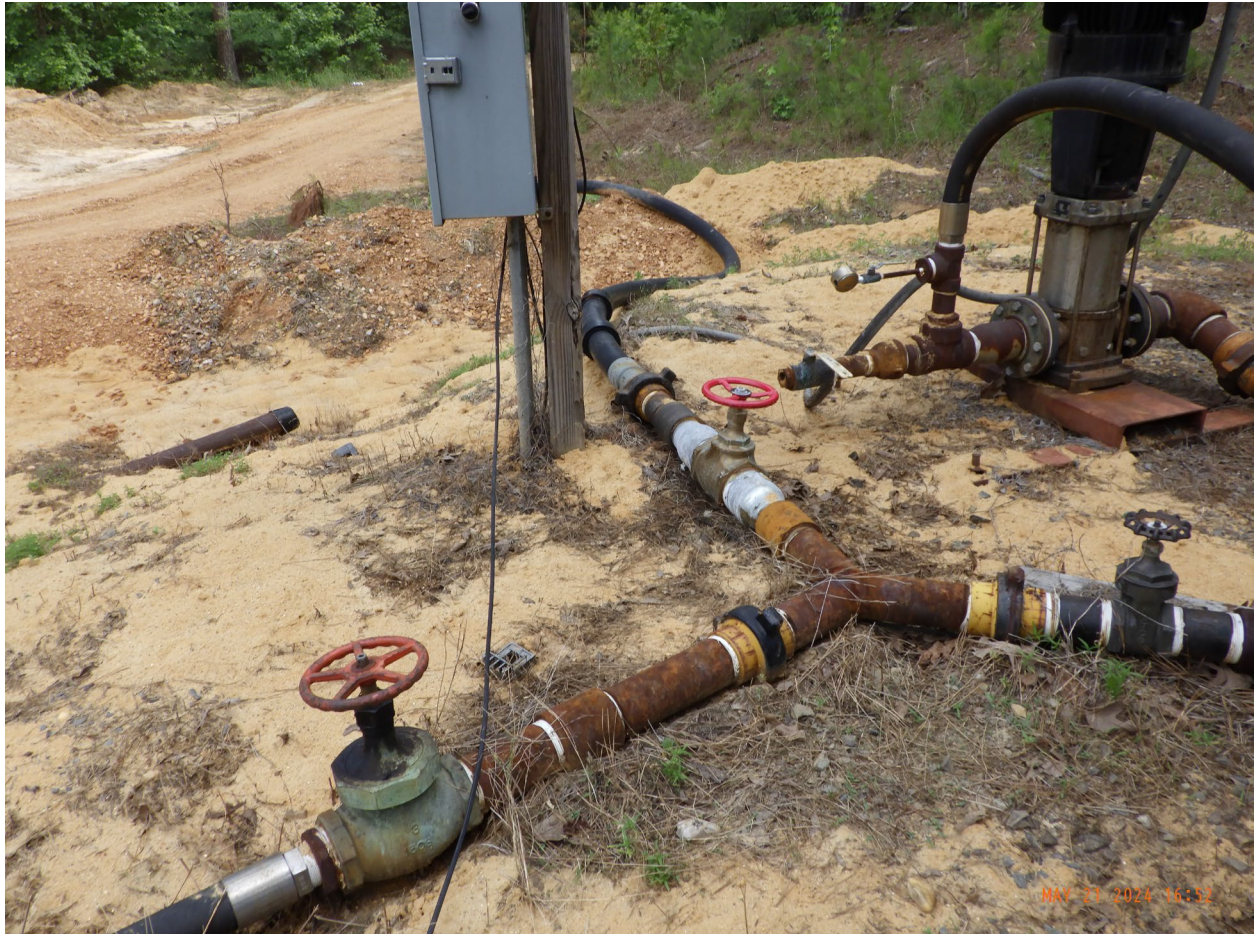
Photo No. 6

I observed the pump, valves, and flowlines connected to the Tom #14 Tank Battery. See Photo No. 6.

**Description:** Looking S-SW, this photo shows the pump and valves associated with the Tom #14 Tank Battery, which directs flow to two (2) SWD injection wells.

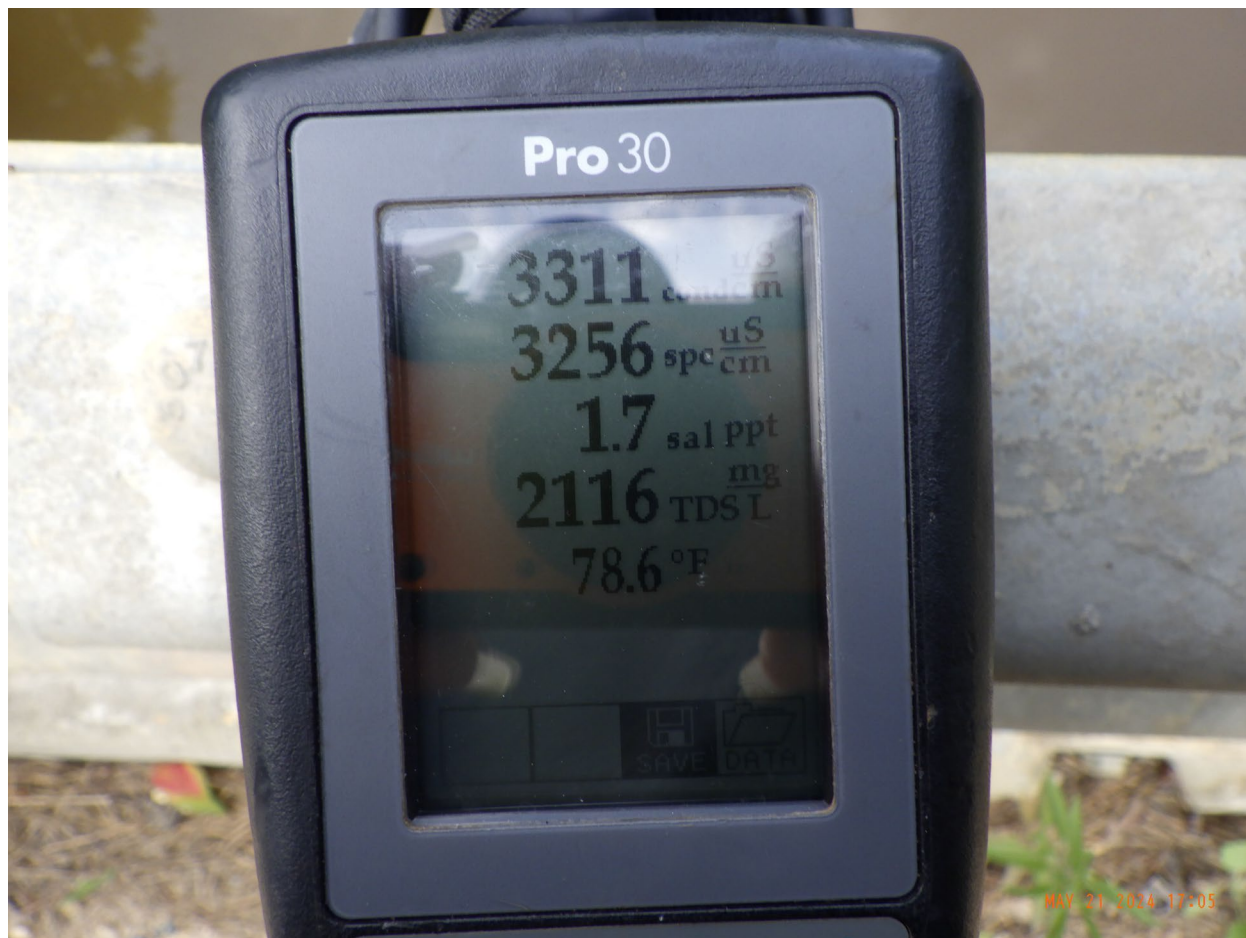
Photo No. 7

I collected a Total Dissolved Solids (TDS) reading of 2,116 mg/L at the All Gulf Road bridge, which is downstream of the impacted wetland, at an unnamed tributary (UT) of Smackover Creek. See Photo No. 7.

**Description:** Looking NE, this photo shows a TDS reading of 2,116 mg/L at the All Gulf Road bridge, which is the downstream location for the wetlands in Photo No. 1-3.

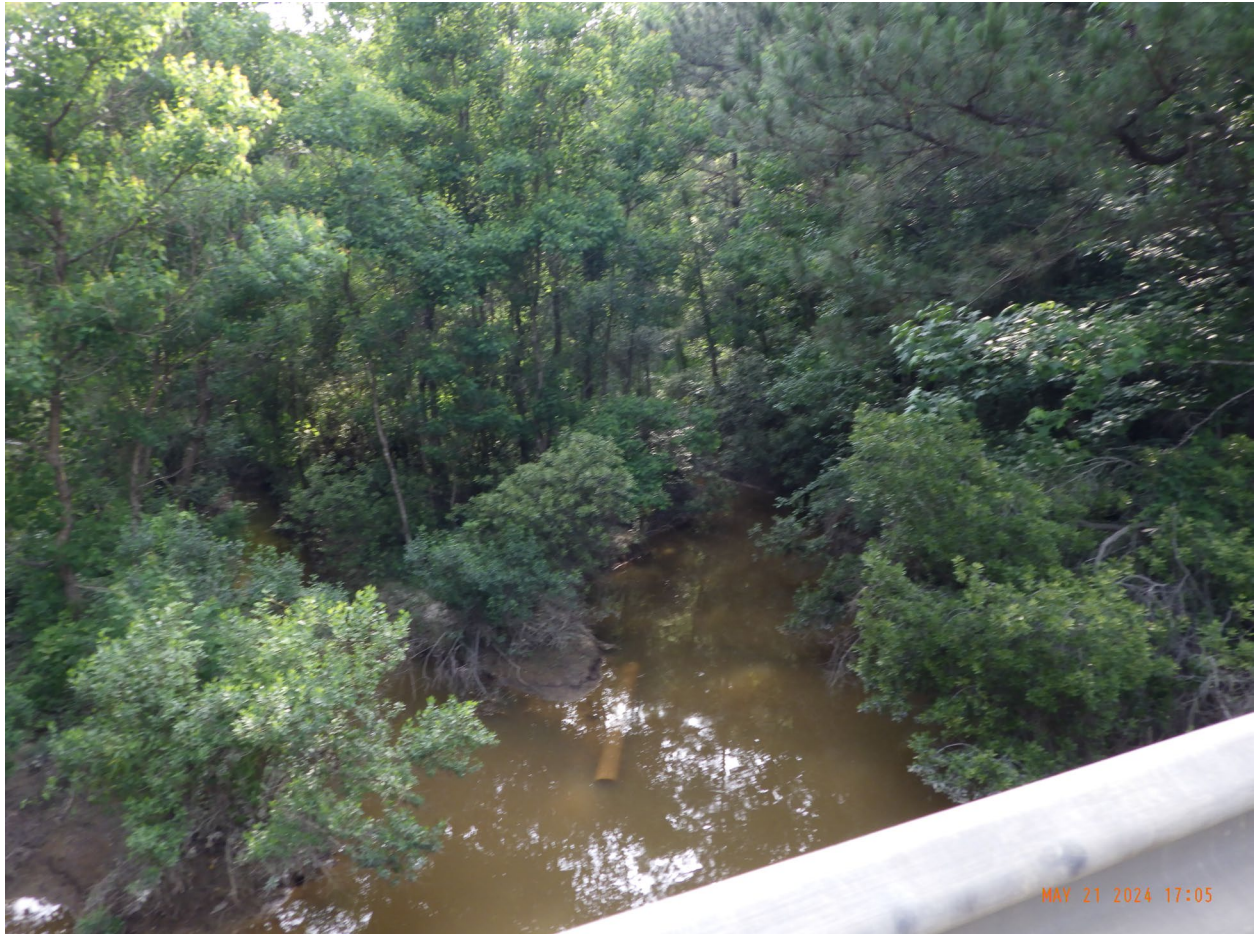
I observed the vegetation and bed and bank features upstream and downstream of the UT of Smackover Creek, where the TDS reading was collected. See Photo No. 8 and No. 9.

**Description:** Looking W-SW, this photo shows the upstream view of the receiving stream, unnamed tributary (UT) of Smackover Creek, for the TDS reading in Photo No. 8.

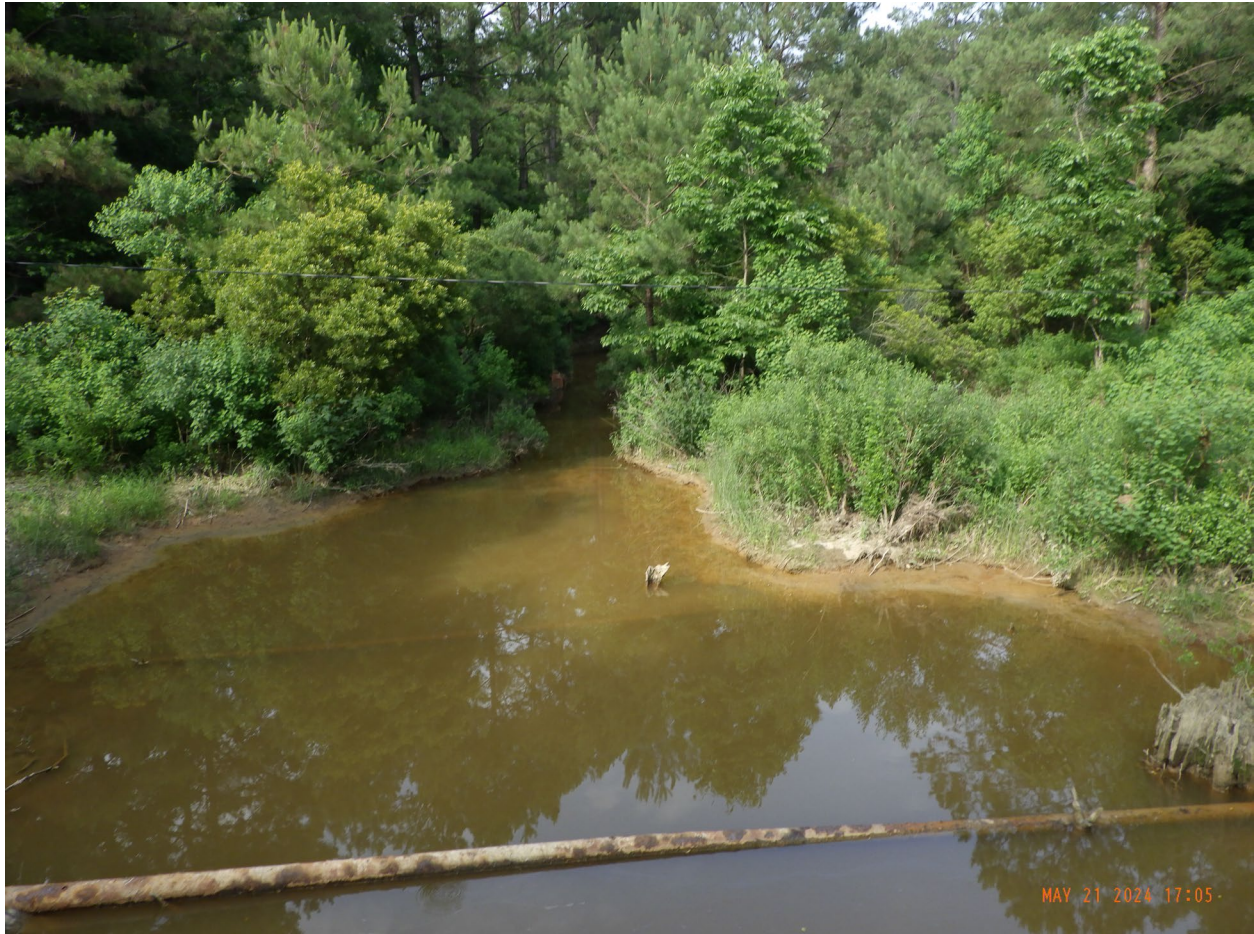
Photo No. 9

**Description:** Looking NE, this photo shows the downstream view of the receiving stream, UT of Smackover Creek, for the TDS reading in Photo No. 8.

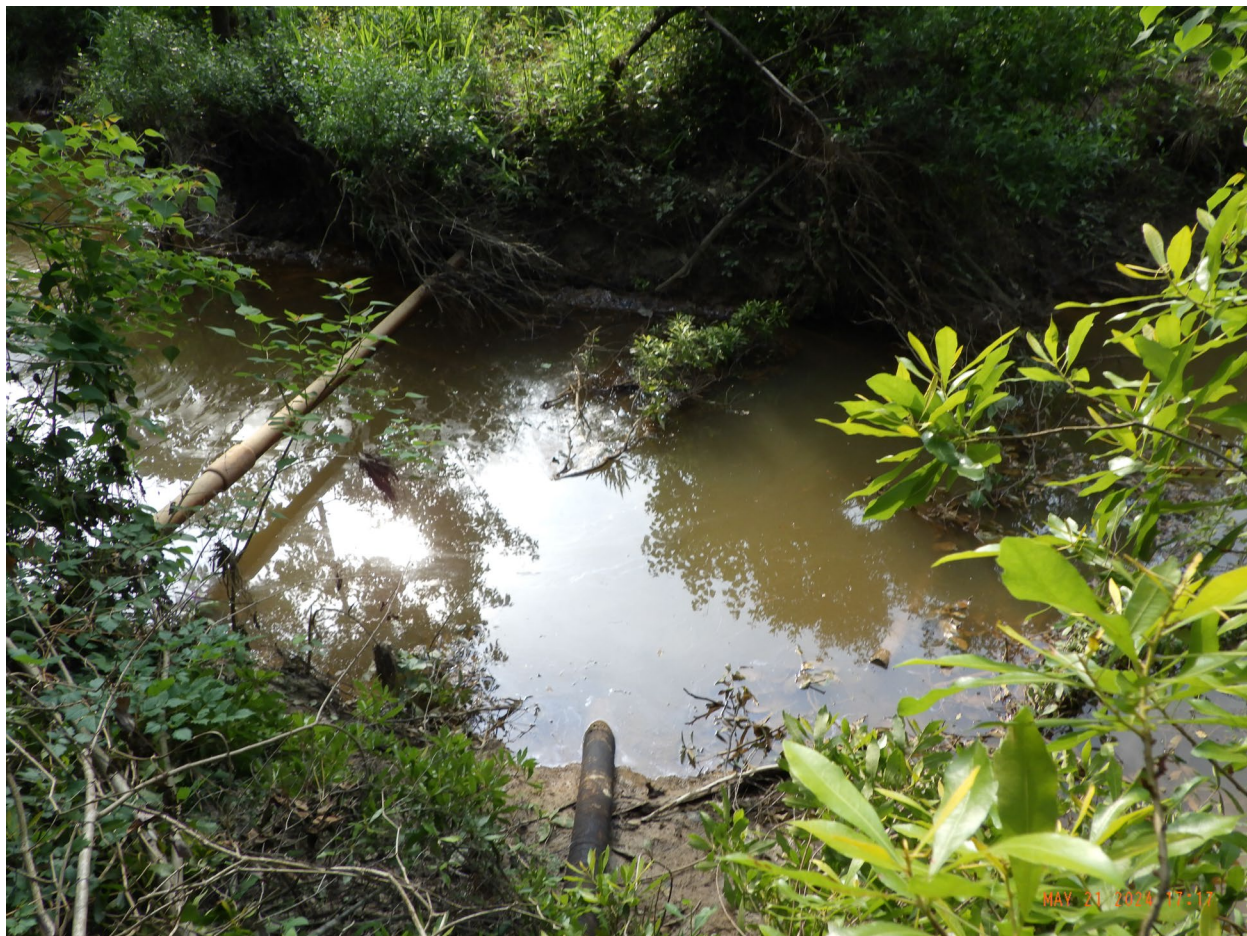
I observed the area in and around the UT of Smackover Creek that was used by Jerry Langley Oil Co., LLC personnel to collect flush water from the impacted wetland. See Photo No. 10 and No. 11.

**Description:** Looking W-NW, this photo shows the area in the receiving stream, UT of Smackover Creek, used for the collection of flush water. The hose in the photo was used to connect to a pumper truck operated by Jerry Langley Oil Co., LLC personnel.

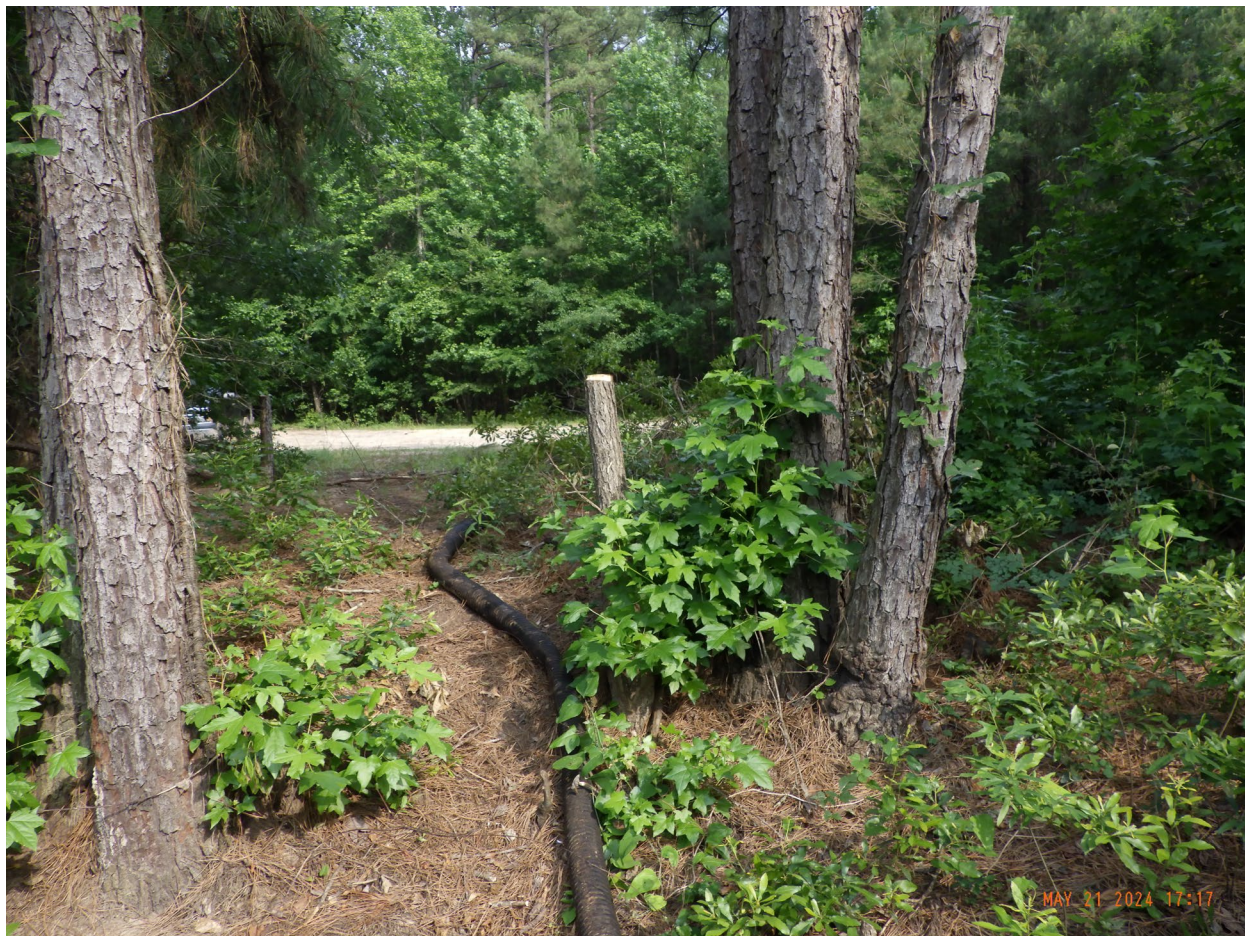
Photo No. 11

**Description:** Looking SE, this photo shows the hosing, from Photo No. 10, that was used for collecting flush water, staged on a well pad for the pumper truck.

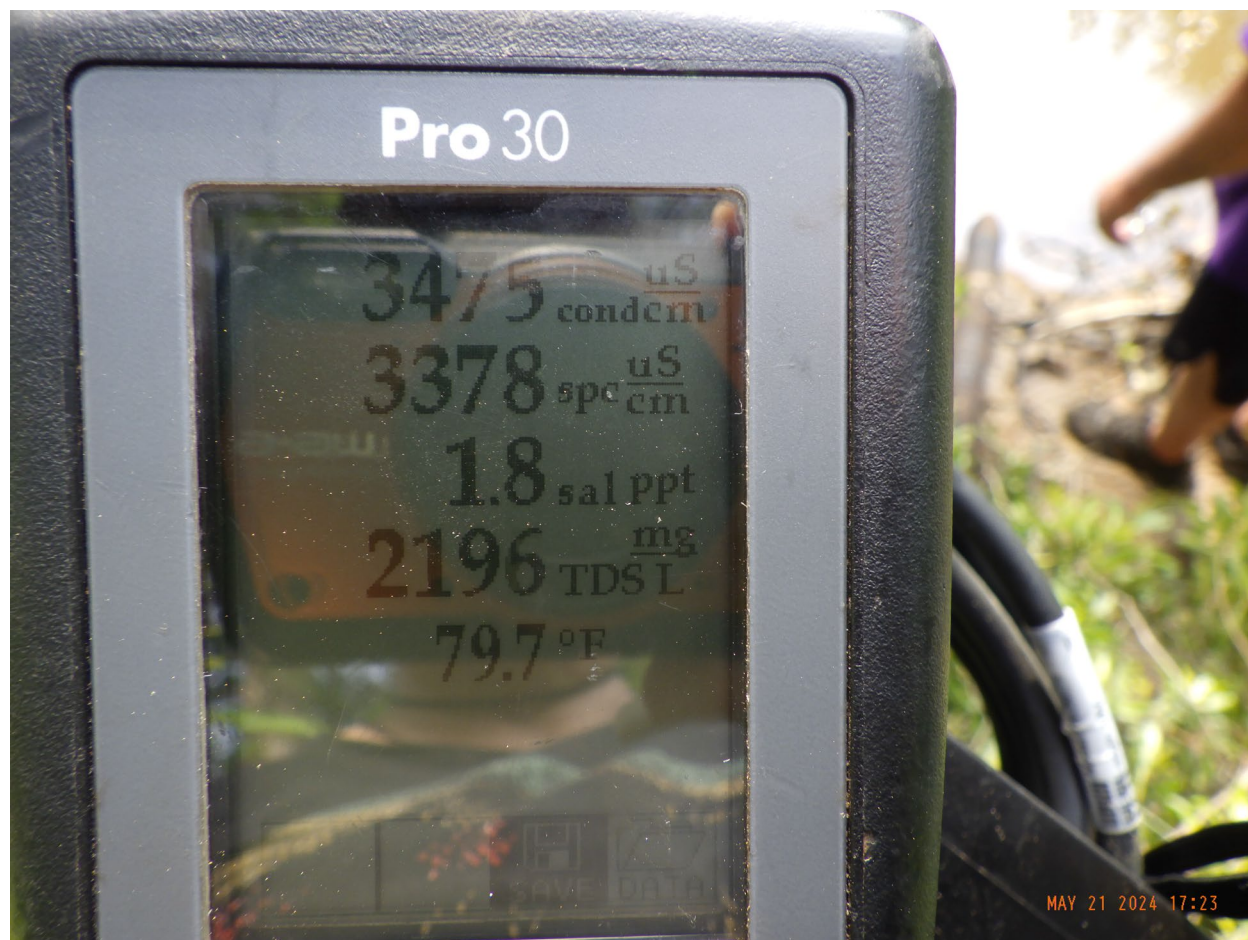
Photo No. 12

I collected a TDS reading of 2,196 mg/L from the area used as a collection site for the flush water from the impacted wetland. See Photo No. 12.

**Description:** Looking NW, this photo shows a TDS reading of 2,196 mg/L for the flush water collection site in the receiving stream, UT of Smackover Creek.

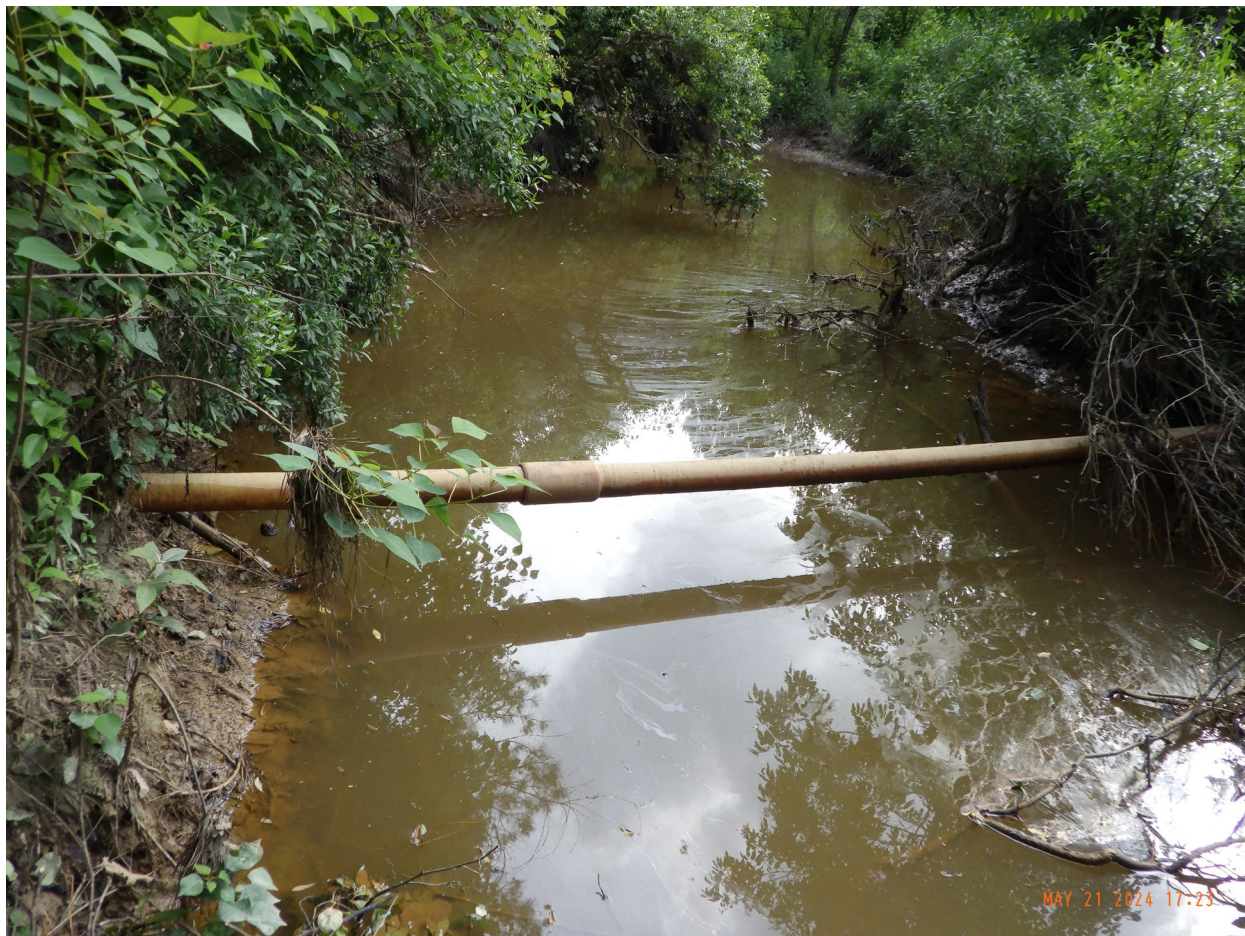
I observed the vegetation and bed and bank features upstream and downstream of the collection site, where the TDS reading was collected. See Photo No. 13 and No. 14.

**Description:** Looking W-SW, this photo shows the upstream view of the receiving stream, UT of Smackover Creek, for the TDS reading in Photo No. 12.

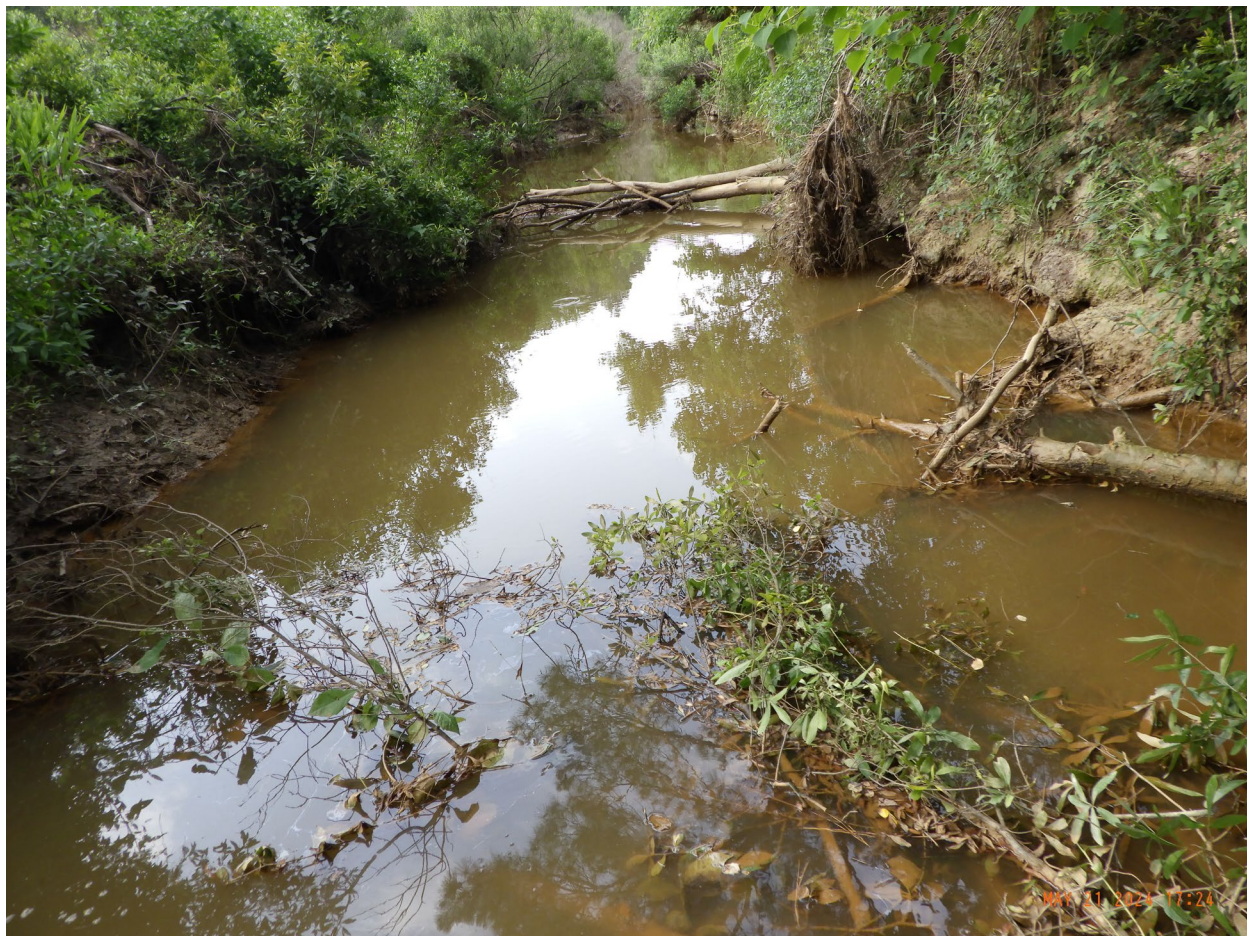
Photo No. 14

**Description:** Looking N, this photo shows the downstream view of the receiving stream, UT of Smackover Creek, for the TDS reading in Photo No. 12.
