## **RCRA Inspection Report**

United Parcel Service, Inc.  
2401 Jackson Ferry Road  
Montgomery, Alabama 36104

EPA ID#: ALD981758246  
NAICS #: 492110 - COURIERS AND  
EXPRESS DELIVERY SERVICES

9:30 AM June 15, 2013

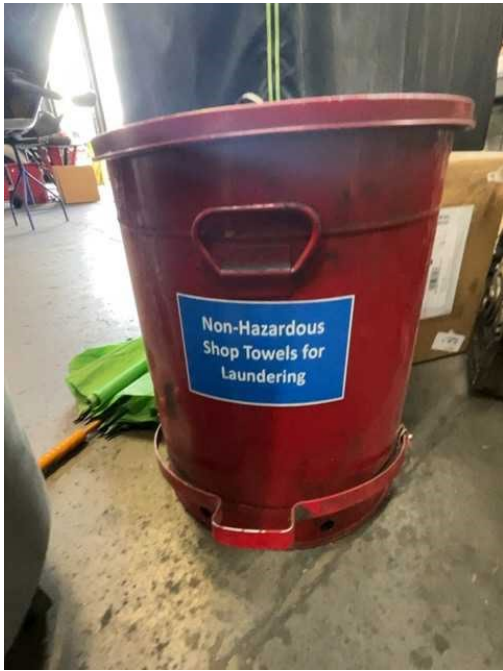
The facility Auto Shop is located in the southwest corner of the Warehouse. The Auto Shop conducts routine maintenance and repair operations including oil and tire changes and engine repair for UPS fleet vehicles. Used oil, universal waste batteries, and waste spray paint and lube aerosol cans are generated in the Auto Shop. UPS generates and stores universal waste aerosol cans in a container in this area before transferring aerosol cans to the damage processing area.. The container was marked Oily rags generated in this area are laundered by Aramark. Inspectors observed four 25-gallon containers in this area labeled “nonhazardous rags for laundering,” (Photo #1) and a shelf storing spent lead acid batteries (Photo #2).

| | <p>Photo #1 – 25-gallon container for oily rags in the Auto Shop. Rags generated in this area are laundered by Aramark.</p> |

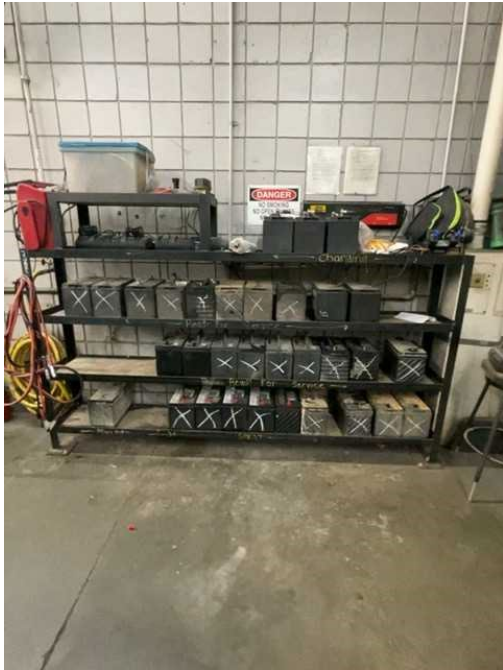
| | <p>Photo #2 – Shelf of spent lead acid batteries observed in the Auto Shop.</p> |

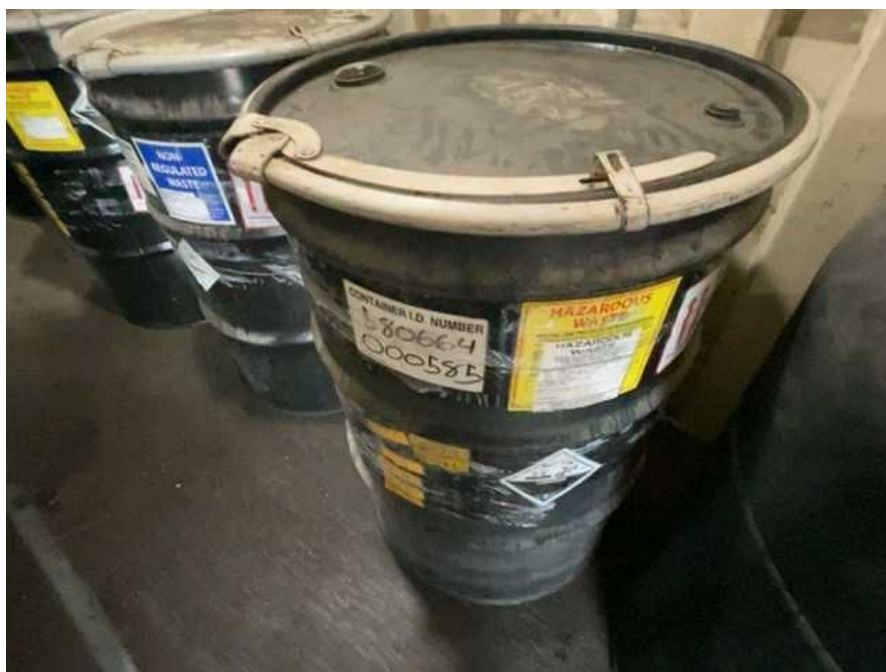
- One 55-gallon drum labeled "Hazardous Waste, UN3265 Waste Corrosive Liquid, Accumulation Start: April 26, 2023." This container was marked with a DOT Class 8 Corrosive placard (Photo #5).

Photo #5 –  
Partially full  
hazardous  
waste container  
in the  
hazardous  
waste storage  
area.

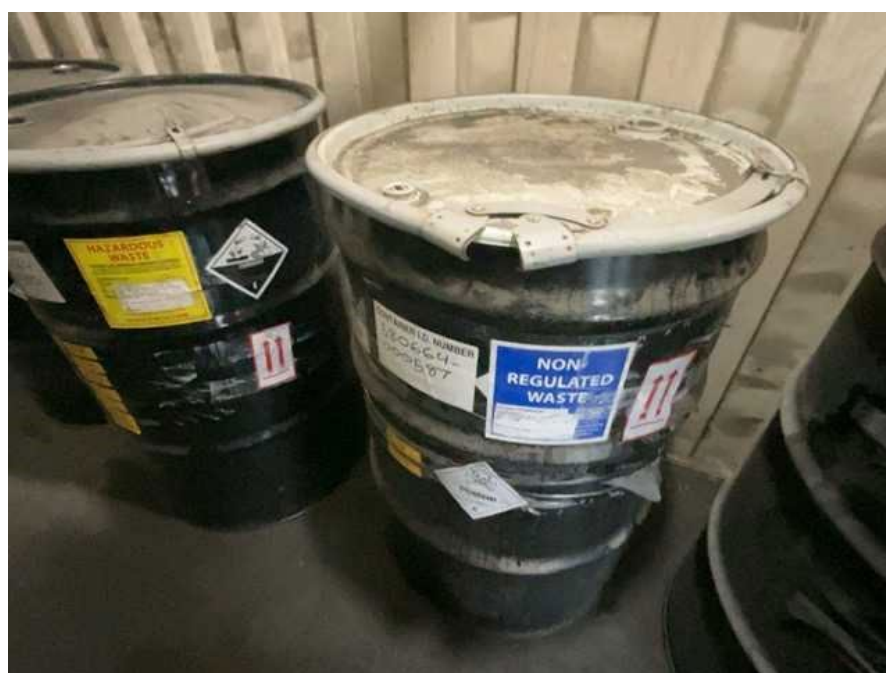
- One 55-gallon drum labeled “Nonhazardous Corrosive Basic Liquid” Facility representatives informed inspectors that the material in these containers was not RCRA hazardous (Photo #6).

Photo #6 –  
Containers of  
non-RCRA  
hazardous toxic  
and corrosive  
wastes
