**Region 6 - Enforcement & Compliance Assurance Division**  
**INSPECTION REPORT**

| Inspection Date(s): | 01/19/2022 | |
| Company Name: | Town of Red River | |
| Facility Name: | Red River WWTP | |

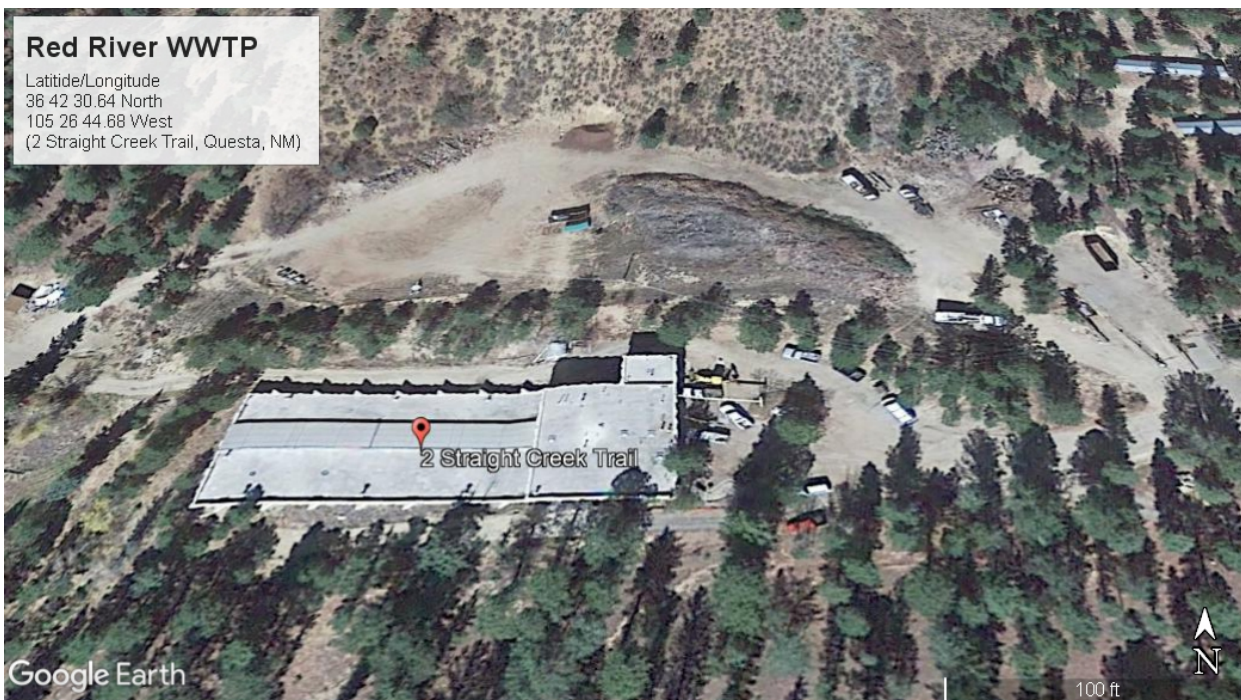
**Aerial Image #1:** Overall view of the Town of Red River’s Wastewater Treatment Plant. Aerial from Google Earth maps.

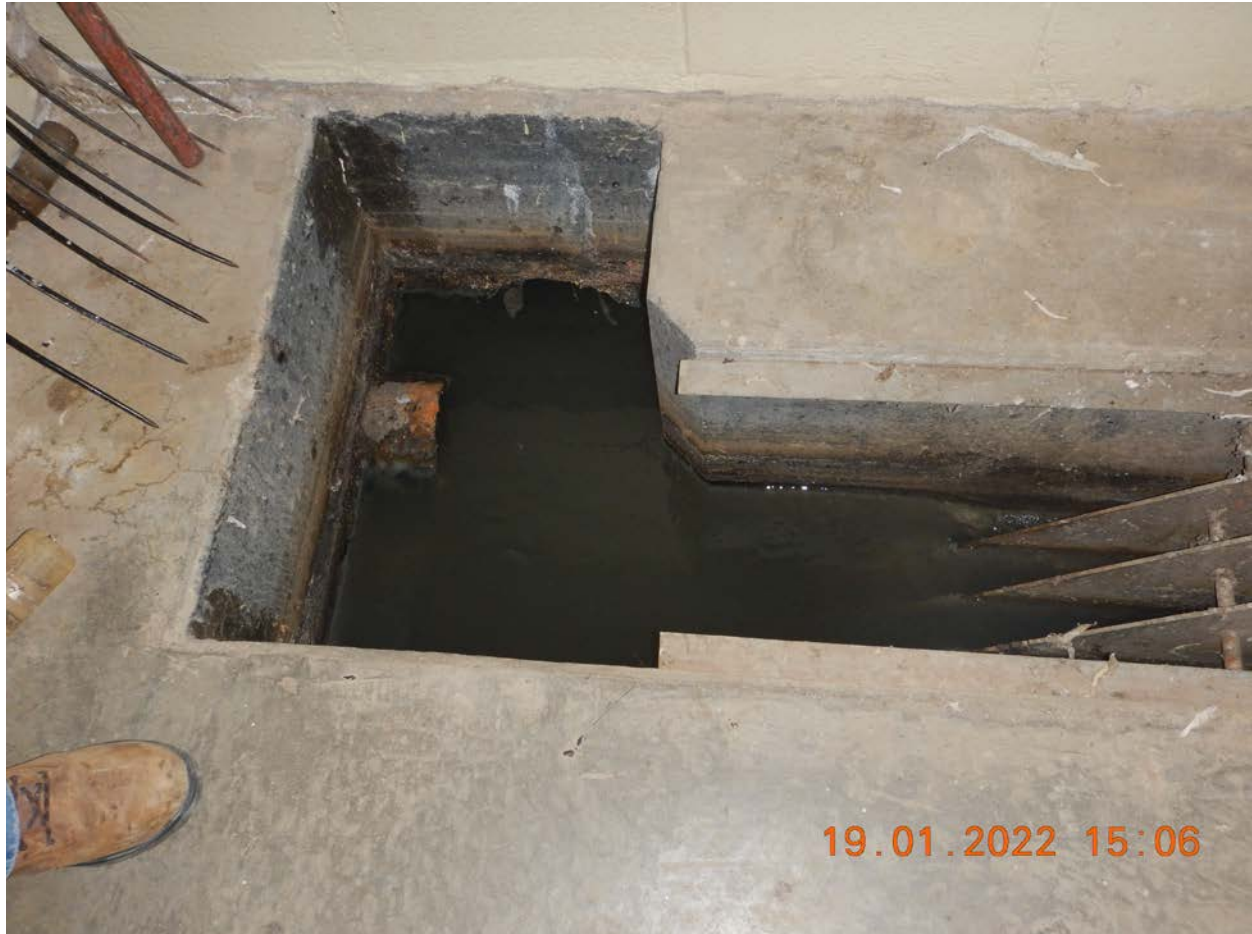
Photo No. 1

View of the headworks comprised of a bar screen/grit removal system. (DSCN2098). Photographed by D. Esparza

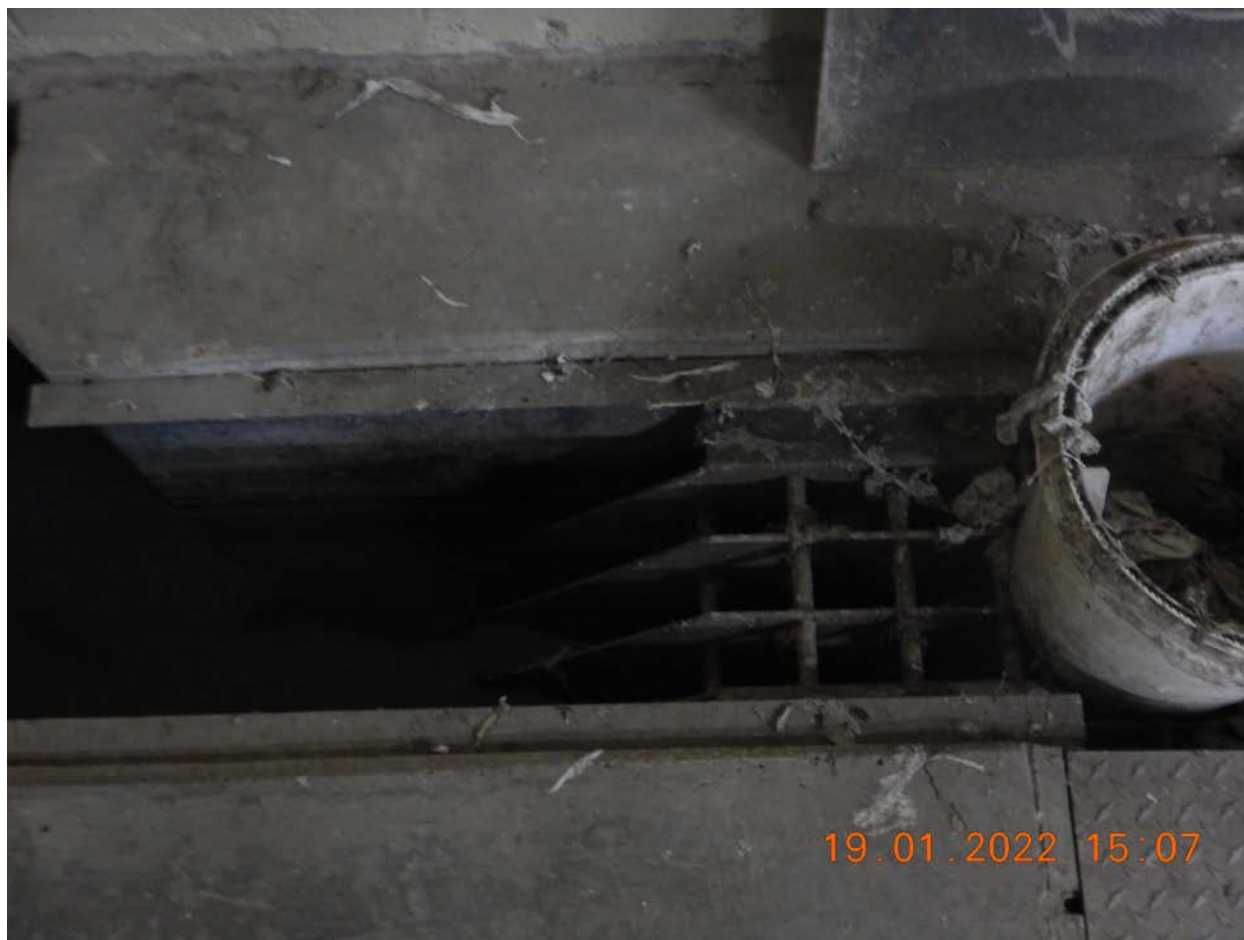
Photo No. 2

Another view of the headworks comprised of a bar screen/grit removal system. (DSCN2099).  
Photographed by D. Esparza

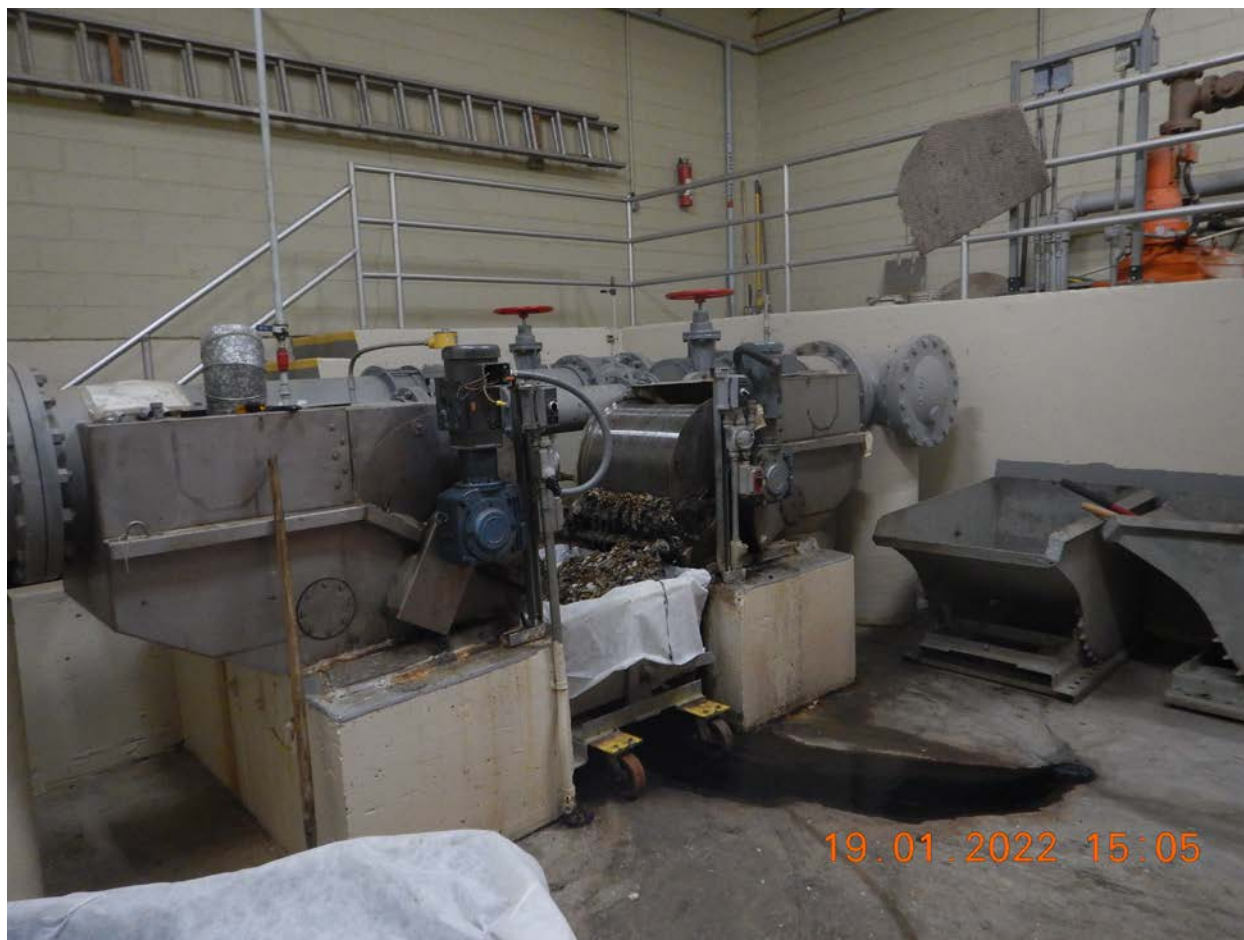
Photo No. 3

- The WWTP does not have back-up for some of its aging treatment process equipment (**Appendix 1 Photograph #3, and Photograph #4**), i.e., if equipment or mechanical systems go off-line replacement parts are difficult to locate and often require specific manufacture reproduction.

View of the screened fine mesh filter. (DSCN2097). Note: one (1) mesh filter is currently off-line awaiting repair and/or maintenance. Photographed by D. Esparza

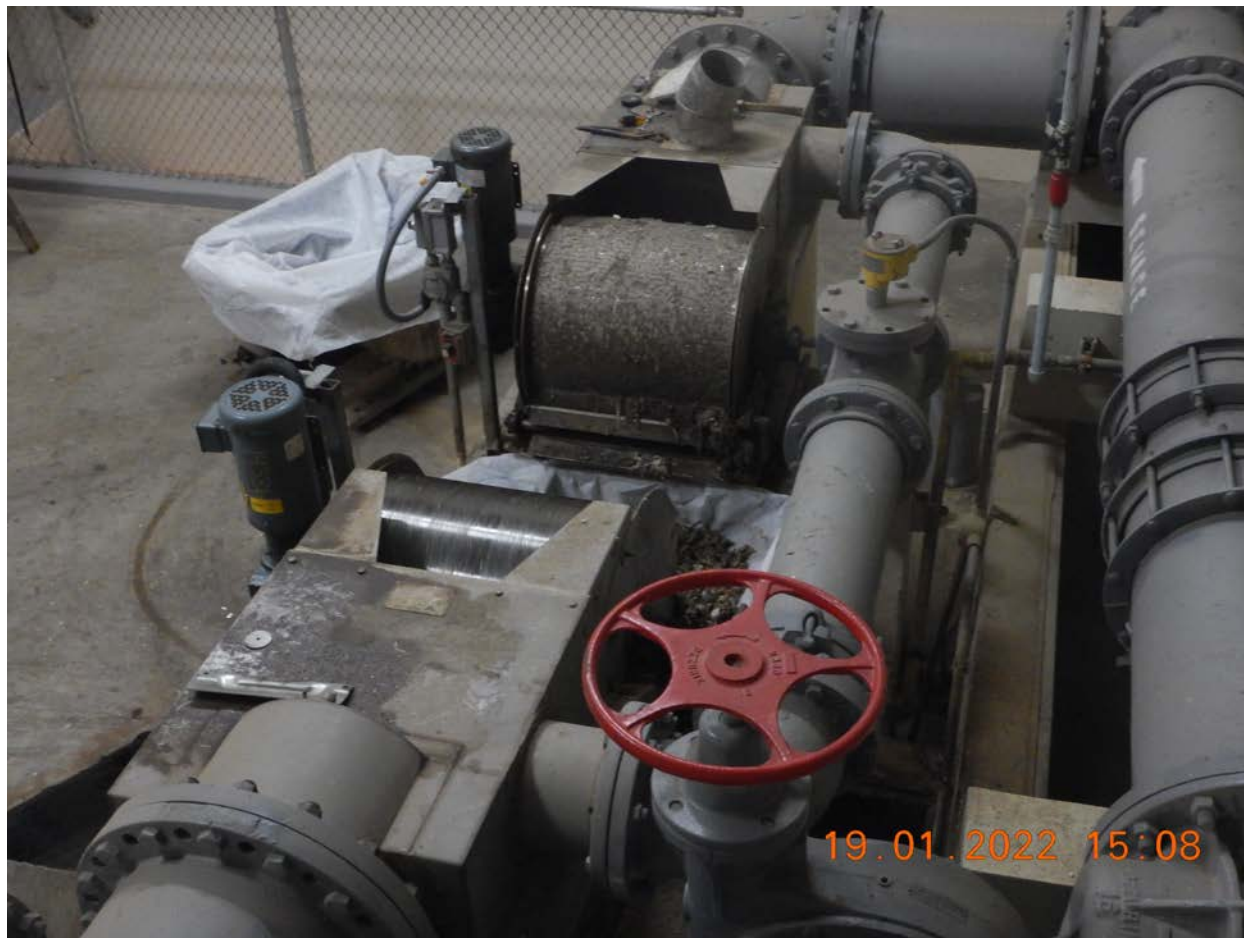
Photo No. 4

Another view of the screened fine mesh filter. (DSCN2100). Note: one (1) mesh filter is currently off-line awaiting repair and/or maintenance. Photographed by D. Esparza

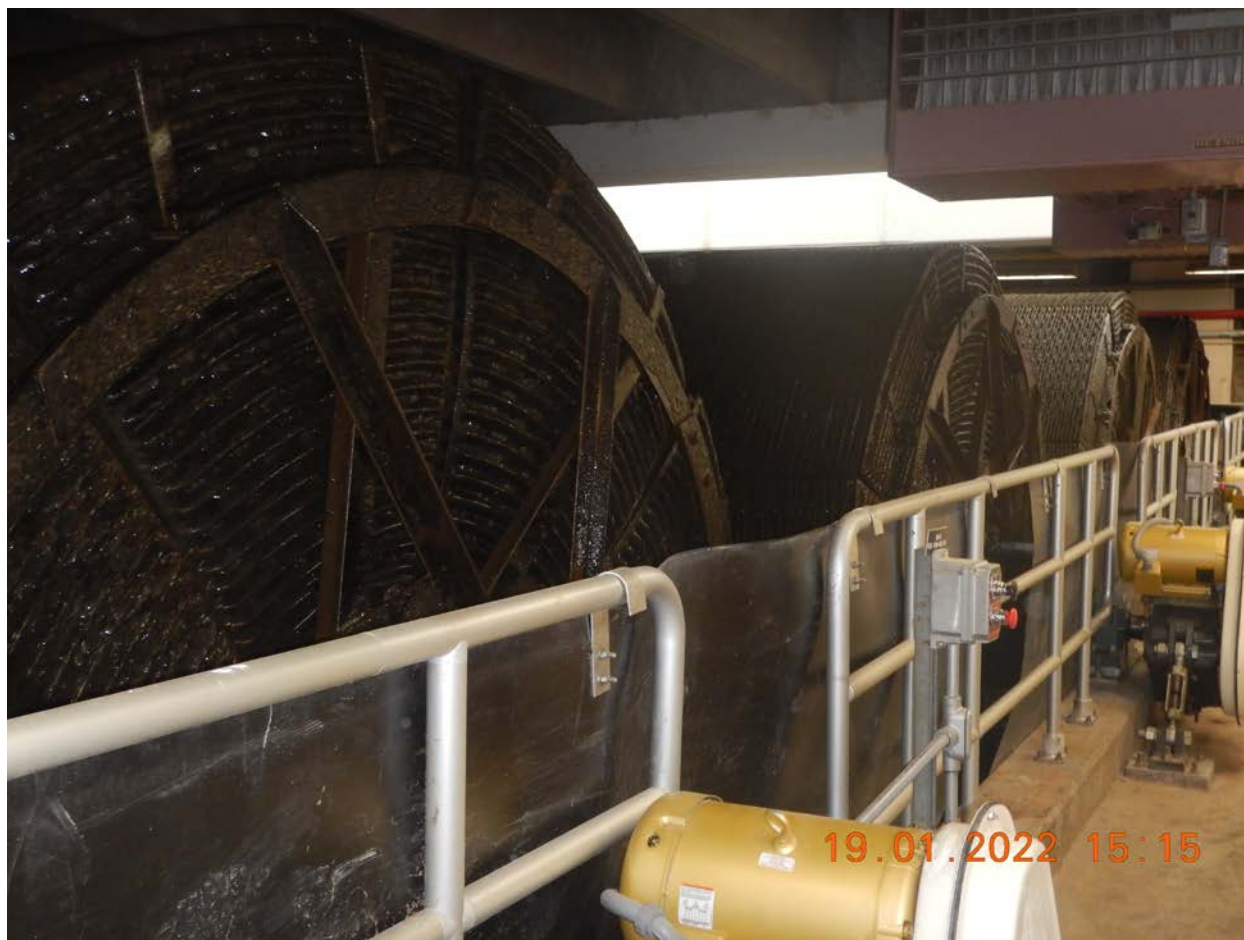
Photo No. 5

View of the three (3) trains of Rotating Biological Contactors (RBCs): one (1) for biological oxygen demand (BOD) removal and two (2) for ammonia removal. (DSCN 2102). Photographed by D. Esparza

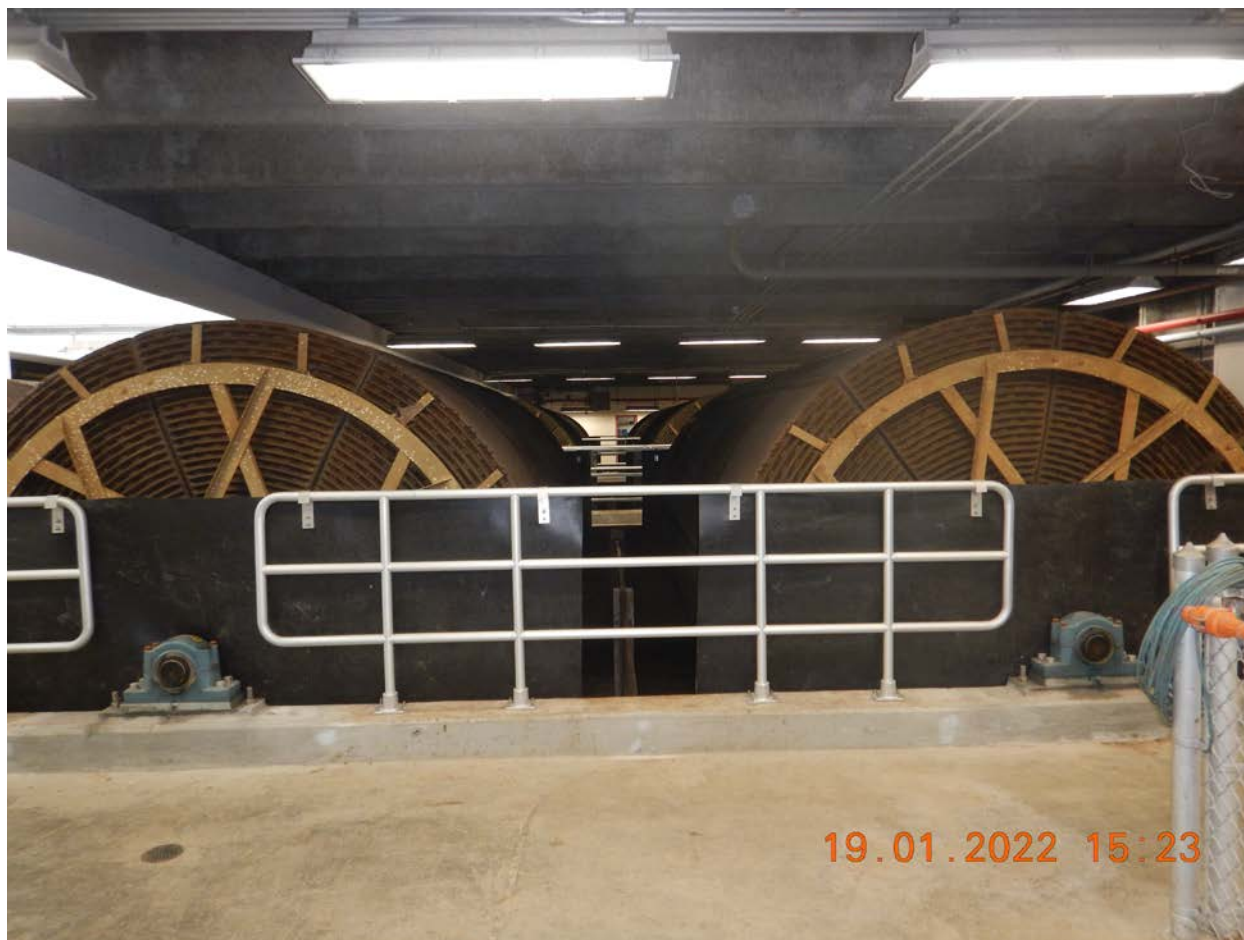
Photo No. 6

Another view of the Rotating Biological Contactors (RBCs): one (1) for biological oxygen demand (BOD) removal and two (2) for ammonia removal. (DSCN 2105). Photographed by D. Esparza

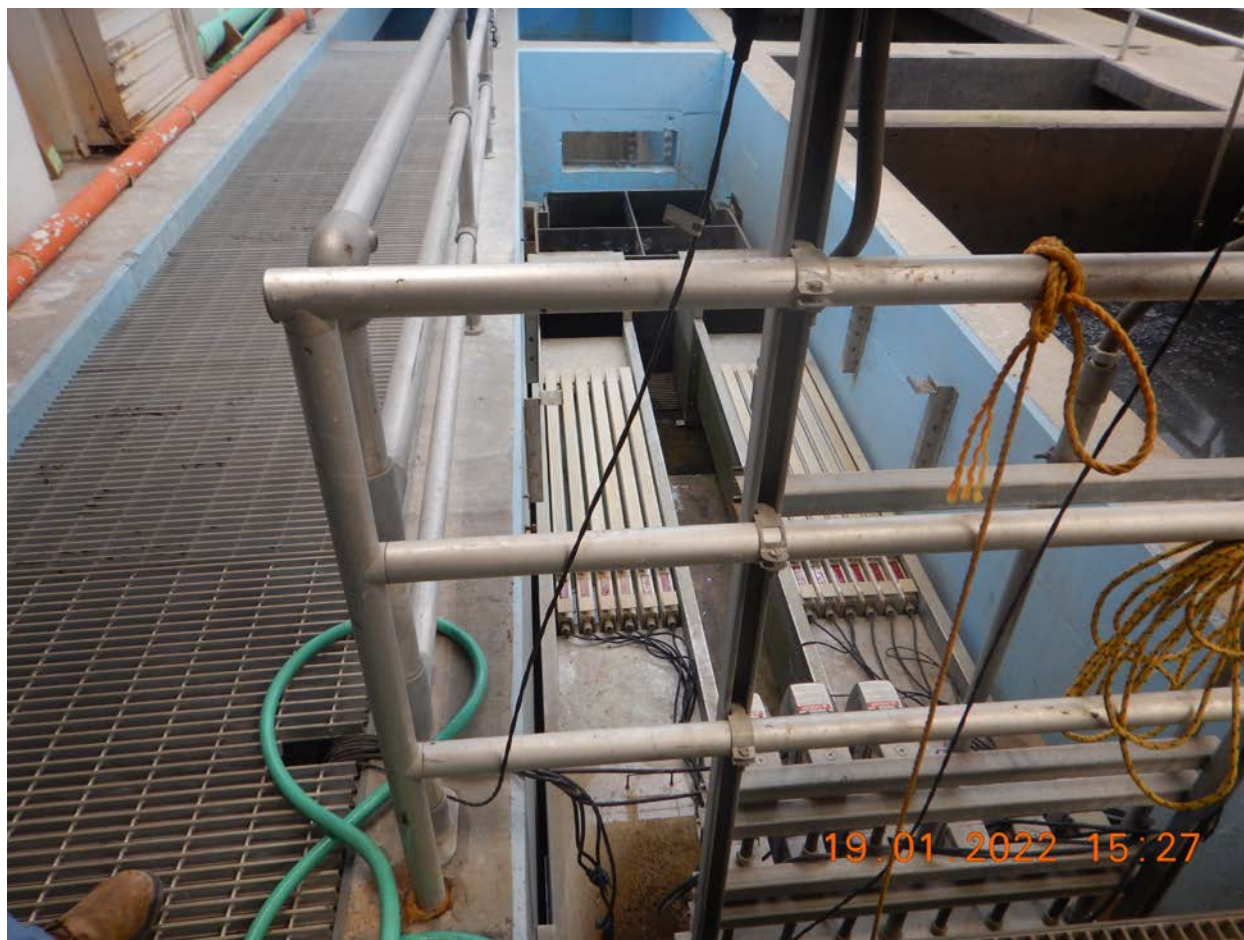
Photo No. 7

View of the three (3) parallel ultraviolet (UV) disinfection banks. (DSCN 2107) Photographed by D. Esparza

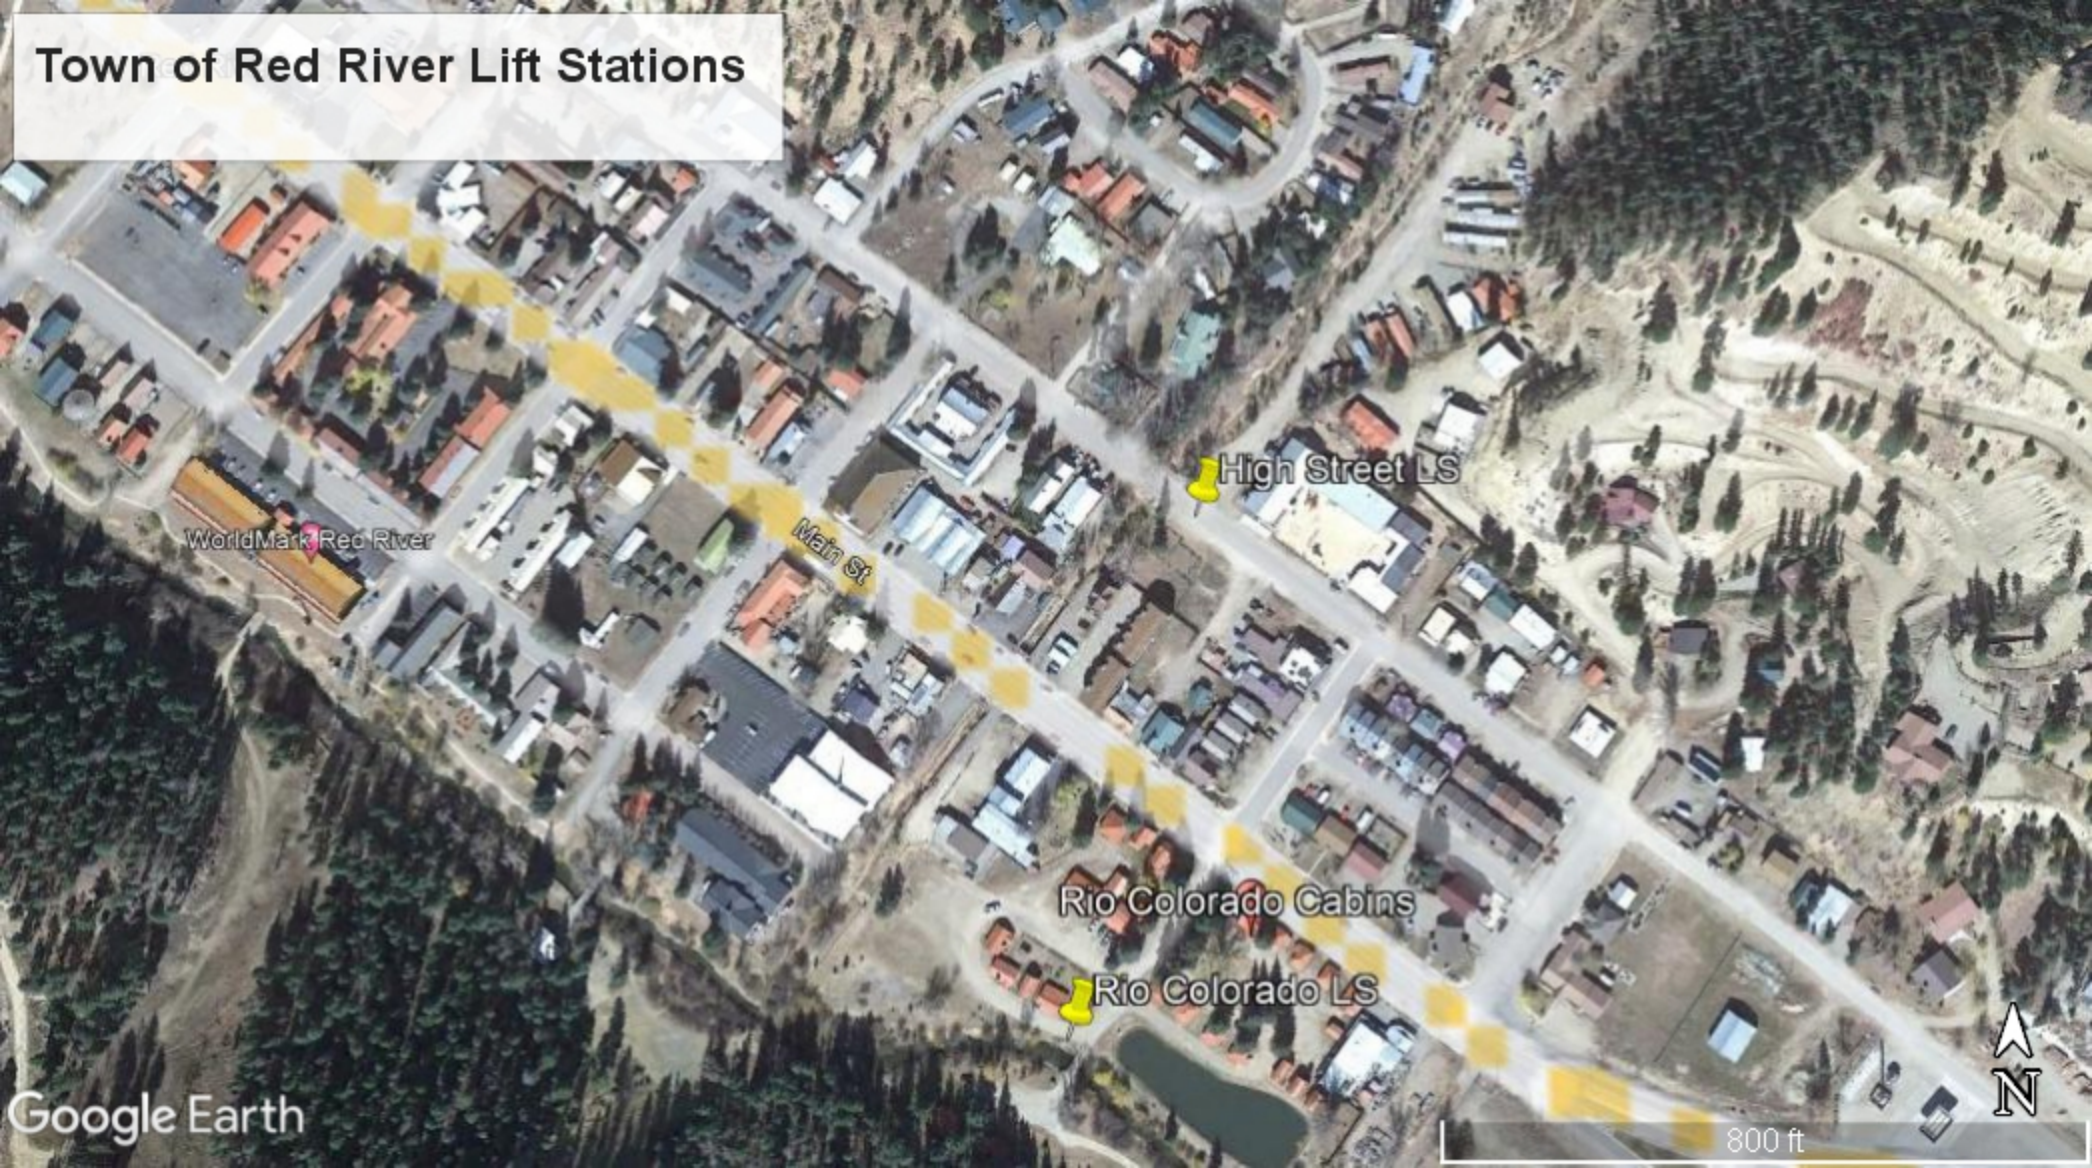
### Aerial Image of The Lift Station Locations

**Table 1: Town of Red River Lift Stations**

| | Lift Station | Address |
| 1 | High Street | 461 East High Street |
| 2 | Rio Colorado | approximately at the end of Golden Treasure Trail |
