# Photographs for Emit Technologies; Optio WG-II GPS Camera, Memory Card - 0613 SL1214 Q

Inspection Type: Pretreatment

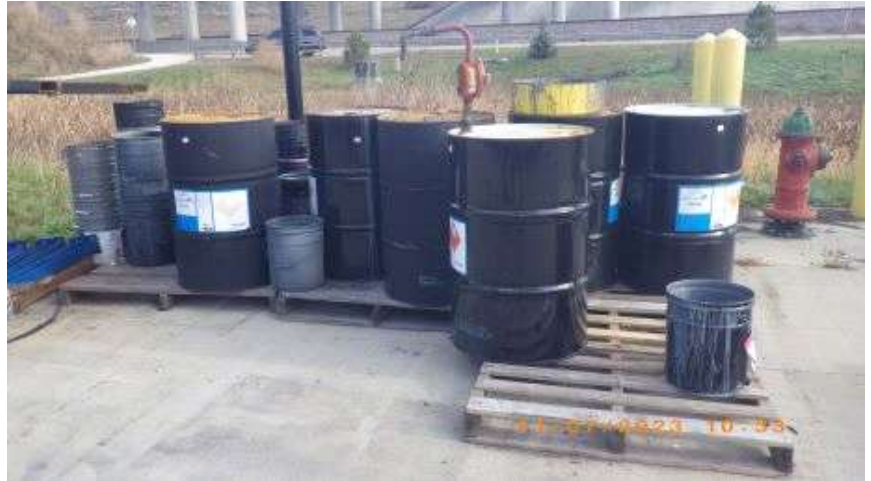
Photo number 116 taken by Stephanie Passarelli on 11/7/2023.

Xylene Storage/Handling and Waste Paint collection/storage; Note: below-grade stormwater detention pond behind the storage location and within 50 feet.

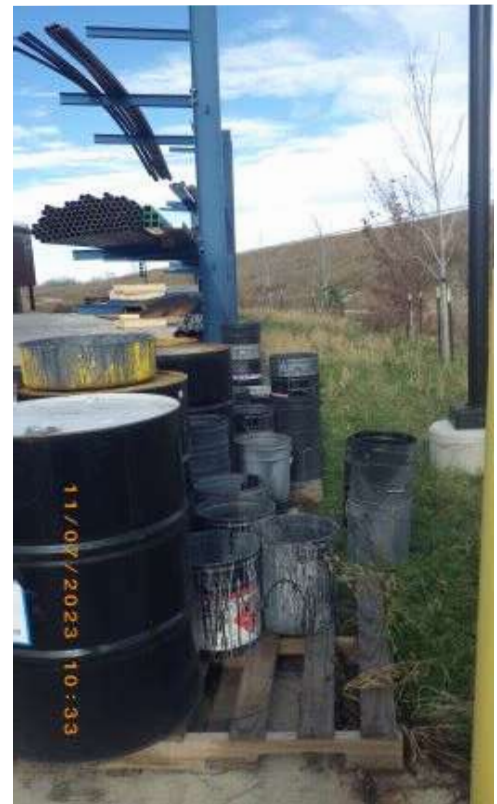
Photo number 117 taken by Stephanie Passarelli on 11/7/2023.

Xylene and Waste Paint Storage - buckets of wet paint stored in the location for evaporation

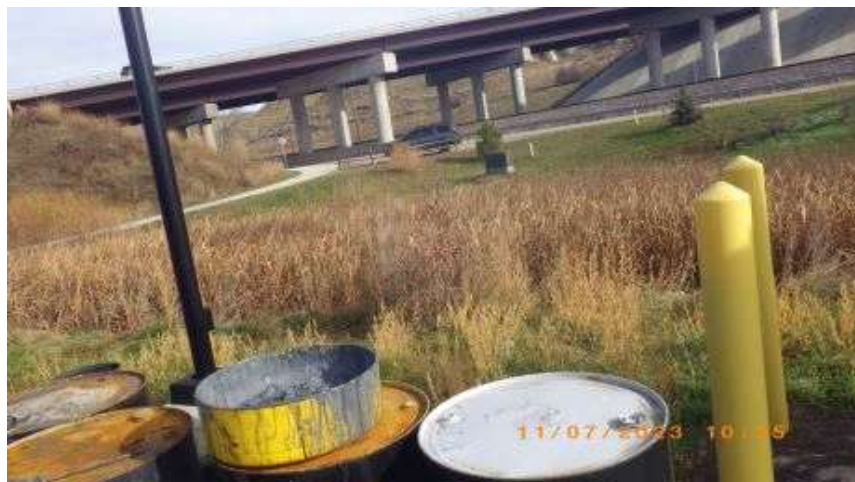
Photo number 118 taken by Stephanie Passarelli on 11/7/2023.

Xylene and Waste Paint Storage - View of Stormwater detention pond

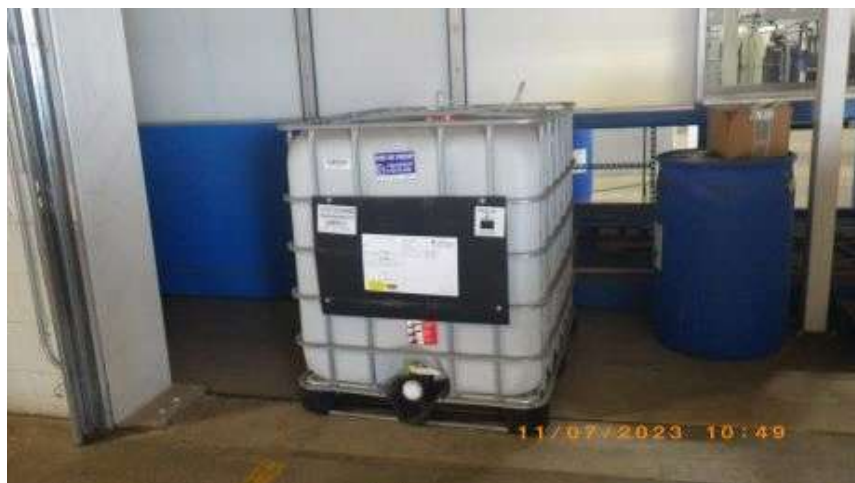
Photo number 119 taken by Stephanie Passarelli on 11/7/2023.

4-Stage Phosphating Line - Sealant 250-gallon tote  
Chemical storage(Stage 4)

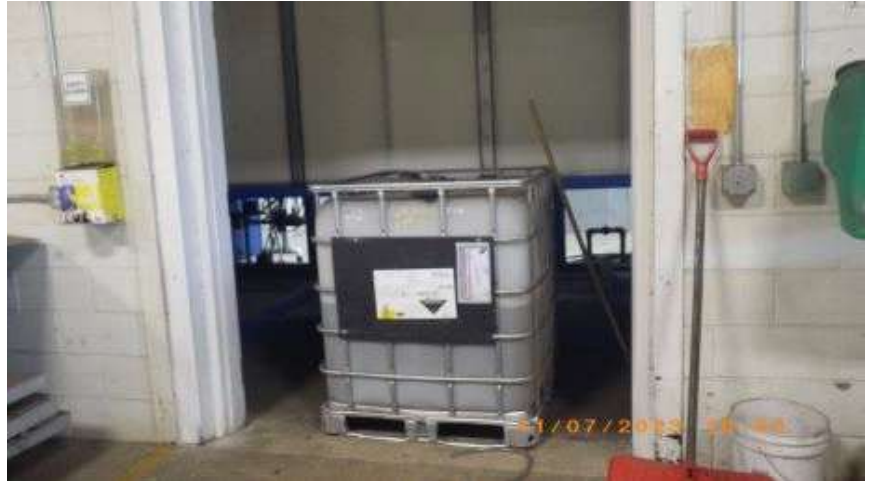
Photo number 120 taken by Stephanie Passarelli on 11/7/2023.

4-Stage Phosphating Line - Phosphoric Acid 250-gallon tote Chemical storage(Stage 1)

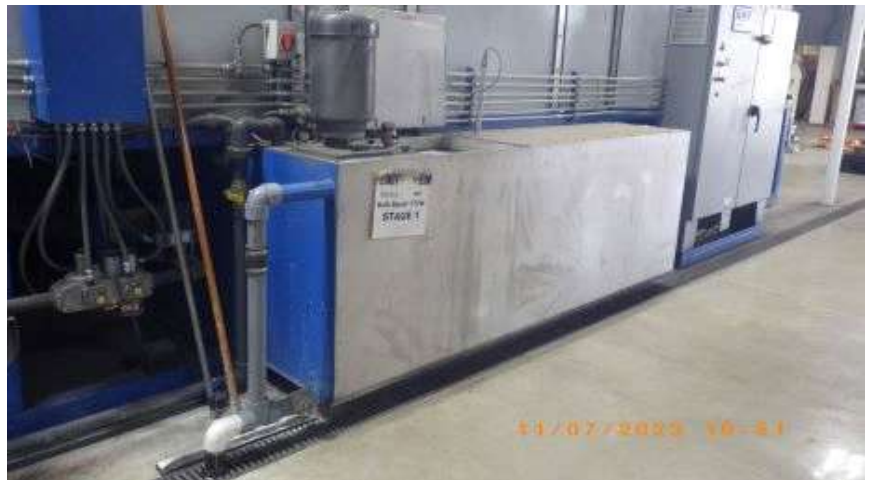
Photo number 121 taken by Stephanie Passarelli on 11/7/2023.

4-Stage Phosphating Line - Phosphoric Acid 1,750-gallon chemical sump (Stage 1), Note: discharge pipe to trench drain leading to the City sewer system

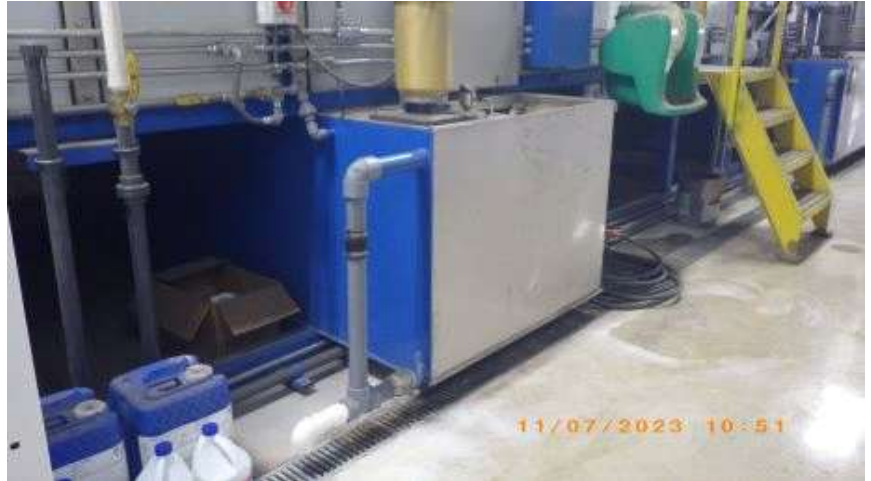
Photo number 122 taken by Stephanie Passarelli on 11/7/2023.

4-Stage Phosphating Line -Rinse water 650-gallon sump (Stage 2), Note: continuous overflow discharge pipe to trench drain leading to the City sewer system

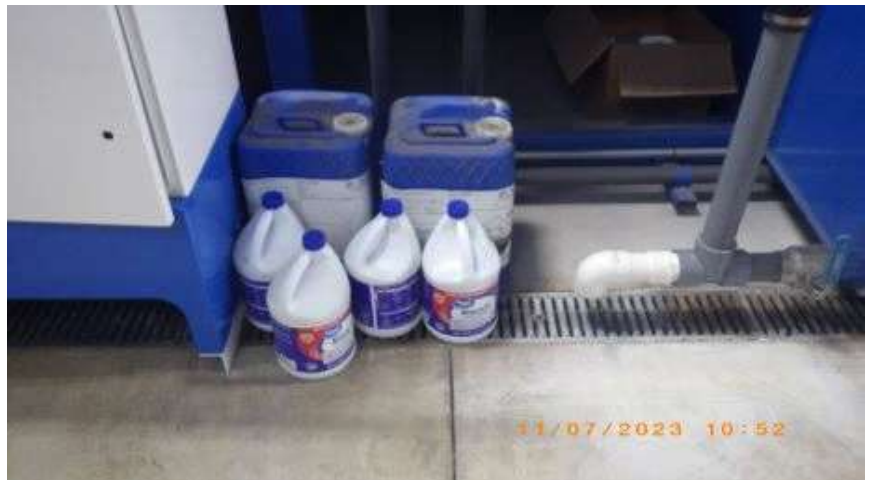
Photo number 123 taken by Stephanie Passarelli on 11/7/2023.

4-Stage Phosphating Line - Rinse water, 650-gallon chemical sump (Stage 2), Note: close up of bleach and acid storage containers over trench drain in prior photo #122

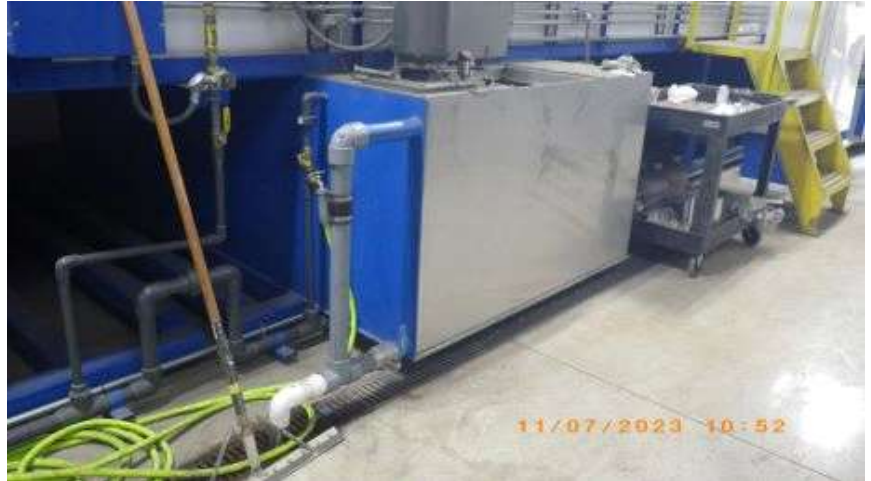
Photo number 124 taken by Stephanie Passarelli on 11/7/2023.

4-Stage Phosphating Line - Rinse water 650-gallon sump (Stage 3), Note: continuous overflow discharge pipe to trench drain leading to the City sewer system

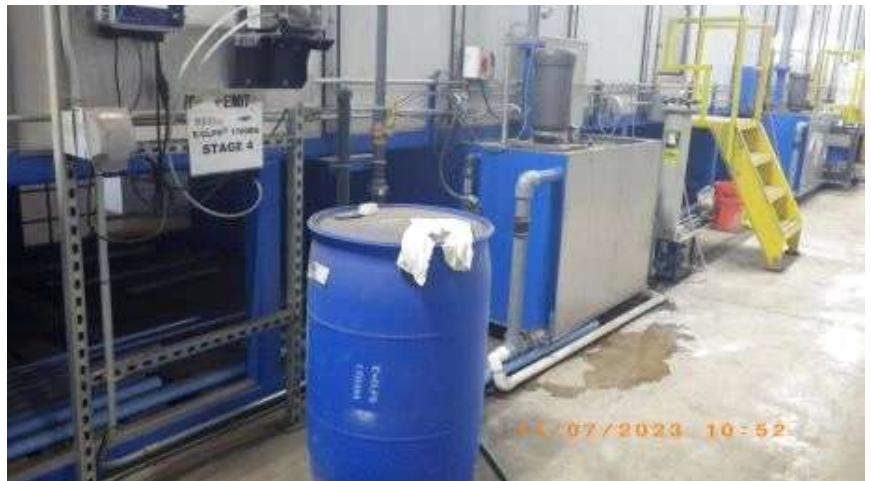
Photo number 125 taken by Stephanie Passarelli on 11/7/2023.

4-Stage Phosphating Line - Sealant [E-CLPS 1700 RA] 650-gallon chemical sump (Stage 4), Note: discharge pipe to trench drain leading to the City sewer system
