# Tittabawasse River and Floodplain Cleanup: **A Model for Success**

JUNE 15, 2017

# Tittabawasse River and Floodplain Cleanup

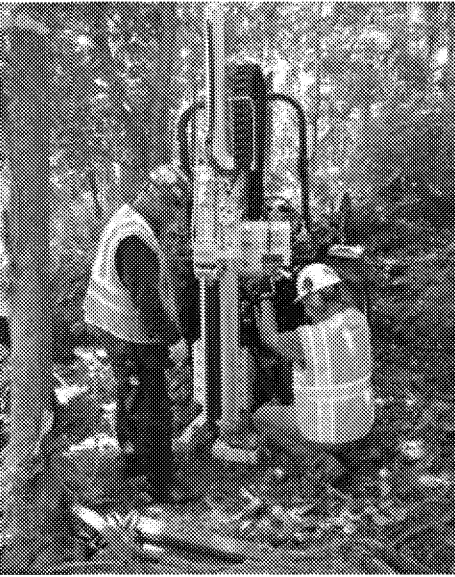
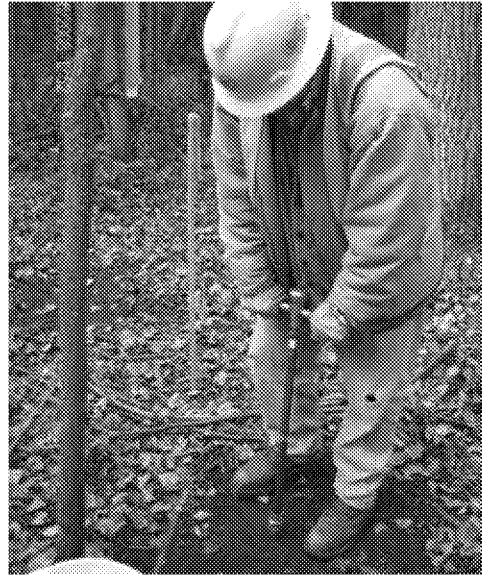
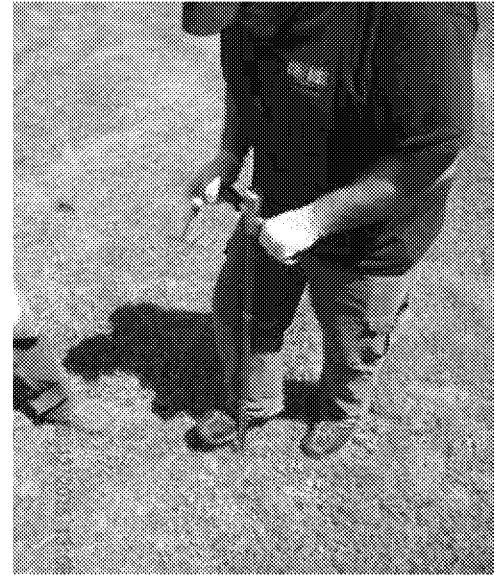
**Field crews collecting floodplain and bank soil samples**

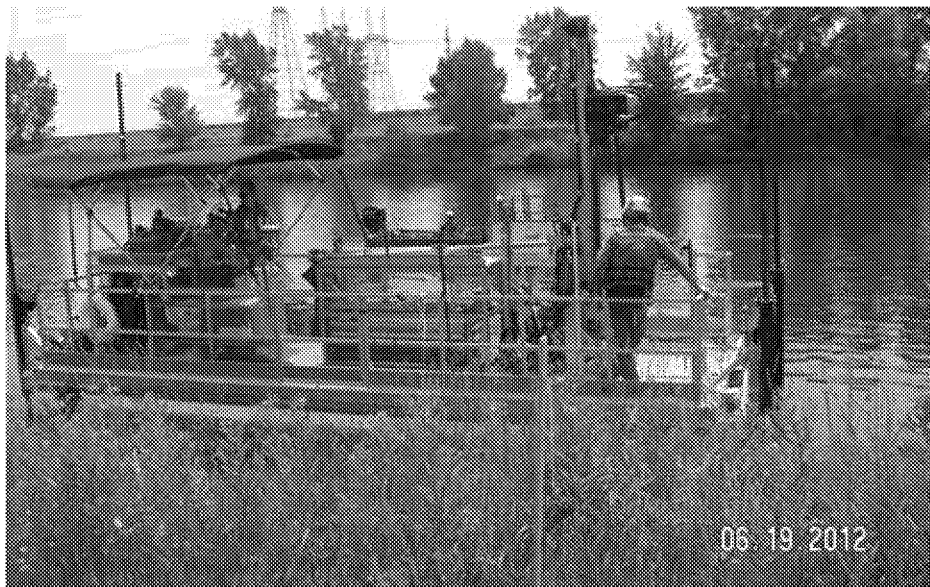
**Sonic rig used to install sampling wells**

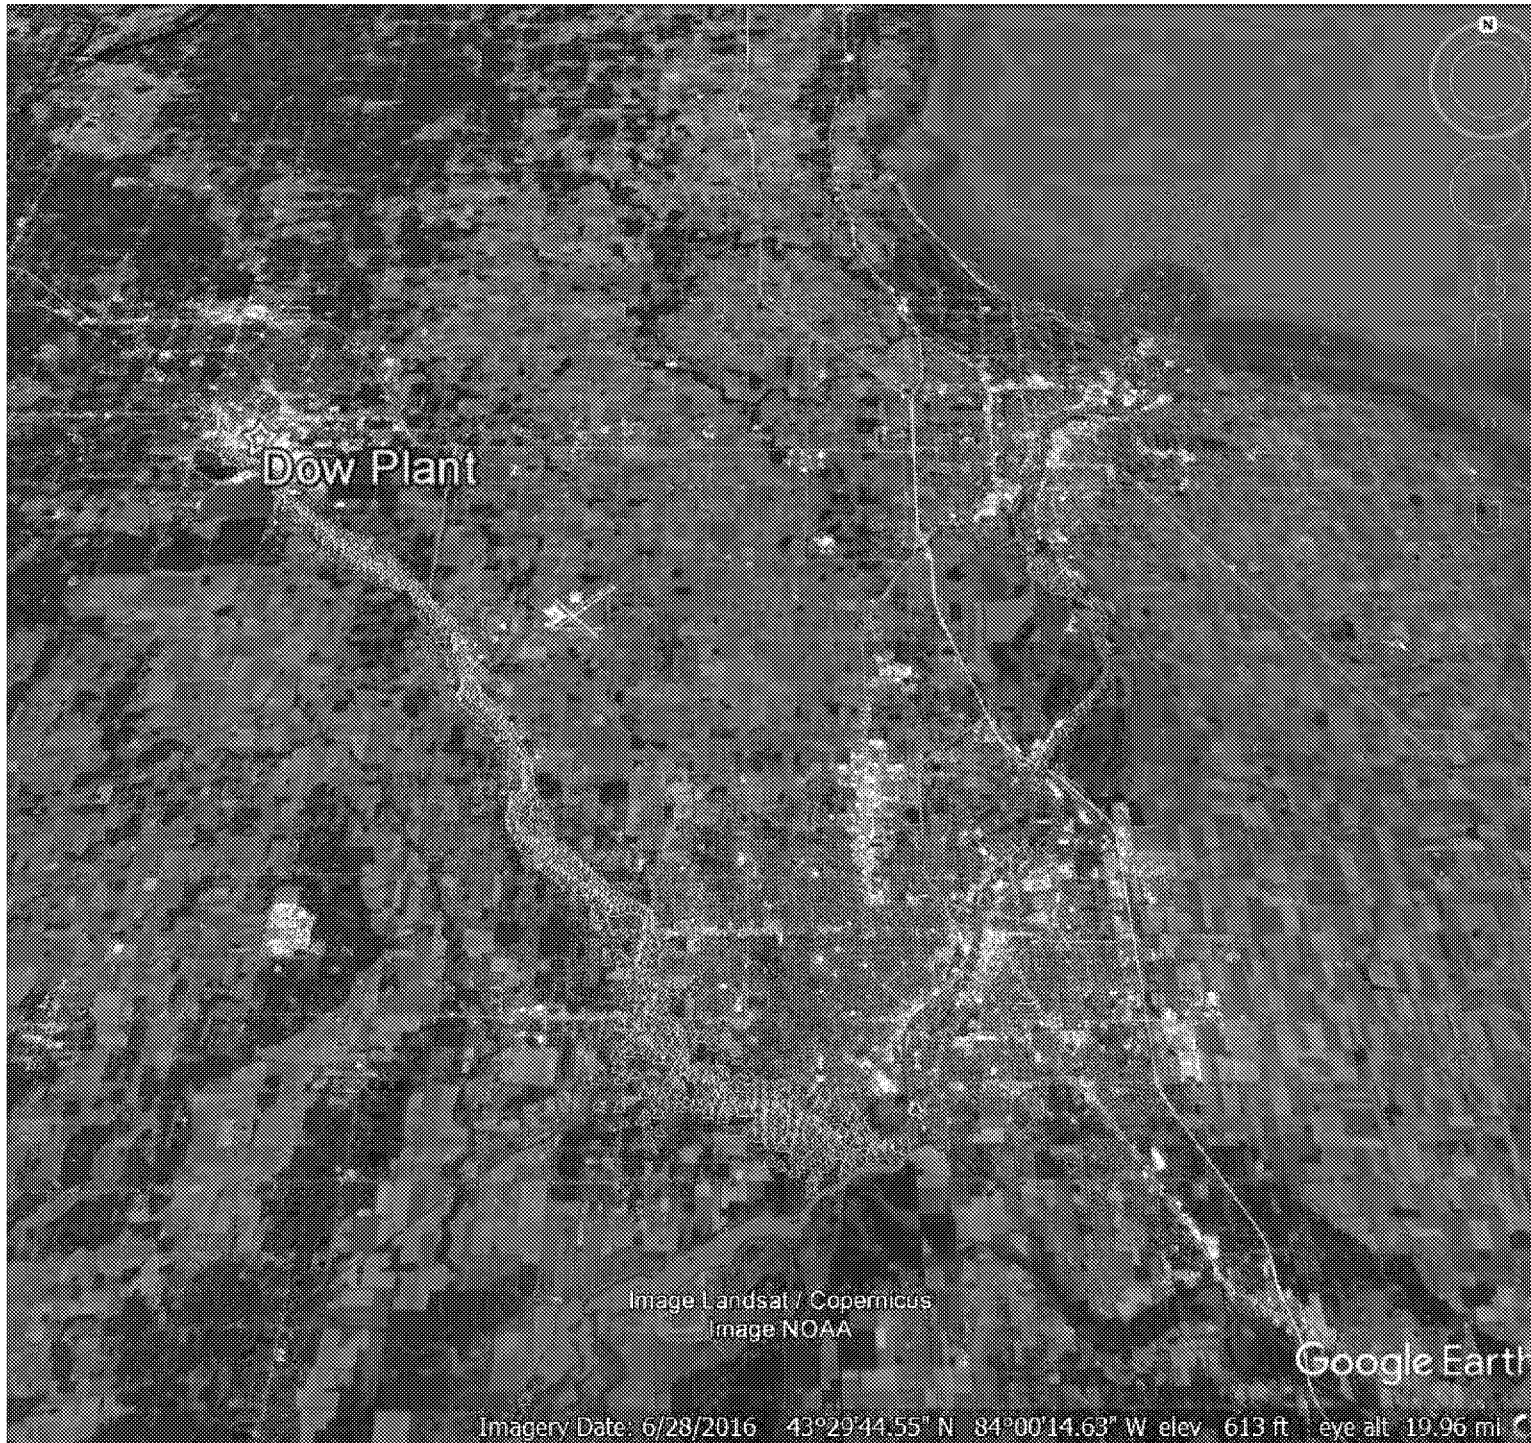
Site map showing soil and sediment sample locations

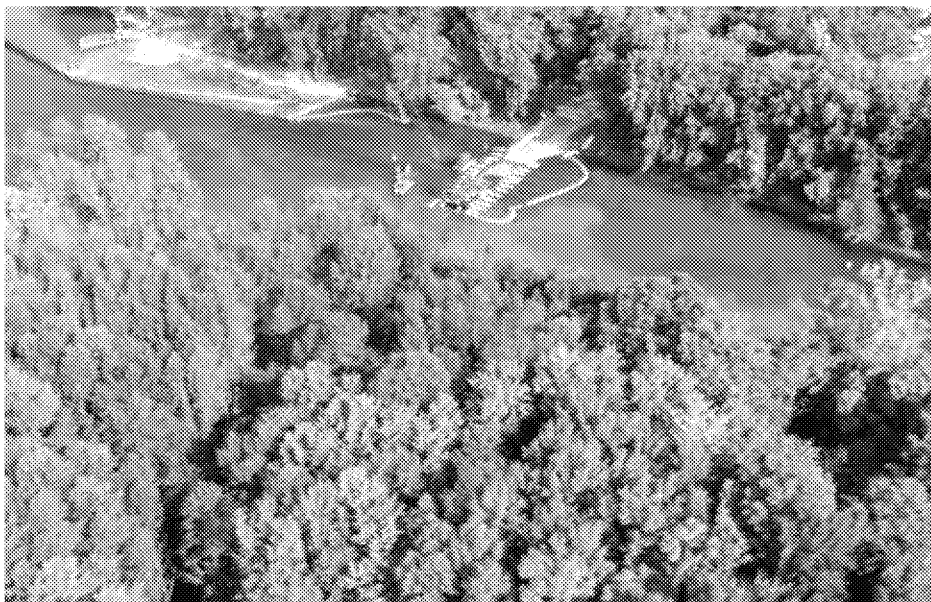
**In-channel sediment removal**

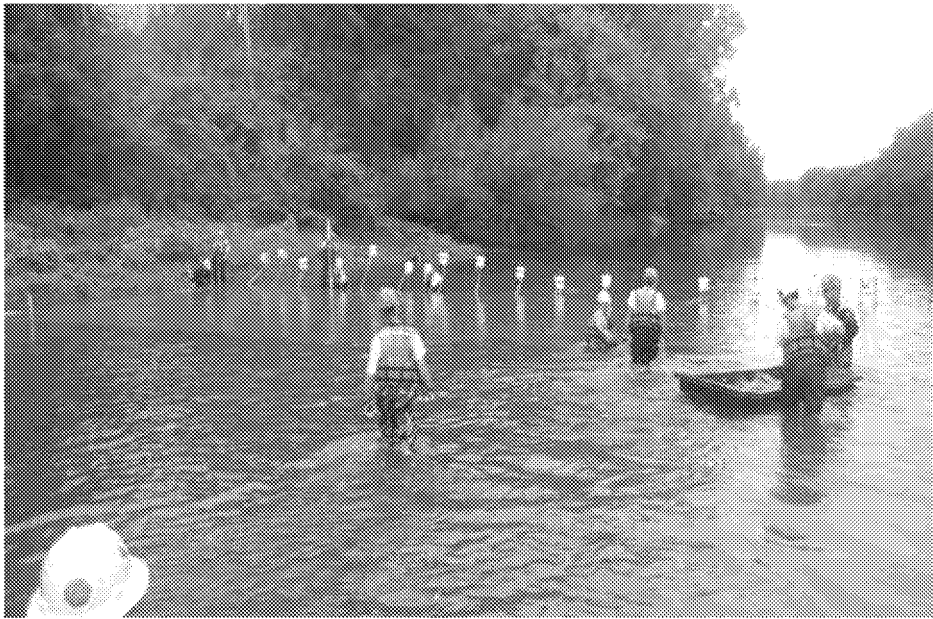
**Installation of a Cellular Containment System (CCS)**

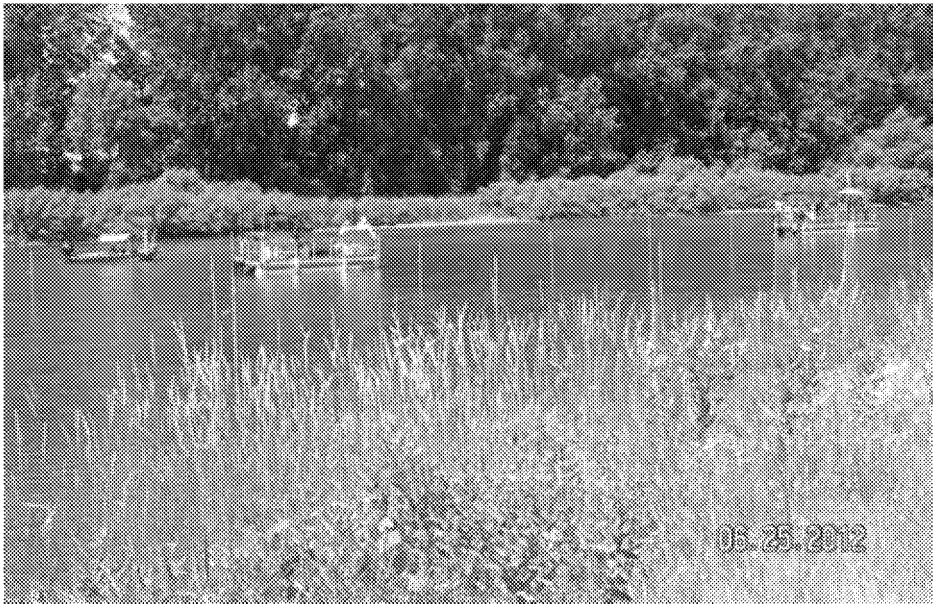
**DNAPL Recovery activities in Segment 1**

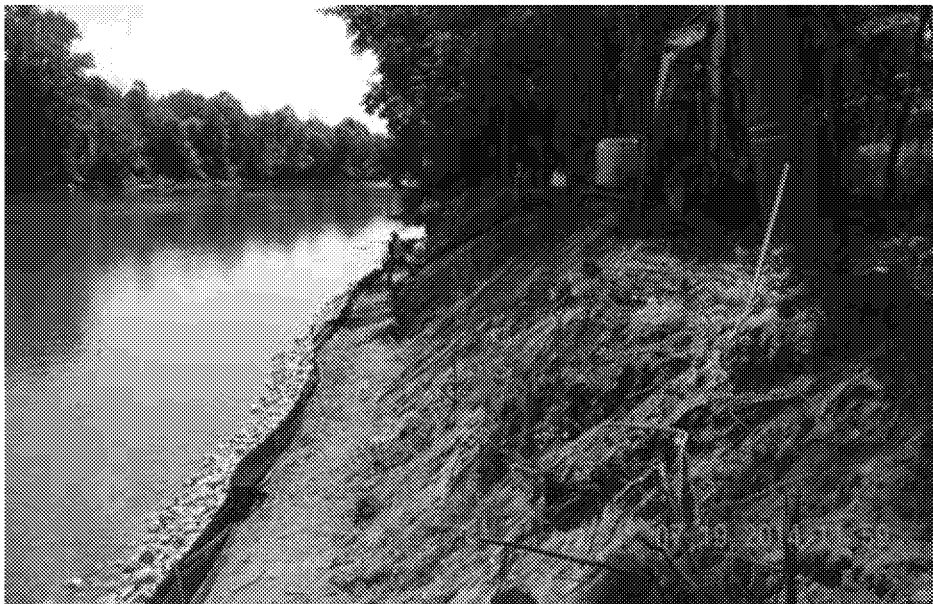
**Bank preparation for stabilization including canopy management**

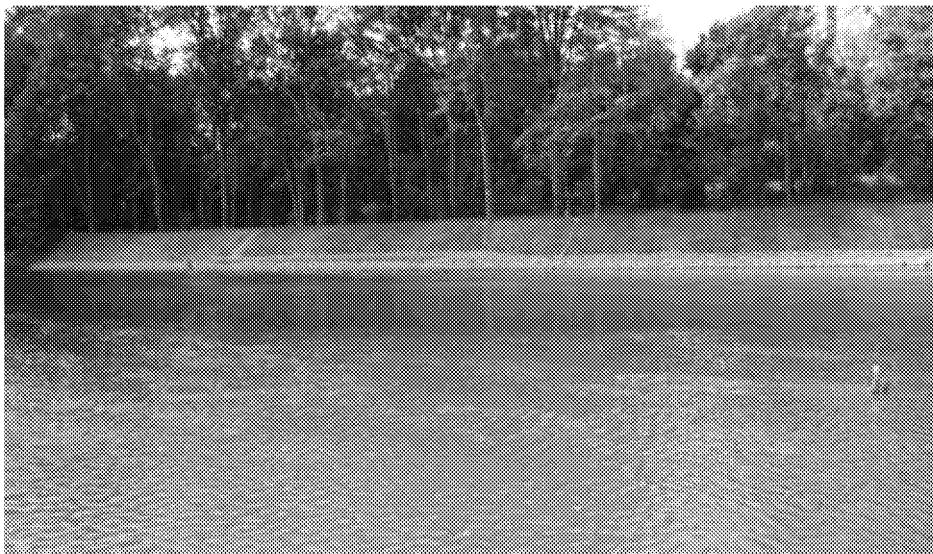
**Bank management area after construction and early vegetation growth**

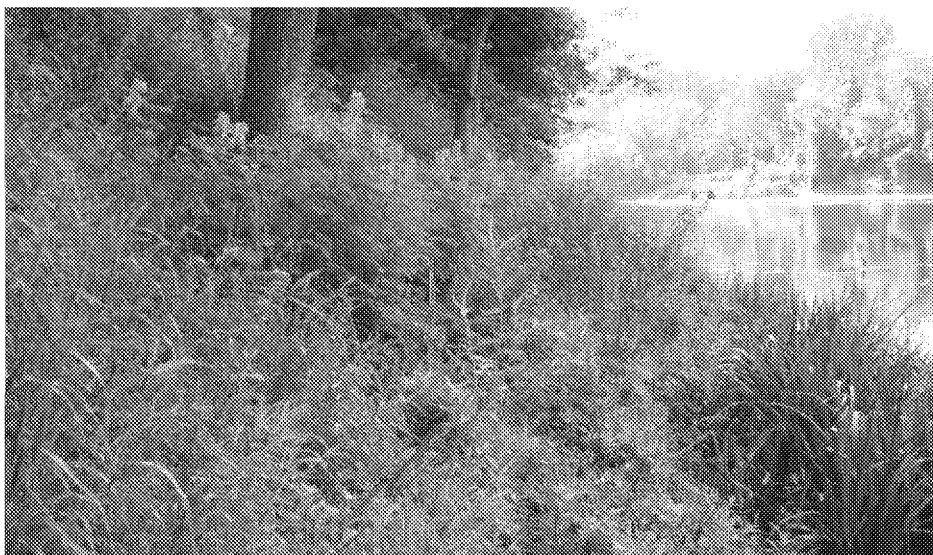
**Bank management area showing established vegetation**

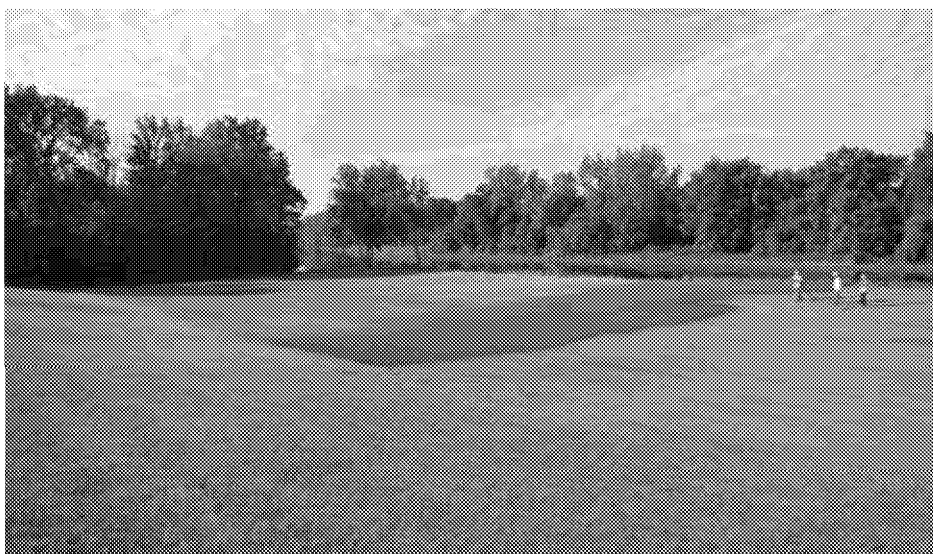
**Floodplain removal area being seeded following the completion of removal activities**

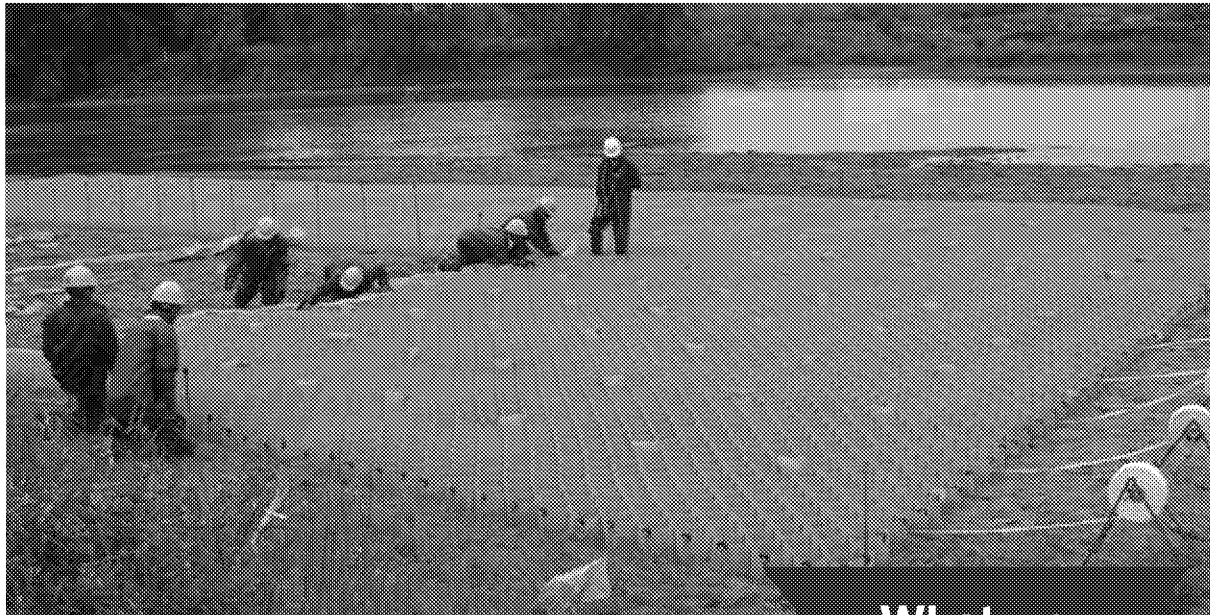
**In-channel CCS cap pilot technology installed at Reach J in 2010. Information gained from the pilot about the implementability and effectiveness of the cap was used to inform future cap projects.**

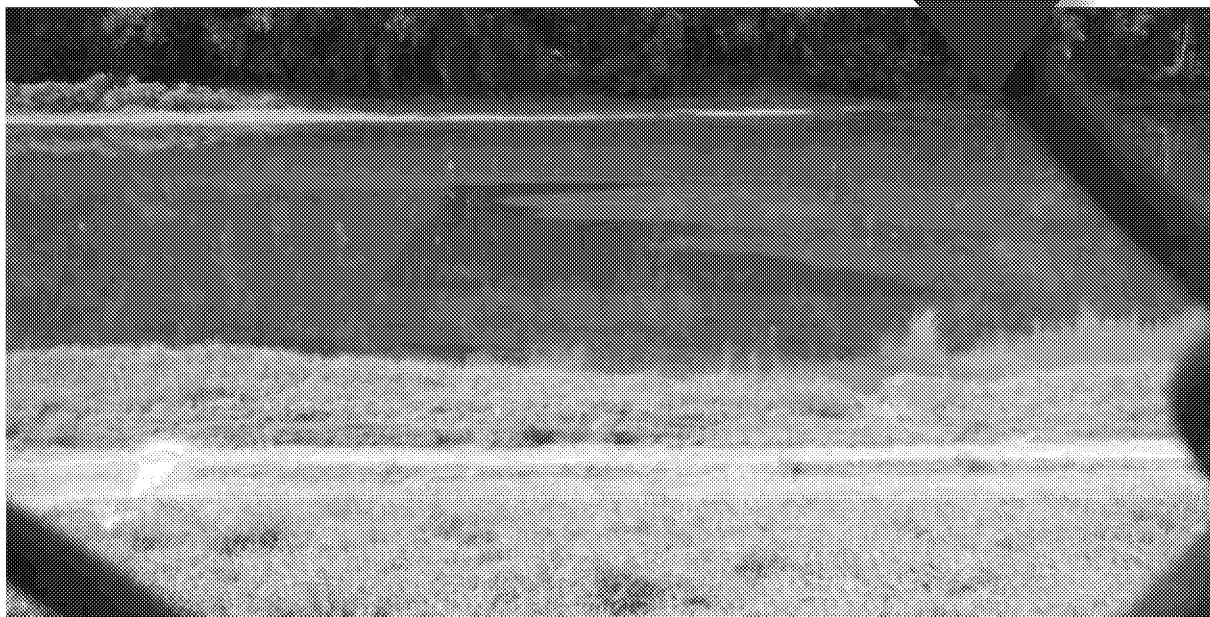
**The piloted cap technology became a final remedy selected by the EPA. Picture of cap installed at Sediment Management Area 1-4.**

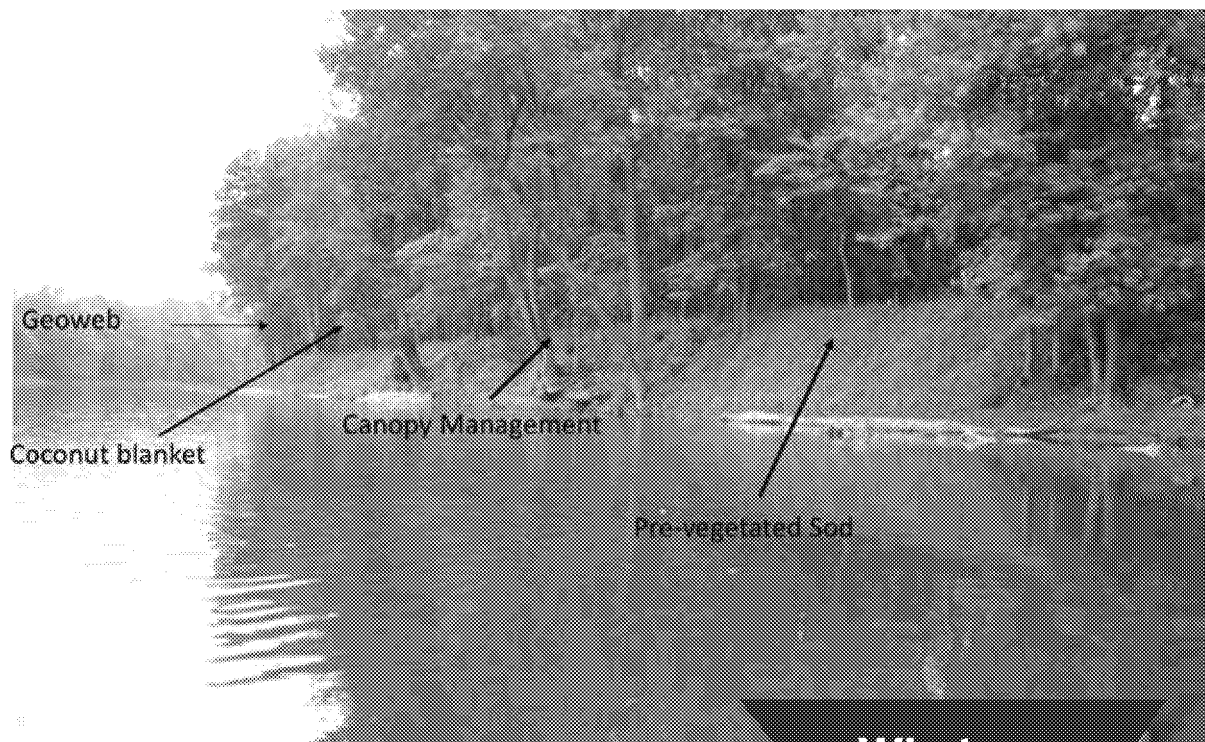
Pilot bank stabilization technologies were installed in 2008 through 2011 along the Tittabawasse River. The pilots provided EPA and Dow information to select and design effective, bioengineered and sustainable technologies for banks.

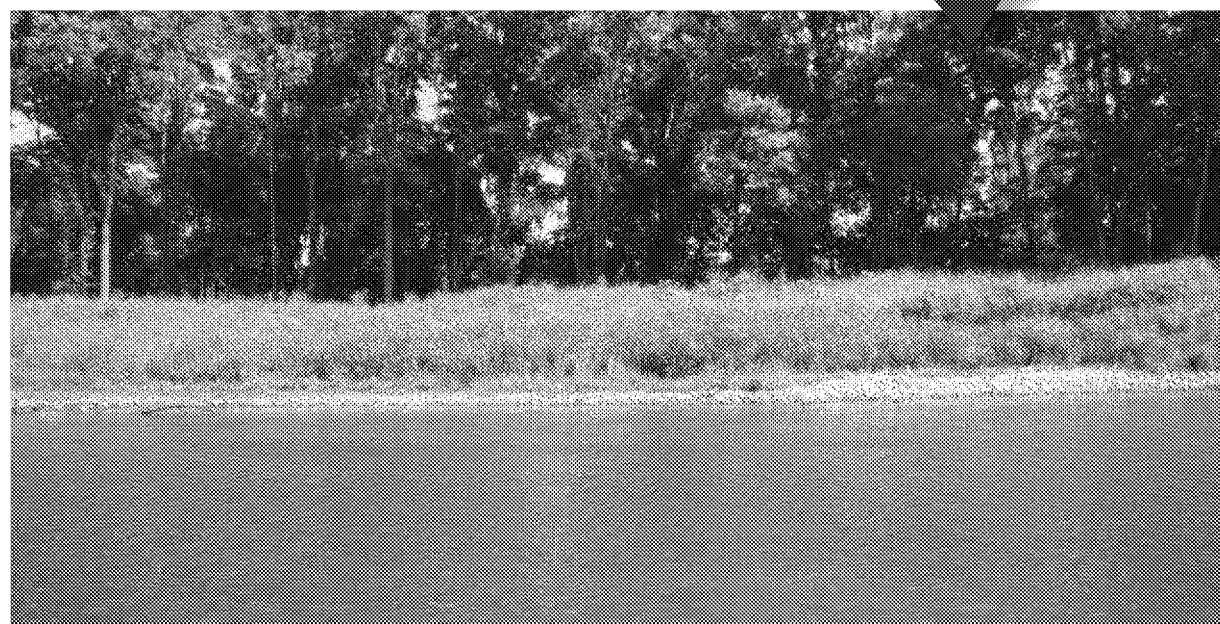
The piloted bank technologies that performed well became final cleanup technologies at bank management areas. Pictures depicts stabilized bank at Bank Management Area 2-4.

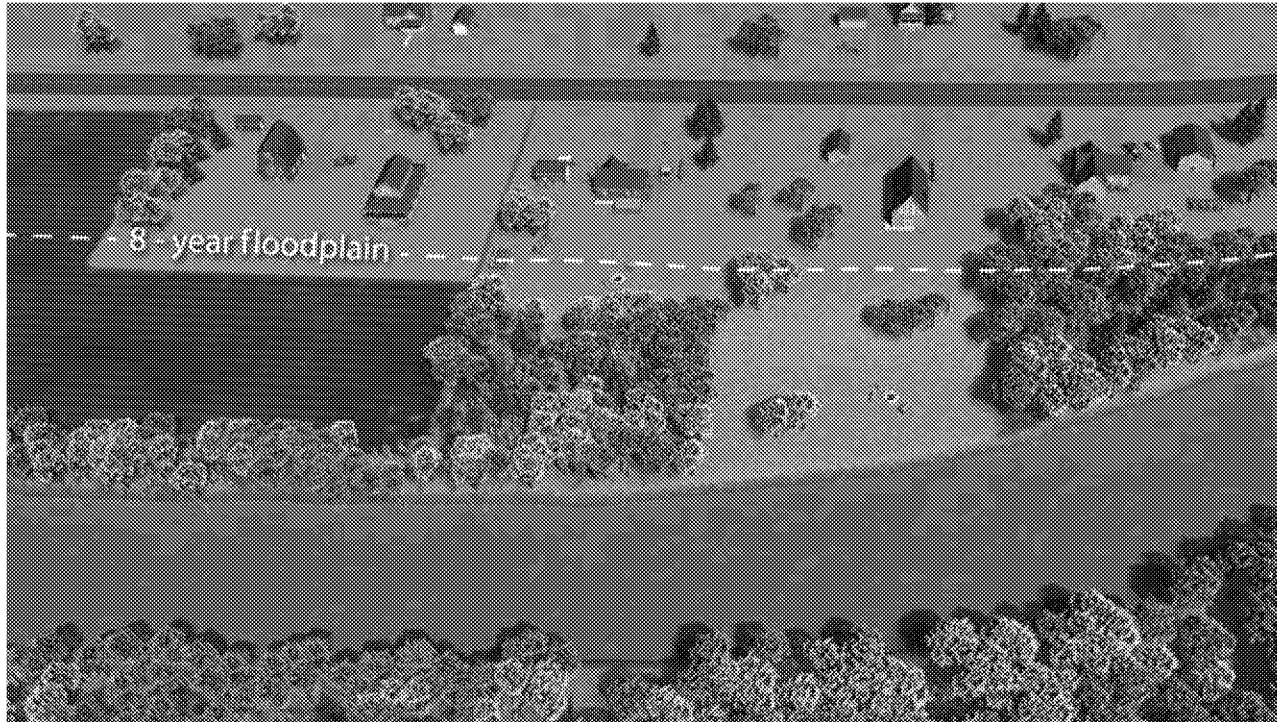
**FIGURE: Eight-Year Floodplain Along the Tittabawassee River**

Dow created this voluntary program to preserve the natural features of the river and floodplain and ensure the long-term effectiveness of the cleanup. The Tittabawassee River Conservation program is available to qualifying land owners who have property within the eight-year floodplain and whose land will be evaluated for cleanup. The current use of the floodplain consists of 5% residential maintained, 18% active agriculture, and 76% forest, wetland, meadows or ponds.

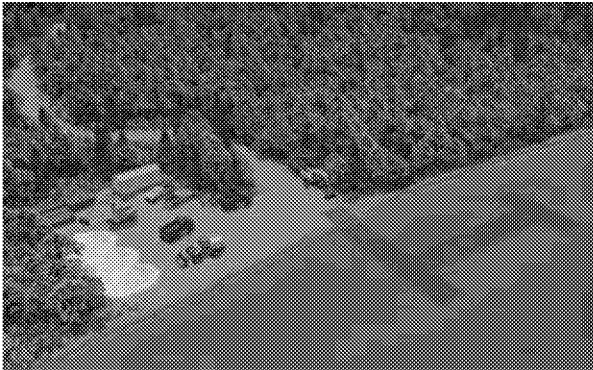
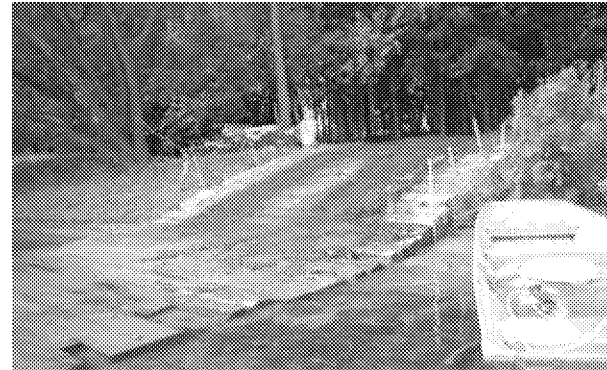
Site access for equipment into the sediment management area at SMA 1-5.

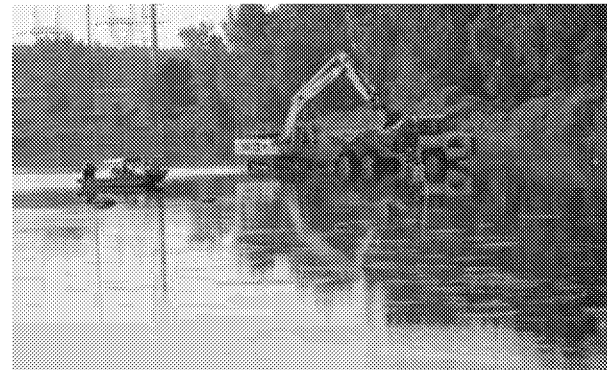
Installing armor stone over the sediment management area in SMA 1-5.

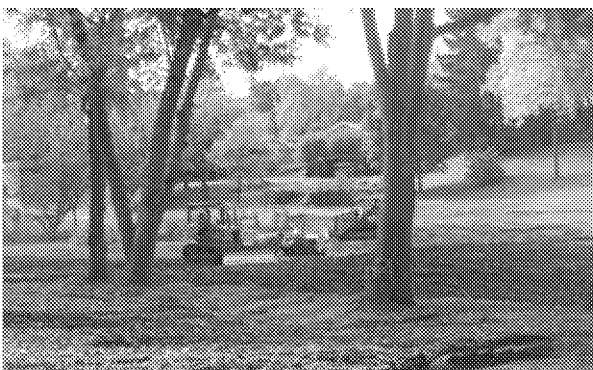
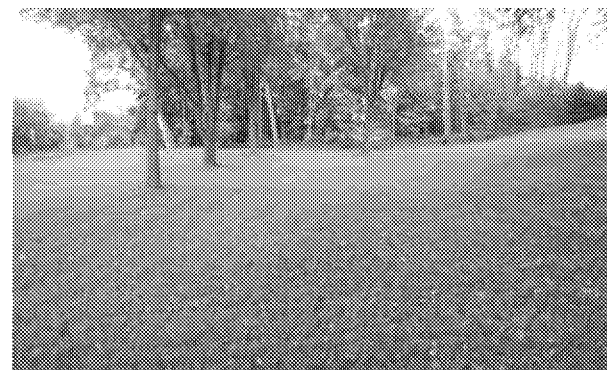
Floodplain removal activities along the Tittabawassee River.

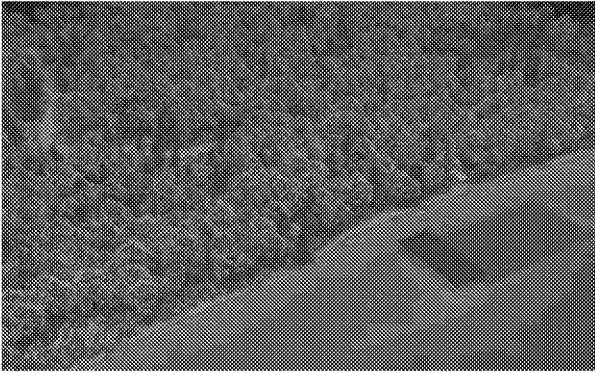
After establishing access, installation of cellular containment system (CCS) cap.

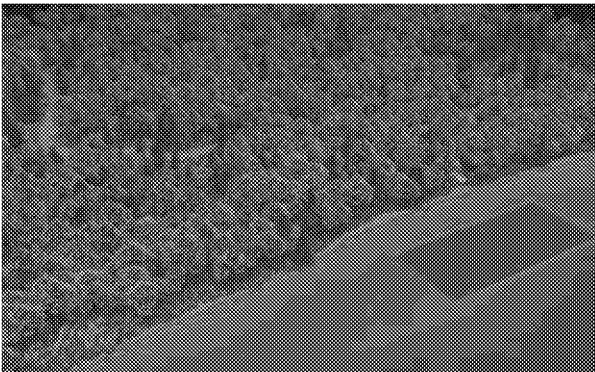
Installation of armor stone around the outer edge of the CCS cap using a pontoon boat with a conveyor system.

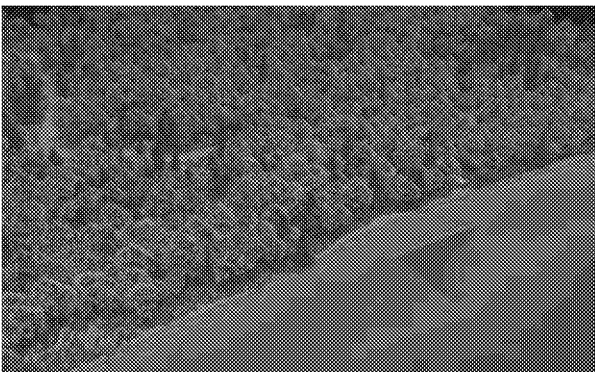
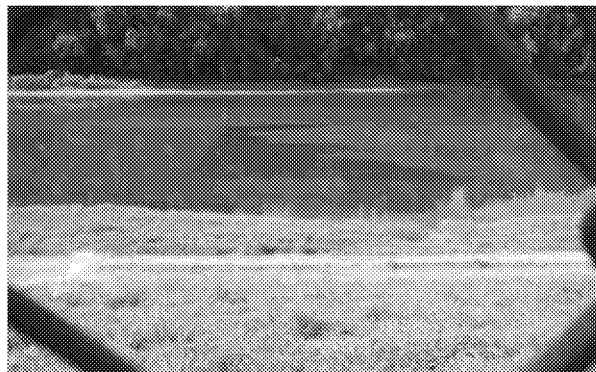
CCS cap filling with clean river sediment which naturally moved down the river system.

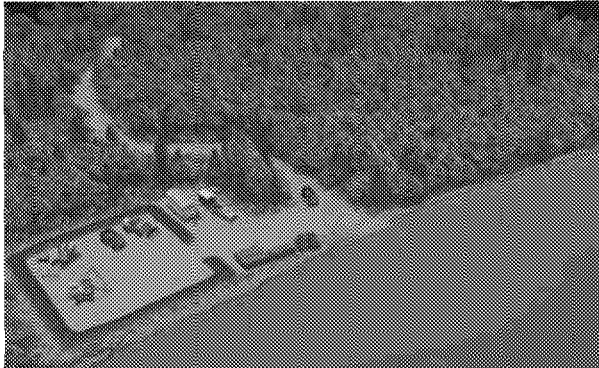
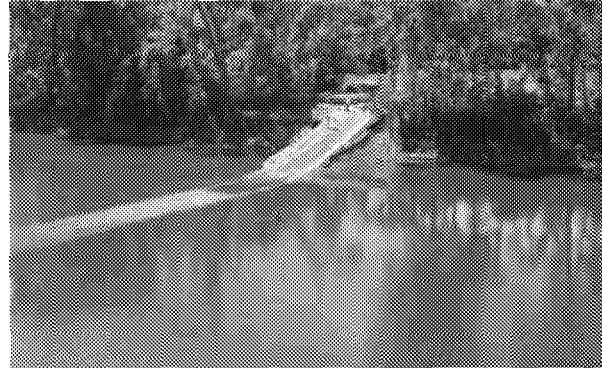
**Establishing access into the sediment management area.**

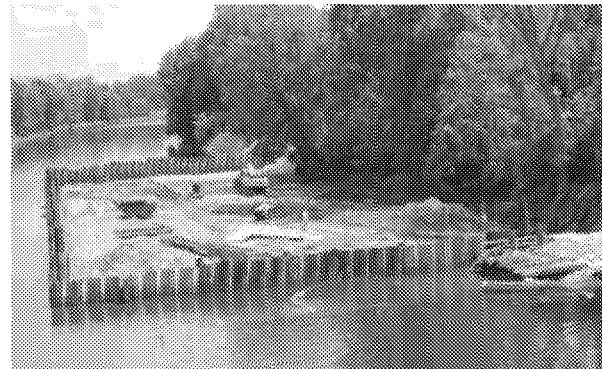
**Removal of river sediment with direct loading into trucks for transportation and disposal.**

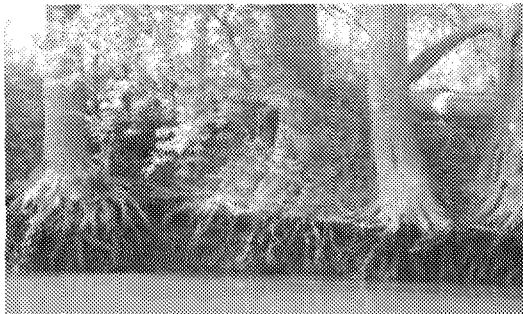
## Before

Banks that are unstable and contain contaminated soil are being stabilized to stop bank erosion.

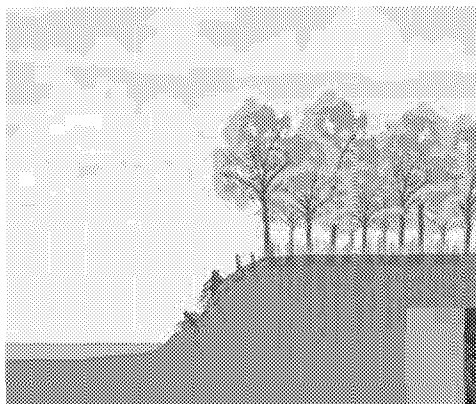
**Step 1:** Trees are trimmed or removed to allow sun light to the bank so deep rooting vegetation can stabilize the banks.

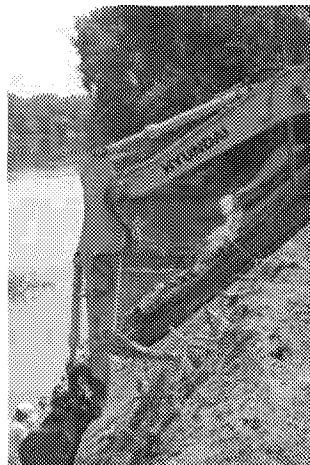
**Step 3:** Special materials are often used to help stabilize the banks and allow the native vegetation to be established.

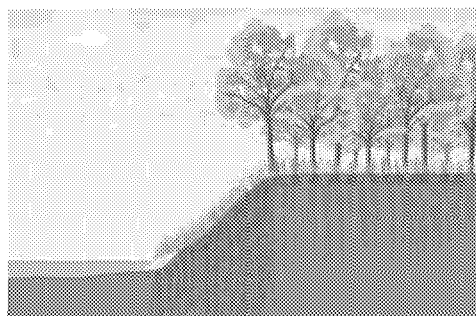
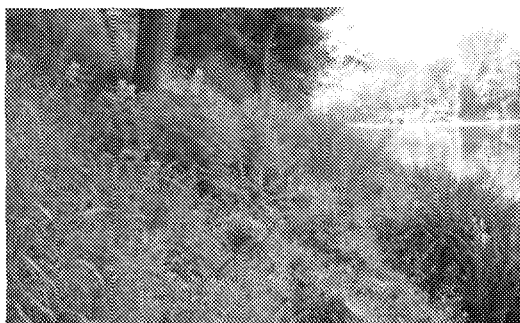
## After

Monitoring and maintenance activities will ensure that the remedy continues to maintain bank stability over time.
