**Region 6 - Enforcement & Compliance Assurance Division**  
**INSPECTION REPORT**

| Regulatory Program(s) | CWA, NPDES, Storm Water Industrial GP | |
| Company Name: | <b>The Yaffe Companies, Inc.</b> | |
| Facility Name: | <b>Rogers Iron and Metal Corporation (RIMCO)</b> | |

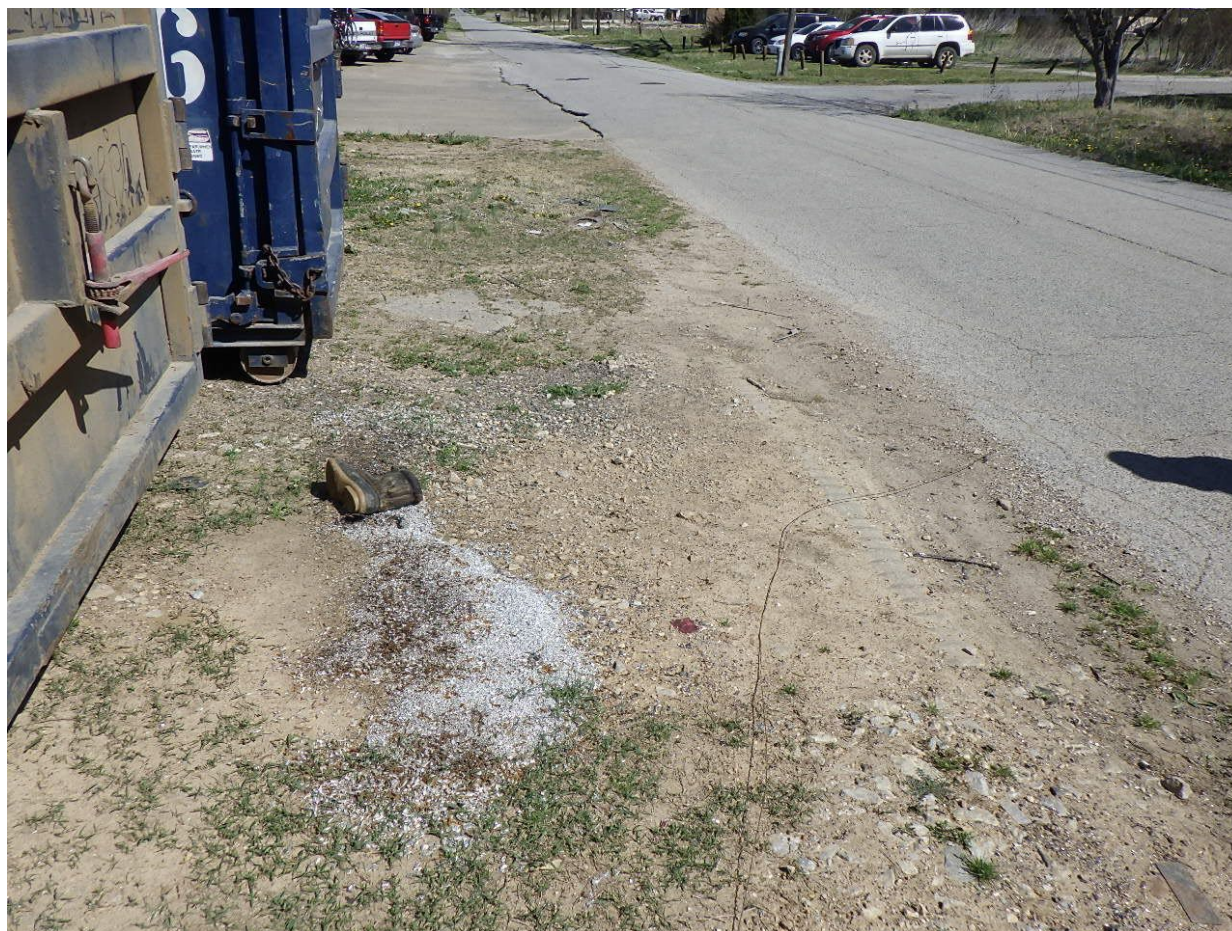
Photo No. 1

| Description: | Fugitive solid waste was observed outside containment along the southeastern corner of the facility grounds. | | | | |

- Fugitive solid waste was observed outside containment on the southeastern corner of the facility (Appendix 1; Photo 1).
- Outfall 002 appeared to be well-maintained with added Best Management Practices (BMP), including three (3) metal absorbent bags and rip-rap (Appendix 1; Photo 2).
- Outfall 001 had fugitive solid waste present at the time of the inspection. Three (3) absorbent booms were staked into the ground and utilized as additional BMPs (Appendix 3; Photo 3)
- Additional fugitive solid waste was observed outside the facility's boundary near Outfall 001 (Appendix 1; Photo 4). Good housekeeping practices were recommended during the inspection.

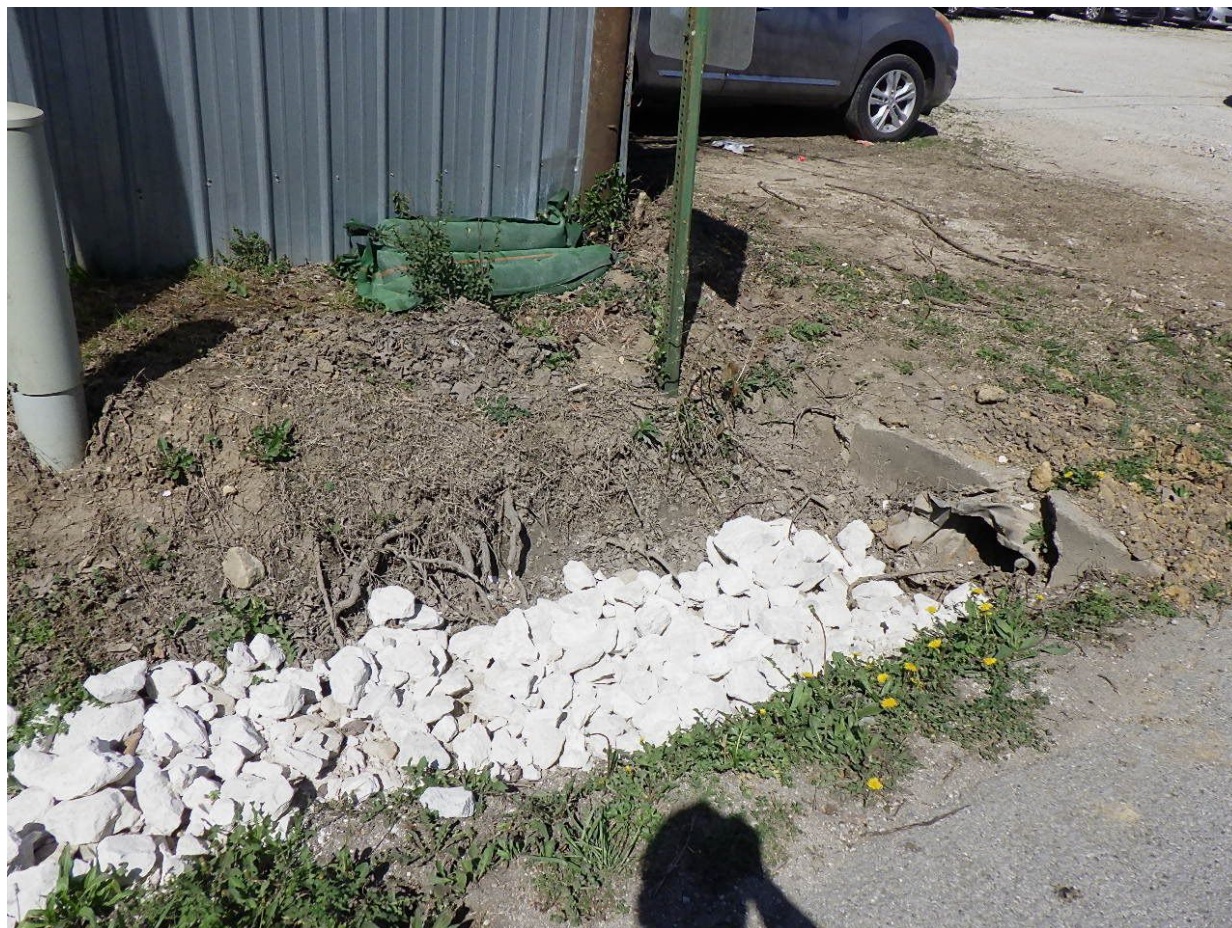
Photo No. 2

| Description: | Outfall 002 appeared well-maintained with three (3) green metal-absorbent bags and rip-rap. | | | | |

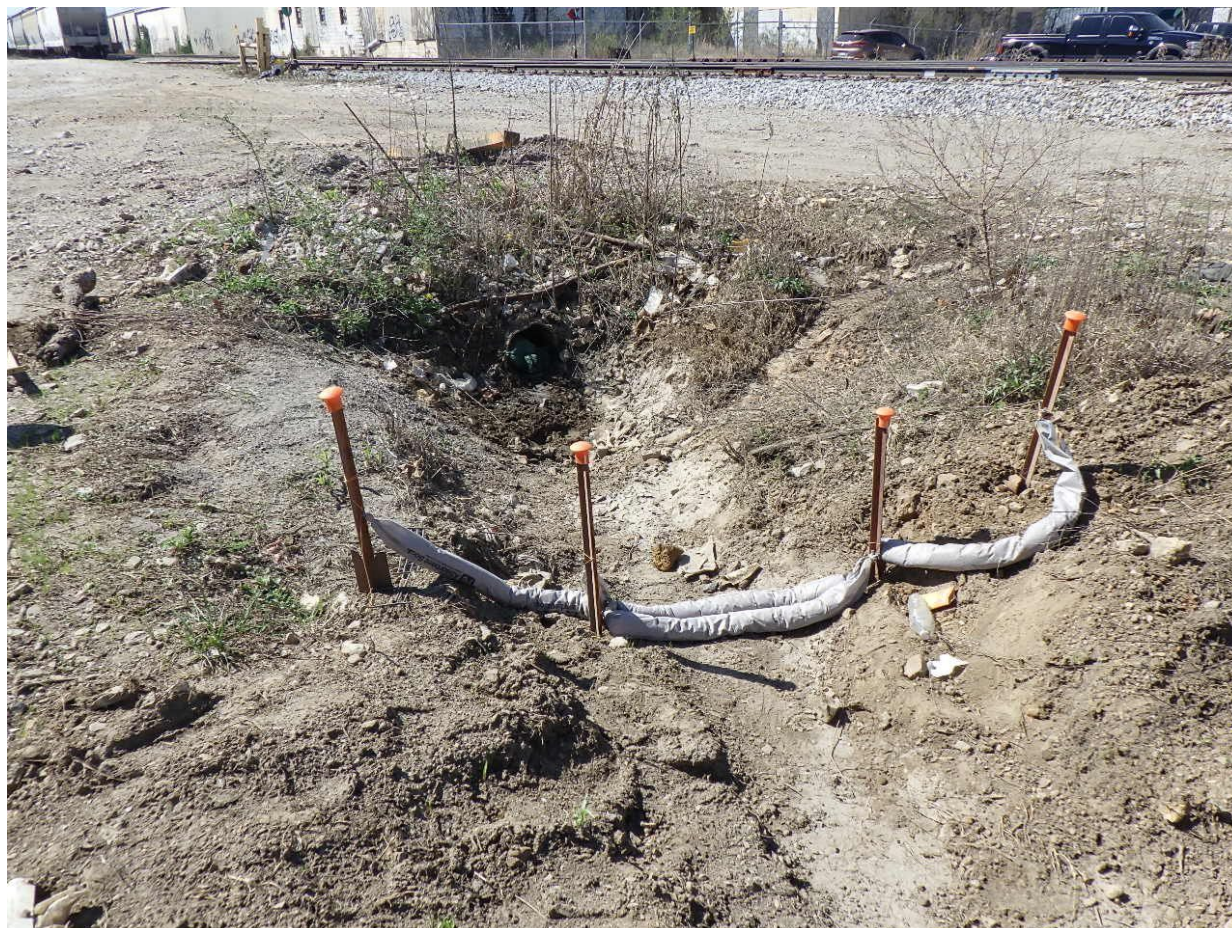
Photo No. 3

| Description: | Outfall 001. A light and absorbent boom was observed as an additional BMP. Solid waste run-on from surrounding city streets was observed at or near Outfall 001. | | | | |

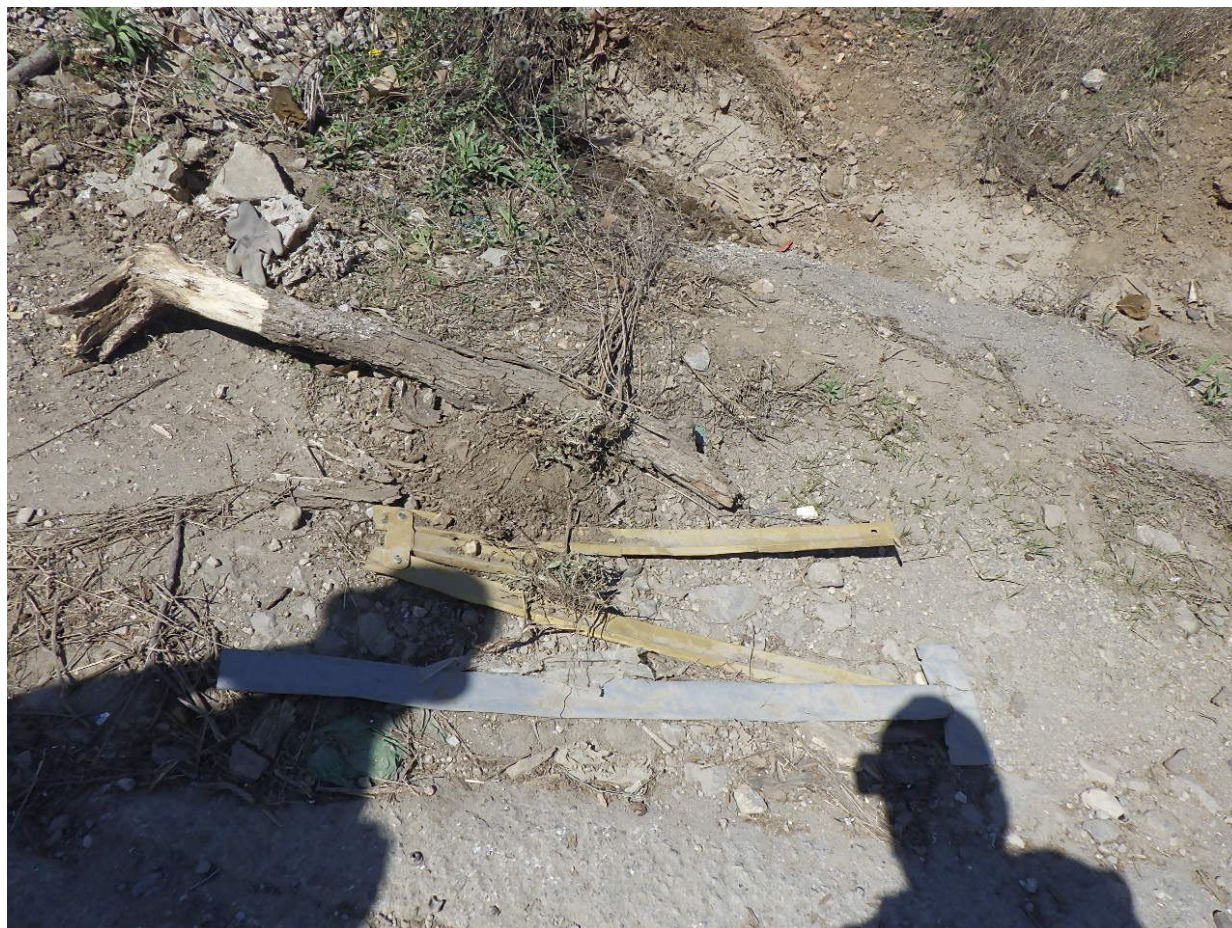
Photo No. 4

| Description: | Fugitive solid waste observed in proximity to Outfall 001. | | | | |
