# Clean Water Act Section 404: Site Visit/Case Development

Site Name	Town of Ramapo - Pinebrook Road Sewer Line
-----------	--------------------------------------------

CWA 404 Inspection  
Town of Ramapo – Sewer Line  
40 Pinebrook Road  
Chestnut Ridge, NY

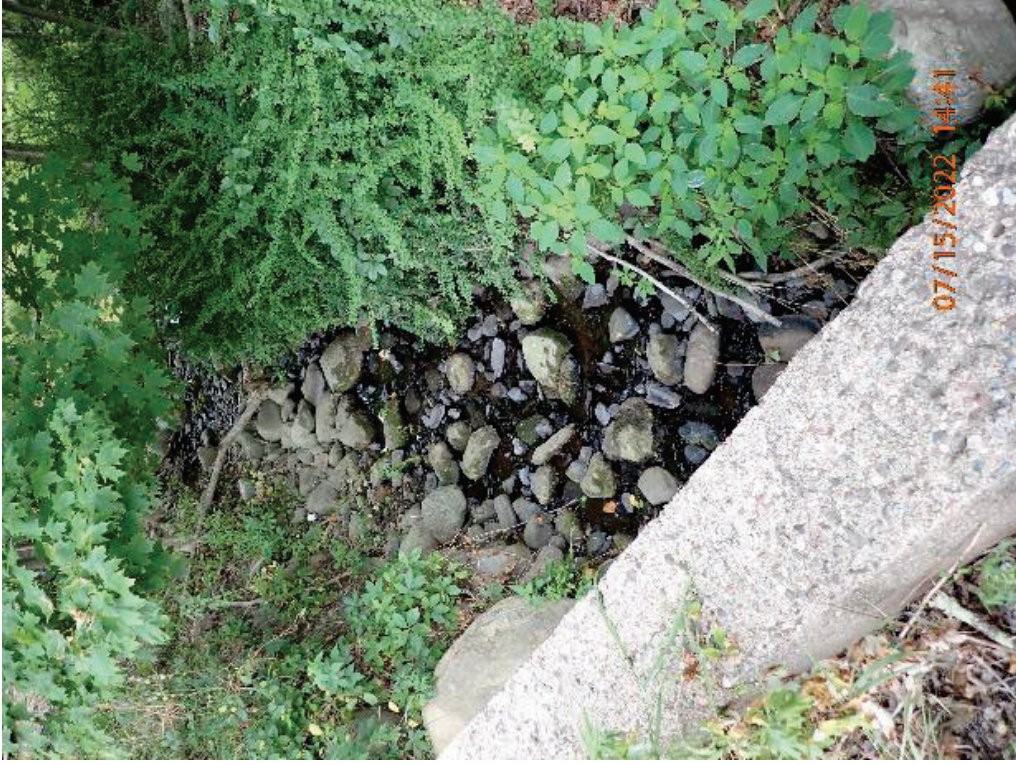
**Date:** 7/15/2022  
**Time:** 2:41 PM  
**Photographer:** SSA  
**Photo ID:** 1 – P7150350

Stream culverted under  
Pinebrook Road.  
Substrate: Cobble, silt, some  
boulder  
Defined bed and banks  
~5 feet wide  
~2" deep at time of inspection

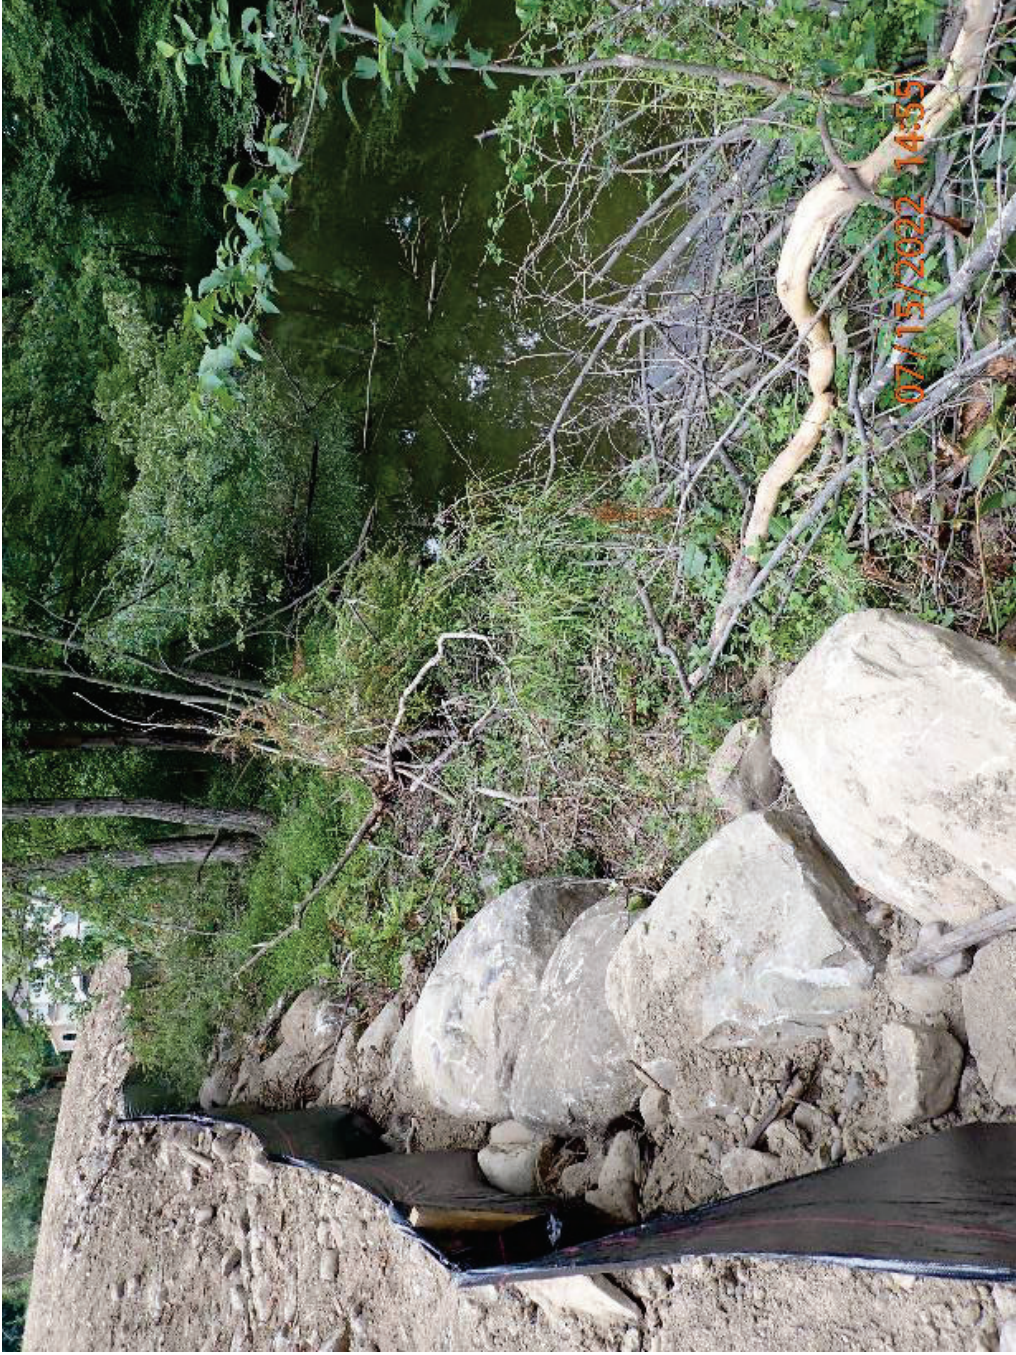
**Date:** 7/15/2022  
**Time:** 2:55 PM  
**Photographer:** SSA  
**Photo ID:** 2 – P7150351

**Description:**  
Boulders at edge of disturbance  
and near edge of pond

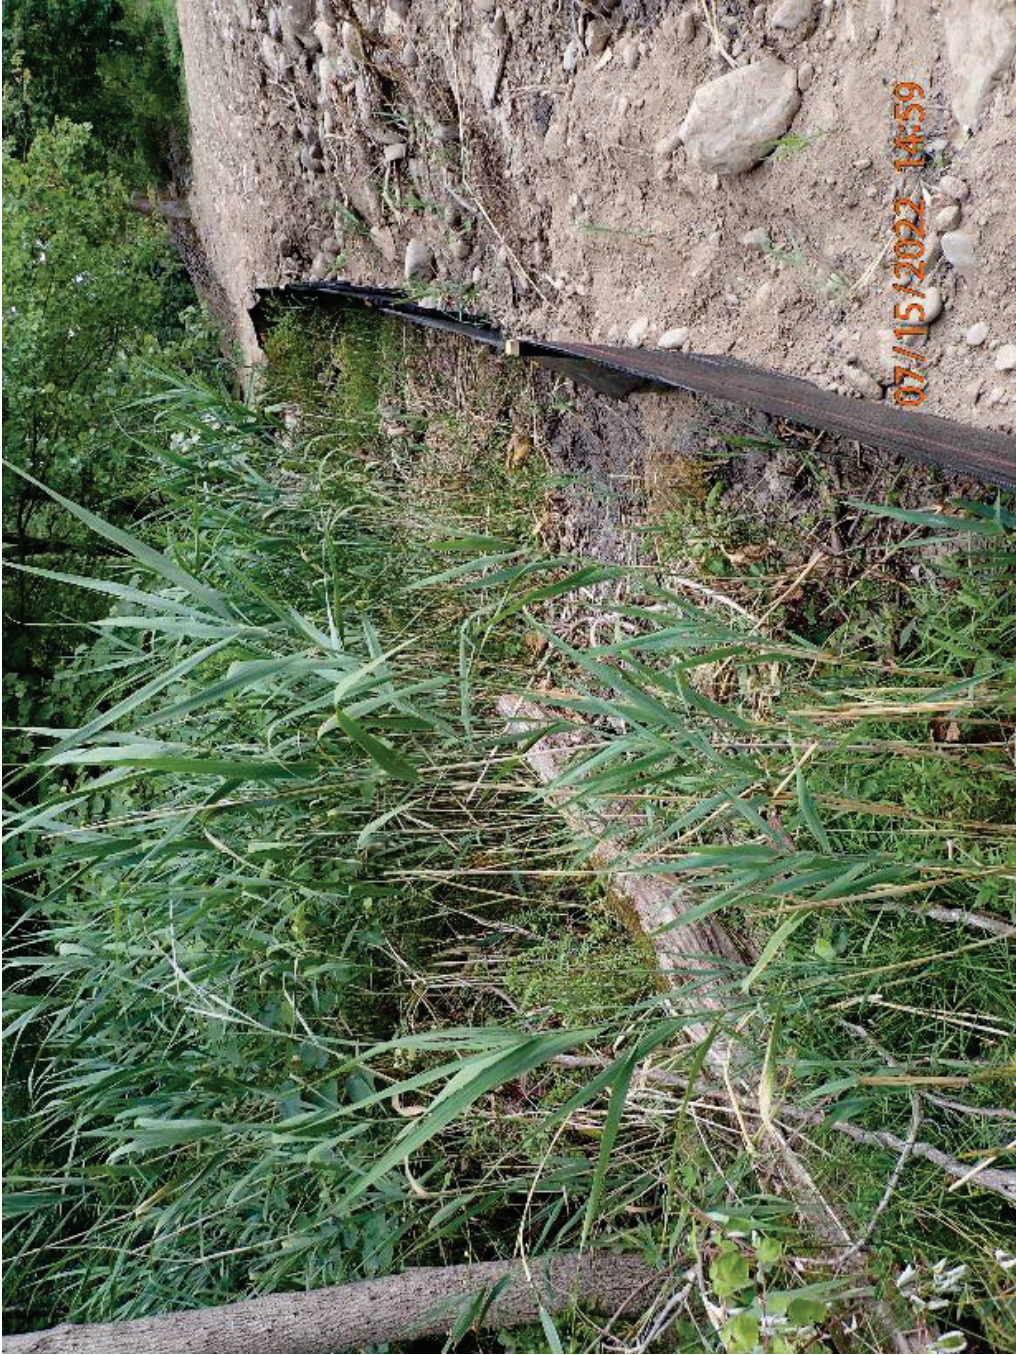
**Date:** 7/15/2022  
**Time:** 2:59 PM  
**Photographer:** SSA  
**Photo ID:** 3 – P7150352

**Description:**  
Common reed-dominated  
presumed wetland area  
adjacent to edge of fill

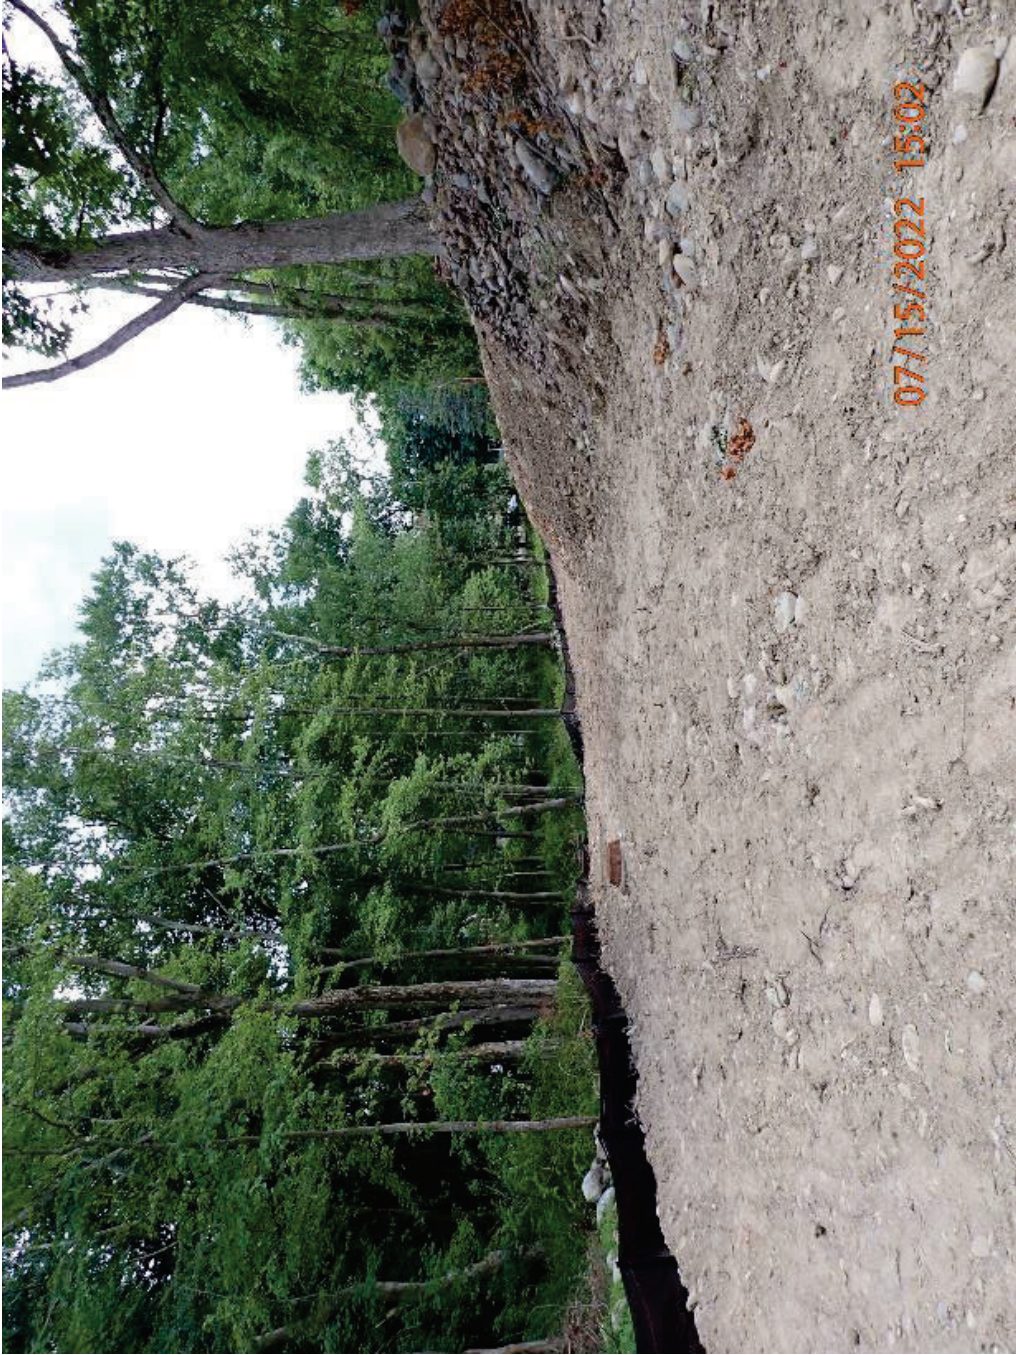
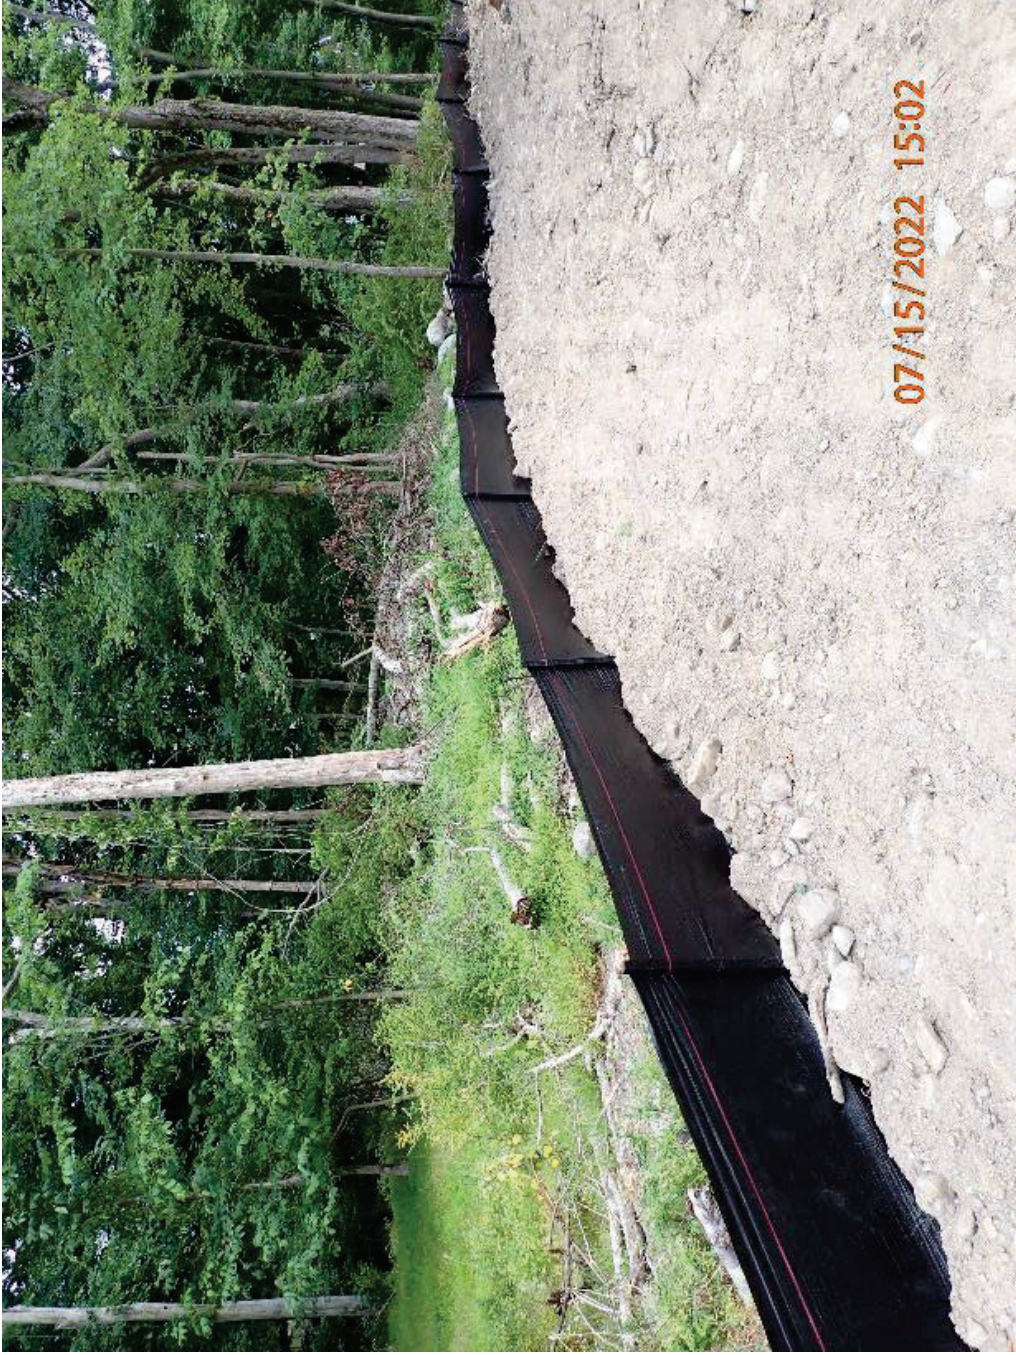
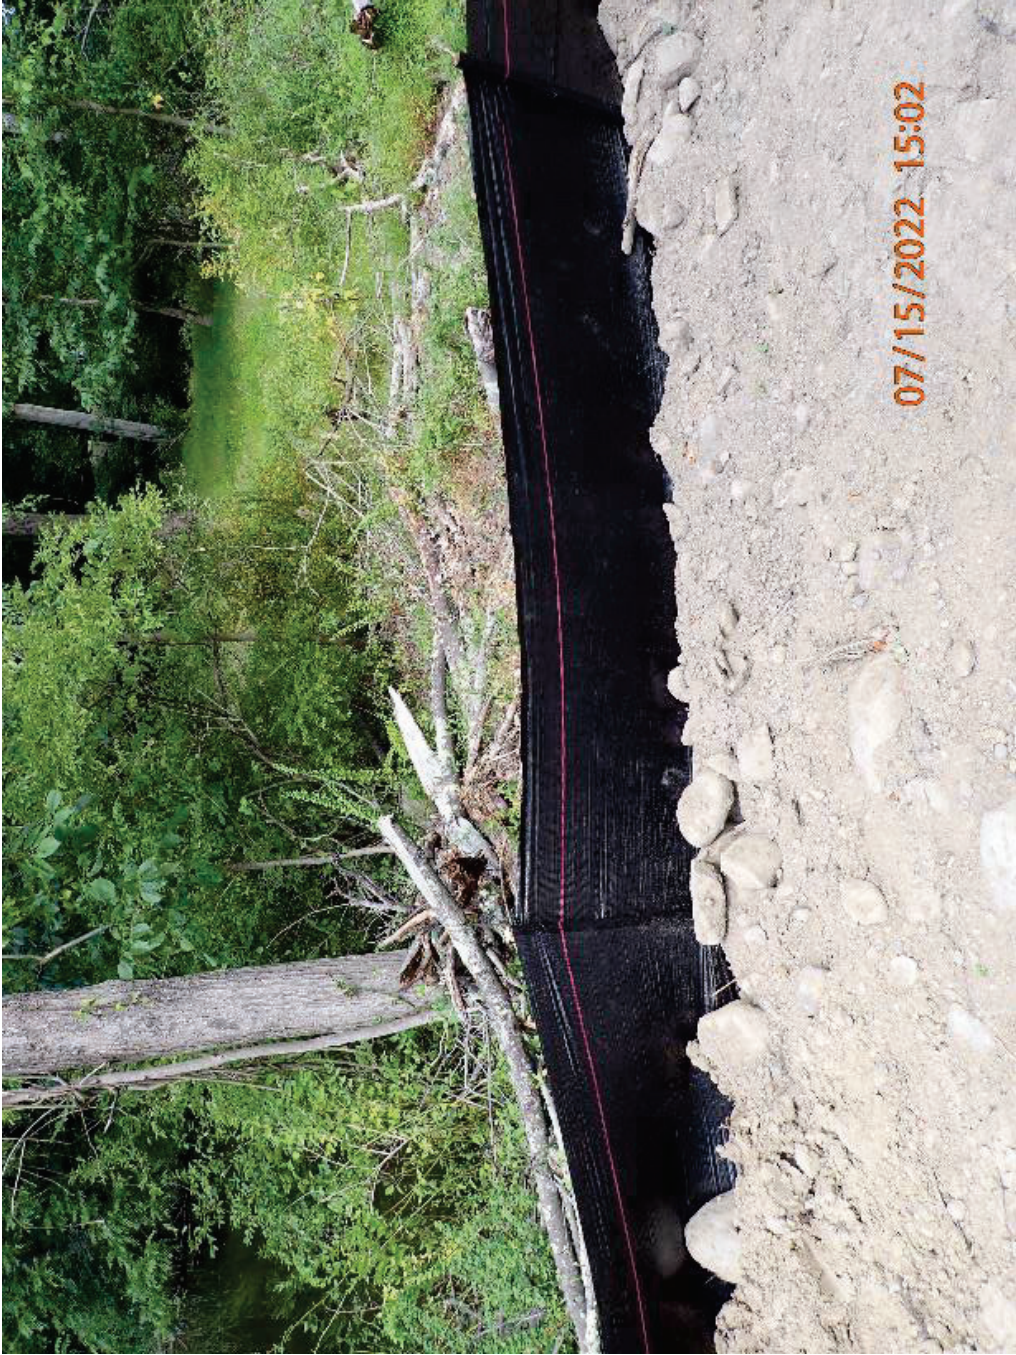
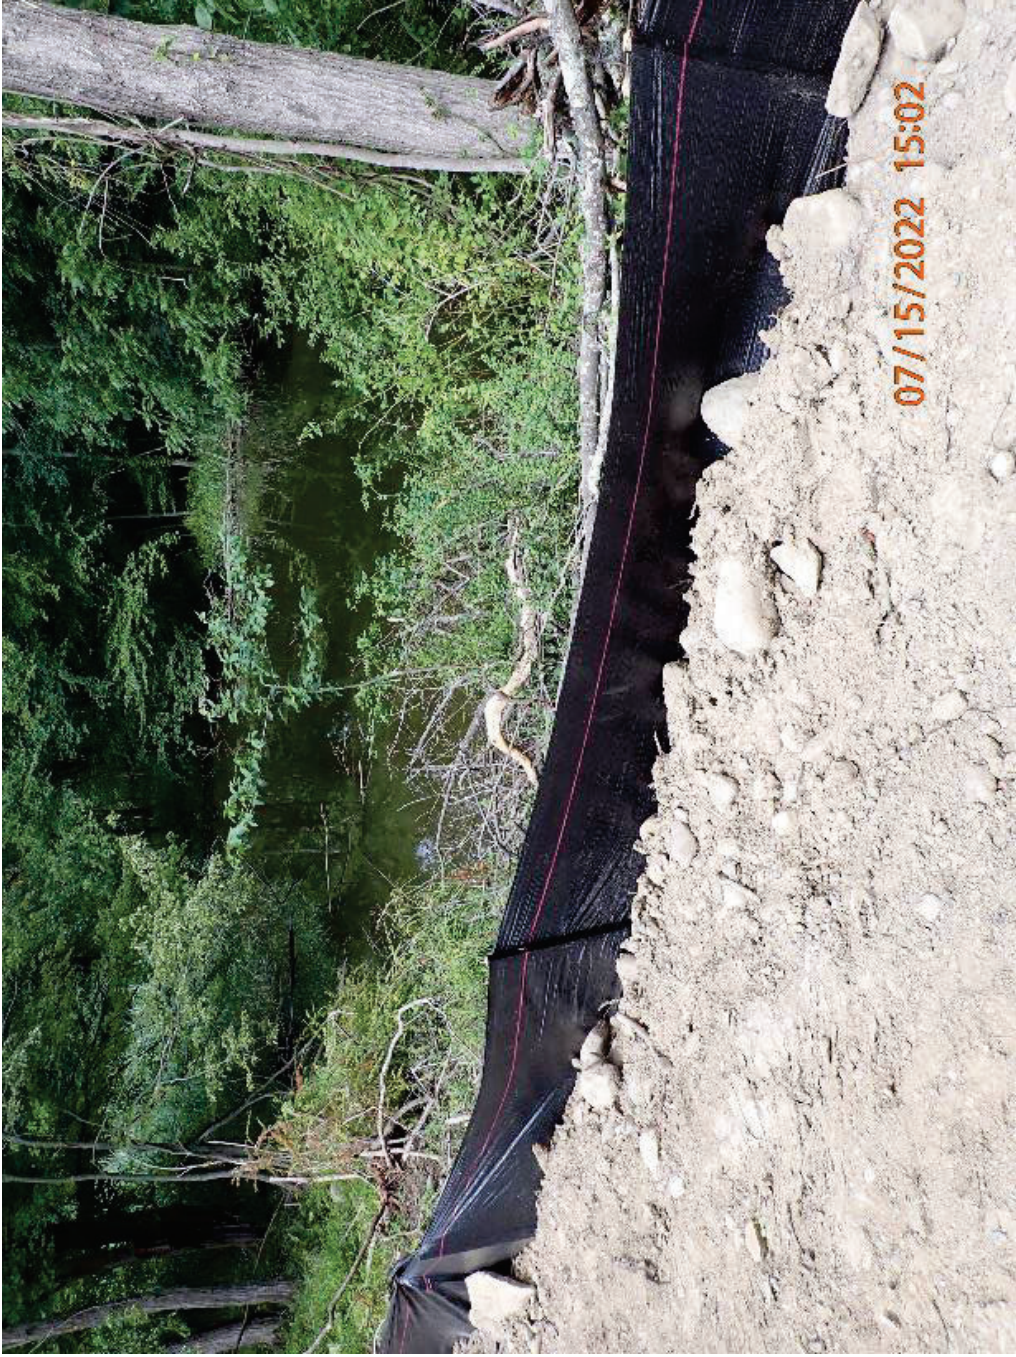
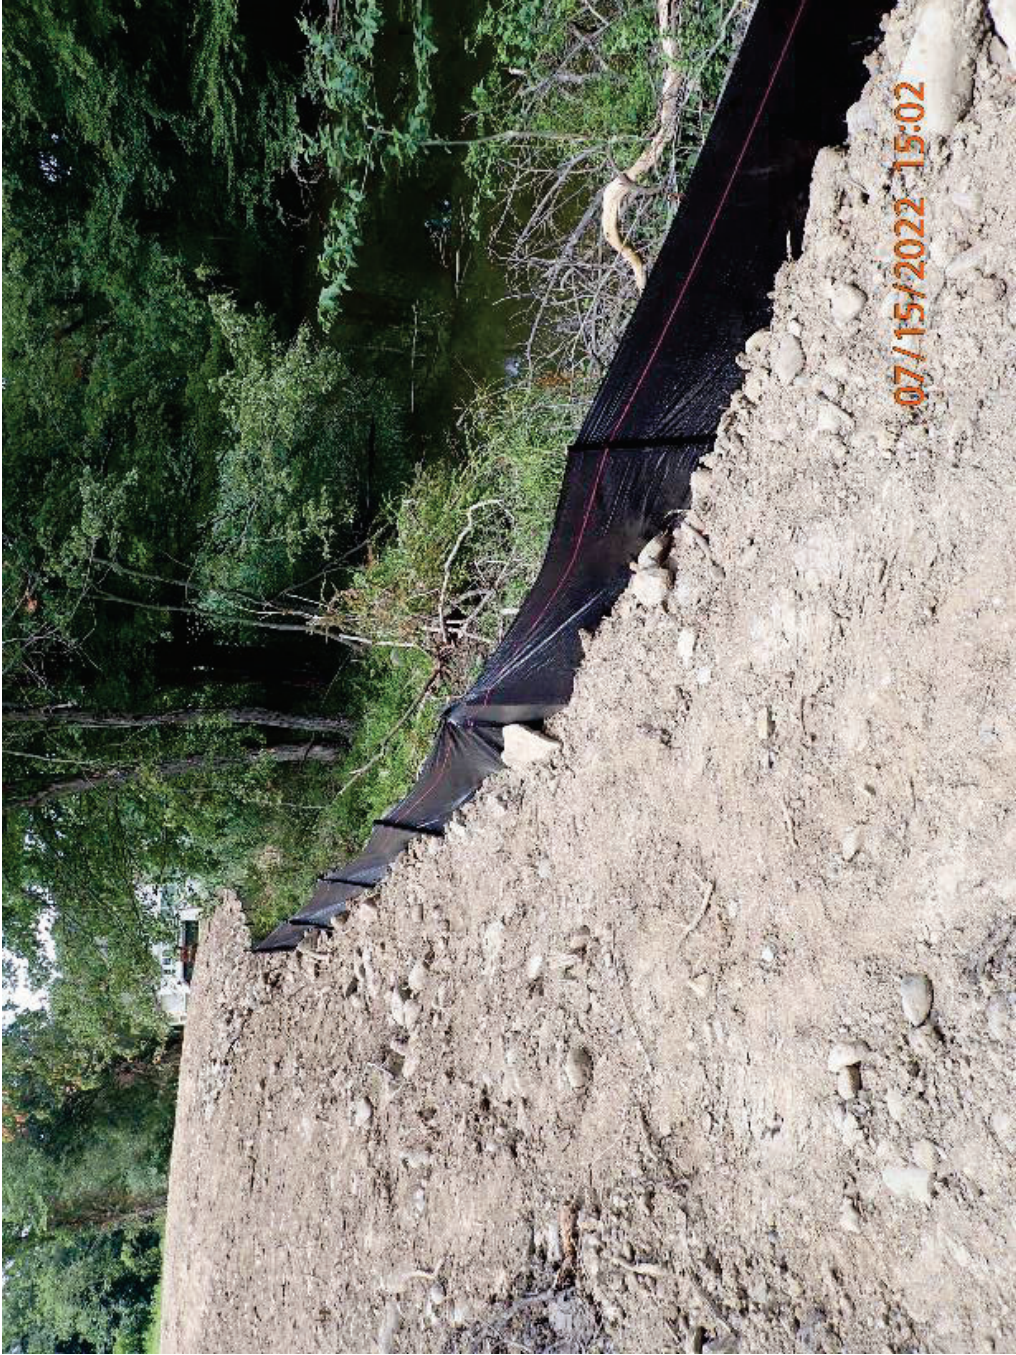
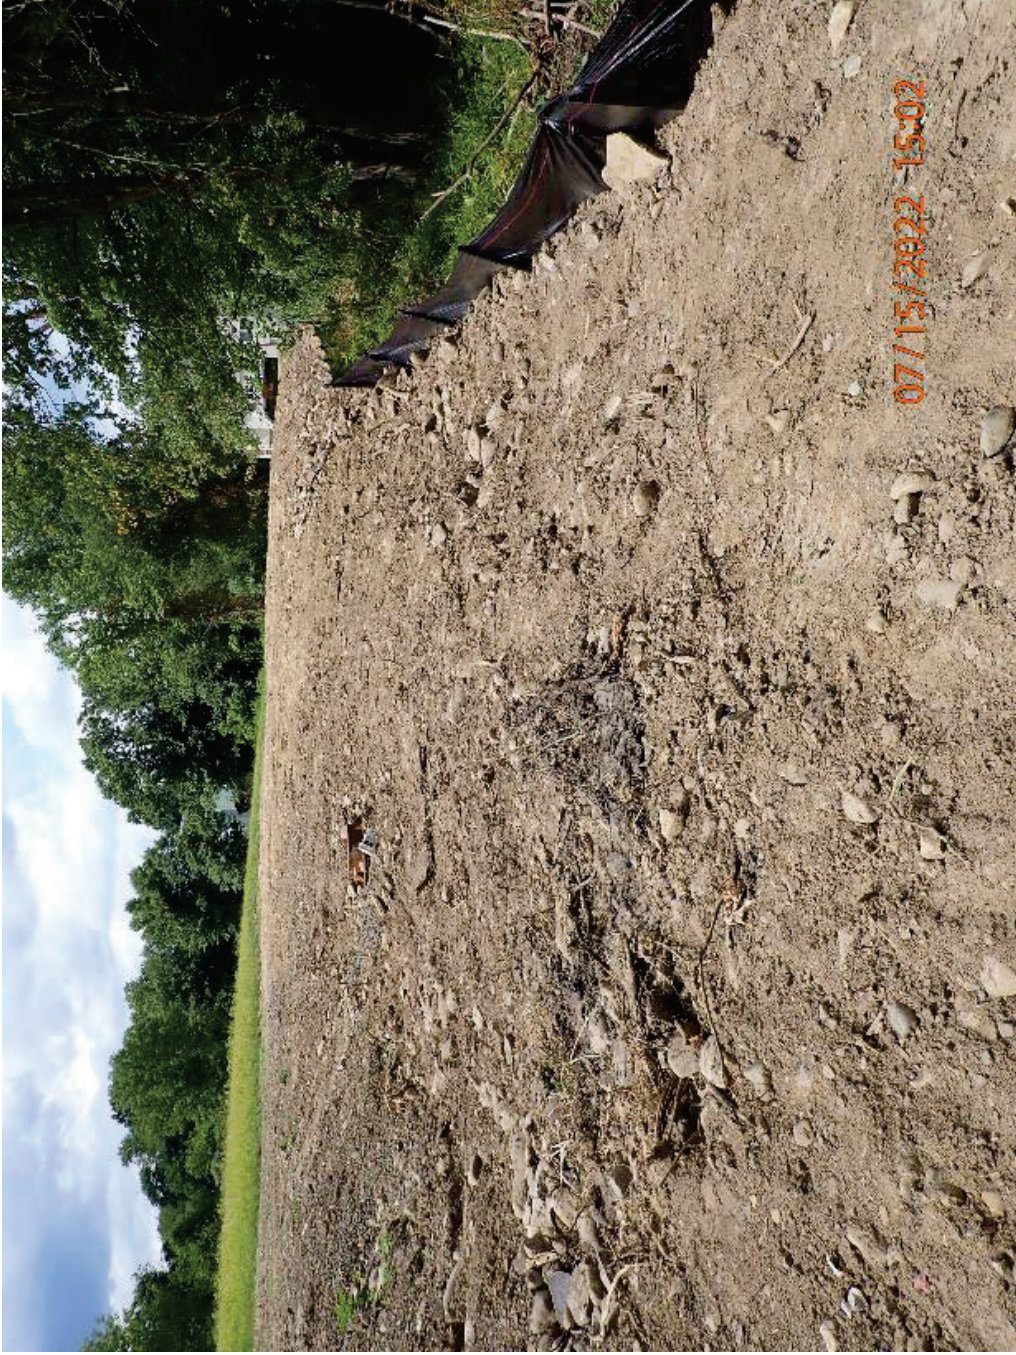
**Date:** 7/15/2022  
**Time:** 3:02 PM  
**Photographer:** SSA  
**Photo ID:** 4 – P7150353

**Description:**  
(1/6) Panorama of ROW

**Description:**  
(2/6) Panorama of ROW

**Description:**  
(3/6) Panorama of ROW

**Description:**  
(4/6) Panorama of ROW

**Description:**  
(5/6) Panorama of ROW

**Description:**  
(6/6) Panorama of ROW

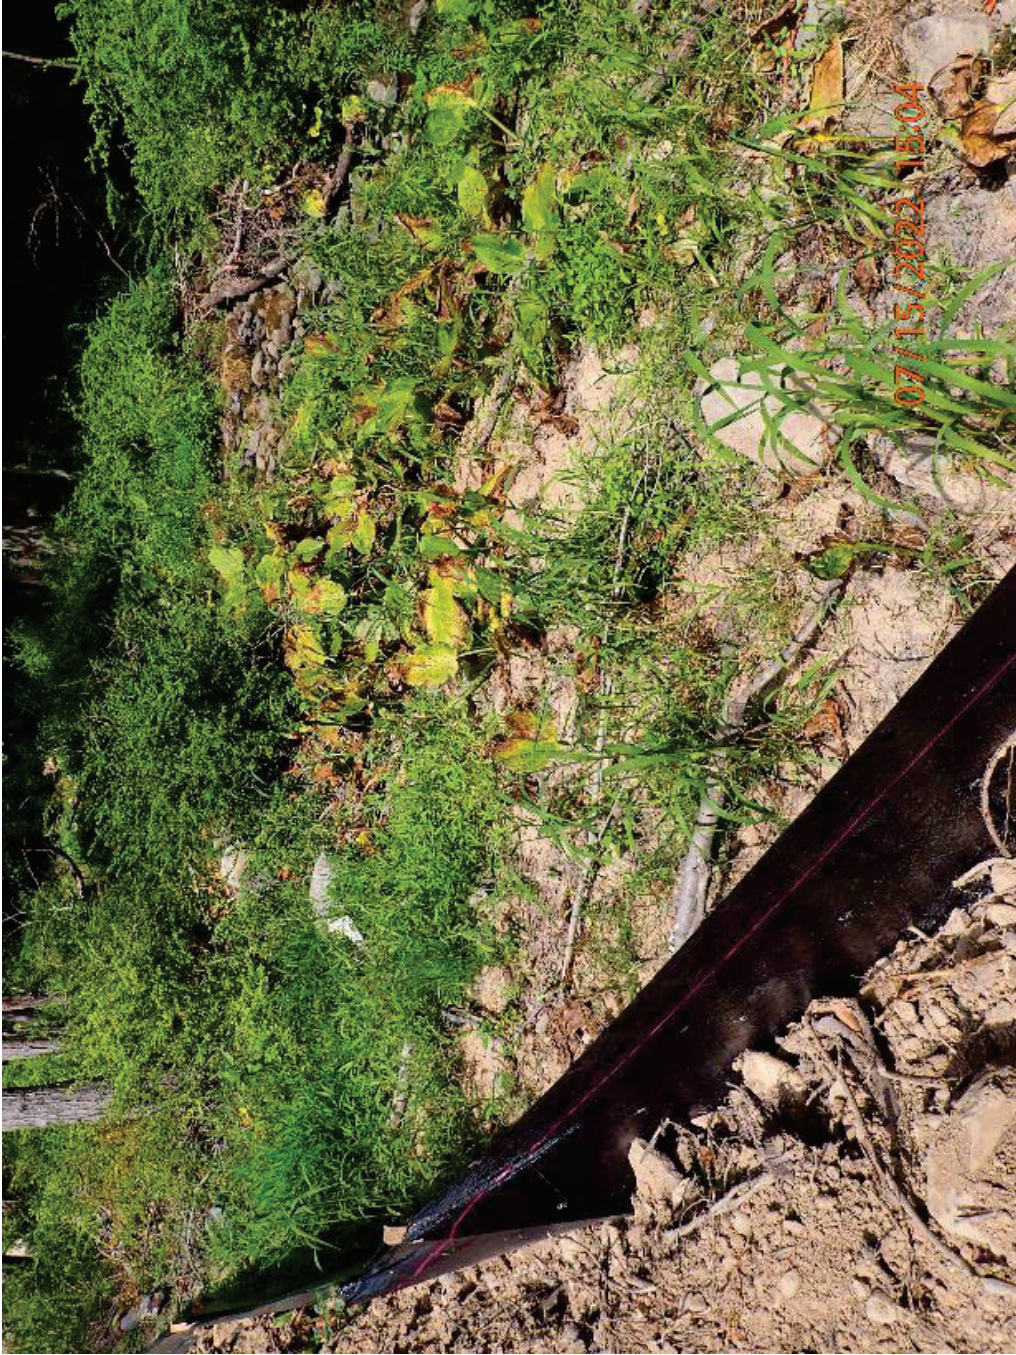
**Date:** 7/15/2022  
**Time:** 3:04 PM  
**Photographer:** SSA  
**Photo ID:** 10 – P7150359

**Description:**  
Sediment beyond silt fence

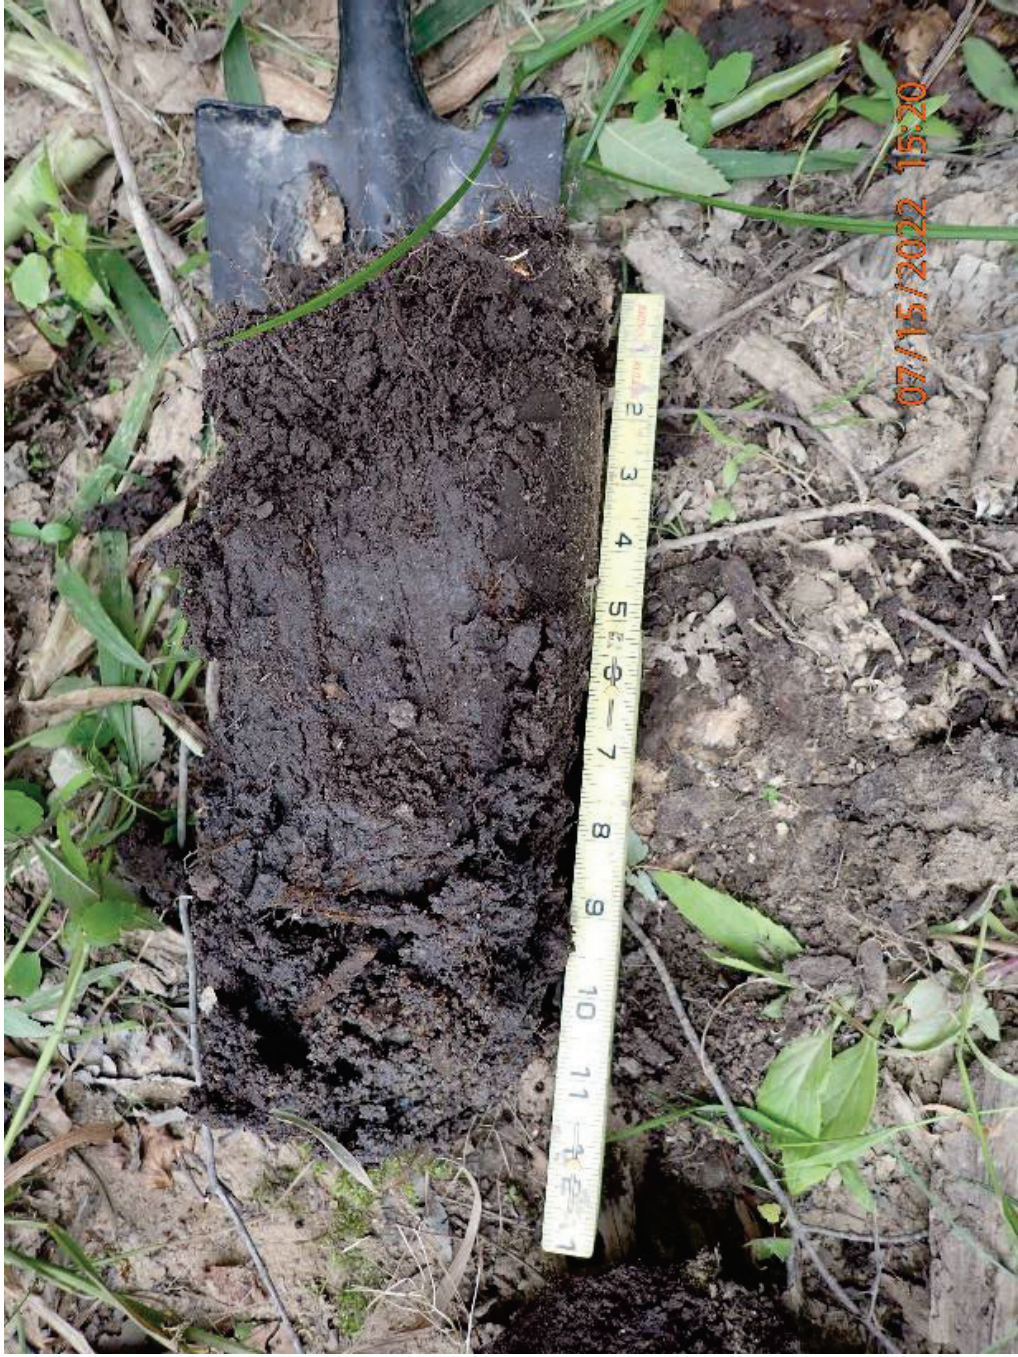
**Date:** 7/15/2022  
**Time:** 3:20 PM  
**Photographer:** SSA  
**Photo ID:** 12 – P7150361

Vegetation, soils, and hydrology data were collected at a sampling location near the toe of the fill slope. These data confirmed that the area was a wetland.

Soil profile from sampling location

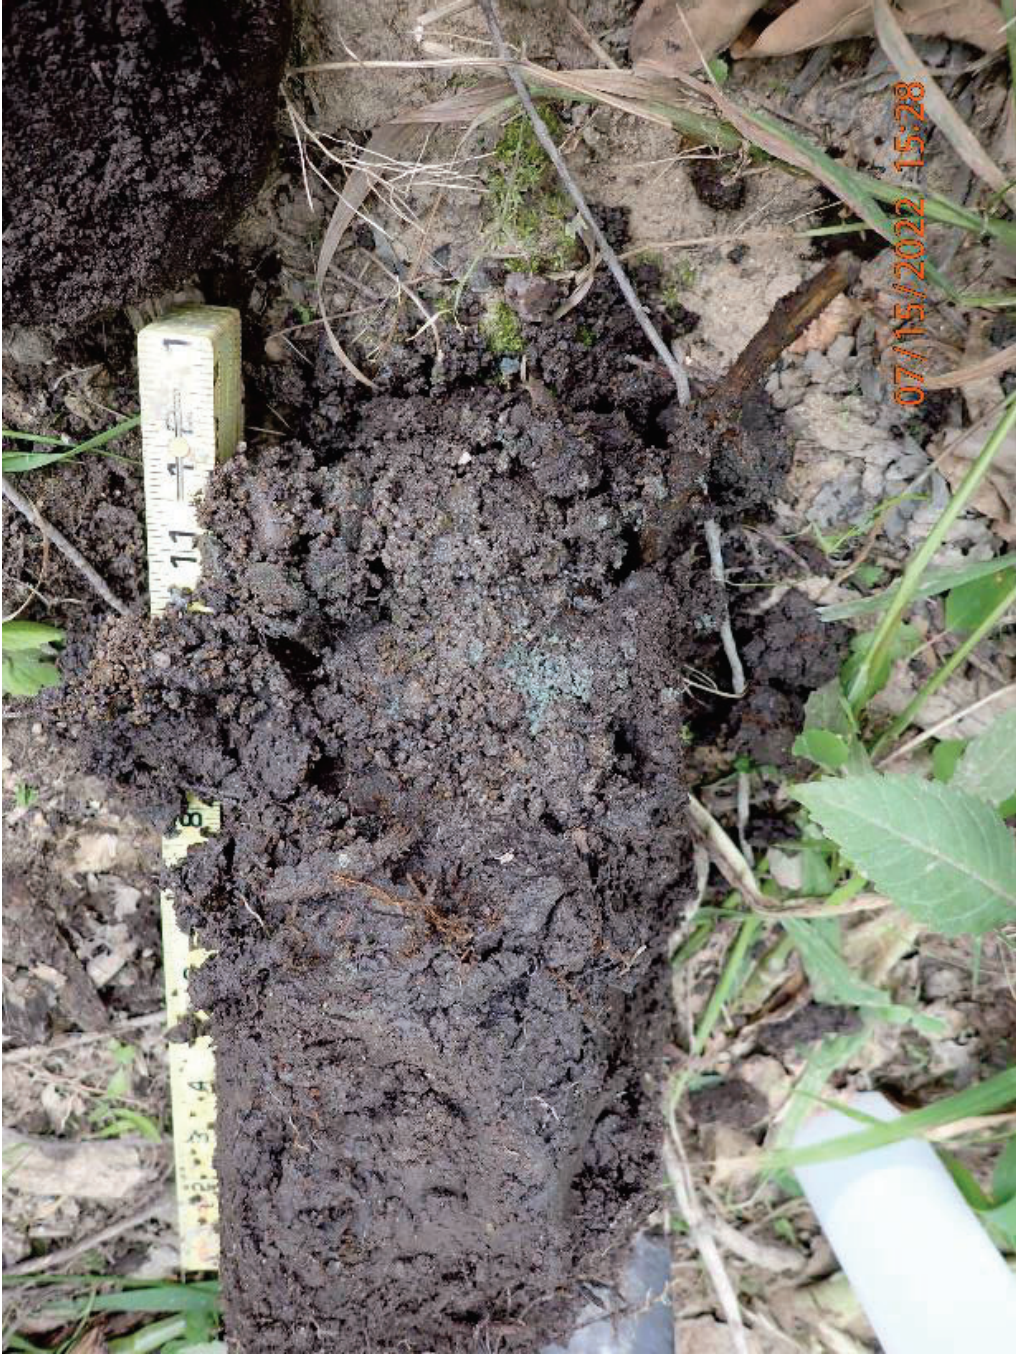
**Date:** 7/15/2022  
**Time:** 3:28 PM  
**Photographer:** SSA  
**Photo ID:** 13 – P7150362

**Description:**  
Soil profile with gley soil

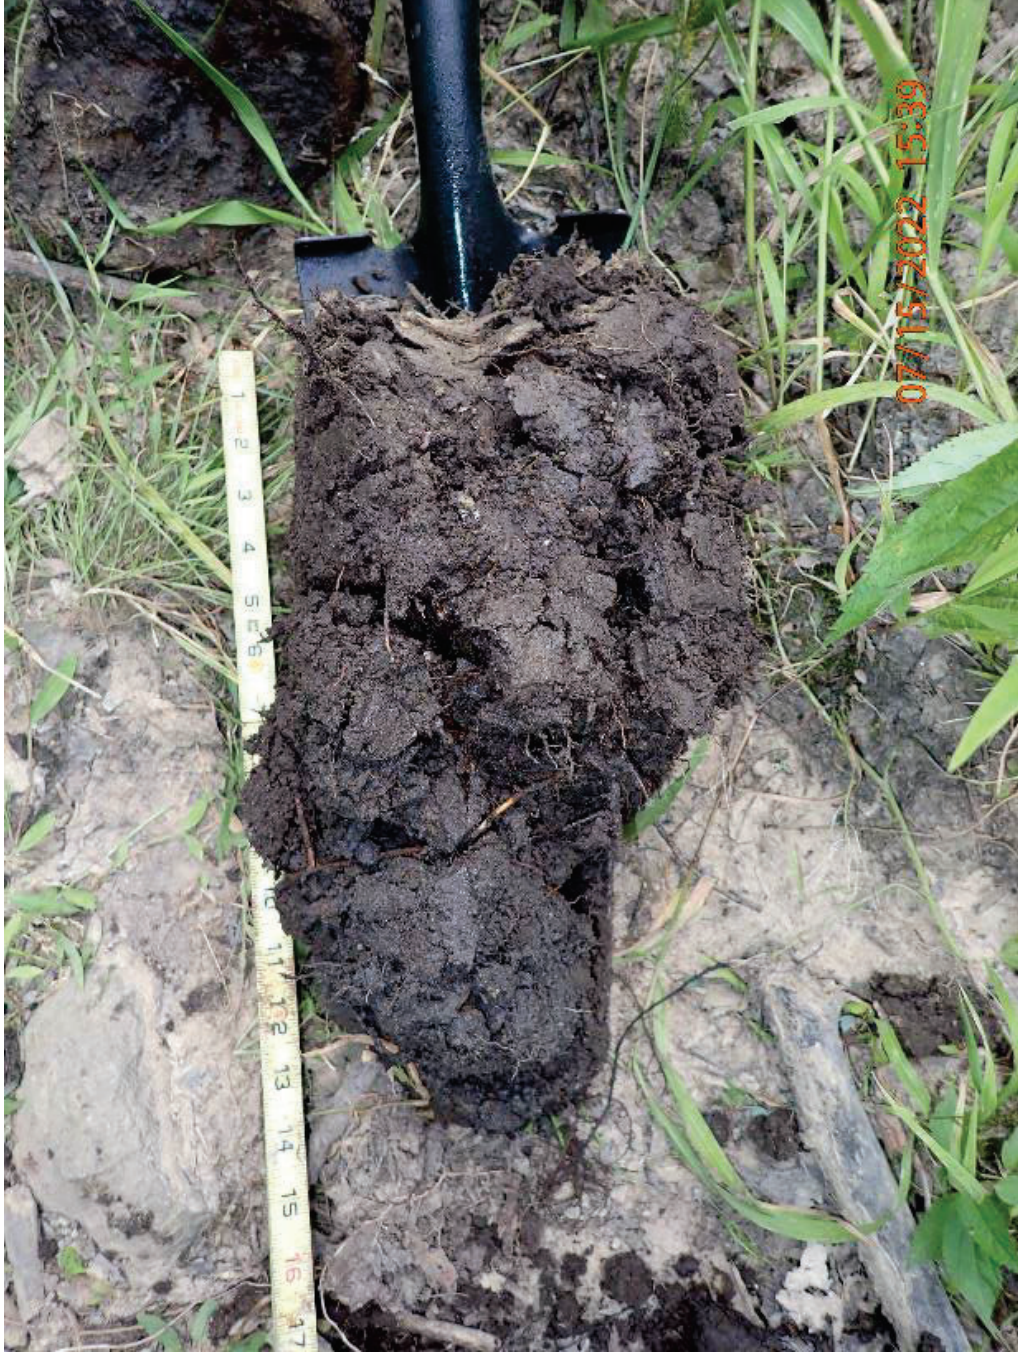
**Date:** 7/15/2022  
**Time:** 3:39 PM  
**Photographer:** SSA  
**Photo ID:** 14 – P7150363

Soil profile (to 14”) at sampling location

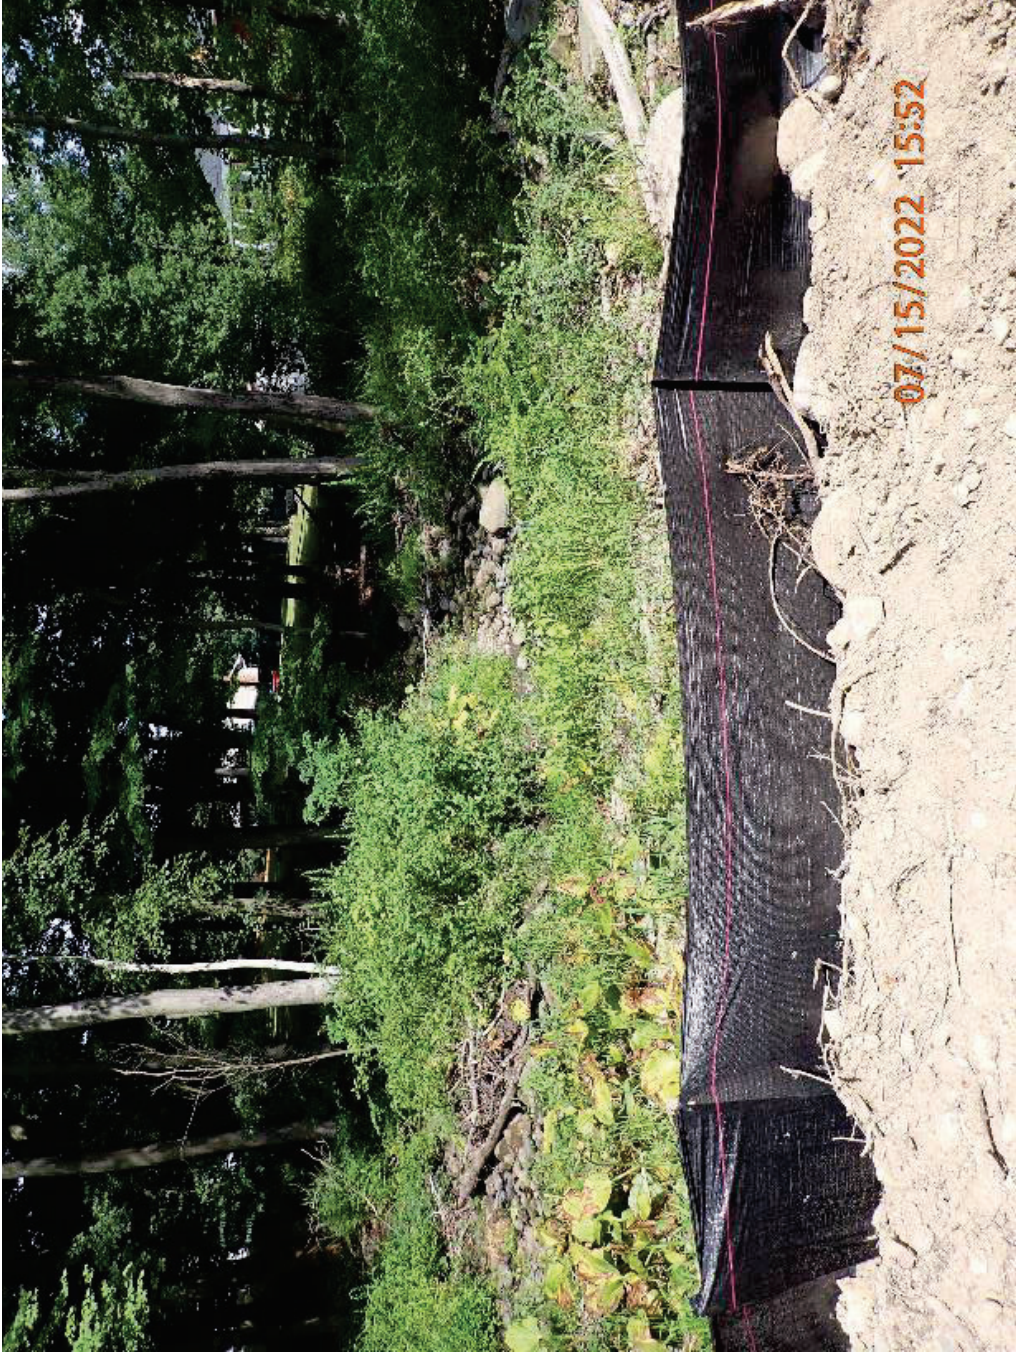
**Date:** 7/15/2022  
**Time:** 3:52 PM  
**Photographer:** SSA  
**Photo ID:** 15 – P7150364

EPA observed fill material, consisting of dirt and rock (including boulders), adjacent to the confirmed wetland areas.

Photo of ROW fill adjacent to wetland area

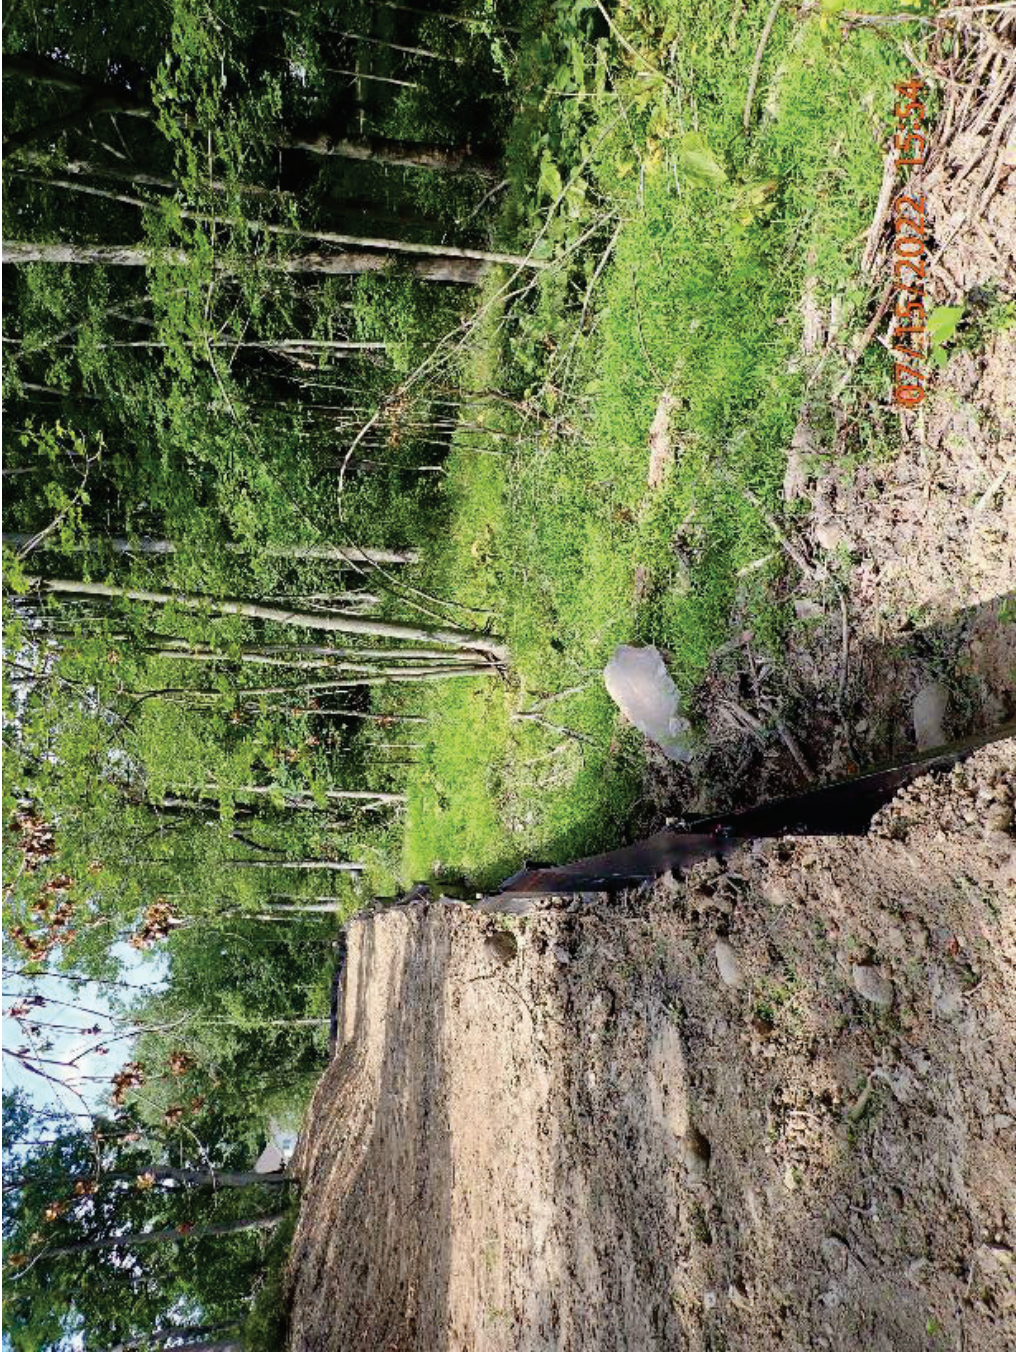
**Date:** 7/15/2022  
**Time:** 3:54 PM  
**Photographer:** SSA  
**Photo ID:** 16 – P7150365

Edge of ROW disturbance  
adjacent to wetland area

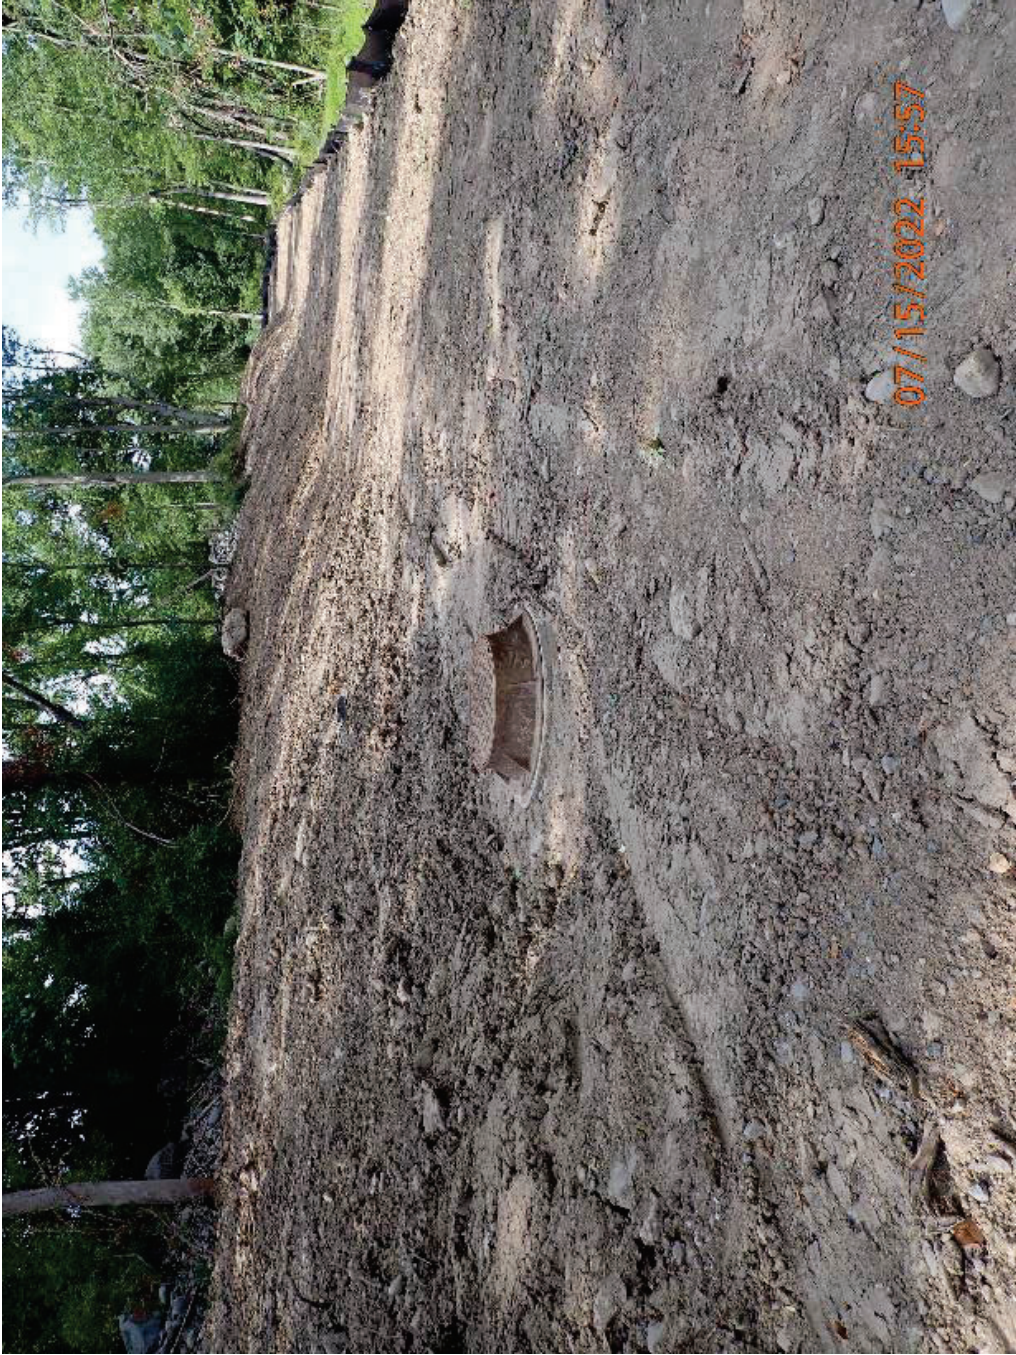
**Date:** 7/15/2022  
**Time:** 3:57 PM  
**Photographer:** SSA  
**Photo ID:** 17 – P7150366

**Description:**  
ROW with manholes
