# Clean Water Act Section 404: Site Visit/Case Development

Site Name	Town of Ramapo - Pinebrook Road Sewer Line
-----------	--------------------------------------------

CWA 404 Inspection  
Town of Ramapo – Sewer Line  
40 Pinebrook Road  
Chestnut Ridge, NY

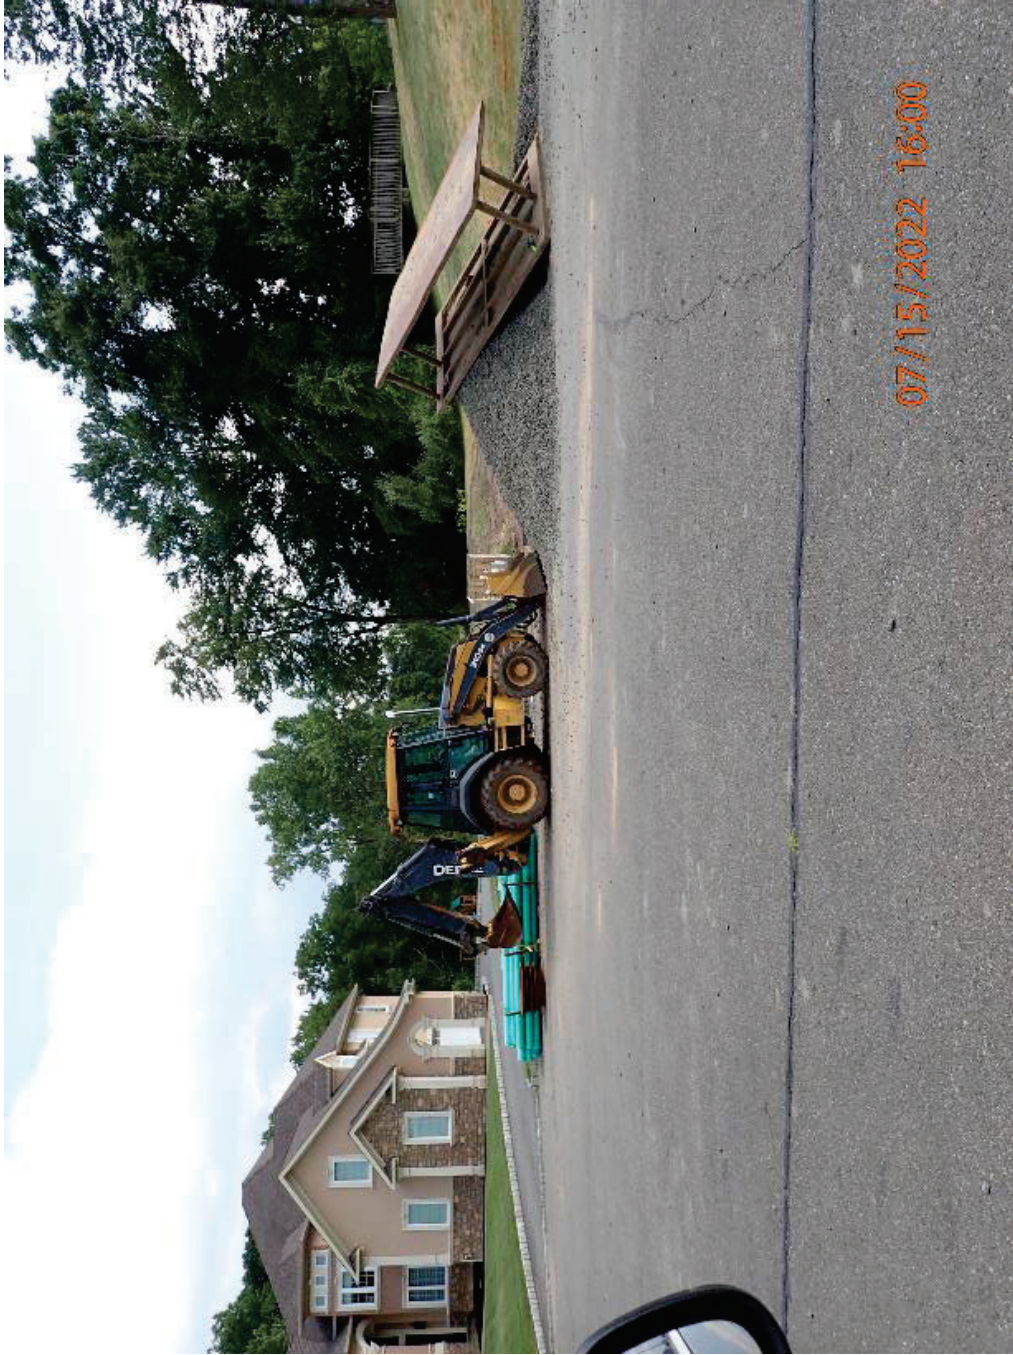
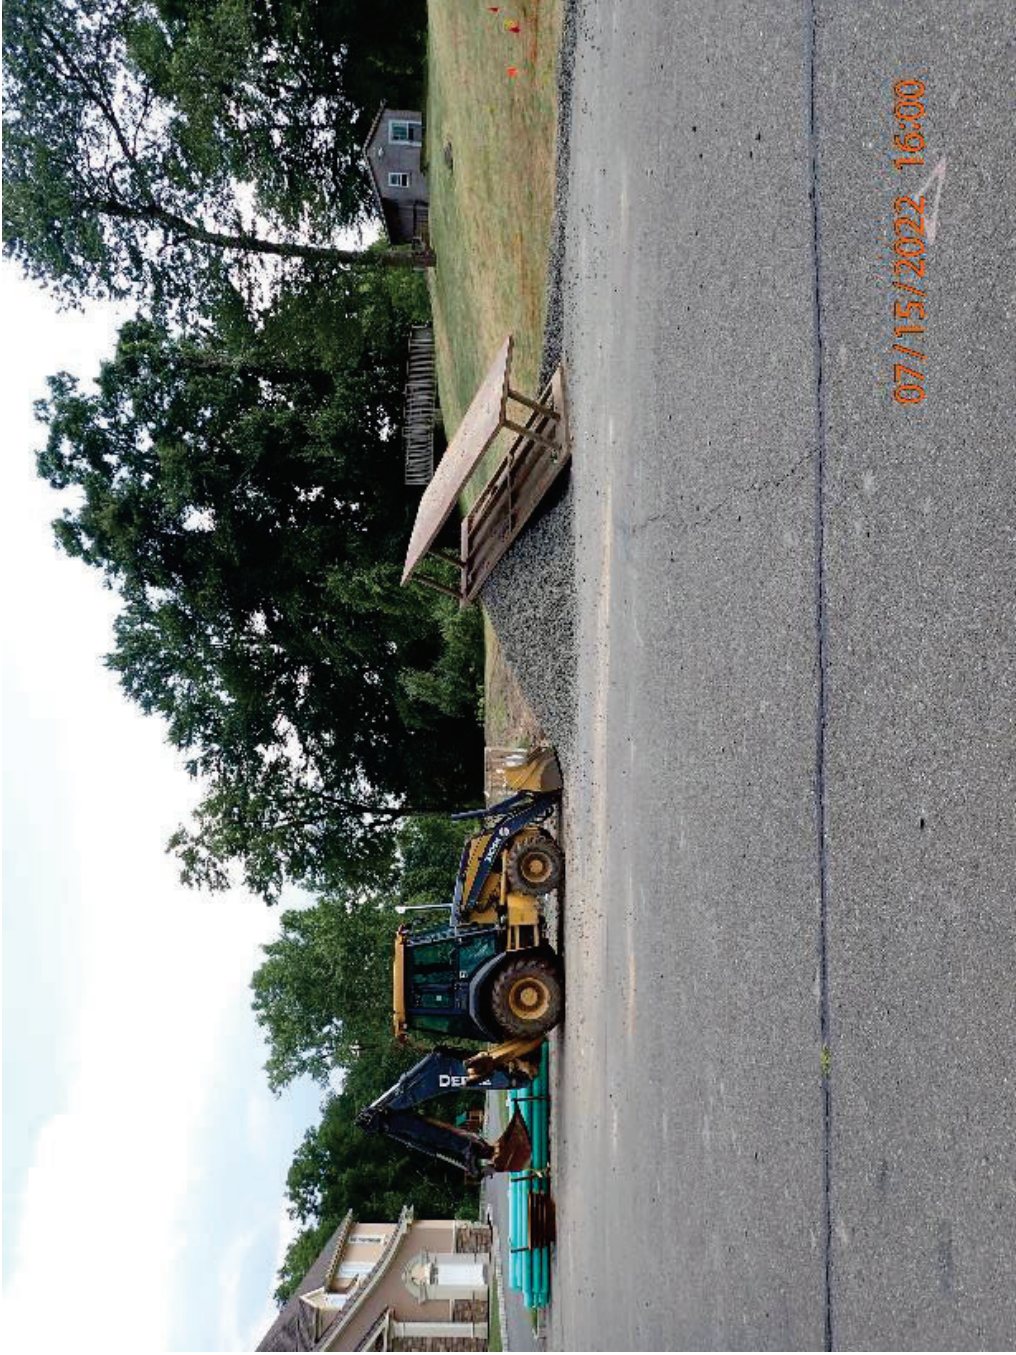
**Date:** 7/15/2022  
**Time:** 4:00 PM  
**Photographer:** SSA  
**Photo ID:** 18 – P7150367

Godwin Terrace staging area,  
backhoe
