INSPECTION REPORT

| Type of Inspection | Compliance Evaluation Inspection (CEI) | | |
| Facility or Site Name | Coral Marine Services LLC | | |
| Type of Operation | Coral Marine Services LLC (CMS) conducts tank cleanings of boats, vessels, and barges, along with performing repairs and maintenance on boats in their marine division. | | |

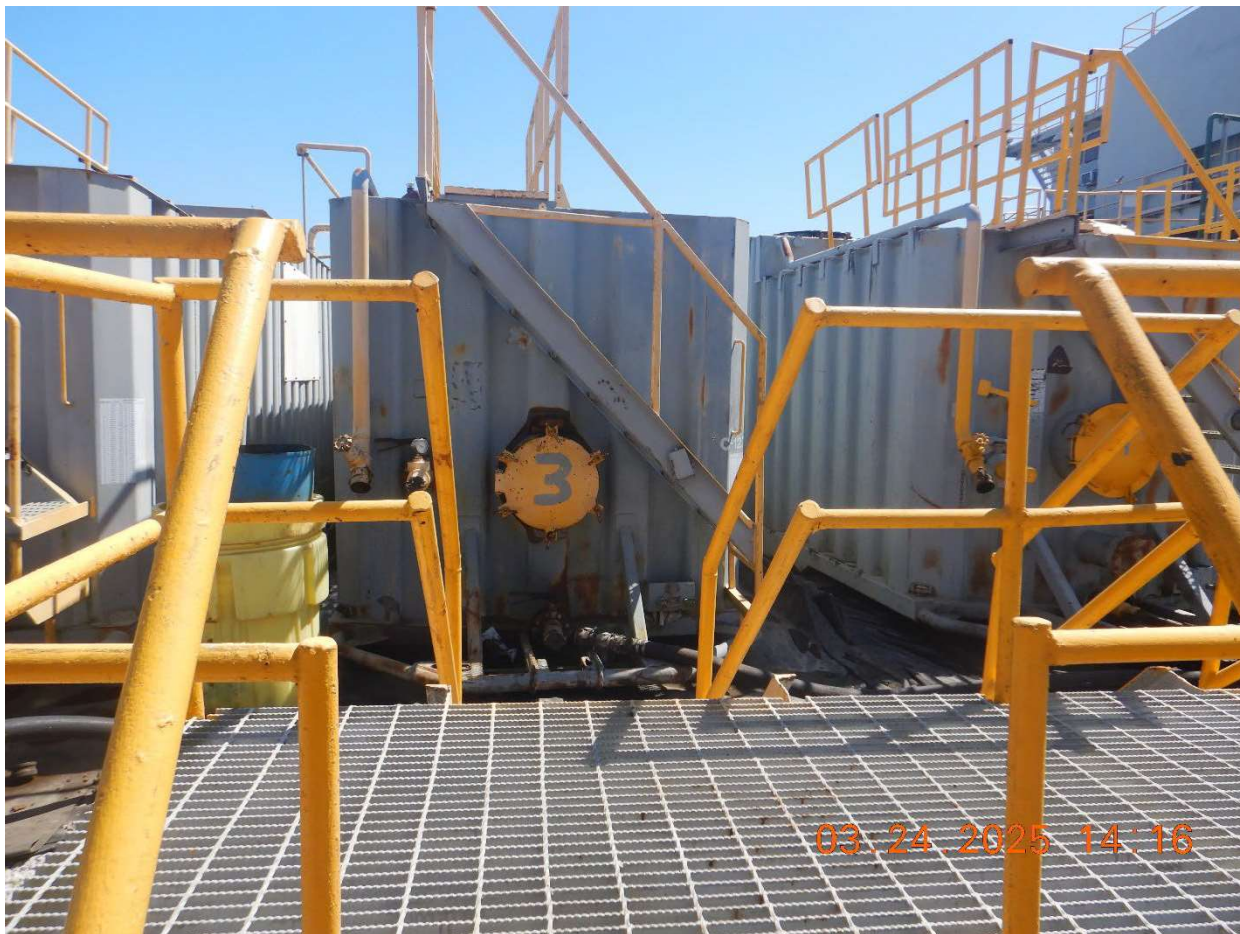
Photo No. 1

Description: View of a  $\frac{3}{4}$  full frack tank (#3) storing used oil in the CMS tank farm that was not labeled as used oil.

| <b>Facility:</b> Coral Marine Services LLC | | |
|---|---|---|
| <b>AOC #1</b> – CMS did not clearly label aboveground tanks used to store used oil with the words “Used Oil.” | <b>Citation:</b> 40 CFR 279.45(g)(1) | Section: 2.1 |

Please find attached photos showing that all the tankage that is/ or may be used for “Used Oil” have been labeled as such.

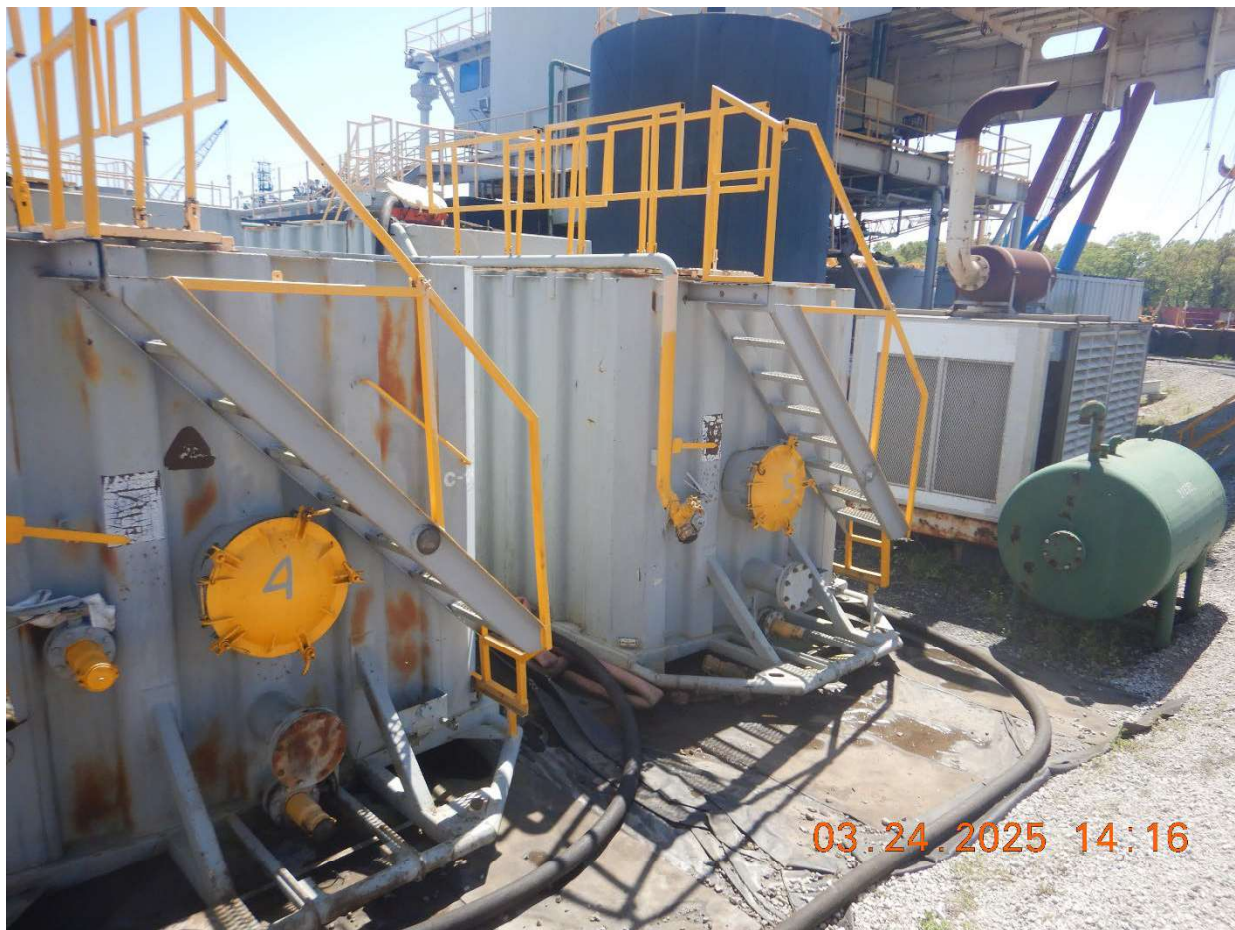
Photo No. 2

Description: View of a  $\frac{3}{4}$  full frac tank (#4) and a full frac tank (#5) storing used oil in the CMS tank farm that were not labeled as used oil.

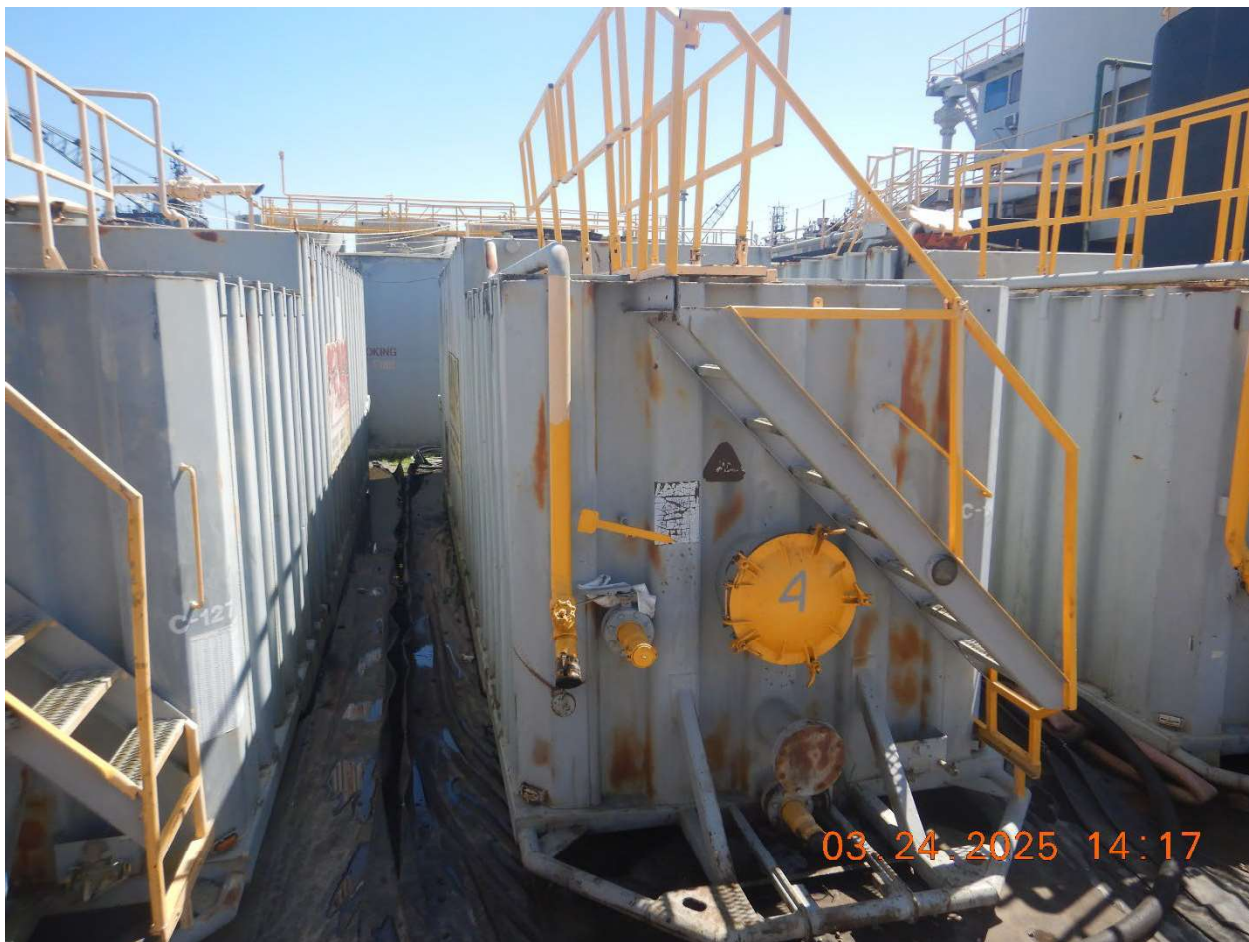
Photo No. 3

Description: View of a  $\frac{3}{4}$  full frack tank (#4) storing used oil in the CMS tank farm that was not labeled as used oil.

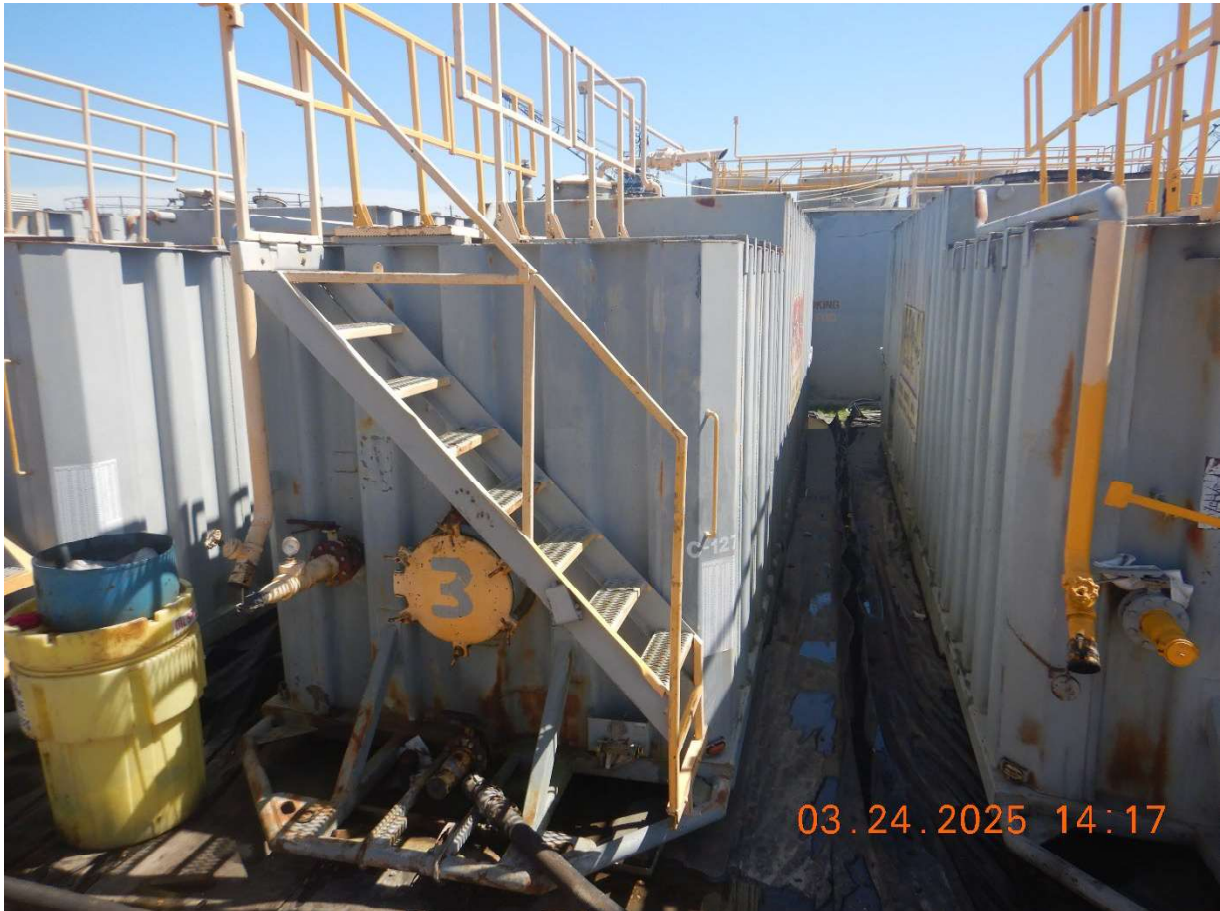
Photo No. 4

Description: View of a  $\frac{3}{4}$  full frack tank (#3) storing used oil in the CMS tank farm that was not labeled as used oil.
