**Region 6 - Enforcement & Compliance Assurance Division**  
**INSPECTION REPORT**

| Inspection Date(s): | 4/3/24 | |
| Company Name: | <b>MidAmerica Environmental Holdings, LLC</b> | |
| Facility Name: | <b>Hutcheson B-2 SWD Commercial</b> | |

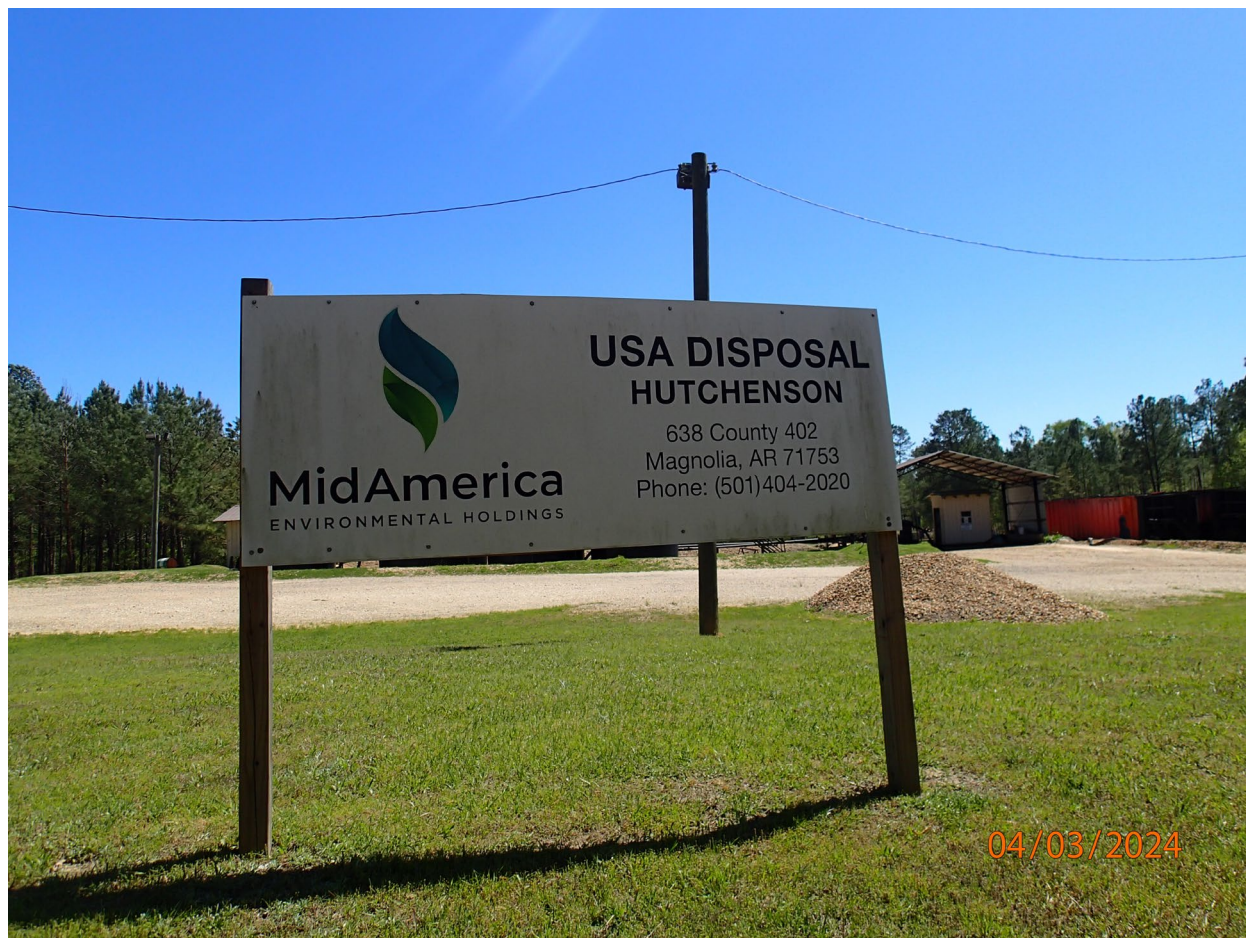
Photo No. 1

**Description:** Looking SSW, this photo showed the signage at the facility.

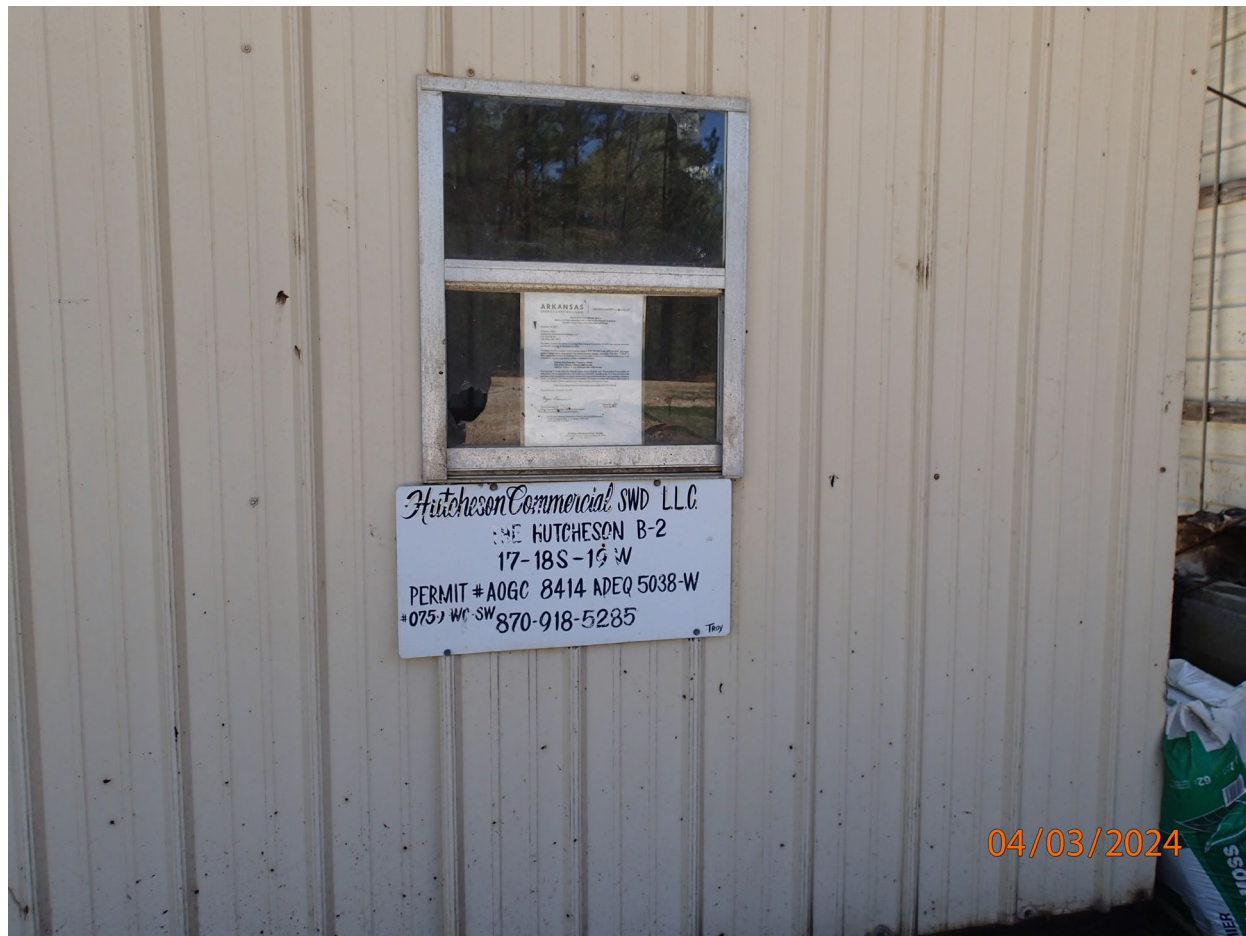
Photo No. 2

**Description:** Looking SSW, this photo showed additional signage at the facility.

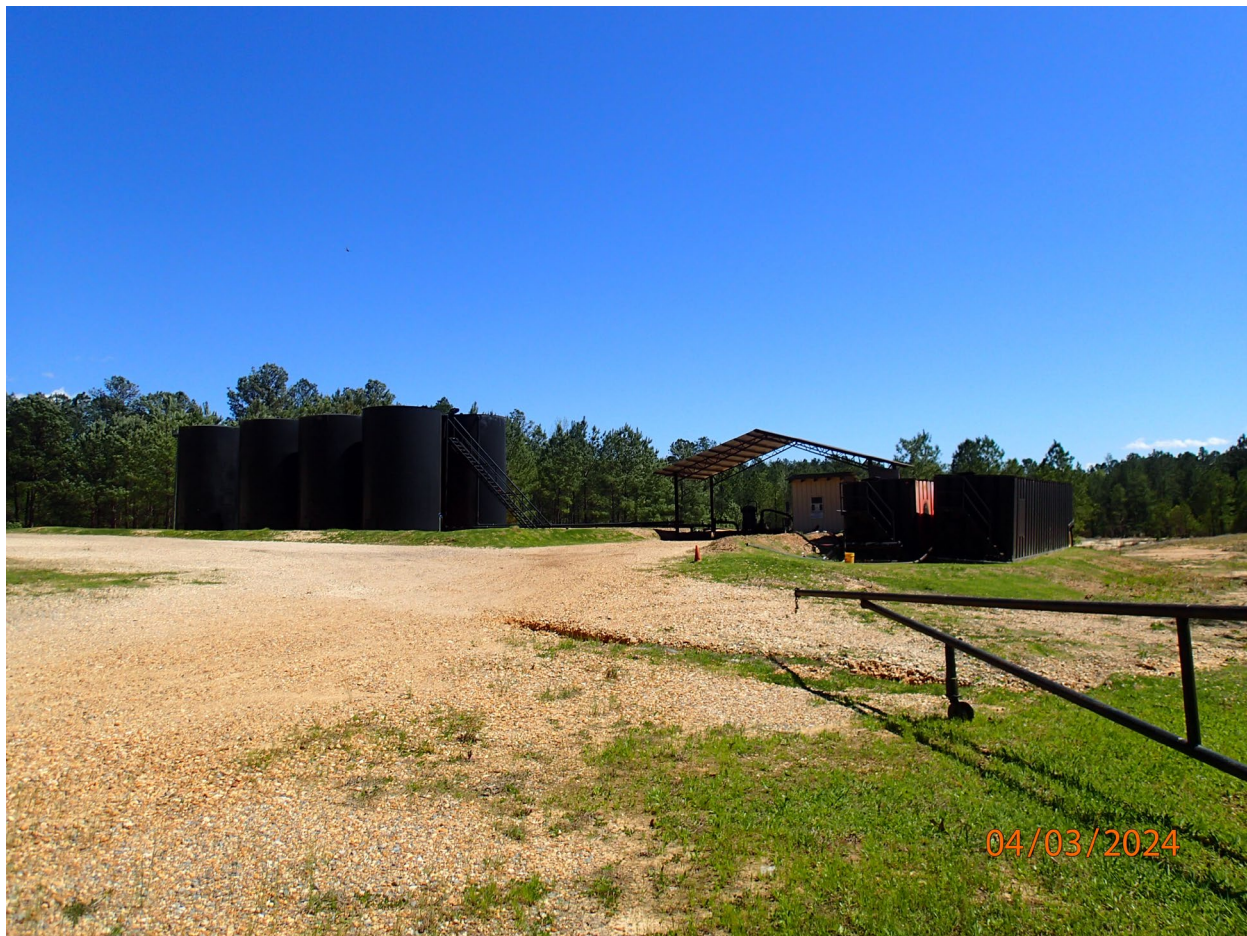
Photo No. 3

I observed the facility sign, secondary containment, pipes and valves, and storage tanks located at the facility; see Appendix 1 (Photograph Log), Photo No. 1 through No. 3. For additional GPS location and photo metadata, see Appendix 1.

**Description:** Looking SW, this photo showed an overview of the facility.

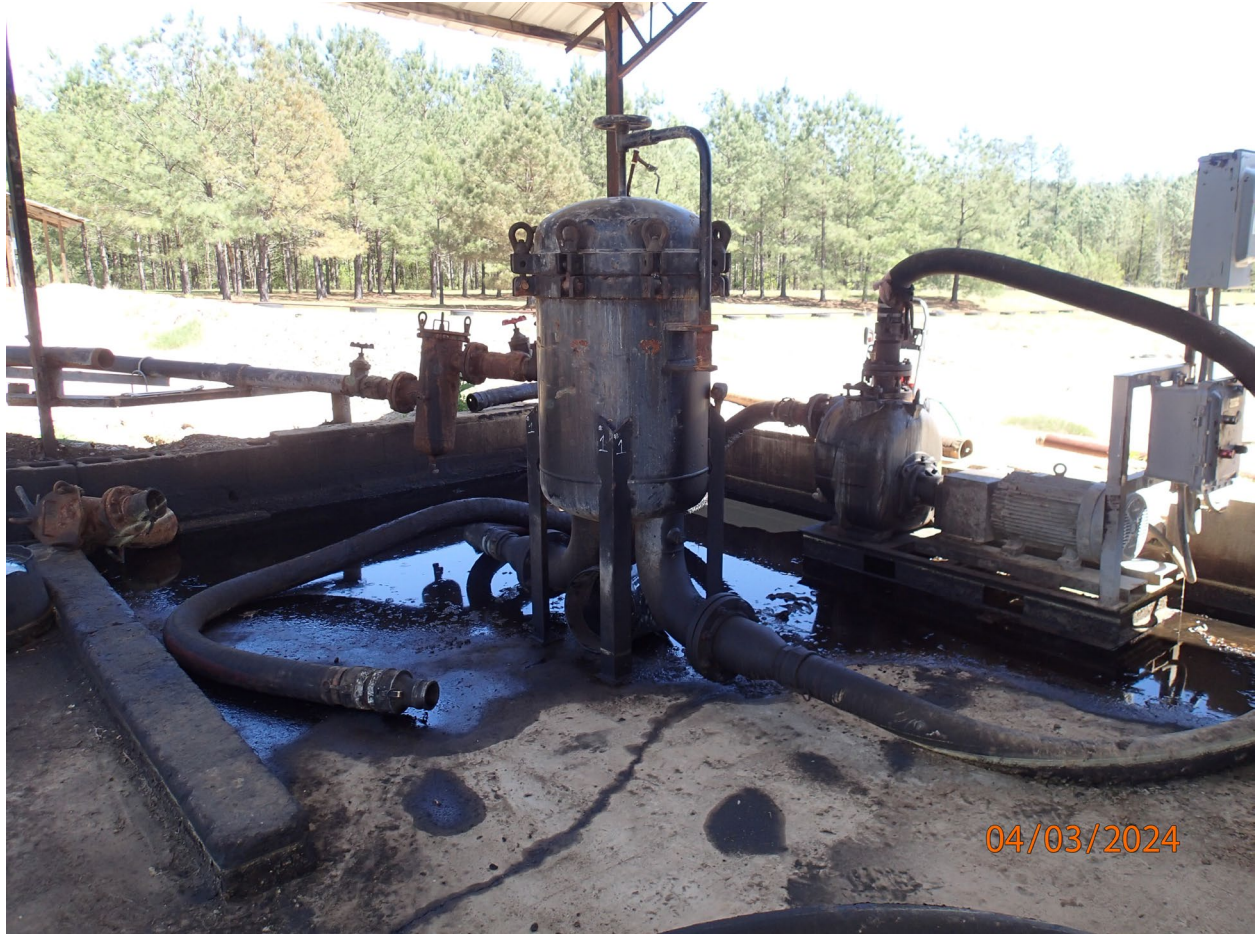
Photo No. 4

I observed the transfer area with loose oil inside containment and under cover, see Photo No. 4.

No closing conference was held due to no personnel with MidAmerica Environmental Holdings, LLC being present during the inspection. Areas of concern at the time of the inspection include the loose oil around the transfer area, two frac tanks outside secondary containment, the open valve and no cap on the drainpipe, the erodible soils behind the secondary containment and drainpipe, and some minor issues associated with the tanks inside secondary containment (not pictured).

**Description:** Looking SW, this photo showed loose oil around a transfer pump inside a concrete berm.

Inspector will conduct follow-up phone calls with the company representative(s) over the coming weeks and months to ensure areas of concern are properly addressed.

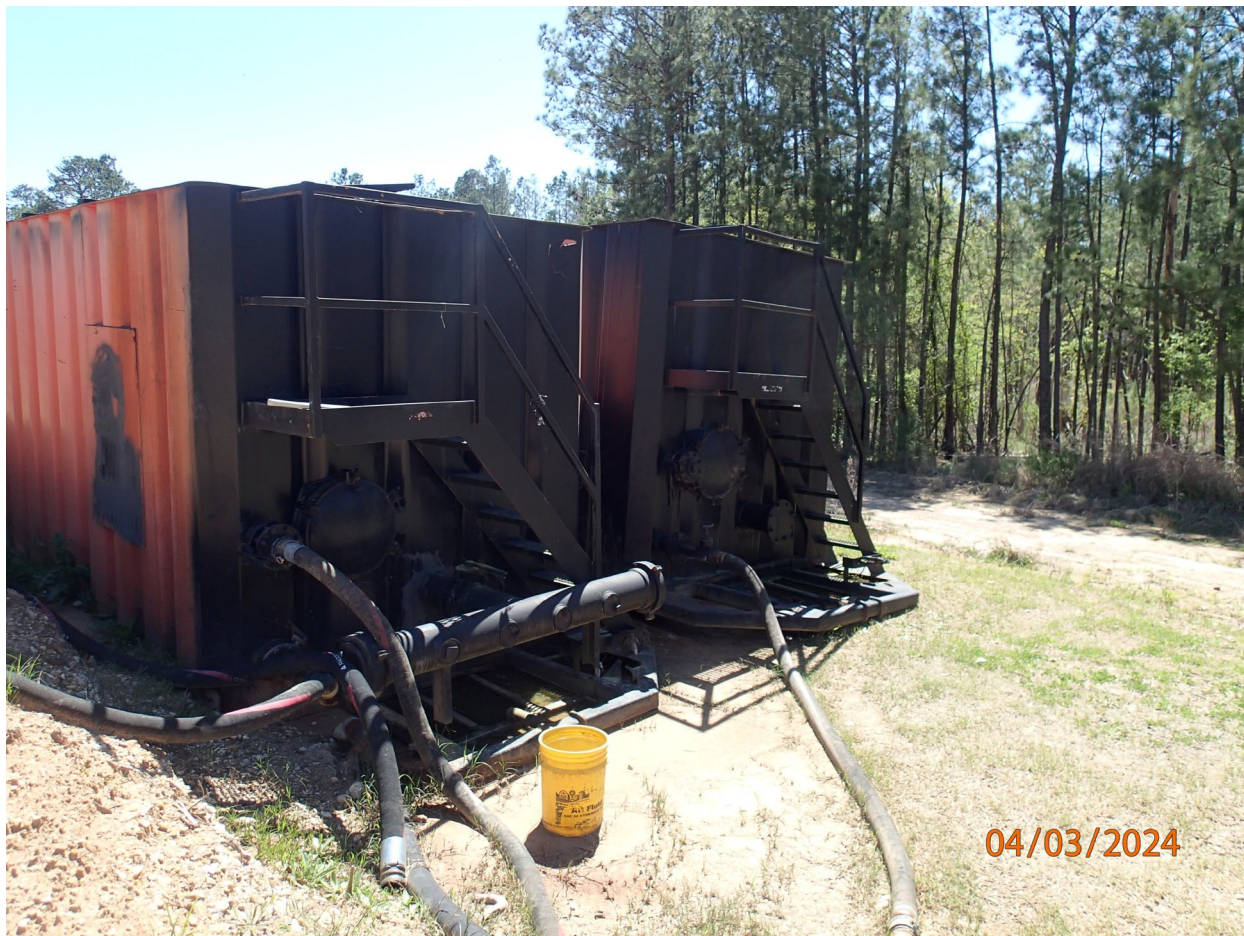
Photo No. 5

I observed two frac tanks used for storage outside secondary containment, see Photo No. 5.

**Description:** Looking SSE, this photo showed two frac tanks outside secondary containment.

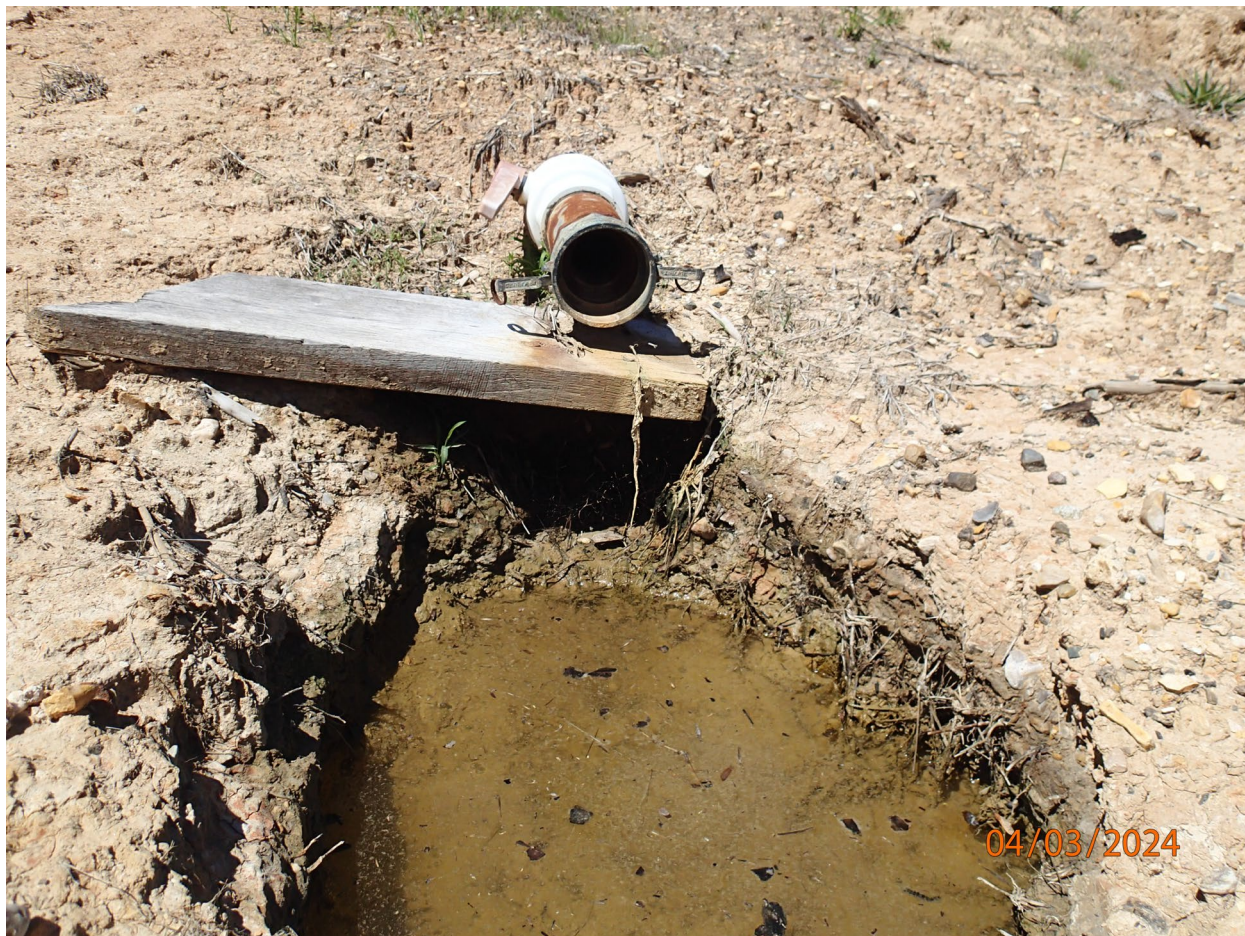
I observed the drainpipe for secondary containment with an open valve and no cap, see Photo No. 6 through No. 8.

**Description:** Looking N, this photo showed the drainpipe through secondary containment with an open valve and no cap on the pipe.

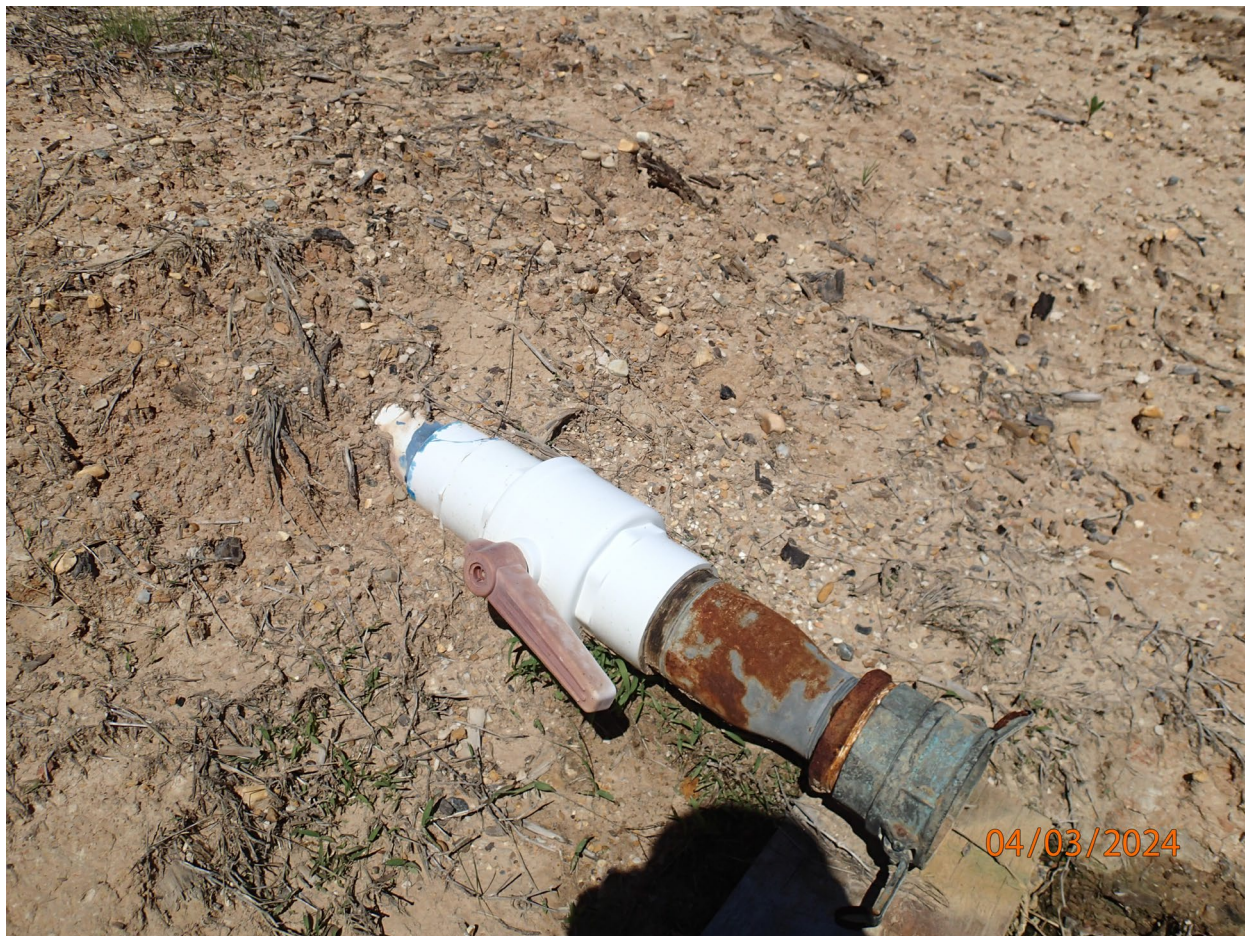
Photo No. 7

**Description:** Looking NE, this photo showed a closeup of the drainpipe in Photo No. 6.

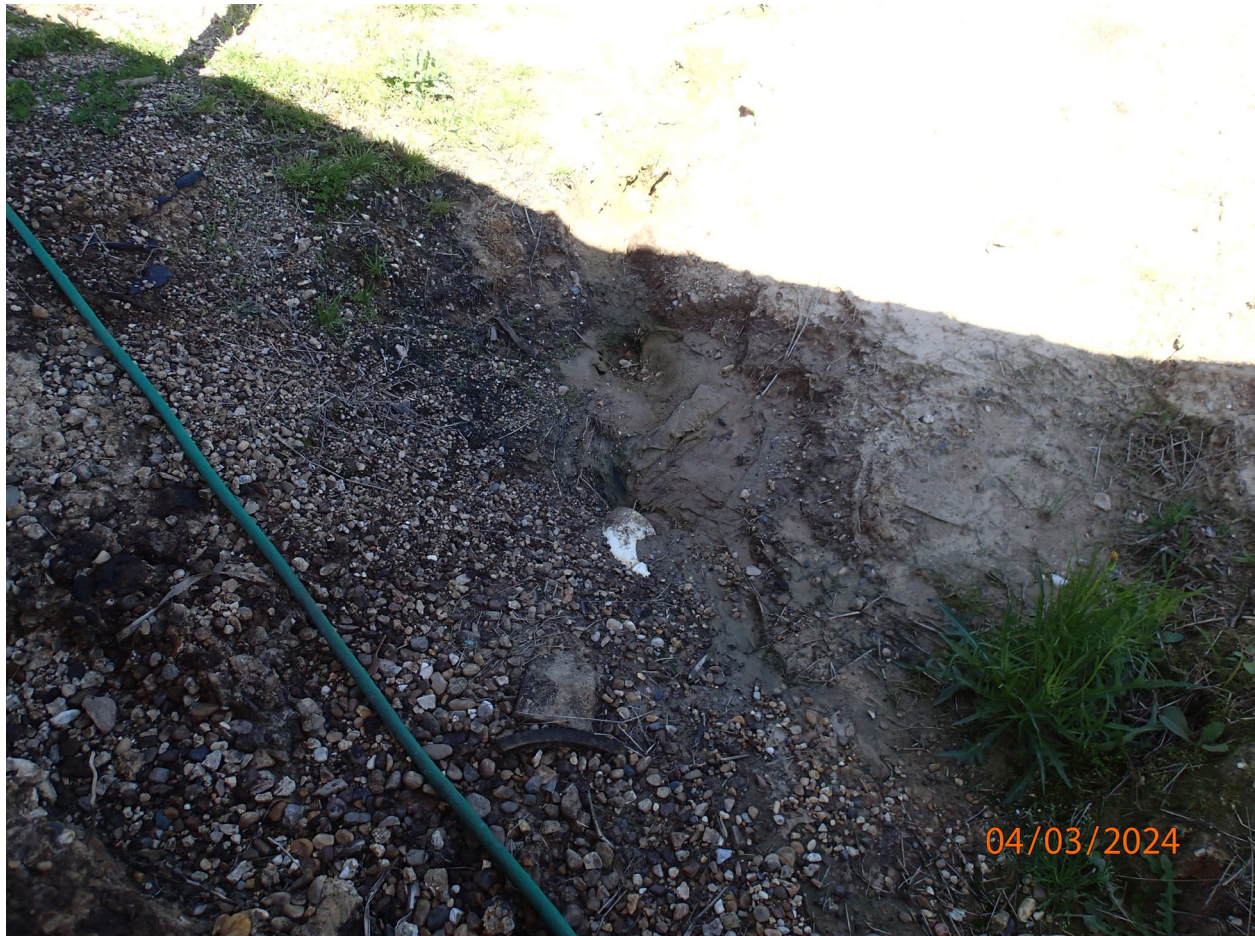
Photo No. 8

**Description:** Looking NE, this photo showed the drainpipe for secondary containment inside the firewall for Photo No. 6.

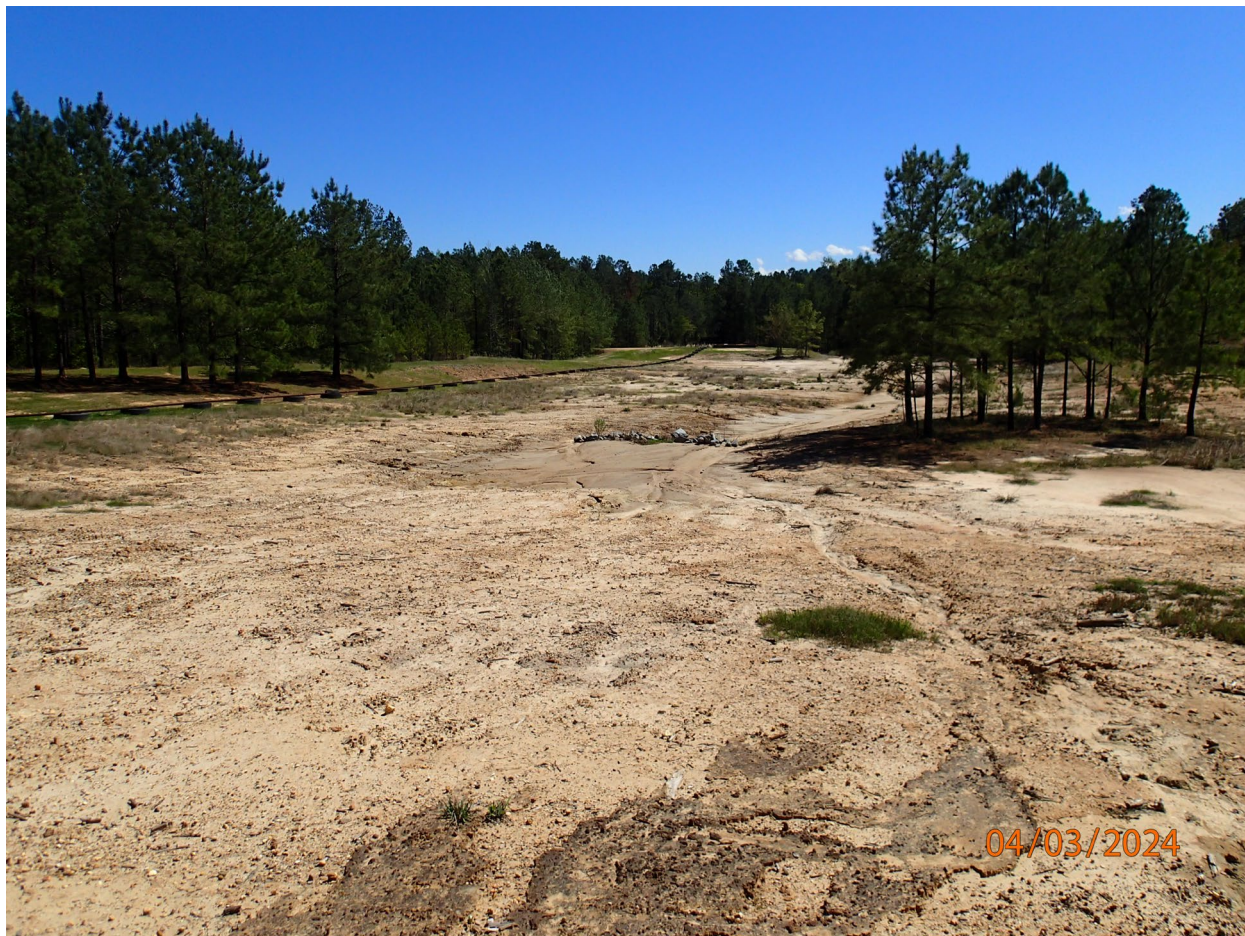
Photo No. 9

I observed an area with bare soils and dead vegetation behind secondary containment and downstream of the drainpipe for secondary containment, see Photo No. 9.

**Description:** Looking SW, this photo showed the area downstream of the drainpipe for secondary containment; I saw an extensive area with exposed/eroded soil.
