## **RCRA Inspection Report**

Gulfstream Aerospace Corporation - Main  
500 Gulfstream Road  
Savannah, Georgia 31408  
EPA ID # GAD061022216  
NAICS Code: 336411 - AIRCRAFT MANUFACTURING

June 2, 2021, 09:00 hours

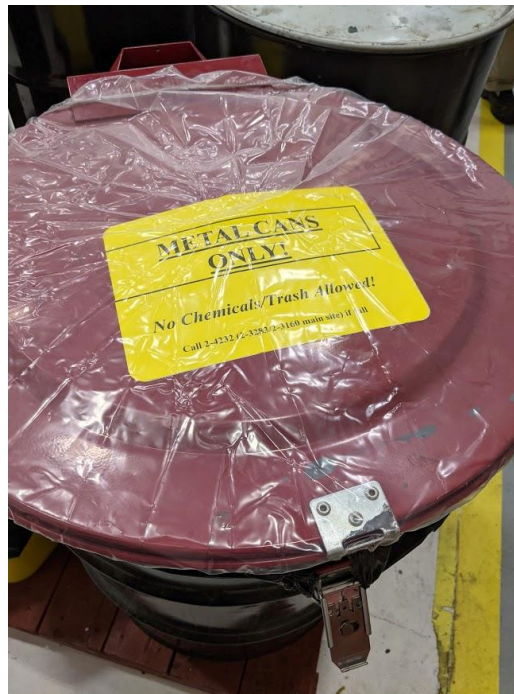
Hanger 2 is where the final inspection and testing of the aircraft is conducted. This area consists of the same SAA set up as Hanger 1. At the time of the inspection, a non-hazardous container that was labeled “Metal Cans Only” consisted of hazardous personal protective equipment (PPE) (Photographs 1 and 2 of 3). This container was not labeled hazardous waste and did not have the indication of the hazardous contents.

Photograph 1 of 3: SAA Hanger 2 Metal Cans Container

**Pursuant to Ga. Comp. R. and Regs. 391-3-11-.08(1) [40 C.F.R. § 262.15(a)(5)], which is a condition of the SAA Permit Exemption, a generator is required to do the following: mark or label its containers (i) with the words “Hazardous Waste” and (ii) with an indication of the hazards of the contents.**

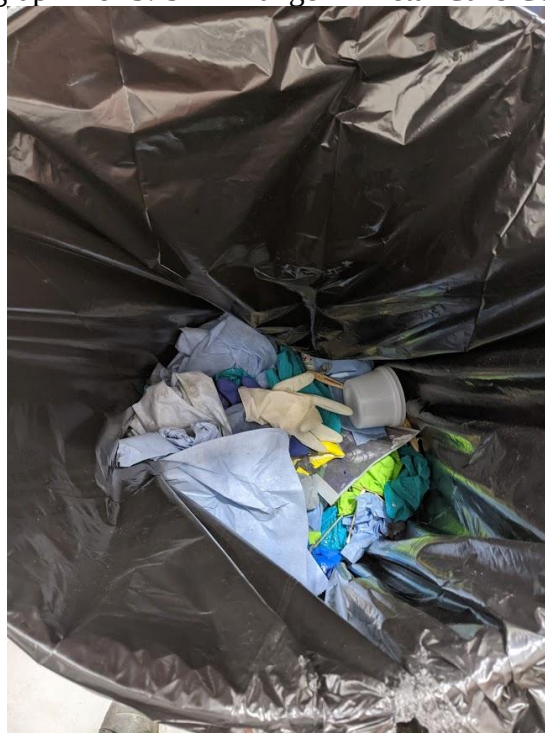
Photograph 2 of 3: SAA Hanger 2 Inside Metal Cans Container

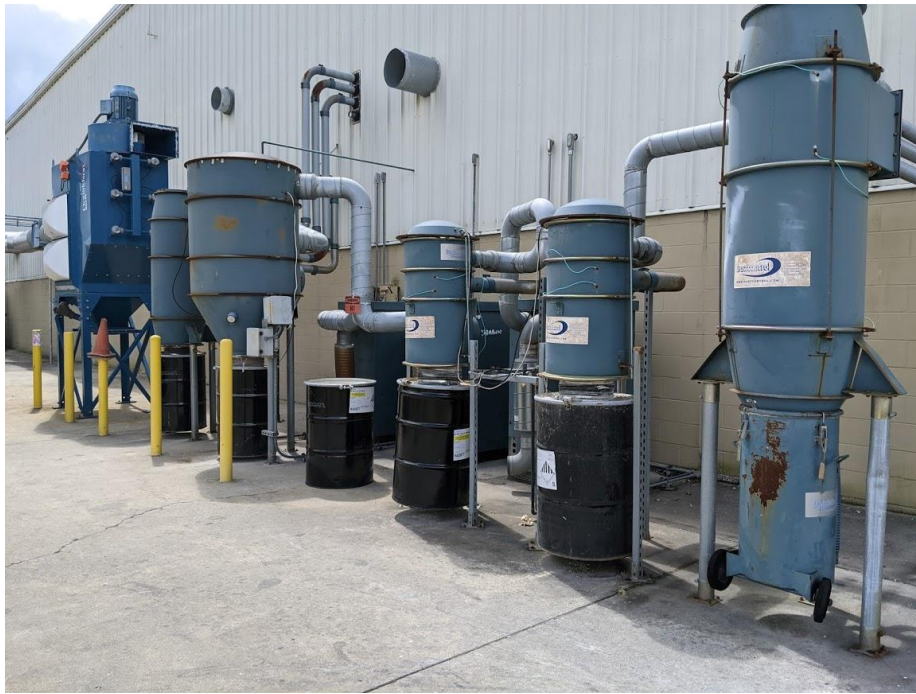
The wood shop is divided into 6 separate workstations throughout building. Each workstation has a 55-gallon container managing paint sealant hazardous waste and a 55-gallon container of toxic hazardous waste blast media (EPA waste codes: D005, D006, D007, and D008). At the time of the inspection, all SAA paint sealant containers were labeled hazardous waste, had the indication of the hazardous contents, and were closed. Blast media is collected from workstations and transferred via duct conduit to an outside collection area (Photograph 3 of 3). The sealant around the rim of the 55-gallon SAA container where the duct conduit meets the container had been compromised and deemed open by the inspection team.

Photograph 3 of 3: Hazardous Waste Blast Media Collection Area

**Pursuant to Ga. Comp. R. and Regs. 391-3-11-.08(1) [40 C.F.R. § 262.15(a)(4)], which is a condition of the SAA Permit Exemption, a generator is required to keep containers of hazardous waste closed at all times during accumulation, except when adding, removing, or consolidating waste; or when temporary venting of a container is necessary for the proper operation of equipment, or to prevent dangerous situations, such as build-up of extreme pressure.**
