**Region 6 Compliance Assurance and Enforcement Division  
INSPECTION REPORT**

| Facility Name: | Dublin Livestock Auction | | |
| Identification/Permit Number: | WQ0004136000 | | |

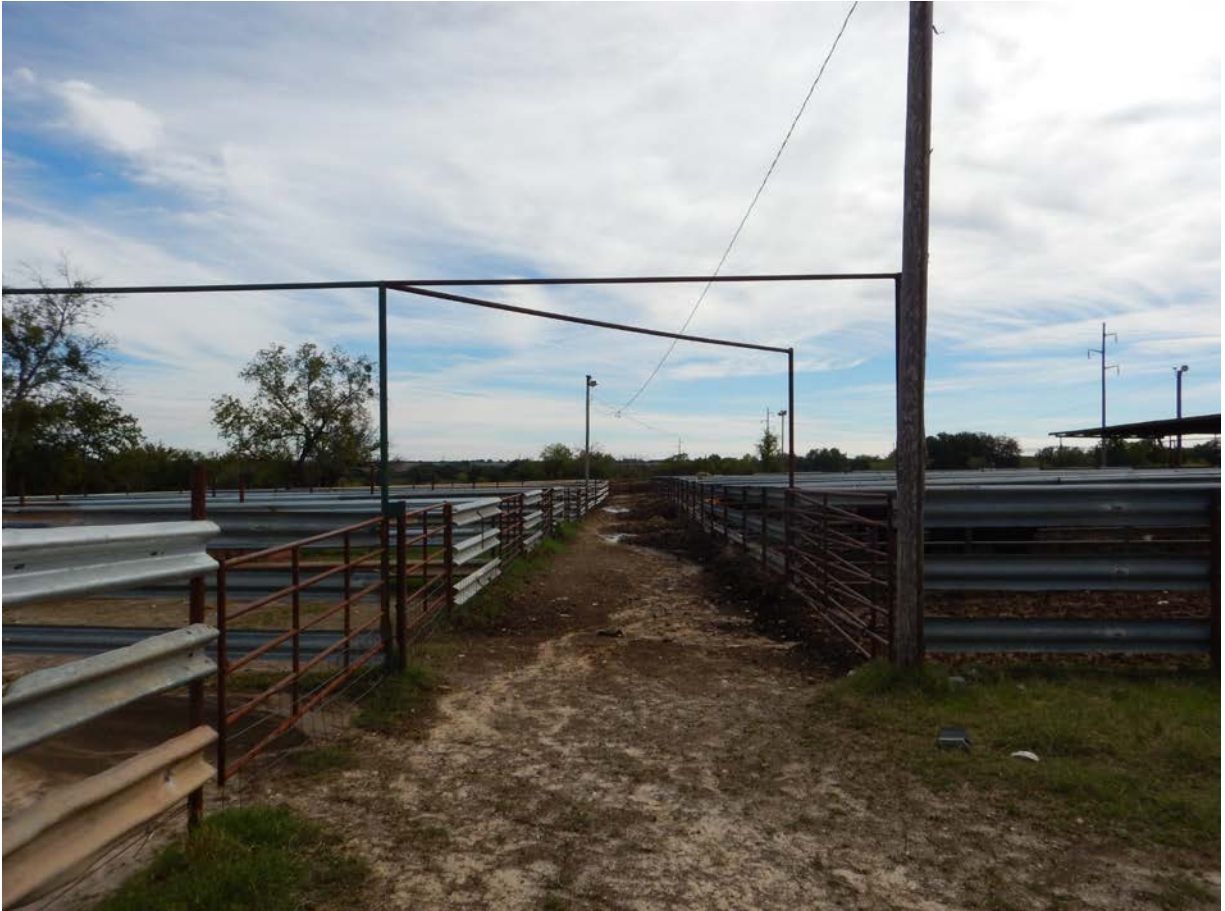
Photo No. 1

Description: This photo was taken facing southeast toward the uncovered pen area.

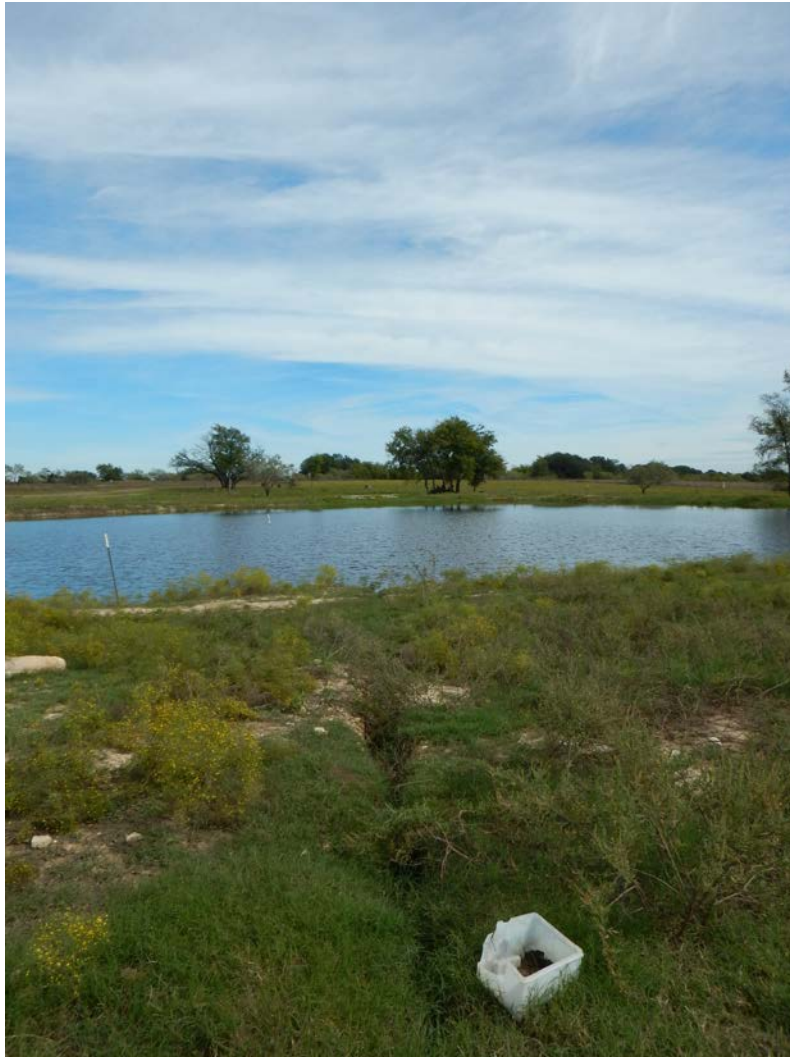
Photo No. 2

Description: This photo was taken facing east across RCS #1.

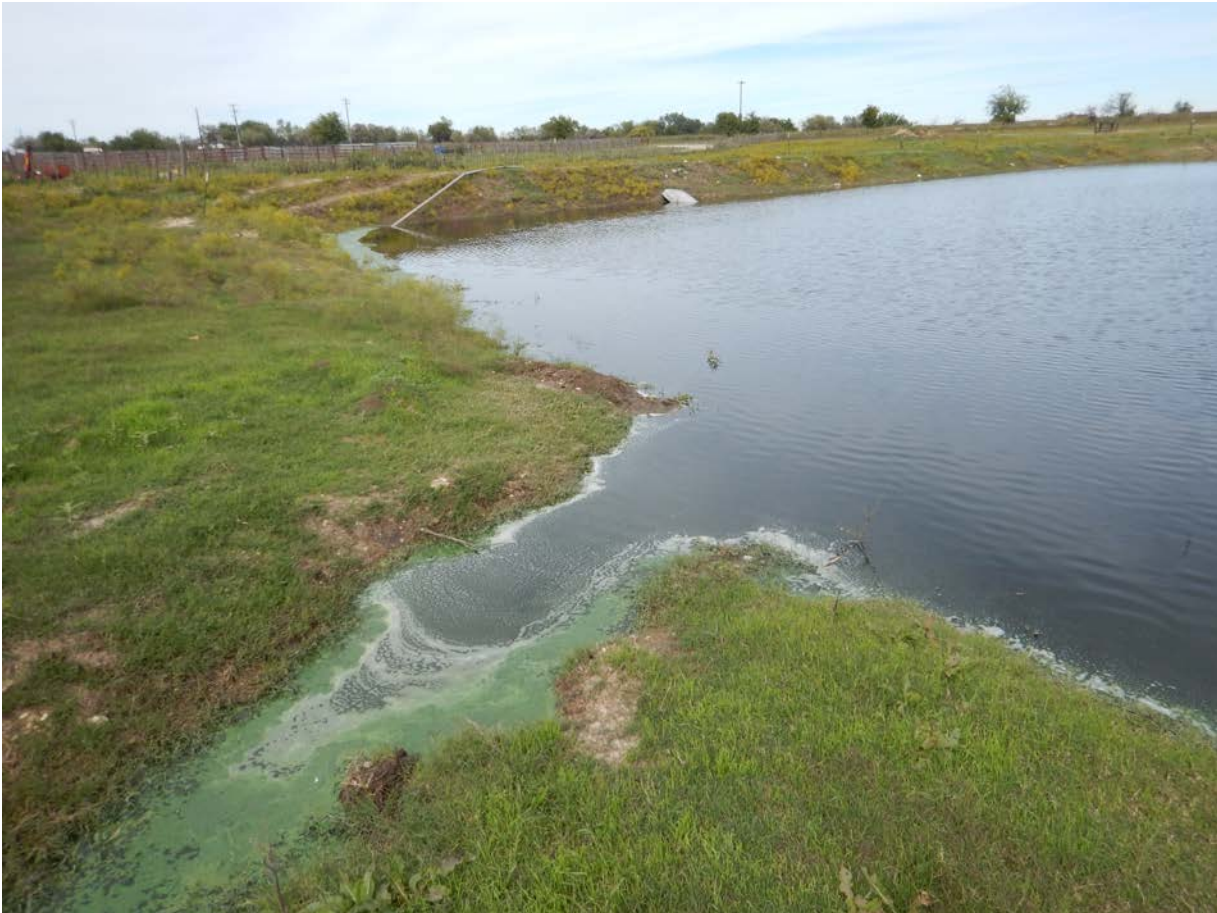
Photo No. 3

Description: This photo was taken facing north towards the inlet in RCS #1 which receives wastewater from the compost area and lots.

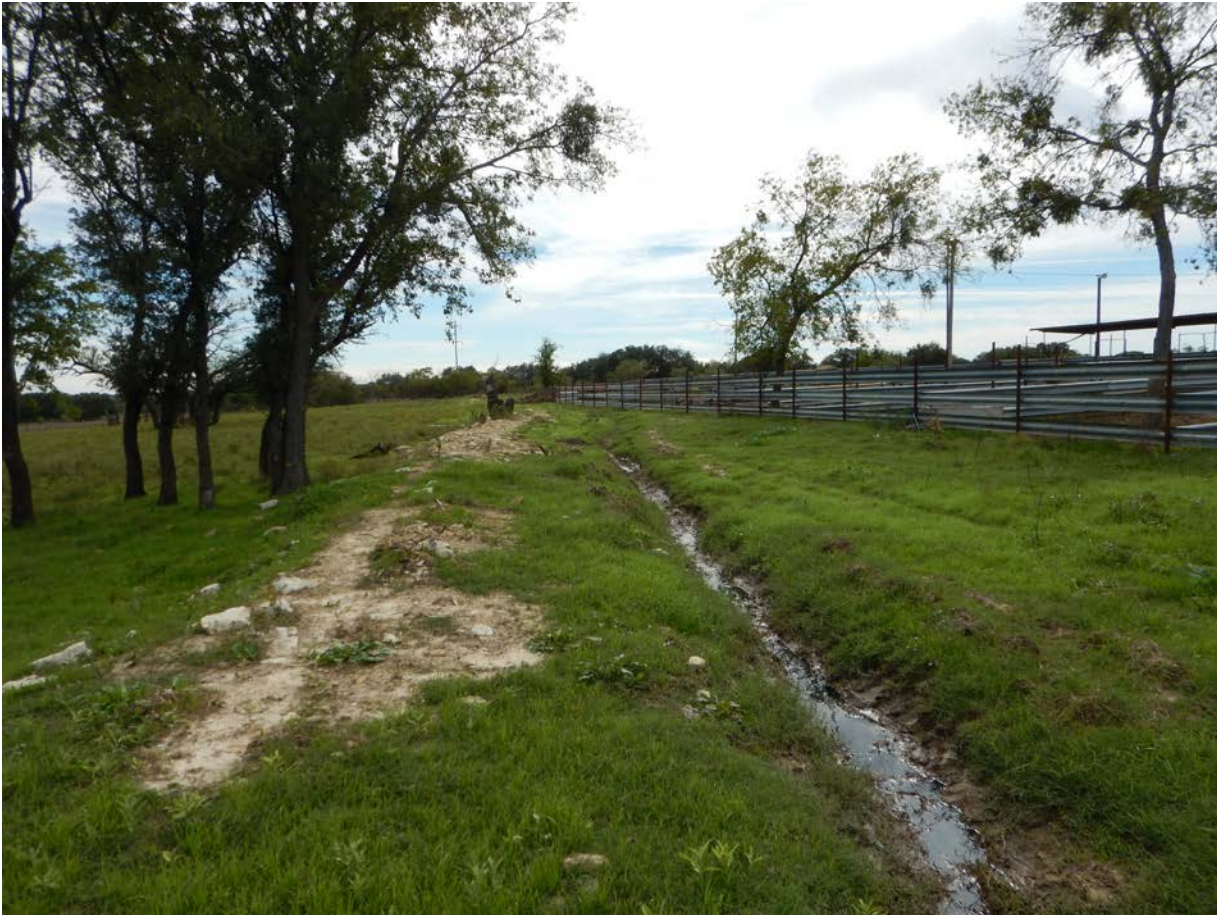
Photo No. 4

Description: This photo was taken facing southwest towards the bermed drainage ditch which conveys wastewater from the end of the pens and compost area.

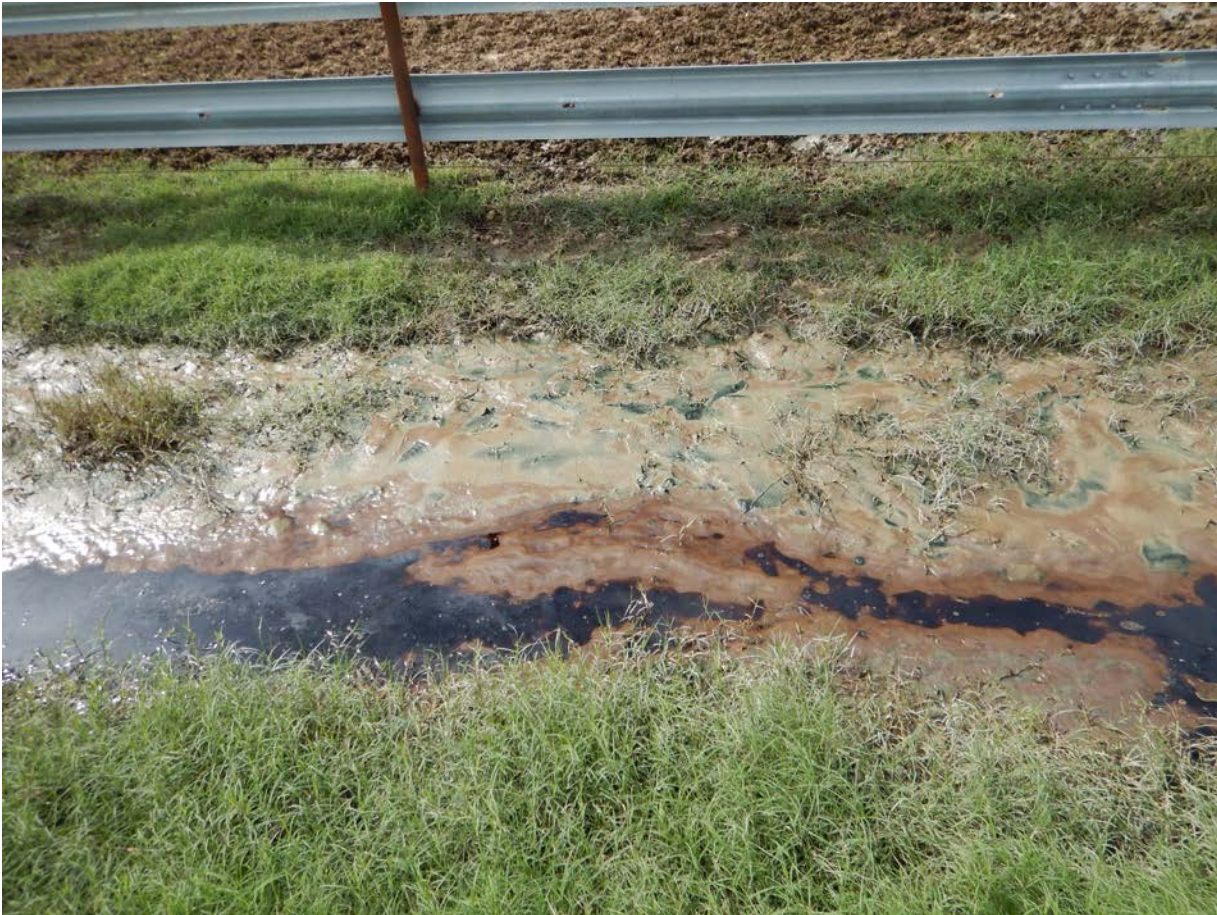
Photo No. 5

Description: This photo was taken facing the wastewater sitting in the drainage ditch which conveys wastewater from the end of the pens and compost area.

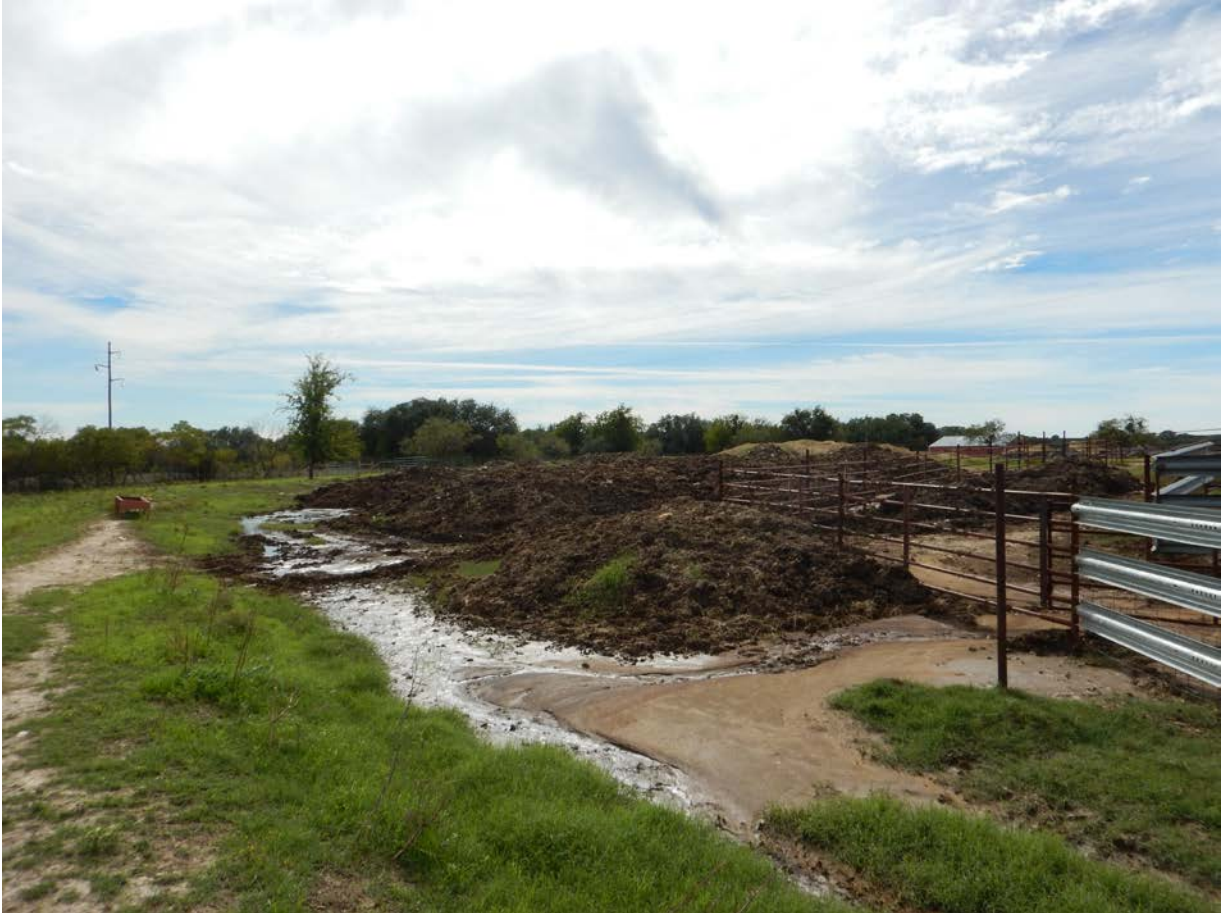
Photo No. 6

Description: This photo was taken facing southwest toward the facility's compost and solids storage area.

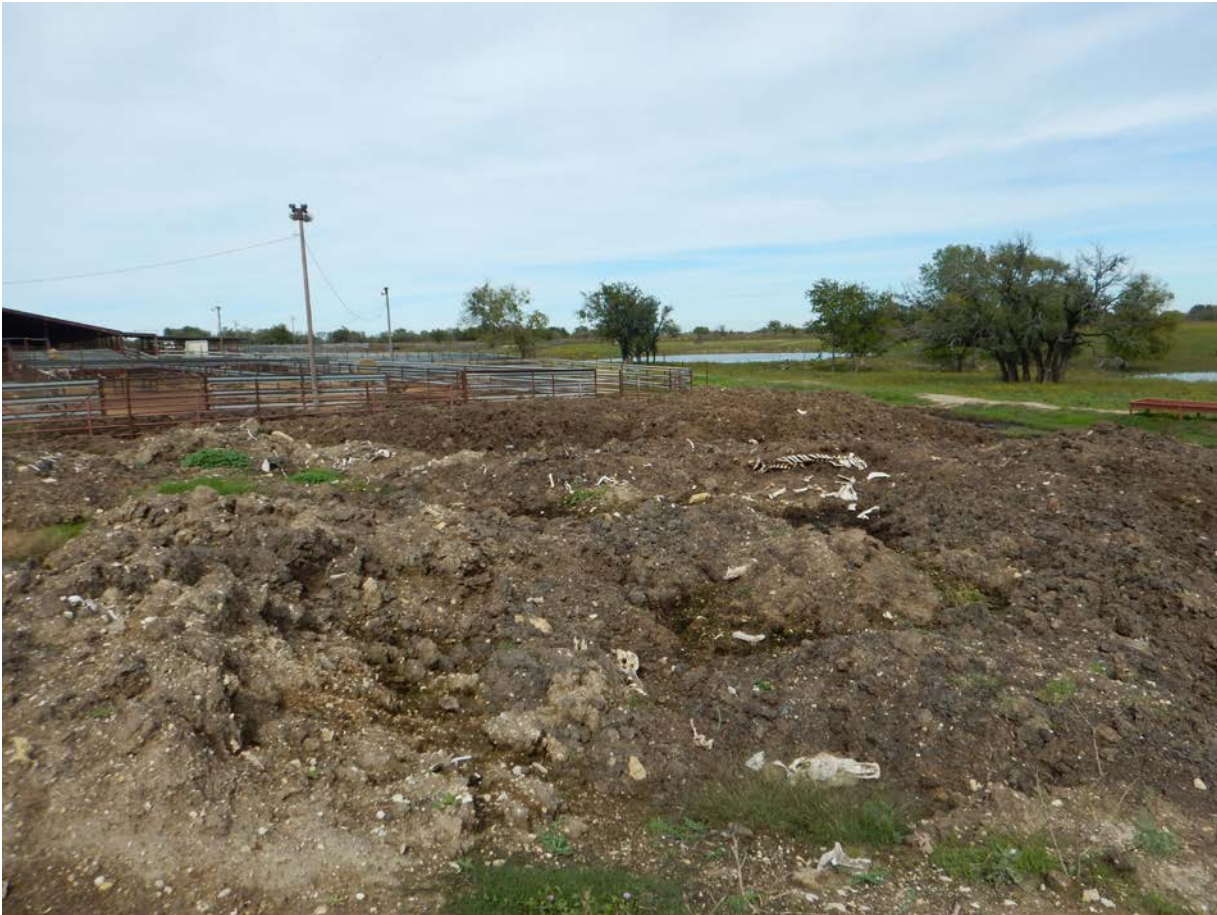
Photo No. 7

Description: This photo was taken facing north towards the facility's compost area.

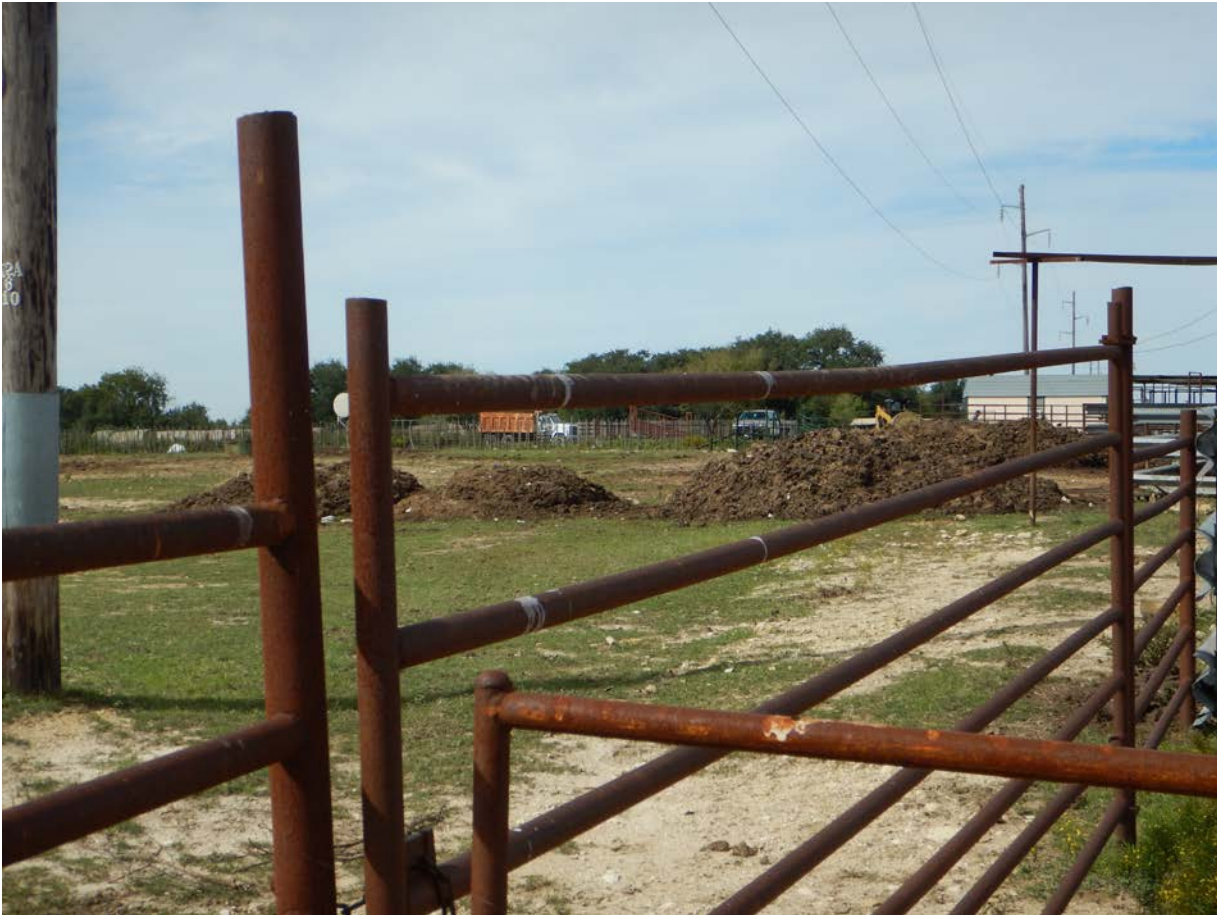
Photo No. 8

On the day of the inspection, I observed that the open lots and lot scraping stockpile area all drained toward the facility's Retention Control Structure (RCS). The berm which conveys this wastewater appeared to be in good shape and functioning as intended. I observed three piles just northeast of the stockpile which appeared to be lot scrapings not contained within the watershed of the RCS (Photo #8).

- Piles of lot scrapings were being stored outside the watershed of an RCS. Per WQ0004136000 VII.A.5(d)(2), manure or sludge areas must be located within the drainage area of the RCS.

Description: This photo was taken facing northwest toward what appears to be piles of lot scrapings being stored outside the watershed of the RCS.

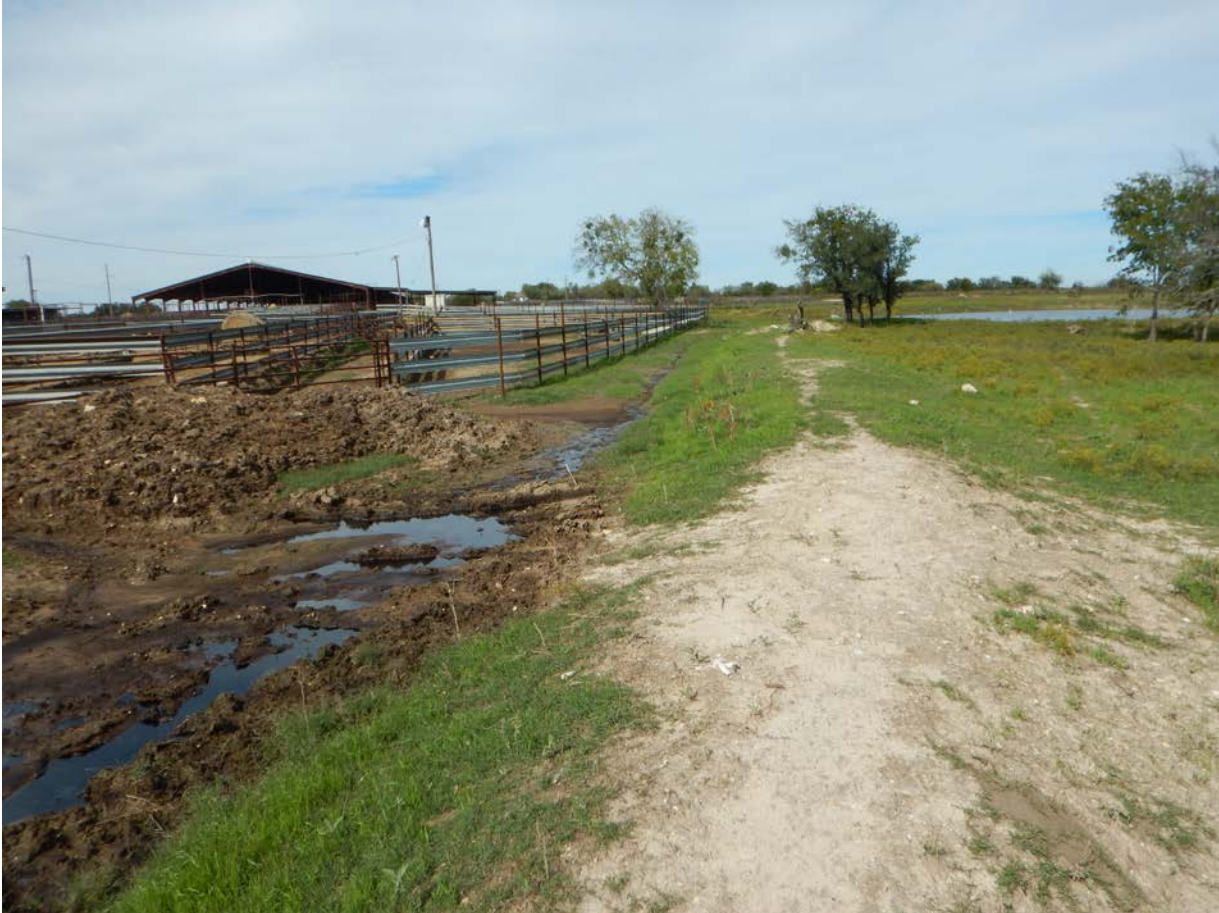
Photo No. 9

Description: This photo was taken facing northeast toward the berm which contains and directs effluent from the compost storage area to RCS #1.

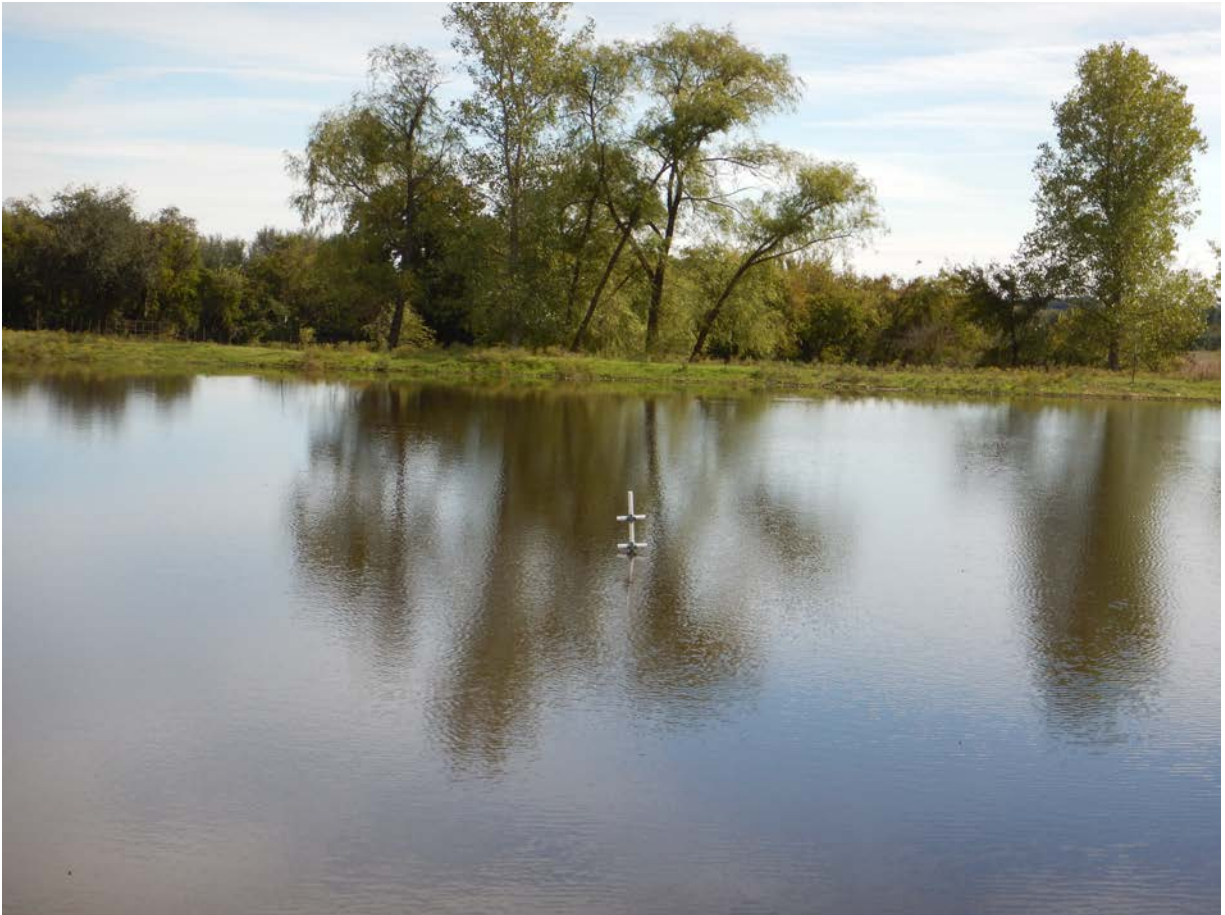
Photo No. 10

On the day of the inspection I observed that RCS #1 had less than two feet of freeboard and pole marker which was intact and readable (Photo #10).

Description: This photo was taken facing southeast toward the pole marker in RCS #1.
