## **RCRA COMPLIANCE EVALUATION INSPECTION**

GKN Aerospace South Carolina, Inc. (GKNASC)  
174 Millennium Drive  
Orangeburg, South Carolina 29115  
EPA ID: SCR000784041

November 30, 2021

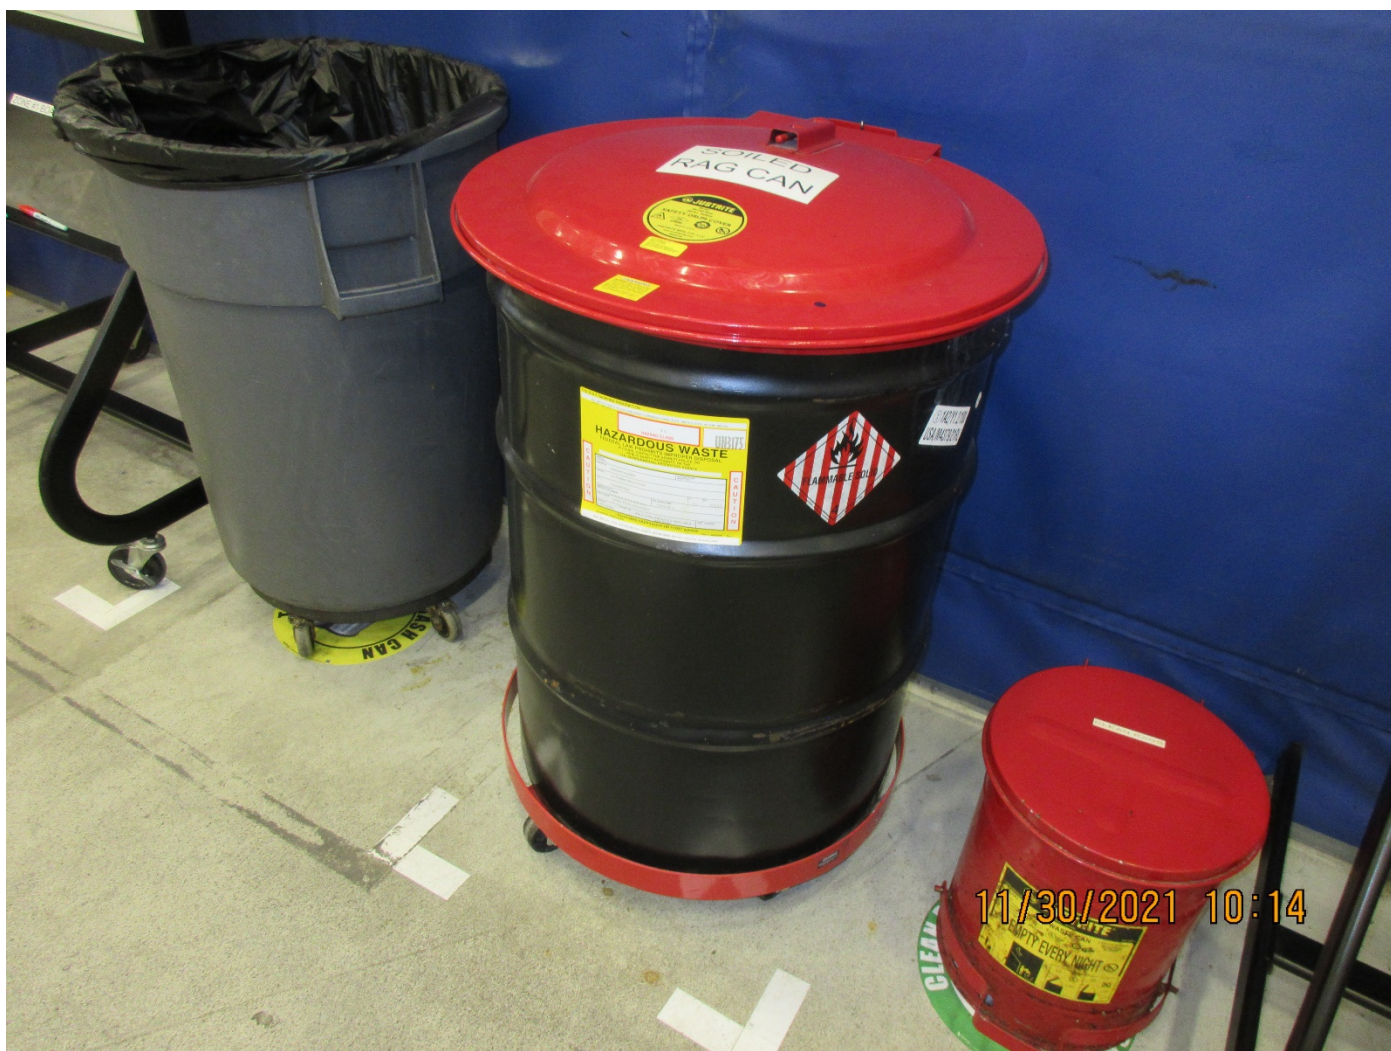
One 55-gallon container of hazardous waste rags was observed within a SAA in this area (Photo 1). The rags were contaminated with methyl ethyl ketone (MEK) used to clean any contamination on the surface of the lip skins upon finishing the initial spinning formation operation. The placard on this container of hazardous waste rags and all other placards observed during the walk-through inspection indicate that rags used by the facility to perform surface cleaning operations are managed as a flammable solid.

**Photo 1 – Satellite accumulation container in Spinform Area**

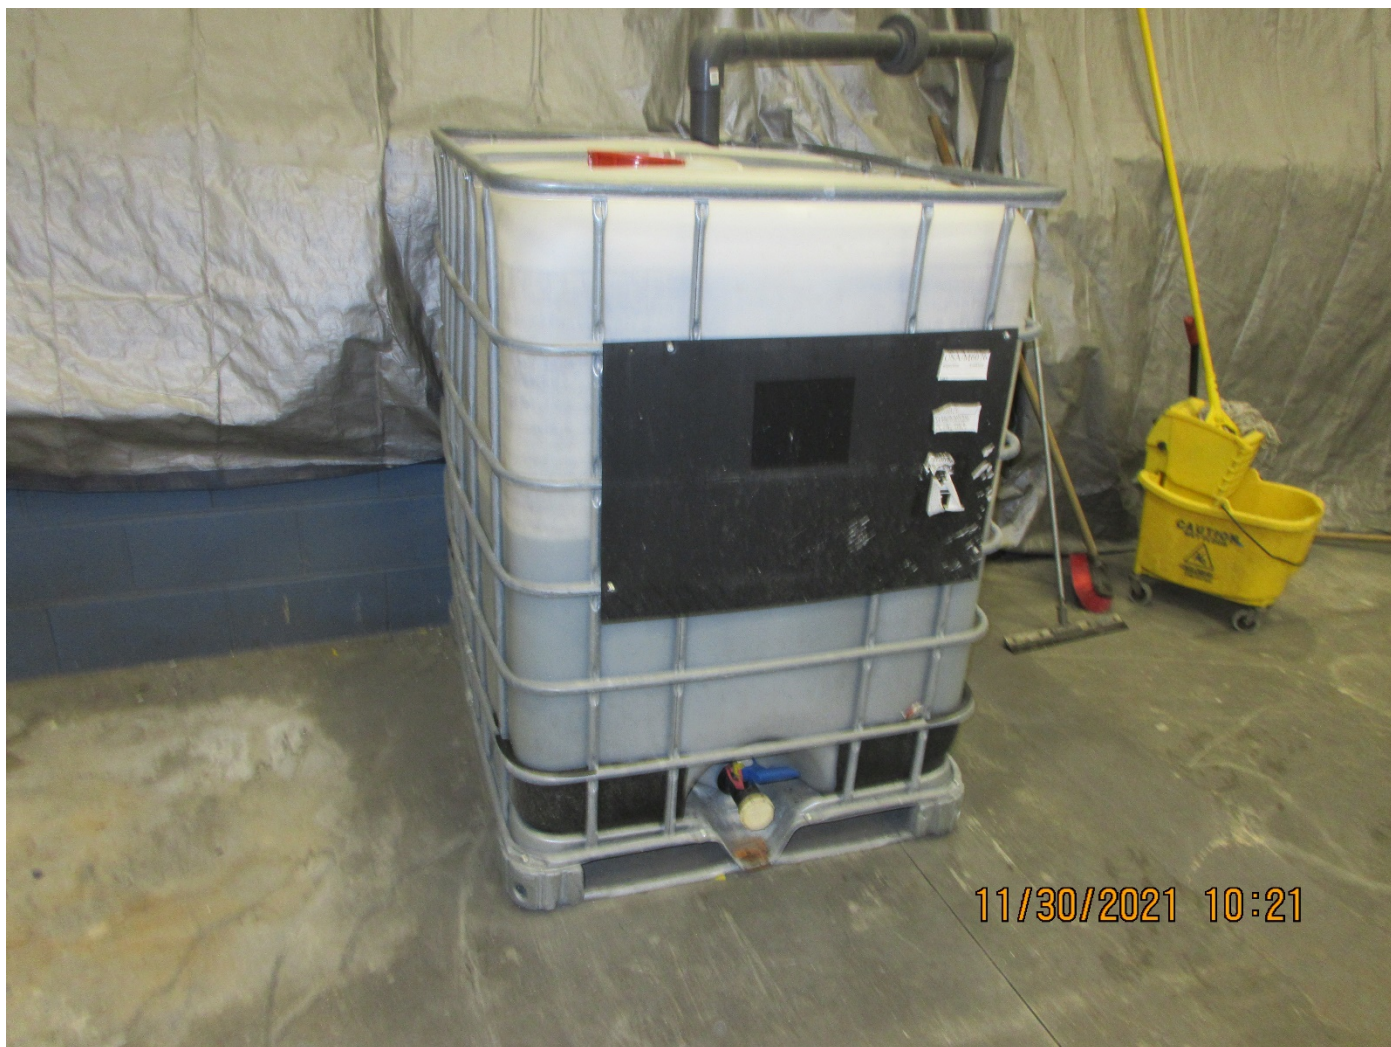
The lip skins formed in the Spin Form Area are pressure washed in this area using a mixture of “Simple Green” and water. Simple Green is a nonhazardous cleaning compound. Aluminum scrap generated in the wash water is collected and sent off-site to be recycled. The spent wash water is collected in a 275-gallon plastic tote (Photo 2) and sent off-site as a nonhazardous wastewater.

**Photo 2 – Plastic tote used to collect wastewater containing Simple Green in the Spin Form wash bay**

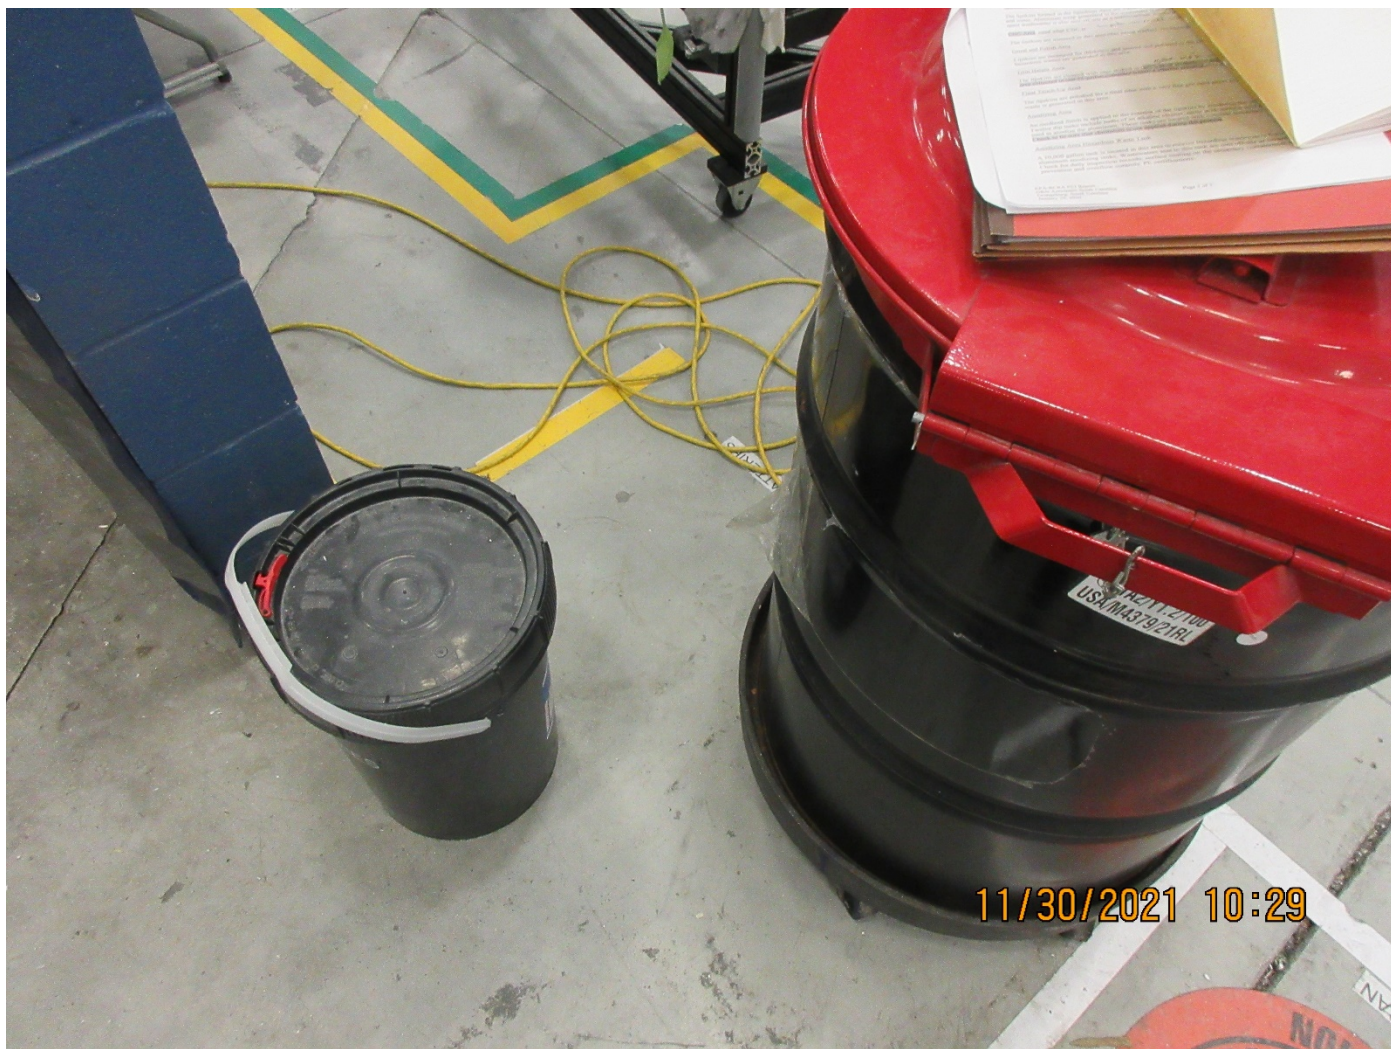
One 55-gallon container of hazardous waste rags were observed within a SAA in this area for cleaning purposes in advance of using the ATOS equipment (Photo 3). The rags were contaminated with MEK. One 5-gallon container of universal waste batteries was also observed in this area. The container of universal waste batteries was not labeled with any universal waste language or marked with an accumulation start date.

**Photo 3 – 55-gallon Container of hazardous waste rags and 5-gallon container of Universal Waste batteries observed in the ATOS Area**

**Pursuant to 25 S.C. Code Ann. Regs. 61-79.273.14(a) [40 C.F.R. § 273.14(a)], a SQHUW must label or mark each Universal Waste battery or container or tank in which the batteries are contained clearly with one of the following phrases: “Universal Waste - Battery(ies),” or “Waste Batterie(A),” or “Used Batterie(s).”**

**Pursuant to 25 S.C. CODE ANN. REGS. 61-79.273.15(a and c) [40 C.F.R. § 273.15(a) and (c)], a SQHUW may accumulate universal waste no longer than one year and must be able to demonstrate the length of time that the universal waste has accumulated from the date that it became a waste or was received.**

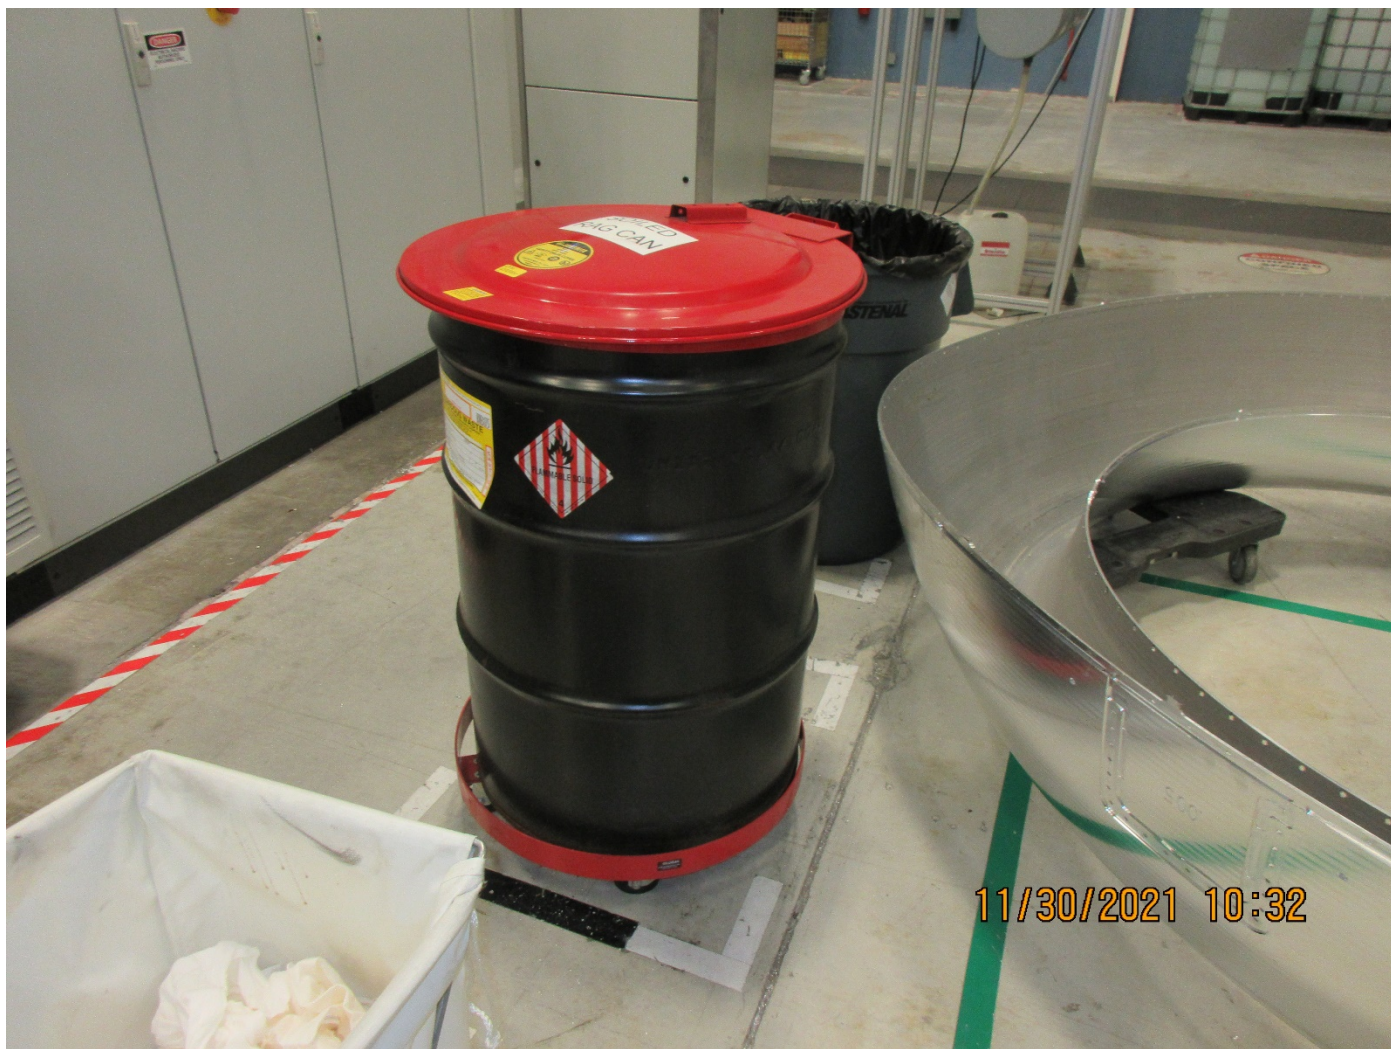
One 55-gallon container of hazardous waste rags were observed within a SAA in this area (Photo 4). The rags are contaminated with MEK used to perform surface cleaning on the lip skins to enhance performance of an advanced topometric sensor (ATOS) used on the surface of the lip skins during the performance of the CNC mechanical trimming operations.

**Photo 4 – 55-gallon Container of hazardous waste rags observed in the CNC Area**

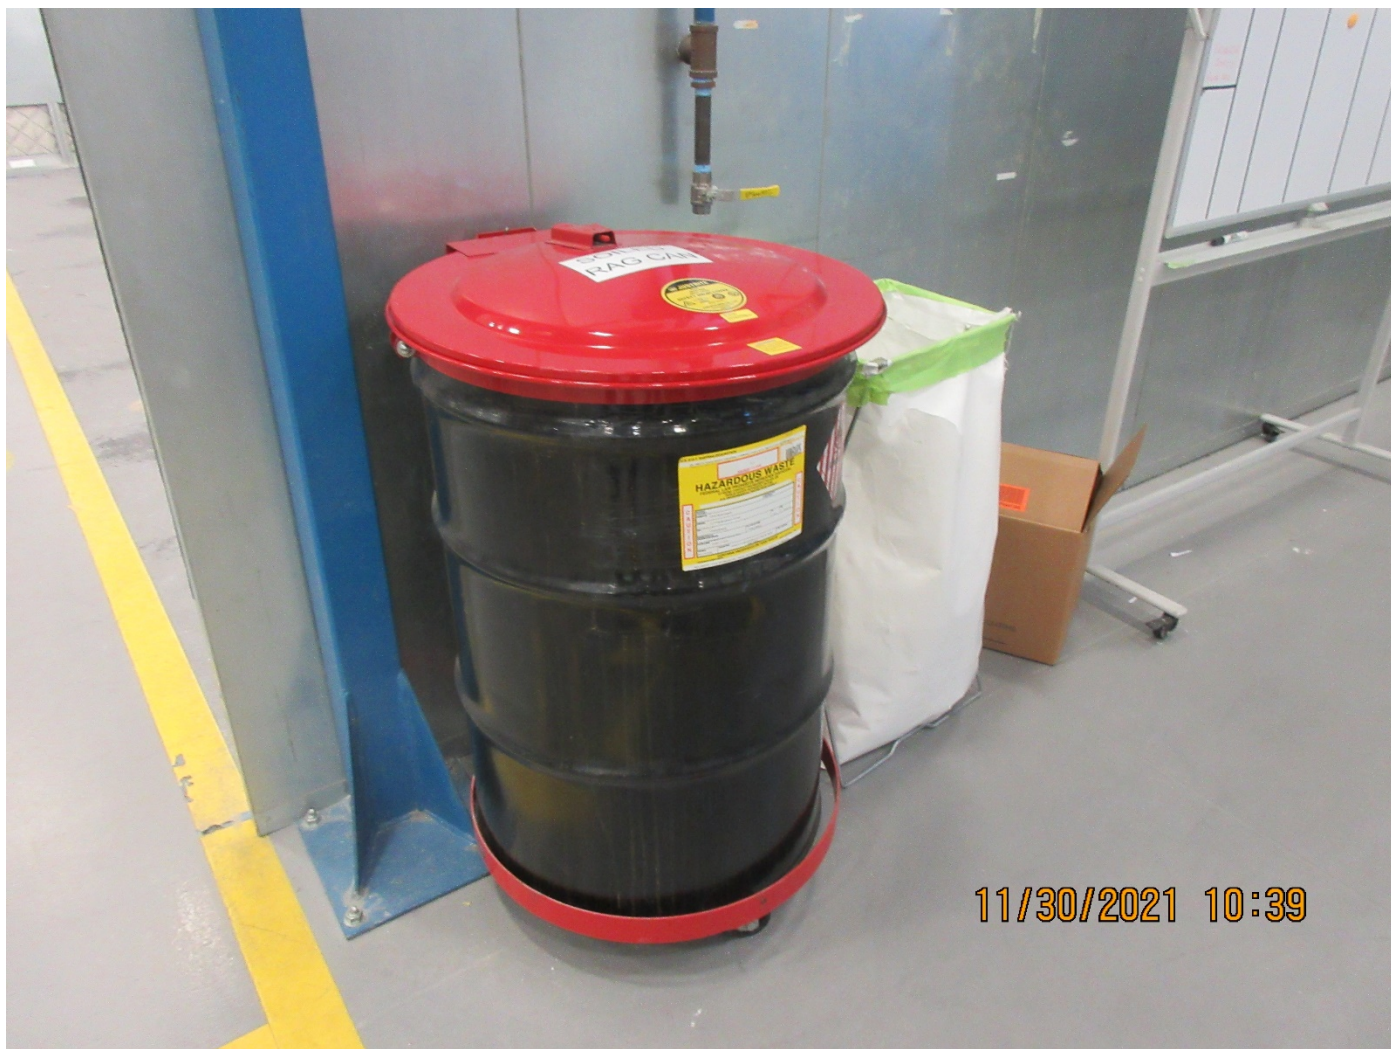
One 55-gallon container of hazardous waste rags were observed within a SAA in this area (Photo 5). The rags were contaminated with MEK used to cleaning purposes.

**Photo 5 – 55-gallon Container of hazardous waste rags observed in the Final Touch-Up Area**

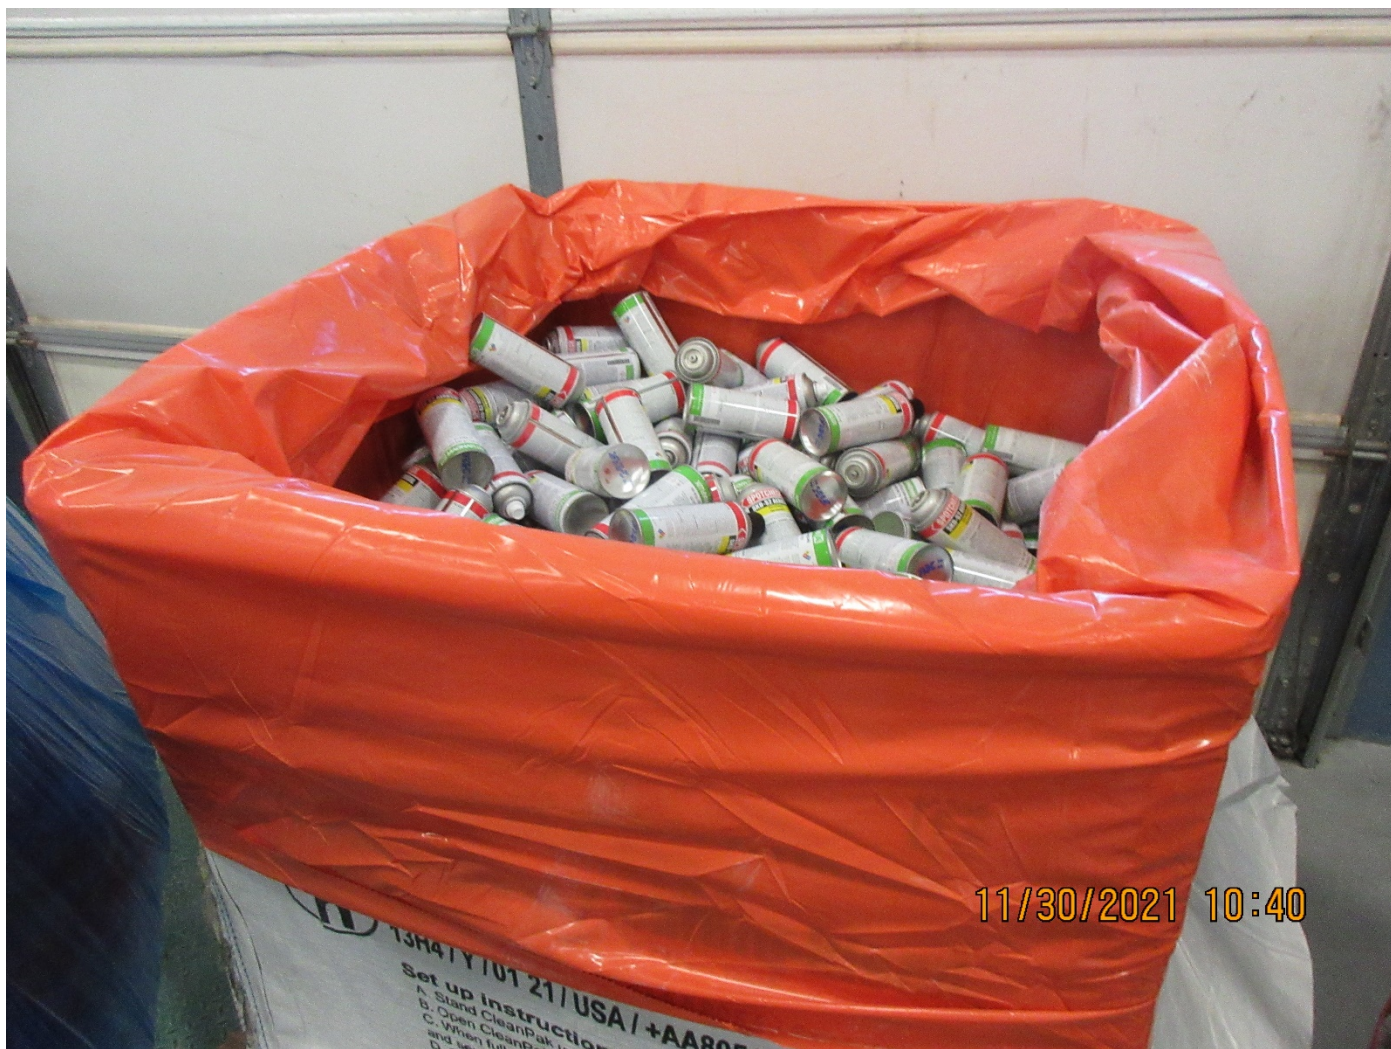
One box of used aerosol cans of “SKD-S2 Aerosol” was observed in a box measuring approximately 4 feet cubed. The box was open at the time of the inspection and unlabeled as universal waste aerosol cans (Photo 6).

**Photo 6 – Aerosol Cans of Magnaflux SKD-S2 in lip skin thickness measurement area**

**Pursuant to 25 S.C. CODE ANN. REGS. 61-79.273.15(a and c) [40 C.F.R. § 273.14(a)], a SQHUW must label or mark each Universal Waste battery or container or tank in which the aerosol cans are contained clearly labeled with one of the following phrases: “Universal Waste – Aerosol Can(s),” or “Waste Aerosol Can(s),” or “Used Aerosol Can(s).”**

**Pursuant 25 S.C. CODE ANN. REGS. 61-79.273.13(e)(1) [40 C.F.R. § 273.13(e)(1)], a SQHUW must manage universal waste aerosol cans in container way that prevents releases of any universal waste or component of a universal waste to the environment.**

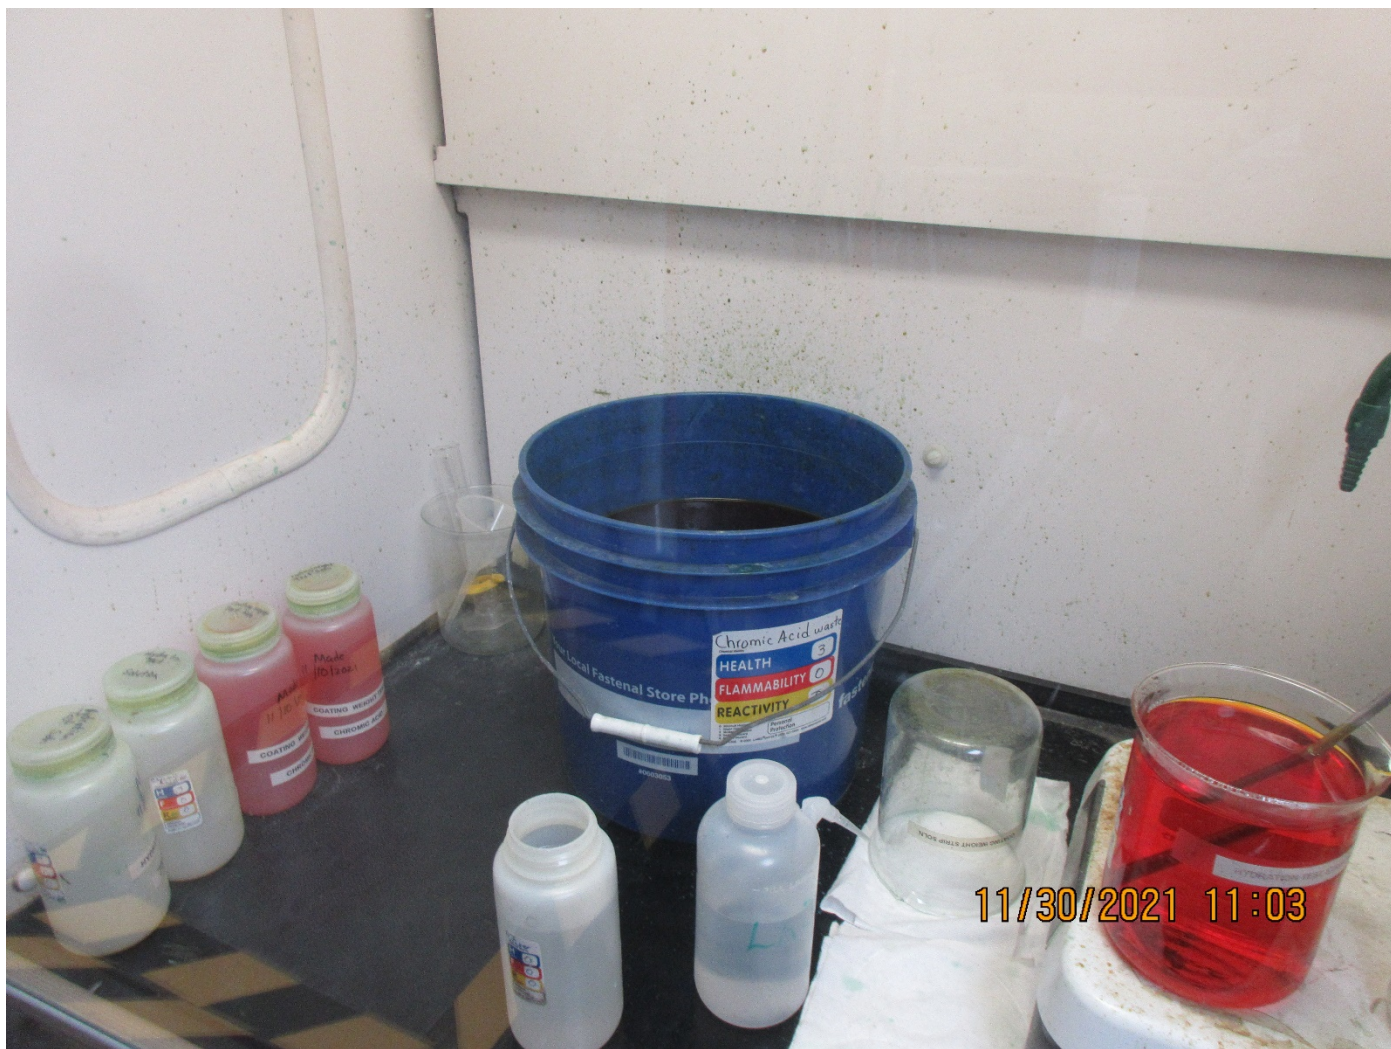
Samples are taken periodically from the alkaline cleaning and acid dip tanks in the anodizing area for quality control purposes. At the time of the inspection, a two-gallon container of chromic acid hazardous waste (Photo 7) was observed in a hood in the lab labeled as “Chromic Acid Waste”. The container was open and not labeled with the words “Hazardous Waste” at the time of the inspection.

**Photo 7 – Chromic acid hazardous waste in blue container in QC lab hood.**

**Pursuant to 25 S.C. CODE ANN. REGS. 61-79.262.15(a)(4) [40 C.F.R. § 262.15(a)(4)], which is a condition of the SAA Permit Exemption, a generator is required to keep containers of hazardous waste closed at all times during accumulation, except when adding, removing, or consolidating waste; or when temporary venting of a container is necessary for the proper operation of equipment, or to prevent dangerous situations, such as build-up of extreme pressure.**

**Pursuant to 25 S.C. CODE ANN. REGS. 61-79.262.15(a)(5) [40 C.F.R. § 262.15(a)(5)], which is a condition of the SAA Permit Exemption, a generator is required to mark or label its containers (i) with the words “Hazardous Waste.”**

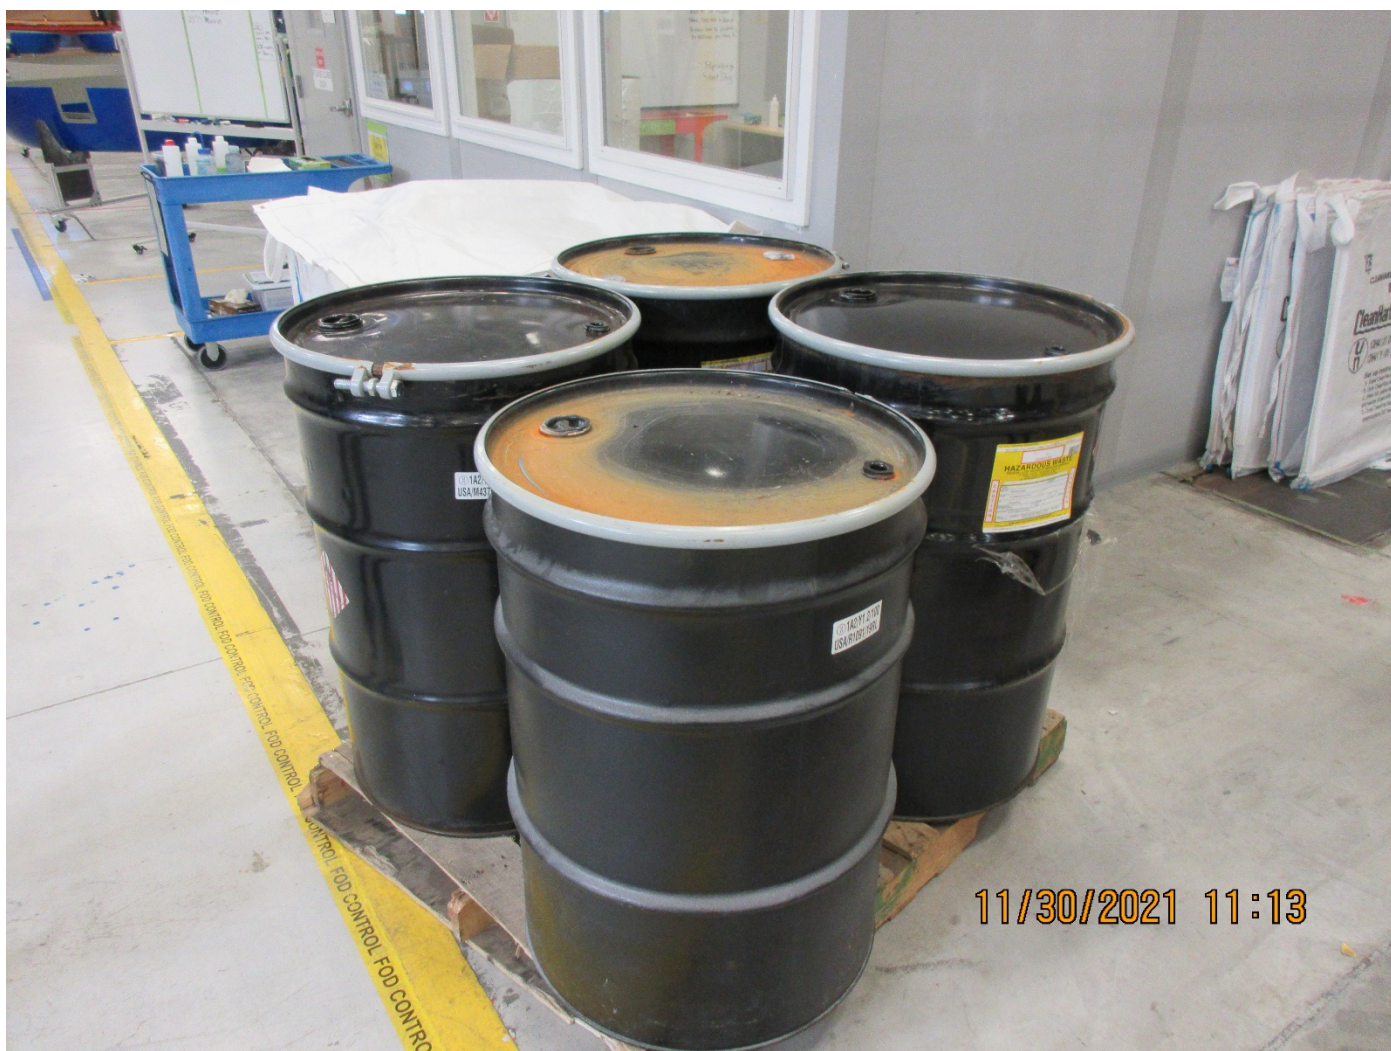
Four drums of paint waste from the prime coat paint booth were observed on a pallet along an aisle adjacent to the prime paint booth (Photo 8). The drums were not marked with an accumulation start date at the time of the inspection. Mr. Shirley stated that this was not designated as a 90-day hazardous waste accumulation area by the facility.

**Photo 8 – Four drums of paint waste along aisle outside of prime coat paint booth.**

**Pursuant to 25 S.C. CODE ANN. REGS. 61-79.262.17(a)(5)(i) [40 C.F.R. § 262.17(a)(5)(i)], which is a condition of the LQG Permit Exemption, a generator must mark or label its containers with (C) the date upon which each period of accumulation begins clearly visible for inspection on each container.**

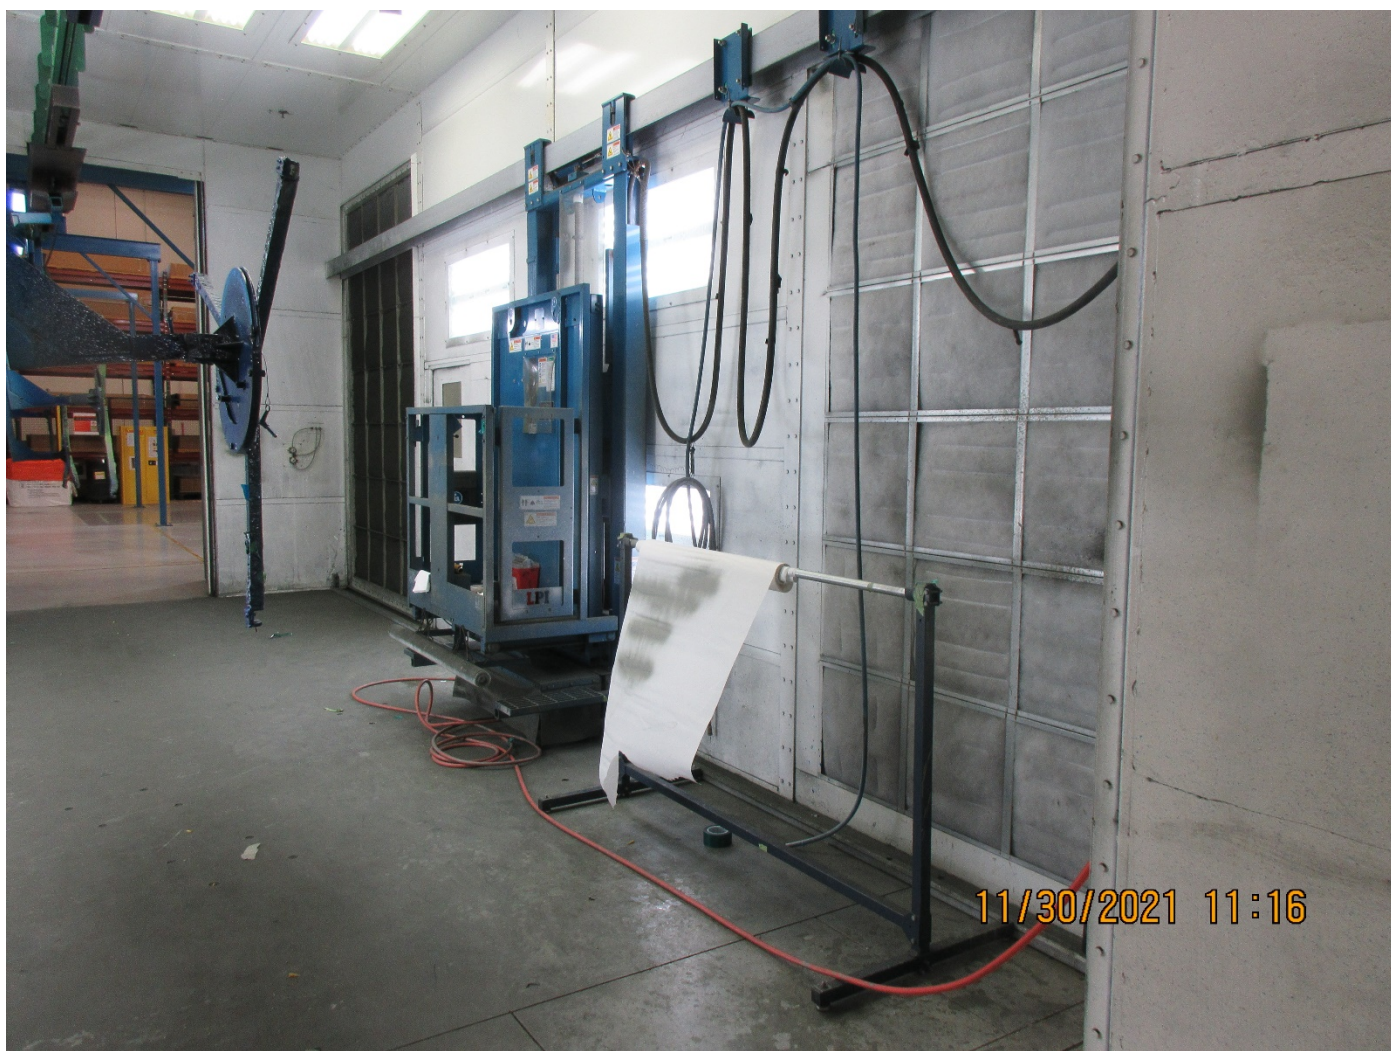
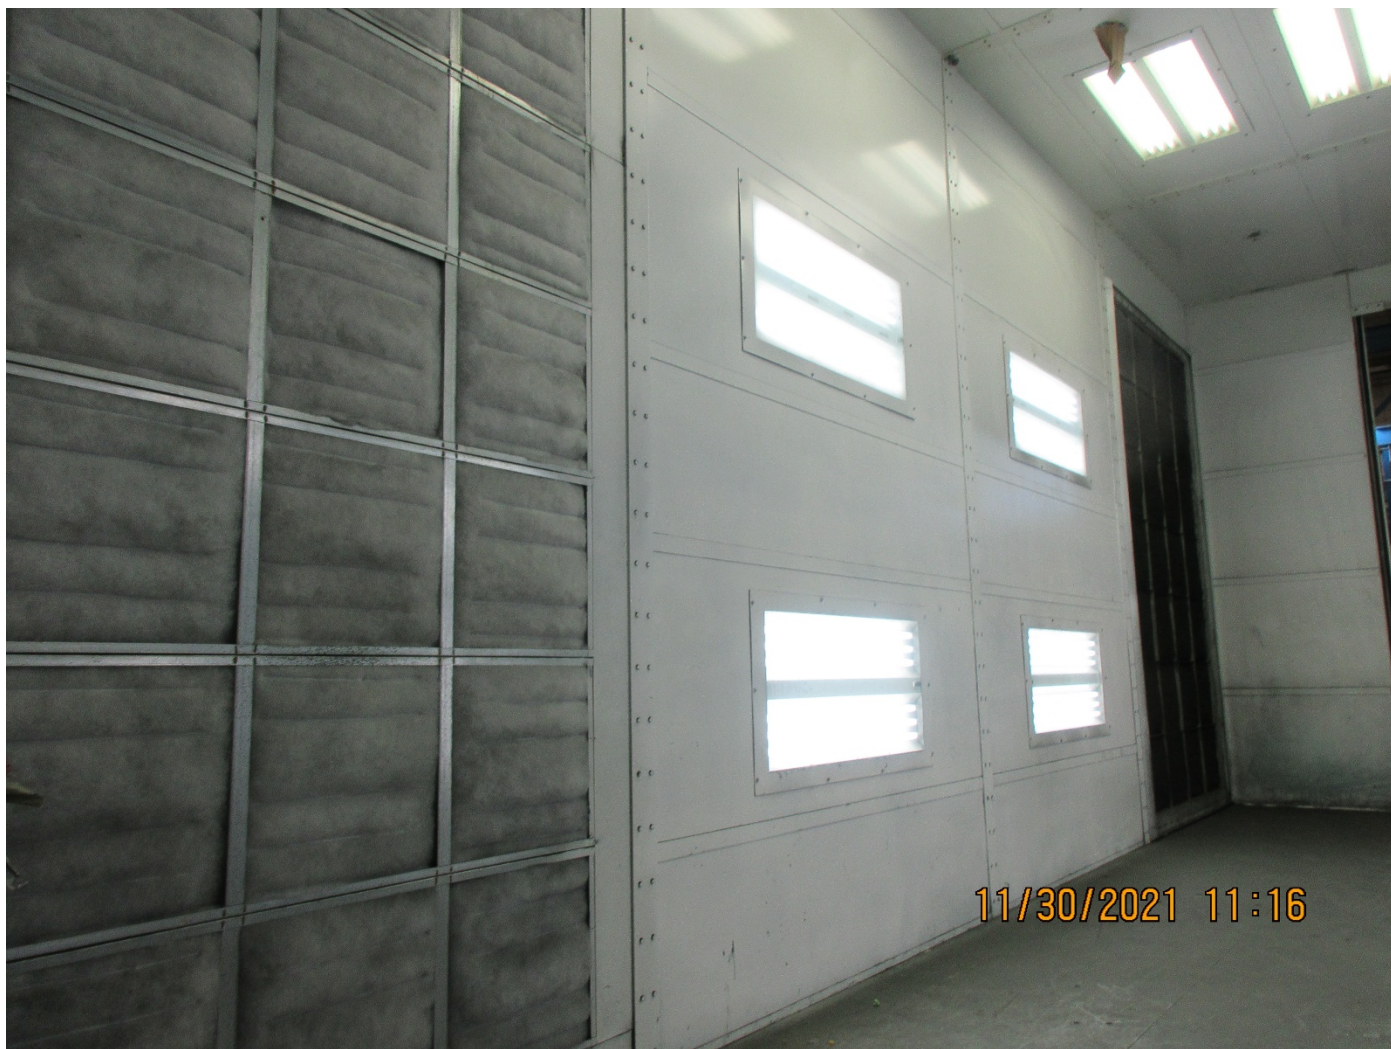
The prime coat paint booth was equipped with 128 exhaust filters measuring approximately 2-feet by 2-feet each (Photos 9 and 10). Analytical data found paint waste coming into direct contact with the primer to be characteristically hazardous for chromium by failing the TCLP test with a chromium level of 5.4 ppm. The facility determined that the filters which are not sprayed directly with any of the facility’s primer paint containing chromium would be characteristically hazardous.

**Photo 9 – Inside prime coat paint booth.**

**Photo 10 – Inside of prime coat paint booth.**

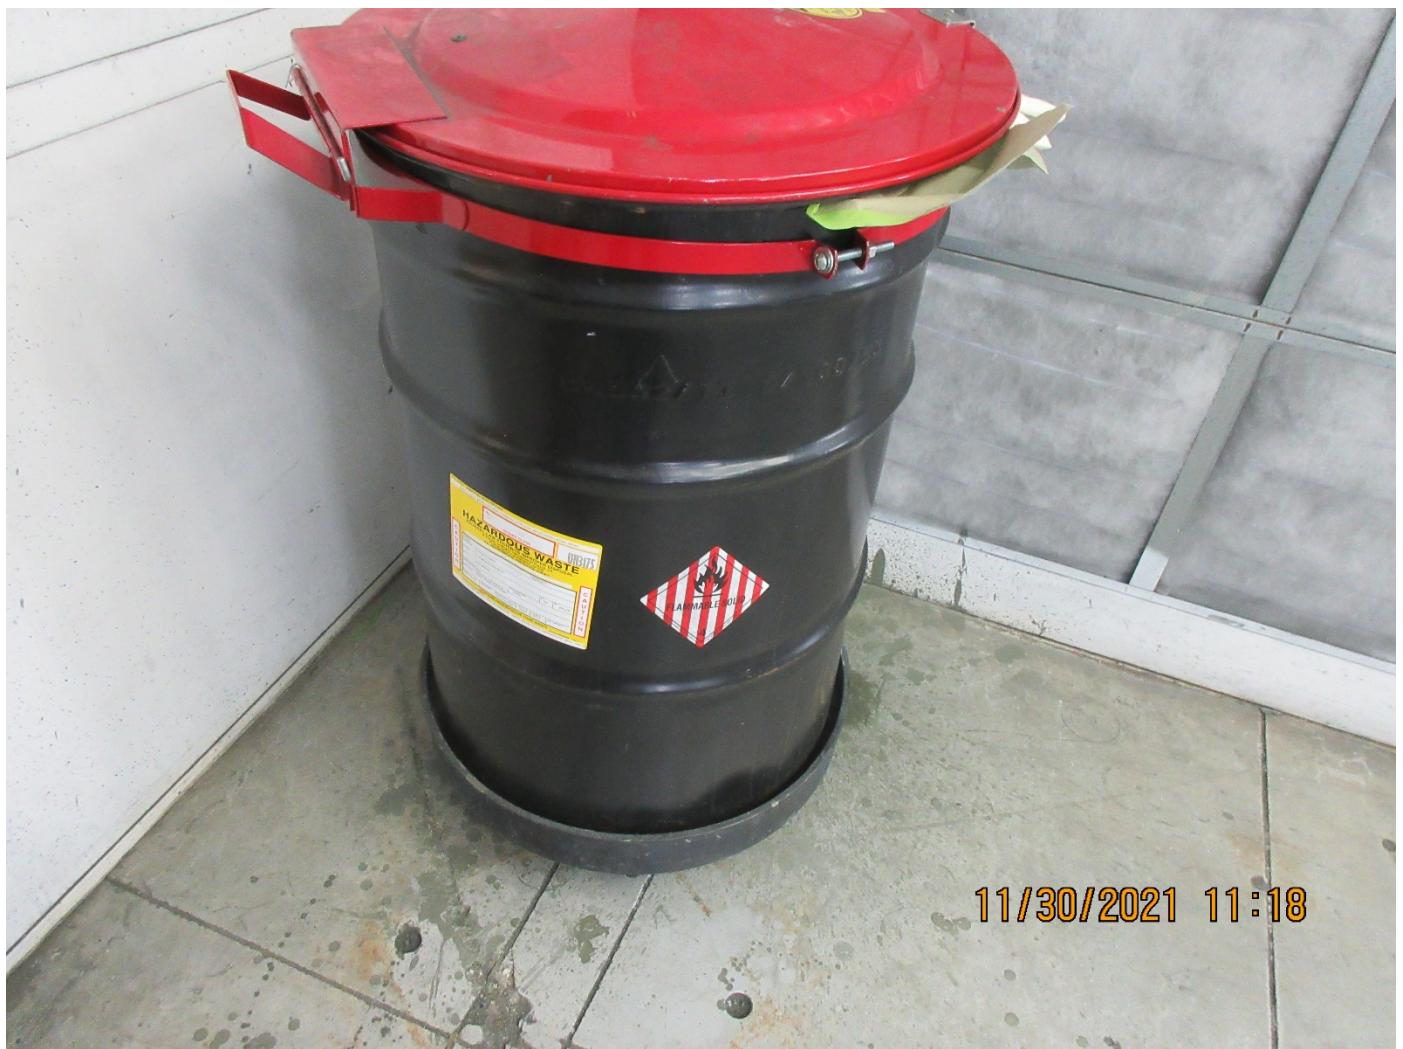
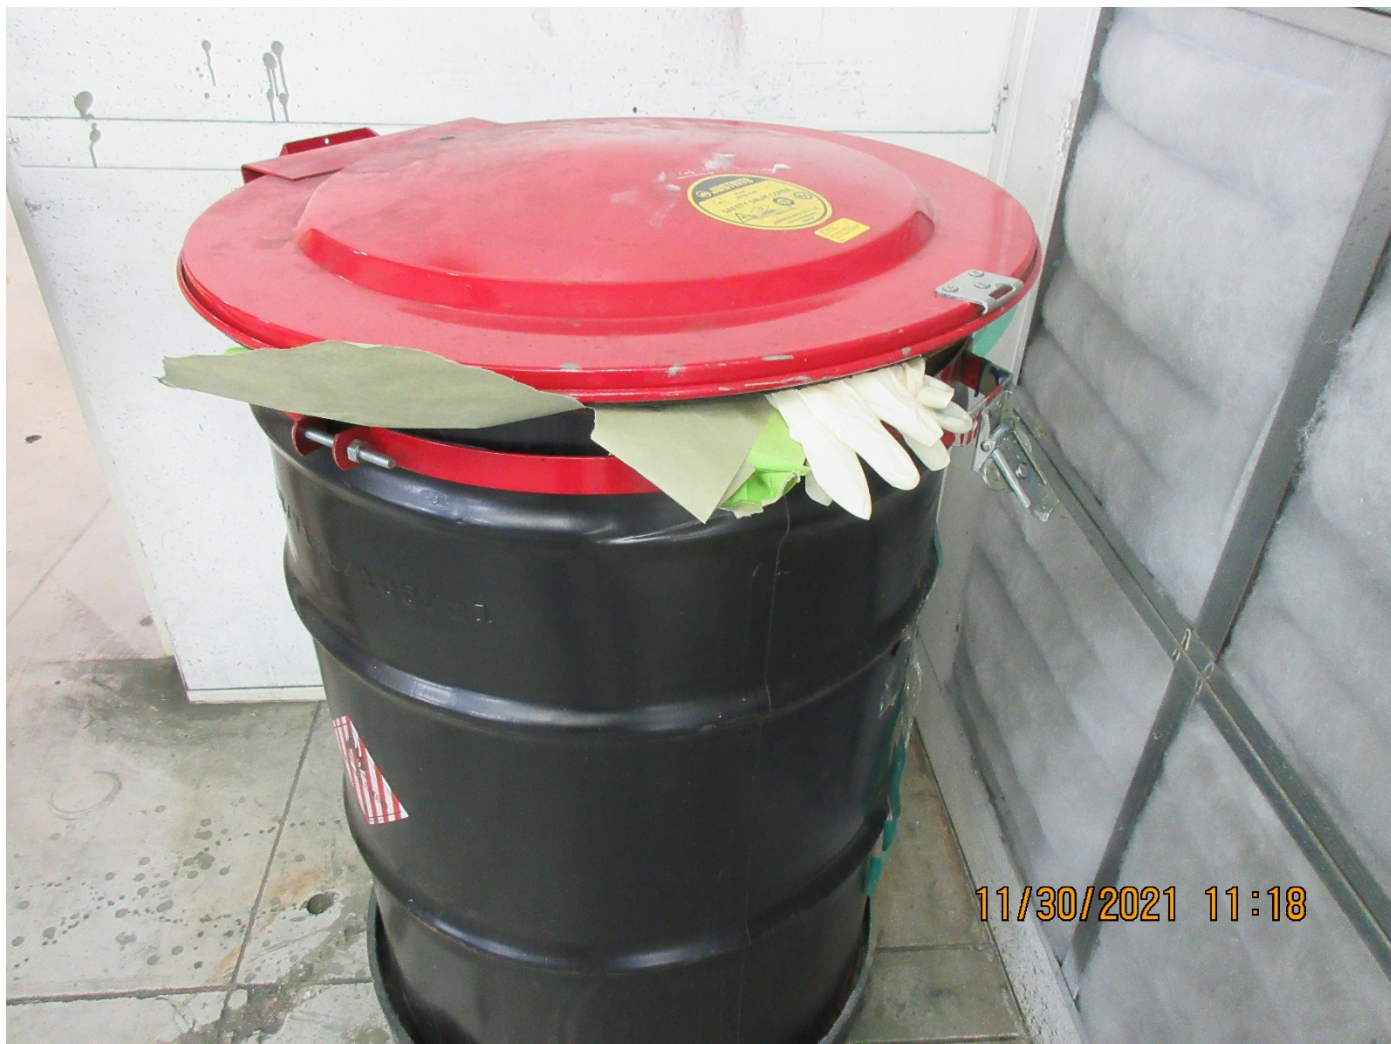
One 55-gallon drum of flammable solid paint waste was observed within this booth. The container was observed to be open at the time of the inspection (Photos 11 and 12).

**Photo 11 – Container of paint waste inside of prime coat paint booth.**

**Photo 12 – Container of paint waste inside of prime coat paint booth.**

**Pursuant to 25 S.C. CODE ANN. REGS. 61-79.262.15(a)(4) [40 C.F.R. § 262.15(a)(4)], which is a condition of the SAA Permit Exemption, a generator is required to keep containers of hazardous waste closed at all times during accumulation, except when adding, removing, or consolidating waste; or when temporary venting of a container is necessary for the proper operation of equipment, or to prevent dangerous situations, such as build-up of extreme pressure.**

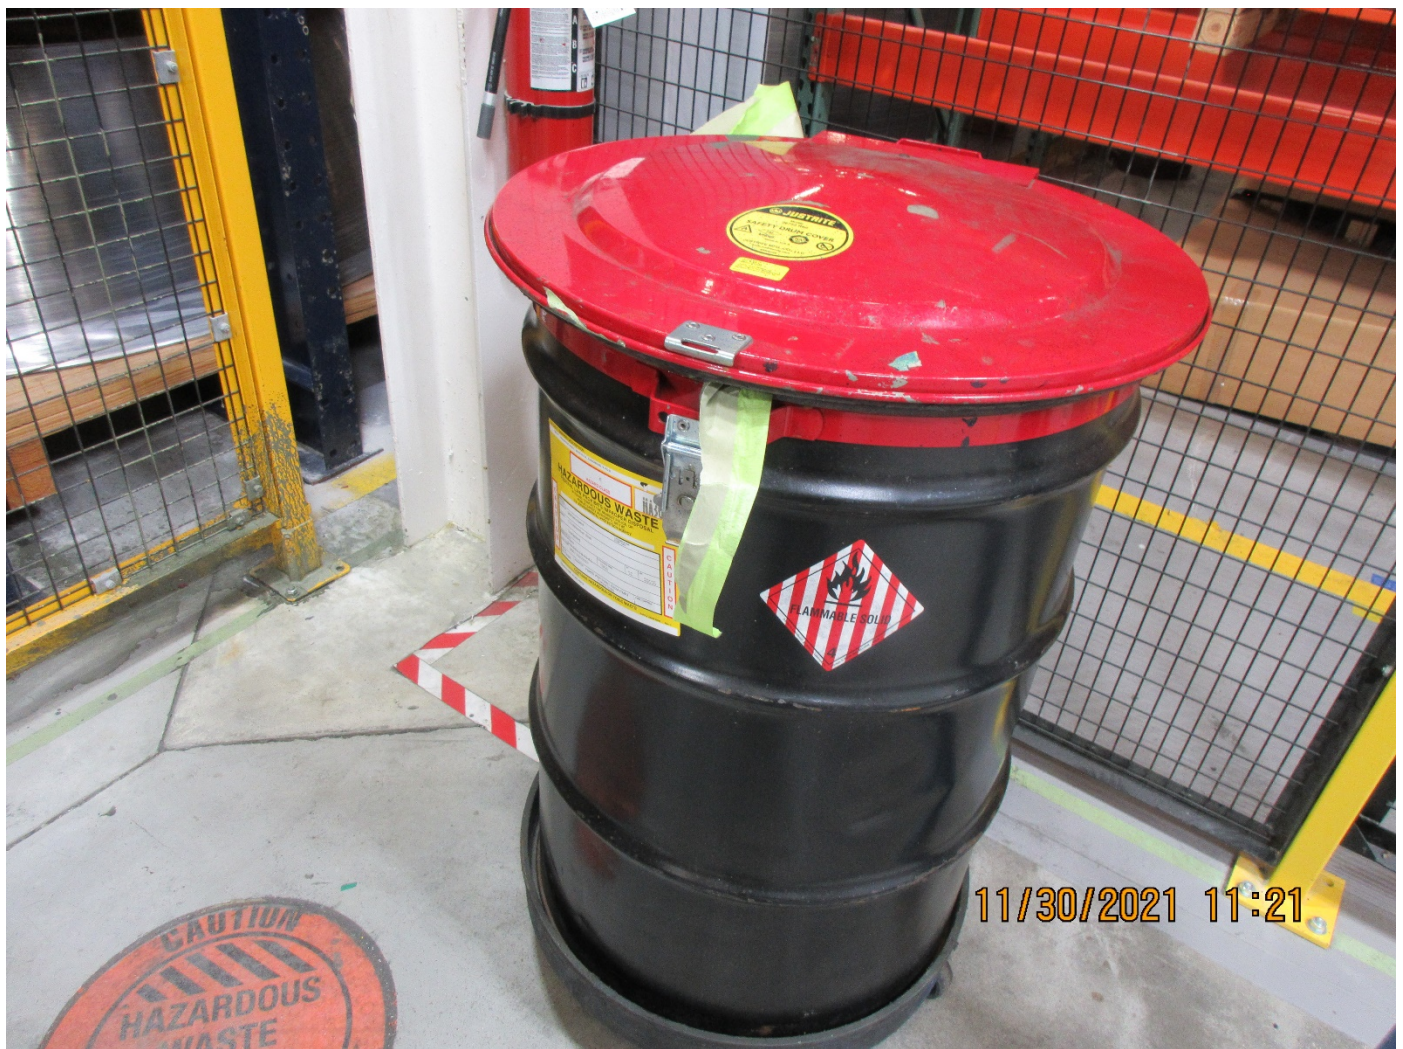
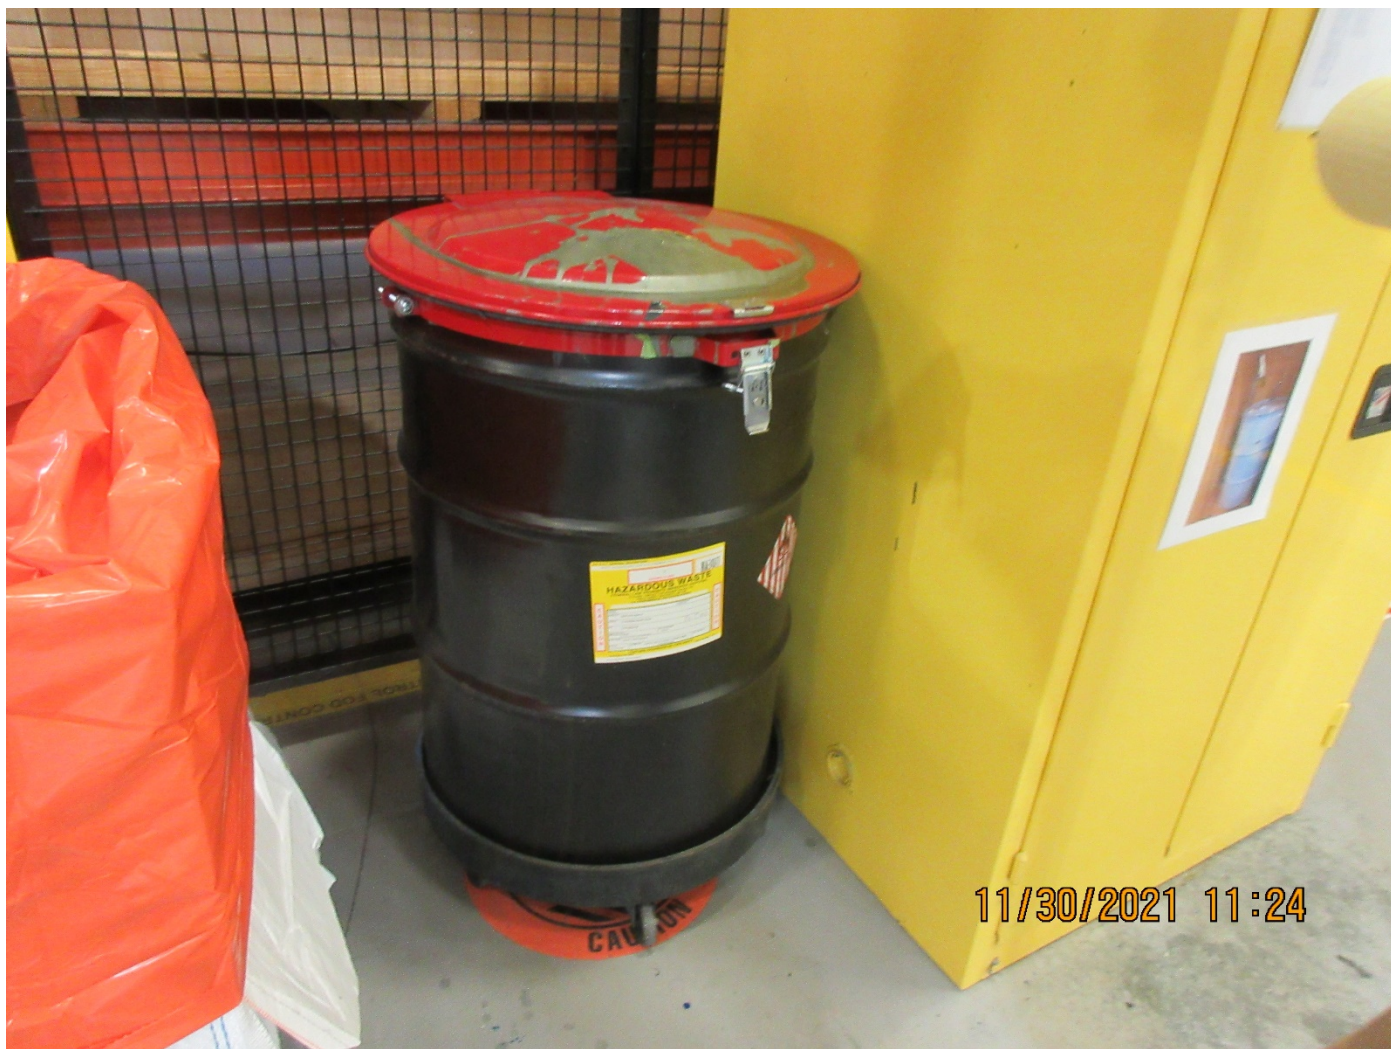
Two separate 55-gallon drums of flammable solid paint waste were observed outside of this booth. The containers were each observed to be open at the time of the inspection (Photos 13 and 14).

**Photo 13 – Container of paint waste solids outside of procoat paint booth.**

**Photo 14 – Container of paint waste solids outside of procoat paint booth.**

**Pursuant to 25 S.C. CODE ANN. REGS. 61-79.262.17(a)(1)(iv) [40 C.F.R. § 262.17(a)(1)(iv)], which is a condition of the LQG Permit Exemption, (A) a container holding hazardous waste must always be closed during accumulation, except when it is necessary to add or remove waste; and (B) A container holding hazardous waste must not be opened, handled, or stored in a manner that may rupture the container or cause it to leak.**
