## **RCRA COMPLIANCE EVALUATION INSPECTION**

GKN Aerospace South Carolina, Inc. (GKNASC)  
174 Millennium Drive  
Orangeburg, South Carolina 29115  
EPA ID: SCR000784041

November 30, 2021

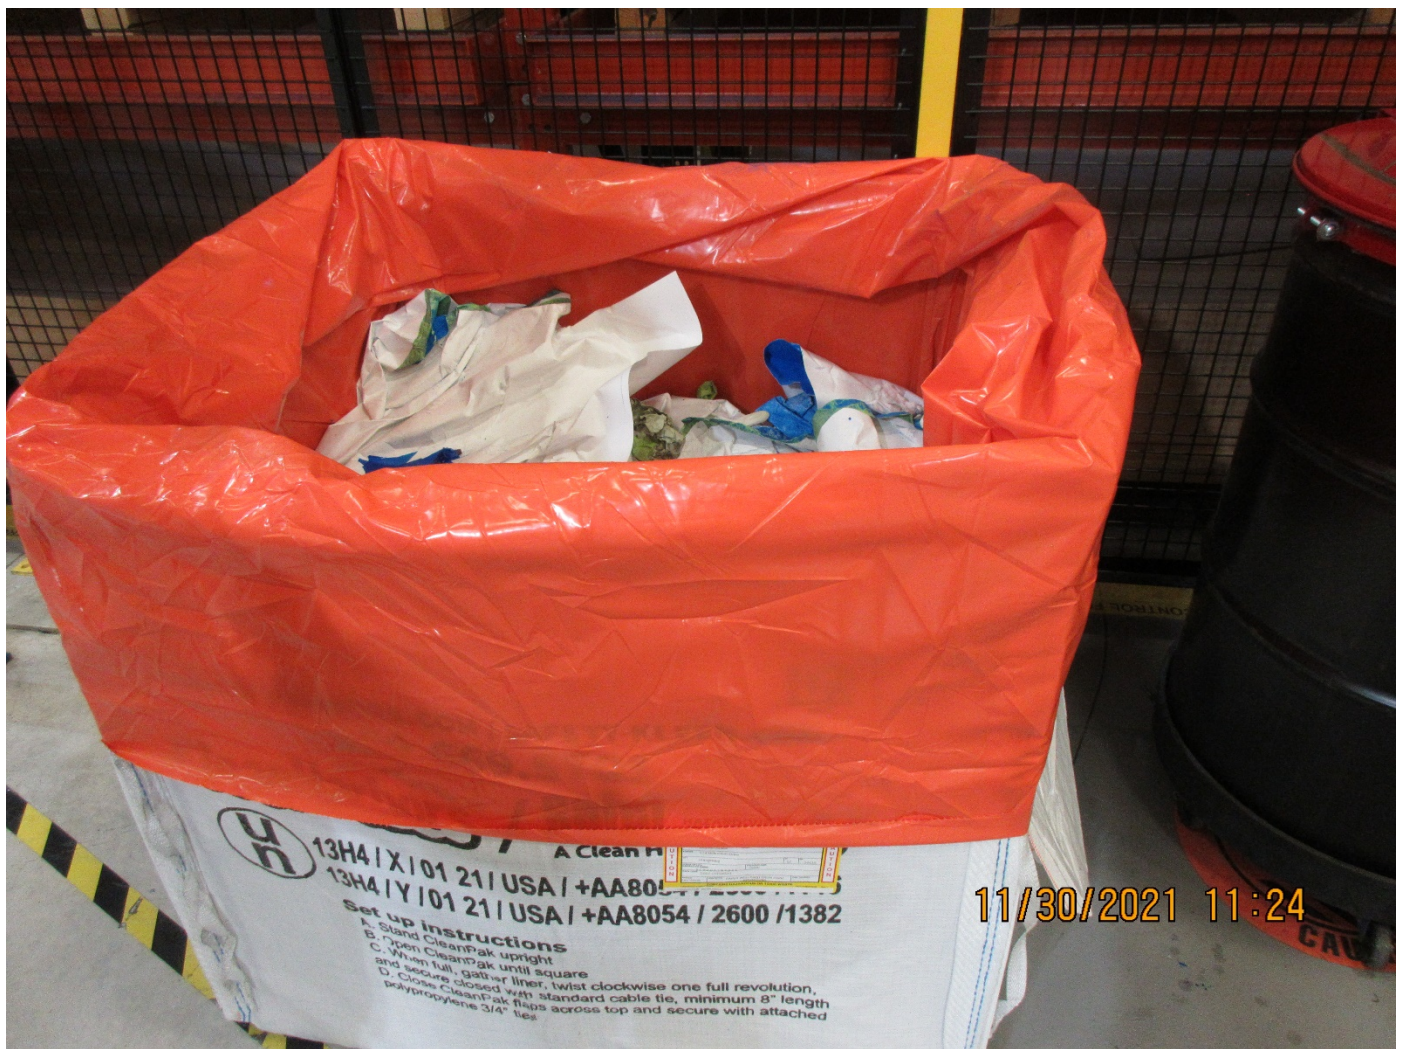
A cardboard container measuring approximately four feet by four feet by three feet high managing hazardous waste flammable solids was also observed in the area outside of the procoat paint booth (Photo 15). The container was open, did not have a placard indicating the hazard within the box (Photo 16) and was not marked with an accumulation start date (Photo 17).

**Photo 15 – Container of paint waste solids outside of procoat paint booth.**

**Pursuant to 25 S.C. CODE ANN. REGS. 61-79.262.17(a)(5)(i) [40 C.F.R. § 262.17(a)(5)(i)], which is a condition of the LQG Permit Exemption, a generator must mark or label its**

containers with the following: (B) an indication of the hazards of the contents; and (C) the date upon which each period of accumulation begins clearly visible for inspection on each container.

**Pursuant to 25 S.C. CODE ANN. REGS. 61-79.262.17(a)(1)(iv) [40 C.F.R. § 262.17(a)(1)(iv)], which is a condition of the LQG Permit Exemption, (A) a container holding hazardous waste must always be closed during accumulation, except when it is necessary to add or remove waste; and (B) A container holding hazardous waste must not be opened, handled, or stored in a manner that may rupture the container or cause it to leak.**

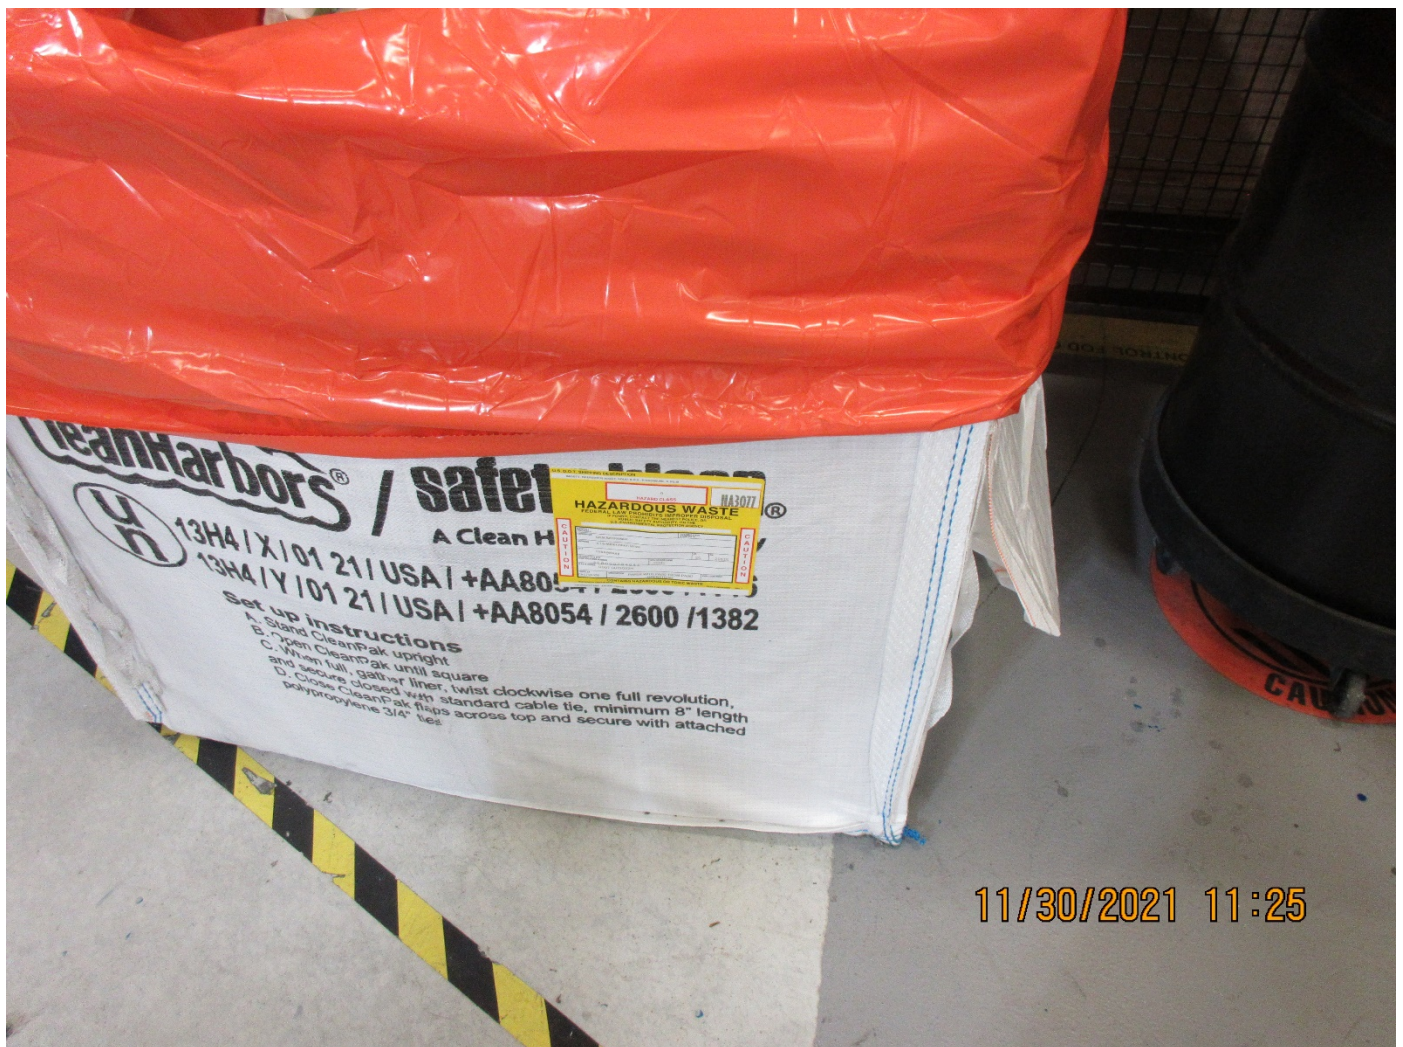
**Photo 16 – Label on Container of paint waste solids outside of procoat paint booth.**

Photo 17 – Label on Container of paint waste solids outside of procoat paint booth.

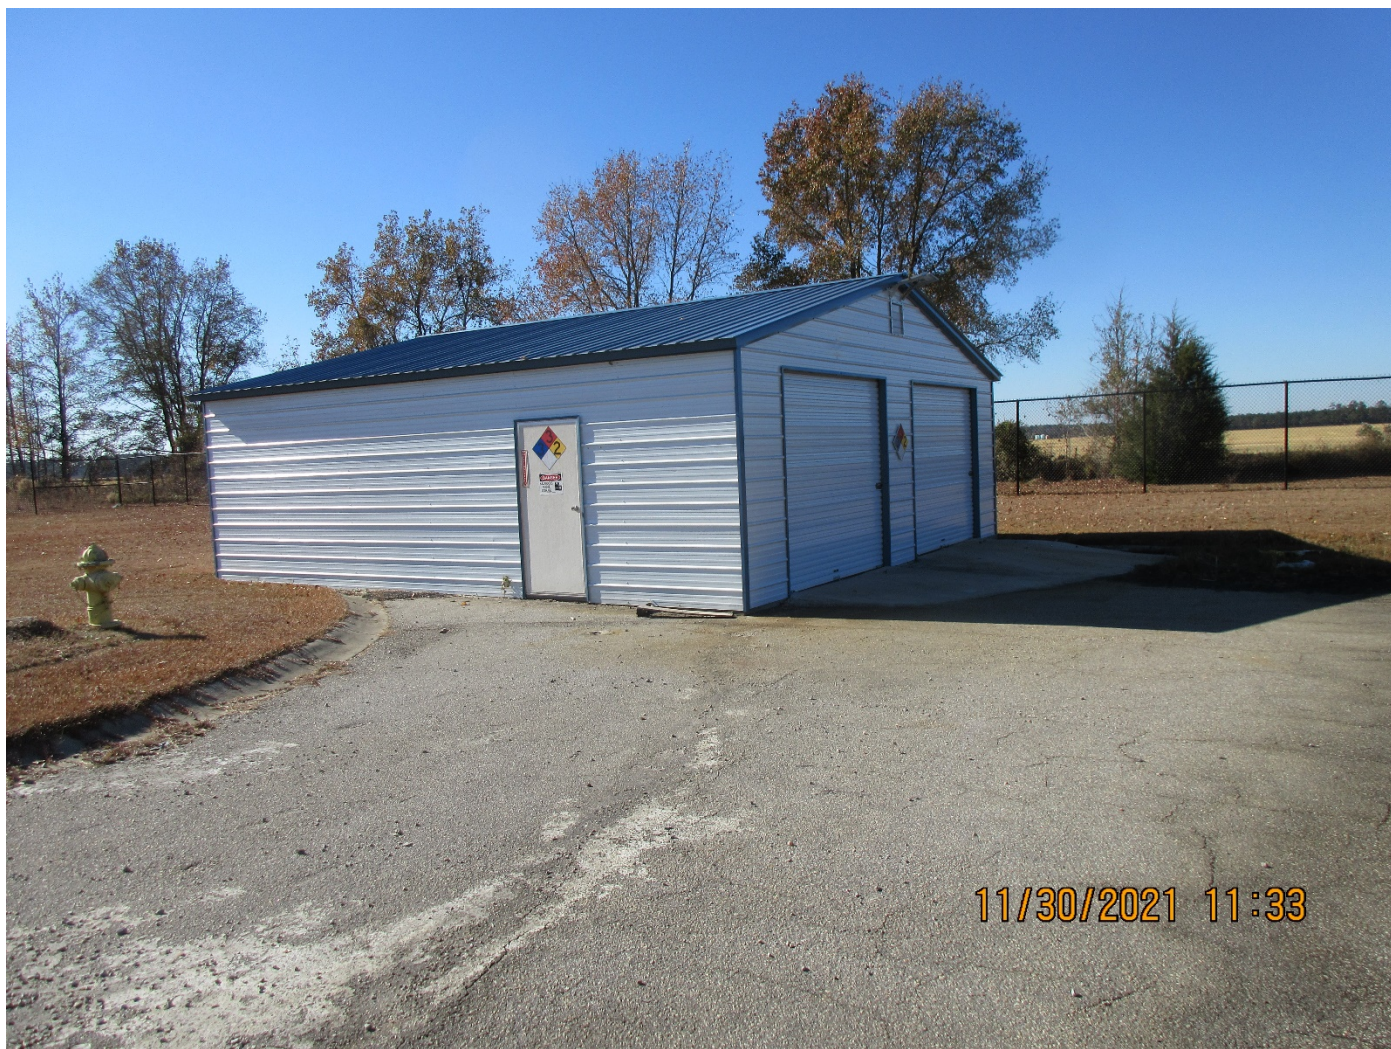
The facility's Hazardous Waste 90-Day Accumulation Building for wastes generated in the main building measured approximately 36 feet by 33 feet and was constructed on a concrete pad (Photo 18).

**Photo 18 – Facility’s 90-day Hazardous Waste Accumulation Building**

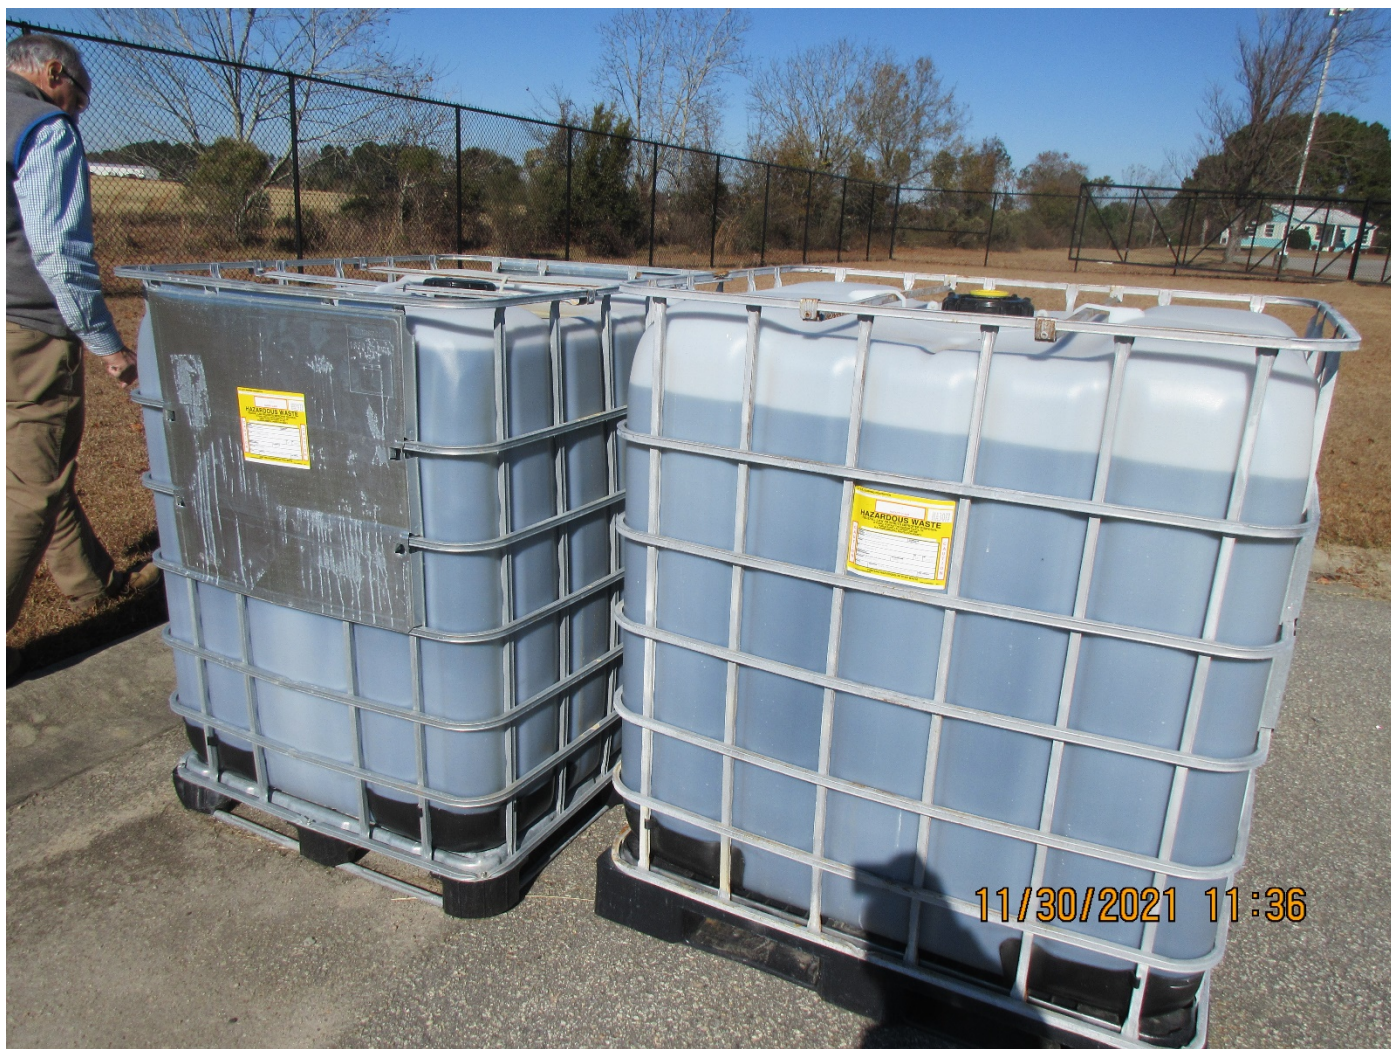
Outside of the Hazardous Waste 90-Day Accumulation building, on an asphalt pad, two 275-gallon plastic totes (Photo 19) were observed about 30 yards away. These totes were used to manage corrosive wastes from the facility's anodizing line which were in excess of hazardous wastes taken with the last tanker truck shipment. A pH reading on the wastewater found them to have a pH of less than one. The containers were not labeled with placards or any indication of the type of hazard in the containers and were not marked with accumulation start dates.

**Photo 19 – Two totes of waste acid from the facility’s anodizing line on a pad in the area outside of the facility’s 90-day Hazardous Waste Accumulation Building**

**Pursuant to 25 S.C. CODE ANN. REGS. 61-79.262.17(a)(5)(i) [40 C.F.R. § 262.17(a)(5)(i)], which is a condition of the LQG Permit Exemption, a generator must mark or label its containers with the following: (B) an indication of the hazards of the contents; and (C) the date upon which each period of accumulation begins clearly visible for inspection on each container.**

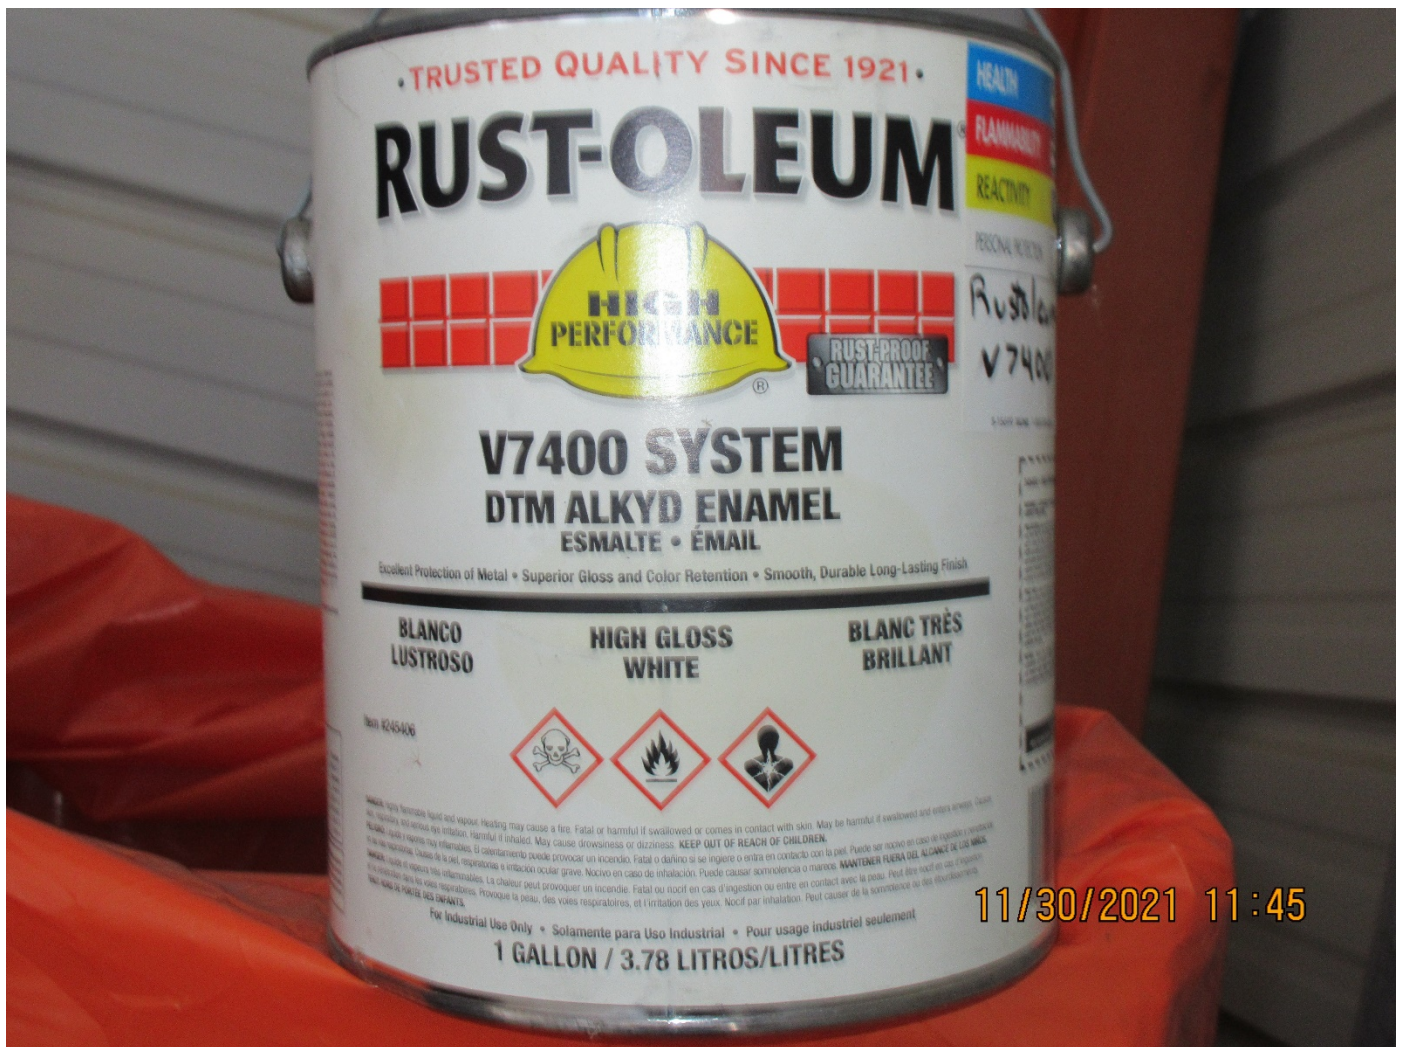
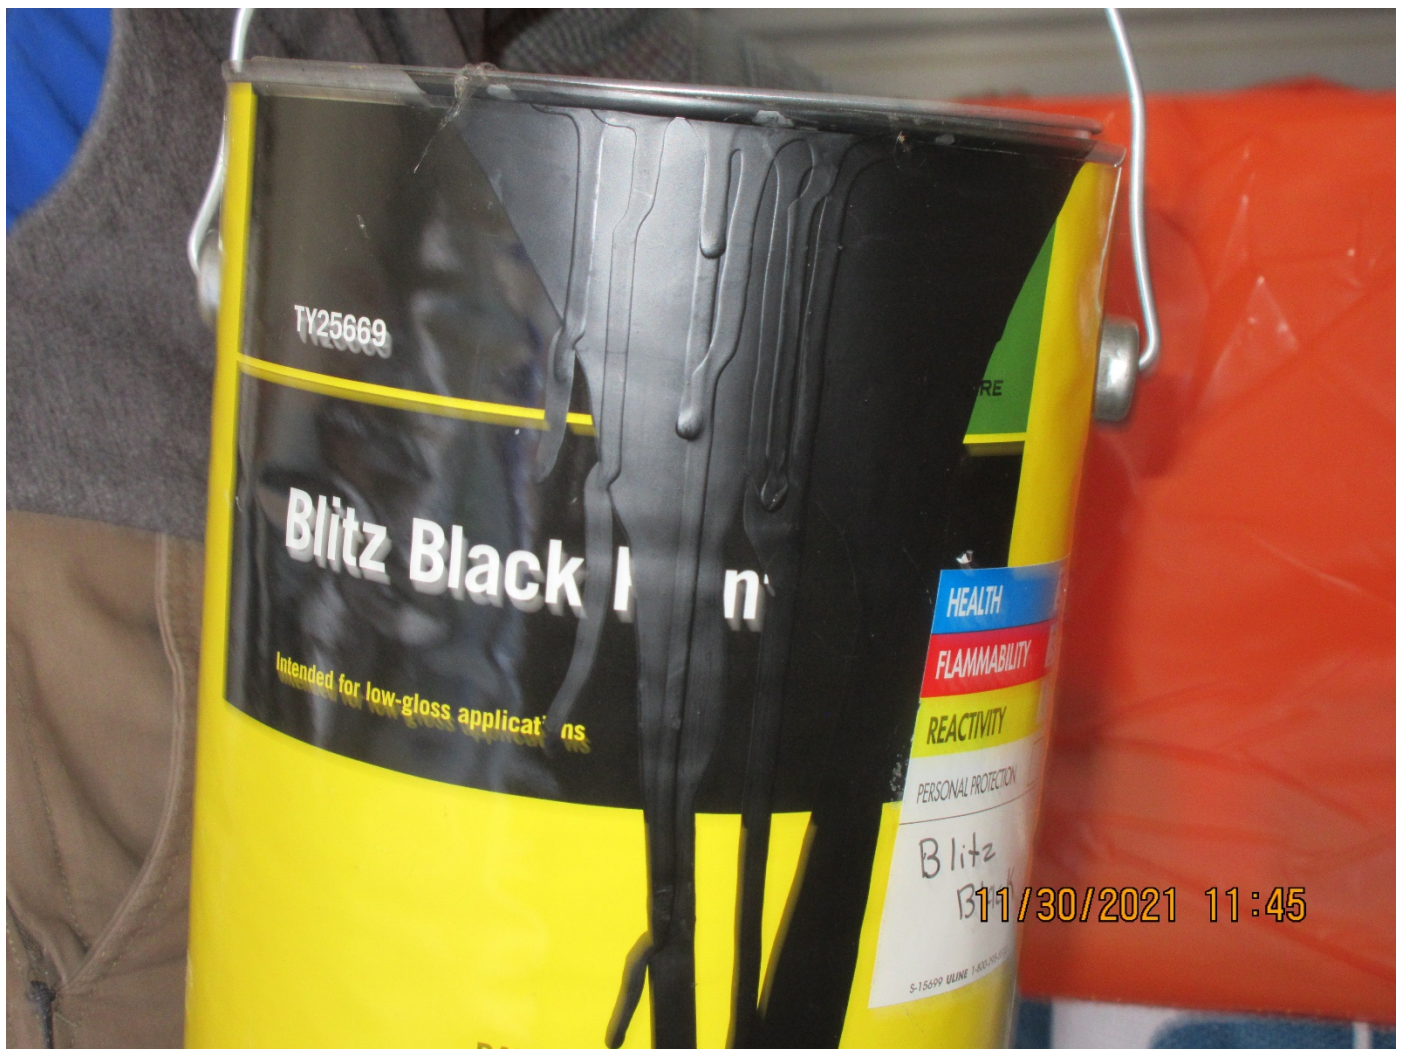
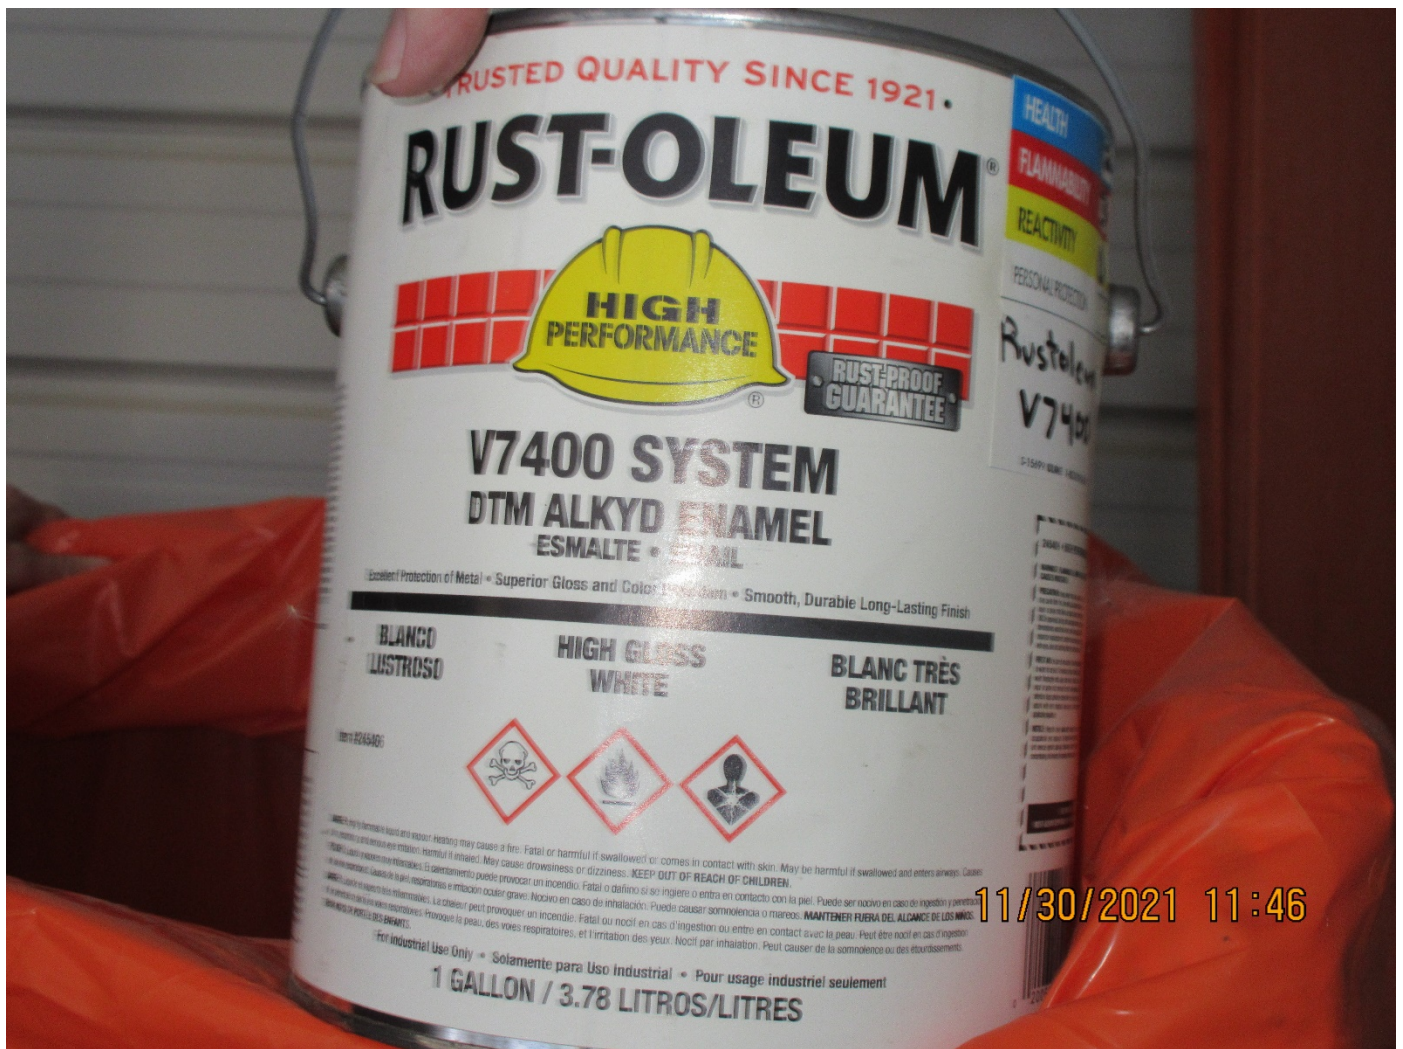
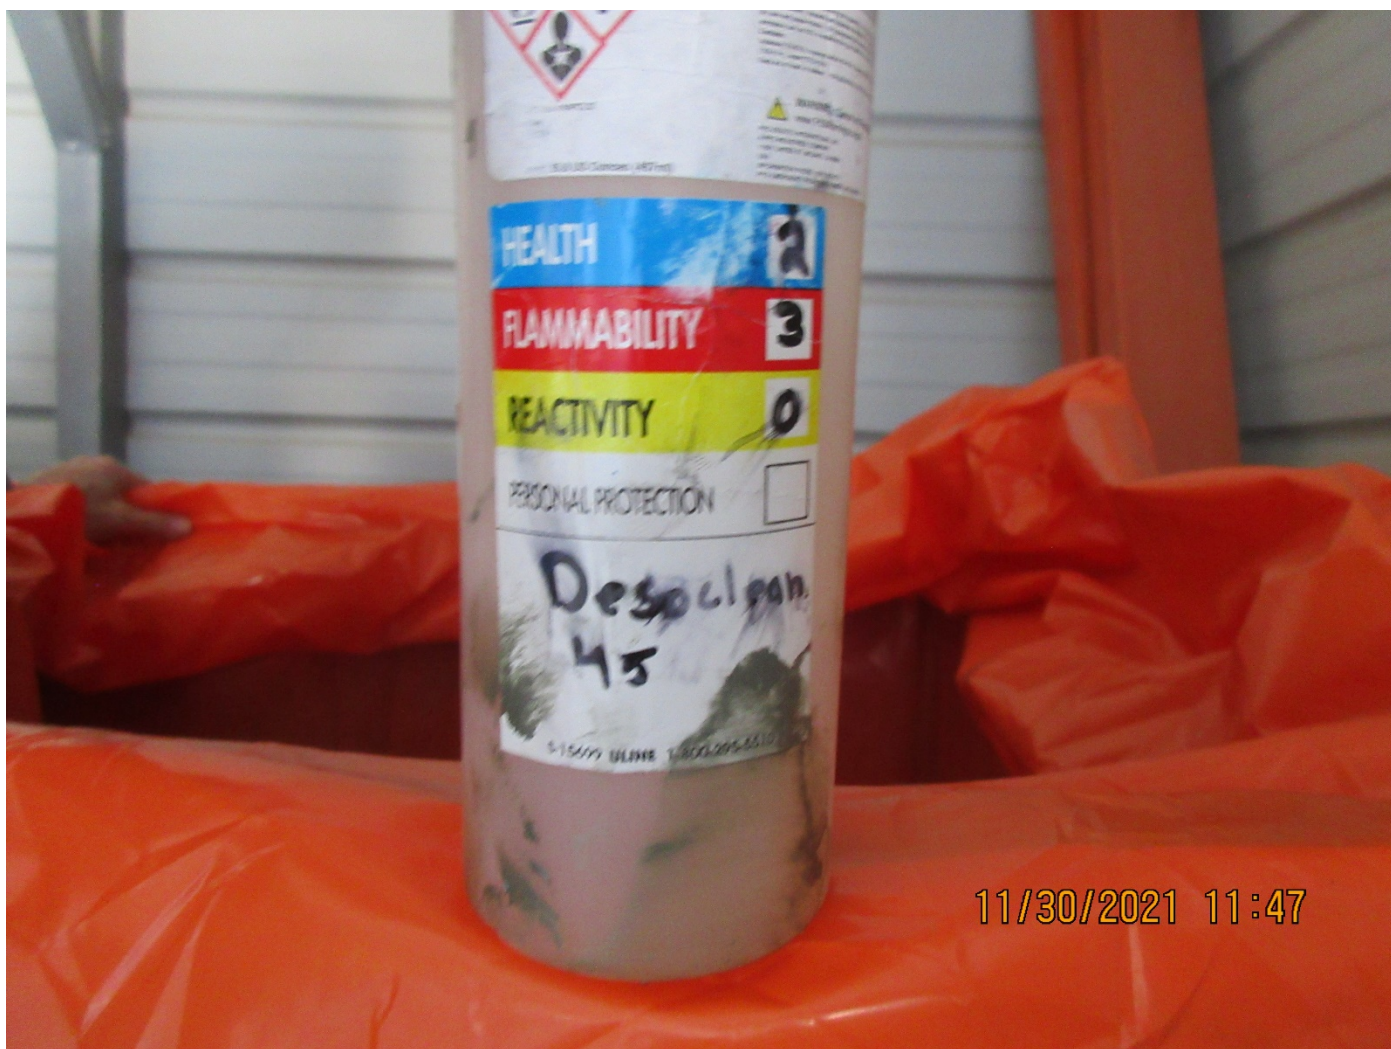
One cardboard box measuring approximately four feet by four feet by three feet containing eight containers of various types of paint wastes (Photos 20 -27). Gallon containers of three PPG Aerospace 020-044 001 Thinner Component have a flash point of 33-degrees Fahrenheit. This cardboard container was open, unlabeled, did not have an indication of the hazard contents of the container and was not marked with an accumulation start date.

**Photo 20 – One of several paint wastes observed within a box in the 90-day Hazardous Waste Accumulation Building**

**Pursuant to 25 S.C. CODE ANN. REGS. 61-79.262.17(a)(5)(i) [40 C.F.R. § 262.17(a)(5)(i)], which is a condition of the LQG Permit Exemption, a generator must mark or label its containers with the following: (A) the words "Hazardous Waste"; (B) an indication of the hazards of the contents; and (C) the date upon which each period of accumulation begins clearly visible for inspection on each container.**

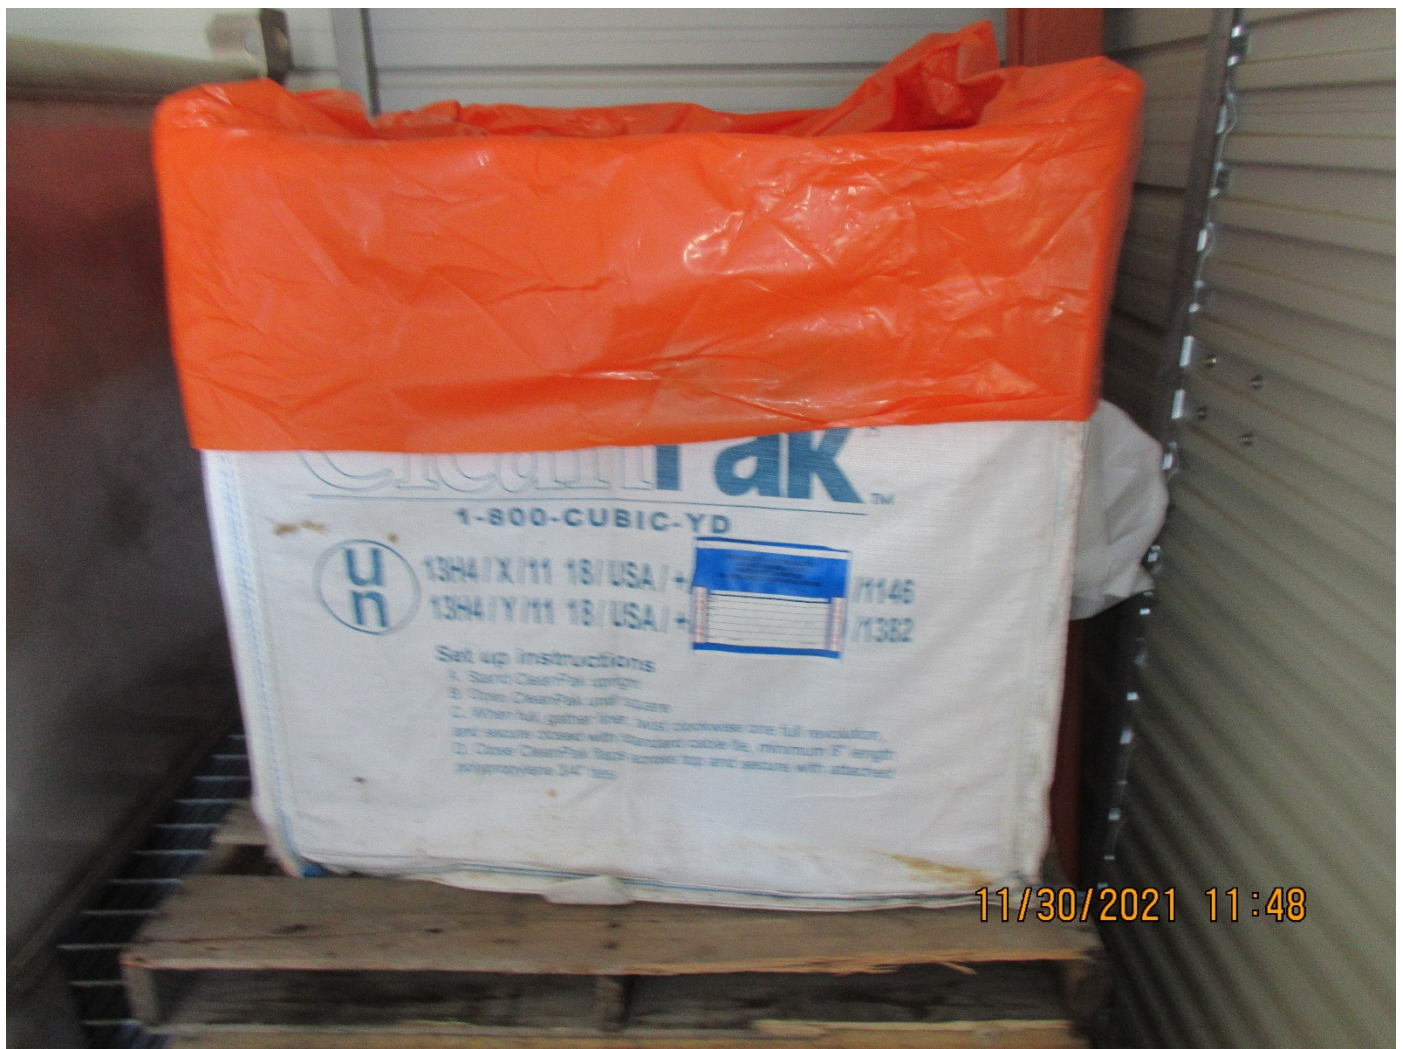
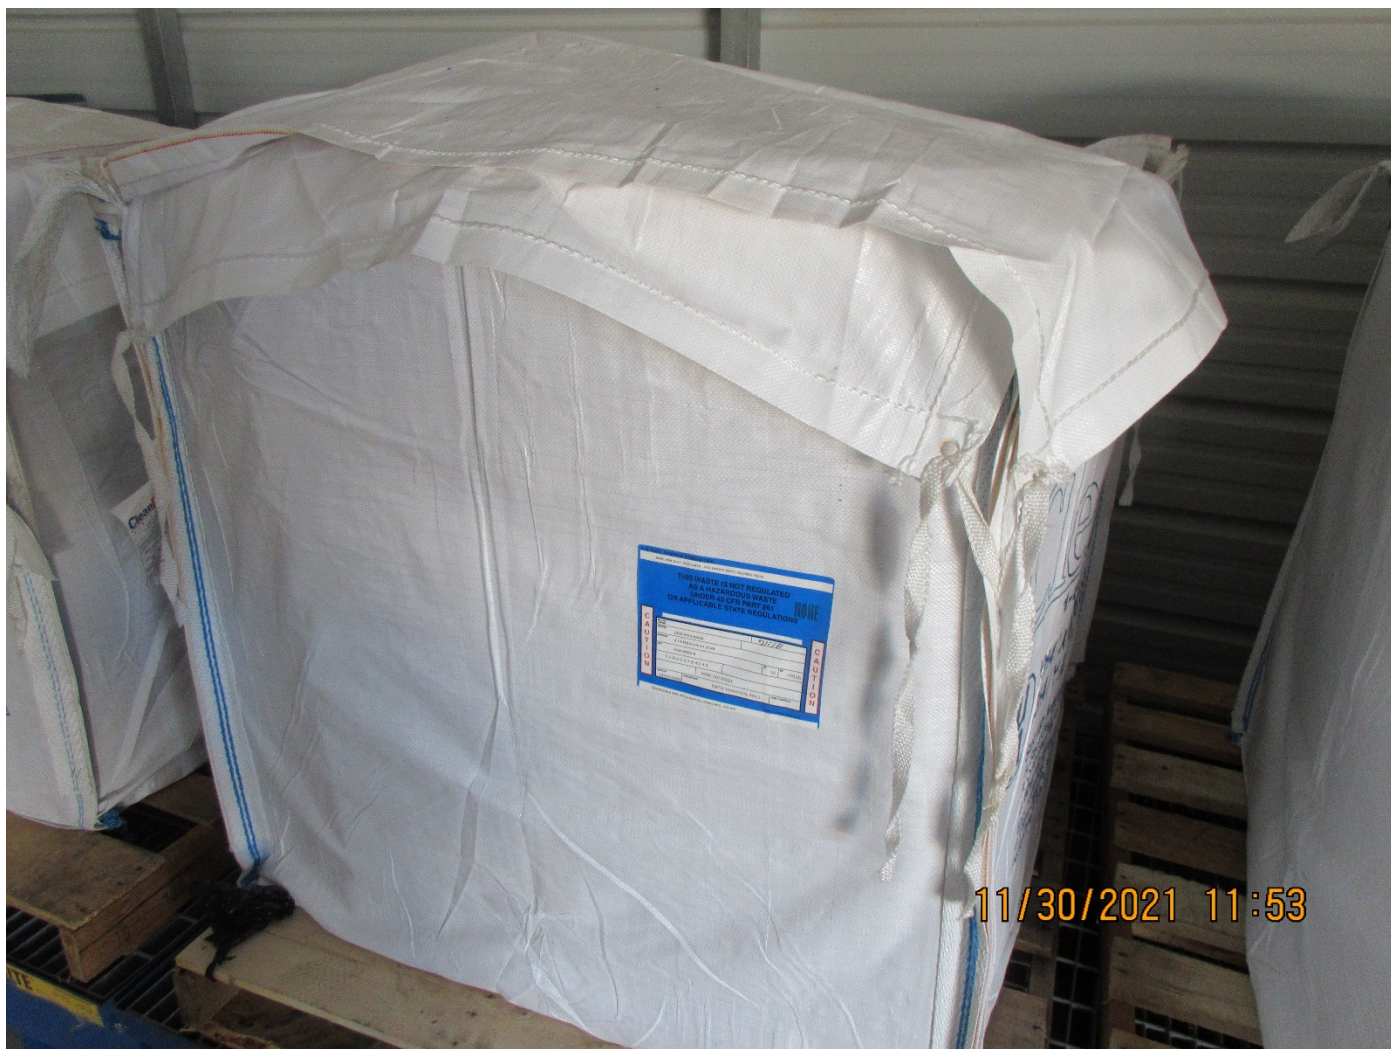
Numerous cubic yard supersacks of nonhazardous paint filters were observed in the building from the facility's paint booths (Photos 28-30).

Photo 28 – Nonhazardous paint filters

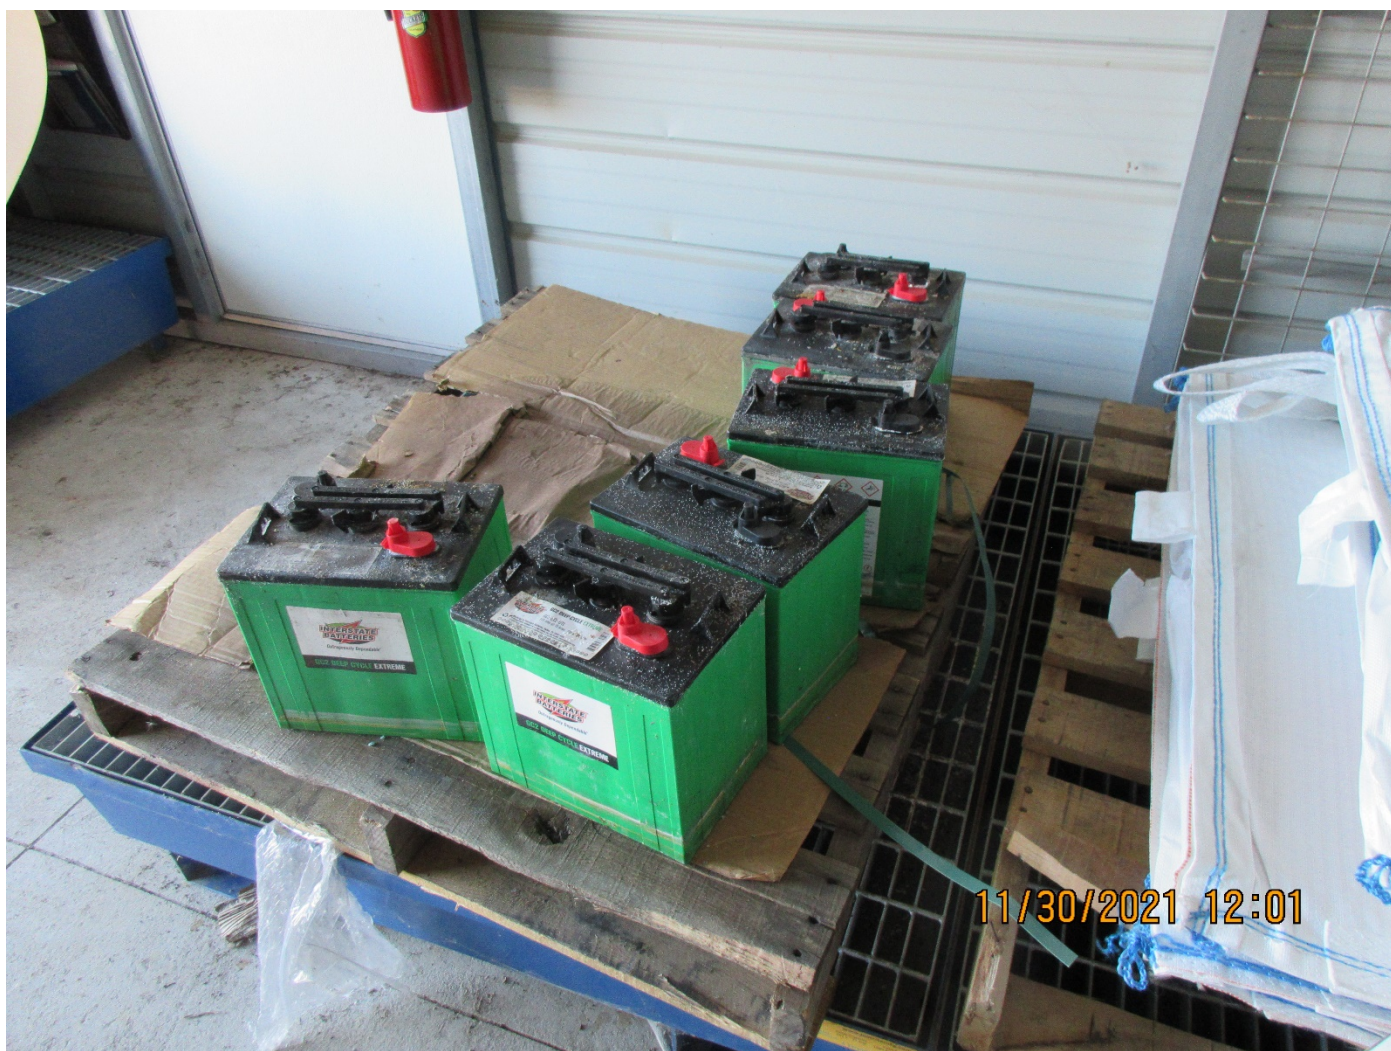
One pallet with six lead acid universal waste batteries were observed. The batteries were not labeled with universal waste language or accumulation start date (Photo 31).

**Photo 31 – Universal Waste Batteries in 90-day accumulation area**

**Pursuant to 25 S.C. CODE ANN. REGS. 61-79.273.14(a) [40 C.F.R. § 273.14(a)], a SQHUW must label or mark each Universal Waste battery or container or tank in which the batteries are contained clearly with one of the following phrases: “Universal Waste - Battery(ies),” or “Waste Batterie(A),” or “Used Batterie(s).”**

**Pursuant to 25 S.C. CODE ANN. REGS. 61-79.273.15(a) and (c) [40 C.F.R. § 273.15(a) and (c)], a SQHUW may accumulate universal waste no longer than one year and must be able to demonstrate the length of time that the universal waste has accumulated from the date that it became a waste or was received.**
