## **RCRA Inspection Report**

The Sherwin-Williams Co.  
404 East Mallory  
Memphis, Tennessee 38109

EPA ID#: TND007017304  
NAICS #: 32551 – Paint and Coating  
Manufacturing

April 10, 2024 at 9:00 A.M.

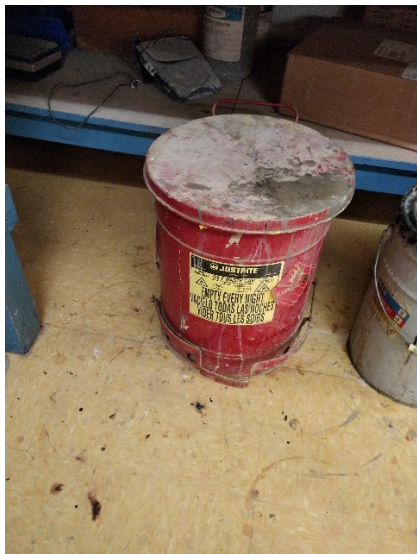
The inspectors met with Stanley Harvey, Laboratory Technician, to discuss the quality control sampling process for paint products. Laboratory samples are kept for three years before being disposed of. The inspectors observed a 5-gallon red container used to store solvent-contaminated wipes. The container was closed and contained a flammables placard on it to indicate the hazard of the contents but did not have a hazardous waste label on it (Photo 1). Sherwin-Williams manages used solvent-contaminated wipes as hazardous waste.

**Photo 1:** 5-gallon red container used to store solvent-contaminated wipes missing a hazardous waste label on it in the QC Laboratory.

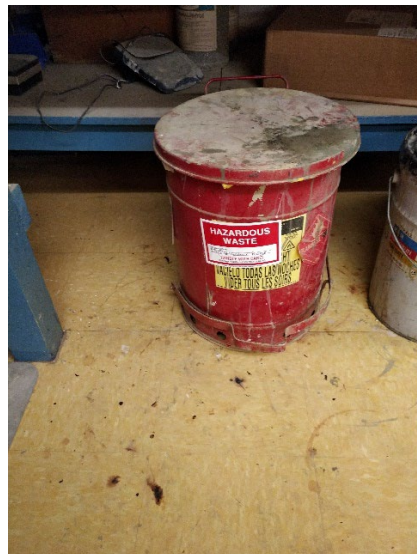
**Photo 2:** Hazardous waste label placed on 5-gallon container of solvent-contaminated wipes.

Facility personnel immediately placed a hazardous waste label on the container during the inspection (Photo 2).

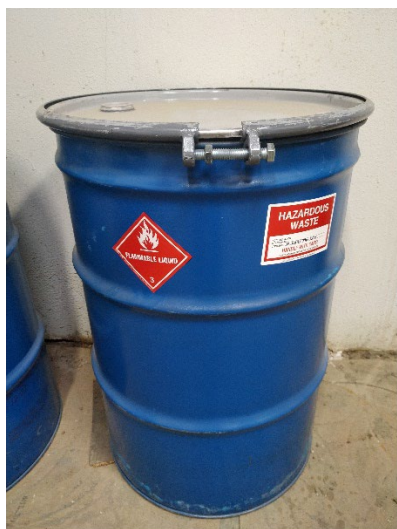
- One 55-gallon closed container labeled "Hazardous Waste H Alkyd Liquid Cans" but was not marked with an indication of the hazard of the contents or labeled with an accumulation start date;
- One 55-gallon closed container labeled "Hazardous Waste H Alkyd Liquid". The container was marked with an indication of the hazard of the contents but was not labeled with an accumulation start date;
- One 55-gallon closed container labeled "Hazardous Waste H Rags". The container was marked with an indication of the hazard of the contents but not labeled with an accumulation start date; and
- One 55-gallon closed container labeled "Hazardous Waste H Coal Tar Cans" but was not marked with an indication of the hazard of the contents or labeled with an accumulation start date.

**Photo 3:** 55-gallon container of hazardous waste labeled H Coal Tar Can in the QC Laboratory CAA.

Facility personnel immediately placed flammable placards on the hazardous waste containers missing indications of the hazards of the contents (Photos 3-6).

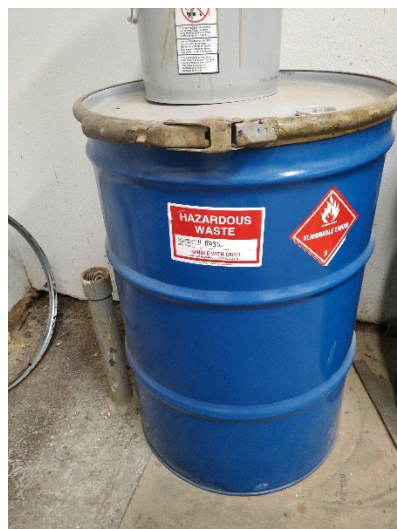
**Photo 4:** 55-gallon container of hazardous waste labeled H Rags in the QC Laboratory CAA.

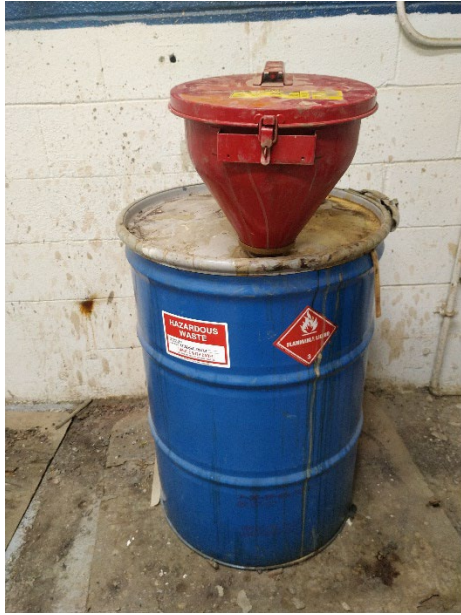
**Photo 5:** 55-gallon container of hazardous waste labeled H Alkyd Liquid in the QC Laboratory CAA.

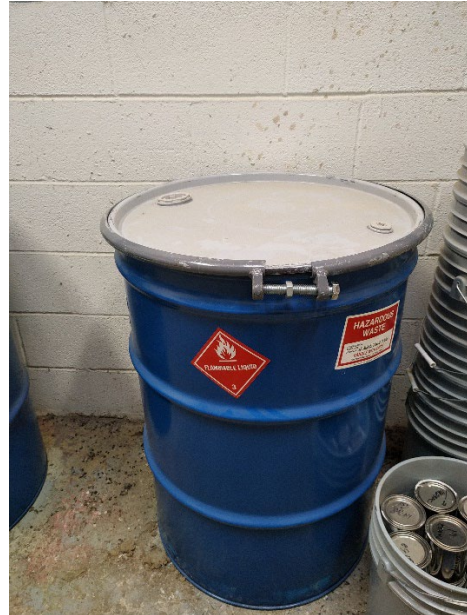
**Photo 6:** 55-gallon container of hazardous waste labeled H Alkyd Liquid Cans in the QC Laboratory CAA.

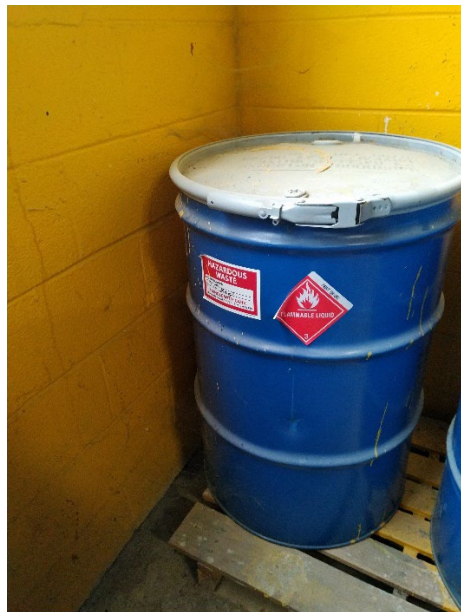
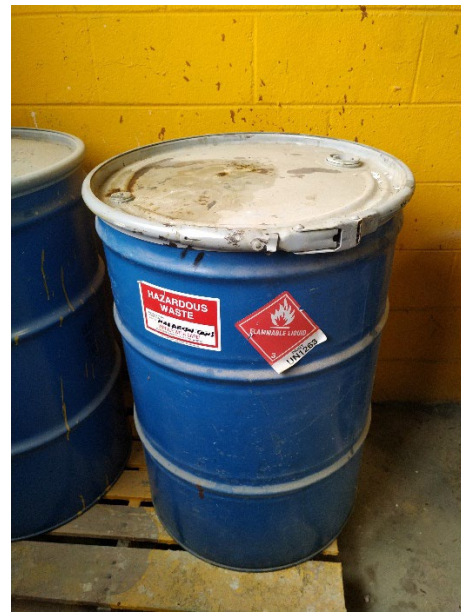
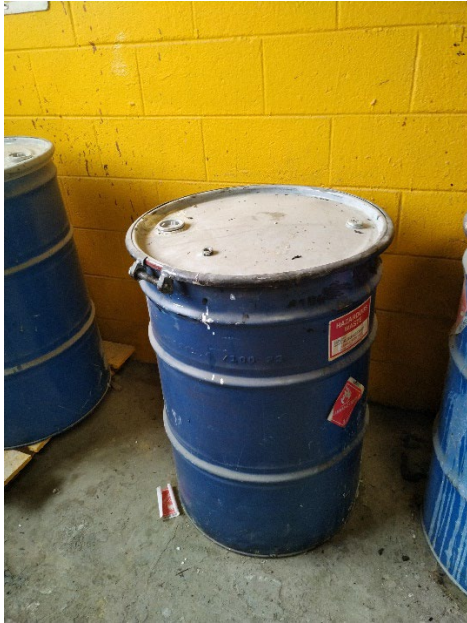
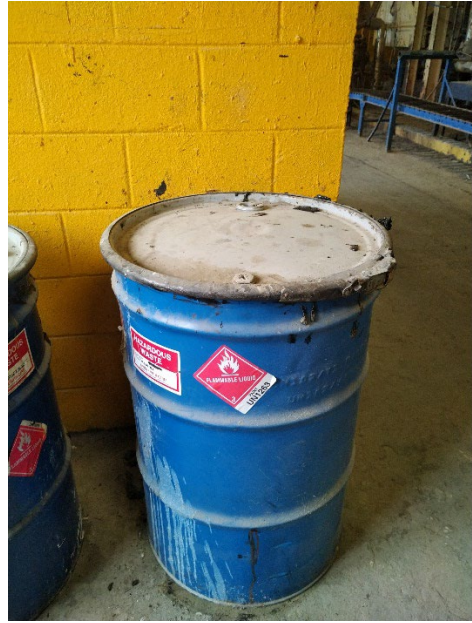
The inspectors observed the following hazardous waste in an SAA next to the Coal Tar Line (Photos 7-10):

- One 55-gallon container labeled “Flammable Liquid”. The container was closed, marked with an indication of the hazard of the contents, but did not have a hazardous waste label on it;
- One 55-gallon container labeled “Hazardous Waste Rags”. The container was closed and marked with an indication of the hazard of the contents;
- One 55-gallon container labeled “Hazardous Waste Aerosol Cans”. The container was closed and marked with an indication of the hazard of the contents;
- One 55-gallon container labeled “Hazardous Waste H Alkyd Liquids”. The container was closed and marked with an indication of the hazard of the contents; and
- One 55-gallon container labeled “Hazardous Waste H Coal Tar”. The container was closed and marked with an indication of the hazard of the contents.

**Photo 7:** 55-gallon Hazardous waste SAA container near Coal Tar Line.

**Photo 8:** 55-gallon Hazardous waste SAA container near Coal Tar Line.

**Photo 9:** 55-gallon Hazardous waste SAA container near Coal Tar Line.

**Photo 10:** 55-gallon Hazardous waste SAA container near Coal Tar Line.

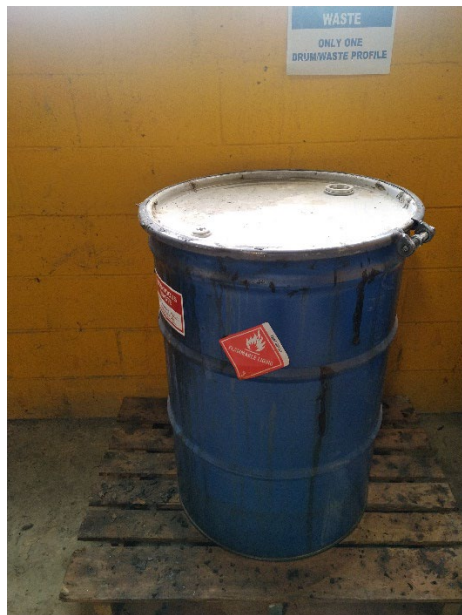
**Photo 11:** 55-gallon Hazardous waste SAA container near Coal Tar Line that was missing a hazardous waste label. Corrected onsite.

Facility personnel immediately placed a hazardous waste label on the container (Photo 11).

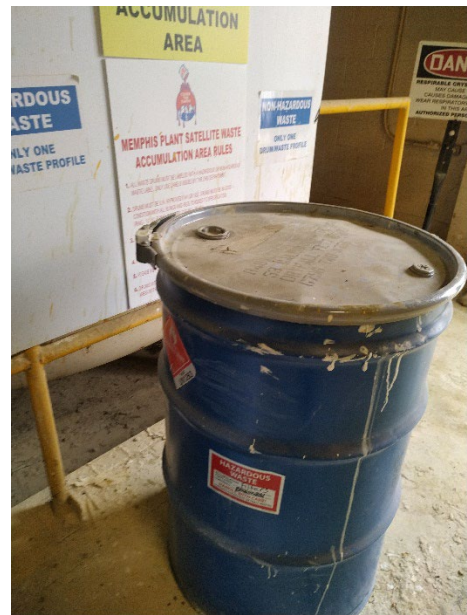
The inspectors observed one 55-gallon SAA container of hazardous waste in the mixing area. The container was closed, labeled “Hazardous Waste Filters”, and marked with an indication of the hazard of the contents (Photo 12).

**Photo 12:** 55-gallon SAA container of hazardous waste in the mixing area.

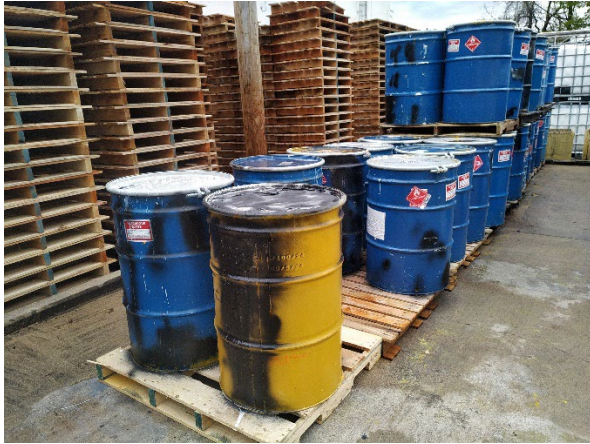
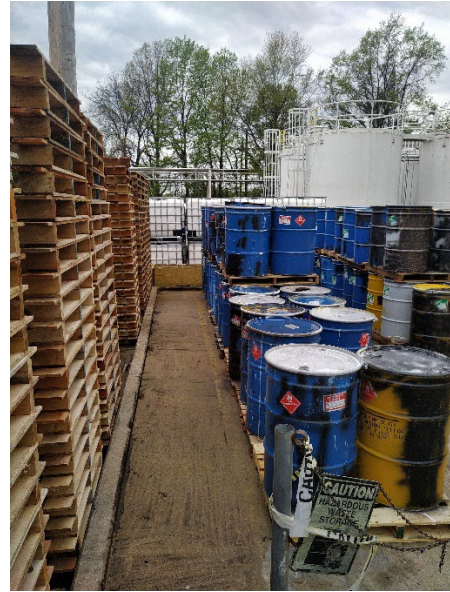
The inspectors observed 41 55-gallon containers of hazardous waste (Photo 13-14) in this CAA. Adequate aisle space was observed for the containers which were all closed, labeled “Hazardous Waste”, and dated (the oldest date observed was 02/22/2024). All but four of the containers were marked with an indication of the hazard of the contents.

**Photo 13:** Main CAA

**Photo 14:** Main CAA

Facility representatives immediately placed flammable placards on the four-container missing an indication of the hazard of the contents.

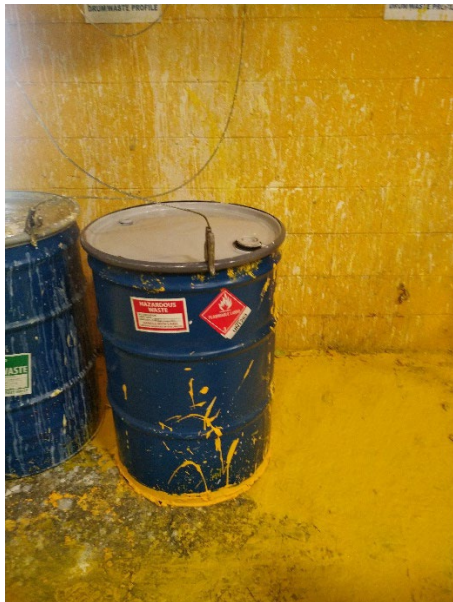
- One 55-gallon container labeled “Hazardous Waste H Alkyd Liquids” (Photo 15). The container was closed and marked with an indication of the hazard of the contents; and
- One 10-gallon container labeled “Hazardous Waste Rags” (Photo 16). The container was closed and marked with an indication of the hazard of the contents.

As shown in photos 15 and 16, there was paint-related material splattered on the floor and walls which did not appear to be cleaned up often. Footsteps with yellow paint appeared to be tracking from the Filling Area to other areas in the building.

**Photo 15:** 55-gallon container labeled "Hazardous Waste H Alkyd Liquids" in the Filling Area.

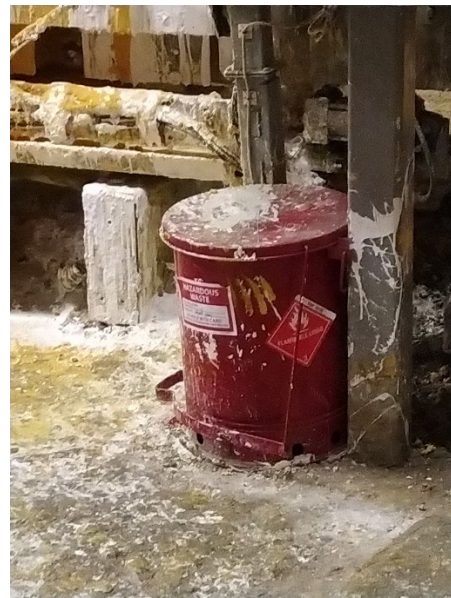
**Photo 16:** 10-gallon container labeled "Hazardous Waste Rags" in the Filling Area.
