## Clean Water Act Section 404: Site Visit/Case Development

| Site Name | Eastgate Corporate Park LLC (1 Coates Drive) & Eastgate Offices II LLC (4 Coates Drive) | | | | |

EPA CWA 404 Inspection Photolog  
Eastgate Coates Drive Properties  
1 & 4 Coates Drive  
Goshen, NY

May 23, 2023

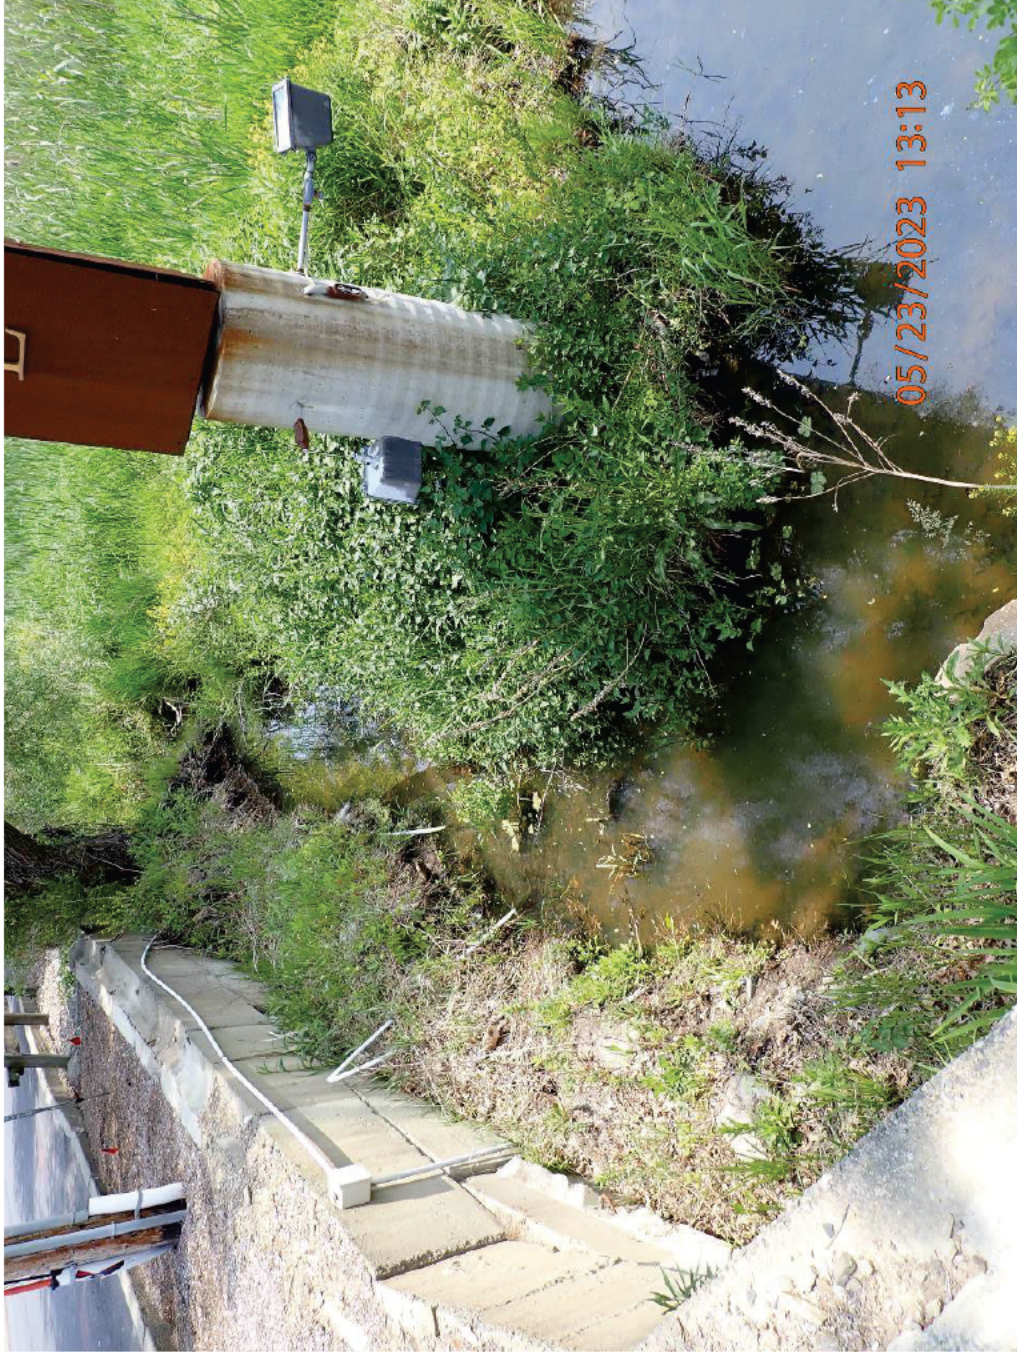
**Date:** 5/23/2023  
**Time:** 1:13 PM  
**Photographer:** S. Andreescu  
**Photo ID:** 1 – P5230096

(1/4) Potential wetland area on  
4 Coates Drive property

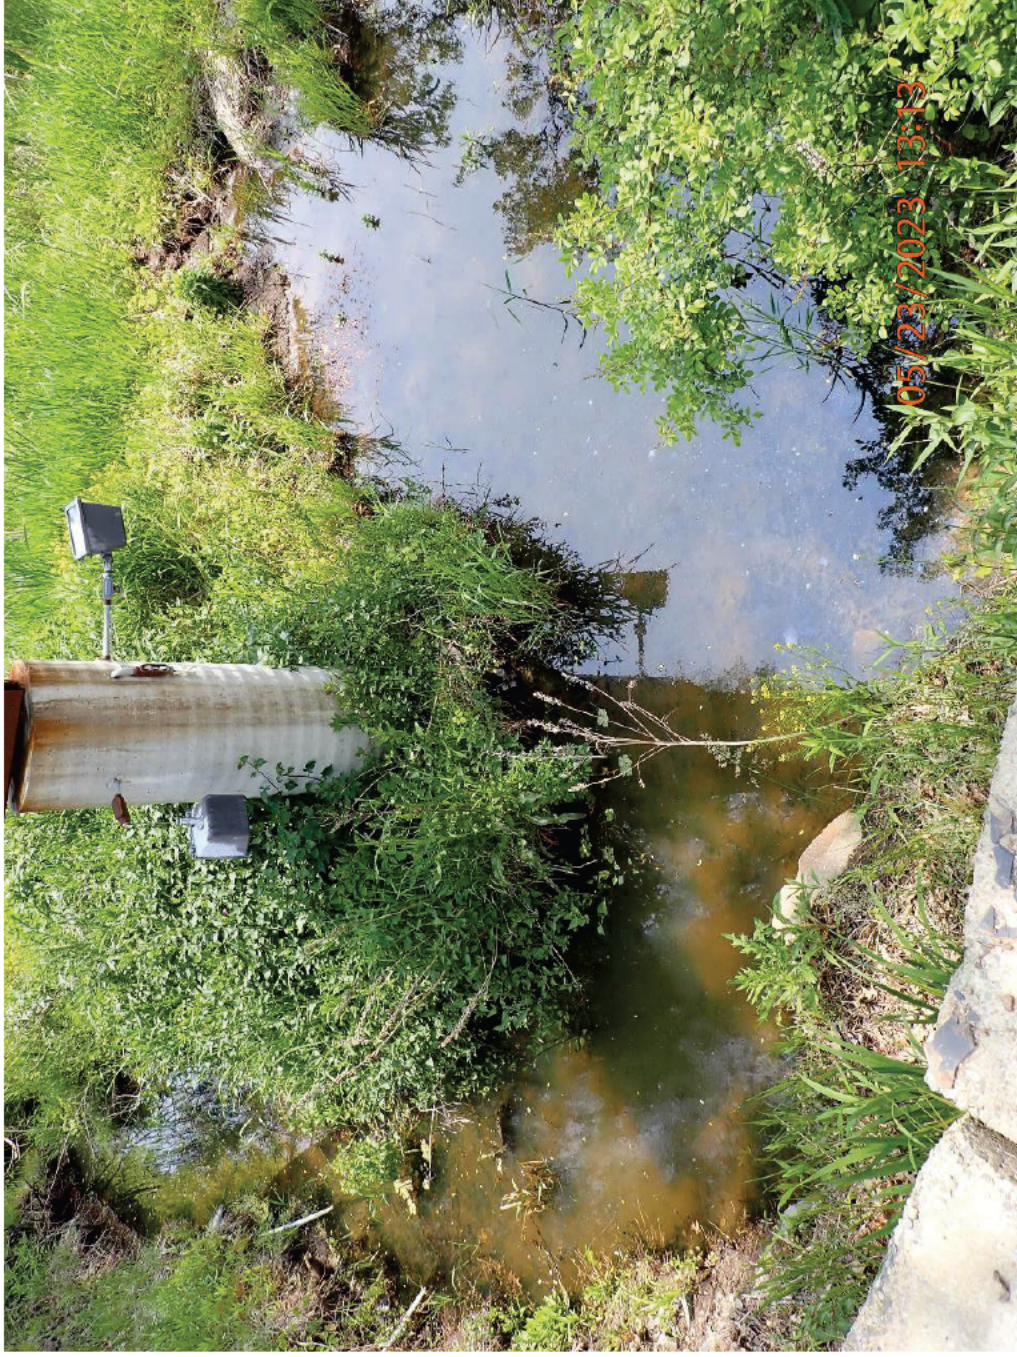
**Date:** 5/23/2023  
**Time:** 1:13 PM  
**Photographer:** S. Andreescu  
**Photo ID:** 2 – P5230097

(2/4) Potential wetland area on  
4 Coates Drive property

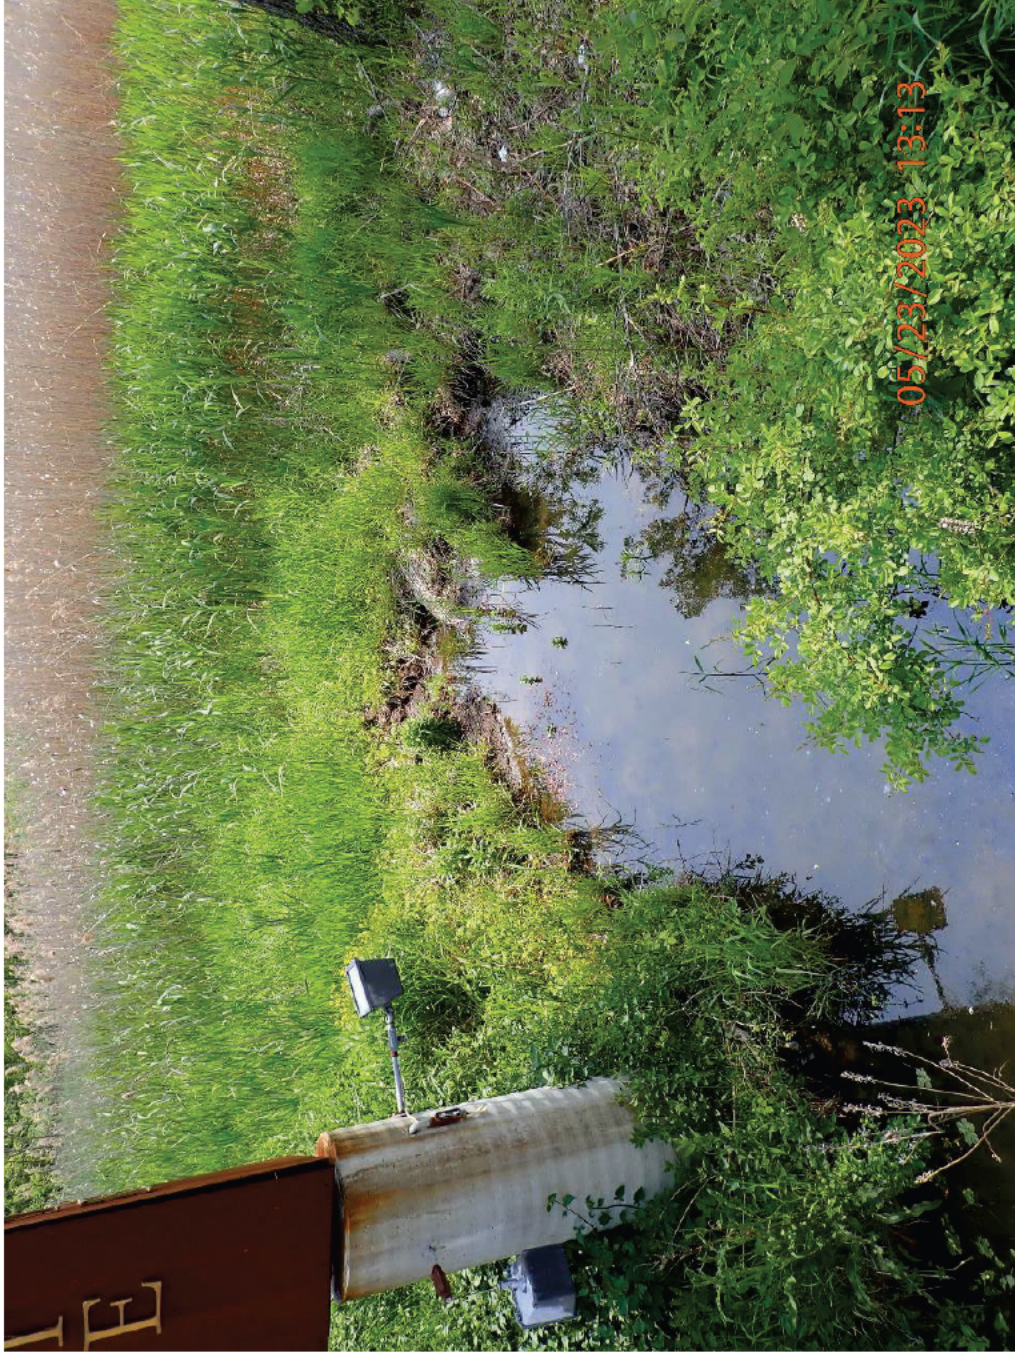
**Date:** 5/23/2023  
**Time:** 1:13 PM  
**Photographer:** S. Andreescu  
**Photo ID:** 3 – P5230098

(3/4) Potential wetland area on  
4 Coates Drive property

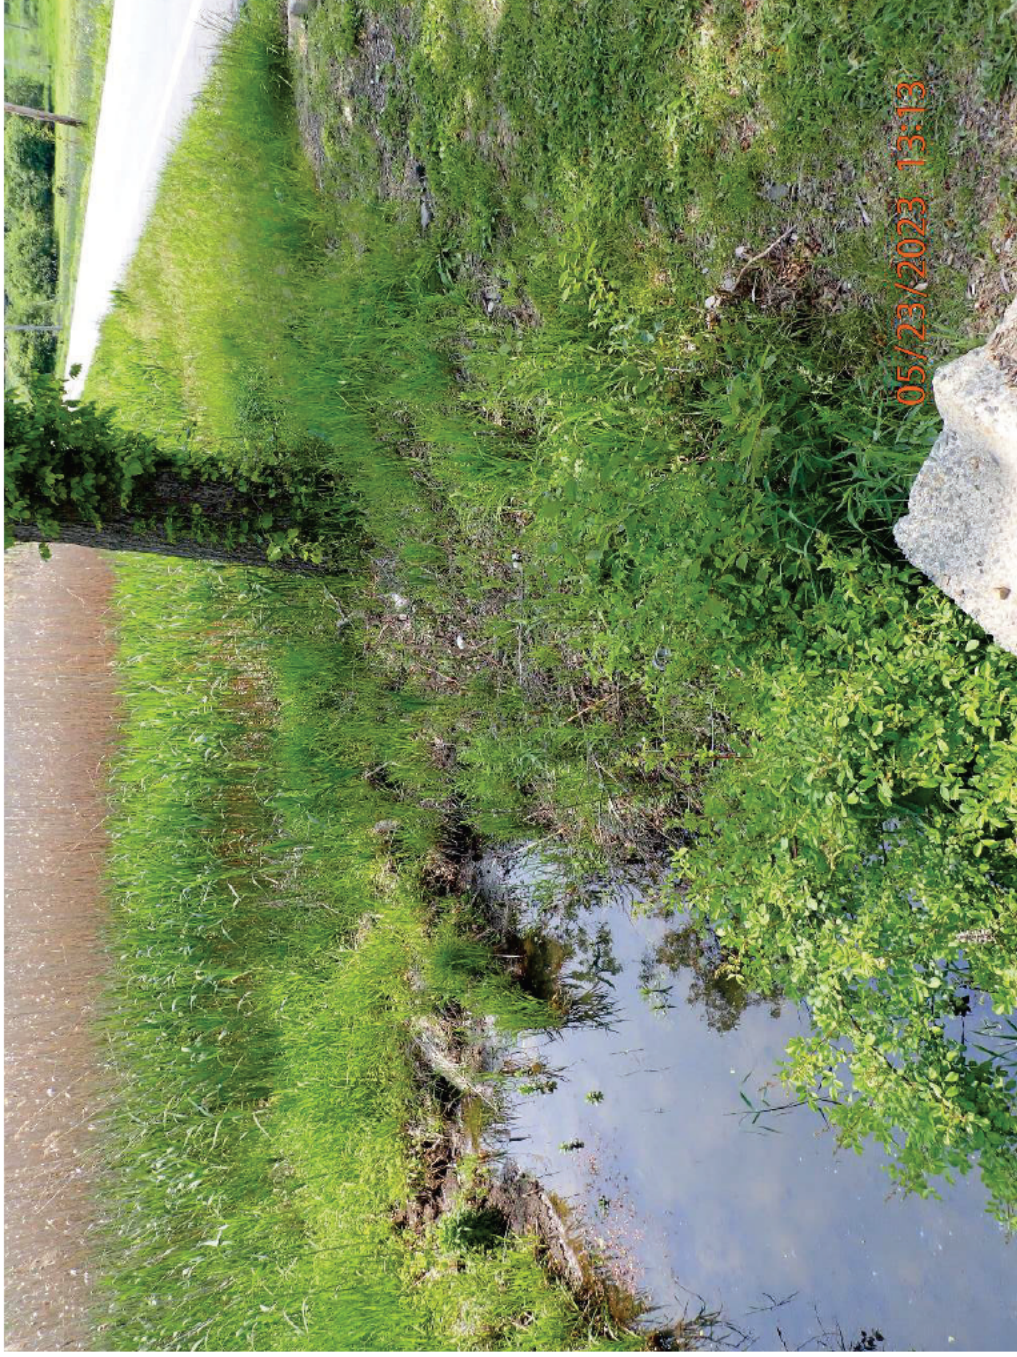
**Date:** 5/23/2023  
**Time:** 1:13 PM  
**Photographer:** S. Andreescu  
**Photo ID:** 4 – P5230099  
**Description:**  
(4/4) Potential wetland area on  
4 Coates Drive property

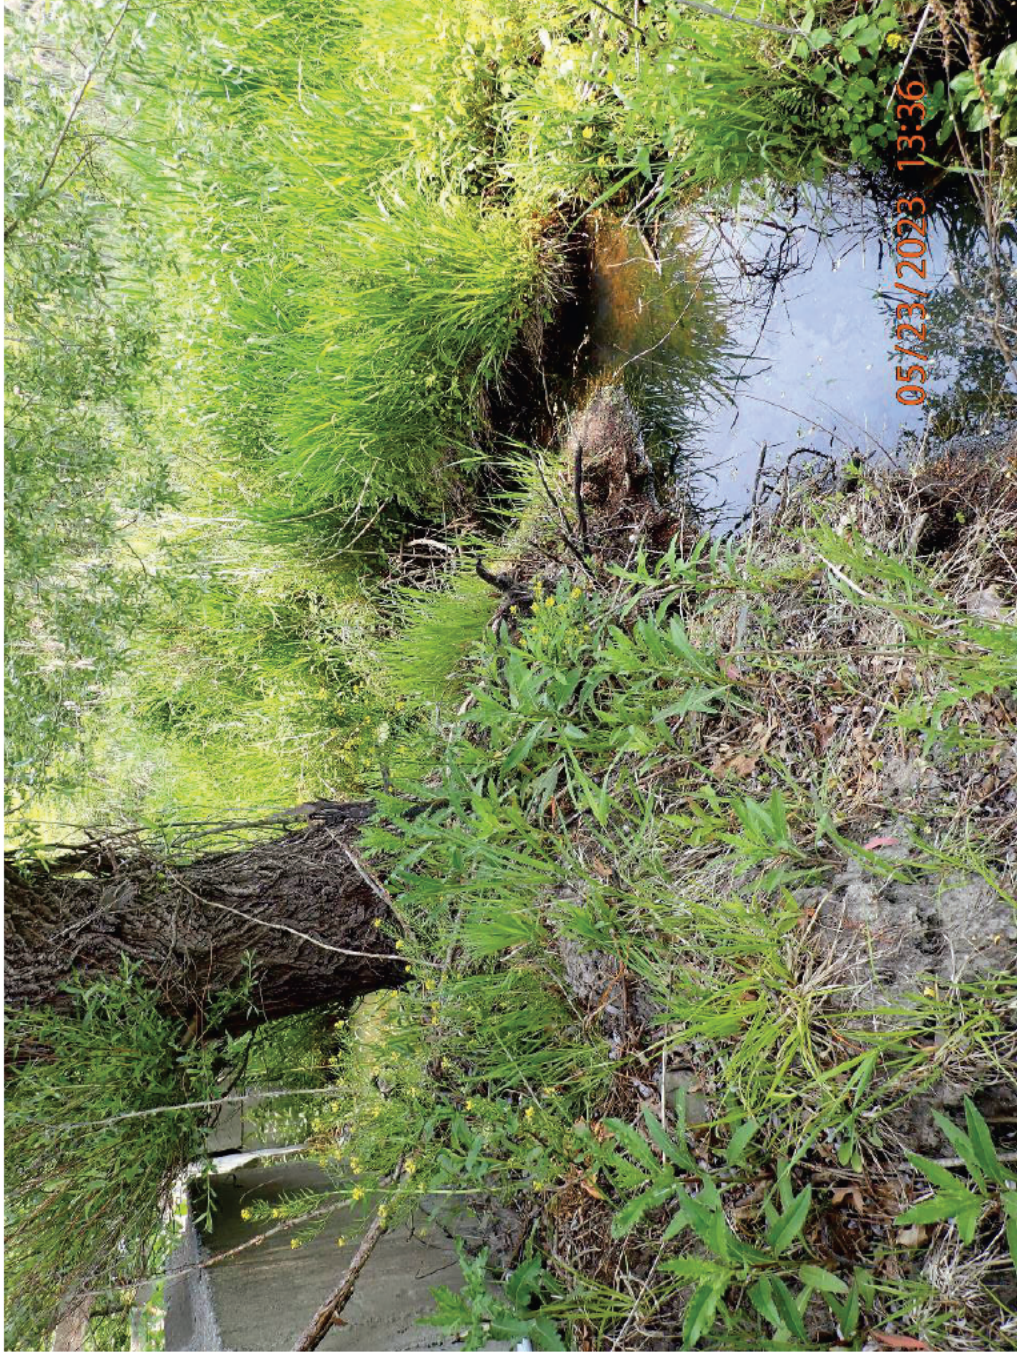
**Date:** 5/23/2023  
**Time:** 1:36 PM  
**Photographer:** S. Andreescu  
**Photo ID:** 5 – P5230100

(1/5) Panorama of potential wetland area and stream under Coates Drive

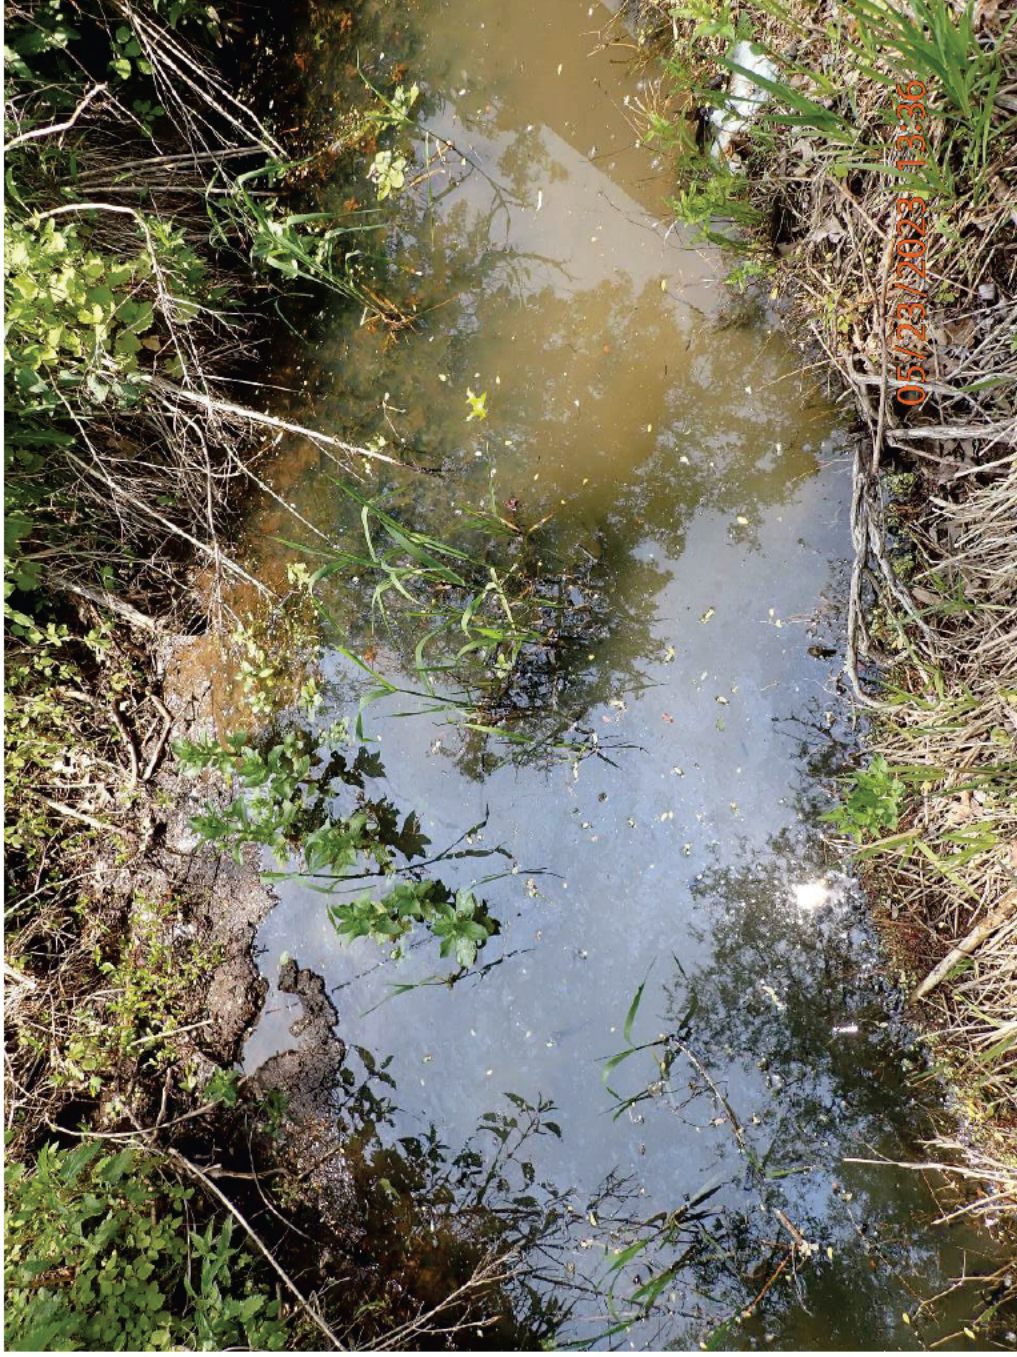
**Date:** 5/23/2023  
**Time:** 1:36 PM  
**Photographer:** S. Andreescu  
**Photo ID:** 7 – P5230102  
**Description:**  
(3/5) Panorama of potential wetland area and stream under Coates Drive

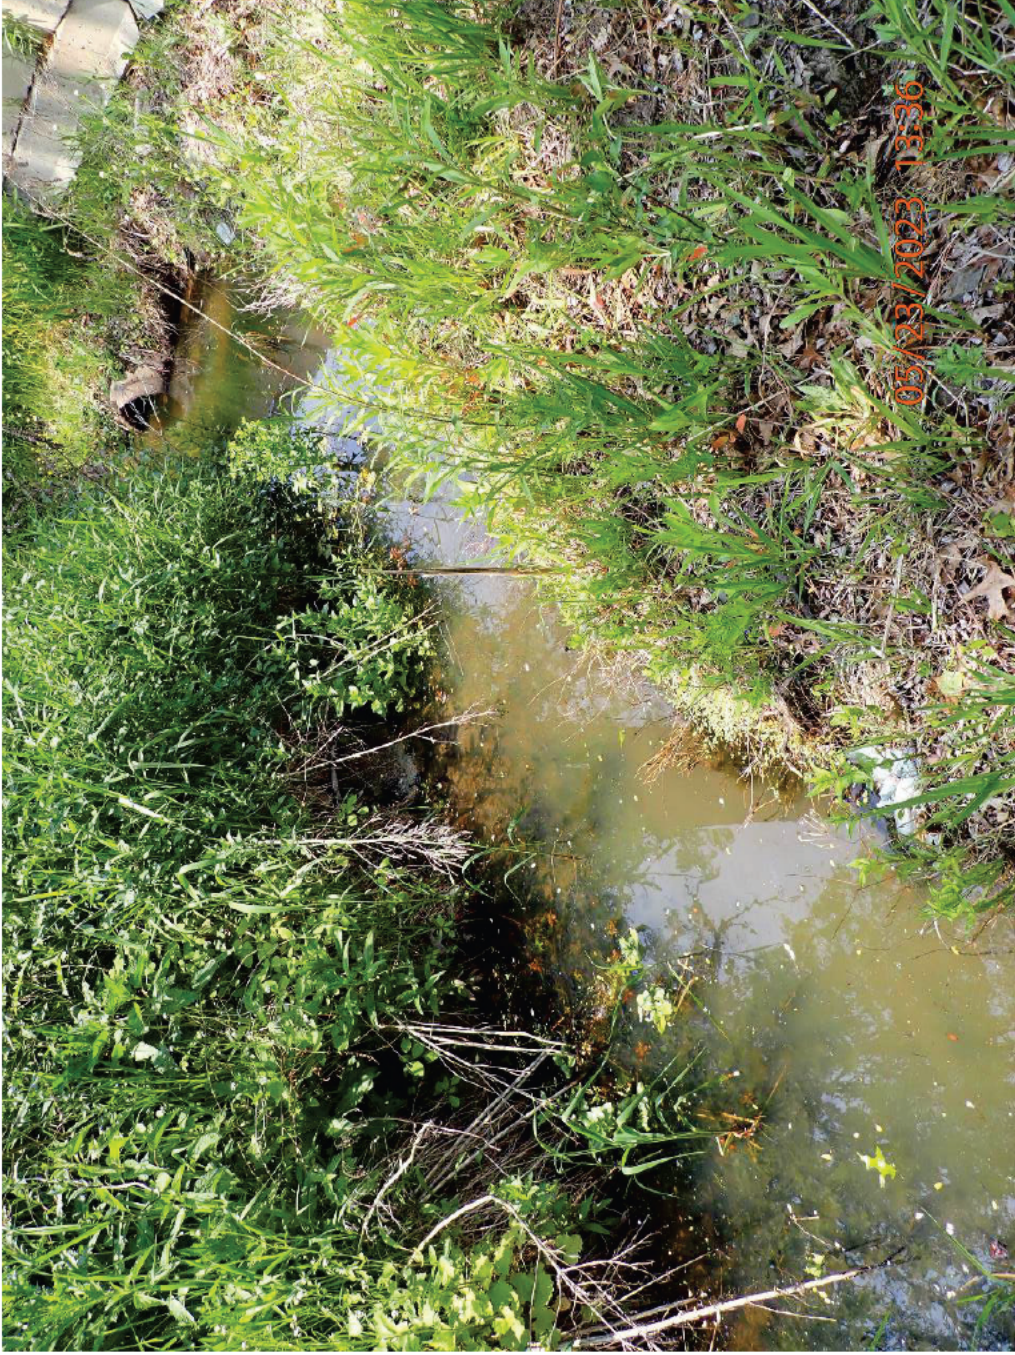
**Date:** 5/23/2023  
**Time:** 1:36 PM  
**Photographer:** S. Andreescu  
**Photo ID:** 8 – P5230103  
**Description:**  
(4/5) Panorama of potential wetland area and stream under Coates Drive

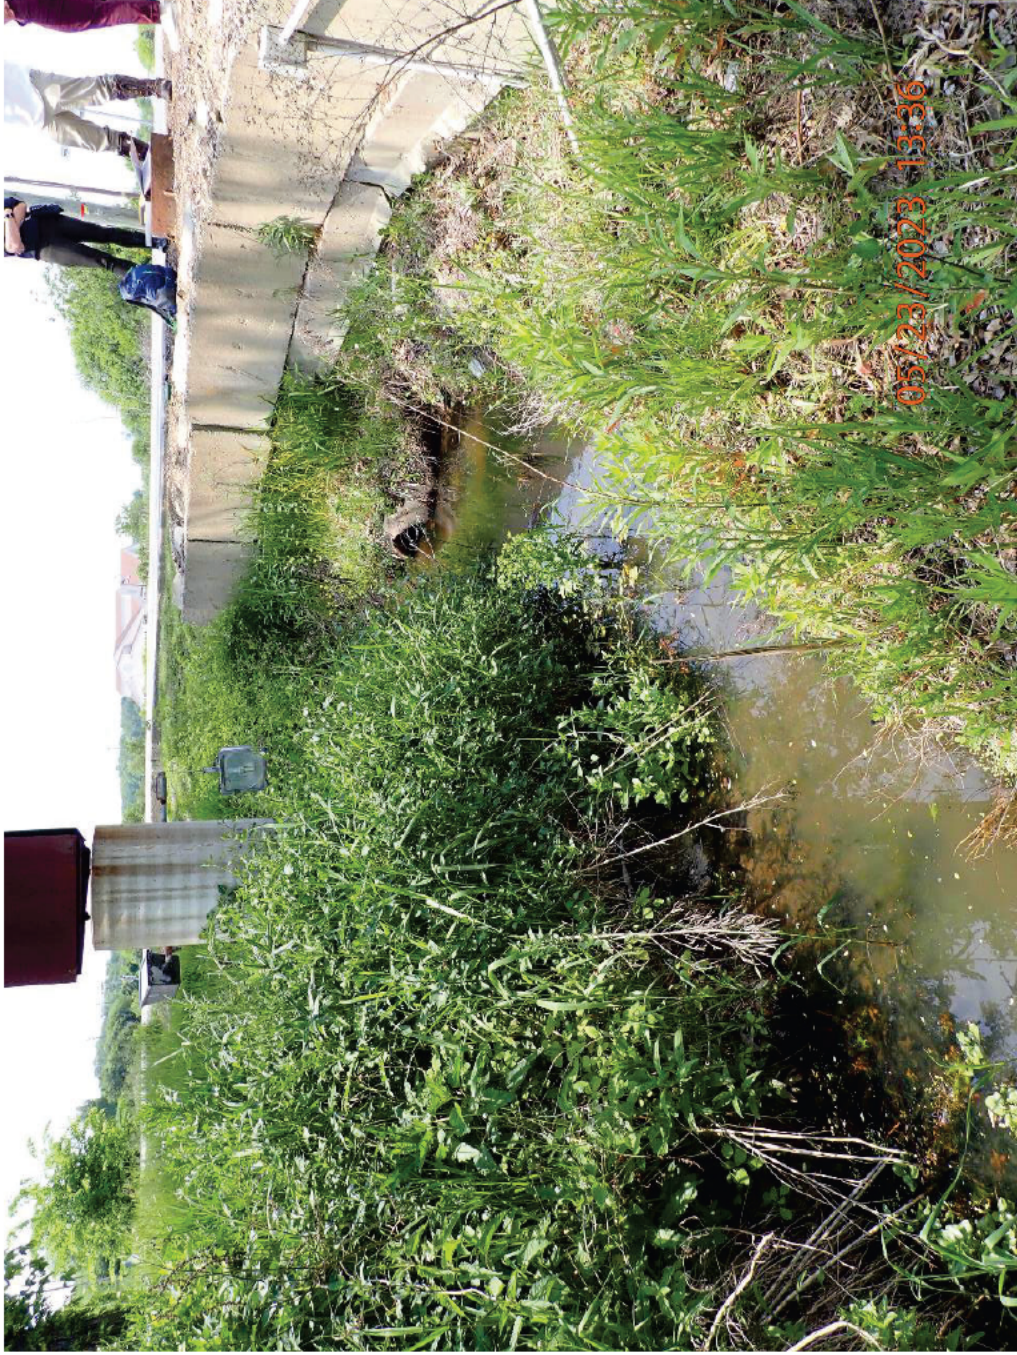
**Date:** 5/23/2023  
**Time:** 1:36 PM  
**Photographer:** S. Andreescu  
**Photo ID:** 9 – P5230104

(5/5) Panorama of potential wetland area and stream under Coates Drive

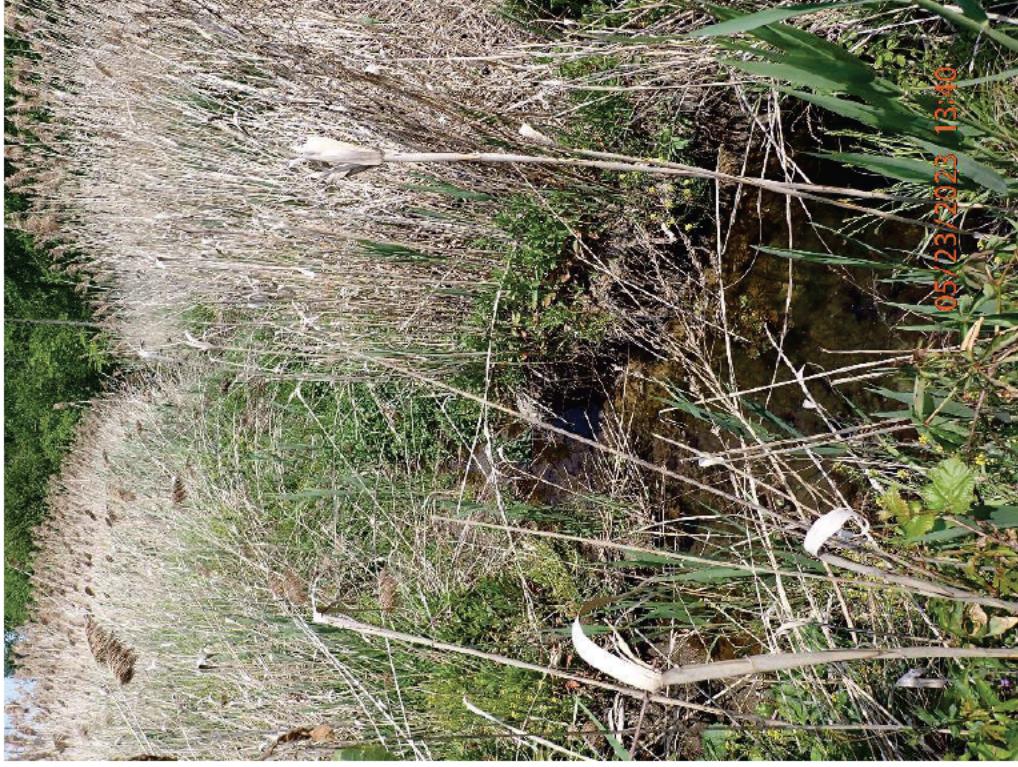
**Date:** 5/23/2023  
**Time:** 1:40 PM  
**Photographer:** S. Andreescu  
**Photo ID:** 10 – P5230105

Flowing stream through 1  
Coates Drive

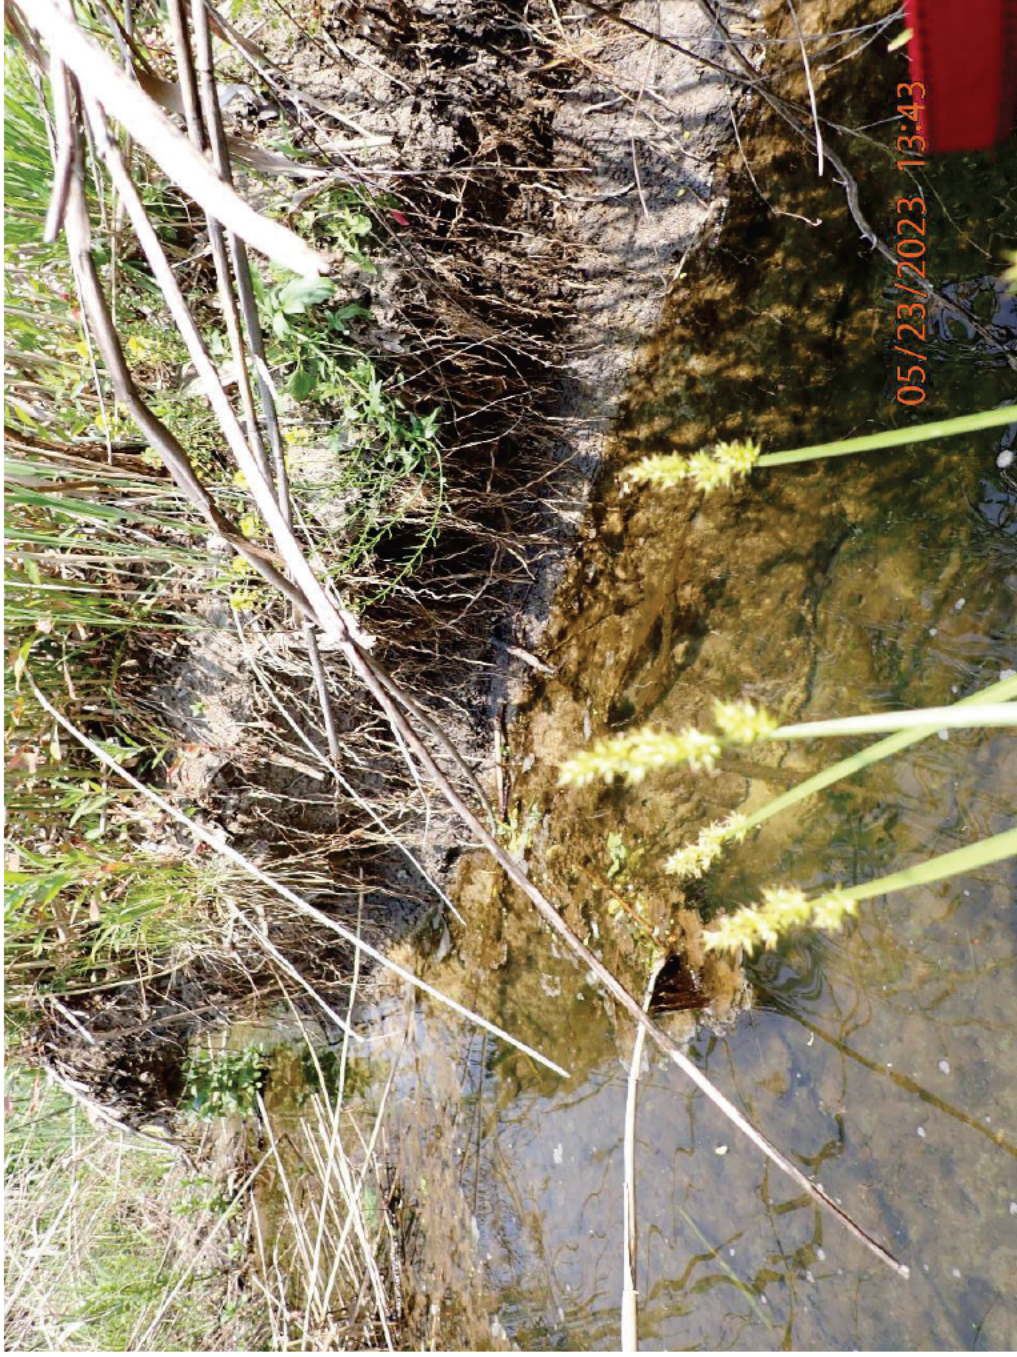
**Date:** 5/23/2023  
**Time:** 1:43 PM  
**Photographer:** S. Andreescu  
**Photo ID:** 11 – P5230106

| EPA observed indicators of stream excavation and sidecasting within a wetland at the 1 Coates Drive property. | | | |

Stream with banks cut with  
machinery
