**US Environmental Protection Agency – Region 2
 Caribbean Environmental Protection Division
 Response and Remediation Branch**

**Resource Conservation and Recovery Act (RCRA)
 Compliance Evaluation Inspection**

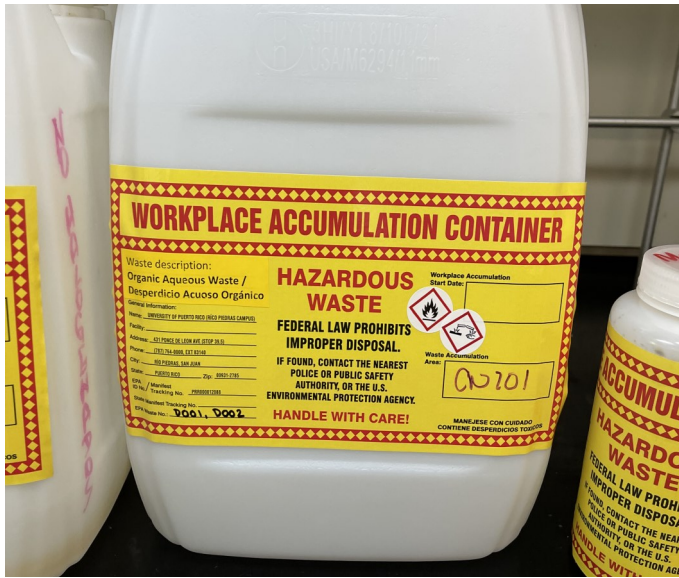
Picture 1 - UPR NATURAL SCIENCES - At the Lab CN-101, there was one (1) 5-gallon white container with “Organic Aqueous Wastes,” labeled with the words “Hazardous Waste,” and identified with RCRA codes “D001” and “D002” and with its hazard pictograms as “Ignitable, and Corrosive” as required by RCRA.

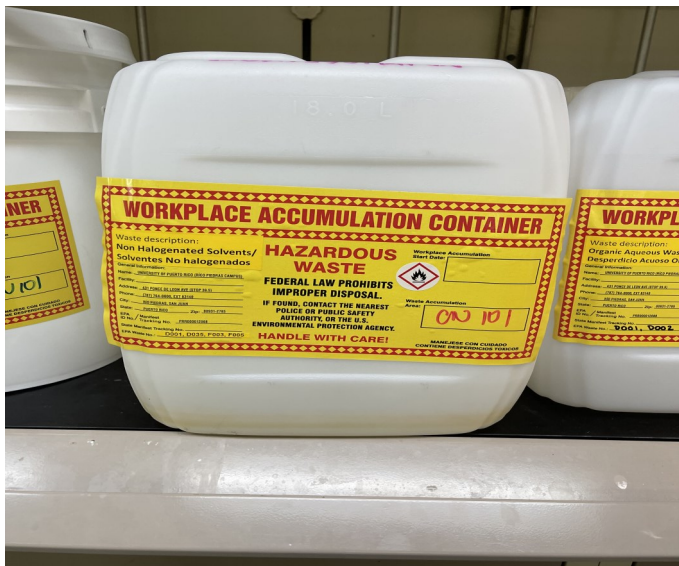
Picture 3 - UPR NATURAL SCIENCES - At the Lab CN-101, there was one (1) 5-gallon white container with “Spent Non-Halogenated Solvent Wastes,” labeled with the words “Hazardous Waste,” and identified with RCRA codes and with its hazard communication pictogram “Flammable Liquids.”

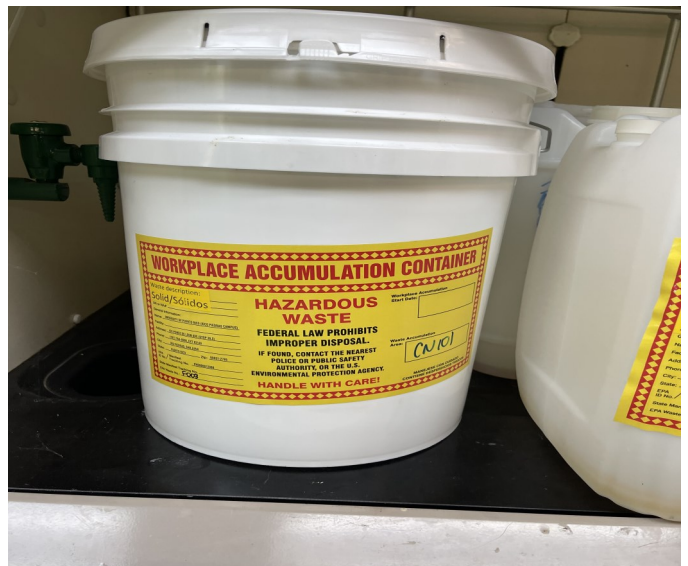
Picture 4 - UPR NATURAL SCIENCES - At the Lab CN-101, there was one (1) 5-gallon white container with “Solid Waste” contaminated with laboratory silica trash and desiccant” labeled with the words “Hazardous Waste,” and identified as “F003” and not identified with its pictogram “Flammable Solids.”

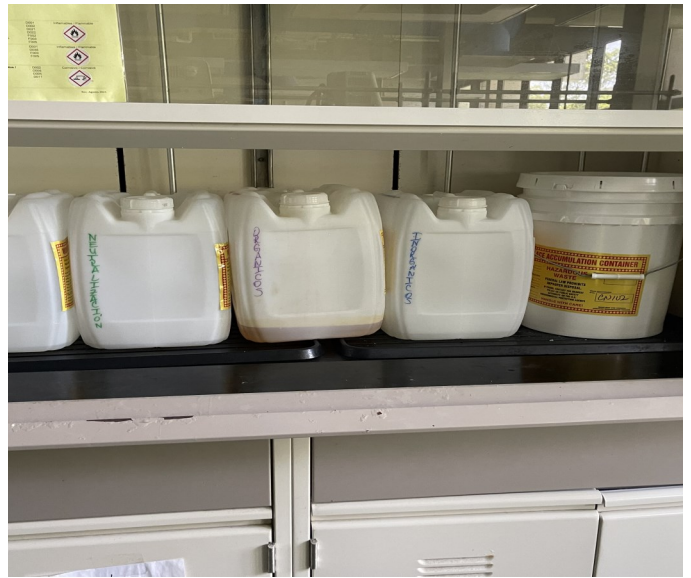
Picture 6 - UPR NATURAL SCIENCES - At the Lab CN-102, EPA Inspector noted that containers were in good conditions and sealed to secure of any potential releases of waste content, however, some containers were not properly identified nor posted with their hazardous communication pictograms.

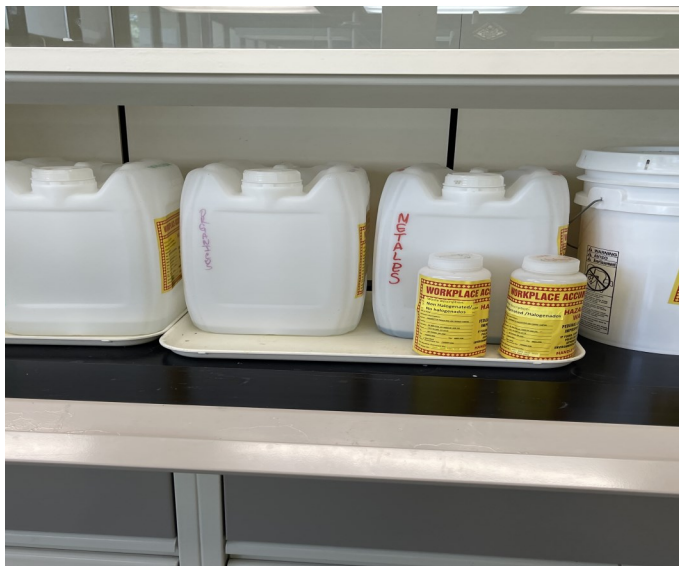
Picture 11 - UPR NATURAL SCIENCES - At the Lab CN-204A, EPA Inspector noted that containers were in good conditions and sealed to secure of any potential releases of waste content, however, some containers were not properly identified nor posted with their hazardous communication pictograms.

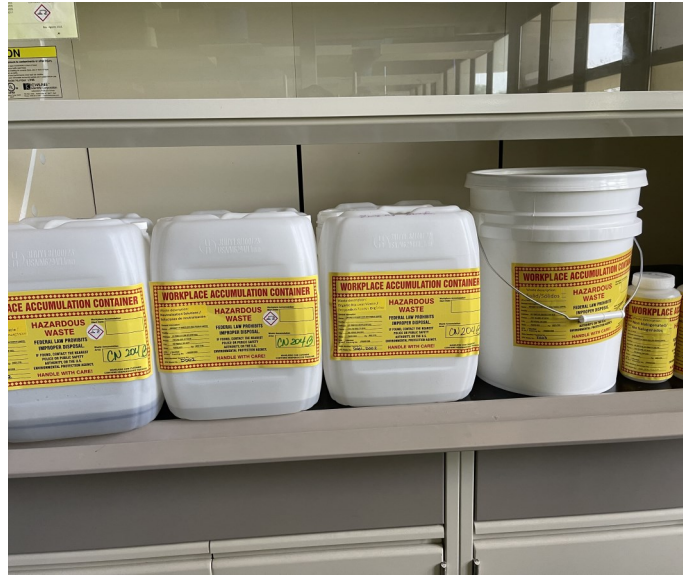
Picture 14 - UPR NATURAL SCIENCES - At the Lab CN-204B, EPA Inspector noted that containers were in good conditions and sealed to secure of any potential releases of waste content, however, some containers were not properly identified nor posted with their hazardous communication pictograms.

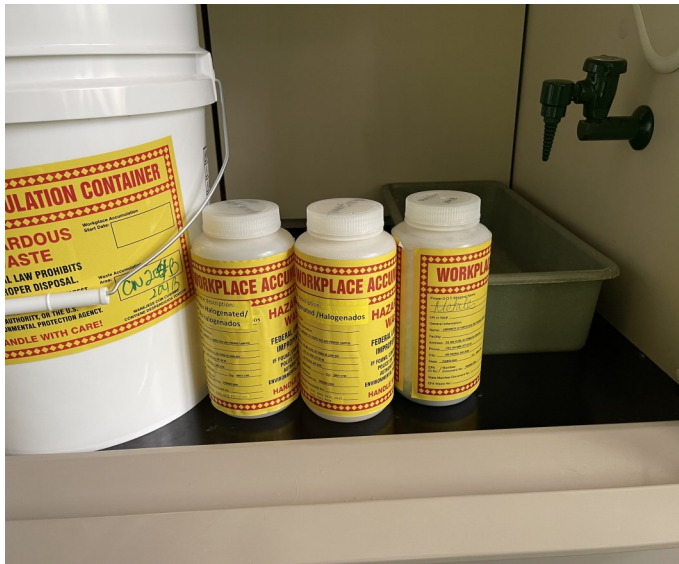
Picture 15 - UPR NATURAL SCIENCES - At the Lab CN-204B, EPA Inspector noted various containers with “Spent Non-Halogenated Solvent Wastes,” “Spent Halogenated Solvent Wastes,” and “Heavy Metals Wastes,” labeled with the words “Hazardous Waste,” but not posted with hazard pictograms.

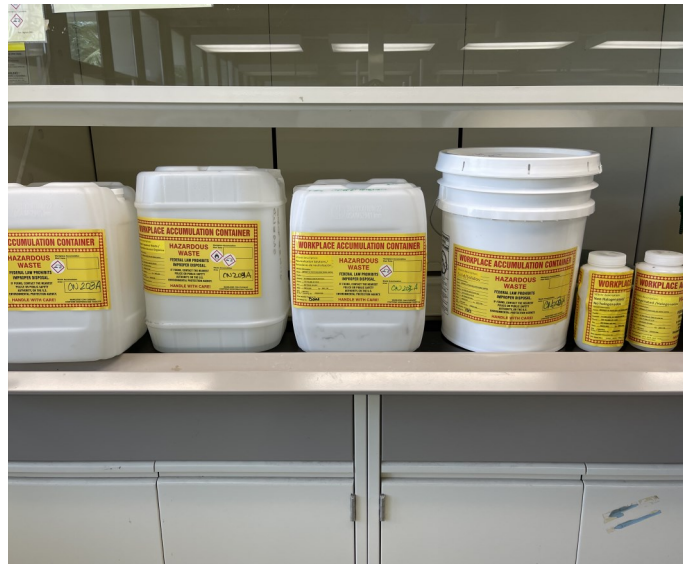
Picture 16 - UPR NATURAL SCIENCES - At the Lab CN-203A, EPA Inspector noted that containers were in good conditions and sealed to secure of any potential releases of waste content, however, some containers were not properly identified nor posted with their hazardous communication pictograms.

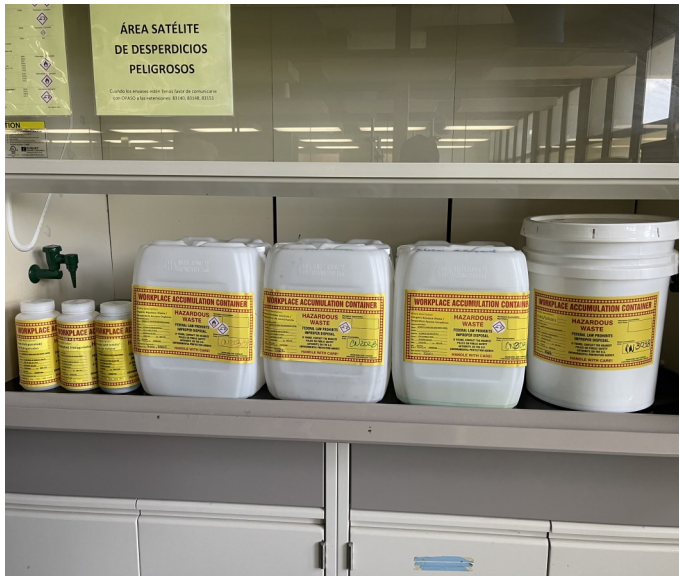
Picture 17 - UPR NATURAL SCIENCES - At the Lab CN-203B, EPA Inspector noted that containers were in good conditions and sealed to secure of any potential releases of waste content, however, some containers were not properly identified nor posted with their hazardous communication pictograms.

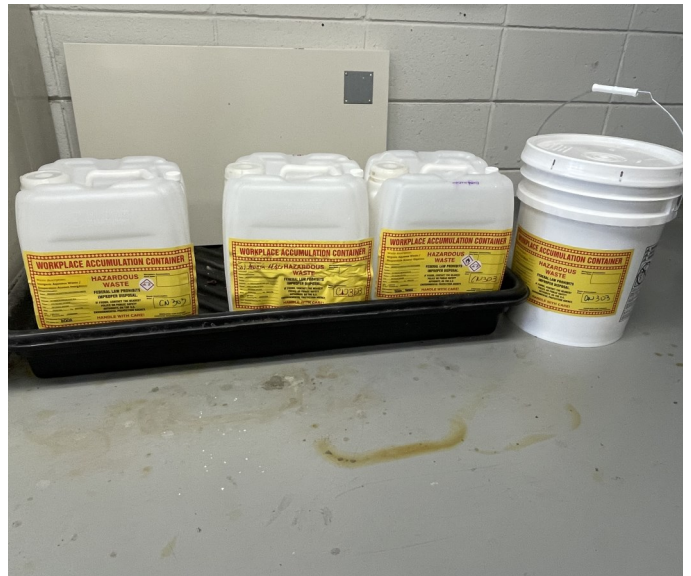
Picture 18 - UPR NATURAL SCIENCES - At the Lab CN-303, EPA Inspector noted various containers with "Organic and Inorganic Solvents," "Heavy Metals Wastes," and "Solid Wastes," labeled with the words "Hazardous Waste," but not posted with hazard pictograms.

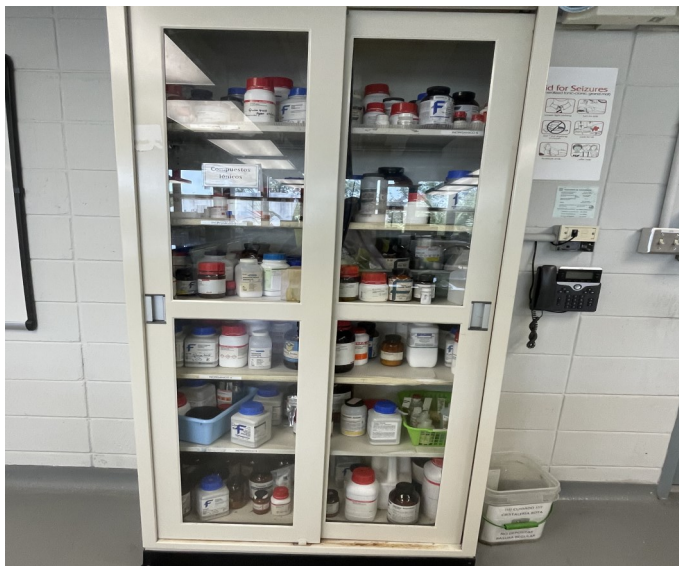
Picture 19 - UPR NATURAL SCIENCES - At the Lab CN-303, EPA indicated that storage of chemical reagents at laboratory cabinets was conducted without following any safety protocols or compatibility characteristics of the reagents failing to minimize the possibility of a fire, explosion, or any violent reaction.

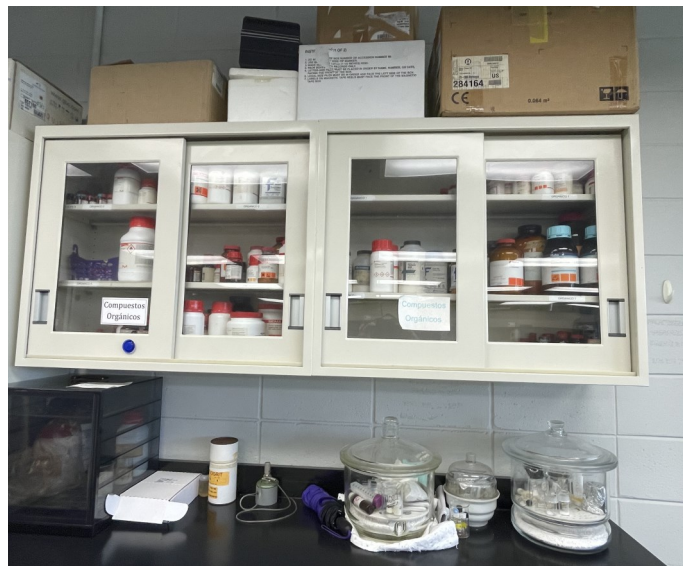
Picture 20 - UPR NATURAL SCIENCES - At the Lab CN-303, EPA also indicated that chemical reagents did not appear to be segregated by compatibility, and that shelving was not self-contained to prevent chemical leaks or spillage from incompatible waste containers.

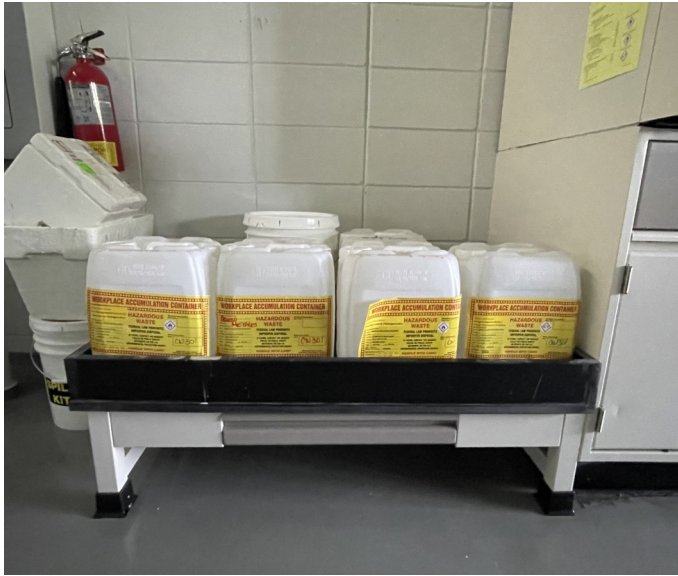
Picture 21 - UPR NATURAL SCIENCES - At the Lab CN-301, EPA Inspector noted that containers were in good conditions and sealed to secure of any potential releases of waste content, however, some containers were not properly identified nor posted with their hazardous communication pictograms.

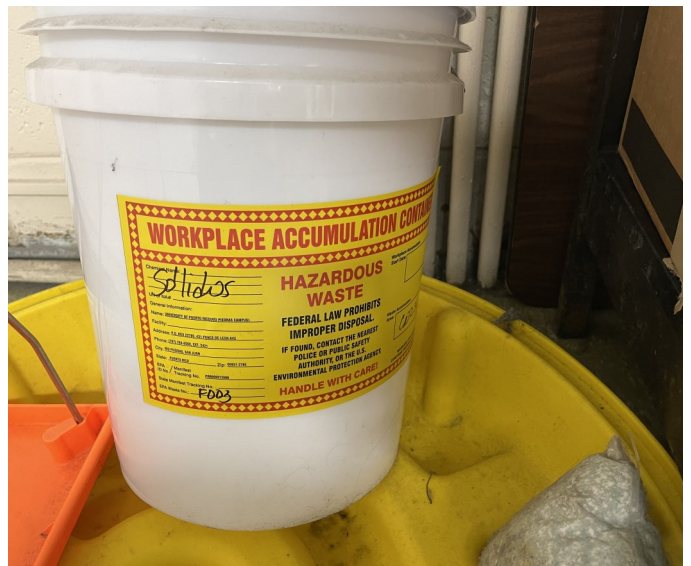
Picture 24 - UPR NATURAL SCIENCES - At the Lab CN-236, there was one (1) 5-gallon white container with "Solid Wastes" contaminated with laboratory silica trash" labeled with the words "Hazardous Waste," and identified with RCRA F003, but was not identified with its hazard on pictogram "Flammable Solids."

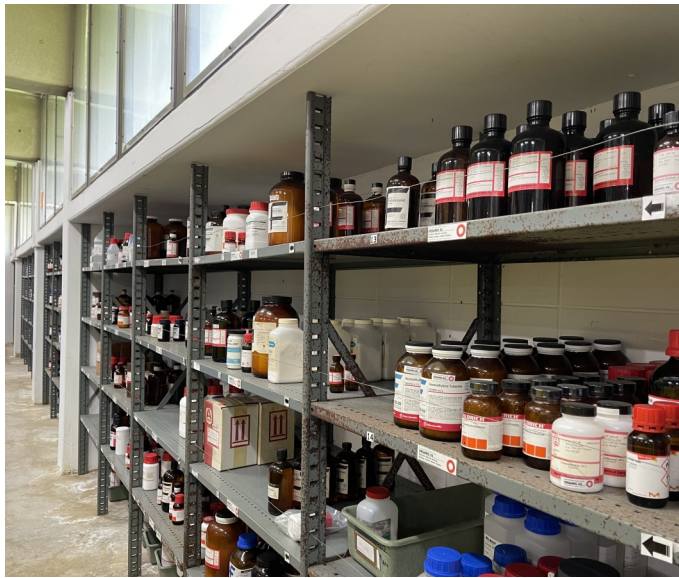
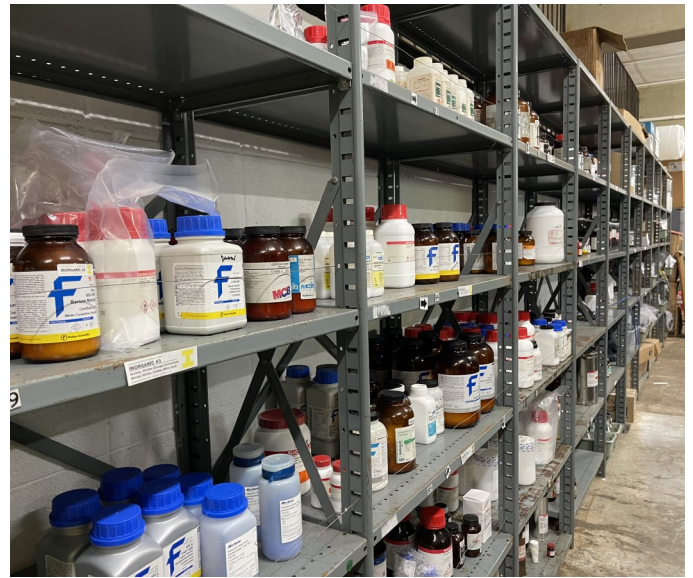
Picture 25 - UPR NATURAL SCIENCES - At the Lab CN-006, EPA Inspector observed the storage of these “Organic Chemical Reagents” conducted following Flinn’s safety protocols and compatibility characteristics to minimize the possibility of a fire, explosion, or any chemical violent reaction.

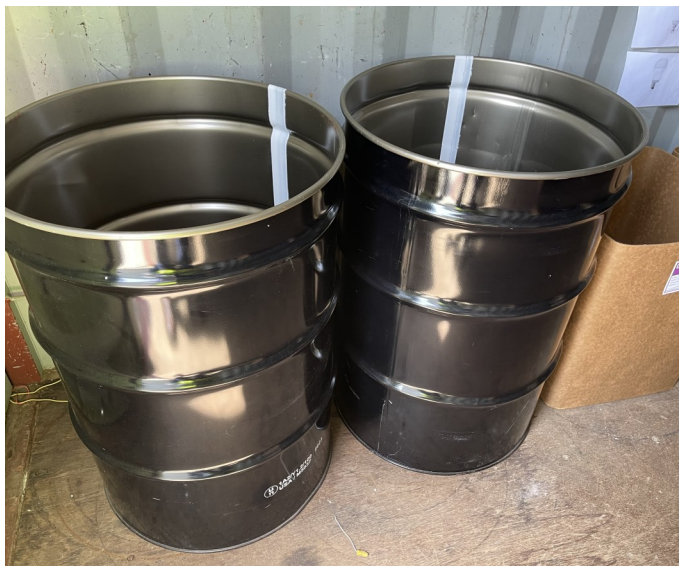
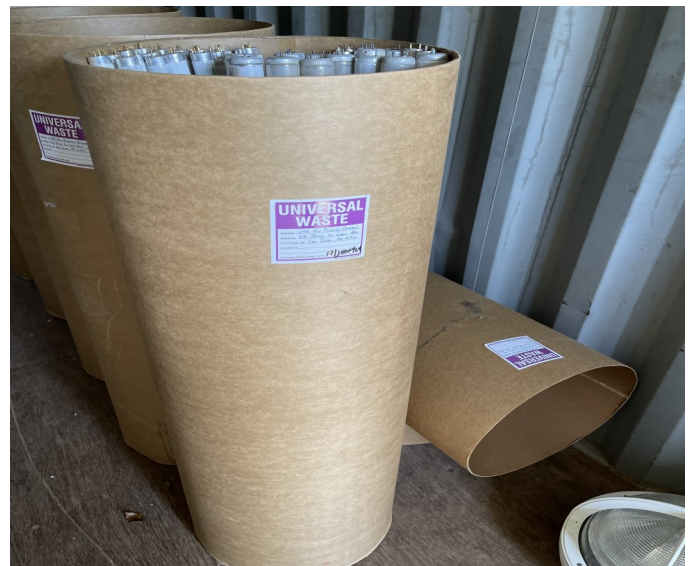
Picture 27 - UPR BUILDINGS AND LAND DEPARTMENT - At the UW area there were two (2) 55-gallon black steel drums without lids (open) containing “Ballast” which were removed from aluminum frames. None of the drums were clearly labeled with the words, “Universal Waste-Mercury Containing Equipment.”

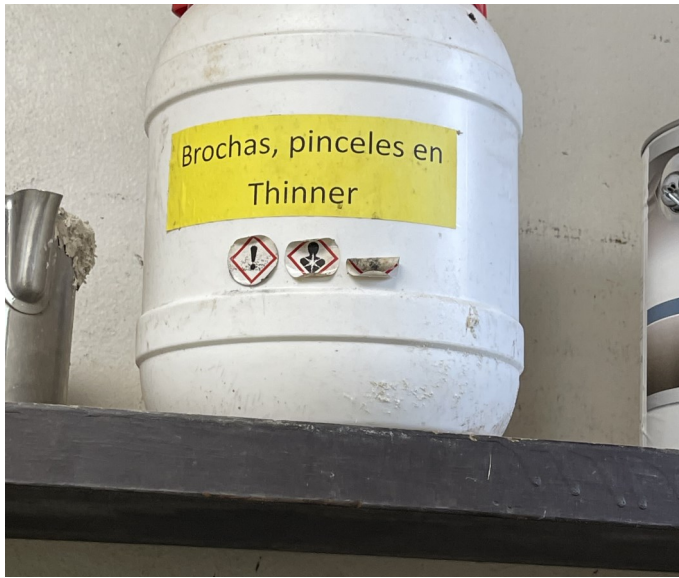
Picture 33 - UPR Welding Iron Shop - At the Welding Shop area, there was one (1) 5-gallon white container with mineral spirits used to clean parts, components, and the residual waste gets collected in the container and later disposed of as "Hazardous Wastes," by OPASO.

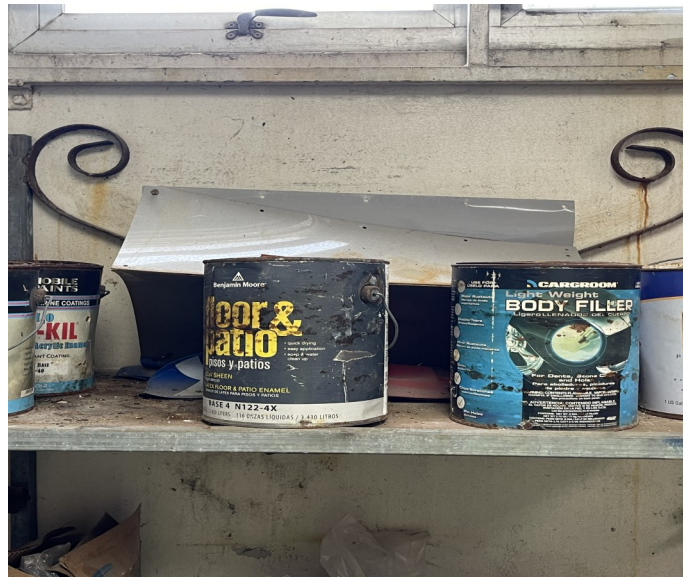
Picture 34 - UPR Welding Iron Shop - At the Welding Shop area, there was one (1) 1-gallon pail with wallboard compound to be discarded as "Hazardous Wastes," and pick up by OPASO officials.

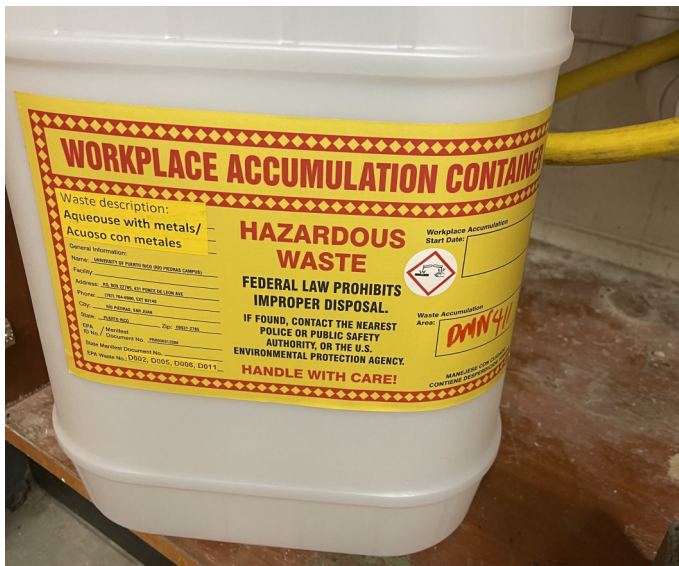
Picture 35 - UPR GENERAL STUDIES - At the Lab DMN-411, there were two (2) 5-gallon white containers with "Heavy Metals Aqueous Solution Wastes," labeled as "Hazardous Waste," and identified with RCRA codes D002, D005 (Barium), D006 (Cadmium), D011 (Silver) and with its pictograms "Corrosive."

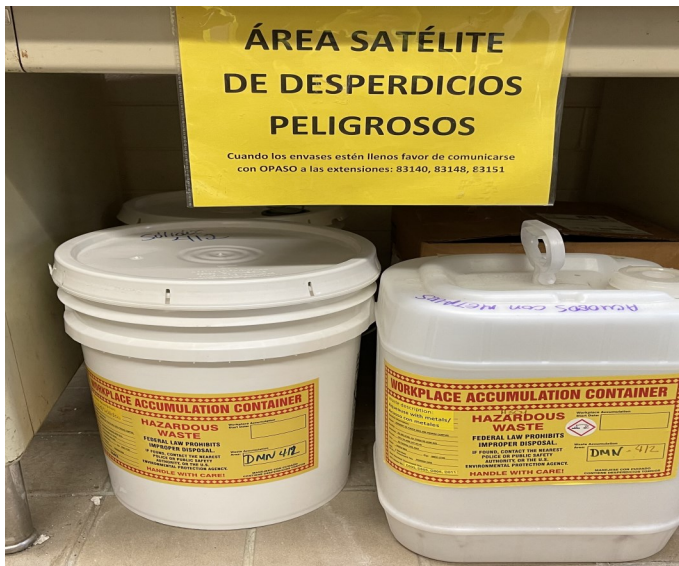
Picture 39 - UPR GENERAL STUDIES - At the Lab DMN-412, there were two (2) 5-gallon white containers with “Heavy Metals Aqueous Solution Wastes,” and “Solid Wastes,” labeled as “Hazardous Waste,” and not identified with its pictograms “Corrosive Liquids,” or “Flammable Solids.”

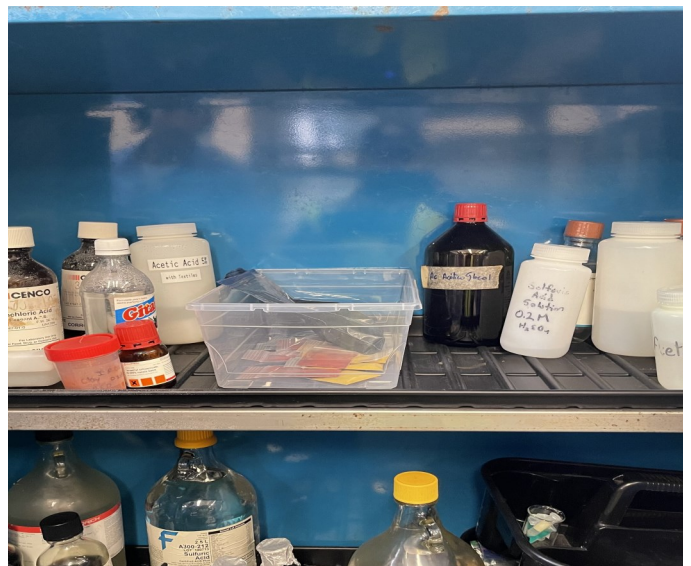
Picture 40 - UPR GENERAL STUDIES - At the Lab DMN-412, chemical reagents were stored in a blue cabinet identified as “Corrosive,” and included hydrochloric acid, acetic acid anhydrous, sulfuric acid, acetic acid glacial, without any safety protocols or compatibility characteristics of the reagents.

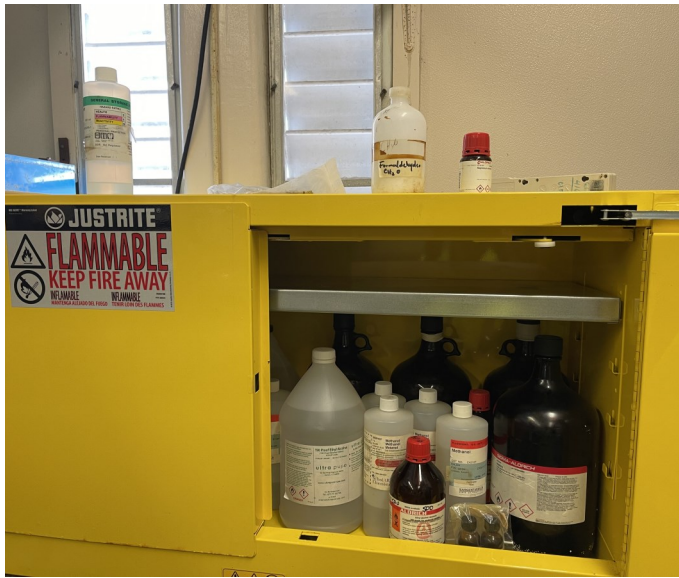
Picture 41 - UPR GENERAL STUDIES - At the Lab DMN-412, chemical reagents were stored in a yellow cabinet identified as “Flammable,” and included Methanol, Ethyl Alcohol, Acetone, Formaldehyde (i.e., a flammable and an explosion hazard) along with other oils and Magnesium Silicone (“Non-Flammable”).

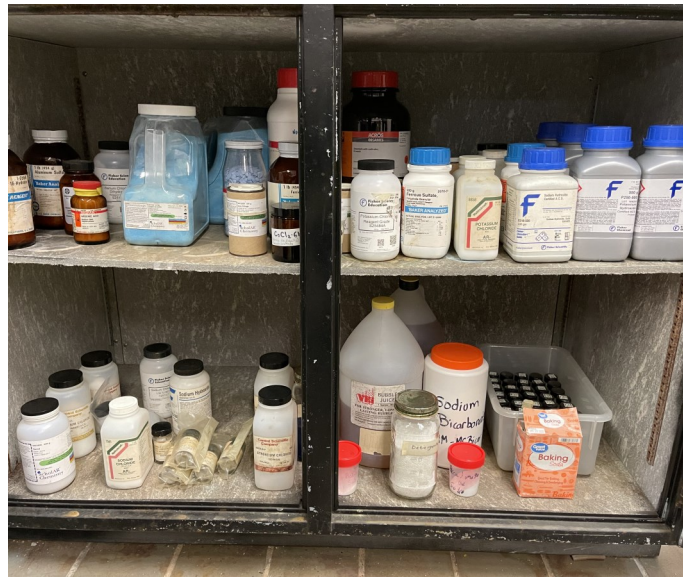
Picture 42 - UPR GENERAL STUDIES - At the Lab DMN-412, chemical reagents were found stored in a black cabinet including strontium choride (toxic and corrosive), arsenic acid (corrosive and very toxic), sodium hydroxide (strong base), potassium chloride (toxic), and ammonium sulfate in an incompatible manner.

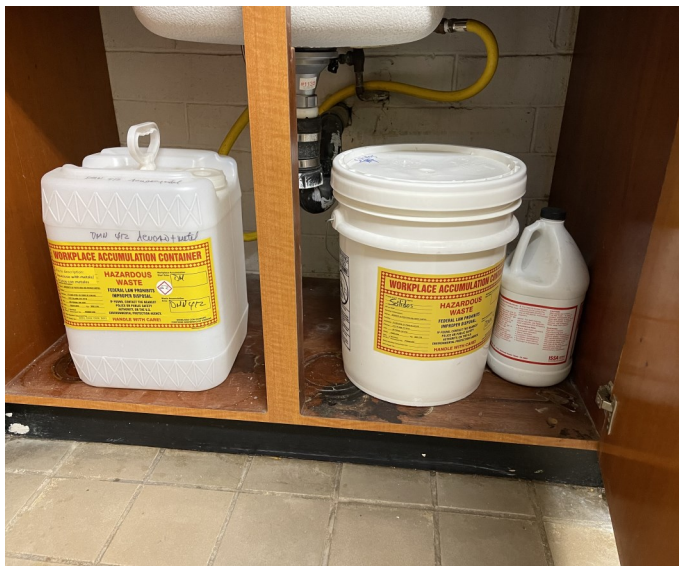
Picture 43 - UPR GENERAL STUDIES - At the Lab DMN-414, there were two (2) 5-gallon white containers with “Heavy Metals Aqueous Solution Wastes,” and “Solid Wastes,” labeled as “Hazardous Waste,” one identified with its pictogram “Corrosive Liquids,” and not the other as “Flammable Solids.”

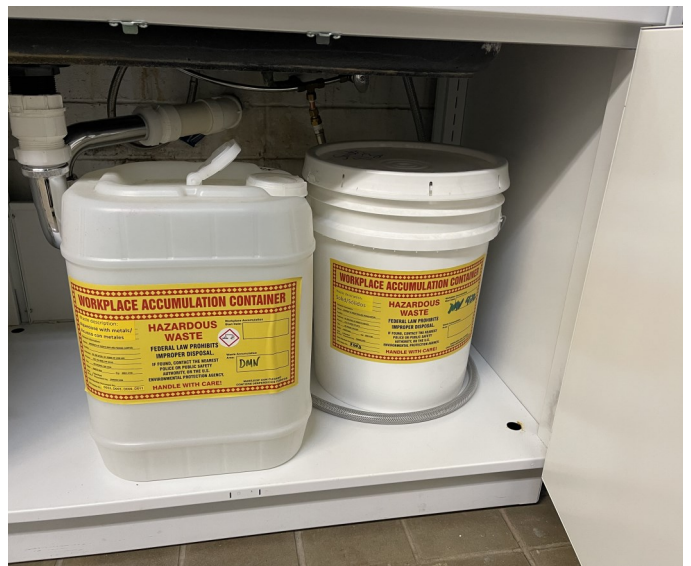
Picture 44 - UPR GENERAL STUDIES - At the Lab DMN-413, there were two (2) 5-gallon white containers with “Heavy Metals Aqueous Solution Wastes,” and “Solid Wastes,” labeled as “Hazardous Waste,” one identified with its pictogram as “Corrosive Liquids,” and not the other as “Flammable Solids.”

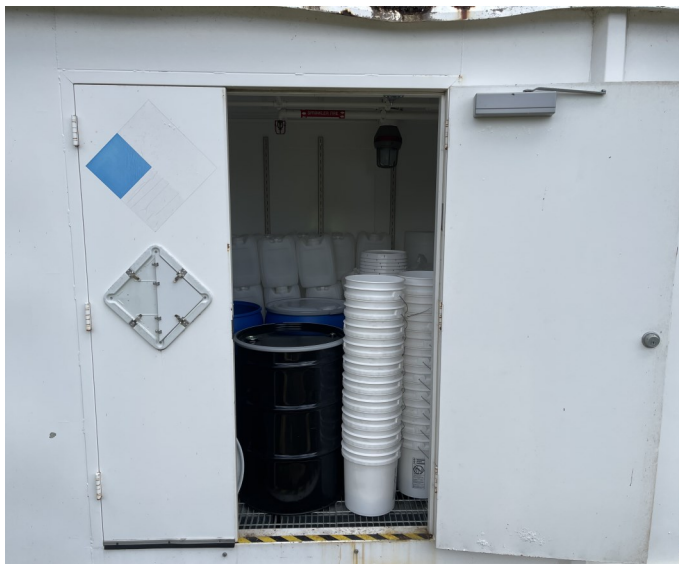
Picture 59 - UPR 90-DAY CENTRAL HAZARDOUS WASTE STORAGE - At the 90-Day Central Storage Area there was not any hazardous waste present in the shed at the time of the inspection and was used to store spill prevention materials and emergency equipment.

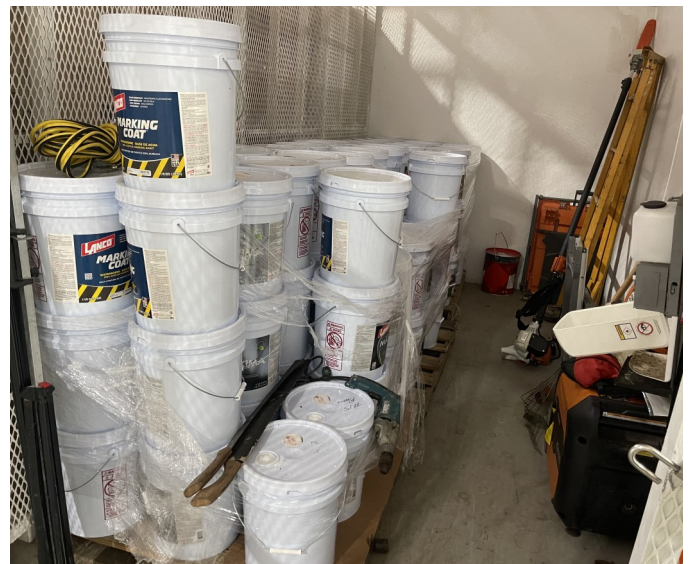
Picture 60 - UPR PAINT WAREHOUSE - At the Paint Warehouse there were approximately fifty-six (56) 5-gallon pails seemed clean, organized, secured and under the control of the supervisor. All paints were well documented, in good conditions, dated and identified as "Lanco – Marking Coat."

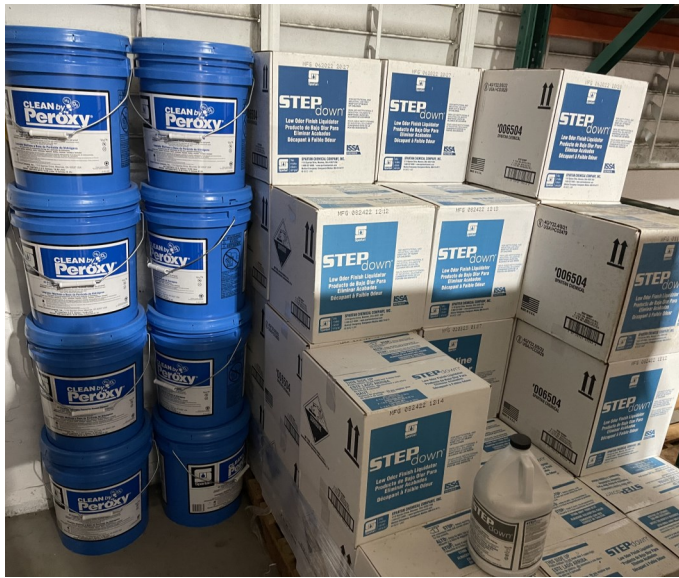
Picture 61 - UPR CLEANING PRODUCTS WAREHOUSE - At the Cleaning Products Warehouse there were many of the cleaning solvent products were concentrated and contained hazardous substances as active ingredients.

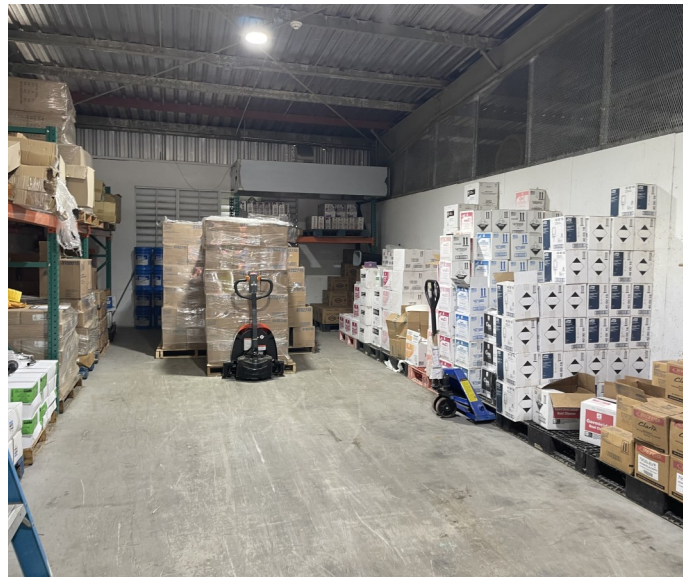
Picture 62 - UPR CLEANING PRODUCTS WAREHOUSE - At the Cleaning Products Warehouse the inventory of products is always in use, and that expired products, if any, are disposed of as hazardous waste with OPASO such as peroxy (concentrated), DMQ Dam Mop Neutral (concentrated) among others.

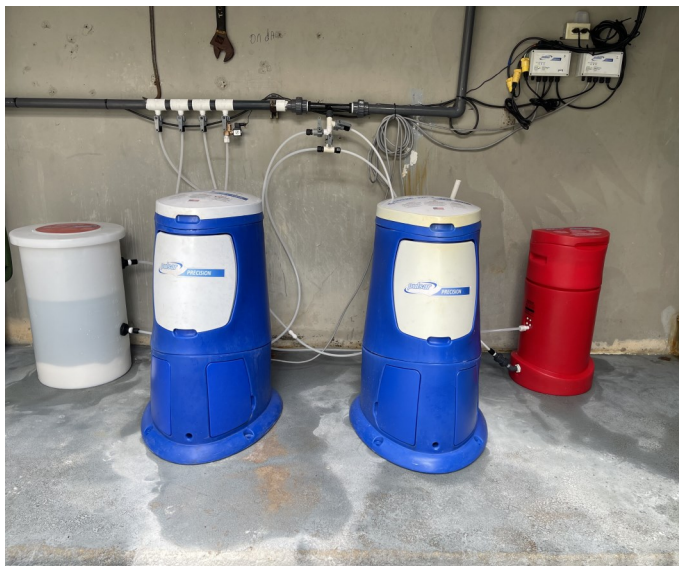
Picture 63 - UPR SWIMMING POOL AREA - At the Swimming Pool Area no chlorine gas is used at the at the swimming pool area instead all chlorine treatment is based on solid dosage of Sodium Chloride (NaCl) by a Pulsar 4 System.

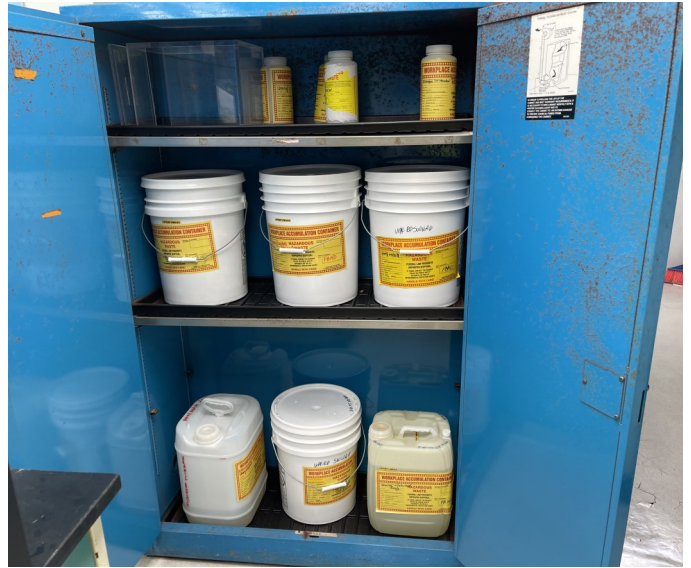
Picture 66 - UPR BIOSENSOR RESEARCH FOR HEALTH LABORATORY - At the Lab FB-140, there were Six (6) 5-gallon white containers containing radioactive waste of "Uranyl Acetate," being stored inside a blue cabinet labeled with the words "Hazardous Waste," and not identified with RCRA codes nor its pictograms.

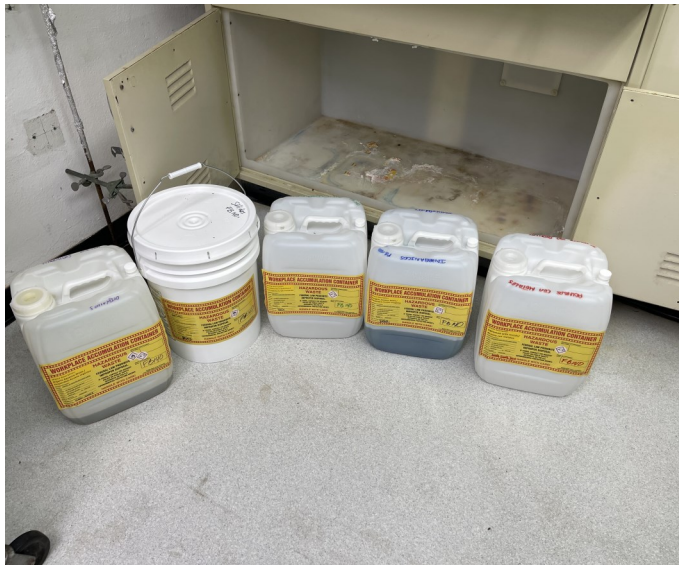
Picture 67 - UPR BIOSENSOR RESEARCH FOR HEALTH LABORATORY - At the Lab FB-140, there were another Satellite Accumulation Area (SAA) with four (4) 5-gallon containers inside a cabinet labelled as "Organic Aqueous Wastes," "Inorganic Aqueous Wastes," "Solid Wastes," and "Neutralization Solution Wastes."

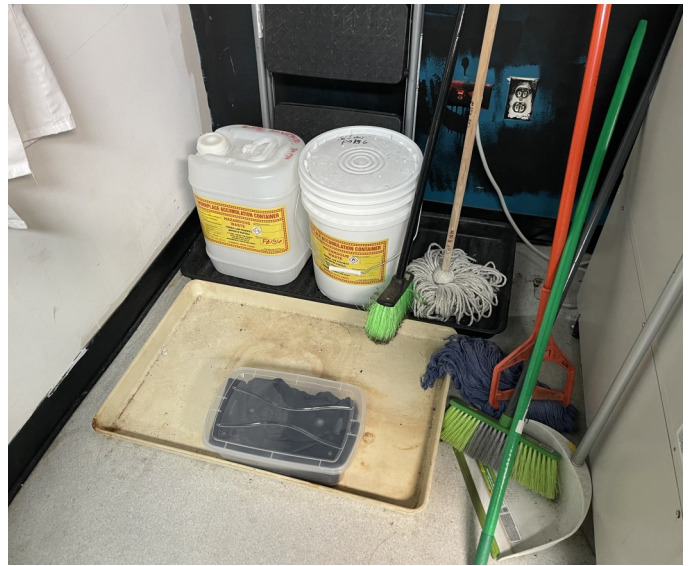
Picture 68 - UPR CELLULAR CULTURE VIROLOGY LABORATORY - At the Lab FB-136, there were two (2) 5-gallon containers with "Solid Waste" and "Heavy Metals Aqueous Solution Wastes," labeled as "Hazardous Waste," identified with RCRA codes and its hazard communication pictograms.

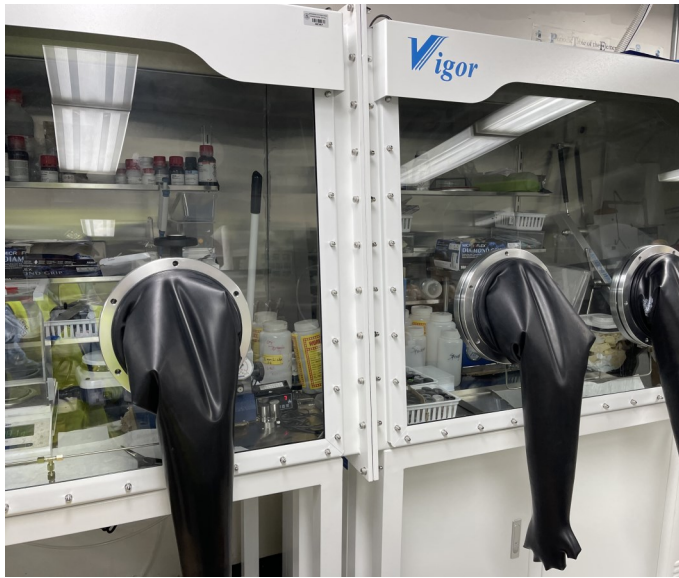
Picture 69 - UPR ELECTROCHEMISTRY RESEARCH LABORATORY - At the Lab FB-101-A, there were four (4) 1-Liter bottles with "Lithium Wastes," inside a pressurized chamber labeled as "Hazardous Waste," not identified with RCRA codes nor its hazard communication pictograms.

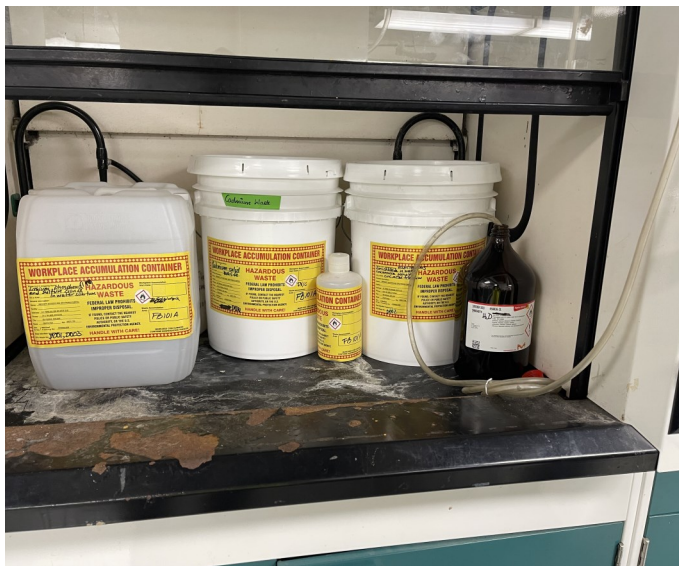
Picture 71 - UPR UPR ELECTROCHEMISTRY RESEARCH LABORATORY - At the Lab FB-101-A, there were three (3) 5-gallon containers with "Zinc Chloride Electrodes," "Cadmium Solid Wastes", "Lithium Phosphate and Sulfured Wastes" and one (1) 1-Liter with "Syringes," contaminated with alcohol as "Hazardous Wastes."

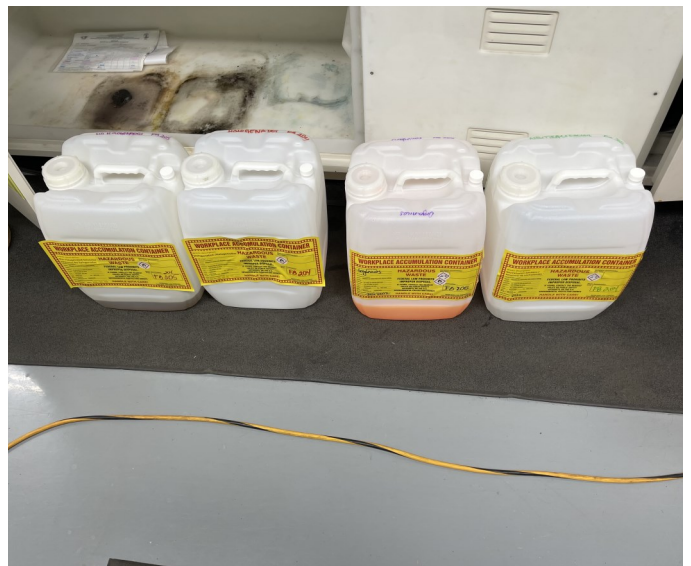
Picture 72 - UPR MATERIALS SCIENCE RESEARCH LABORATORY - At the Lab FB-205, there were four (4) 5-gallon containers with "Organic Solvents," "Non-Halogenated", "Halogenated Wastes," "Neutralization Waste," all labeled as Hazardous Wastes, RCRA codes and hazard communication pictograms.

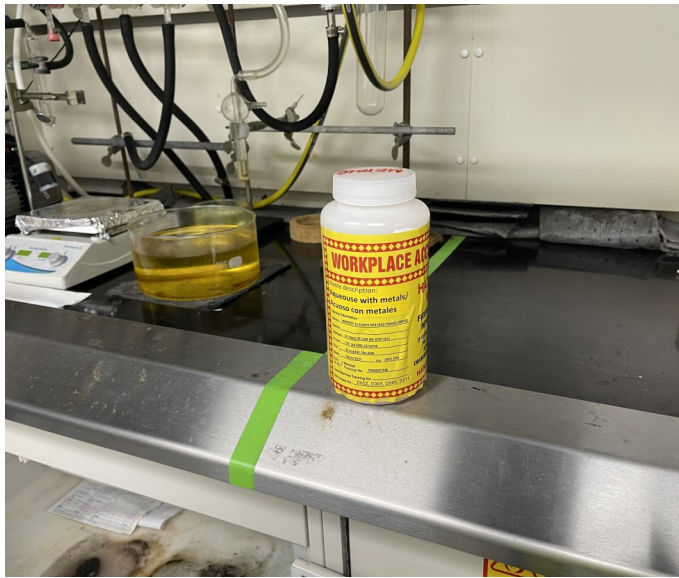
Picture 73 - UPR MATERIALS SCIENCE RESEARCH LABORATORY -
 At the Lab FB-205, there was one (1) 1-liter white container with "Heavy Metals Aqueous Solution Wastes," labeled with the words "Hazardous Waste," and identified with RCRA codes "D002, D005, D006, D011 and with no pictogram.

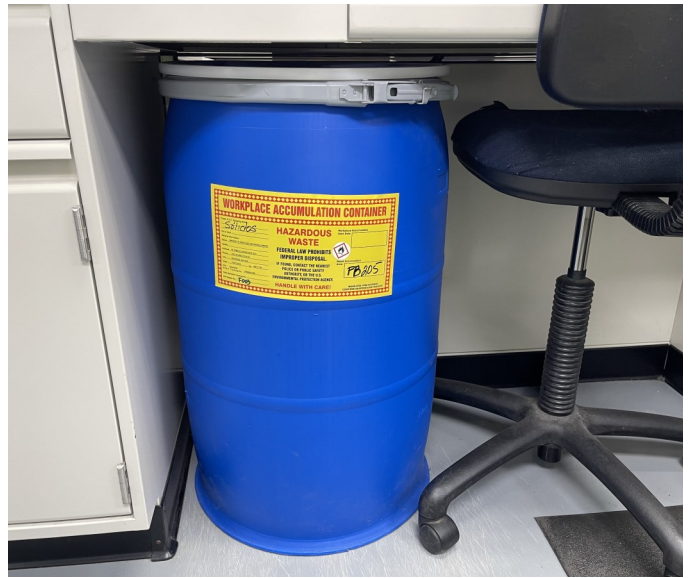
Picture 74 - UPR MATERIALS SCIENCE RESEARCH LABORATORY -
 At the Lab FB-205, there was one (1) 55-gallon blue drum with "Solid Wastes" contaminated with laboratory silica trash and desiccant" labeled with the words "Hazardous Waste," identified with RCRA "F003" and pictogram "Flammable Solids."

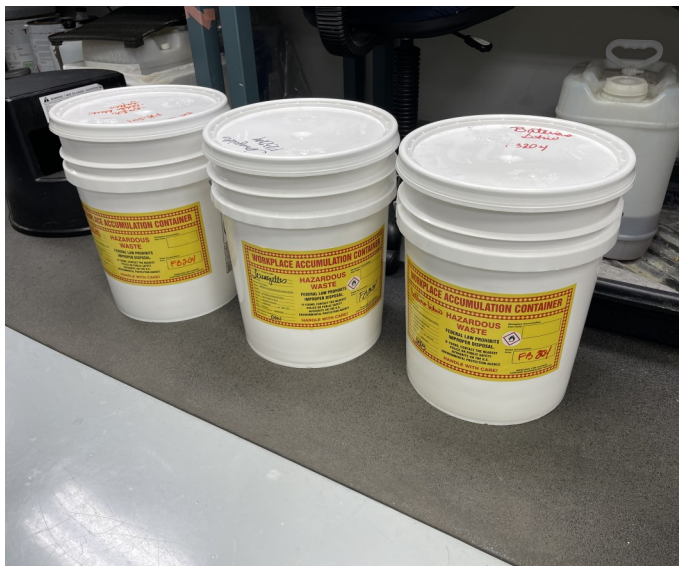
Picture 75 - UPR MATERIALS SCIENCE RESEARCH LABORATORY -
 At the Lab FB-204, there were three (3) 5-gallon white containers with "Lithium Batteries Wastes," "Syringes," and "Carbon Black Graphite," all labeled as "Hazardous Waste," identified with RCRA codes and one with no pictogram.

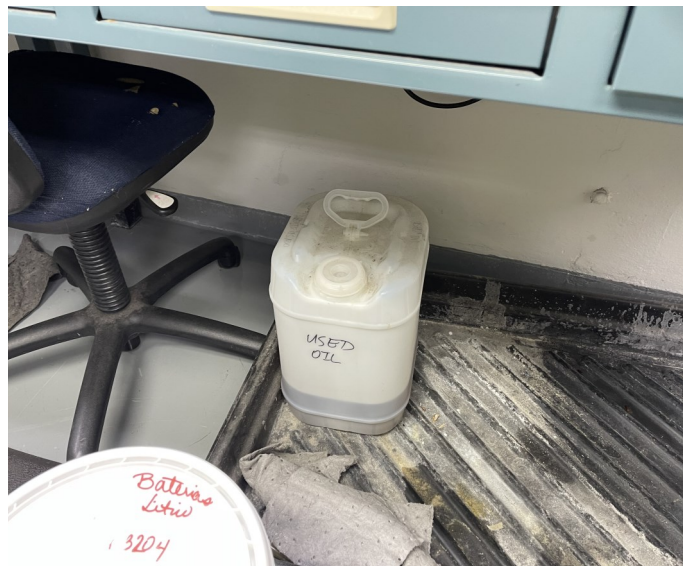
Picture 76 - UPR MATERIALS SCIENCE RESEARCH LABORATORY -
 At the Lab FB-204, there was one (1) gallon white container containing "Used Oil," below a bench table and labeled with the words "Used Oil," as required by RCRA regulations.

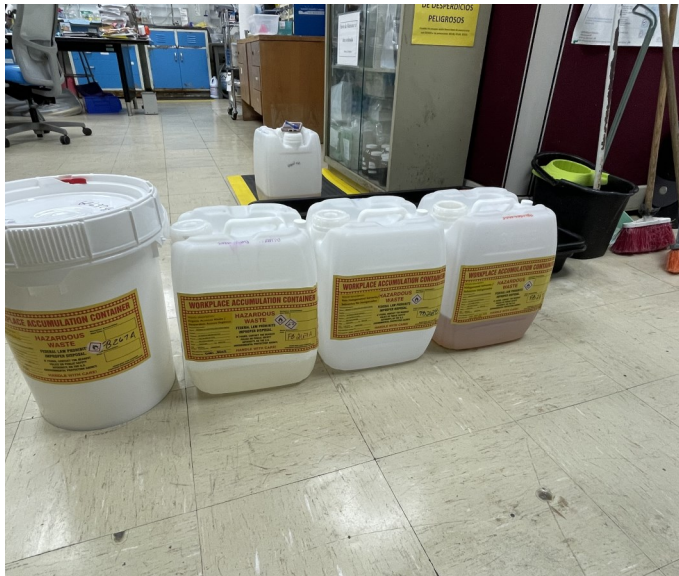
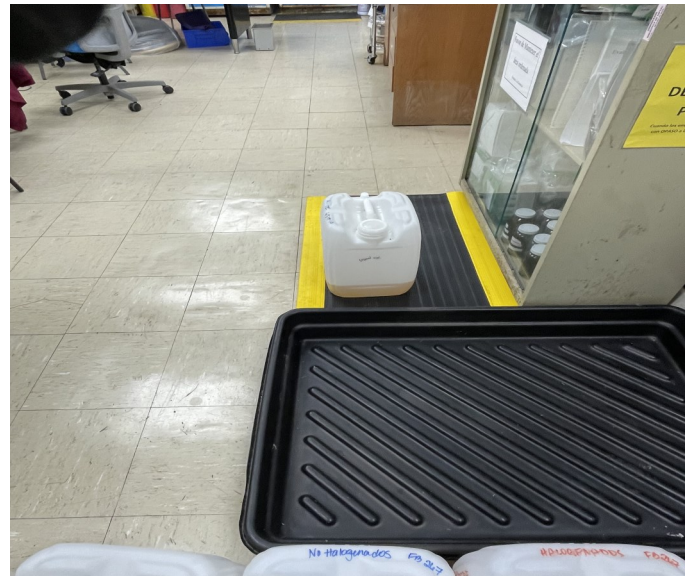
Picture 77 - UPR MATERIALS CHARACTERIZATION CENTER - At the Lab FB-267-A, there were four (4) 5-gallon containers with “Organic Solvents,” “Non-Halogenated”, “Halogenated Wastes,” “Solid Waste,” all labeled as Hazardous Wastes, RCRA codes and hazard communication pictograms.

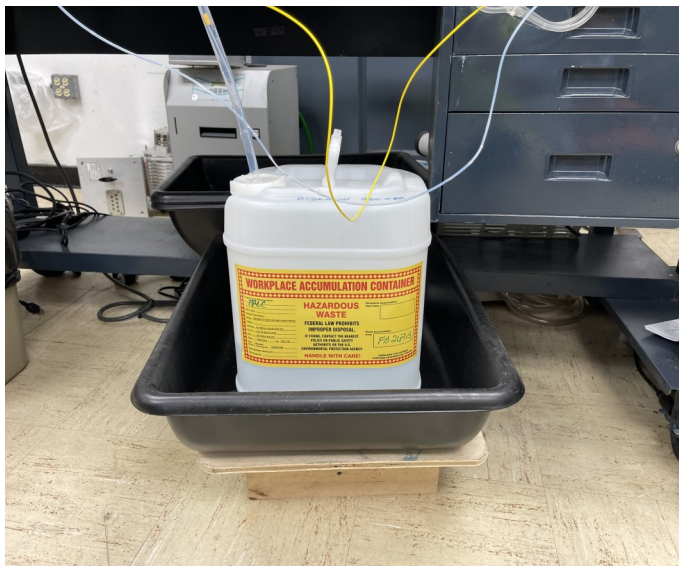
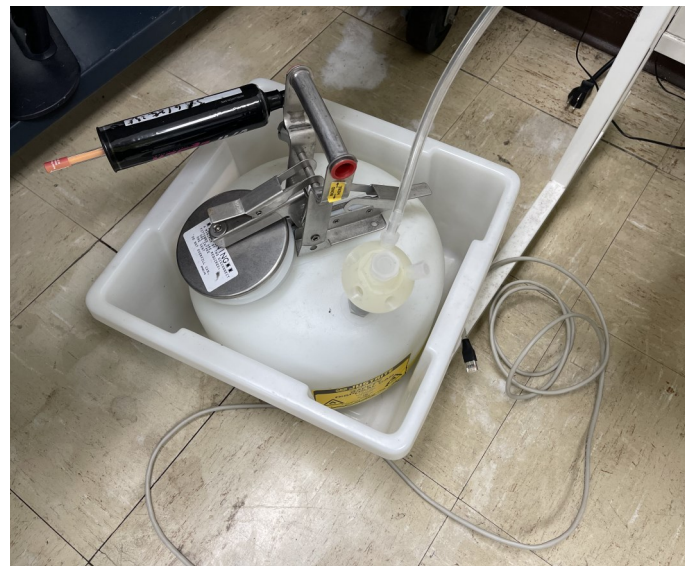
Picture 79 - UPR MATERIALS CHARACTERIZATION CENTER - At the Lab FB-267-A, there was one (1) 5-gallon white container with mobile phase “HPLC” (ACN/Water/ETOH 90/10) connected to HPLC labeled as “Hazardous Waste,” not identified with RCRA code nor with its hazard pictogram “Flammable Liquids.”

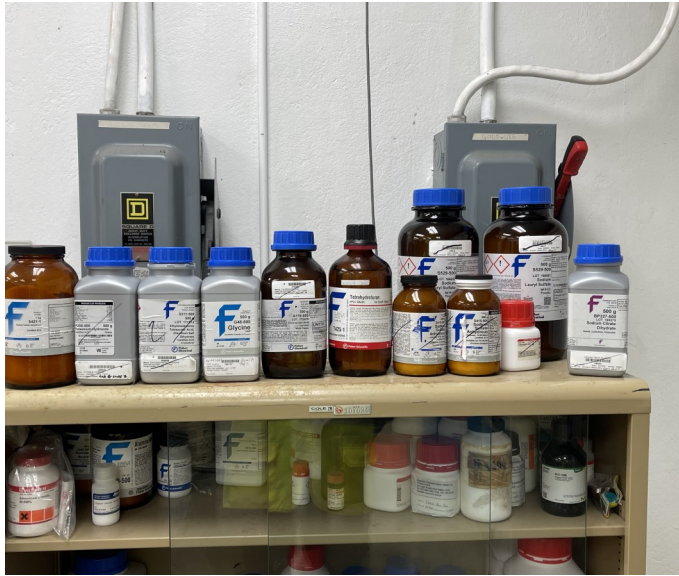
Picture 81 - UPR MATERIALS CHARACTERIZATION CENTER - At the Lab FB-267-A, numerous expired chemicals (1999), discarded, contaminated, unused chemical reagents, deteriorated and stored for a long time in shelves without any physical means to protect each other from incompatibility characteristics.

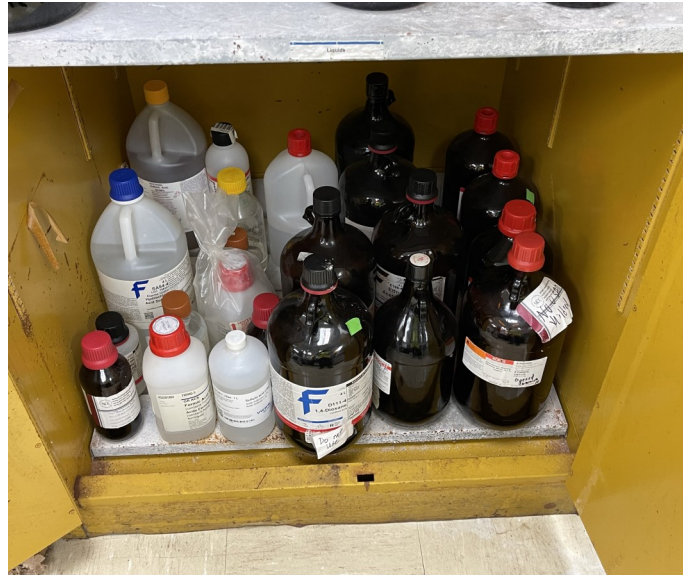
Picture 82 - UPR MATERIALS CHARACTERIZATION CENTER - At the Lab FB-267-A, there was not hazardous waste determination being performed on abandoned, expired, not in use, discarded hazardous chemical waste inventory before its final disposal nor have been managed under the Flinn Lab Management Plan.

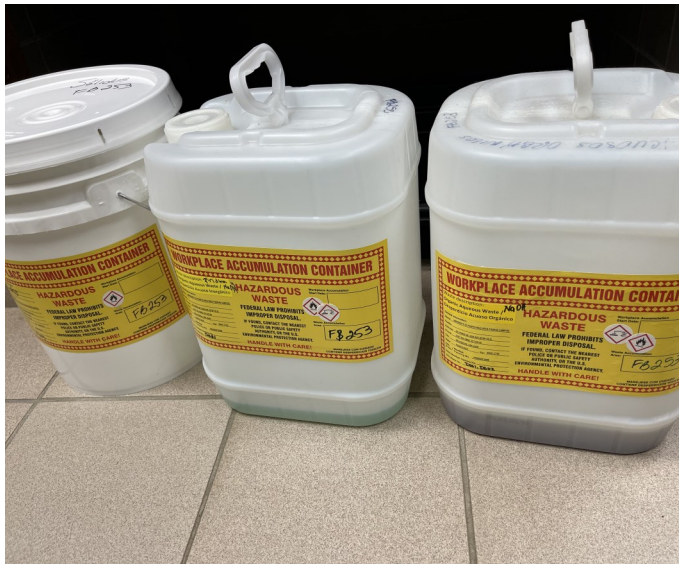
Picture 83 - UPR ECOLOGICAL RESEARCH LABORATORY - At the Lab FB-253, there were three (3) 5-gallon containers with "Organic Solvents," "Inorganic Solvents", and "Solid Waste," all labeled as Hazardous Wastes, RCRA codes and hazard communication pictograms.
