**US Environmental Protection Agency – Region 2
 Caribbean Environmental Protection Division
 Response and Remediation Branch**

**Resource Conservation and Recovery Act (RCRA)
 Compliance Evaluation Inspection**

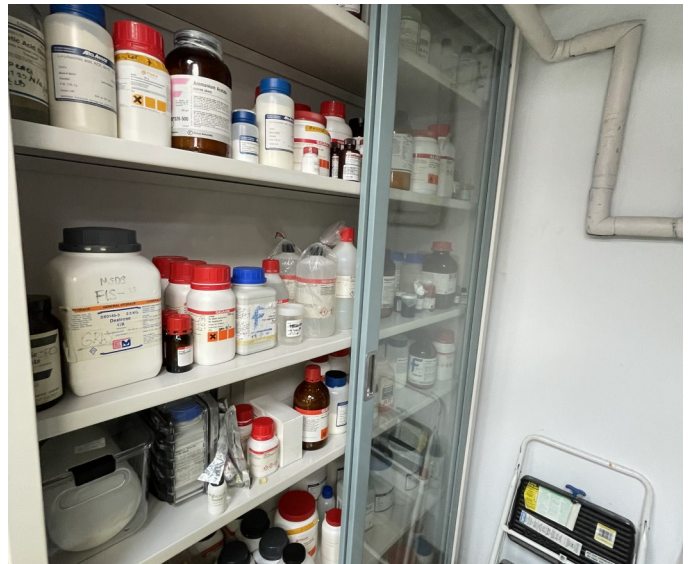
Picture 84 - UPR ECOLOGICAL RESEARCH LABORATORY - At the Lab FB-253, chemical reagents were found stored in a blue cabinet including formaldehyde (toxic and flammable), hydrogen peroxide (oxidizer), sodium hydroxide (strong base), pyridine (toxic), and ammonium acetate in an incompatible manner.
