## **RCRA Inspection Report**

Detyens Shipyard  
1670 Drydock Avenue  
North Charleston, South Carolina 29405  
Charleston County

April 8, 2024, at 9:30 a.m. EDT

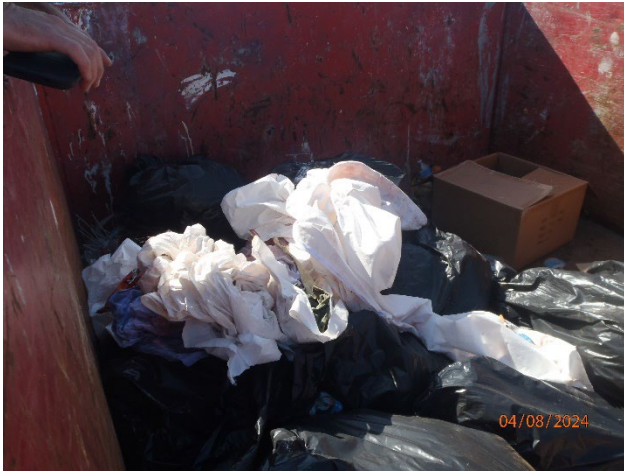
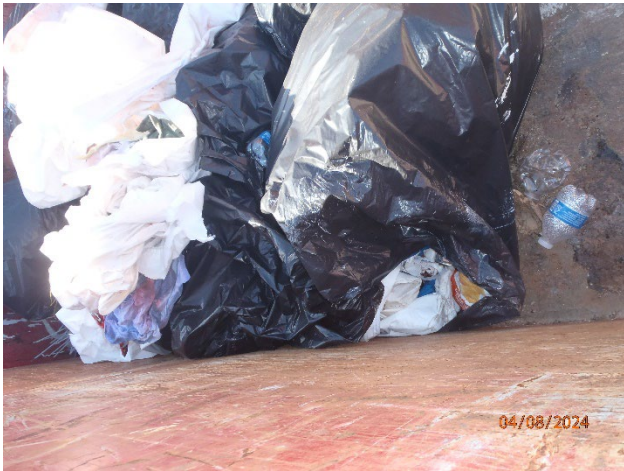
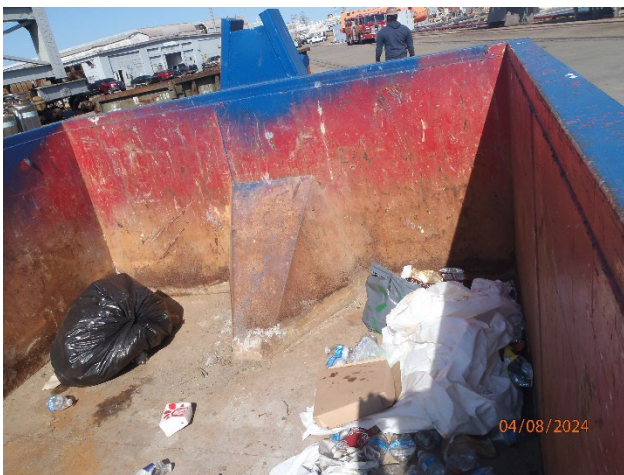
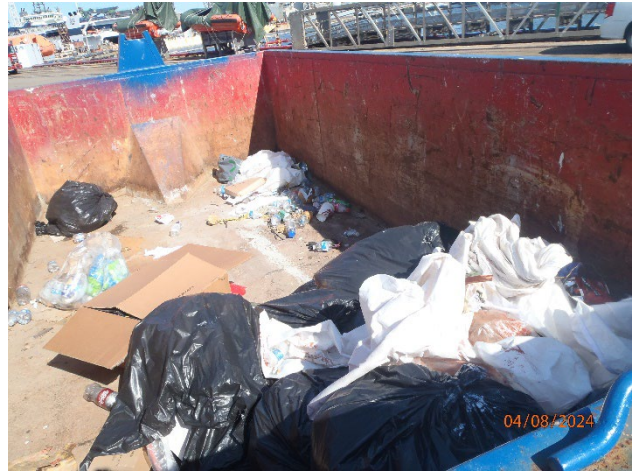
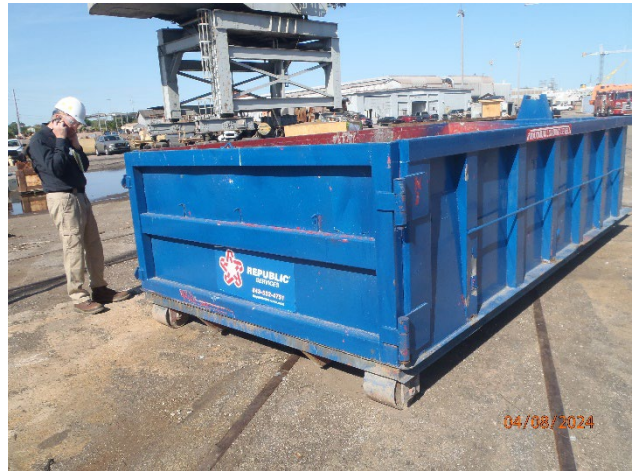
The USNS Leroy Grumman was undergoing repairs, stripping, and repainting. Mr. Marshall and Mr. Mooney escorted the inspectors to the end of the dock, where the hazardous waste containers would be stored. No hazardous waste containers were generated at that time. However, as the inspectors were leaving the dock, they observed a 20-cubic yard Republic roll-off dumpster across from the USNS Leroy Grumman. The inspectors could smell solvent from the roll-off and thus examined inside the roll-off. The inspectors observed black trash bags of discarded rags, Tyvek, and personal protective equipment (PPE) mixed with trash in the roll-off (Pictures 1-5). When asked, Mr. Marshall confirmed that materials generated from painting operations were typically collected and disposed of as hazardous waste. Thus, Detyens failed to make an accurate hazardous waste determination on the material in the roll-off.

Picture 1 – Near USNS Leroy Grumman 20-cubic yard roll-off with discarded HW PPE

Picture 4 – Near USNS Leroy Grumman 20-cubic yard roll-off with discarded HW PPE

Picture 2 – Near USNS Leroy Grumman 20-cubic yard roll-off with discarded HW PPE

Picture 5 – USNS Leroy Grumman 20-cubic yard roll-off with discarded HW PPE

Picture 3 – Near USNS Leroy Grumman 20-cubic yard roll-off with discarded HW PPE

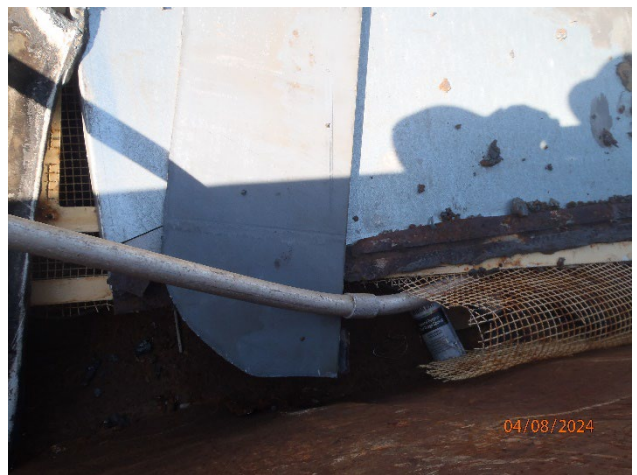
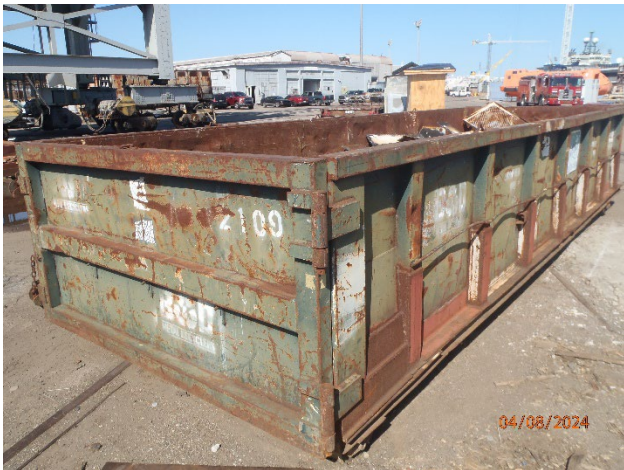
Less than 50 feet away, was a green metal recycling roll-off with a discarded aerosol can inside (Pictures 6-7). Thus, Detyens failed to make an accurate hazardous waste determination on the material in the roll-off.

Picture 6 – Near USNS Leroy Grumman 20-cubic yard recycling roll-off with discarded aerosol can

Picture 7 – Near USNS Leroy Grumman 20-cubic yard recycling roll-off with discarded aerosol can

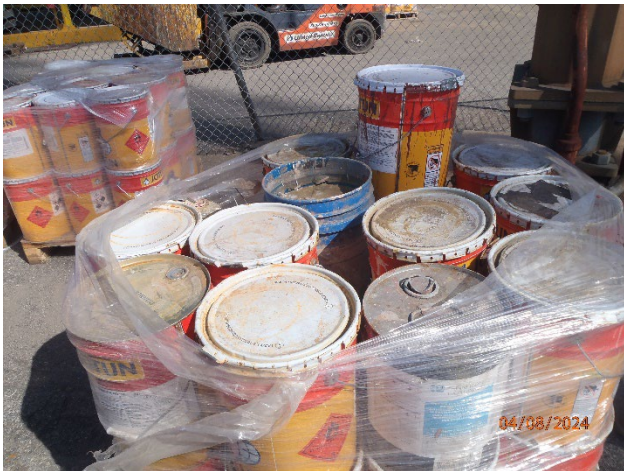
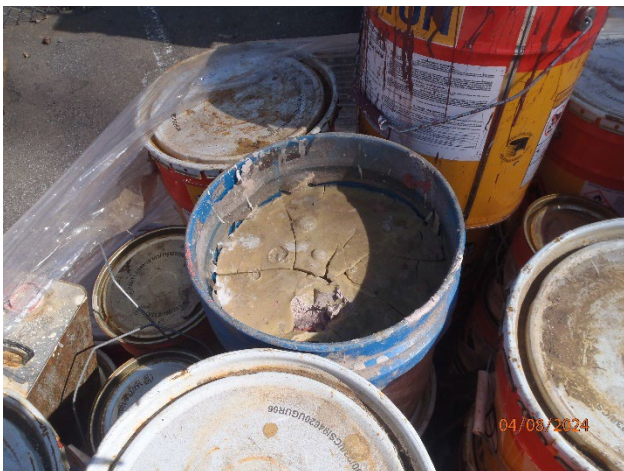
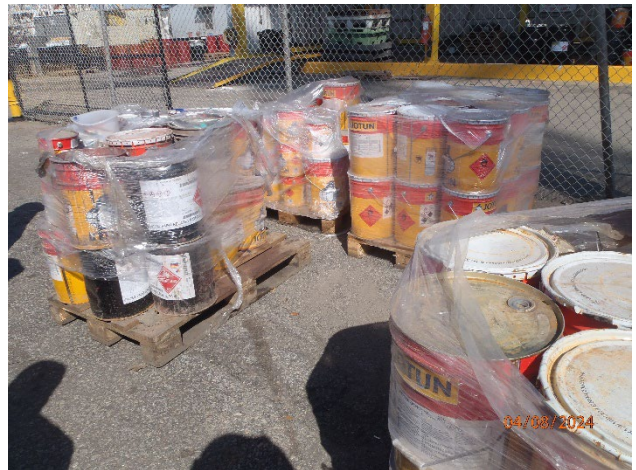
The less than 90-day CAA was located at Pier F on the north side of Dry Dock 5. Outside the gated CAA were five wrapped pallets of discarded paint cans waiting to be drained and consolidated (Pictures 8-10). The palletized containers were observed without labels or accumulation start dates. On one pallet, was a 5-gallon container of dried epoxy paint that was not closed, not labeled, and not dated. The inspectors were told that the contents would be placed into 55-gallon containers.

Picture 10 – Dry Dock 5 Pier F 90-Day CAA used paint cans

Picture 8 – Dry Dock 5 Pier F 90-Day CAA used paint cans

Picture 9 – Dry Dock 5 Pier F 90-Day CAA dry paint sludge

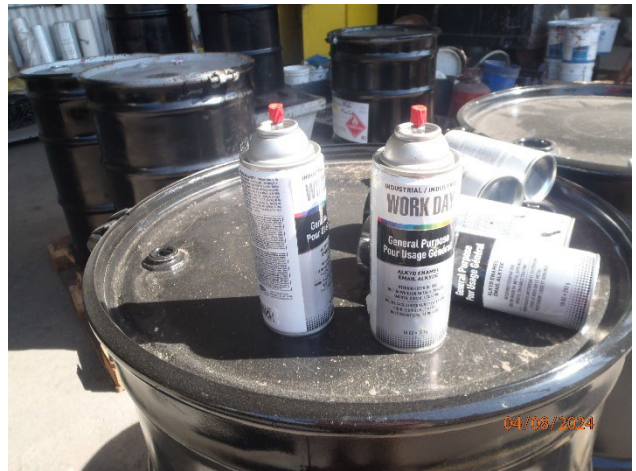
- Aerosol cans used to mark the hazardous waste containers (Picture 11)
- Three pallets and two boxes of spent lead acid batteries that were not labeled, and the facility was not able to demonstrate the length of time that two of these batteries had been accumulating (Pictures 12-13)

Picture 11 – Dry Dock 5 Pier F 90-Day CAA spent aerosol cans

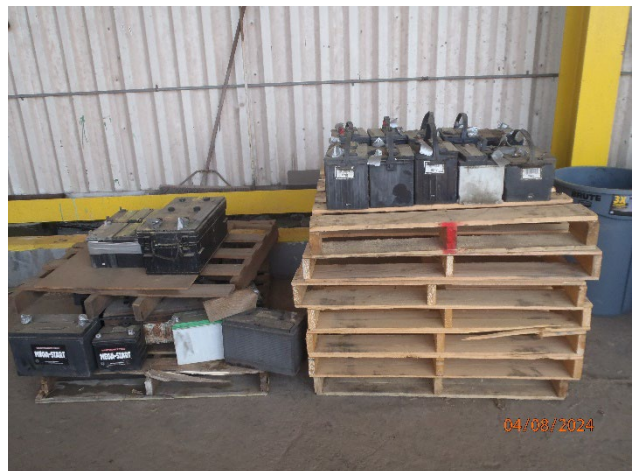
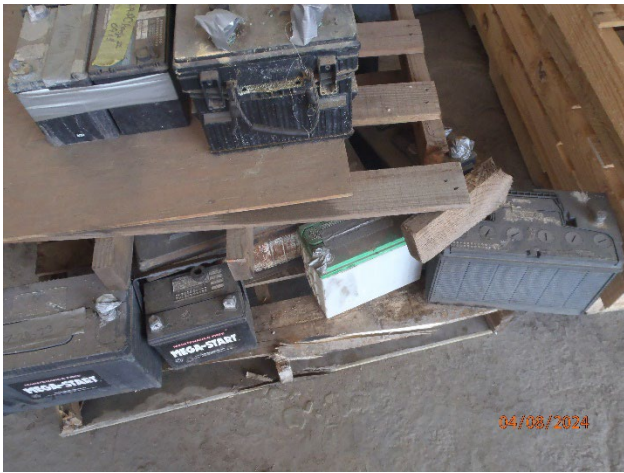
Picture 12 – Dry Dock 5 Pier F 90-Day CAA spent lead acid batteries

Picture 13 – Dry Dock 5 Pier F 90-Day CAA spent lead acid batteries

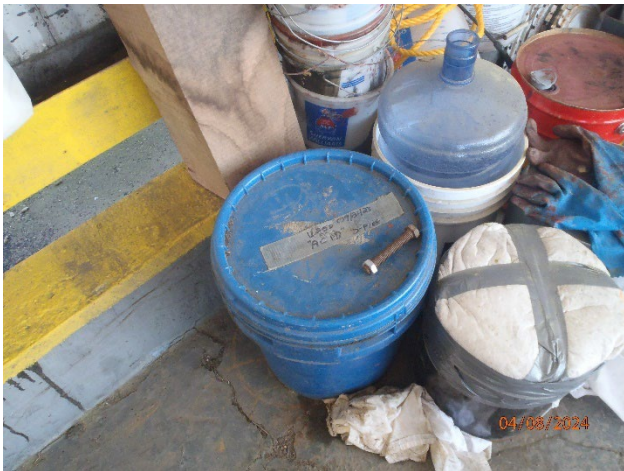
Picture 14 – Dry Dock 5 Pier F 90-Day CAA 5-gal container of spent acid

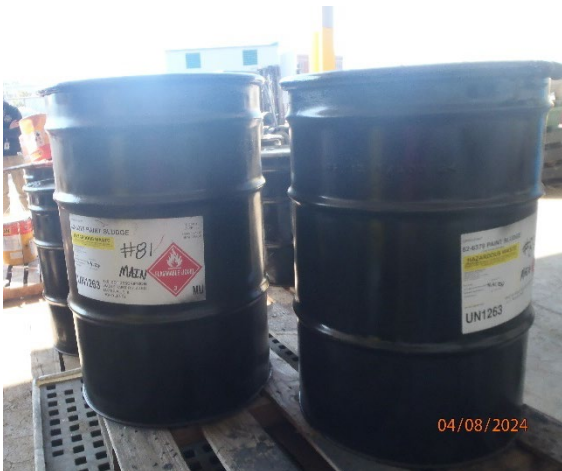
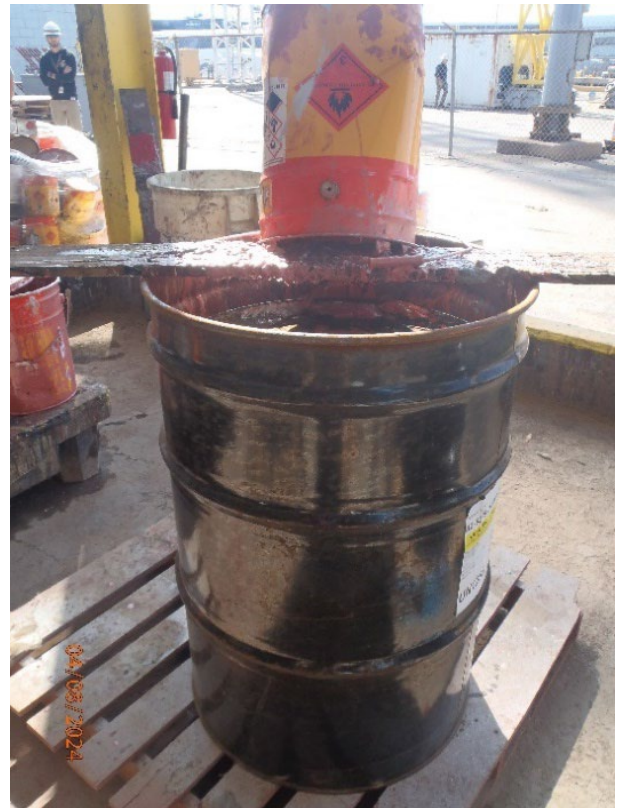
Picture 15 – Dry Dock 5 Pier F 90-Day CAA paint sludge

Picture 16 – Dry Dock 5 Pier F 90-Day CAA paint sludge

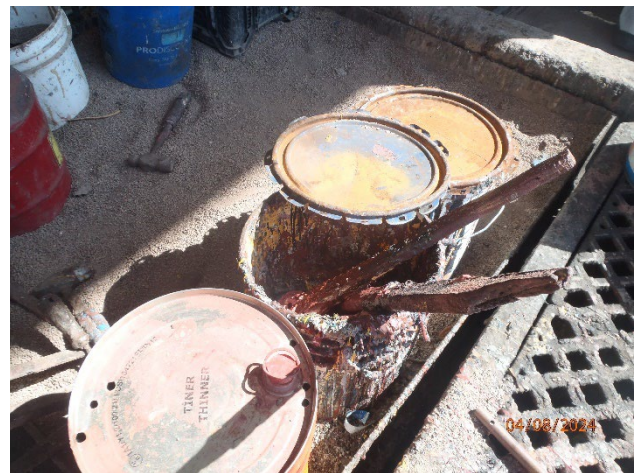
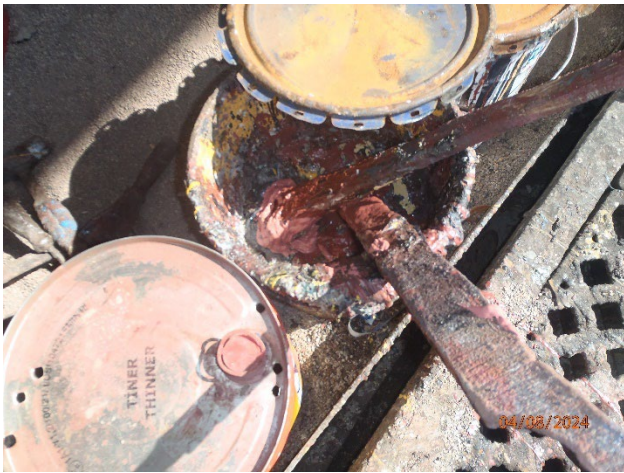
The observed containers held more than one inch of paint residue and were therefore not RCRA empty (Pictures 17-18). The content of the five pallets of paint cans staged outside the CAA gate were marked as Non-Hazardous and Empty rather than with the words “Hazardous Waste” (Picture 19). Inside the CAA, Ms. Robin Mazyck, CAA Attendant was adding solvent to the paint residue, stirring it to loosen the paint residue and then pouring the contents into a 55-gallon container. The inspectors stated the non-hazardous labels on the pallets of spent paint cans should be changed to RCRA Empty.

Picture 17 – Dry Dock 5 Pier F 90-Day CAA paint sludge

Picture 18 – Dry Dock 5 Pier F 90-Day CAA paint sludge

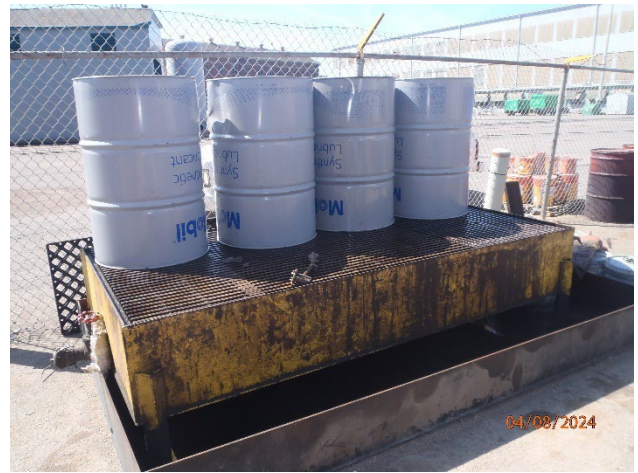
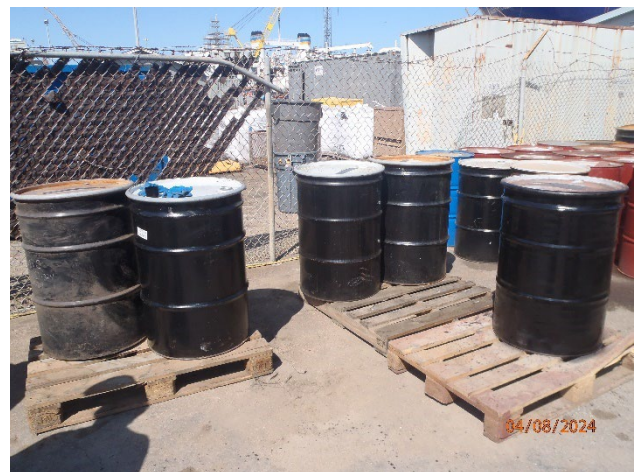
Picture 21 – Dry Dock 5 Pier F 90-Day CAA used oil drain station

Picture 22 – Dry Dock 5 Pier F 90-Day CAA paint sludge and used oil containers

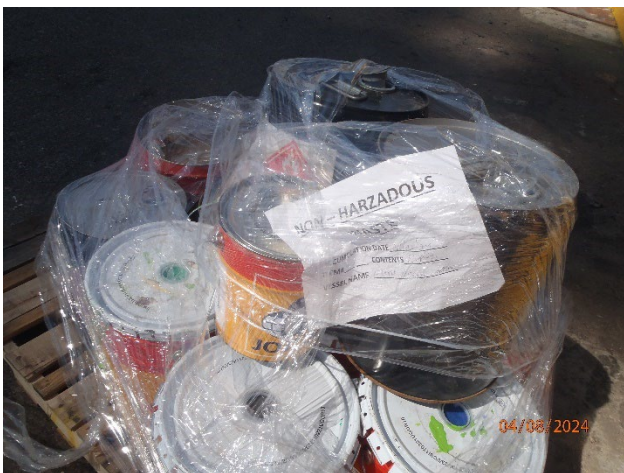
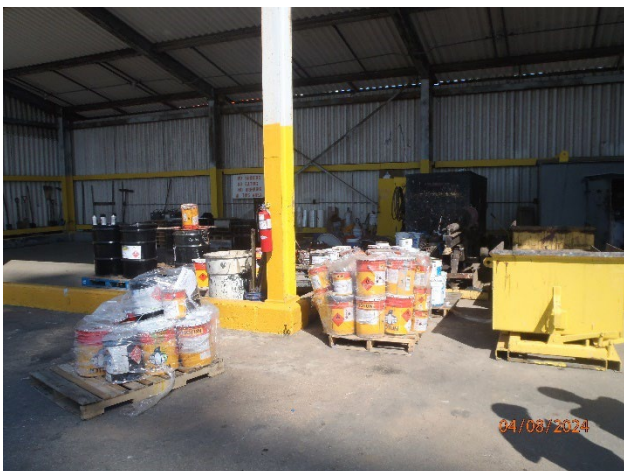
Picture 19 – Dry Dock 5 Pier F 90-Day CAA used paint cans

Picture 20 – Dry Dock 5 Pier F 90-Day CAA

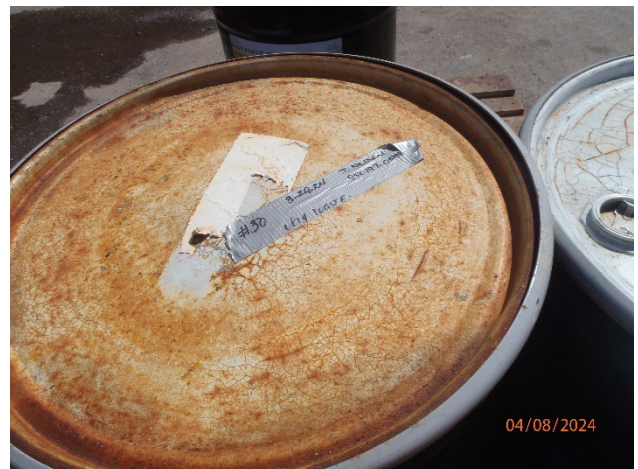
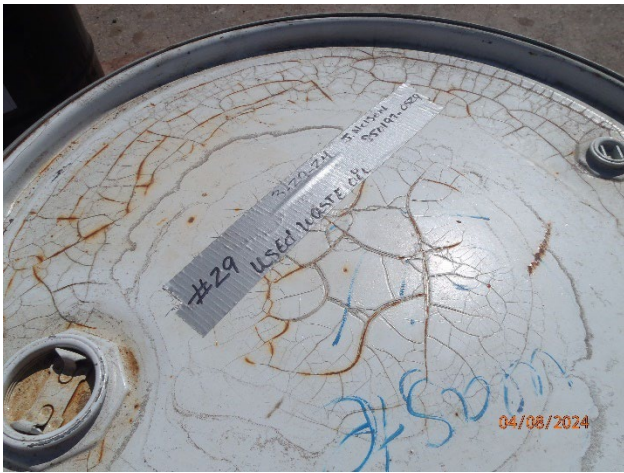
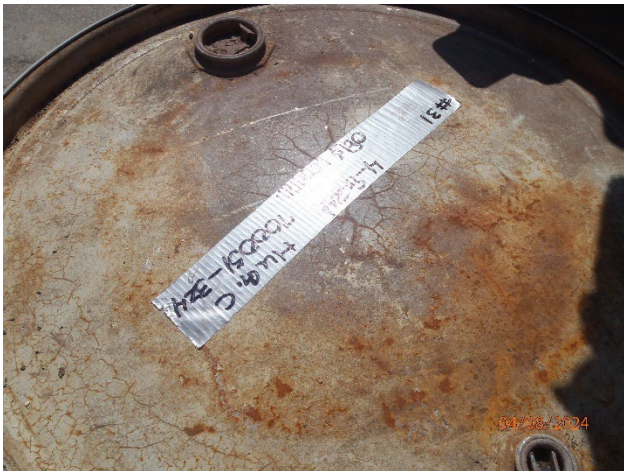
Picture 23 – Dry Dock 5 Pier F 90-Day CAA used oil mislabeled

Picture 24 – Dry Dock 5 Pier F 90-Day CAA used oil mislabeled

Picture 25 – Dry Dock 5 Pier F 90-Day CAA used oil mislabeled

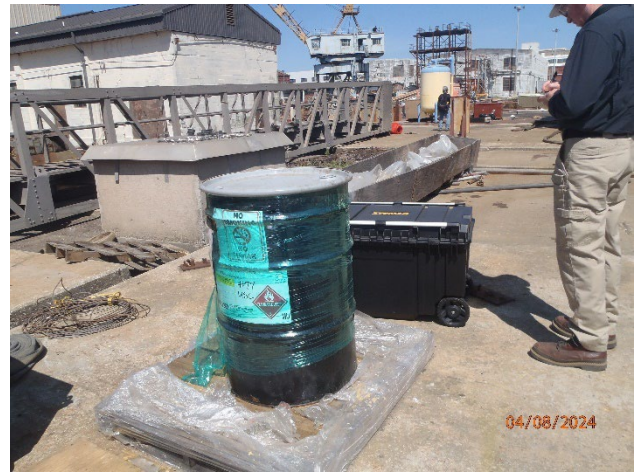
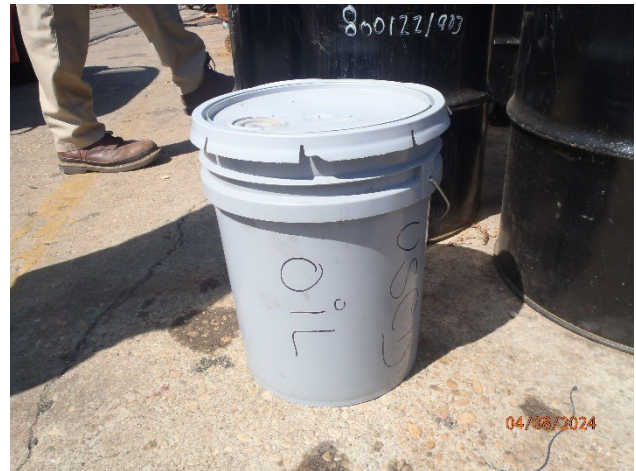
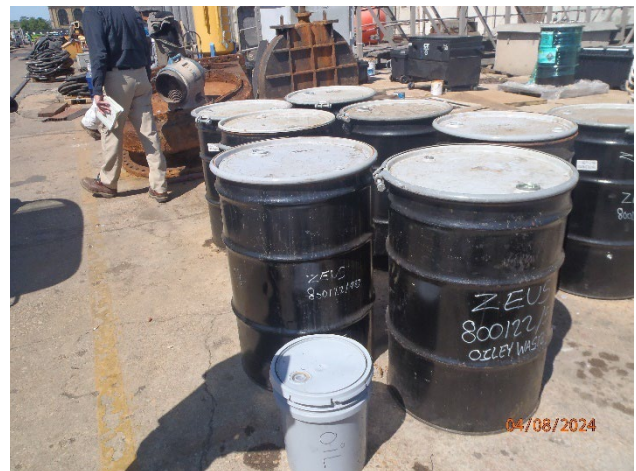
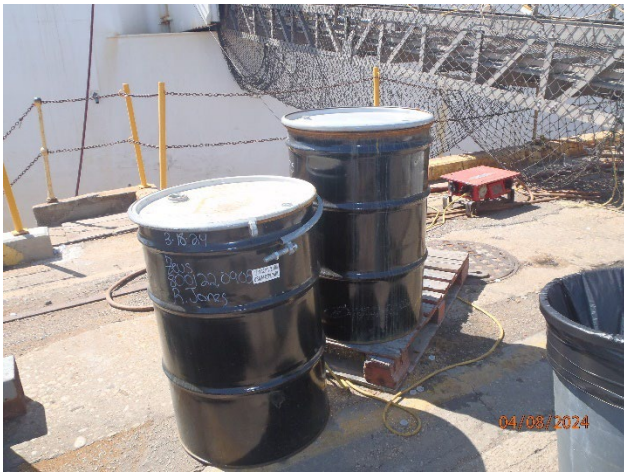
The inspectors observed next to the gangplank of the USNS Zeus a 55-gallon container of paint waste that was closed, labeled, and three-quarters full, six black 55-gallons containers of spent oily filters potentially to be reused, eight empty containers labeled as oily waste, and two 55-gallon containers of machine shop diesel rags that were not labeled, full, and the lid ring did not fit (Pictures 27-30).

Picture 27 – Dry Dock 2 USN Zeus paint waste SAA

Picture 28 – Dry Dock 2 USN Zeus used oil container

Picture 29 – Dry Dock 2 USN Zeus spent oil filters

Picture 30 – Dry Dock 2 USN Zeus spent oil filters

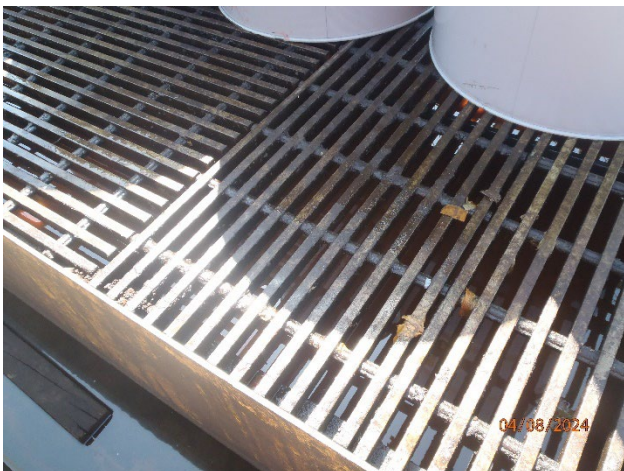
Picture 26 – Dry Dock 5 Pier F 90-Day CAA used oil drain station grate full

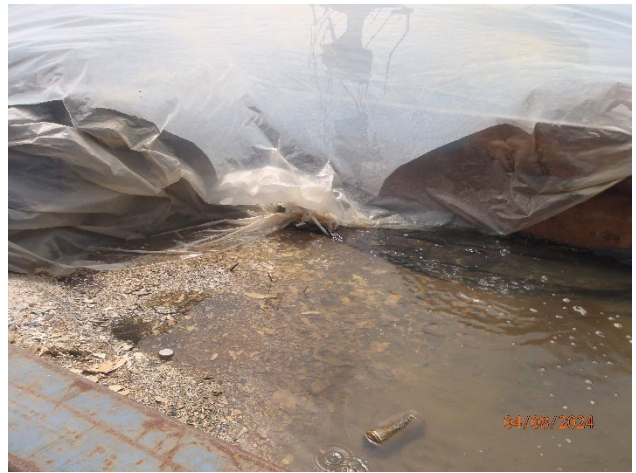
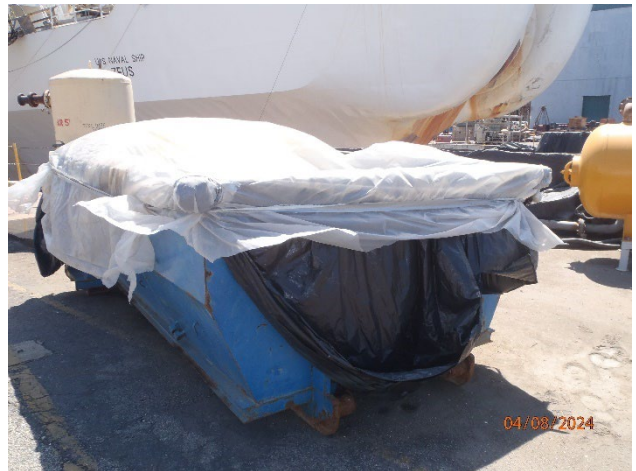
Picture 33 – Dry Dock 2 20-cubic yard roll-off of paint chips

Picture 34 – Dry Dock 2 20-cubic yard roll-off of paint chips

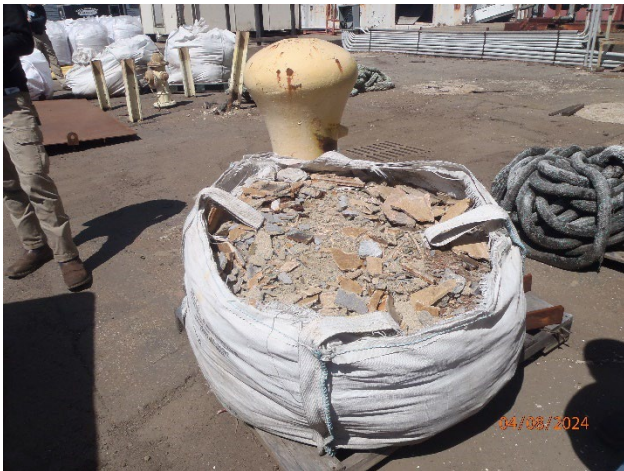
Picture 31 – Dry Dock 2 discarded ship flooring

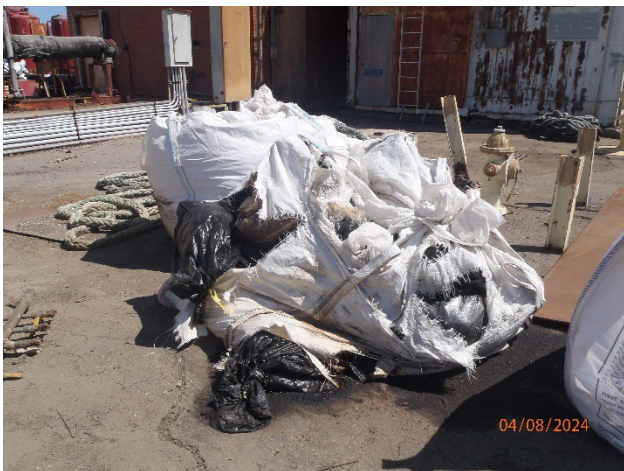
Picture 32 – Dry Dock 2 torn supersack of oily material

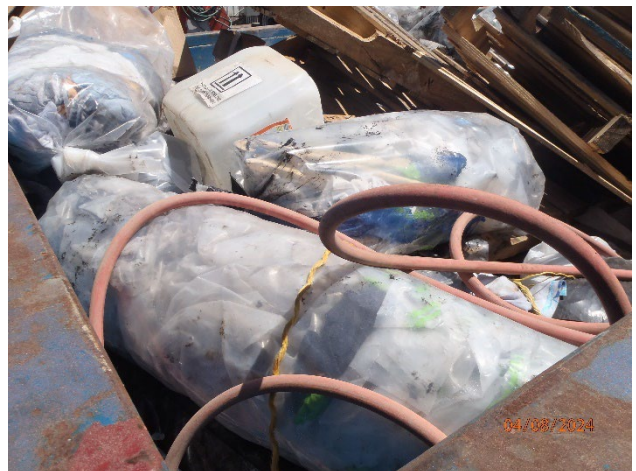
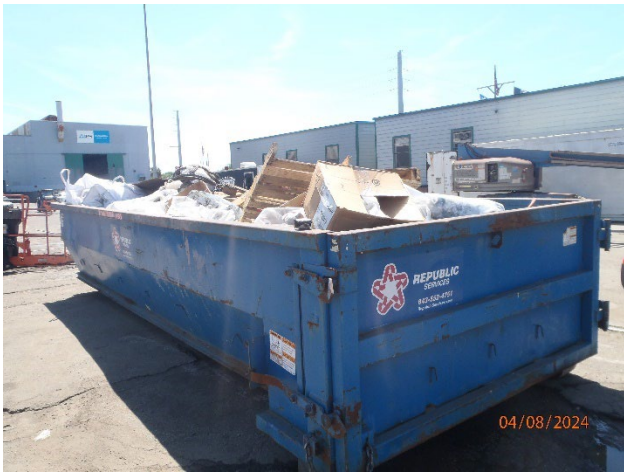
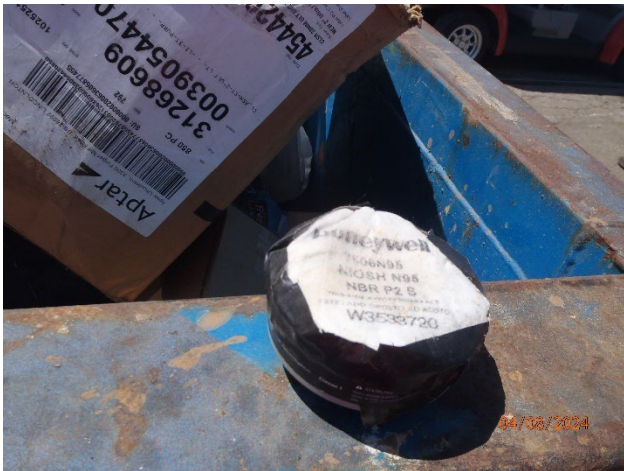
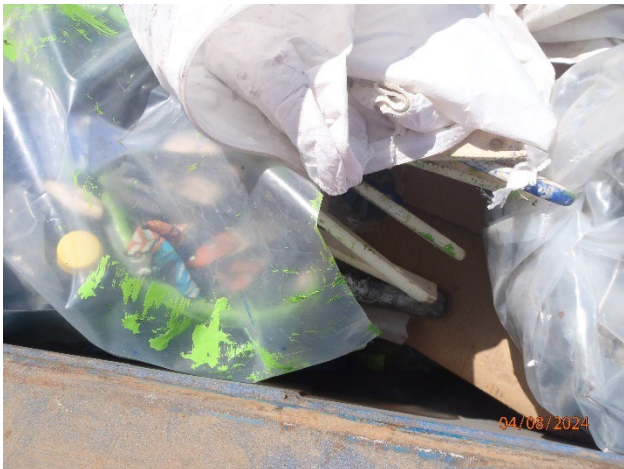
- A 20-cubic yard Republic trash roll-off was observed behind the condominiums. The roll-off was filled with hazardous waste paint debris mixed with trash (Pictures 35-38). According to the facility’s waste profile records, waste paint debris observed in the roll-off container should have been identified as hazardous waste.

Picture 35 – Behind Condos Republic trash roll-off with HW paint debris

Picture 36 – Behind Condos Republic trash roll-off with HW paint debris

Picture 37 – Behind Condos Republic trash roll-off with HW paint debris

Picture 38 – Behind Condos Republic trash roll-off with HW paint debris

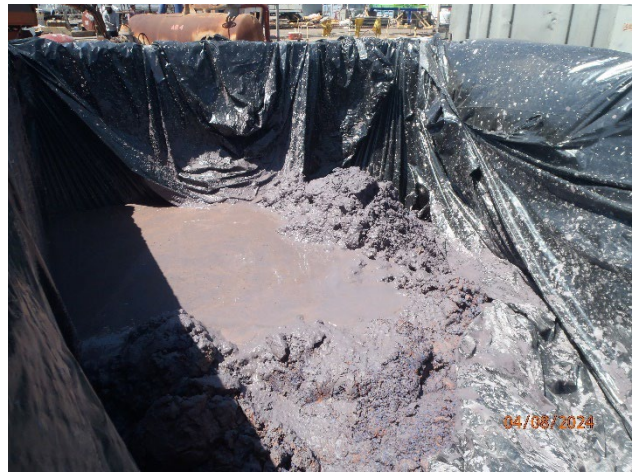
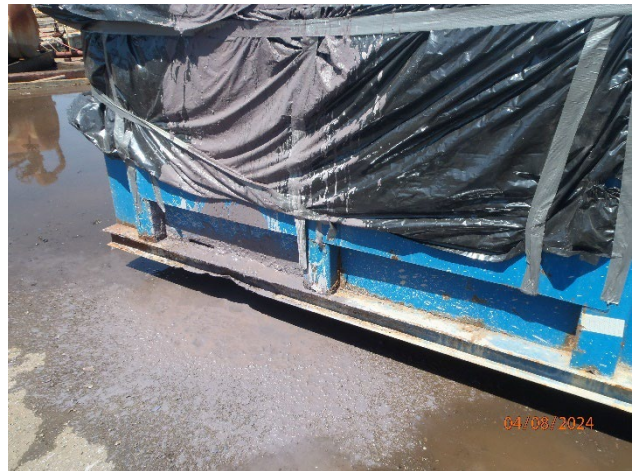
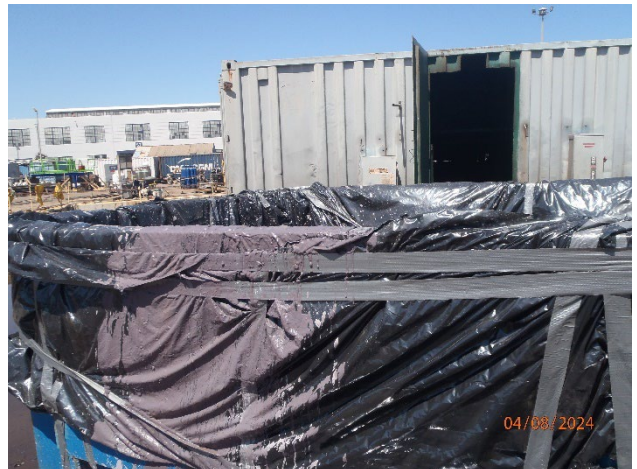
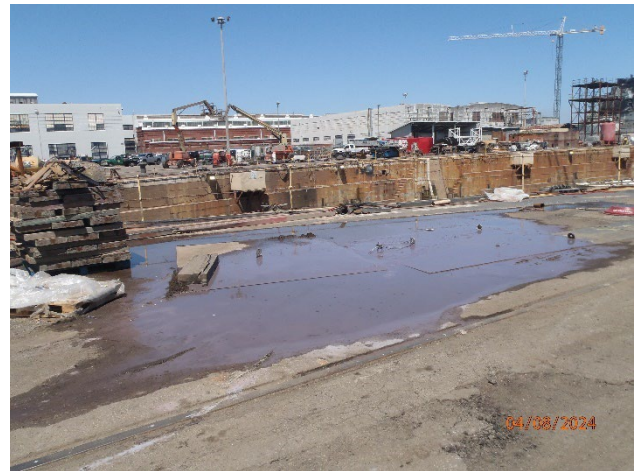
- A 20-cubic yard roll-off of slurried paint chips blended with water (Pictures 39-41, 46, 49, 50). At the time of the inspection, the slurried paint chips was observed down the side of the roll-off and onto the ground. In addition, the contents of the roll-off were

leaking through the black plastic liner. A large puddle of slurry water was observed on the ground. A yellow VAX box was used to collect and store the paint sludge until it could be properly disposed. The job supervisor in this area stated that the paint sludge and slurry were non-hazardous, and the employee tasked with handling the paint sludge and slurry was not managing it properly.

Picture 39 – Behind Condos 20-cubic yard roll-off of paint chips water slurry

Picture 40 – Behind Condos 20-cubic yard roll-off of paint chips water slurry on the ground

Picture 41 – Behind Condos 20-cubic yard roll-off of paint chips water slurry

Picture 46 – Behind Condos paint slurry on the ground

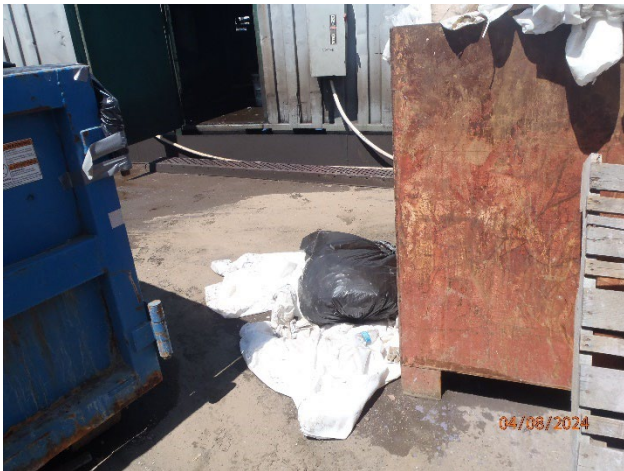
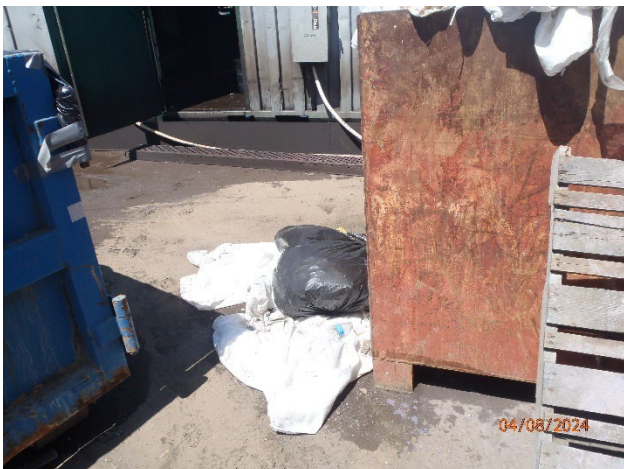
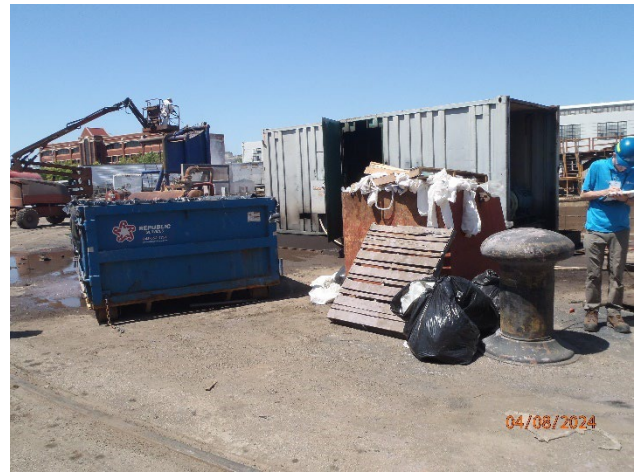
- A red metal box of discarded PPE that was not being properly managed as hazardous waste (Picture 42-45). Bags of the discarded PPE and broken wooden pallets were strewn around the red metal box.

Picture 42 – Behind Condos discarded HW PPE in open metal container

Picture 45 – Behind Condos discarded paint slurry and HW PPE in open metal container

Picture 43 – Behind Condos discarded HW PPE in open metal container

Picture 44 – Behind Condos discarded HW PPE in open metal container

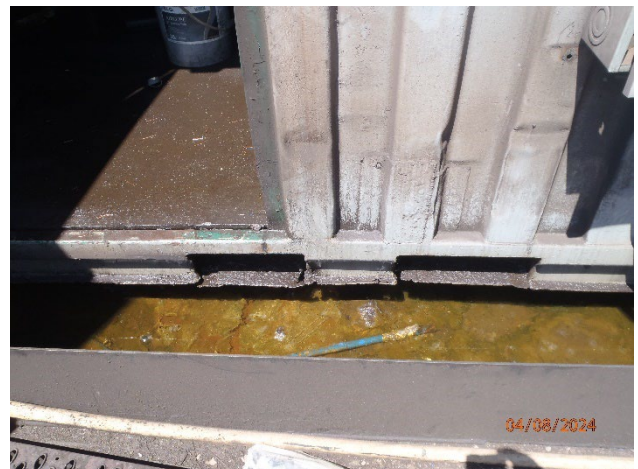
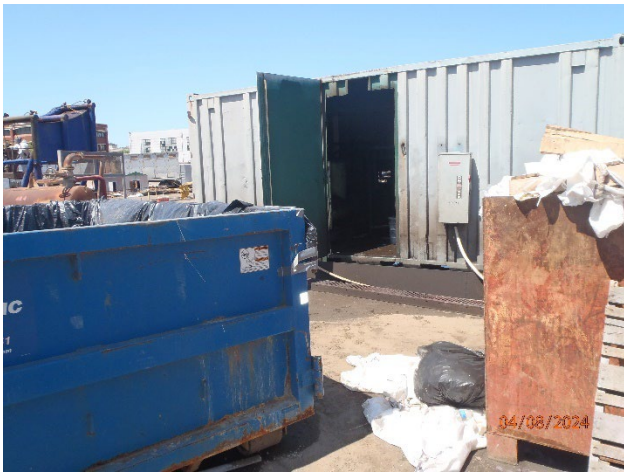
Picture 47 – Behind Condos compressor used oil

Picture 48 – Behind Condos compressor building

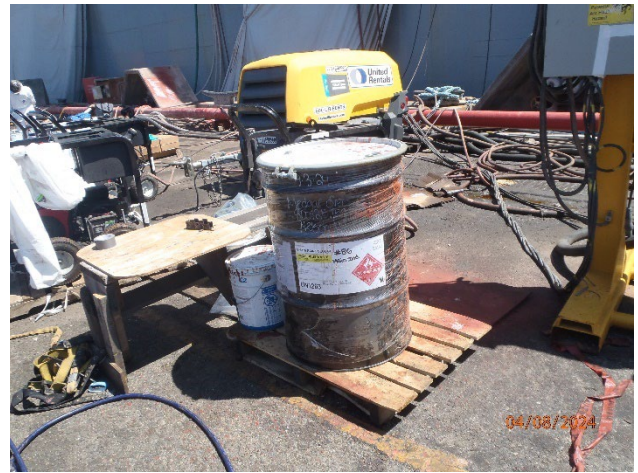
The USNS Medgar Evers was undergoing paint removal and repainting. The inspectors observed two 55-gallon containers of hazardous waste paint sludge in a SAA in this area. The first container (#86) (Picture 51), which was on a wooden pallet, the container was full, closed, labeled but not dated. The second hazardous waste container (#89) was currently in use. The inspectors also observed a pallet, with two wrapped RCRA empty discarded paint containers ready to transport to the CAA.

Picture 51 – USN Medgar Evers SAA full container

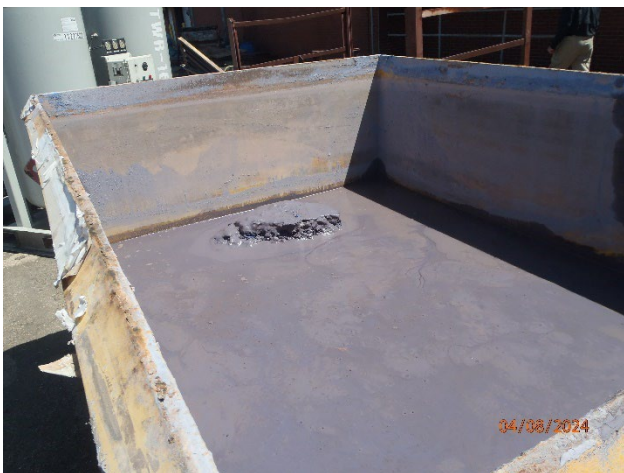
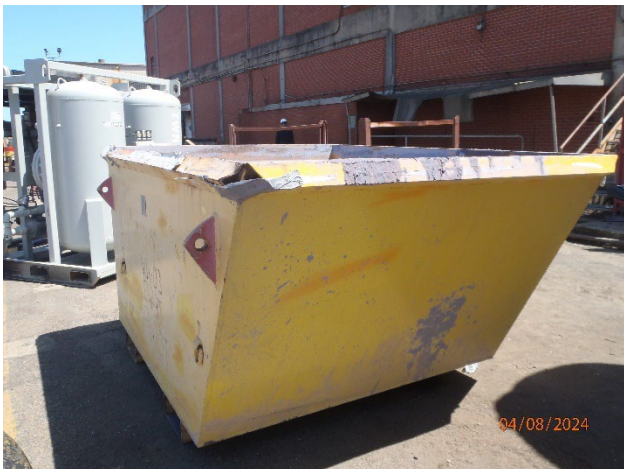
Picture 49 – Between Dock 1&2 discarded paint slurry in yellow container

Picture 50 – Between Dock 1&2 discarded paint slurry in yellow container

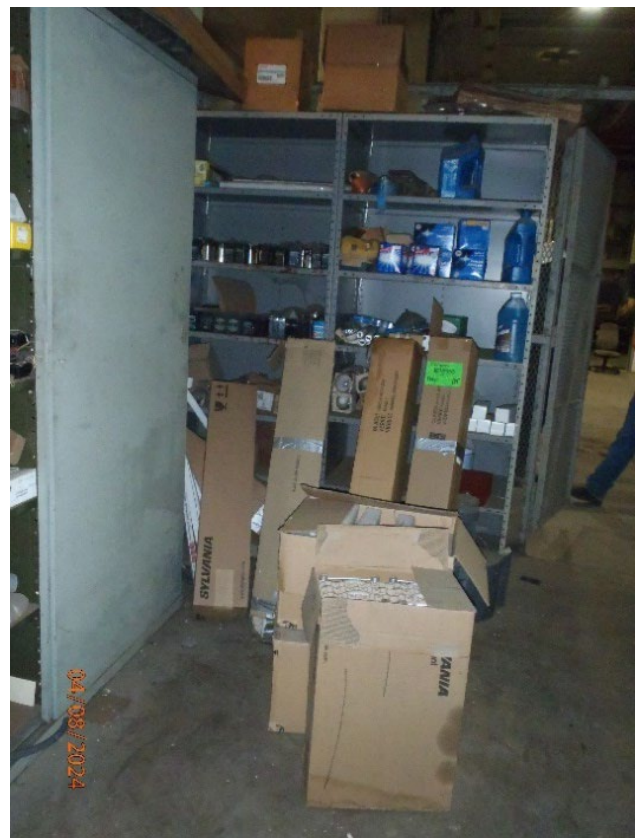
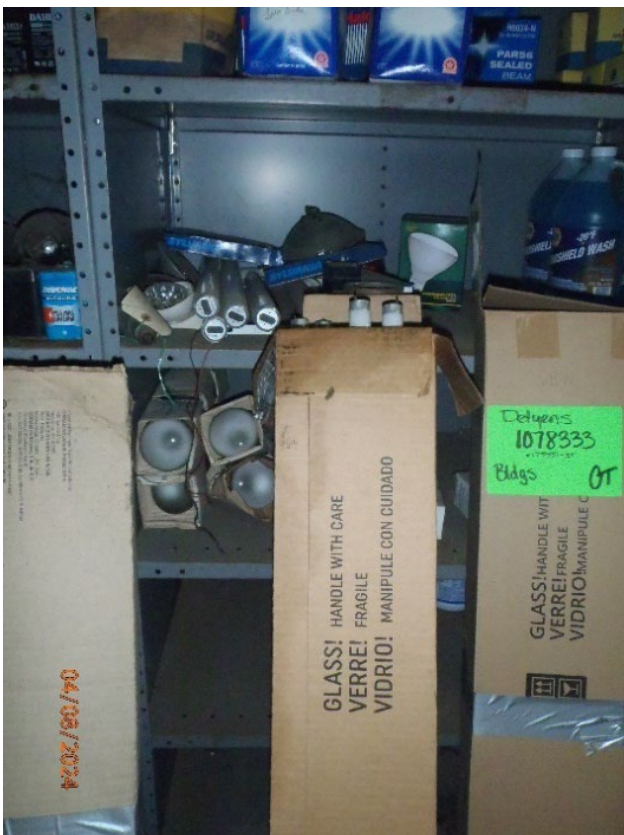
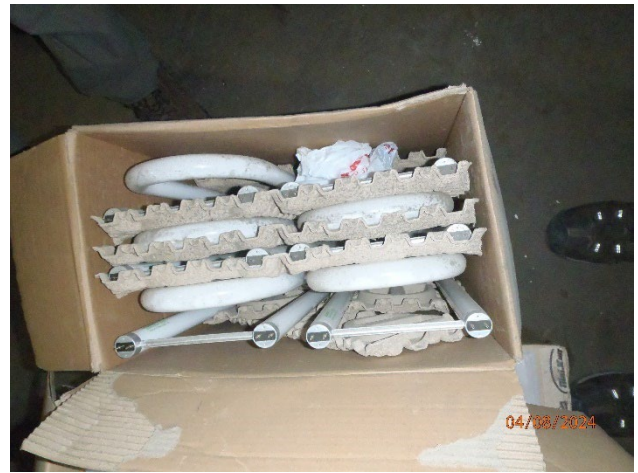
The maintenance department services the facility vehicles. The inspectors toured the main shop and observed used oil on the floor with absorbent on top. The universal waste lamps and batteries were stored in the Parts Room. The inspectors observed two new 4-foot boxes of fluorescent lamps, and three 4-foot boxes of universal waste lamps that were not closed, not labeled, and the facility was not able to demonstrate the waste was accumulated less than one year (Pictures 52, 54, 55).

Picture 52 – Building 177 Maintenance Department UW

Picture 55 – Building 177 Maintenance Department old and unused lamps and batteries

Picture 54 – Building 177 Maintenance Department old and unused lamps and batteries

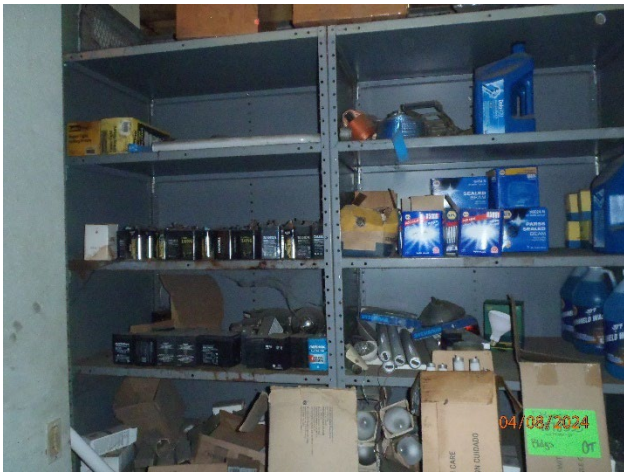
Picture 53 – Building 177 Maintenance Department old and unused lamps and batteries

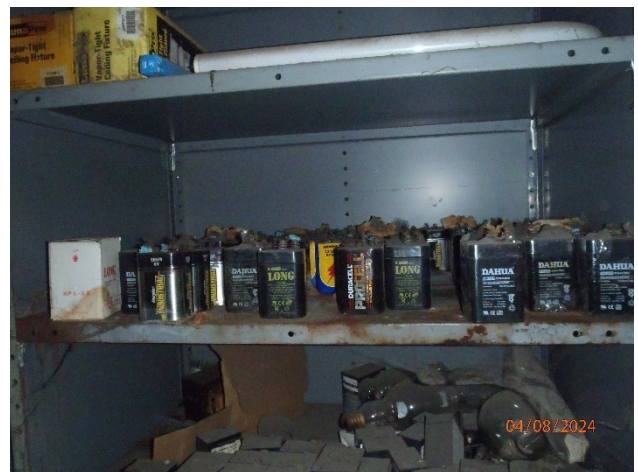
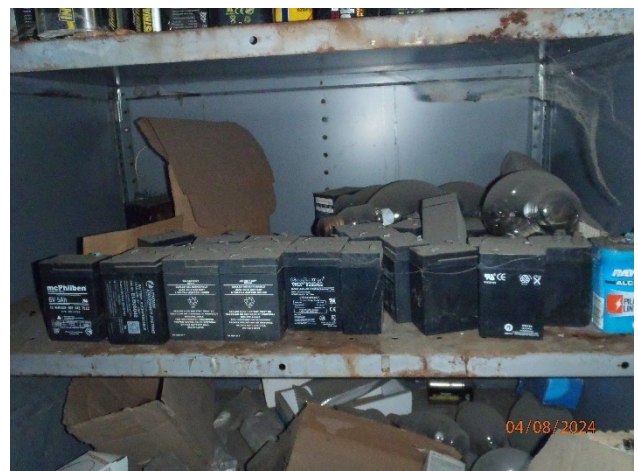
Picture 56 – Building 177 Maintenance Department old and unused batteries

Picture 57 – Building 177 Maintenance Department old and unused batteries

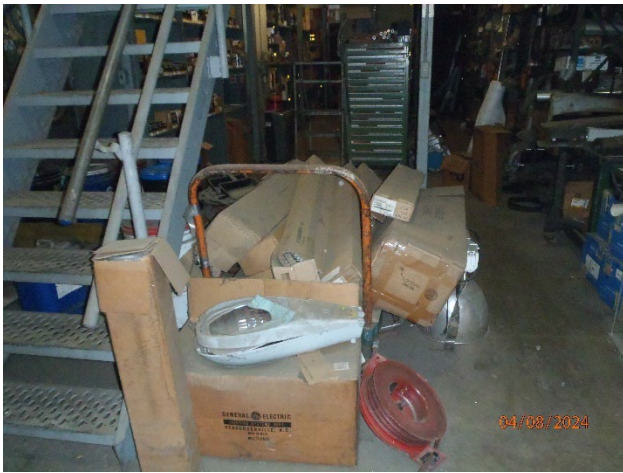
Picture 58 – Building 177 Maintenance Department unused lamps

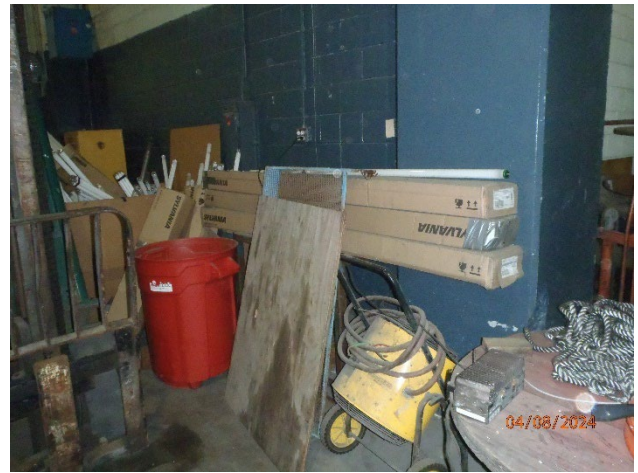
Back in the main shop area, the inspectors observed several boxes of universal lamps piled up adjacent to a yellow flammable cabinet (Pictures 59-61). The containers of discarded lamps were not secured, not closed, not labeled, and the facility was not able to demonstrate if the waste lamps were accumulated less than one year.

Picture 61 – Building 177 Maintenance Department universal waste lamps

Picture 59 – Building 177 Maintenance Department universal waste lamps

Picture 60 – Building 177 Maintenance Department universal waste lamps

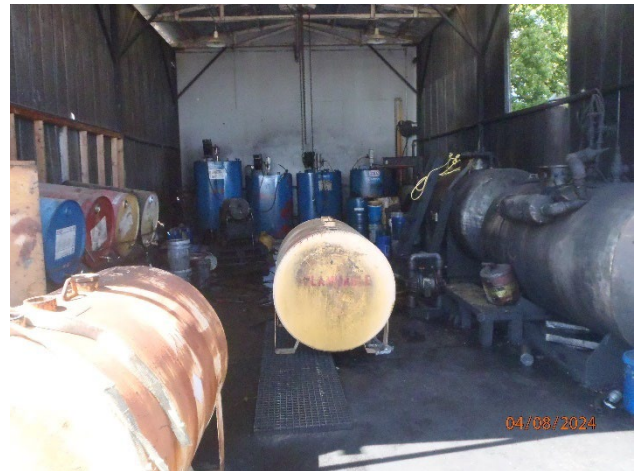
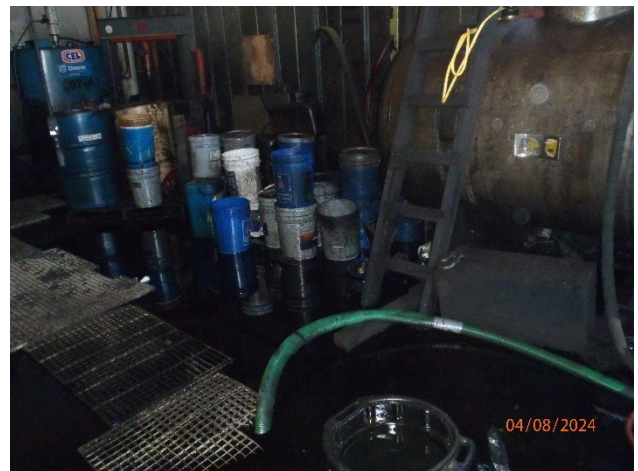
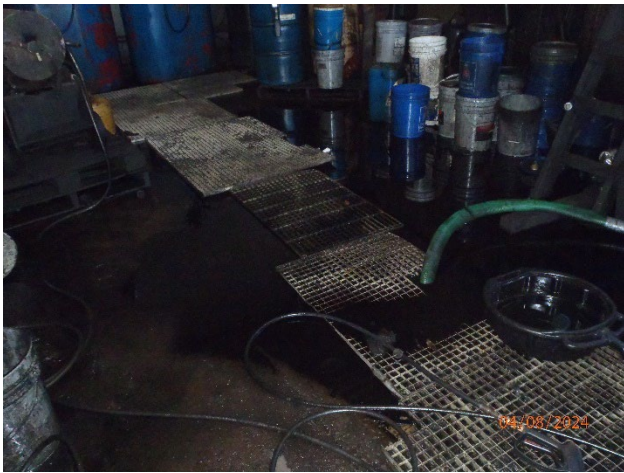
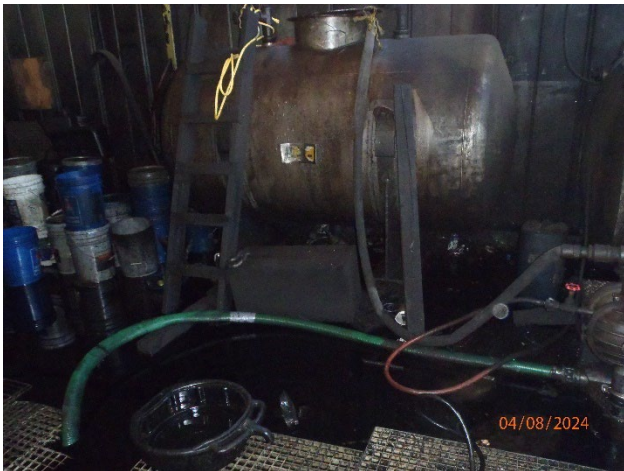
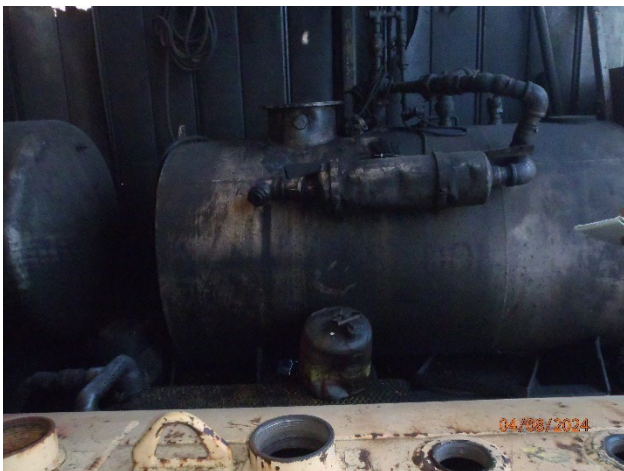
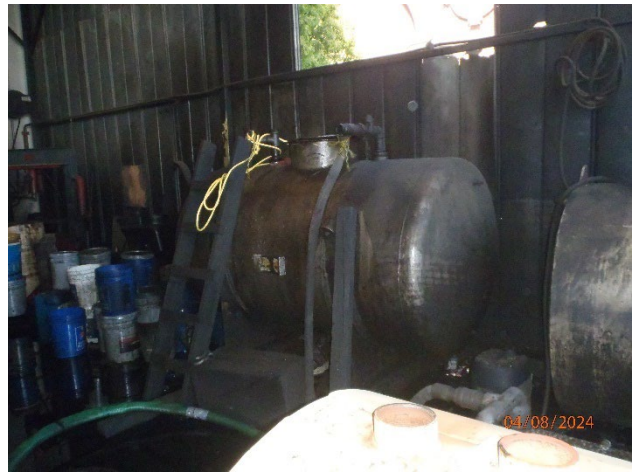
Outside the shop was a used oil shed. Inside the shed, the inspectors observed two 1,000-gallon used oil tanks that were not labeled, a used oil sump overflowing onto the floor, and a large release of used oil across the shed floor and under the exterior wall (Pictures 62-67).

Picture 62 – Building 177 Maintenance Department used oil area

Picture 63 – Building 177 Maintenance Department used oil release to ground

Picture 64 – Building 177 Maintenance Department used oil release to ground

Picture 67 – Building 177 Maintenance Department used oil tank

Picture 65 – Building 177 Maintenance Department used oil release to ground

Picture 66 – Building 177 Maintenance Department used oil tank
