## RCRA Compliance Evaluation Inspection Report

Inteplast Engineered Films Corp.  
7549 Brokerage Drive  
Orlando, Florida 32809-5625  
County: Orange  
Latitude: 28.453796  
Longitude: -84.418123  
EPA ID Number: FLD984201251  
Primary NAIC: 323111 – Commercial Gravure Printing  
Other NAICS: 326111 – Plastics Bag and Pouch Manufacturing

April 8, 2021 09:00 a.m.

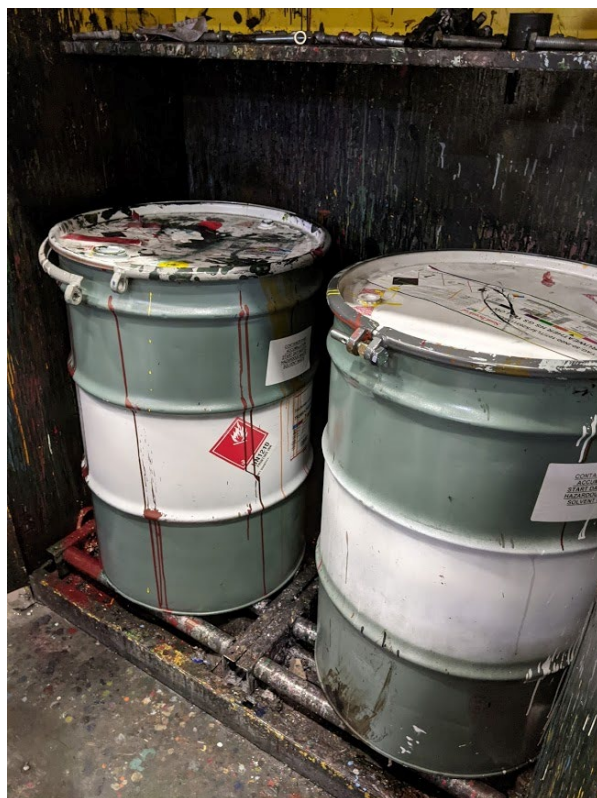
Photograph 5 of 21: Printing Department - Hazardous Waste CAA

Waste generated in the Ink Dispensing Room and the Printing Department, are collected, and stored in a CAA within this designated area. At the time of the inspection there were three (3) 55-gallon hazardous waste containers in this CAA. All containers were labeled and dated. One container was not closed during accumulation at the time of the inspection (Photograph 5 of 21).

**Pursuant to Fla. Admin. Code Ann. r. 62-730.160(1) 262.17(a)(1)(iv)(A), which is a condition of the LQG Permit Exemption, a container holding hazardous waste must always be closed during accumulation, except when it is necessary to add or remove waste.**

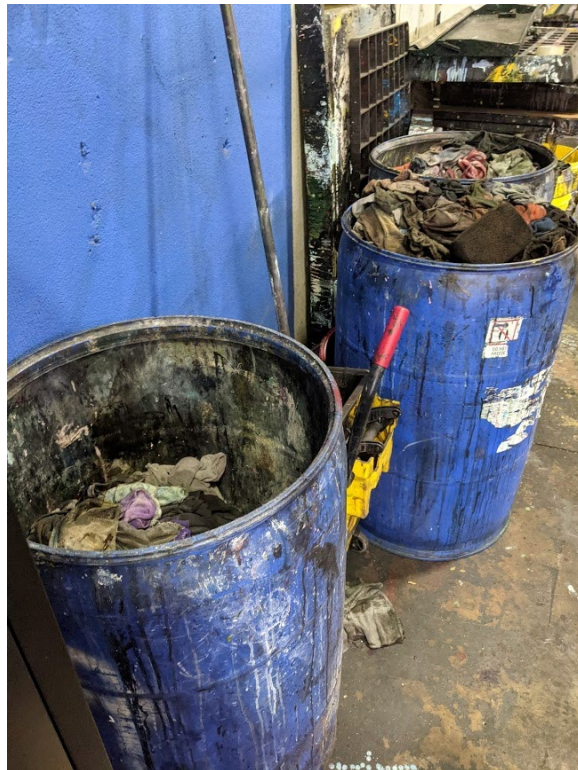
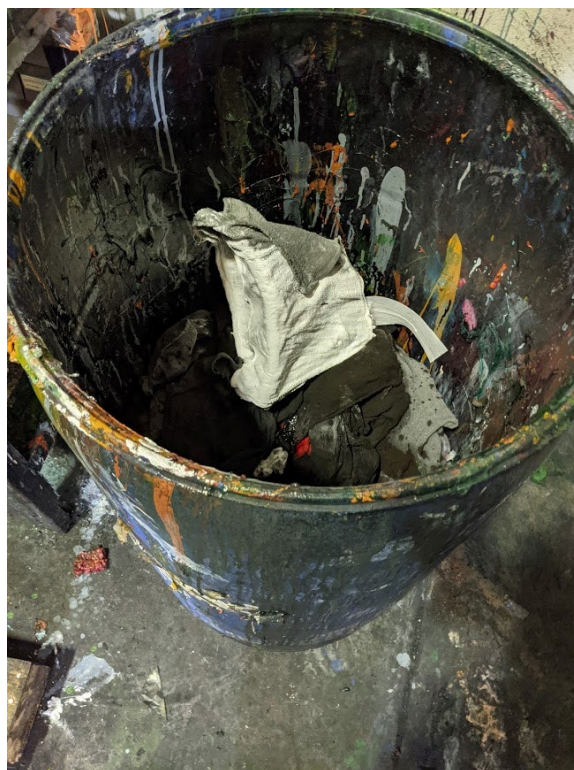
Located in the Worker Station of the Printing Department, the facility was managing six (6) 55-gallon containers, two (2) 10-gallon containers, and a 5-gallon container of spent solvent-contaminated rags. The inspection team asked the facility to make a hazardous waste determination on the spent solvent-contaminated rags prior to disposal (Photographs 7-9 of 21).

**Pursuant to Fla. Admin. Code Ann. r. 62-730.160(1) [40 C.F.R. § 262.11], a person who generates a solid waste, as defined in Fla. Admin. Code Ann. r. 62-730.030(1) [40 C.F.R. § 261.2], must make an accurate determination as to whether that waste is a hazardous waste in order to ensure wastes are properly managed according to applicable RCRA regulations articulated in Fla. Admin. Code Ann. r. 62-730.160(1) [40 C.F.R. § 262.11].**

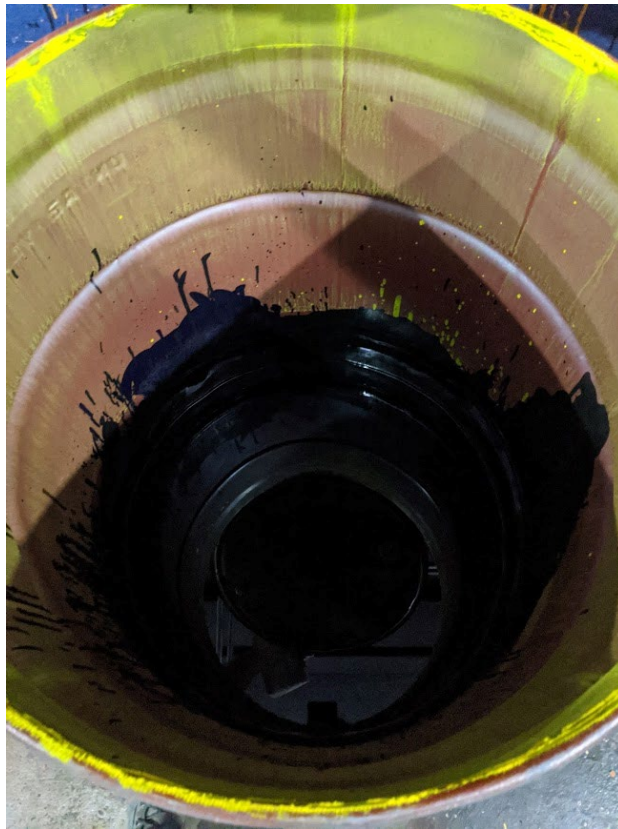
Paint is formulated and mixed in this area. At the time of the inspection, there was D001 paint-related hazardous waste in a 55-gallon container in a SAA that was not closed, not labeled with the words “Hazardous Waste” nor an indication of the hazard of the contents (Photographs 10 and 11 of 21).

**Pursuant to Fla. Admin. Code Ann. r. 62-730.160(1) [40 C.F.R. § 262.15(a)(4)], which is a condition of the SAA Permit Exemption, a generator is required to keep containers of hazardous waste closed at all times during accumulation, except when adding, removing, or consolidating waste; or when temporary venting of a container is necessary for the proper operation of equipment, or to prevent dangerous situations, such as build-up of extreme pressure.**

**Pursuant to Fla. Admin. Code Ann. r. 62-730.160(1) [40 C.F.R. § 262.15(a)(5)(i) and (ii)], which is a condition of the SAA Permit Exemption, a generator is required to mark or label its containers (i) with the words “Hazardous Waste” and (ii) with an indication of the hazards of the contents.**

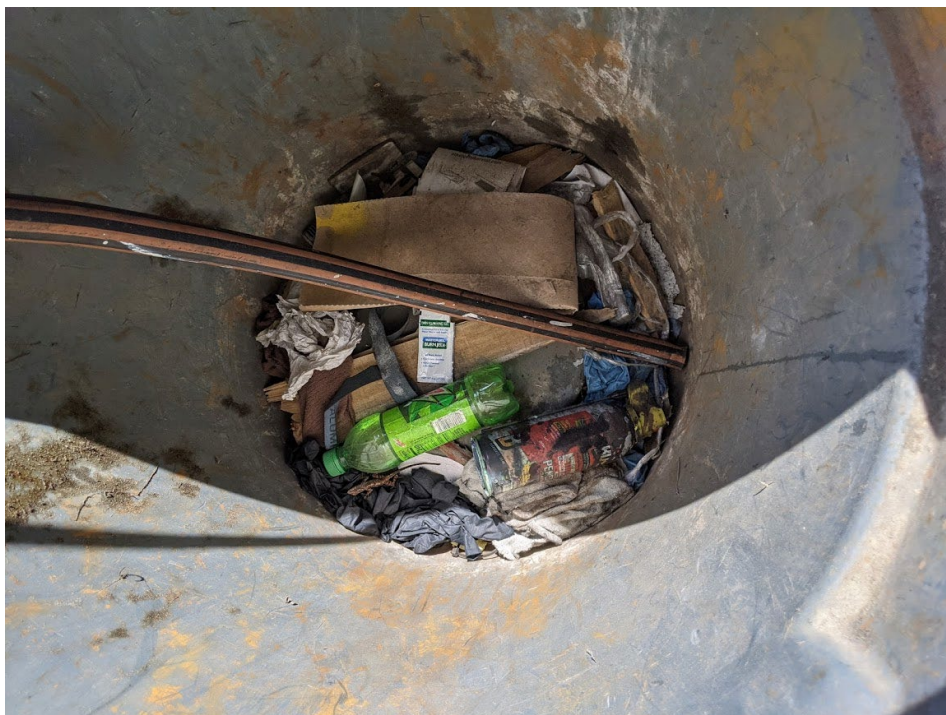
Photograph 12 of 21: Maintenance Department – Aerosol Can Disposal

Aerosol cans are used for various touch-ups and general maintenance on parts or machines and are thrown in the regular trash. The inspection team requested a hazardous waste determination for the municipal disposal of unpunctured aerosol cans (Photograph 12 of 21).

**Pursuant to Fla. Admin. Code Ann. r. 62-730.160(1) [40 C.F.R. § 262.11], a person who generates a solid waste, as defined in Fla. Admin. Code Ann. r. 62-730.030(1) [40 C.F.R. § 261.2], must make an accurate determination as to whether that waste is a hazardous waste in order to ensure wastes are properly managed according to applicable RCRA regulations articulated in Fla. Admin. Code Ann. r. 62-730.160(1) [40 C.F.R. § 262.11].**

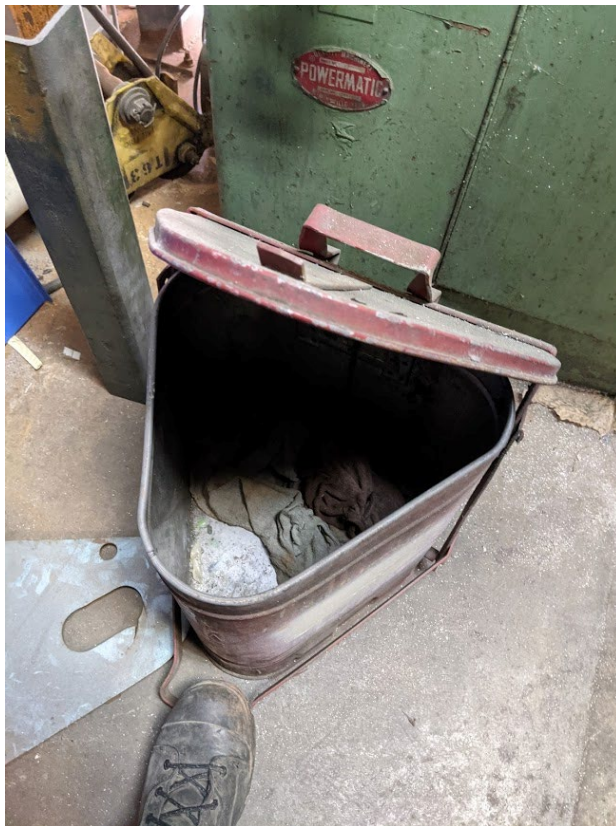
The maintenance department generates spent rags. At the time of the inspection, it was unclear how the facility was managing two (2) 10-gallon containers storing spent rags. A hazardous waste determination was requested (Photographs 13 and 14 of 21).

**Pursuant to Fla. Admin. Code Ann. r. 62-730.160(1) [40 C.F.R. § 262.11], a person who generates a solid waste, as defined in Fla. Admin. Code Ann. r. 62-730.030(1) [40 C.F.R. § 261.2], must make an accurate determination as to whether that waste is a hazardous waste in order to ensure wastes are properly managed according to applicable RCRA regulations articulated in Fla. Admin. Code Ann. r. 62-730.160(1) [40 C.F.R. § 262.11].**

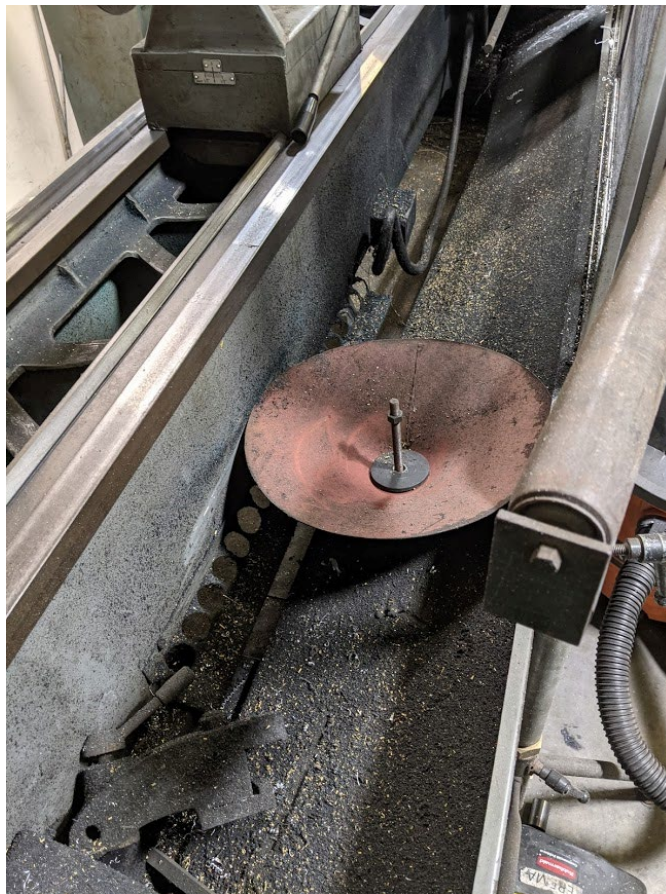
The maintenance department has a two milling machines. At the time of the inspection, a waste determination was requested for the scrap metal and documentation indicating where the metal is shipped for disposal or recycling (Photographs 15 and 16 of 21).

**Pursuant to Fla. Admin. Code Ann. r. 62-730.160(1) [40 C.F.R. § 262.11], a person who generates a solid waste, as defined in Fla. Admin. Code Ann. r. 62-730.030(1) [40 C.F.R. § 261.2], must make an accurate determination as to whether that waste is a hazardous waste in order to ensure wastes are properly managed according to applicable RCRA regulations articulated in Fla. Admin. Code Ann. r. 62-730.160(1) [40 C.F.R. § 262.11].**

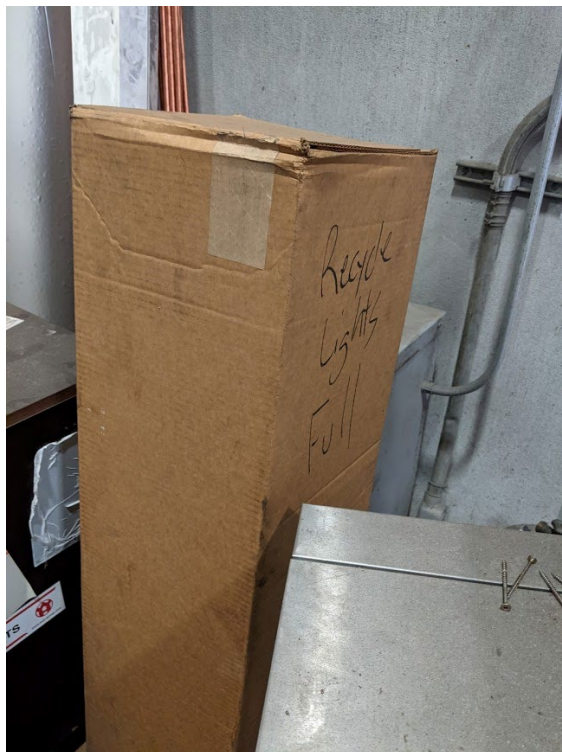
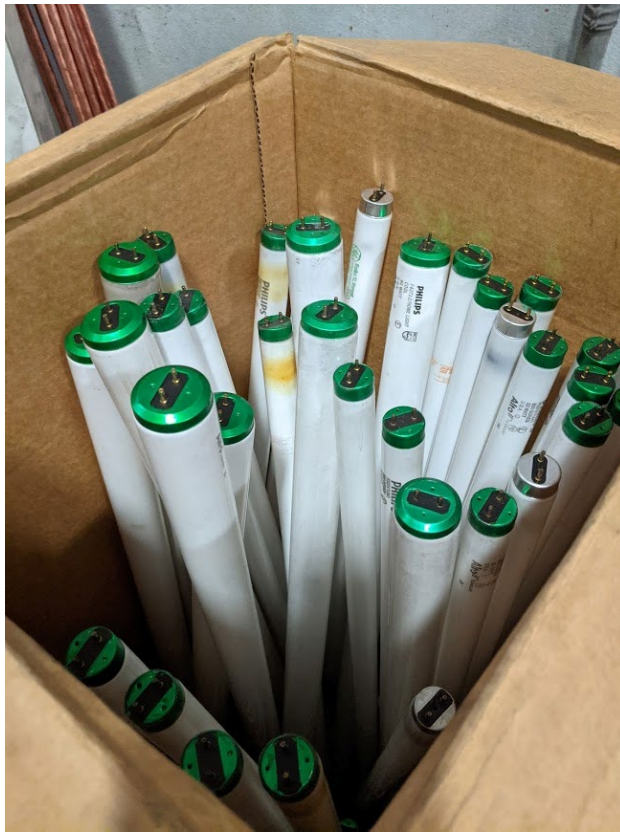
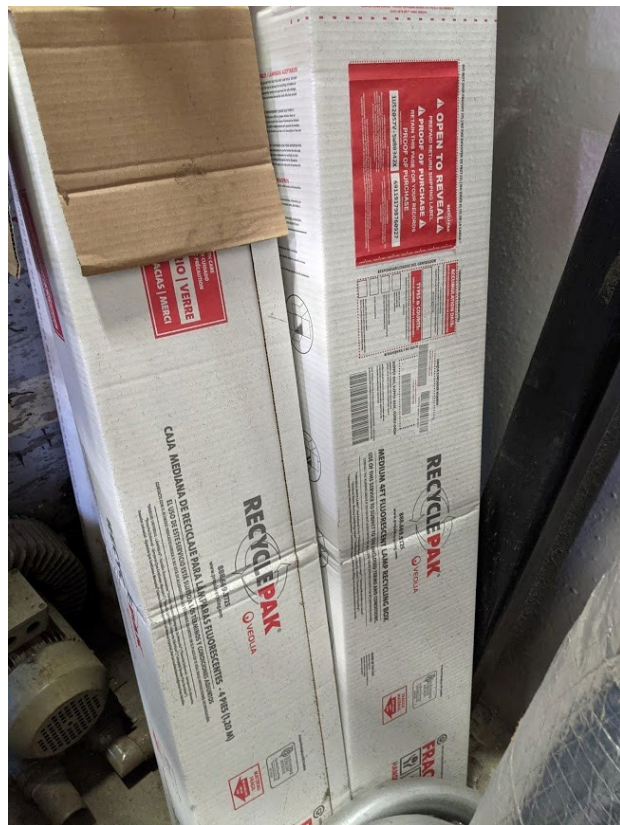
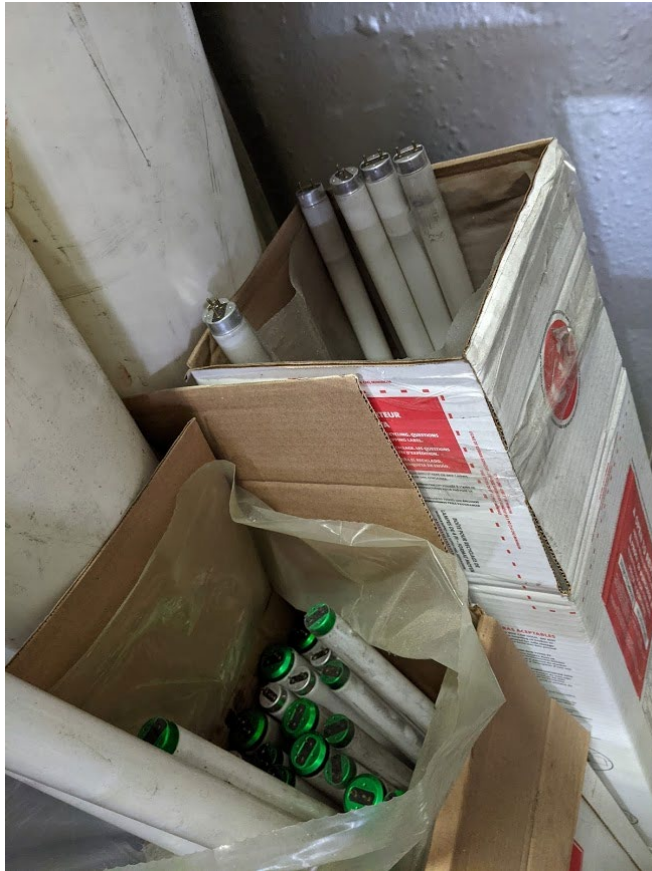
Located in the Maintenance Parts Room was storage for universal waste. At the time of the inspection, there was a 4-foot container of universal waste lamps that was not labeled, dated, or closed. There were two (2) additional 4-foot containers of universal waste lamps that were labeled, but not dated, or closed. There were also four (4) 8-foot universal waste lamps that were not in containers, labeled or dated

(Photographs 17-21 of 21).

**Pursuant Fla. Admin. Code Ann. r. 62-730.185(1) and Fla. Admin. Code Ann. r. 62-737.400(5) [40 C.F.R. § 273.13(d)], a SQHUW must manage universal waste lamps in a way that prevents releases of any universal waste or component of a universal waste to the environment.**

**Pursuant to Fla. Admin. Code Ann. r. 62-730.185(1)[40 C.F.R. § 273.14(e)], a SQHUW must label or mark each lamp or container of lamps clearly with one of the following phrases: “Universal Waste-Lamp(s),” or “Waste Lamp(s),” or “Used Lamps.”**

**Pursuant to Fla. Admin. Code Ann. r. 62-730.185(1) and Fla. Admin. Code Ann. r. 62-737.400(7) [40 C.F.R. § 273.15(a) and (c)], a SQHUW may accumulate universal waste no longer than one year and must be able to demonstrate the length of time that the universal waste has accumulated from the date that it became a waste or was received.**
