**Inspection Report**  
**Mechanical Integrity Test**  
**Osage DNR / Environmental Protection Agency**  
**1201 Elm Street, Suite 500**  
**Dallas TX 75270**

| | | <b>Lease Name</b> POND CREEK | | | | | |
| | | <b>Well ID</b> 3 | | | | | |
| <b>Type of MIT</b> Ada Pressure Test | | <b>Test Reason</b> Routine | | | | | |

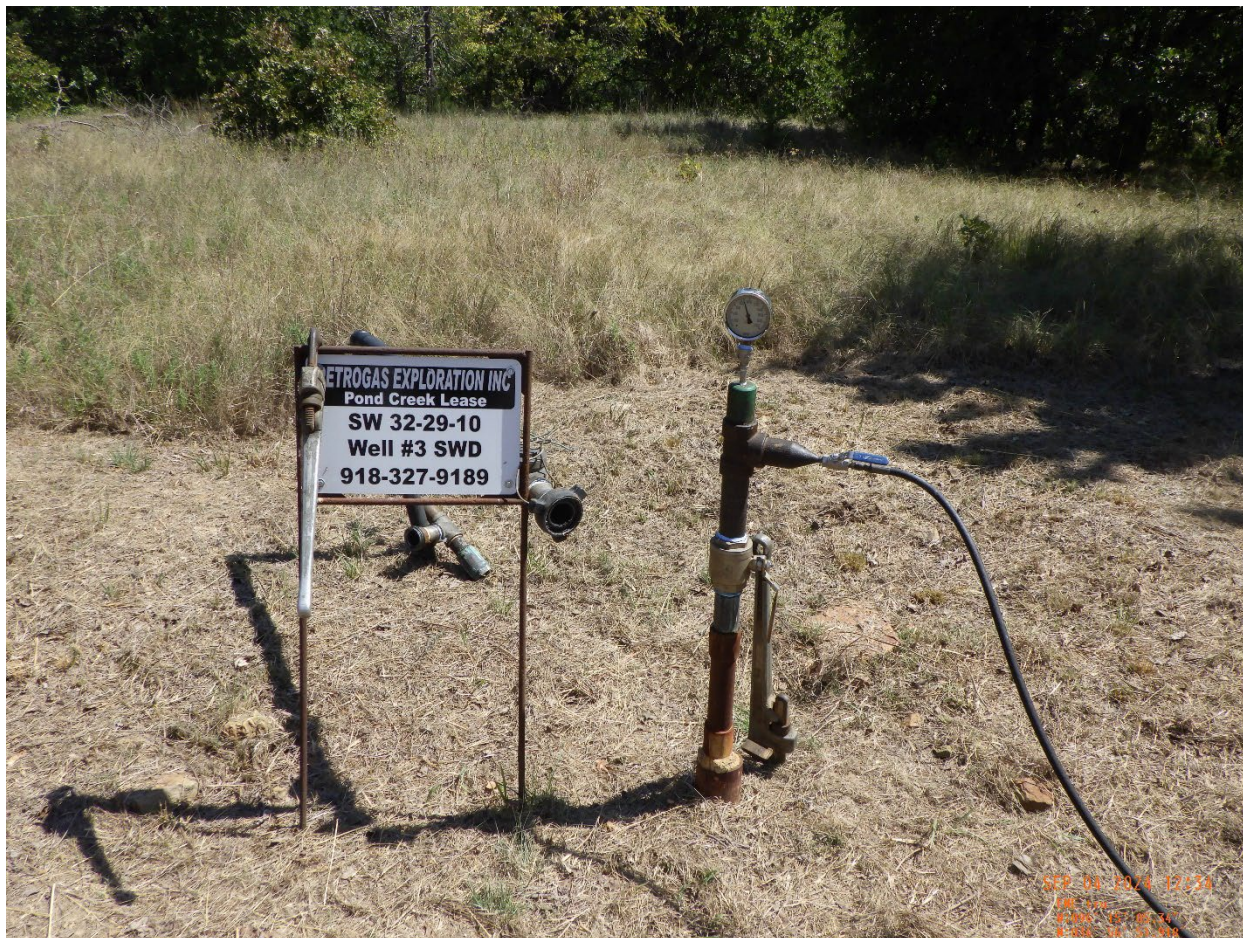
Photo No. 1

**Description:** This was well OS4465000 connected and being pressured for the MIT. At the time of the inspection, the well signage was not yet updated to reflect the new owner/operator. The change of ownership was not yet completed with the EPA UIC permitting group at the time of the inspection.
