## EPA REGION 5 Enforcement and Compliance Assurance Division

### INSPECTION REPORT

| <b>Type of Inspection</b> | Compliance Evaluation Inspection (CEI) | | |
| <b>Facility or Site Name</b> | Marietta Wastewater Treatment Works | | |

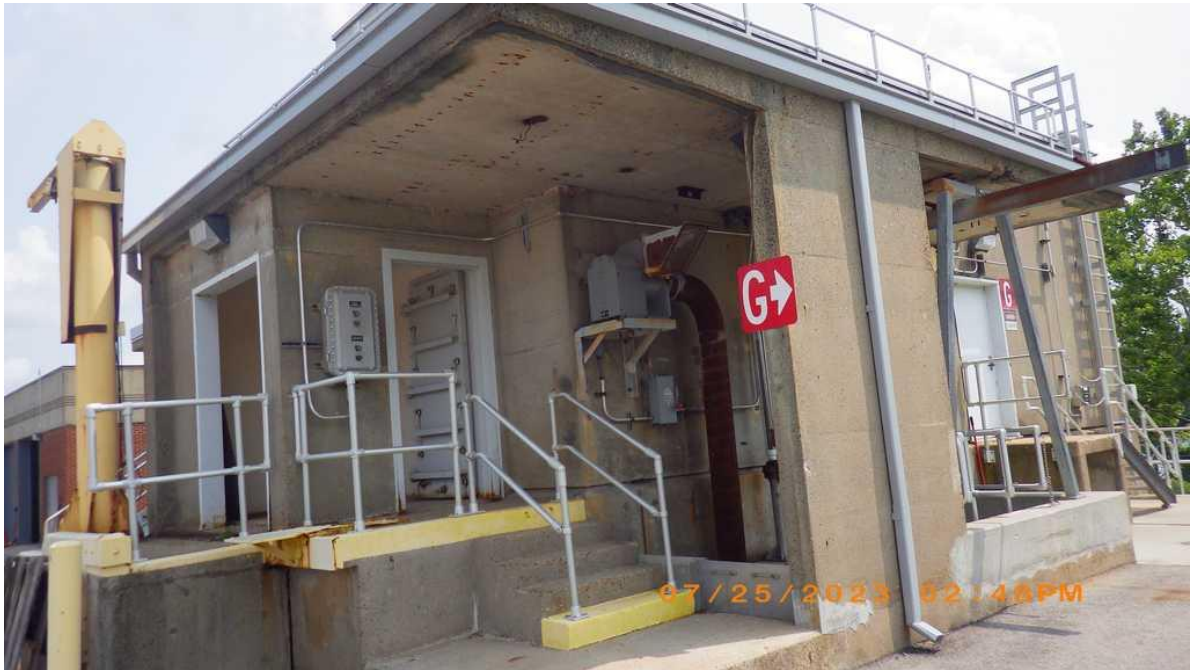
| Influent pump station | | | MRTA0252.JPG |

| Bar screens cleaned weekly. | | | |

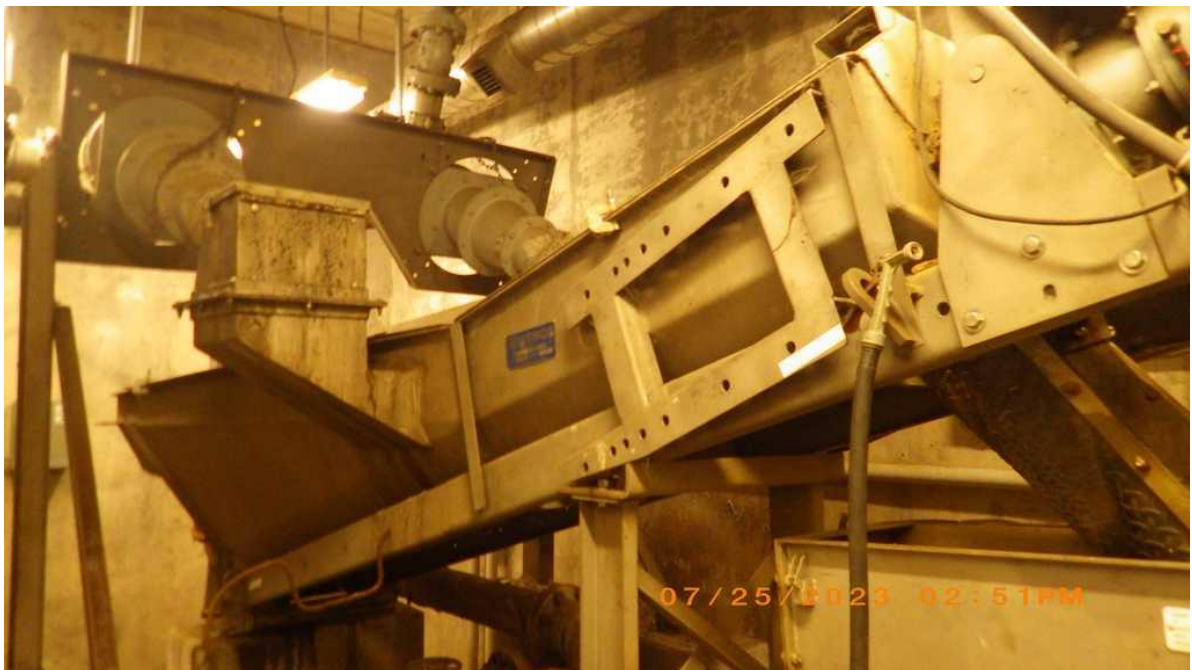
| Grit removal | | | MRTA0253.JPG |

| Grit dewatering system (Vortex). | | | |

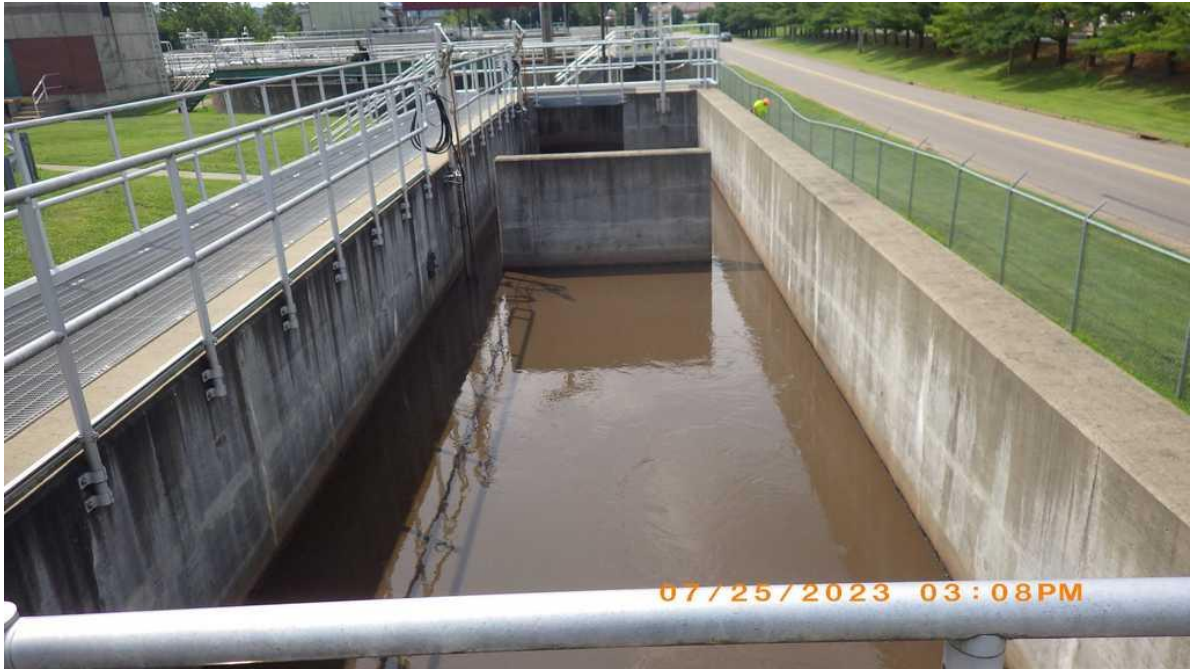
| Biological anoxic selector | | | MRTA0258.JPG |

| Biological anoxic selector stirs wastewater prior to secondary. | | | |

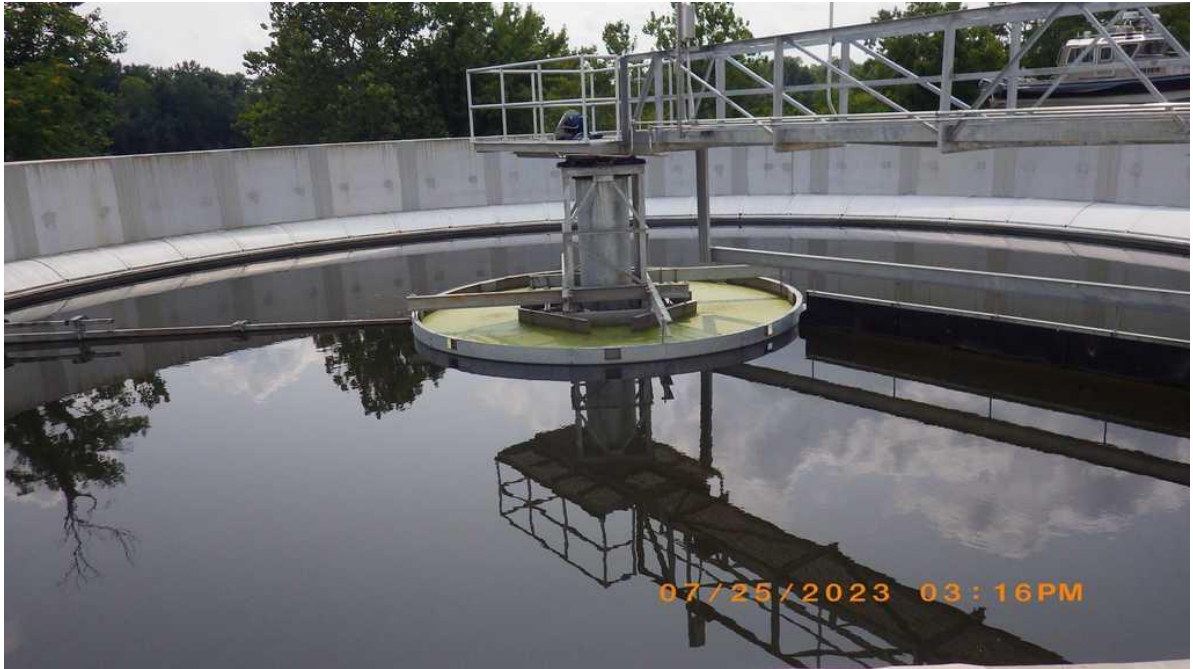
| Final clarifiers (2) | | | MRTA0260.JPG |

| Installed in 2019. No significant growth or O&M issues observed. | | | |

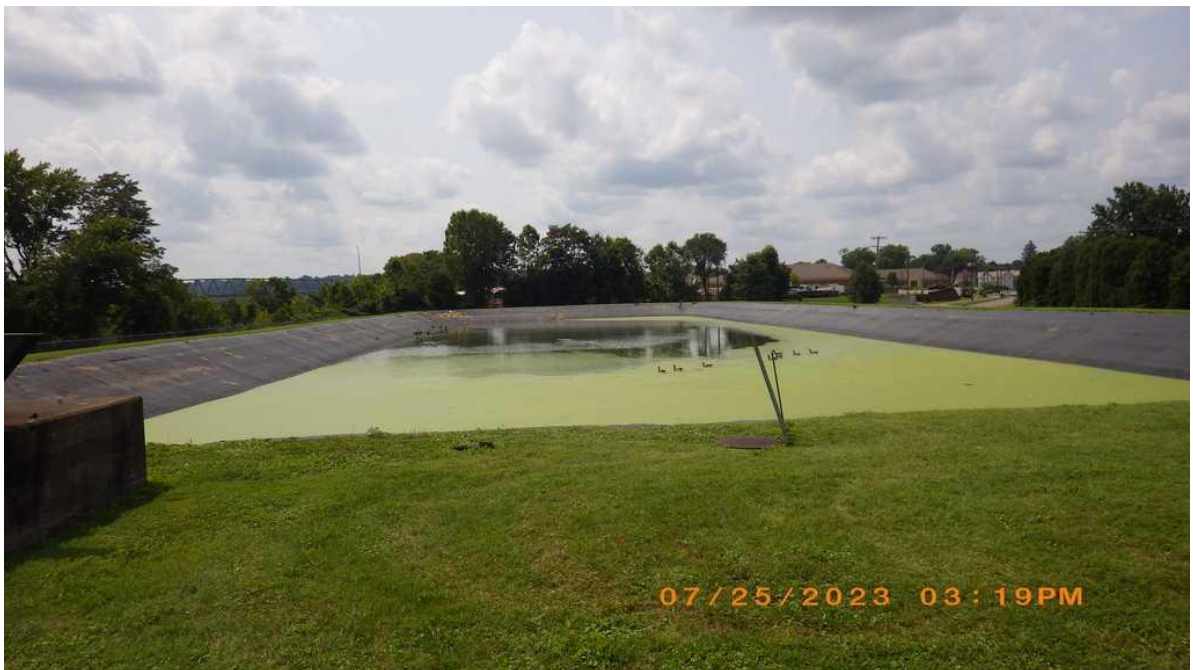
| EQ basin | | | MRTA0261.JPG |

| 2.6 MGD capacity. Used infrequently. | | | |

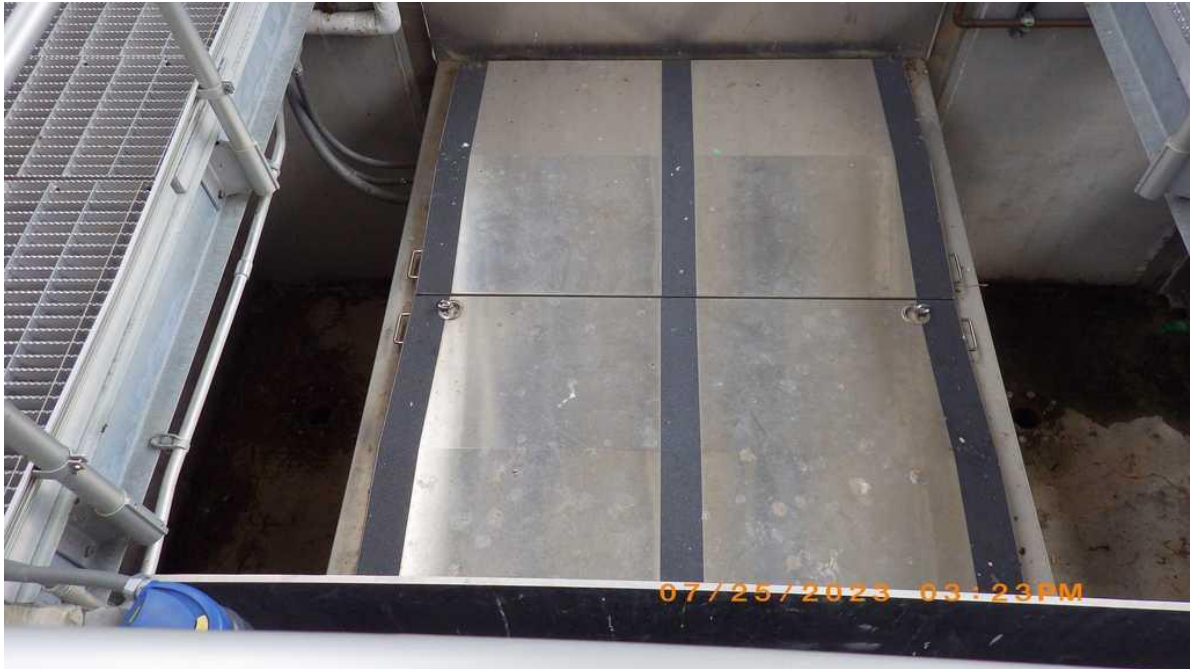
| UV system | | | MRTA0262.JPG |

| 2 channel system. One channel offline due to low flows. Photo of UV-2. | | | |

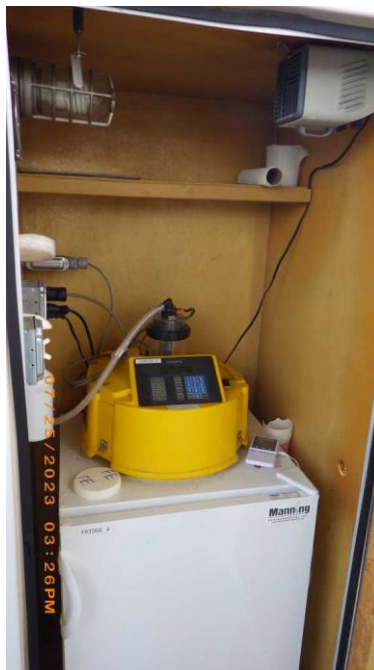
| Effluent sampler | | | MRTA0263.JPG |

| Manufacturer: Manning Env., Inc. Noted thermometer to measure cooler temps. | | | |

| Observed growth inside effluent tubing. Tubing replaced twice per year. | | | |

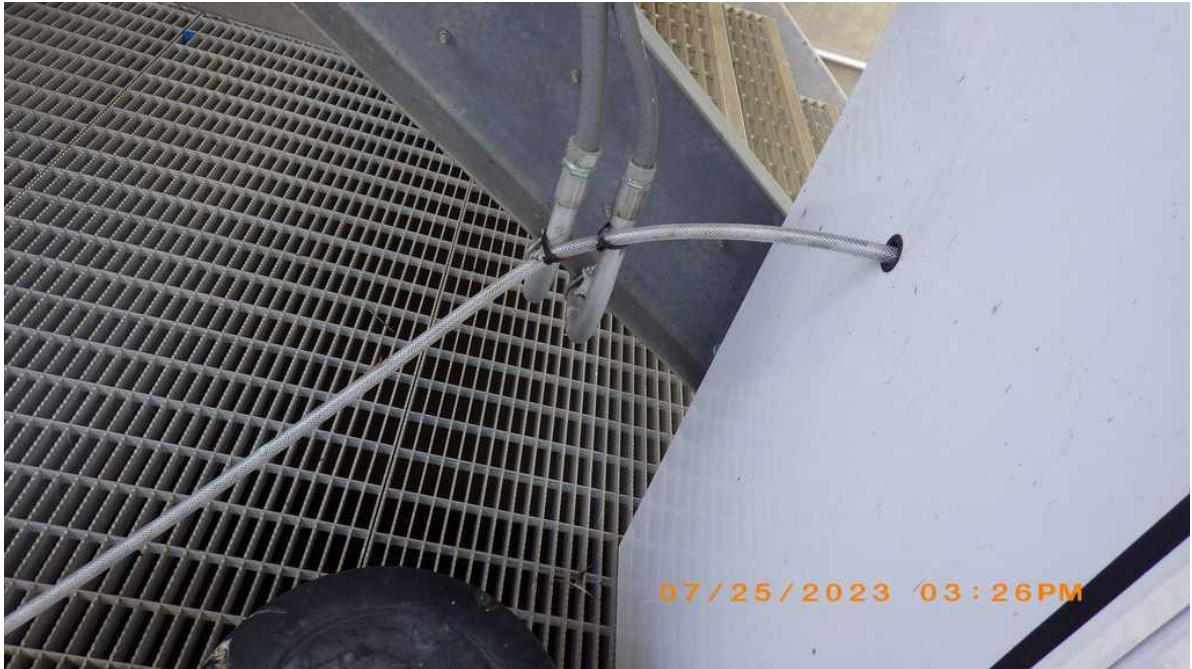
| Effluent sampler tubing | | | MRTA0264.JPG |

Observed growth inside the effluent autosampler tubing (see Photo Log image MRTA0264.JPG). Tubing normally replaced twice per year.

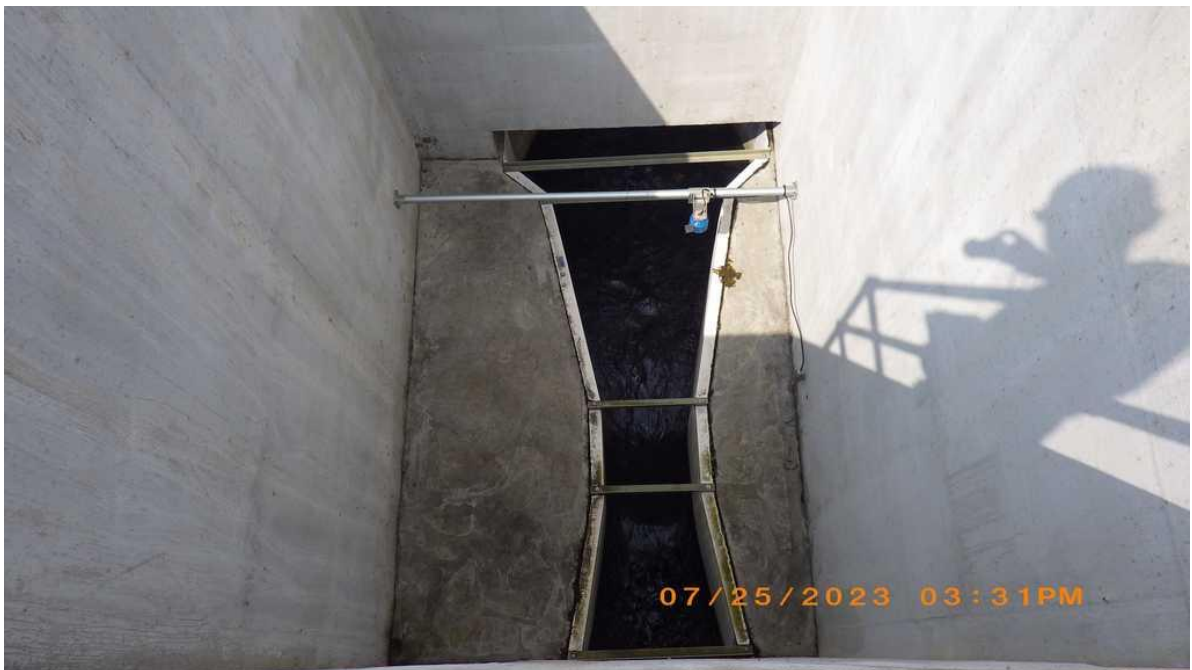
| Effluent Parshall flume | | | MRTA0265.JPG |

Observed flow sensor off center of flume (see Photo Log image MRTA0265.JPG). Ryan Boley said the off-center sensor placement was due to turbulence in the center of flume.

| Observed flow sensor off center of flume. Ryan Boley said this was due to turbulence in the center of flume. | | | |

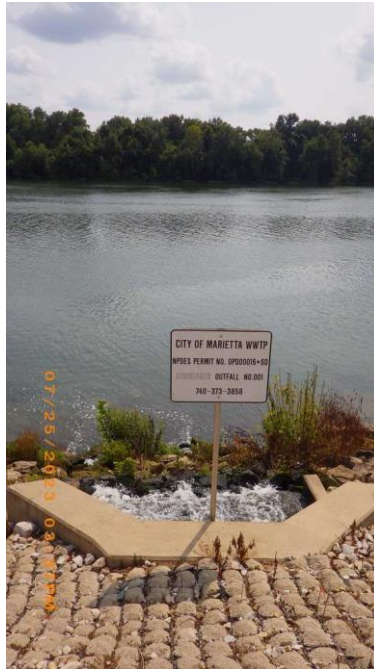
| Outfall 001 (Ohio River) | | | MRTA0266.JPG |

| Actual outfall to the Ohio River could not be observed due to vegetation. No outfall sign was observed (permit requires 2'x2' sign including permit number telephone number, etc. for each outfall and bypass on the Ohio River). | | | |

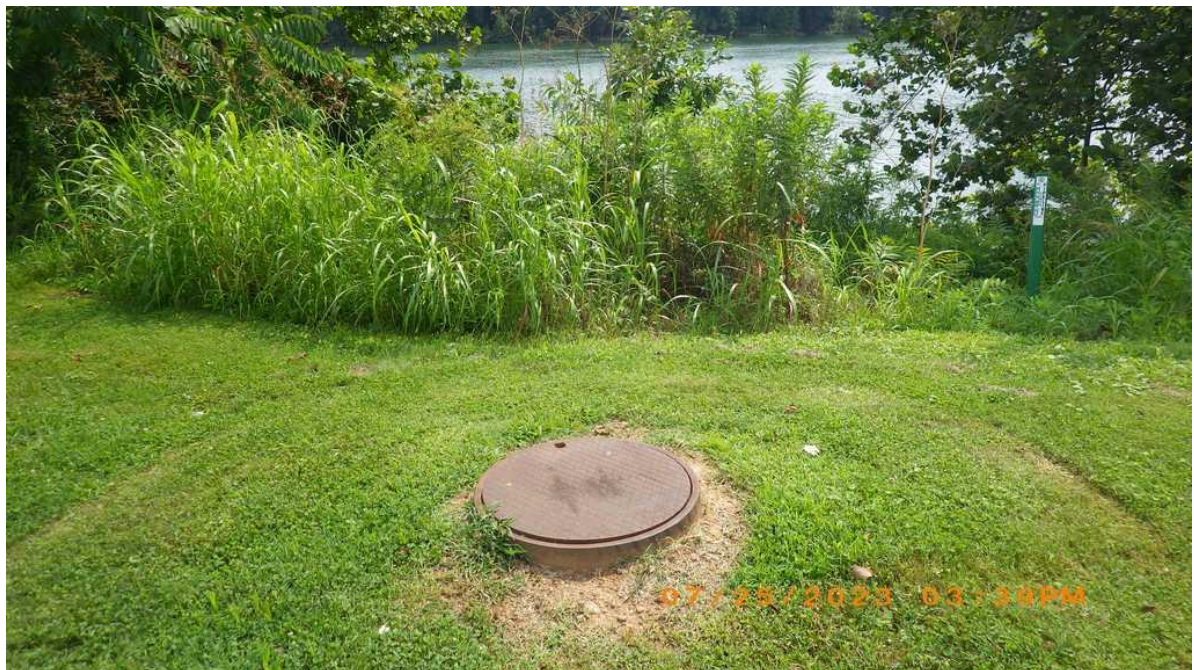
| Manhole for Outfall 002 (Ohio River) | | | MRTA0267.JPG |

Outfall 002 to the Ohio River could not be observed due to heavy vegetation (see Photo Log image MRTA0267.JPG, capturing location of Outfall 002, obscured by riverbank vegetation, and the outfall manhole). No outfall sign was observed for Outfall 002.

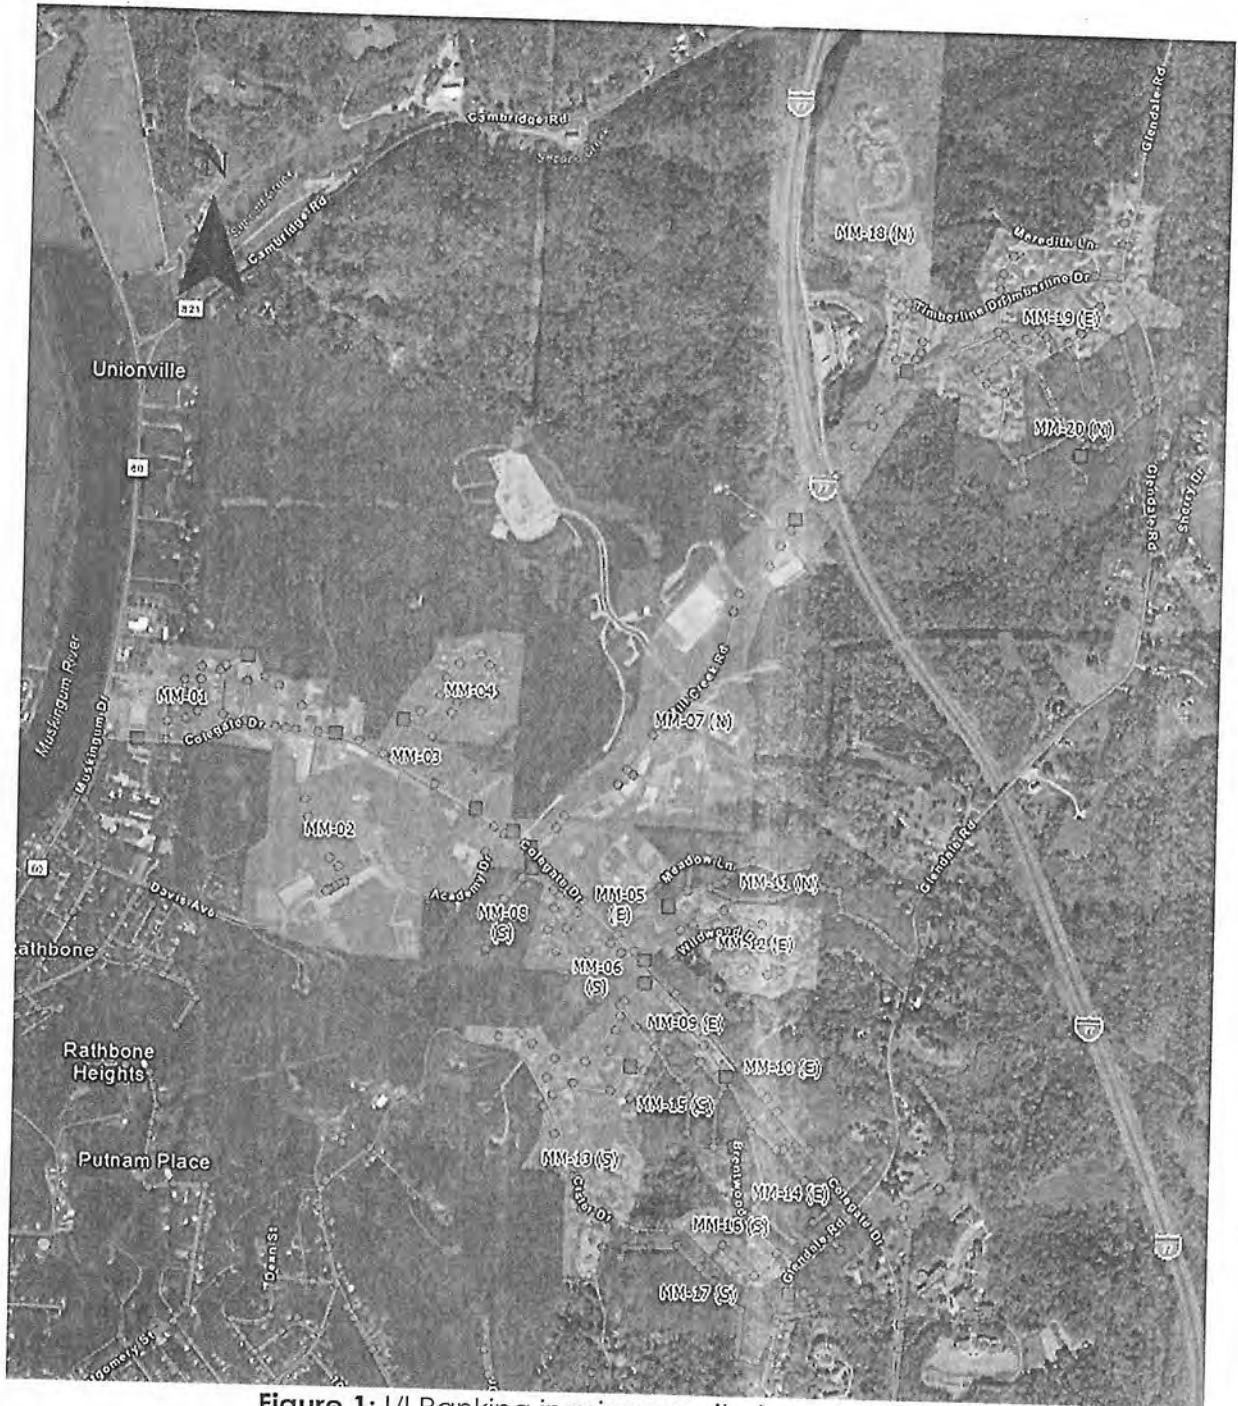
**Figure 1:** I/I Ranking in micromonitoring sub-basins  
Green is Low I/I. Yellow is Moderate I/I. Red is Excessive I/I.

The I/I classifications in Figure 1 are based off a culmination of Stantec's findings along with additional analysis of flow balance graphs. Though meter math of some sites returned negative flow balances, graphical interpretation of the flow balances can provide qualitative clues of RDII presence in these areas. As such sites 01,02,03,05,06,09,12, and 16 have been ranked by flow balance analysis. Though this approach cannot provide a quantitative value of I/I, it can provide direction for further investigation and rehabilitation.

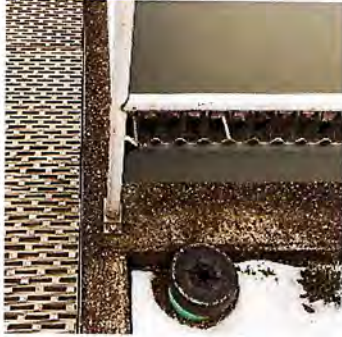
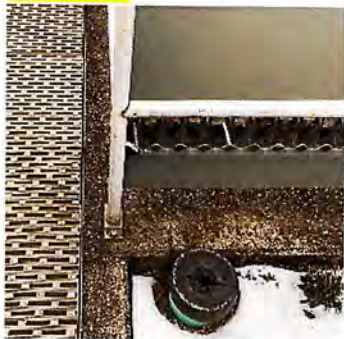
Primary Settling Tank #1  
Drain Valve

-Primary Settling Tank #1, #2, & #3 drain valves need to be shut before opening Influent Valves. These valves require a valve key to open and close them as they are located in the ground or under walkway grates. Primary Settling Tank #1 drain valve is located at the effluent end of the primary settling tank #1 next to the walkway grate. Primary Settling Tank #2 drain valve is located at the effluent end of the primary settling tank #2 under walkway grate. The grate has a hole cut in it to allow access to this valve without removing the grate. Primary Settling Tank #3 drain valve is located at the effluent end of the primary settling tank #3 in the grass area. See pictures below of the location of these three valves.

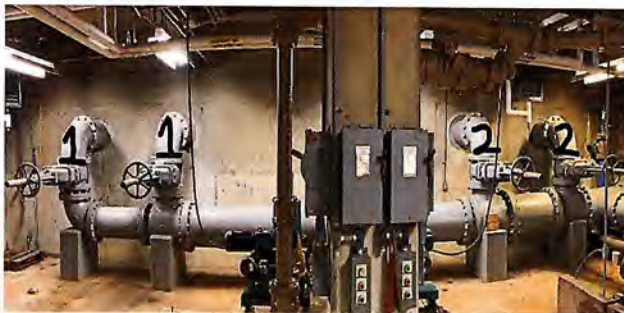
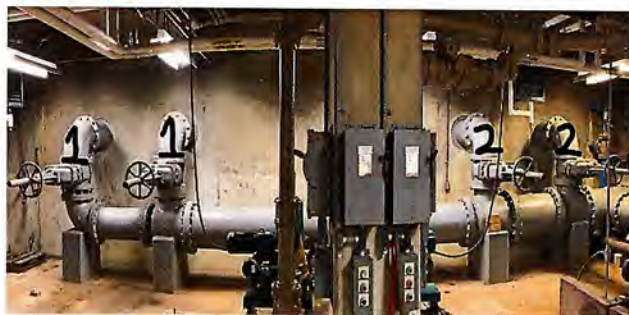
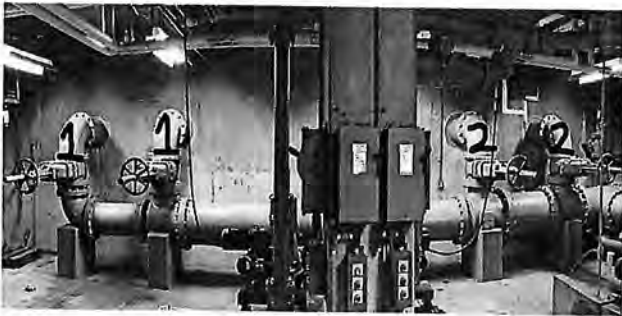
Primary Settling Tank #1 & #2  
Influent Valves

-Primary Settling Tank Influent Valves are shown in pictures below. All three tanks have two influent valves. Primary Tank #1 & #2 valves are in the basement of Bldg. L (Admin. Bldg.). Primary Tank #3 valves are located in the ground between the pre aeration tank and the Influent side of Primary Tank #3. Primary Tank #3 requires a valve key to open and close them. When putting a Primary tank in service both valves should be opened to that tank.

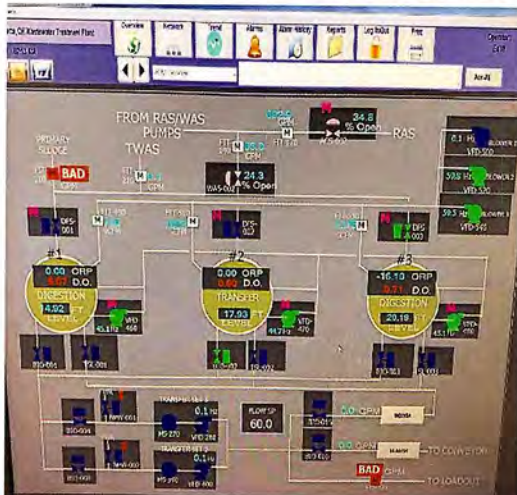
## RAS Pump Operations 2 Final Clarifiers In Service

Once RAS valves are in proper position RAS Pump #1 & RAS Pump #3 can be put in service. During normal operation one of these RAS pumps will already be in service. To put the other RAS put in service on SCADA screen select Overview then select UVB. Once on the UVB screen all 3 RAS pumps will be shown. Select remote and manual on desired pump to put in service then change the Hz to desired speed. Then select start and the pump will turn green/rotate to show the pump is running. It should be noted that when running two RAS pumps the Hz will need adjusted down on the RAS pump that is already in service and the Hz will need to be turned up on the RAS pump being put into service to overcome the head pressure and allow the RAS pump being started to equalize with the RAS pump that's already in service. It should also be noted that the RAS pumps have a tendency to become air locked and the air may need released when starting the RAS pump. The valve to bleed the RAS pumps are under the discharge lines of the RAS pumps over the drain in the floor. Once both pumps are running the Hz can be adjusted along with the RAS valve (ACS-002) to achieve desired GPM pumping rate. See pictures below of mentioned SCADA screens.

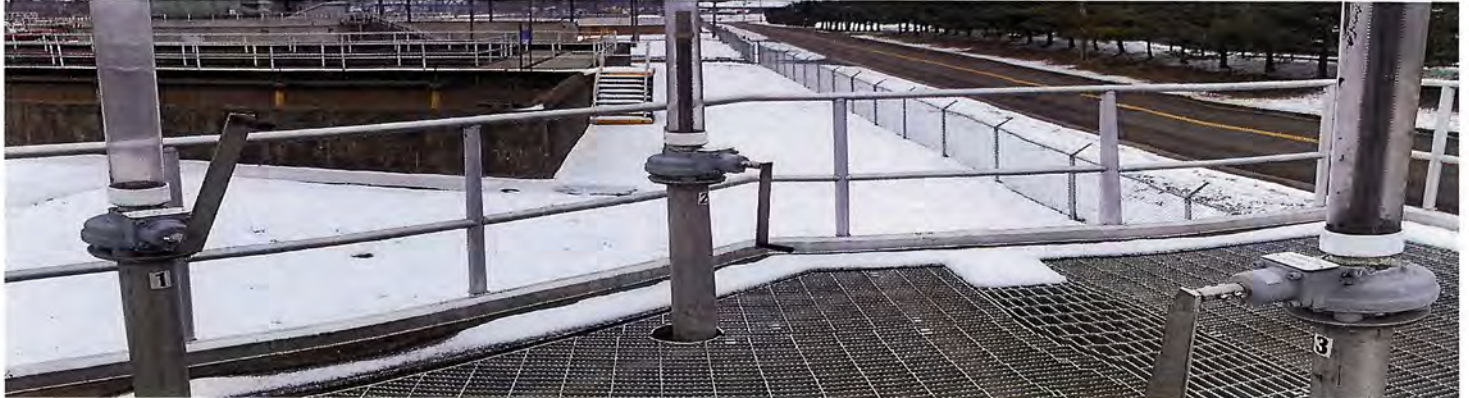
## Final Clarifiers Operation 2 Tanks in Service

On SCADA select Overview at top of page. Then select MLS (Mixed Liquor Splitter). Gate 1 & 3 feed from the Aeration Tanks to Final Clarifier # 1. To put Final Clarifier # 1 in service gate 1 & 3 need opened to 100%. Gate 2 & 4 feed from the Aeration Tanks to Final Clarifier # 2. To put Final Clarifier # 2 in service gate 2 & 4 need opened to 100%.

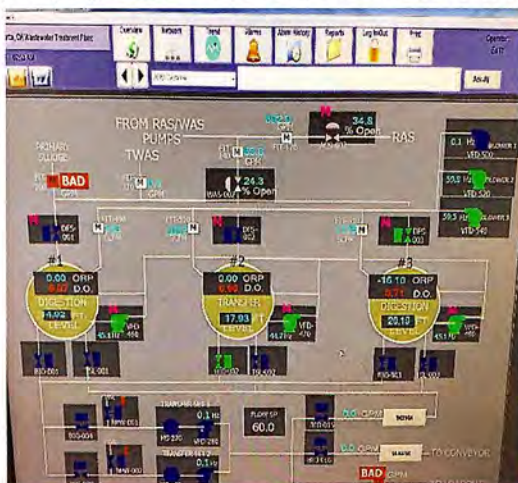
Once RAS valves are in proper position RAS Pump #1 & RAS Pump #3 can be put in service. During normal operation one of these RAS pumps will already be in service. To put the other RAS put in service on SCADA screen select Overview then select UVB. Once on the UVB screen all 3 RAS pumps will be shown. Select remote and manual on desired pump to put in service then change the Hz to desired speed. Then select start and the pump will turn green/rotate to show the pump is running. It should be noted that when running two RAS pumps the Hz will need adjusted down on the RAS pump that is already in service and the Hz will need to be turned up on the RAS pump being put into service to overcome the head pressure and allow the RAS pump being started to equalize with the RAS pump that's already in service. It should also be noted that the RAS pumps have a tendency to become air locked and the air may need released when starting the RAS pump. The valve to bleed the RAS pumps are under the discharge lines of the RAS pumps over the drain in the floor. Once both pumps are running the Hz can be adjusted along with the RAS valve (ACS-002) to achieve desired GPM pumping rate. See pictures below of mentioned SCADA screens.
