**INSPECTION AND SAMPLING REPORT  
CWA, RCRA, TSCA**

**DuPont Circleville  
Circleville, Ohio 43113**

**Report Date: December 3, 2021 (Revised 2/15/2024)**

**Inspection and Sampling Activities: September 13-16, 2021**

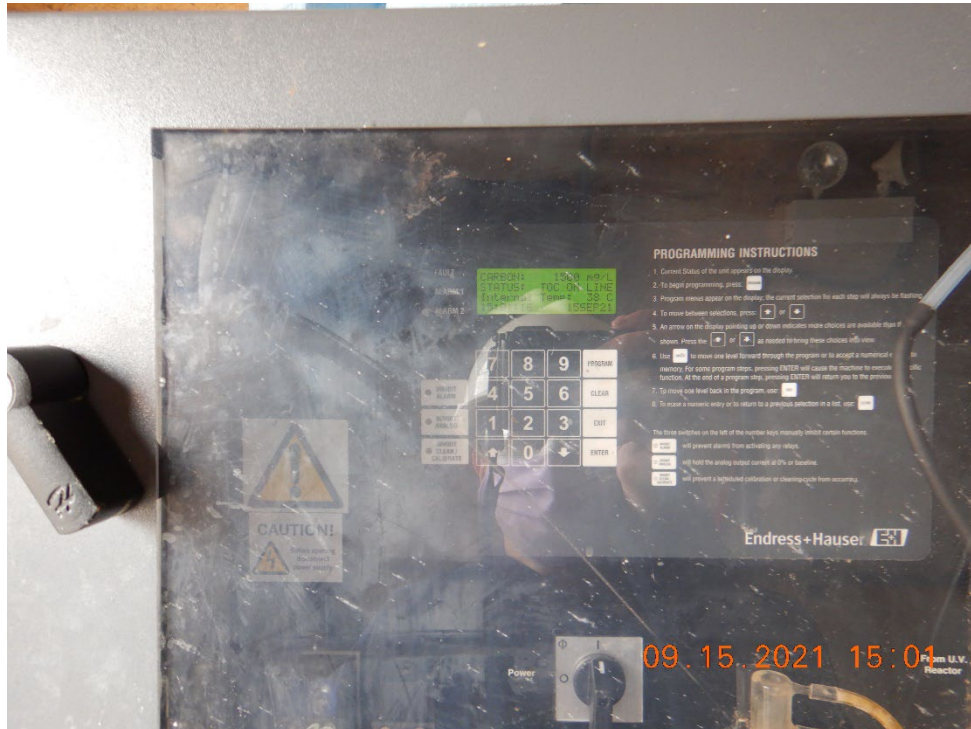
**CWA Photo 1.** View of the KSR1 TOC analyzer, which read 1,500 mg/l (ppm) at the time of the inspection.

- The KSR1 and KSR2 analyzers, which are for the Kapton Solvent Recovery area, have a setpoint of 5,100 ppm TOC. The Inspection Team observed the KSR1 analyzer read 1,500 mg/L and the KSR2 analyzer read 150 mg/L on September 15, 2021 (refer to CWA Photos 1 and 2). Facility representatives believed KSR1 was falsely reading high and required maintenance at the time of the inspection. Additionally, the time shown on the KSR2 analyzer was off by one hour at the time of the inspection.

Facility representatives believed the KSR1 TOC analyzer was falsely reading high and required maintenance at the time of the inspection. The Inspection Team observed the KSR1 analyzer read 1,500 mg/L on September 15, 2021 (refer to CWA Photo 1). Additionally, at the time of the inspection, the KSR2 TOC analyzer was off by approximately one hour (refer to CWA Photo 2) and the K2 analyzer was off by approximately 1 hour and 40 minutes (refer to CWA Photos 5 and 6).

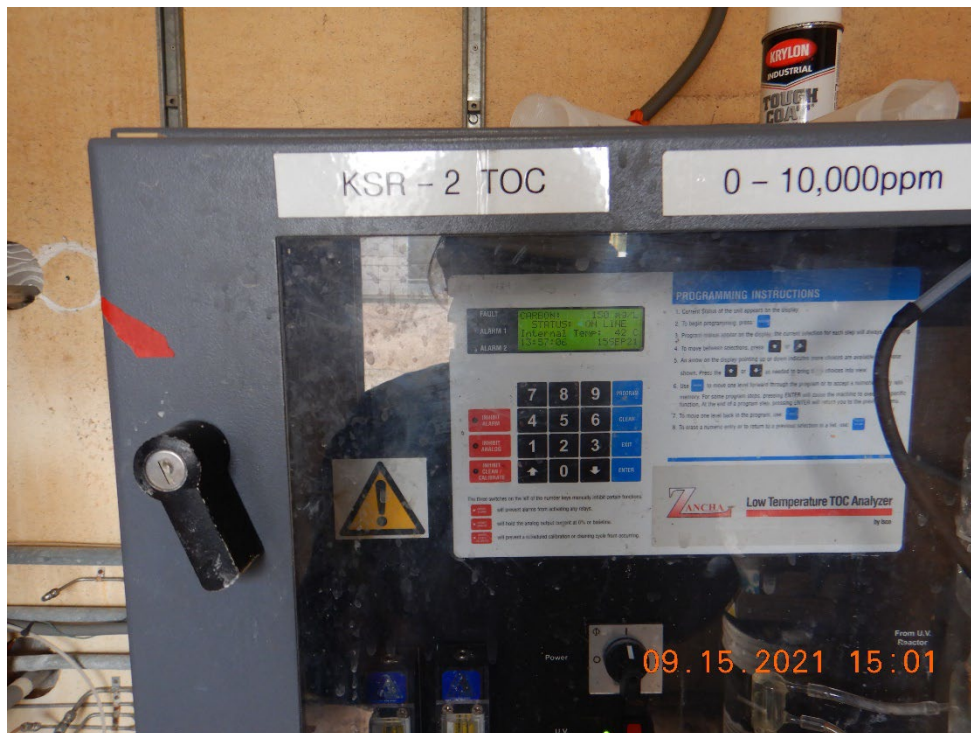
**CWA Photo 2.** View of the KSR2 TOC analyzer, which read 150 mg/l (ppm) at the time of the inspection. The time reading on this analyzer was off by approximately one hour.

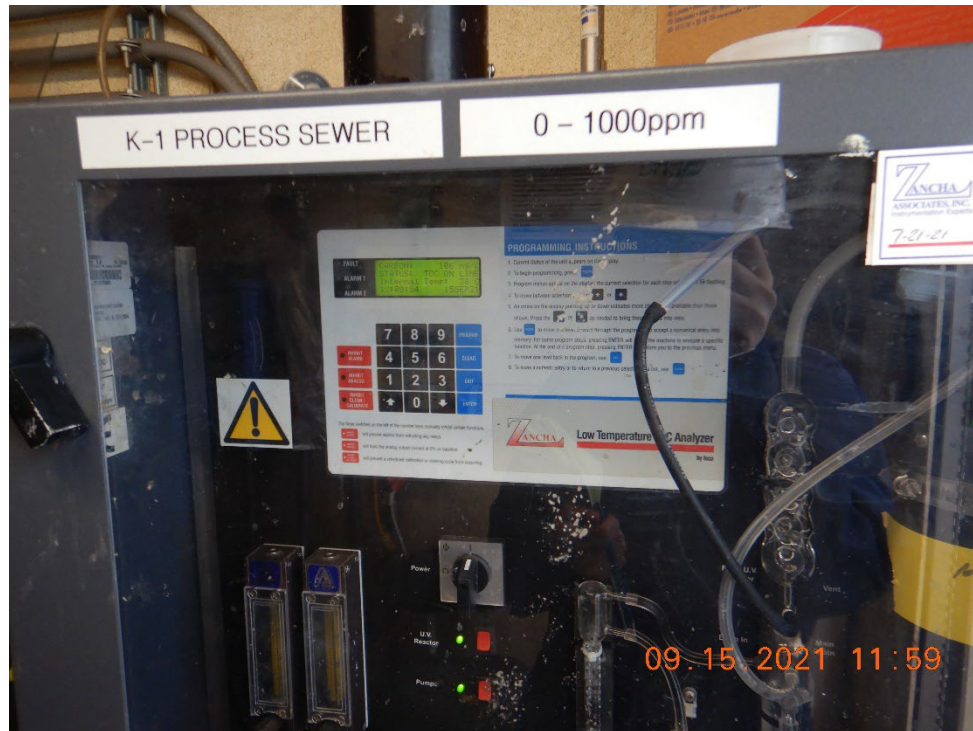
**CWA Photo 3.** View of the K1 TOC analyzer, which read 106 mg/l (ppm) at the time of the inspection on 9/15/2021.

- The K1 analyzer, which is for wastewater from Kapton Building K1 and Teflon, has a setpoint of 600 ppm TOC. The Inspection Team observed the K1 analyzer read 106 mg/L on September 15, 2021, and 185 mg/L on September 16, 2021, at the time of sampling (Sample point SK1) (refer to CWA Photos 3 and 4).

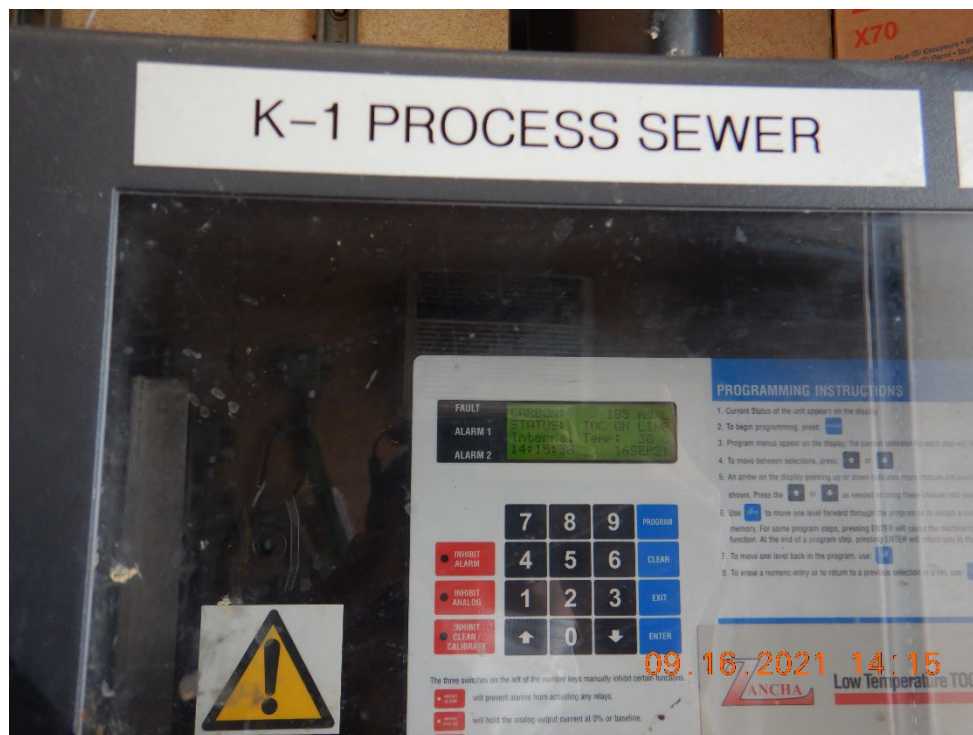
**CWA Photo 4.** View of the K1 TOC analyzer, which read 185 mg/l (ppm) at the time of the sampling on 9/16/2021.

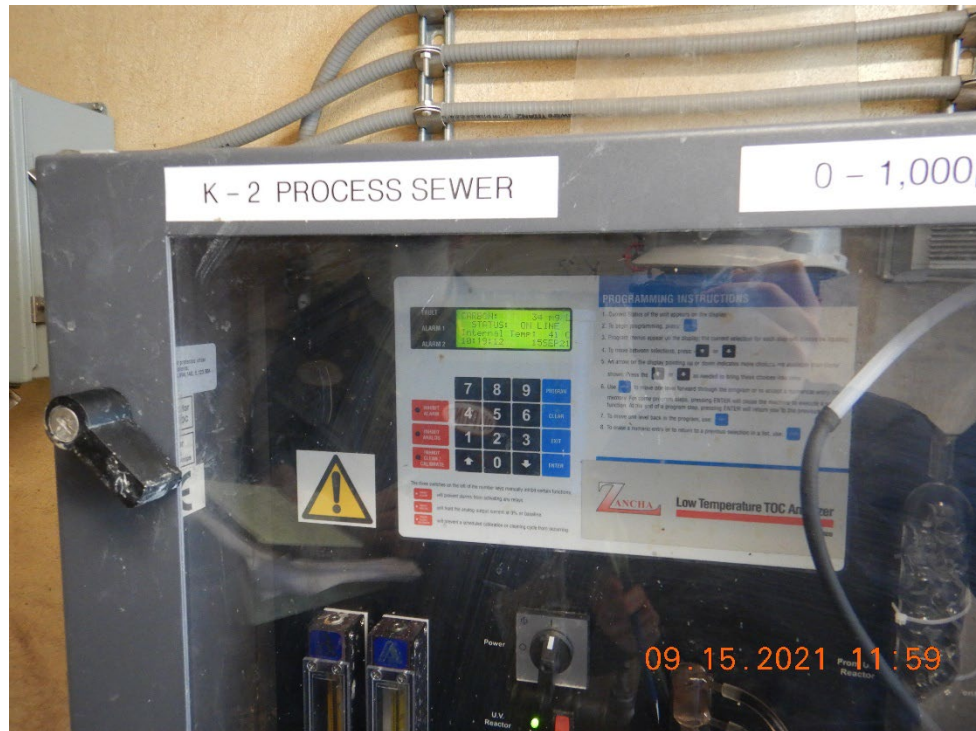
**CWA Photo 5.** View of the K2 TOC analyzer, which read 34 mg/l (ppm) at the time of the inspection on 9/15/2021. The time reading on this analyzer was off by 1 hour and 40 minutes.

- The K2 analyzer, which is for wastewater from Kapton Buildings K2 and K3, Kapton chemical area building, and Vespel SBR effluent, has a setpoint of 600 ppm TOC. The Inspection Team observed the K2 analyzer read 34 mg/L on September 15, 2021, and 12 mg/L on September 16, 2021, at the time of sampling (Sample point SK2) (refer to CWA Photos 5 and 6). The time shown on the K2 analyzer was off by approximately 1 hour and 40 minutes at the time of the inspection.

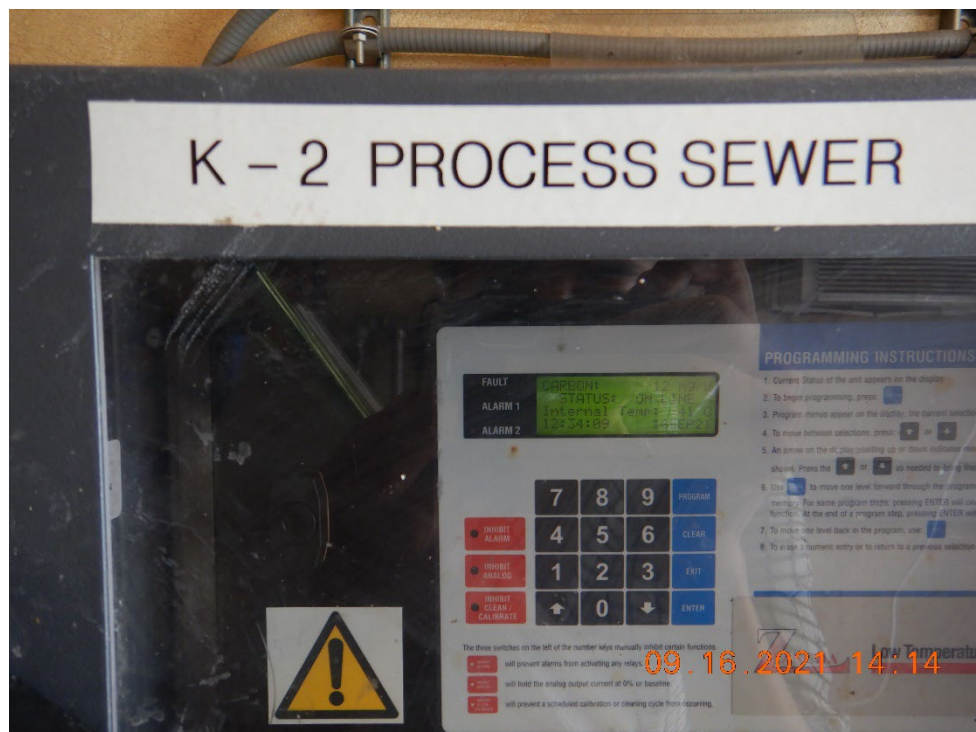
**CWA Photo 6.** View of the K2 TOC analyzer, which read 12 mg/l (ppm) at the time of the sampling on 9/16/2021. The time reading on this analyzer was off by 1 hour and 40 minutes.

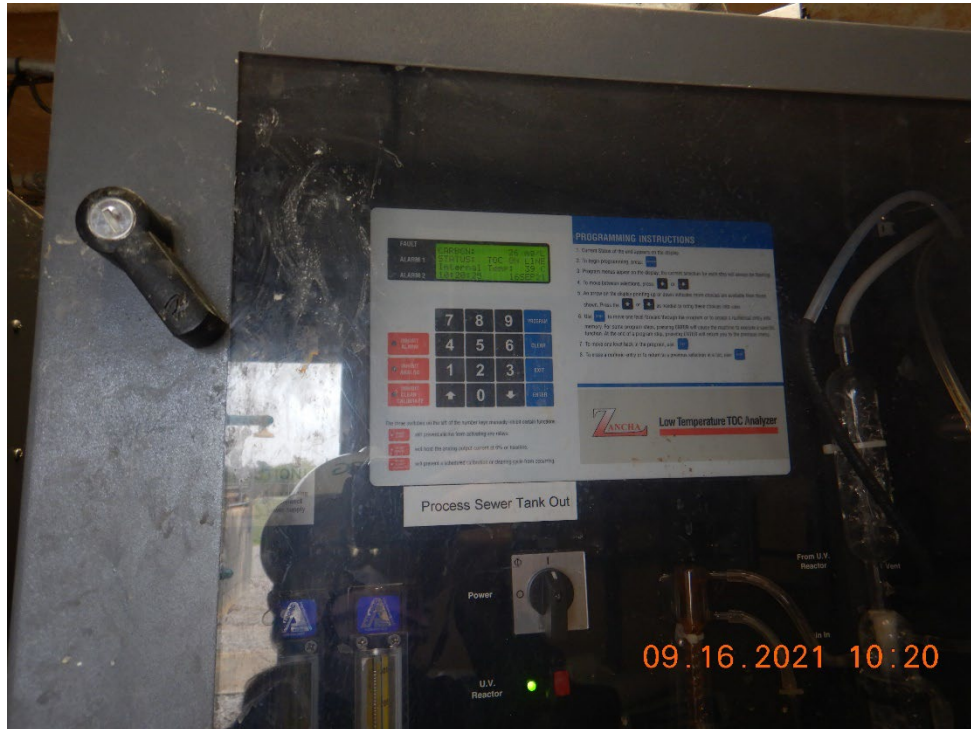
**CWA Photo 7.** View of the Tedlar process sewer tank TOC analyzer, which read 26 mg/l (ppm) at the time of the inspection on 9/16/2021.

200 ppm TOC. The Inspection Team observed the K2 analyzer read 26 mg/L on September 16, 2021 (refer to CWA Photo 7).

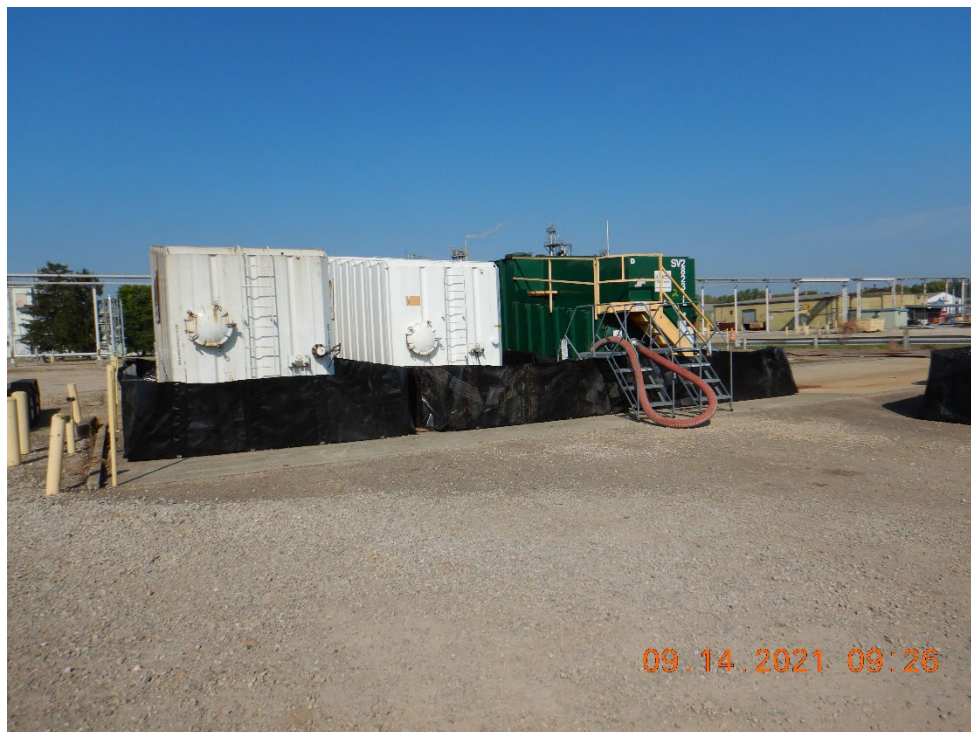
**CWA Photo 8.** View of the frac tanks being used for intermediate waste storage prior to disposal in the North Lagoon or off site.

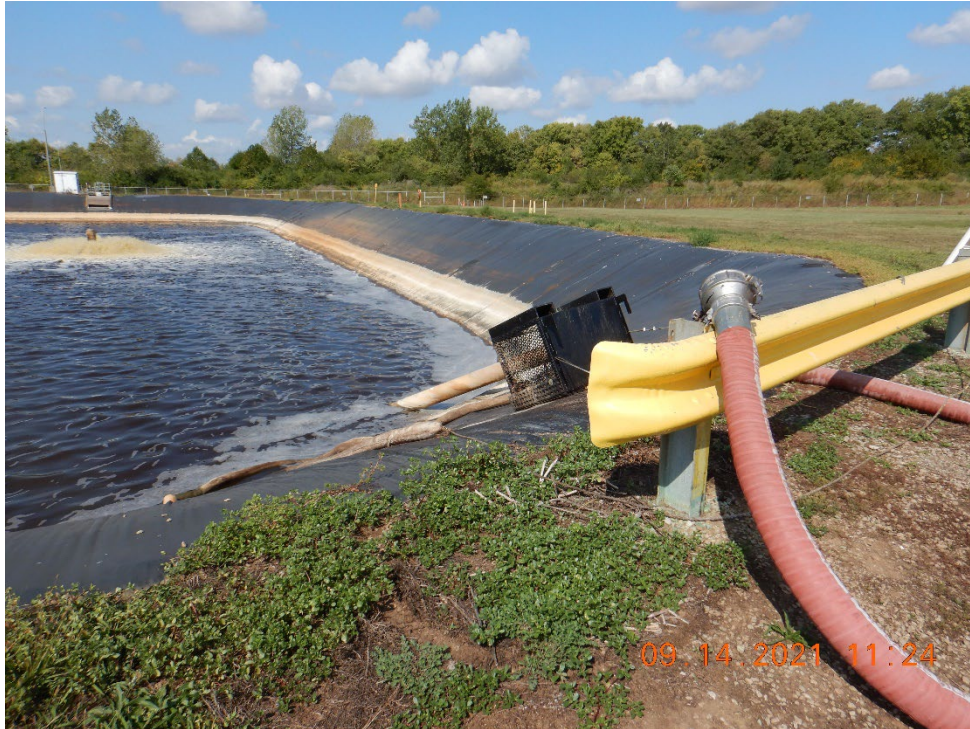
**CWA Photo 9.** View of the hose used to transfer high organics concentration wastewater, collected by vacuum trucks such as those used at the frac tanks, to the North Lagoon.

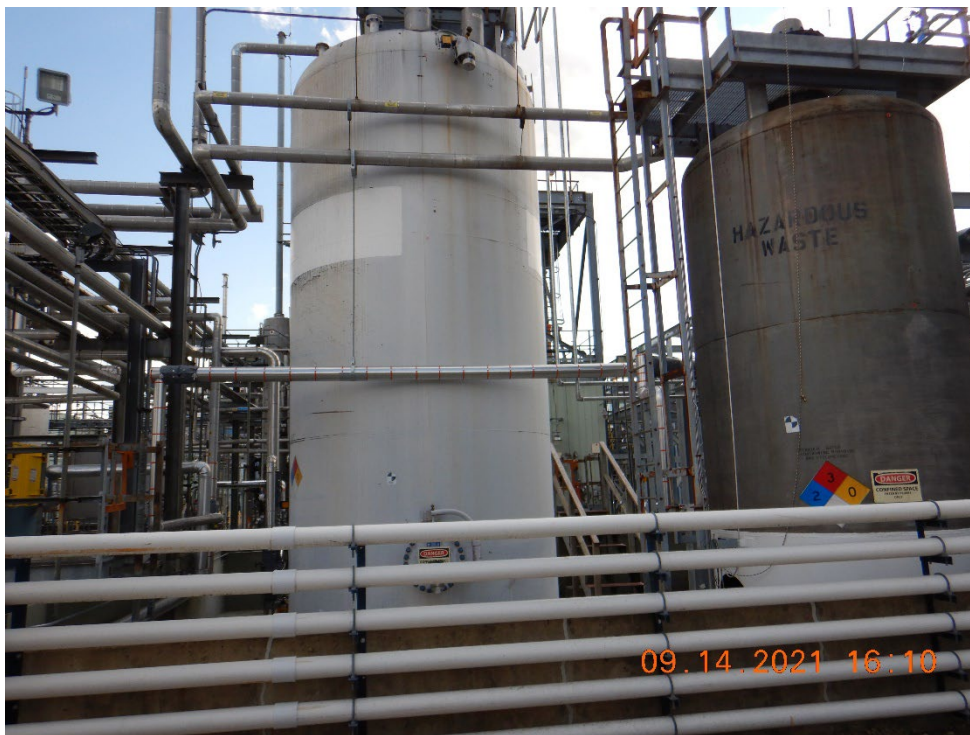
**CWA Photo 10.** View of the 20,000-gal wastewater tank that feeds the Vespel SBRs (white tank).

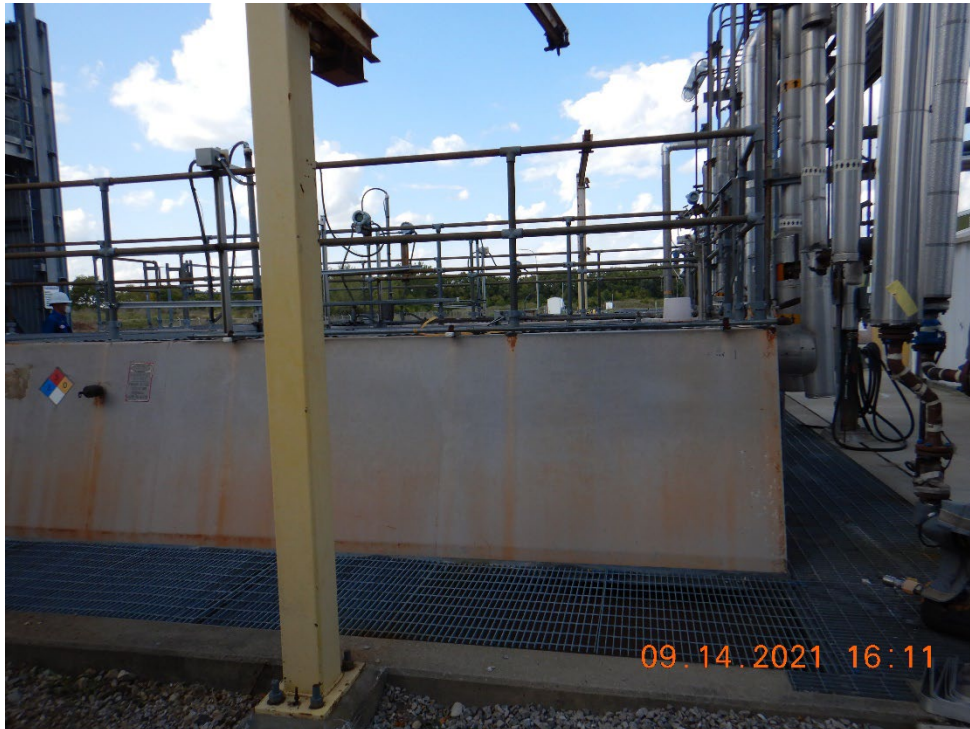
**CWA Photo 11.** View of one of the VespeL SBRs, which was not discharging at the time of the inspection because VespeL was shut down for routine maintenance at the time of the inspection.

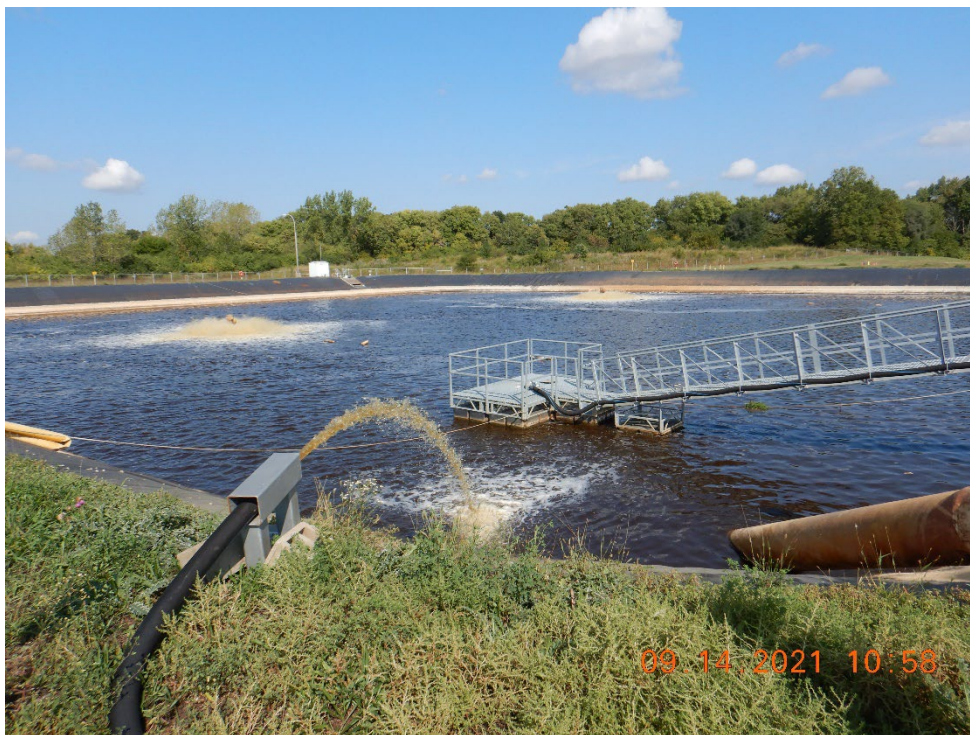
**CWA Photo 12.** View of the North Lagoon, which was not discharging to the South Lagoon at the time of the inspection. The hose viewed in the photo is a recirculation line.

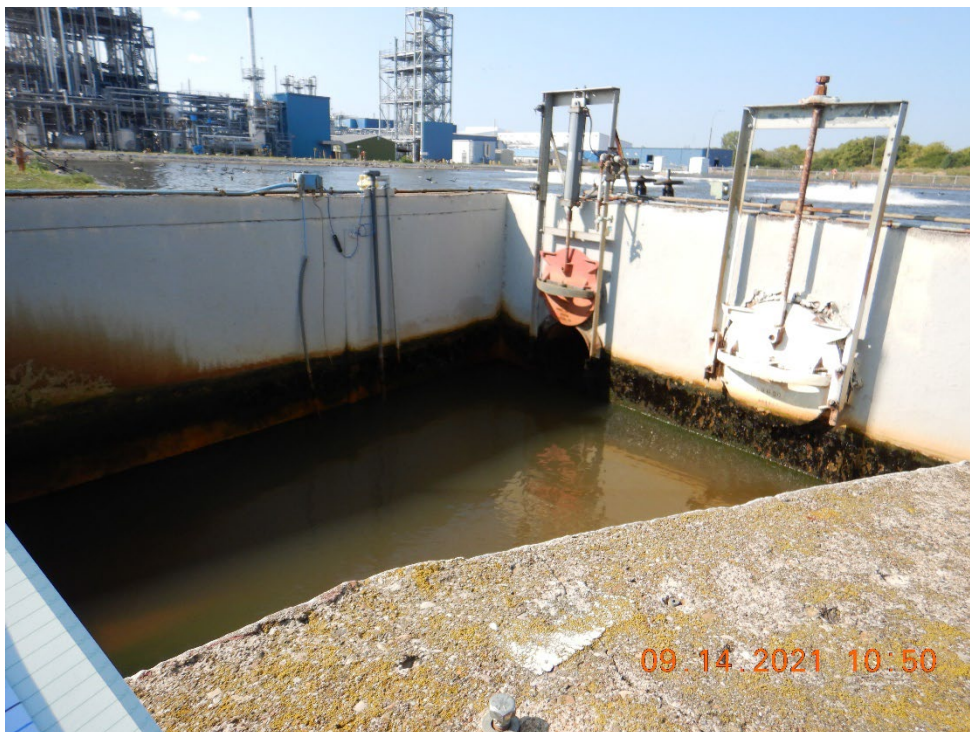
**CWA Photo 14.** View of the diversion box through which wastewater flows to the aerated lagoons. Wastewater was flowing through the left pipe at the time of the inspection, corresponding to the South Lagoon.

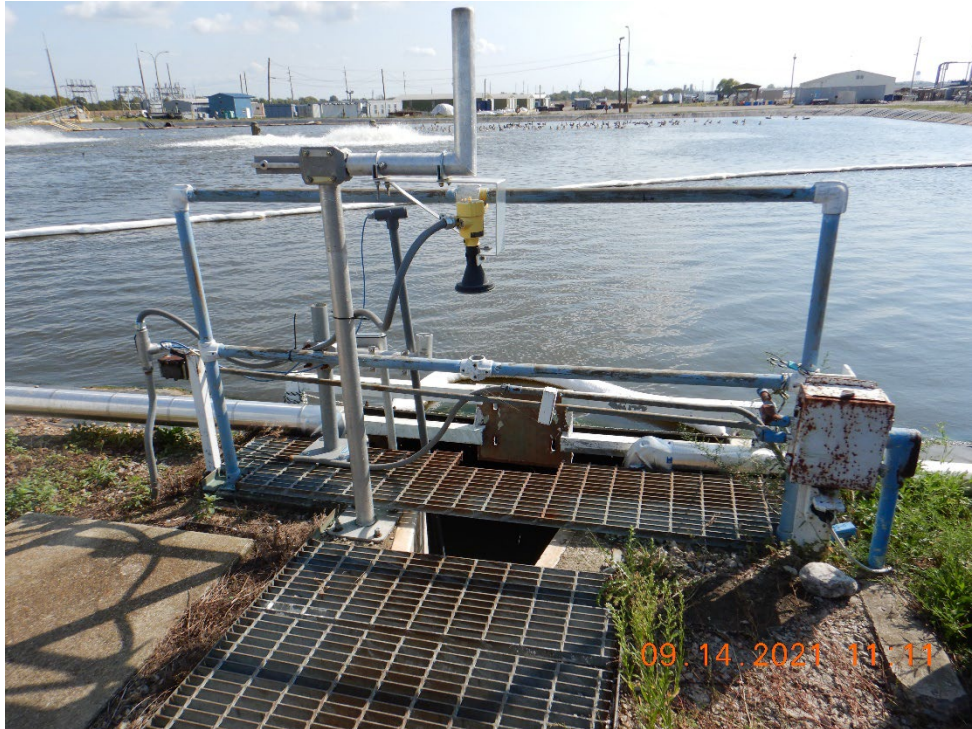
**CWA Photo 15.** View of the Outfall 602 flume, through which there was a consistent discharge from the South Lagoon at the time of the inspection.

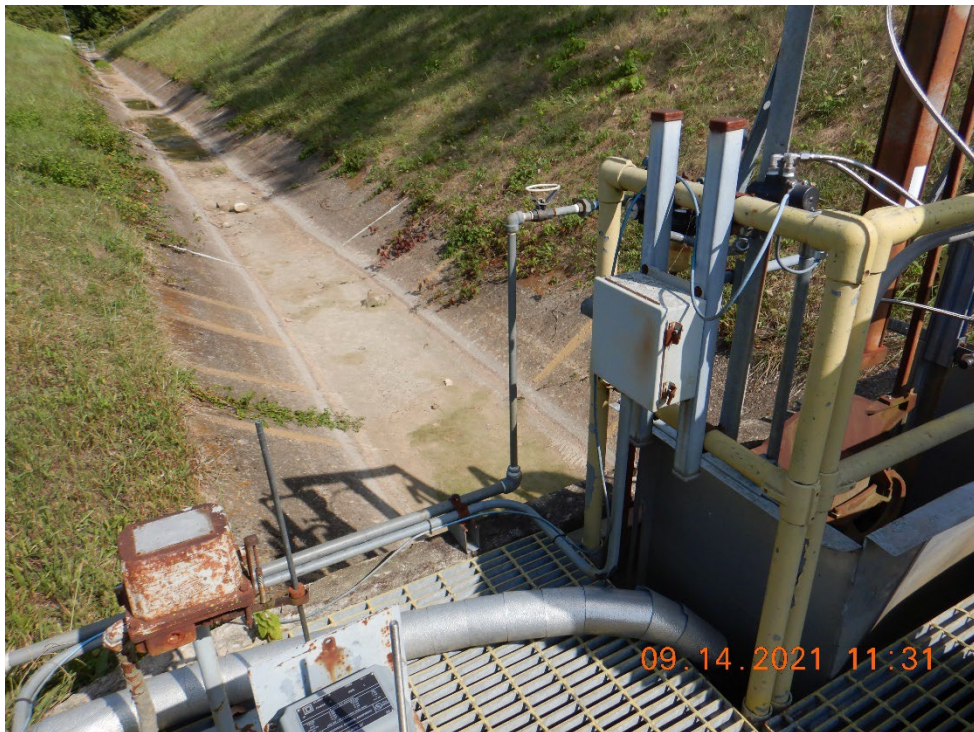
**CWA Photo 18.** View, facing North, towards Outfall 001, of the concrete ditch used to convey stormwater and NCCW to Outfall 001. Flow was not sufficient to reach Outfall 001 at the time of the inspection.

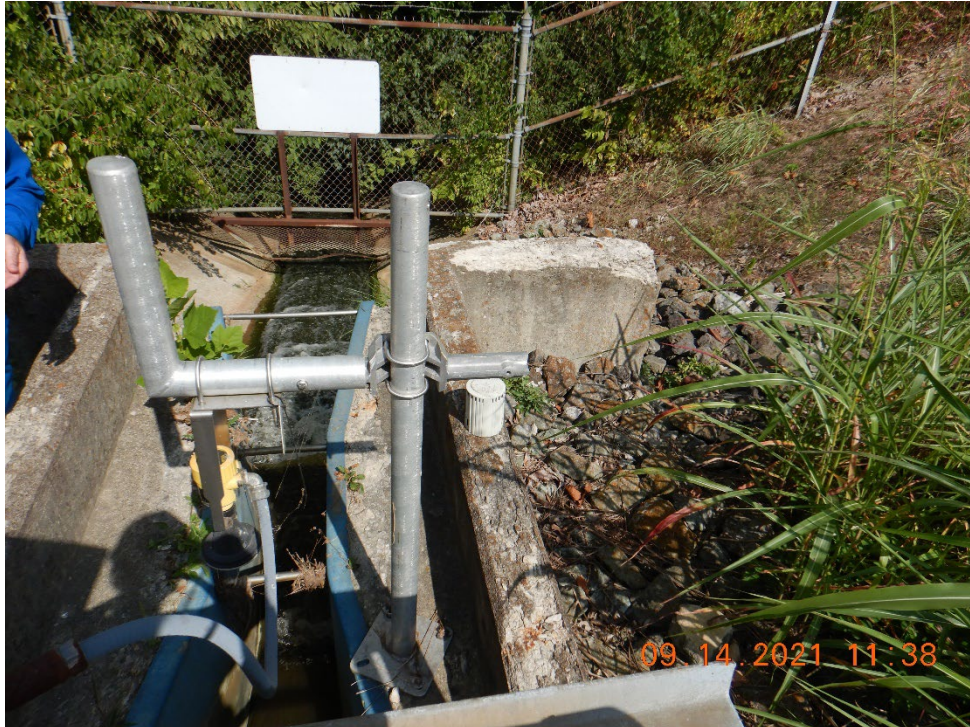
**CWA Photo 19.** View of the Outfall 001 flume, through which there was consistent discharge at the time of the inspection.

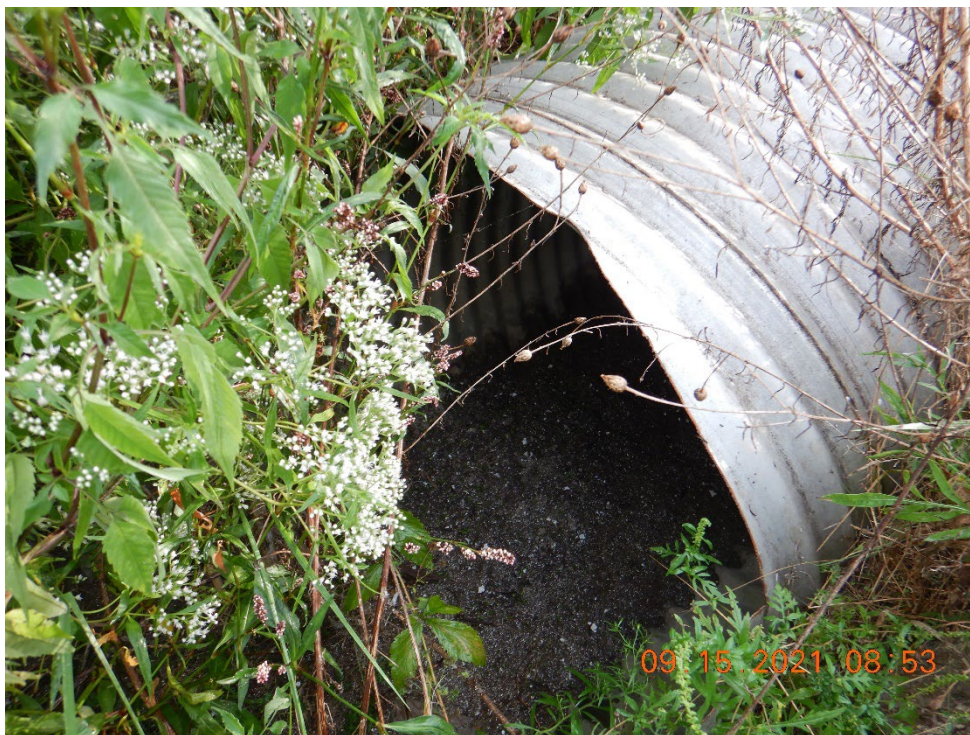
**CWA Photo 20.** View of stormwater Outfall 003, which was not discharging at the time of the inspection.

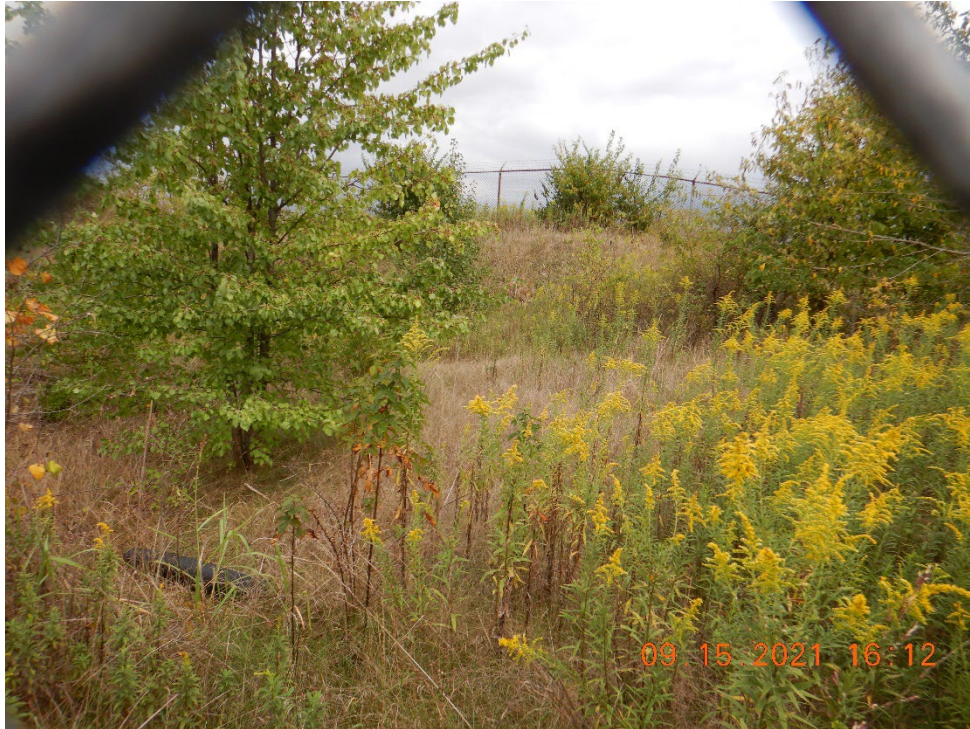
**CWA Photo 21.** View of the discharge area for stormwater Outfall 004. No flow was observed in this area at the time of the inspection.

The Inspection Team inspected Outfalls 001, 003, and 004. The Inspection Team did not inspect Outfall 002. The Inspection Team observed very low flow in the stormwater/NCCW concrete ditch upstream of Outfall 001 after a minor rain event on September 15, 2021. This flow was not sufficient to reach Outfall 001. The Inspection Team sampled this slowly flowing water from the diversion point in the concrete ditch. The Inspection Team observed that Outfall 003 was a corrugated metal pipe that leads to an open grassy area and was not discharging during the inspection (refer to CWA Photo 20). The Inspection Team observed that the secondary containment trench for Outfall 004 is associated with storage of drums of deicing fluid, sodium hydroxide, oil, and other chemicals. The Inspection Team was unable to locate the discharge point for the containment trench; however, the Inspection Team observed the Outfall 004 discharge location was an open vegetated area and did not observe any flow in the area at the time of the inspection (refer to CWA Photo 21).

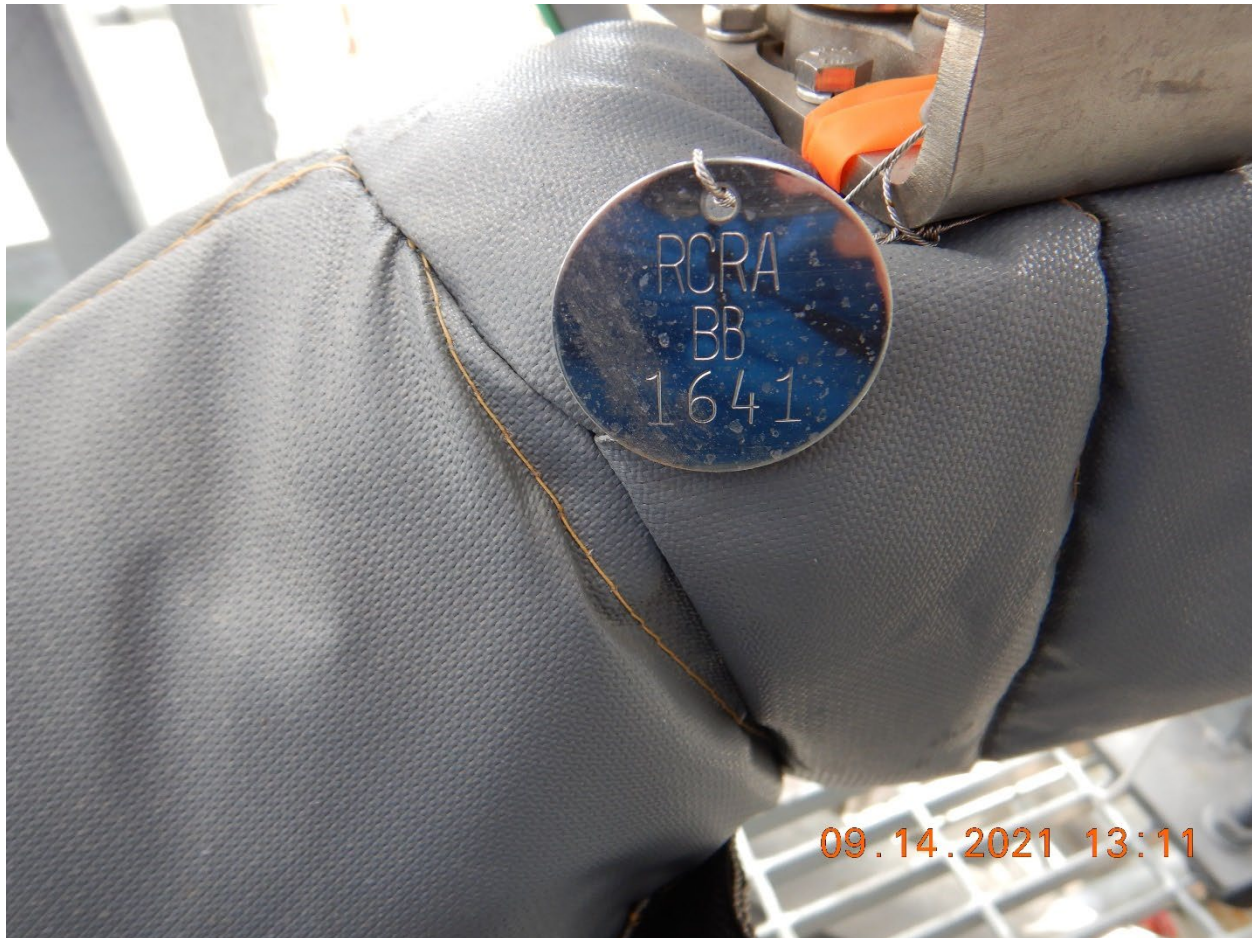
**RCRA Photo 7.** Close-up view of the lines underneath the P-12 decanter tank shown in Photo 6. This photo was taken to show an example of the facility's RCRA subpart BB tagging system.

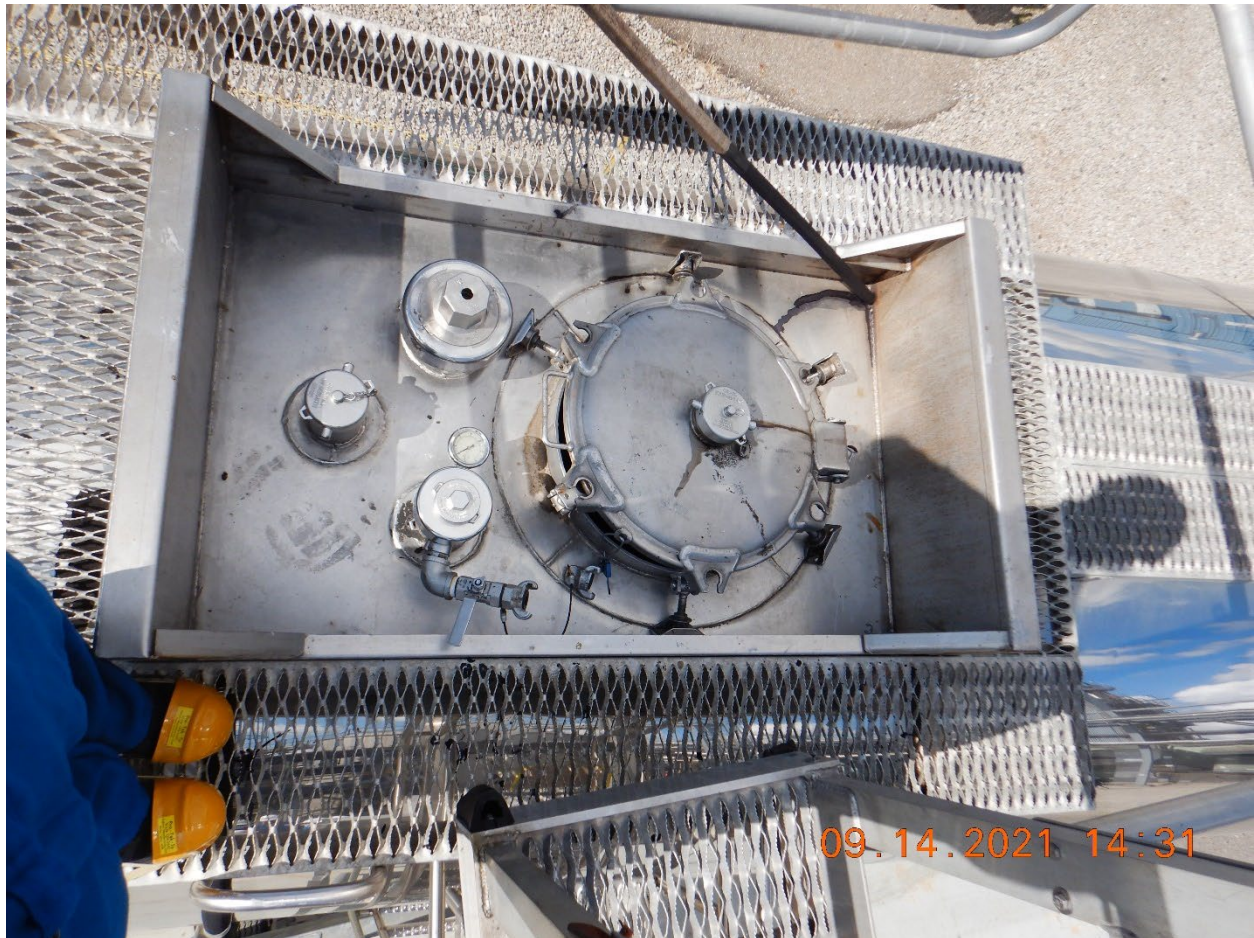
**RCRA Photo 15.** A view of the manway cover on the tanker trailer LT-1087 accumulating hazardous waste photographed in Photo 16. The manway cover was unlatched and venting to the atmosphere.

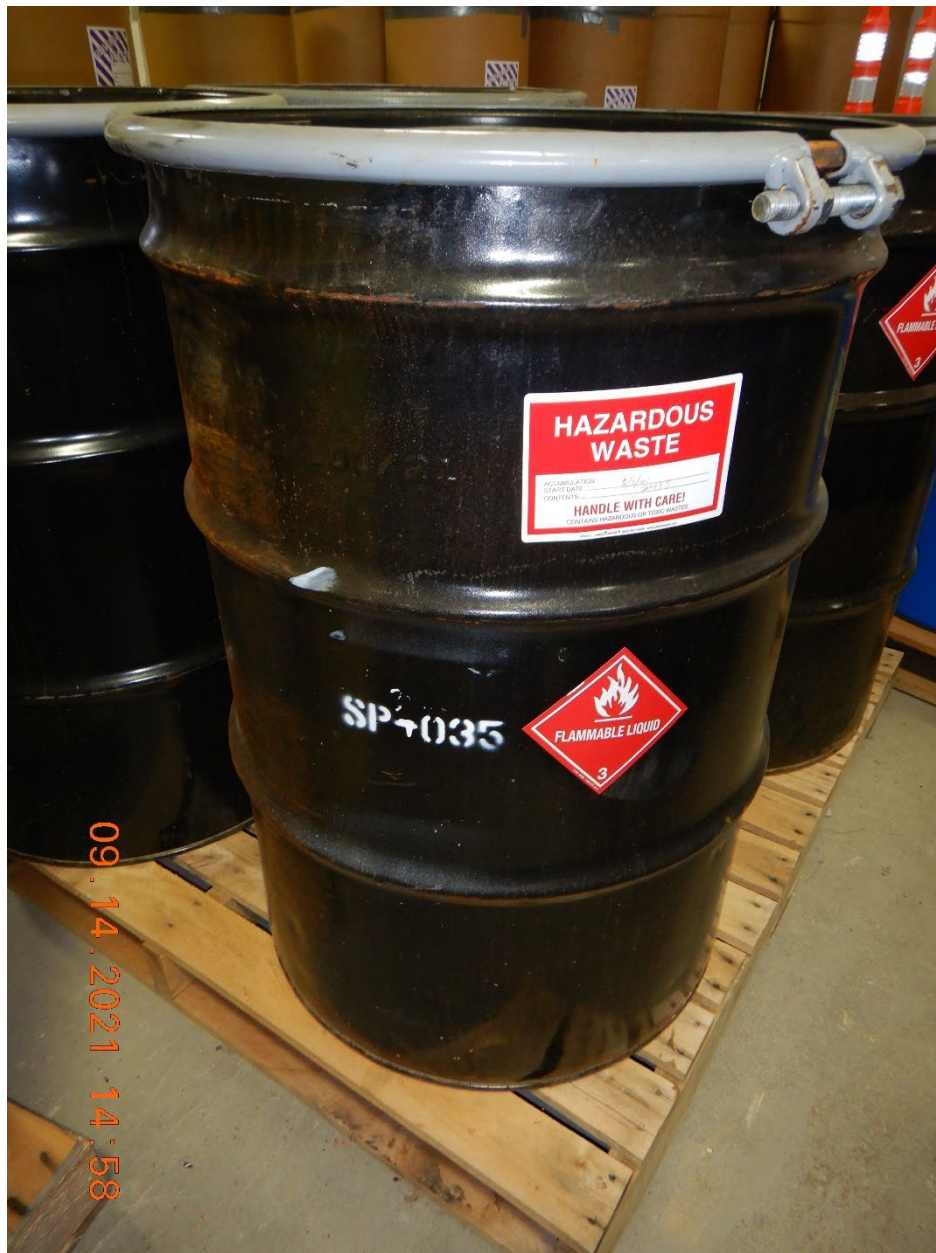
**RCRA Photo 17.** A view of one of four 55-gallon hazardous waste containers located in the facility's Building 510 CAA. The containers had an accumulation date of "6/30/2021". This date is over the 90-day accumulation limit for the facility's CAA.

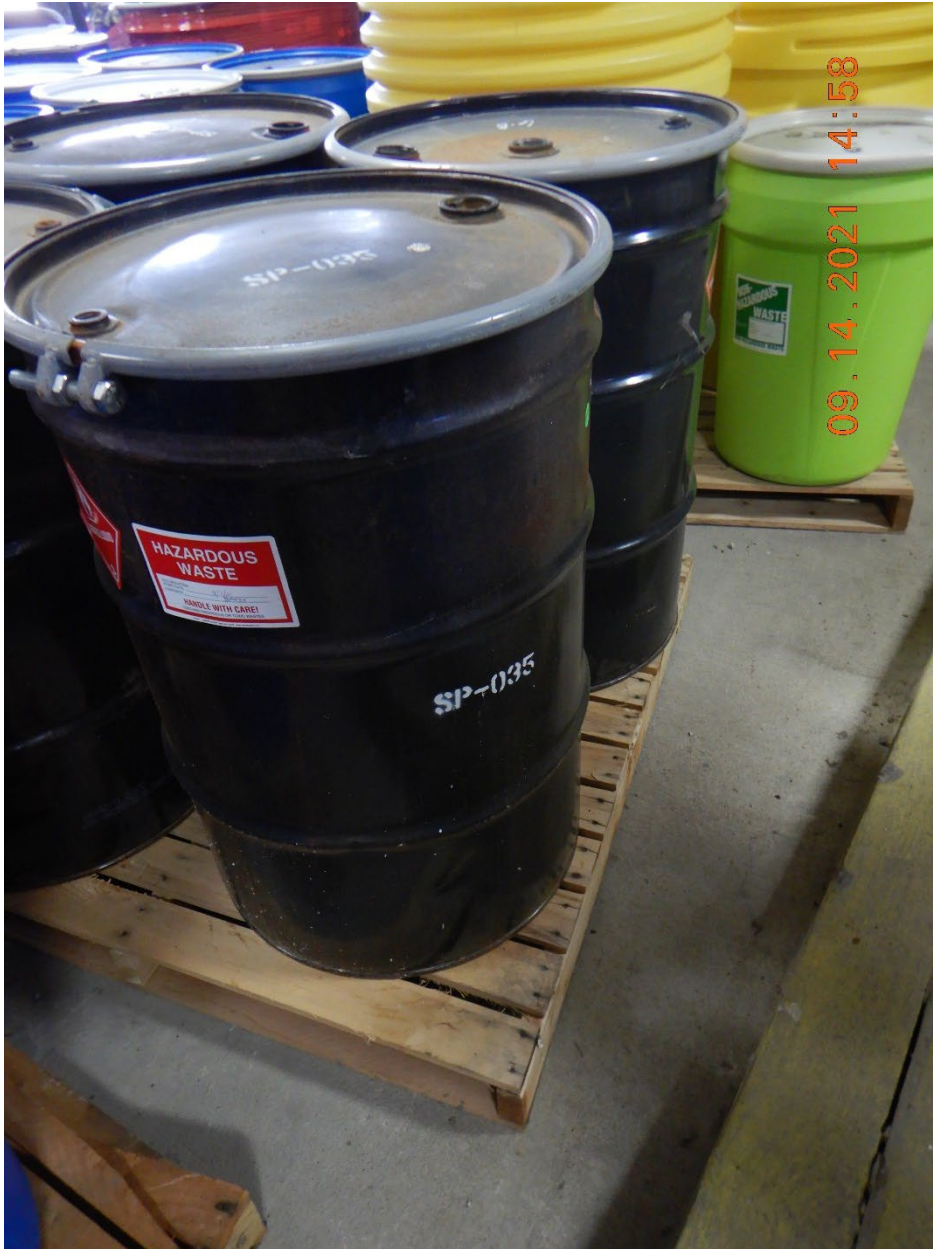
**RCRA Photo 20.** Overview of all four 55-gallon hazardous waste containers described in Photo 17.

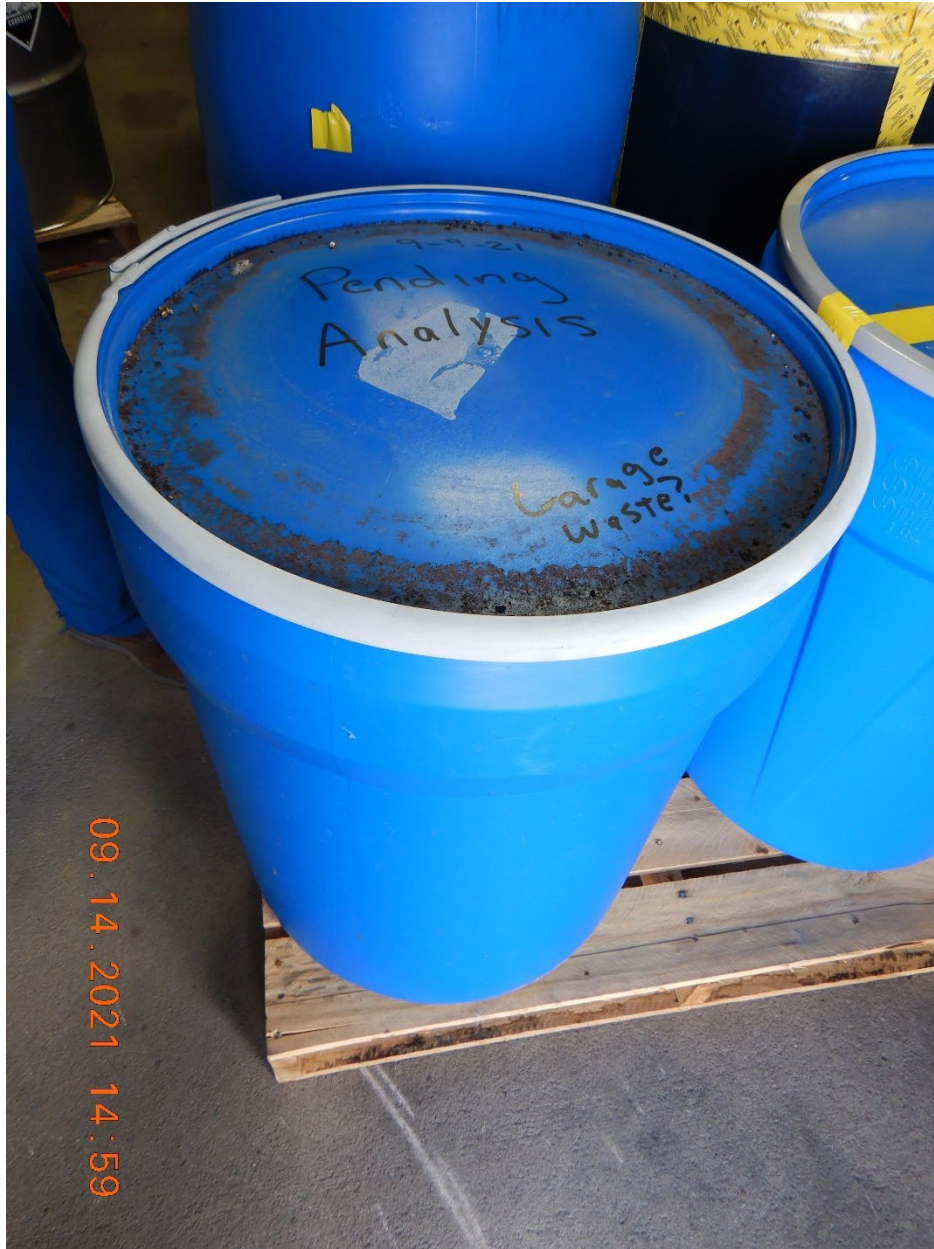
**RCRA Photo 21.** A view of a 55-gallon waste container labeled as “Pending Analysis” in the facility’s Building 510 CAA.

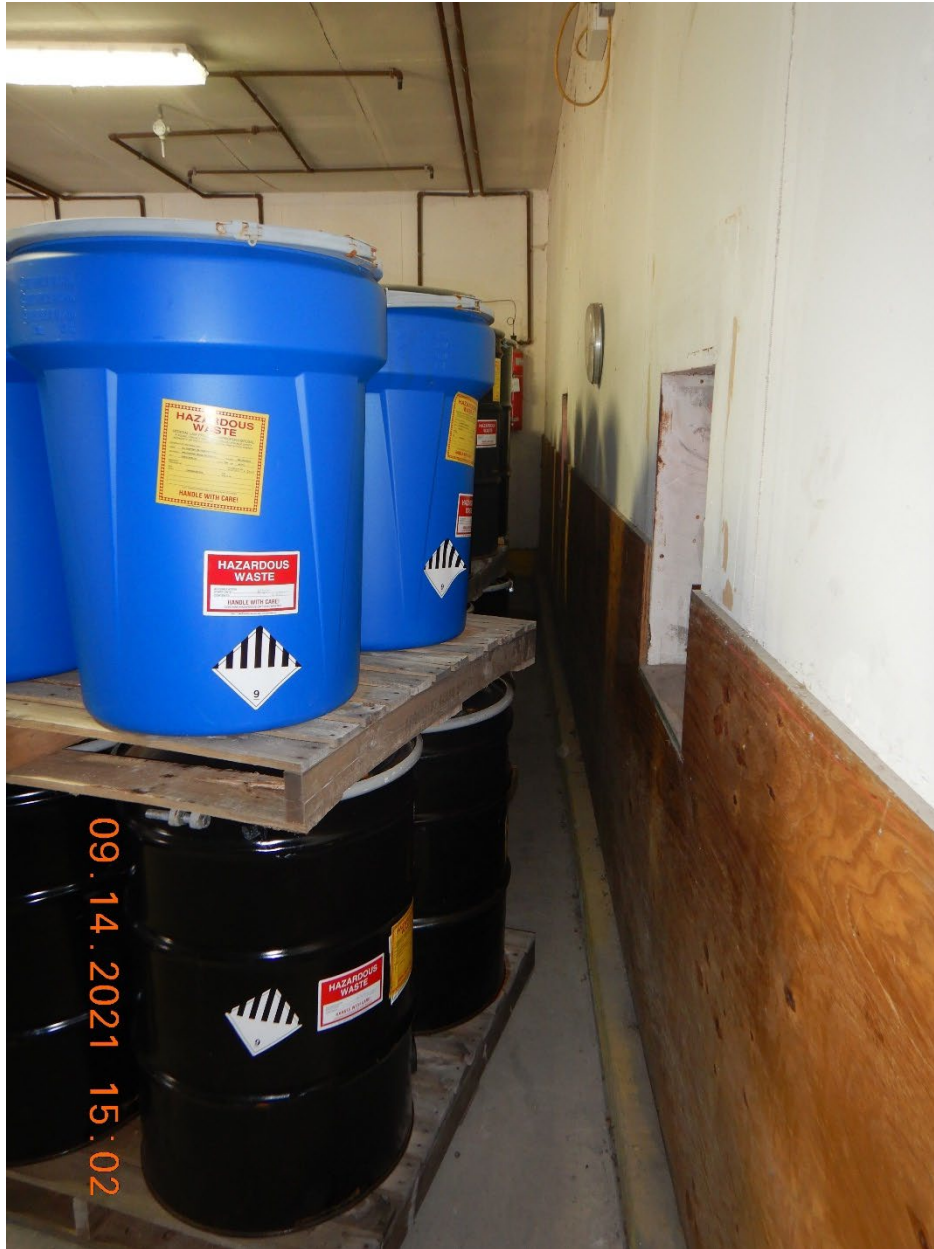
**RCRA Photo 22.** A view of the tight aisle space between hazardous waste containers located in Building 510 CAA.

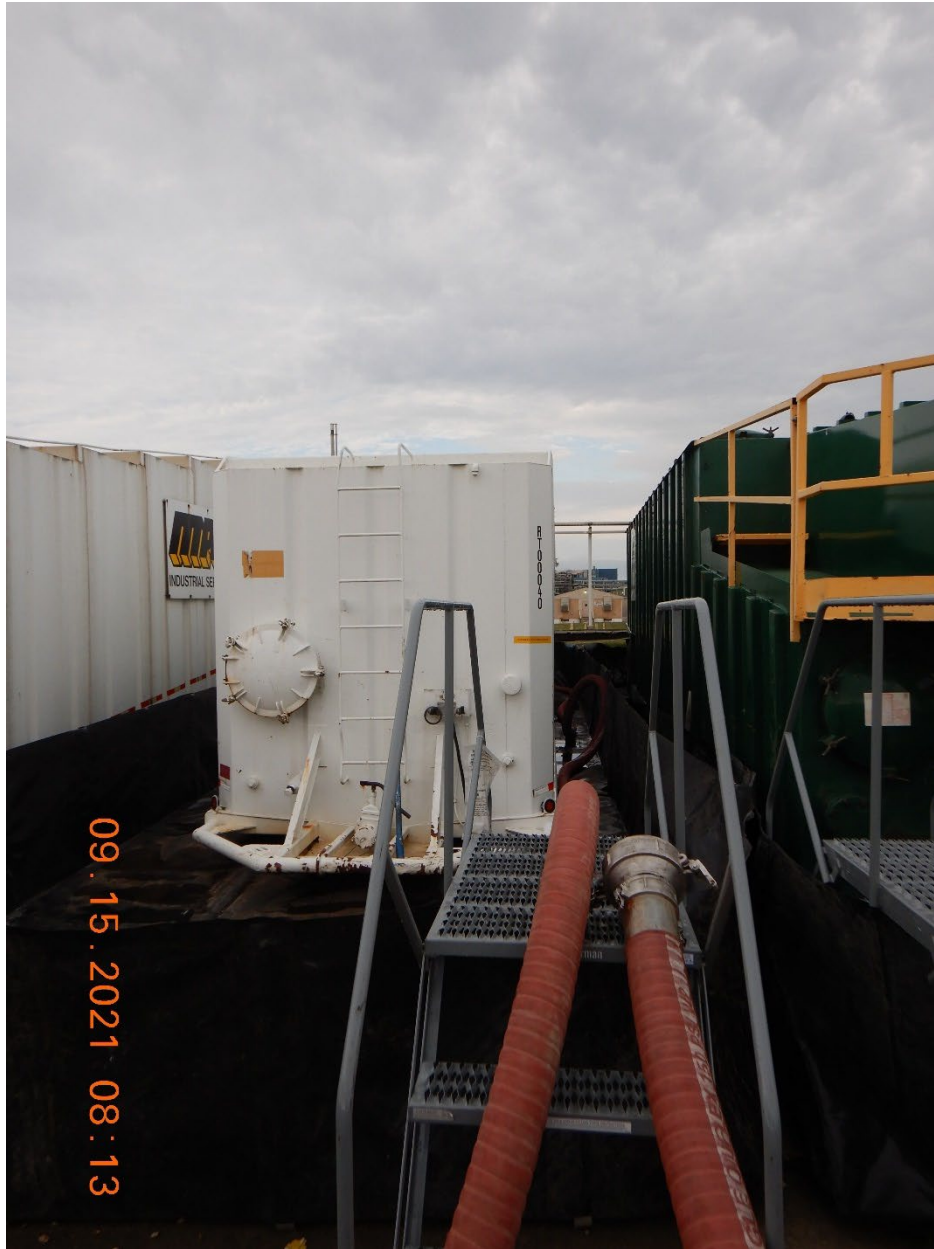
**RCRA Photo 23.** A view of frac tank RT00040 that was labeled with “Hazardous Waste – Pending Analysis” on the side of the tank.
