**INSPECTION AND SAMPLING REPORT  
CWA, RCRA, TSCA**

**DuPont Circleville  
Circleville, Ohio 43113**

**Report Date: December 3, 2021 (Revised 2/15/2024)**

**Inspection and Sampling Activities: September 13-16, 2021**

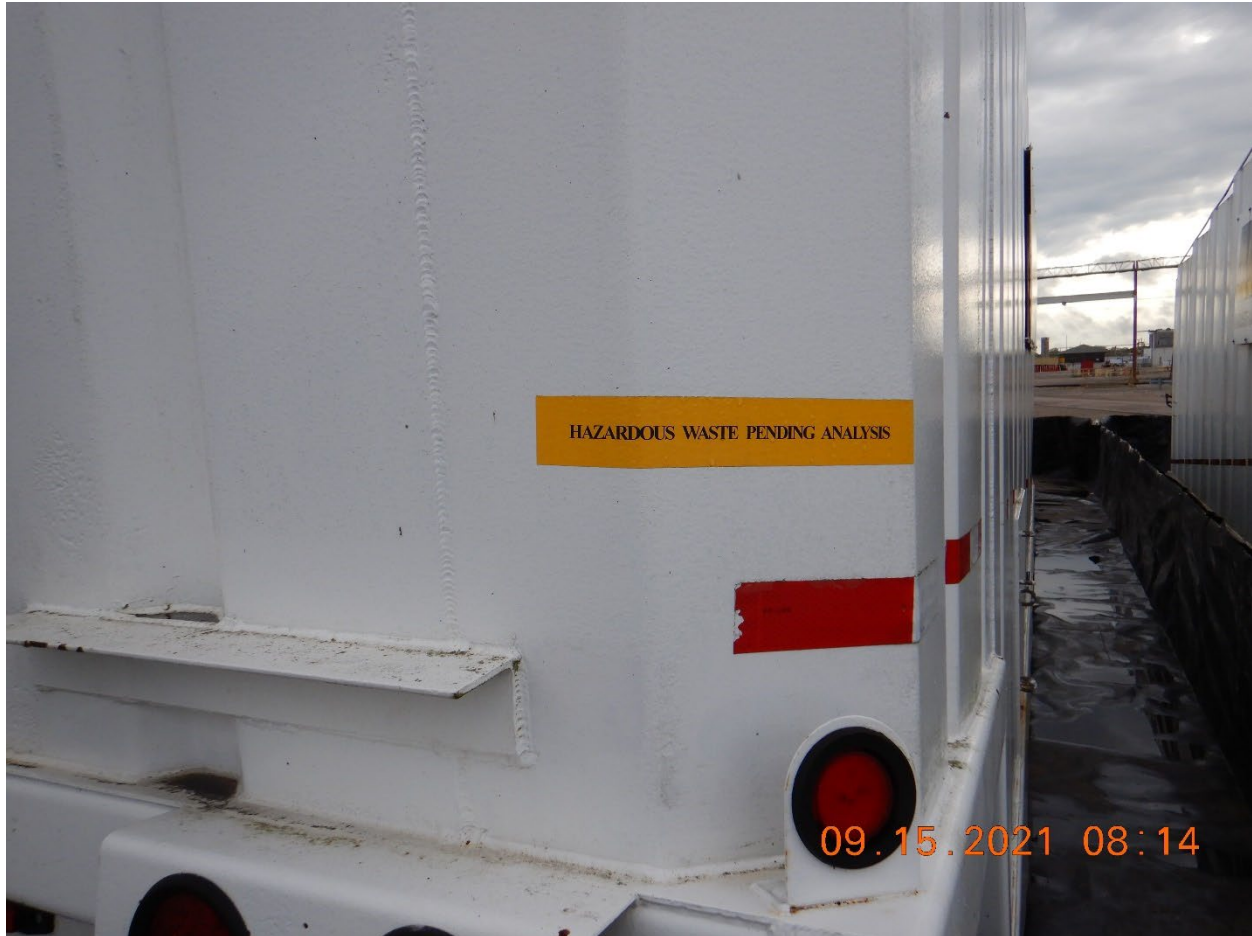
**RCRA Photo 25.** A close-up view of the labeled observed on frac tank RT00040.

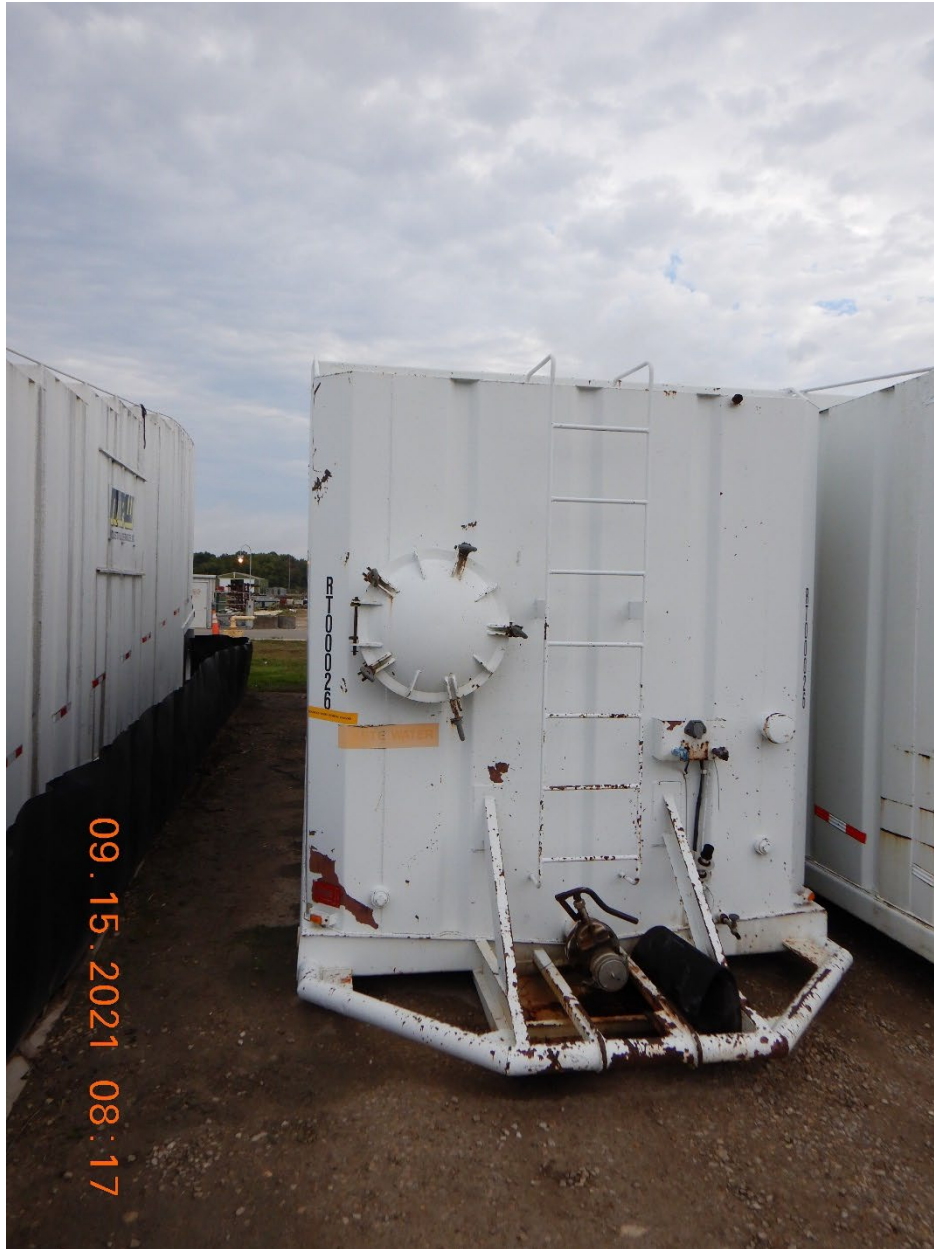
**RCRA Photo 26.** A view of frac tank RT00026 that was also labeled with “Hazardous Waste – Pending Analysis” on the side of the tank as seen on frac tank RT00040 in Photo 25.

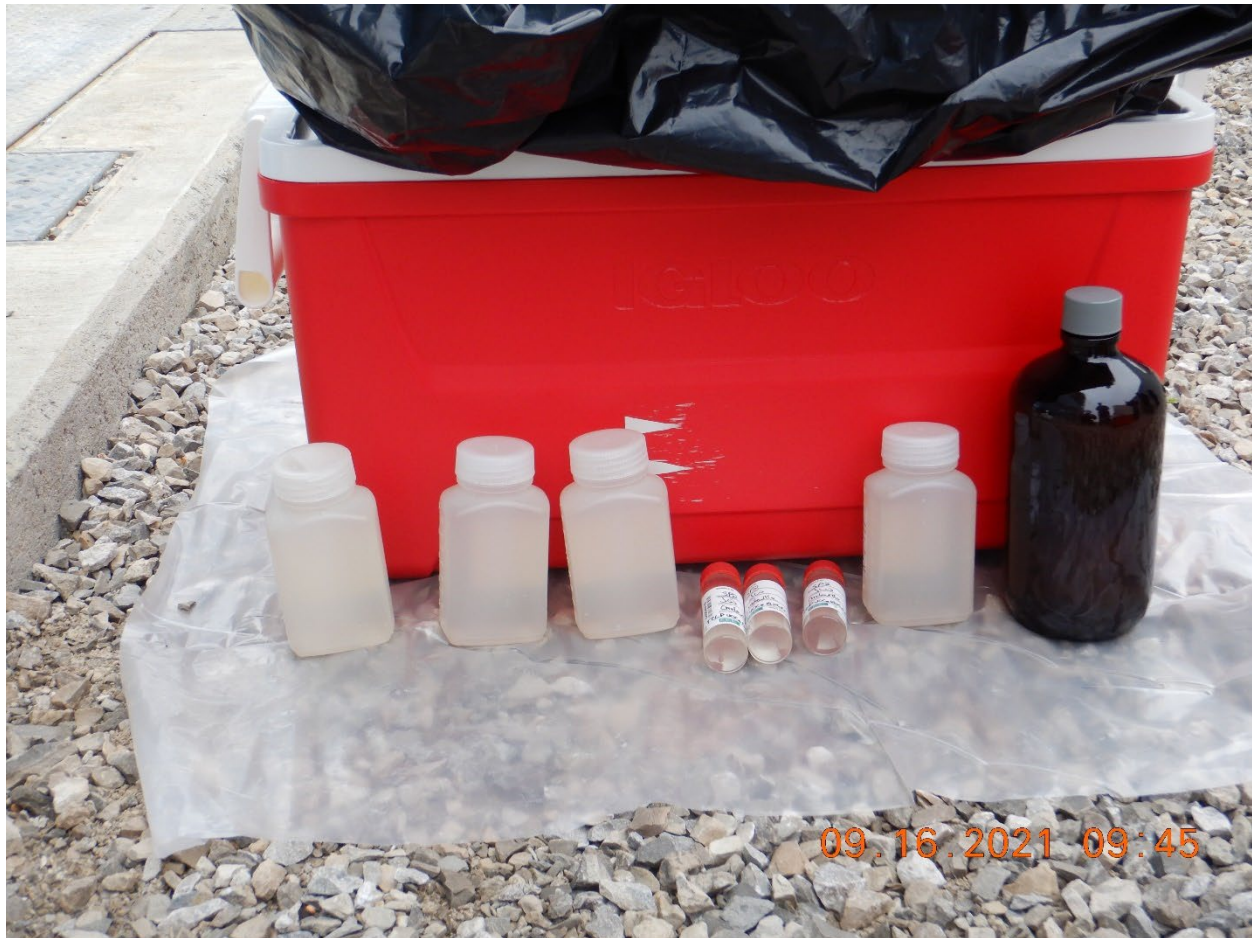
**RCRA Photo 33.** A view the grab sample (SP-2) taken directly from sample tap into sample containers held by sampler. The sample tap was flushed prior to sample being taken. Sample was clear liquid and no visible solids.

Reporting limits may be elevated due to sample dilution, which were required due to elevated levels of target analytes in the samples. SP-2 and SP-3 were taken from the solvent recovery basement tank located in the Vespel process area. The material is then sent through the wastewater treatment plant. Specifically, the basement tank material is sent to the facility's SBR's which are eventually sent to the facility's discharge lagoons. The EPA enforceable regulatory level for pyridine, a D038 characteristic hazardous waste, is 5.0 mg/L. SP-2 was reported with 550 mg/L. SP-3, the duplicate sample of SP-2 was reported with a 530 mg/L.

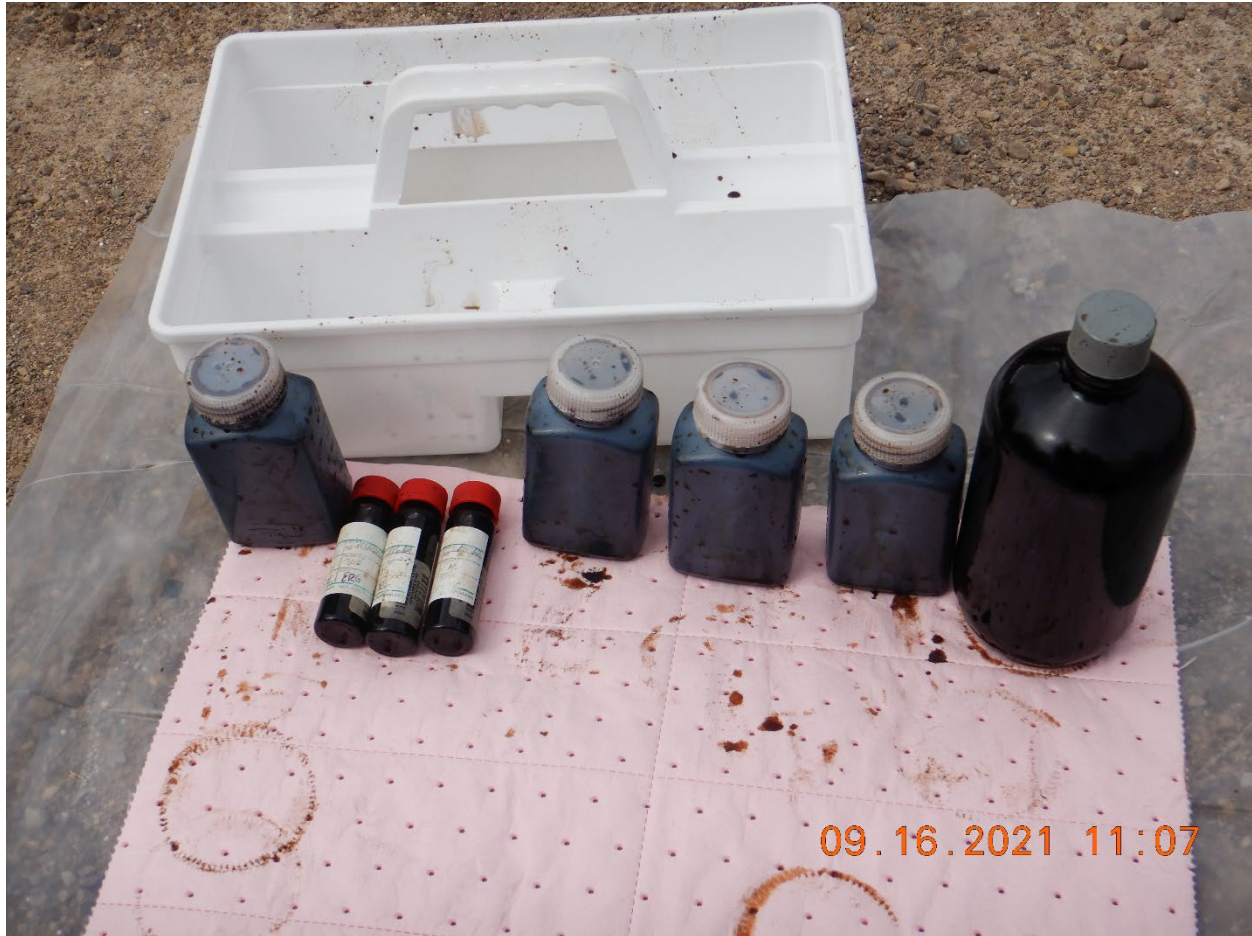
**RCRA Photo 39.** A view of grab sample (SP-5) taken directly from tanker trailer LT-1625 using a colliwasa to allow for a representative columnar sample of all material the tank. Sample was black liquid with visible flakey pea-sized solids.

SP-5 was diluted due to foaming at the time of purging during the original analysis for both Method 8260C and Method 8270D. Elevated reporting limits were provided for Method 82060C. For Method 8270D, surrogate recoveries were below the calibration range and were not reported, but elevated reporting limits were provided. No additional analytical or quality issues were noted for the SVOC and VOC analyses.
