**UNITED STATES ENVIRONMENTAL PROTECTION AGENCY**  
**OFFICE OF ENFORCEMENT AND COMPLIANCE ASSURANCE**

**SUBJECT:** CLEAN AIR ACT INSPECTION REPORT  
River Birch Landfill & Jefferson Parish Landfill, Avondale, LA<sup>1</sup>

**Purpose of Inspection:** Surface monitoring and partial compliance evaluation for the Clean Air Act

**Facility Type:** Municipal solid waste (MSW) landfills and associated renewable gas plant

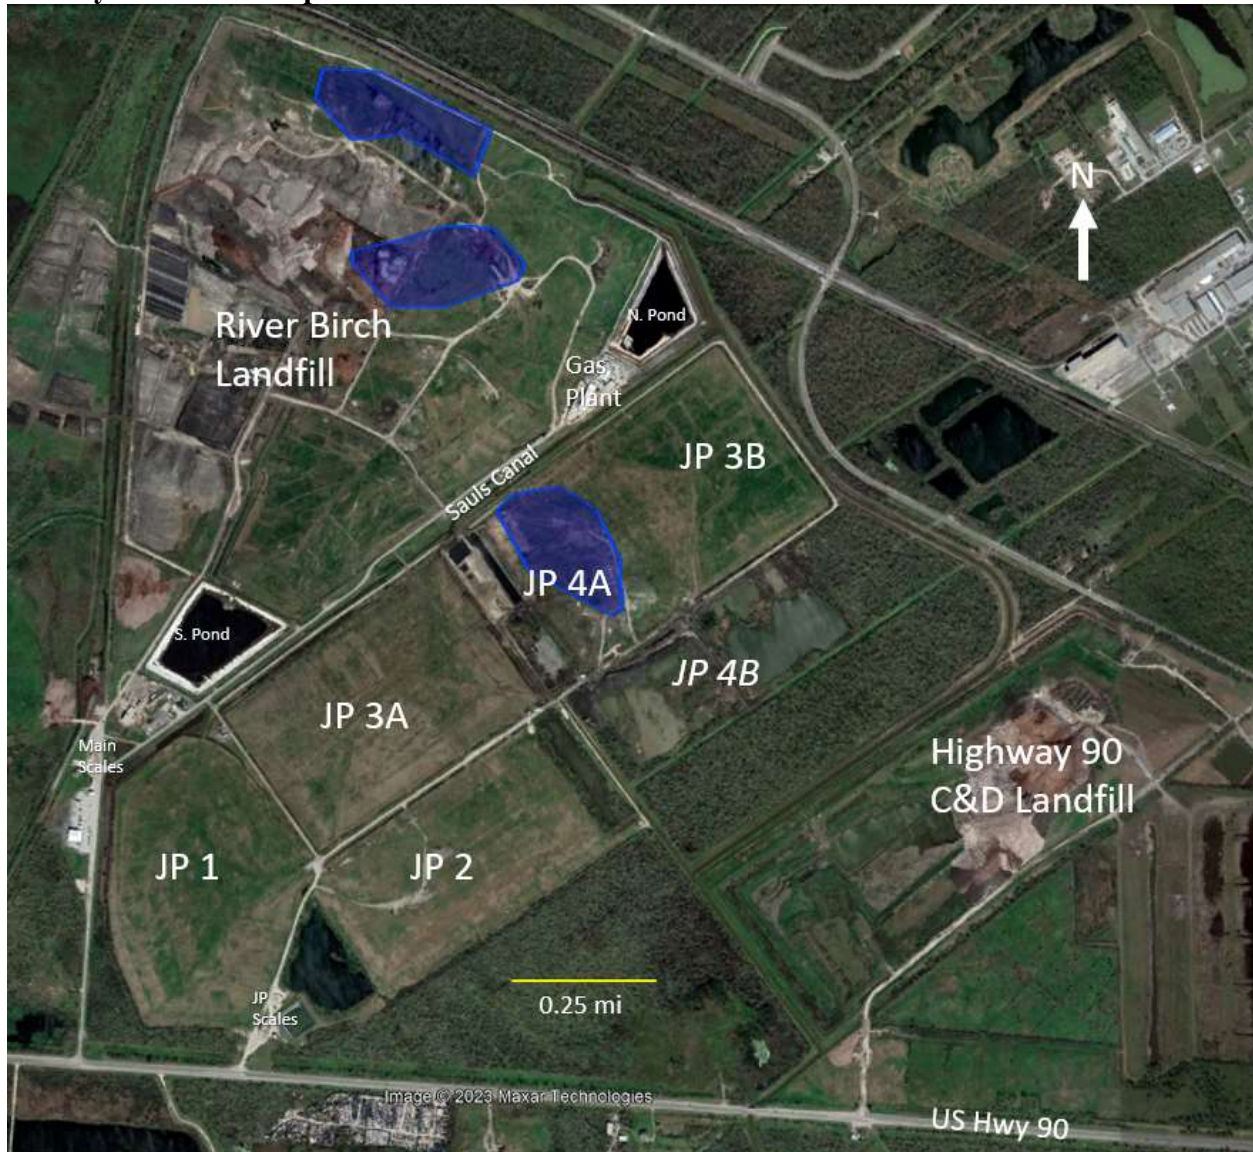
### Facility Overview Map

Blue highlights approximate areas of EPA SEM survey.

JP 1 – 4B label the respective phases of the Jefferson Parish Landfill. Note: At the time of the inspection Phase 4B had not begun accepting waste and Phase 4A was the primary working face for the joint operations, with trucks going through the River Birch main scales.

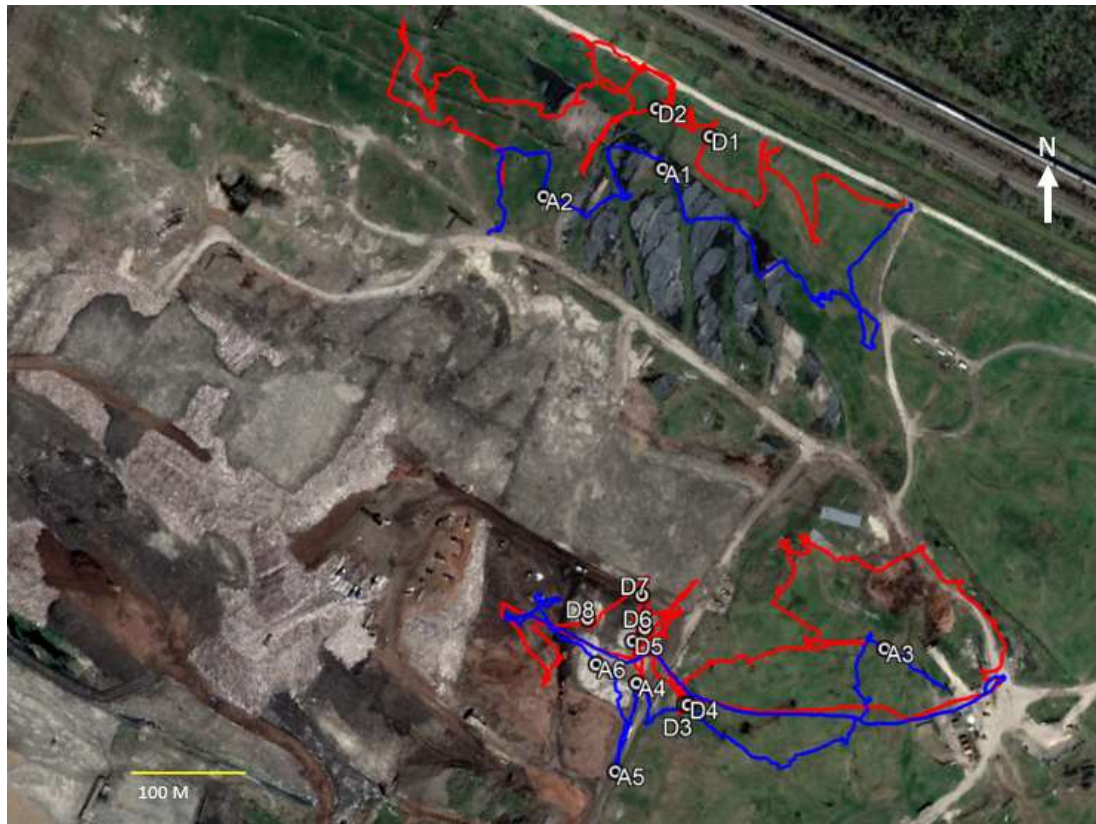
### RB Landfill SEM 6/13

On June 13, 2023, EPA monitored an area of approximately 14 acres on the northern end RB Landfill from approximately 10:15 to 11:15. This area had some synthetic liner in place as part of the cover. During the monitoring, River Birch personnel stated that they believed EPA was monitoring in an area outside of applicability of collection/monitoring requirements due to the age of the waste. The area monitored that morning was covered during the 2022 Quarter 4 SEM survey and was confirmed by River Birch after lunch to be part of the subject area. EPA inspectors found four exceedances in this area, at an active well, an abandoned well, in an area of

After breaking for lunch, monitoring resumed from approximately 13:30 to 15:15, covering an area of approximately 19 acres on the north-central portion of the RB Landfill. As EPA began monitoring in areas with un-vegetated cover and exceedances were found more frequently, River Birch staff again stated that they believed EPA was monitoring in an area outside of the collection/monitoring requirements. EPA continued to monitor, emphasizing that GPS was showing the monitoring to be in areas that prior discussion of the site and historic satellite imagery had shown to have accepted waste more than 5 years prior and had been covered in facility quarterly SEM surveys. River Birch later confirmed that this area was in fact subject to collection/monitoring requirements. EPA detected 10 exceedances in this area, primarily at penetrations but also around exposed waste. EPA noted an area of unkempt vegetation in this area of the landfill, including a tree with a well-developed trunk. EPA observed some exposed waste, including a tire poking through the cover.

Both: Imagery Date: 3/11/22, as depicted on Google Earth. Blue and red lines show approximate paths of each EPA survey team.

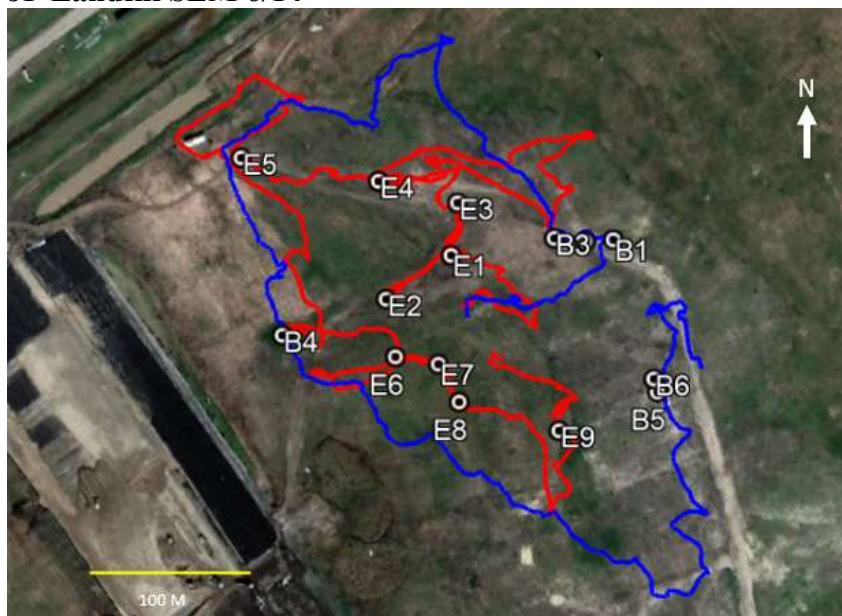
### JP Landfill SEM 6/14

On June 14, 2023, EPA monitored approximately 17 acres of the JP Landfill in Phase 4A from approximately 10:00 to 12:00. EPA detected 15 exceedances, at a mixture of penetrations, exposed waste, and areas of open soil. EPA documented various locations with exposed waste, including pieces of foam and a tire poking through the cover.
