# RCRA Compliance Evaluation Inspection Report

St. Marks Powder, Inc.  
7121 Coastal Highway  
Crawfordville, Florida 32355  
EPA ID Number: FLD047096524

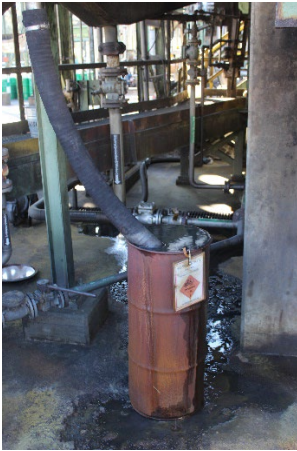
In this area, SMP operates two shakers (de-sanding tables) that generate a propellant contaminated sand. De-sanding is conducted in a bermed area with sloped floors and drains leading to the on-site wastewater treatment plant. The inspectors observed two 30-gallon containers that were in use to accumulate the contaminated sand (Photograph #1). The powder from this operation is continuously accumulated in the containers which are then re-worked back into the process at the lacquer mixing tanks. The 30-gallon containers are managed as “Hazardous Waste” while being stored prior to being reused.

Photograph #1 – De-sanding hazardous waste container in the Wet Line production area.

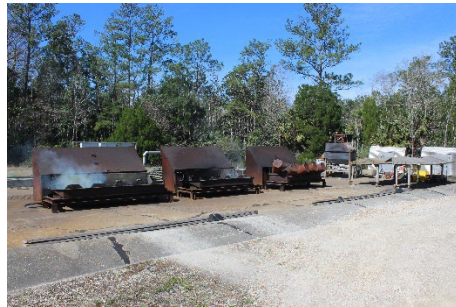
The OBU (SWMU 26) is located southeast of the production areas (Photograph #2). The hazardous wastes SMP is permitted to treat in the OBU and operation requirements are described in Part II of the current operating permit. Propellant, lacquer/nitroglycerin-contaminated paper products, and ball powder are the common materials combusted in the OBU via the permit. The OBU is a concrete circular pad approximately 200 feet in diameter encircled by a moat which contains tidally influenced surface water. There are three steel pans on the pad connected to a propane delivery piping system, which facilitates start-up of burn events. There is also a “popping kettle” on the pad. Reactive waste (D003) generated on-site in the manufacturing process is collected in 30-gallon drums and transported to the OBU where the drums are placed in the burn pans for treatment. Waste explosive devices are placed in the “popping kettles” for treatment by ignition. At the time of the inspection, three steel pans were in operation with one containing drums (Photograph #2). The facility stated that drums are burned to ensure no residues left in the drums and are reused until no longer viable. Unviable and damaged drums are recycled. There was no waste staged at the OBU pad.

Photograph #2 – Open Burn Unit in operation.

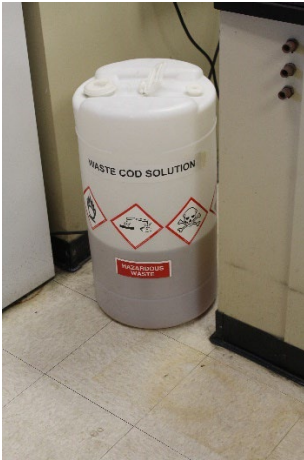
The Pilot Plant houses both the raw materials lab and the environmental Quality Assurance/Quality Control (QA/QC) Lab. In the Environmental Lab, the inspectors observed one 12.5-gallon plastic container for mercury containing “COD” (chemical oxygen demand) testing residues (Photograph #3). The container appeared to be in good condition and was closed, marked “Hazardous Waste” and had hazard indications.

Photograph #3: Satellite accumulation area container for COD testing residues generated in the Environmental Lab.

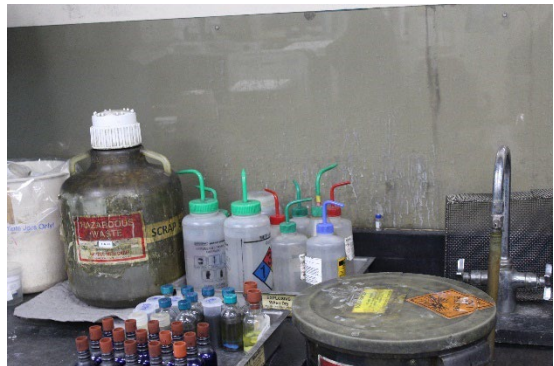
stream is accumulated in a plastic container. From the accumulation container, the waste is passed through a muslin cloth filter to separate the powder from the methanol. The filtrate (spent methanol) is collected in a 20-liter plastic container and the spent filter is accumulated in a metal container (Photograph #4). SMP manages the accumulation containers as a 90-day hazardous waste accumulation area. All containers were closed, marked "Hazardous Waste," dated, and appeared to be in good condition.

Photograph #4: Spent methanol 90-day accumulation area in the chemical's analysis section of the Instrument QA/QC Lab.

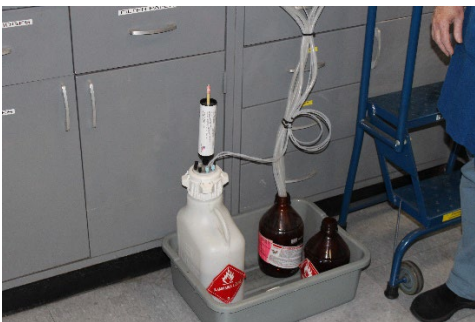
The Instrument Lab also generates a spent solvent from the liquid chromatography (LC) and from the infrared spectrometer. SPM accumulates the spent solvent in one-gallon containers. During the inspection, the inspectors observed three 1-gallon containers that contained spent solvent from two liquid chromatography units and from one infrared spectrometer unit. Each unit had one container attached through soft tubing with a specialized lid to allow the container to be closed while remaining attached to the unit. All containers were marked "Hazardous Waste", with a hazard indication, and appeared to be in good condition. One unit had an additional glass container with soft tubing directly into the opening of the container. The glass container was open at the time of inspection (Photograph #5).

Photograph #5 – Open spent solvent in 1-gallon container – Instrument Lab LC1.

**Pursuant to Fla. Admin. Code Ann. r. 62-730.160(1) [40 C.F.R. § 262.15(a)(4)(i)], which is a condition of the SAA Permit Exemption, a generator is required to keep a container holding hazardous waste be closed at all times during accumulation except when adding, removing, or consolidating waste.** On March 2, 2022, SMP provided a photograph of the glass container showing the tubes conveying solvent waste into the container is secured and closed with a specialized cap/lid. The two chromatography units have the same SAA container set-up each with a closed container with a specialized lid to secure tubing.

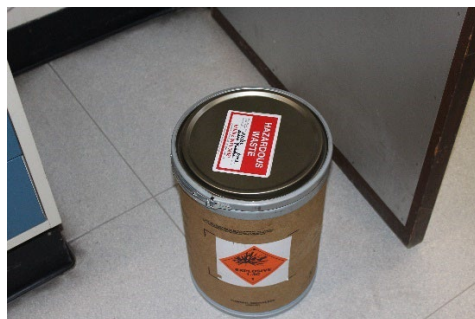
In Building 13-1, the inspectors visited the Chem Lab and the Ballistics Lab. In the Ballistic Lab, the inspectors observed one 2-gallon container of scrap powder. The container was closed, marked "Hazardous Waste," "Explosive", and appeared to be in good condition (Photograph #6). In the Ballistics Lab, the inspectors observed a 90-day accumulation area for "Explosive Scrap Pad" powder in containers. There were three empty containers with labels readily available.

Photograph #6 – 2-gallon container of scrap powder stored in the medium caliber Ballistic Lab.
