## **RCRA Inspection Report**

Axon Circuits, Inc.  
424 S. Ware Blvd  
Tampa, FL 33619

EPA ID#: FLD984174706  
NAICS #: 334412 – Bare Printed Circuit Board  
Manufacturing

March 14, 2024, at 8:33 A.M.

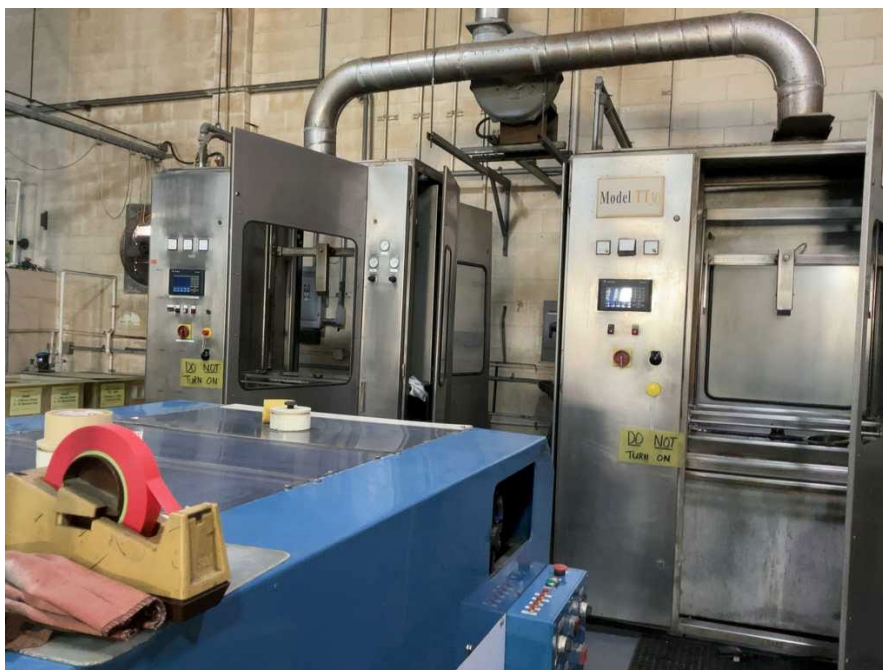
| Photo 1 | IMG-2024031410334633462492451.jpg |

The panels will then be processed through a hot air leveler, nickel-gold plating, or silver plating. This depends on a customer's specification. In the hot air leveler process, panels are dipped into tin and lead solder and introduced to hot air jets to remove excess solder. Next to the hot air leveler is a satellite accumulation area (SAA) for waste flux contaminated with lead, generated from the hot air leveler (Photo 1). The inspectors observed one 55-gallon container D008 waste flux. The container was closed and labeled "Hazardous Waste—Liquid Lead (D008)". The container did not have an indication of the hazard of the contents.

| Hot Air Leveler | 27.94456126, -82.34672959 |

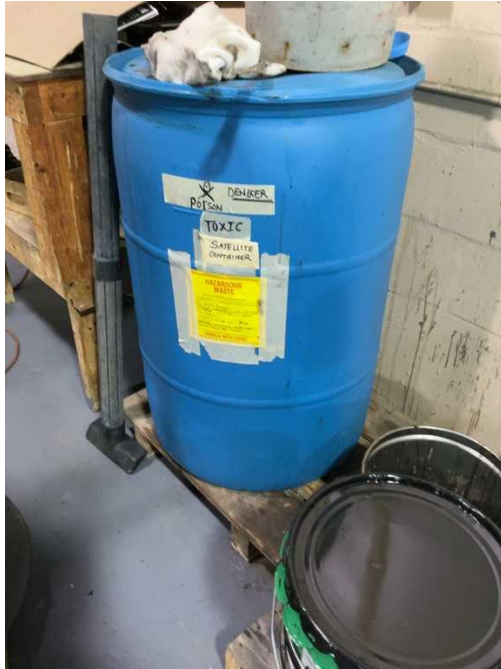
| Photo 2 | IMG-2024031410424942492126238.jpg |

**Pursuant to Fla. Admin. Code Ann. r. 62-730.160(1) [40 C.F.R. § 262.15(a)(5)(ii)], a generator must mark or label its container with the following: (ii) An indication of the hazards of the contents (examples include, but are not limited to, the applicable hazardous waste characteristic(s) (i.e., ignitable, corrosive, reactive, toxic); hazard communication consistent with the Department of Transportation requirements at 49 CFR part 172 subpart E (labeling)**

| 55-gallon container D008 waste flux. | |

This was corrected during the inspection and facility representatives placed a “Toxic” label on the container (Photo 2).

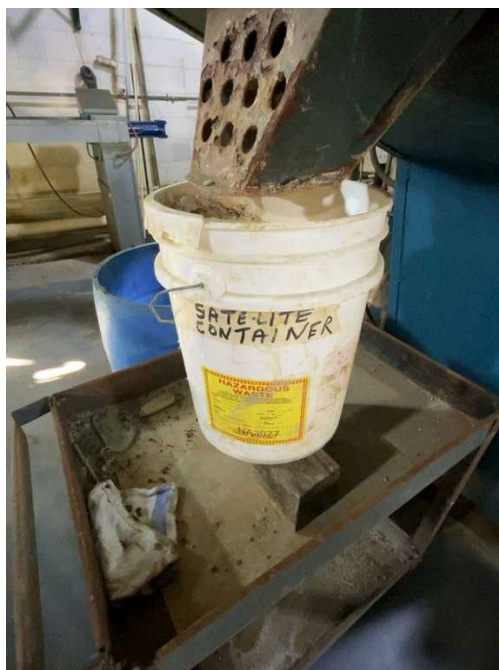
| Photo 3 | IMG-2024031410555555551369151.jpg |

A filter press is used to produce hazardous waste filter cake. The inspectors observed a 5-gallon SAA container of F006 filter cake (Photo 3). The container was in-use actively accumulating filter cake, labeled “Hazardous Waste—Filter Cake”, but missing an indication of the hazard of the contents.

**Pursuant to Fla. Admin. Code Ann. r. 62-730.160(1) [40 C.F.R. § 262.15(a)(5)(ii)], a generator must mark or label its container with the following: (ii) An indication of the hazards of the contents (examples include, but are not limited to, the applicable hazardous waste characteristic(s) (i.e., ignitable, corrosive, reactive, toxic); hazard communication consistent with the Department of Transportation requirements at 49 CFR part 172 subpart E (labeling) or subpart F (placarding); a hazard statement or pictogram consistent with the Occupational**

| 5-gallon SAA container of F006 filter cake. | |

The facility representatives corrected this onsite by placing a toxic label on the container.

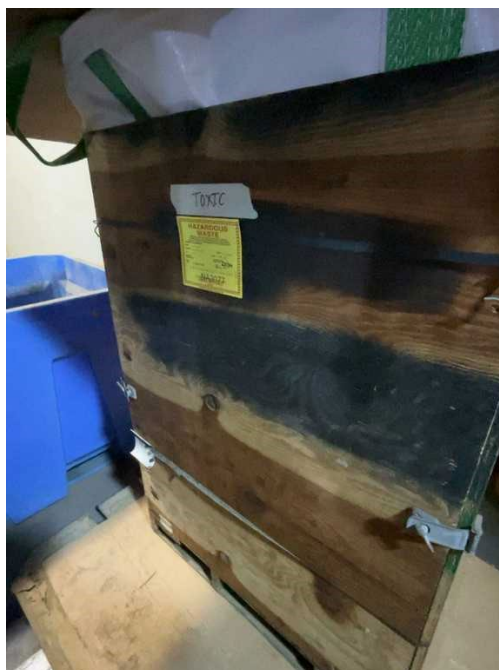
| Photo 4 | IMG-202403141101391391281213.jpg |

The inspectors observed one cubic yard sack of hazardous waste filter cake. The closed cubic yard sack is contained inside of a wooden container. The cubic yard sack was labeled with the words "Hazardous Waste—Filter Cake (F006)", and indication of the hazard of the contents, and dated 02/08/2024. The hazardous waste label on the cubic yard sack could not be viewed easily since it is covered by the wooden container. The inspectors requested that a hazardous waste label be placed on the wooden container itself also, in order to identify the hazardous waste contained inside the cubic yard sack (Photo 4).

| Cubic yard sack of hazardous waste filter cake. | |
